# Arboricultural Impact Assessment

Kemple Side  
Clitheroe Road  
Knowle Green  
Preston  
PR3 2YS

The post development survey for the creation of a garage

Andrew McLoughlin  
**Treestyle Consultancy Ltd**  
info@treestyleconsultancy.co.uk

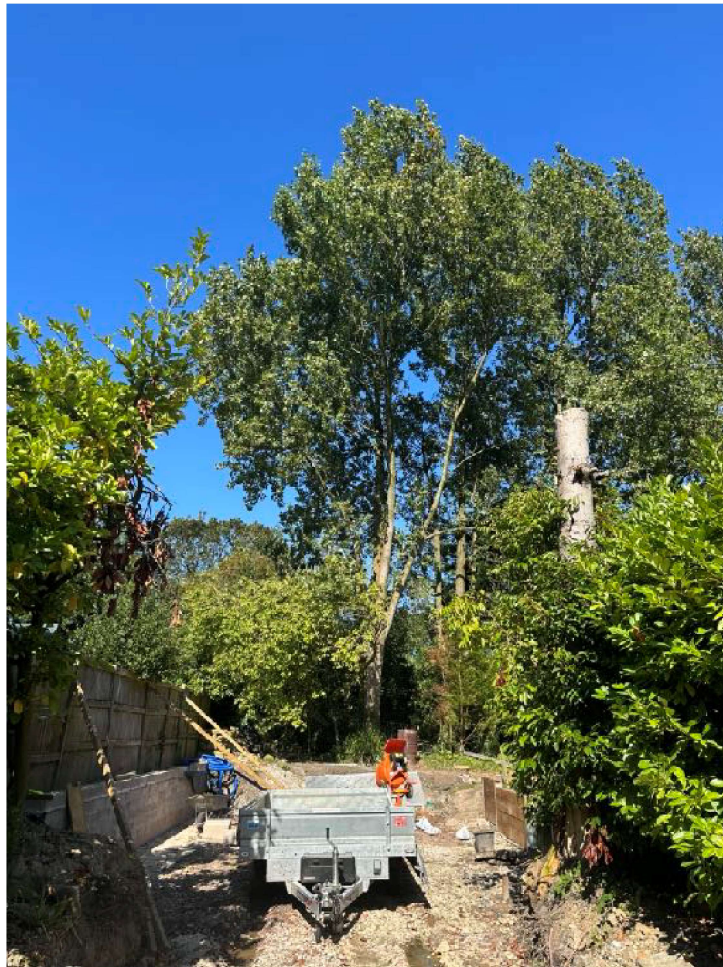
Overlooking the proposed development with the row of low quality trees in the foreground

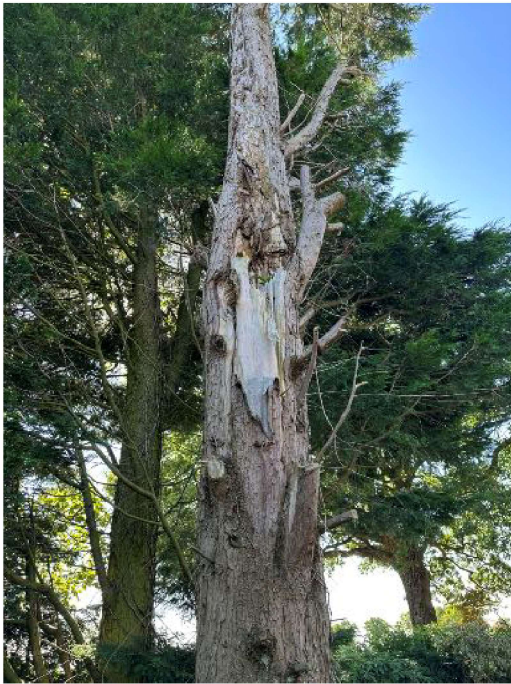
- T15 Conifer has already experienced failure of three limbs due to the aforementioned issue and is now full of decay with entire tree failure a likelihood.

Cavities on T15 conifer

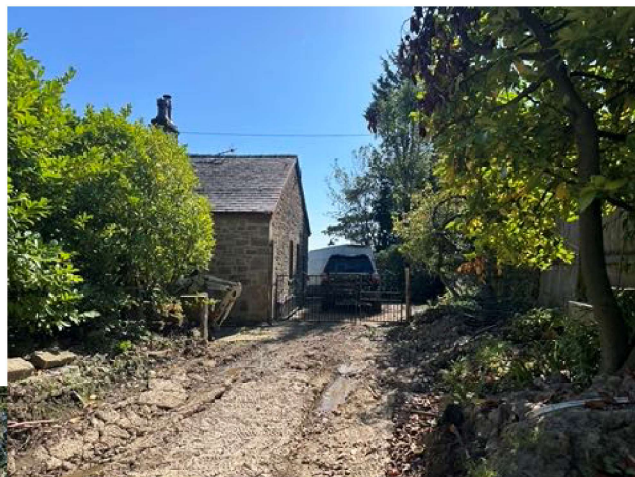
Right is looking south within the rear garden area where the existing surface is to be excavated where tree roots are located and have been excavated.

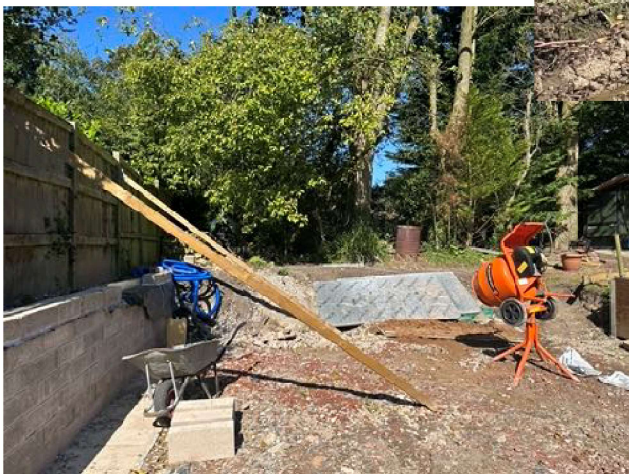
5.2.1 The development of the garage falls within the RPAs of T2 & T3 hybrid black poplar (*Populus x canadensis*).

Simply looking north at the row of poplars where the garage has encroach onto their RPA's which now needs protecting
