# Preliminary Roost Assessment

41-43 Wellgate

Clitheroe

# Gritstone Ecology

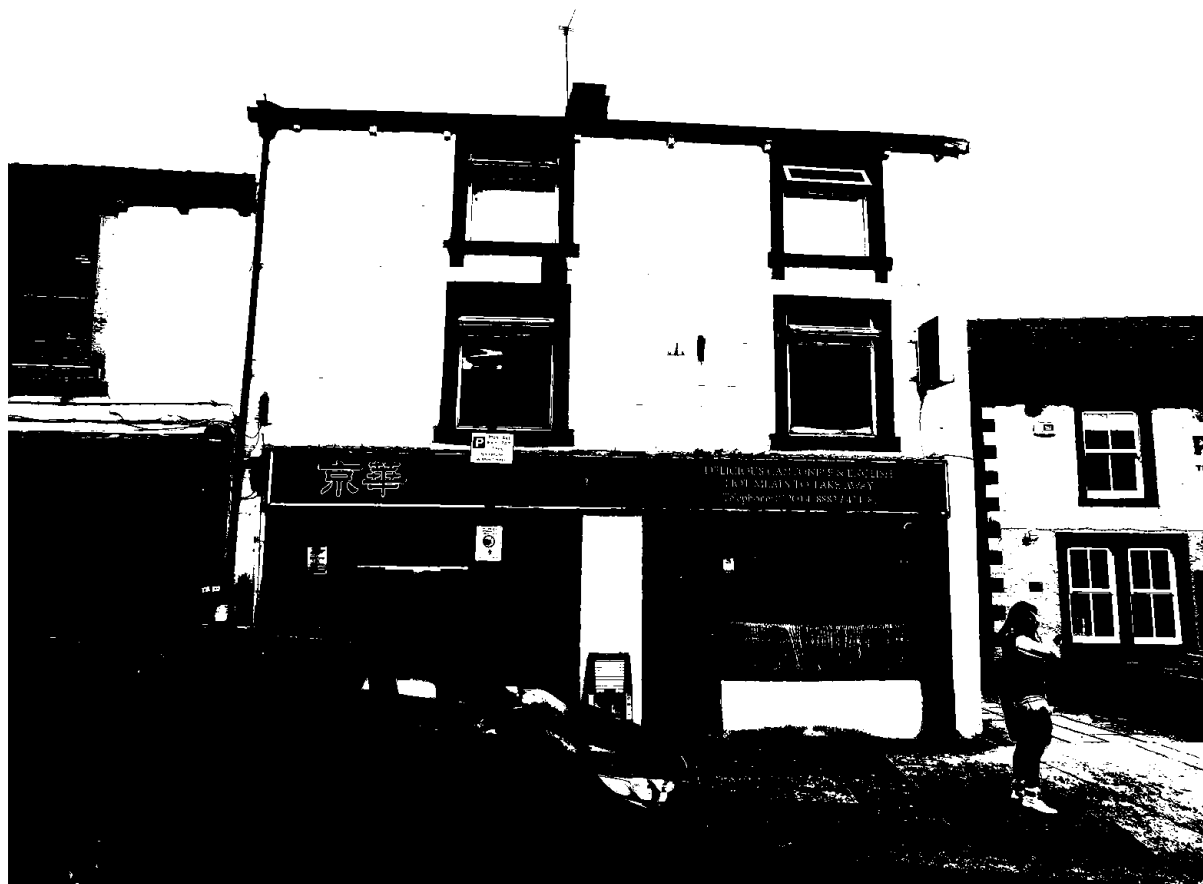
3.1a – The front of the building.

The building is well maintained, and in reasonable condition. Ridge tiles are fixed tightly, there are no damaged or missing ridge tiles. There are no damaged, slipped, or missing roof tiles. Roof tiles are tightly fitted, with no gaps between tiles. Cement at the gable end verges is intact with no viable gaps.

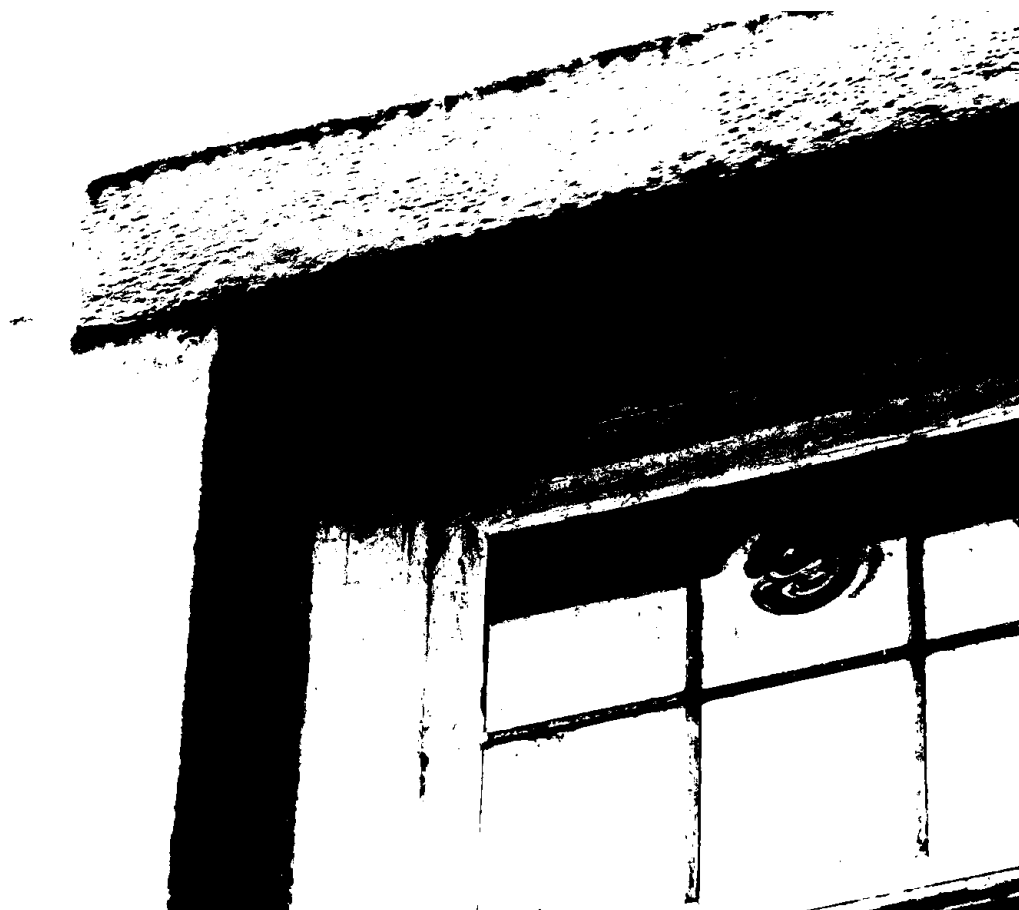
Window and door frames are fixed into the brickwork, gaps are filled with sealant, and offer no suitable roosting opportunities. Timber fascia boards at the eaves to the rear are fixed tightly against walls, with no suitable gaps.

7 – Window and door frames are tightly sealed into walls with no suitable gaps.
