**Project Information**Project Name
WINDY STREET

Project Date
10/06/2024**Site**

Company: Prospus Group
Contact: Derek Mitchell
Street: 5, 7, 9 Windy Street
Town or City: Chipping
County: Preston
Post Code: PR3 2GD

Company: A1 All Clear Ltd
Contact: James Turner
Street: 35a Banastre Road
Town or City: Southport
County: Merseyside
Post Code: PR8 5AL
Email:

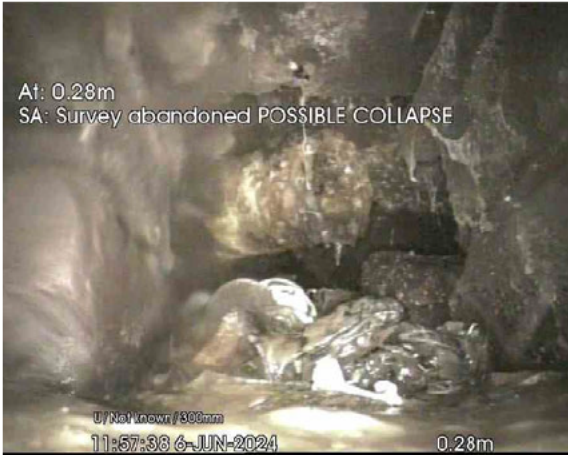
| Section | PLR | Description |
|---|---|---|
| 2 | UNKNOWNX | Survey abandoned |

| Scale: | 1:50 | Position [m] | Code | Observation | Grade |
|---|---|---|---|--|---|
| | | | SA | Survey abandoned: POSSIBLE COLLAPSE CULVERT | |

LAS MH1 UPSTREAM_0-28m_115738.jpg, 00:00:47, 0.28 m
Survey abandoned, POSSIBLE COLLAPSE CULVERT

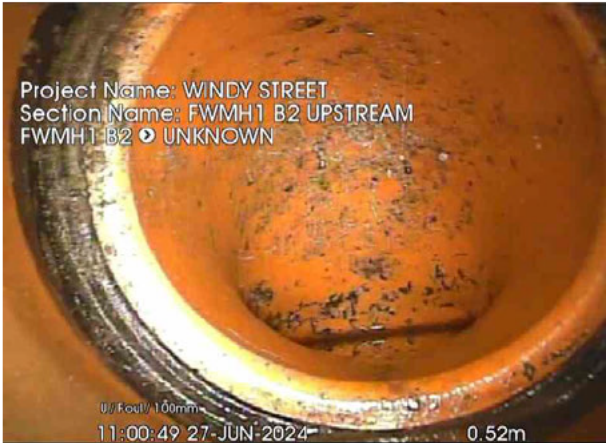
FWGX_a51170b8-ac1c-4053-b36b-cf994d9bccd2_20240701_111649_209.jpg, 00:00:04, 0.52 m
Open joint, large

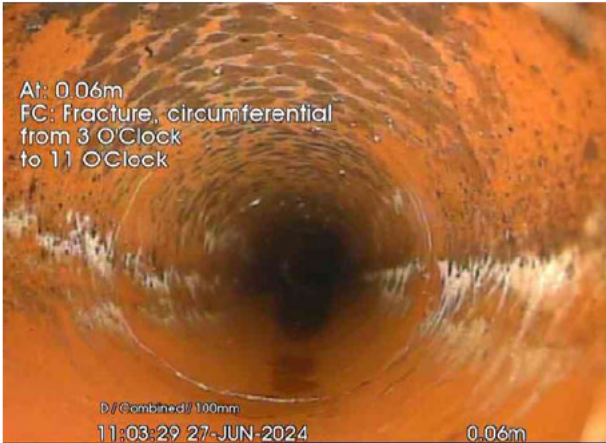
FW1X_ed7e6085-19fb-460f-af5f-e50bd2e6132c_20240701_11937_569.jpg, 00:00:06, 0.06 m
Fracture, circumferential from 12 o'clock to 12 o'clock

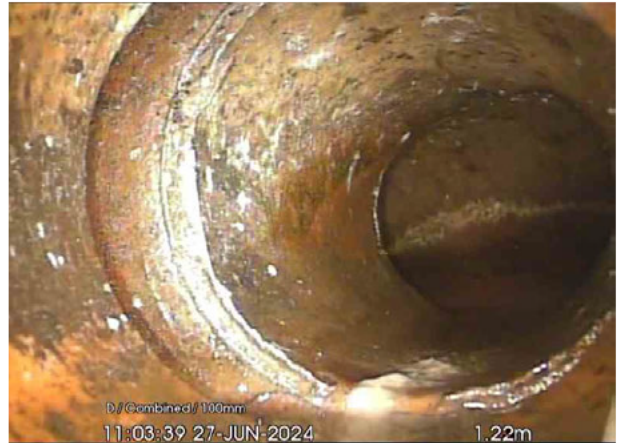
| Section | PLR | Grade | Description |
|---|---|---|--|
| 6 | FWMH1X | 4 | Joint displaced, large |

FW1X_ec44b91d-e102-47e8-9e84-b4a8b3c1812b_20240701_112000_699.jpg, 00:00:16, 1.22 m
Joint displaced, large

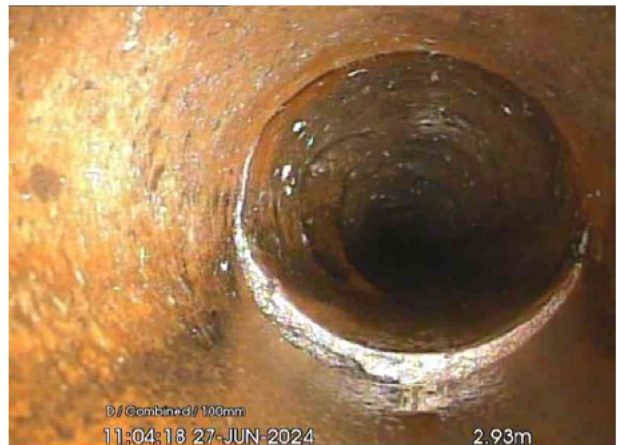
FW1X_aa08e7da-3798-4b9c-ad8d-91663a9c2861_20240701_112055_994.jpg, 00:00:38, 2.90 m
Joint displaced, medium

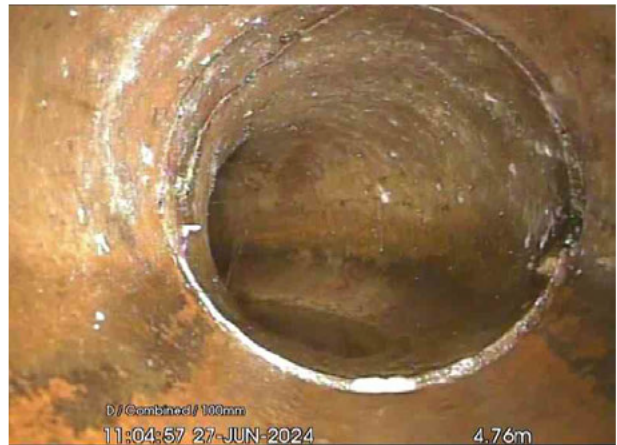
FW1X_c771fd82-17fb-45cb-a40e-eb2a5892b47d_20240701_112208_339.jpg, 00:01:02, 4.76 m
Fracture, circumferential at joint from 9 o'clock to 12 o'clock

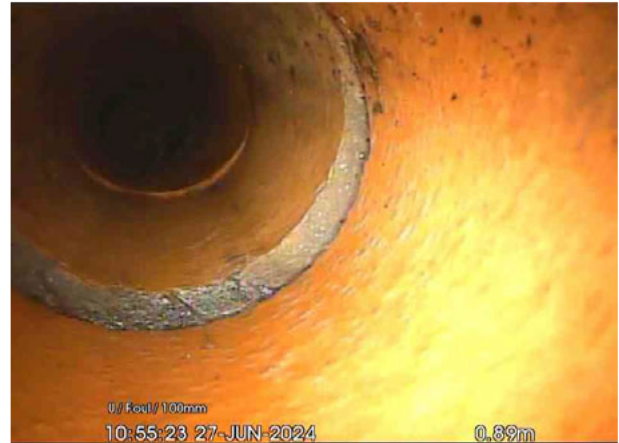
| Section | PLR | Grade | Description |
|---|---|---|--|
| 7 | SVP1X | 4 | Joint displaced, large |

SVP1X_c90036b4-9e08-4e23-b7a7-73cc8126e8dd_20240701_112531_593.jpg, 00:00:09, 0.89 m
Joint displaced, large

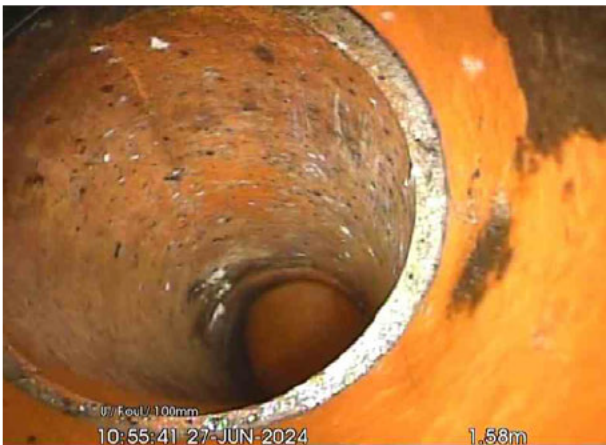
SVP1X_7b0a12f3-0cab-4732-908d-03a4a77b8cf2_20240701_112559_073.jpg, 00:00:21, 1.58 m
Joint displaced, medium

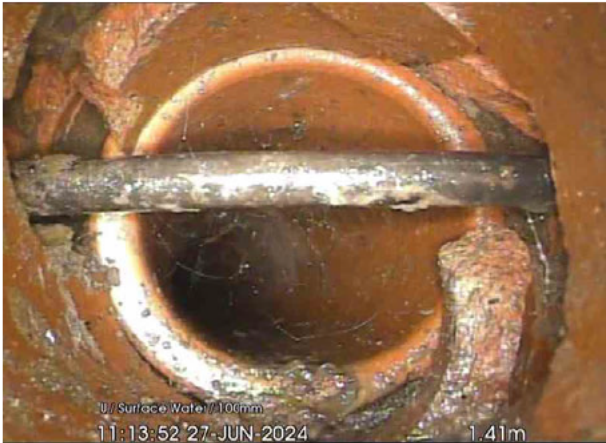
| Section | PLR | Grade | Description |
|---|---|---|--|
| 8 | FWG1X | 5 | Other obstacles, external pipe or cable from 12 o'clock to 12 o'clock, 20% cross-sectional area loss |

FWG1X_13068a09-f90e-40b2-9885-353f1bf6be3d_20240701_112917_688.jpg, 00:00:32, 1.41 m
Other obstacles, external pipe or cable from 12 o'clock to 12

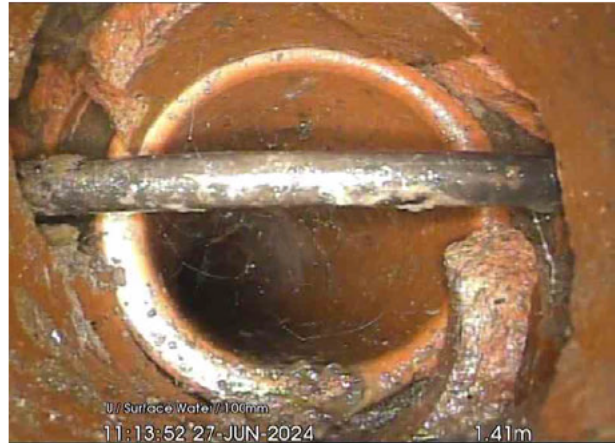
| Section | PLR | Description |
|---|---|---|
| 8 | FWG1X | Survey abandoned |

FWG1X_6a409a7f-89e2-47d4-abb2-d818c7c07e1d_20240701_112946_865.jpg, 00:00:32, 1.41 m
Survey abandoned, Unable to pass intruding pipe

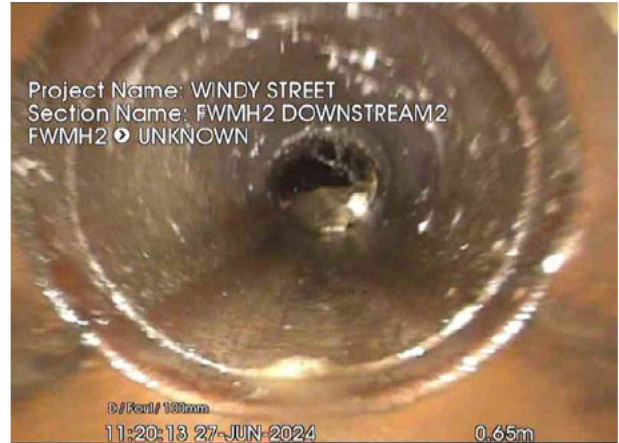
| Section | PLR | Grade | Description |
|---|---|---|--|
| 10 | FWMH2X | 3 | Fracture, circumferential at joint from 12 o'clock to 12 o'clock |

FWMH2X_ff75e588-162b-4416-8182-dc0325489872_20240701_114001_280.jpg, 00:00:04, 0.65 m
Fracture, circumferential at joint from 12 o'clock to 12 o'clock

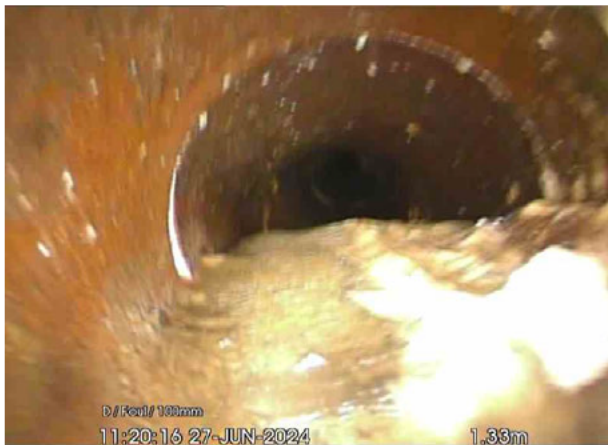
FWMH2X_0a091bb0-7b5e-44bd-9973-3e0f53a431e1_20240701_114023_809.jpg, 00:00:07, 1.33 m
Settled deposits, hard or compacted, 50% cross-sectional area

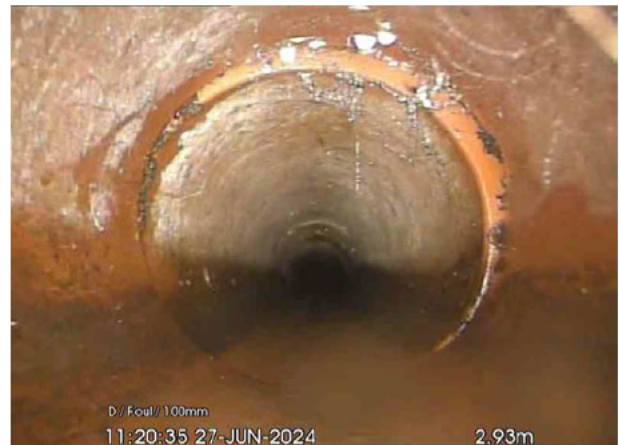
FWMH2X_fd47bc22-ee4e-4841-85af-162f50f26e8e_20240701_114056_121.jpg, 00:00:25, 2.93 m
Joint displaced, medium

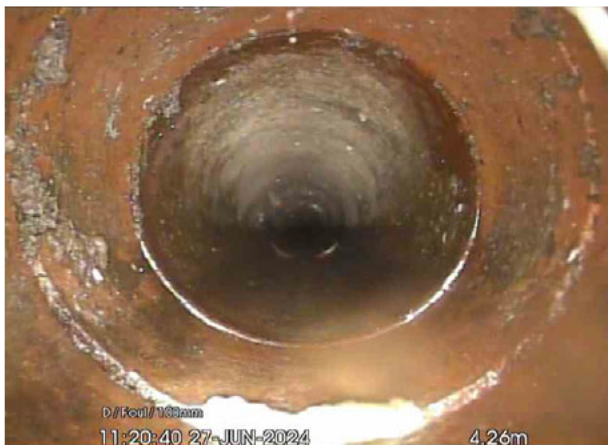
FWMH2X_59358f4b-3add-4a31-b431-0bdc0da22a33_20240701_114120_001.jpg, 00:00:31, 4.26 m
Crack, circumferential at joint from 12 o'clock to 12 o'clock

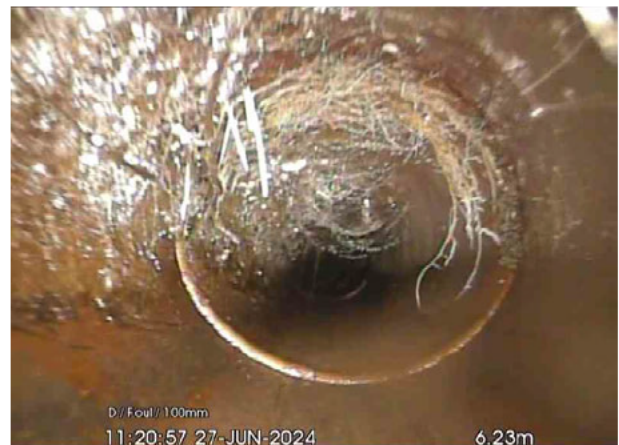
FWMH2X_4740529b-41c2-4d16-a6a0-55832721220a_20240701_114143_169.jpg, 00:00:41, 6.23 m
Roots, fine at joint

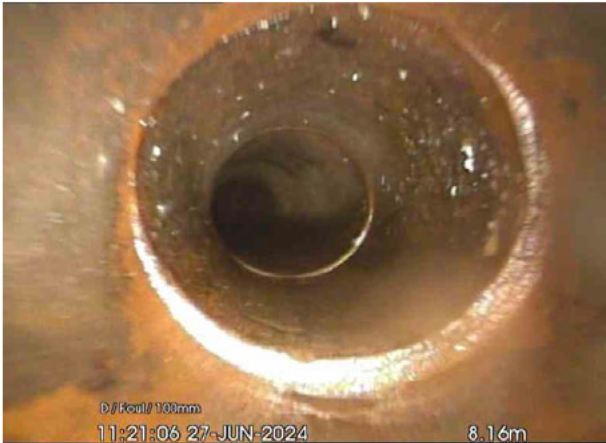
FWMH2X_1f0b3a0f-5a8d-48b4-80d4-6a6671c7ef15_20240701_114204_329.jpg, 00:00:49, 8.16 m
Joint displaced, large
