Barn 1 at Cuckoo Farm, Higher Road, Longridge, PR3 2YX

Structural Condition Survey for Conversion to Dwelling

PSC-872 – B1

April 2024

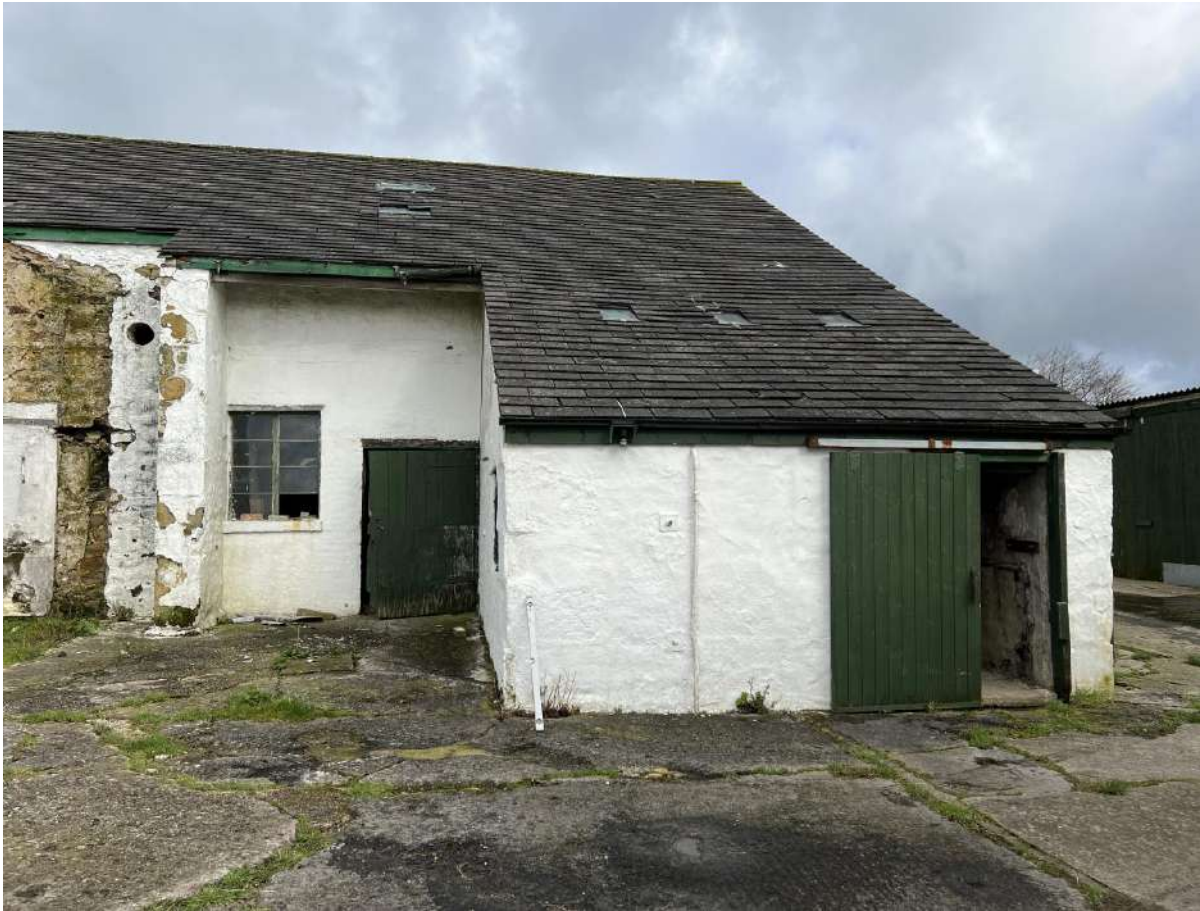
Photo 1 - South Elevation

This elevation is built in random sandstone, which has been painted white, and the wall is 470mm to 500mm thick. There is a single storey outrigger at the east end (photo 1) and there are signs of a former extension adjacent to the house which has been removed (photo 7). All the walls are in reasonable condition. They are plumb, reasonably pointed/painted and there are no signs of previous or ongoing movement. There is some localised damage where the previous building was removed but this is minimal in area (1 to 2 m²). There are three openings at ground floor level, one window and door to the main section of the barn and a large sliding doorway to the outrigger. The recessed area with shelves immediately to the east of the farmhouse (photo 7) is probably a former doorway. The door and window to the main section of the barn is located in a recessed area which is likely to have been a former traditional large barn door. This has been infilled with brickwork as evidenced in photo 46. This elevation has the benefit of guttering and downspouts which are in reasonable condition to the outrigger but in poor condition or missing to the main roof (photo 1).

Viewed externally, the main barn roof appears in reasonable condition with no sign of major damage, slate/tile loss, or deflection. The front (south facing) side of the roof has been recovered with tiles rather than slate. The rear (north facing) side is covered with slate. The internal inspection discussed below indicates that the main barn has been re-covered including felt and the original timber roof trusses have been replaced with lightweight steel trusses at some point.

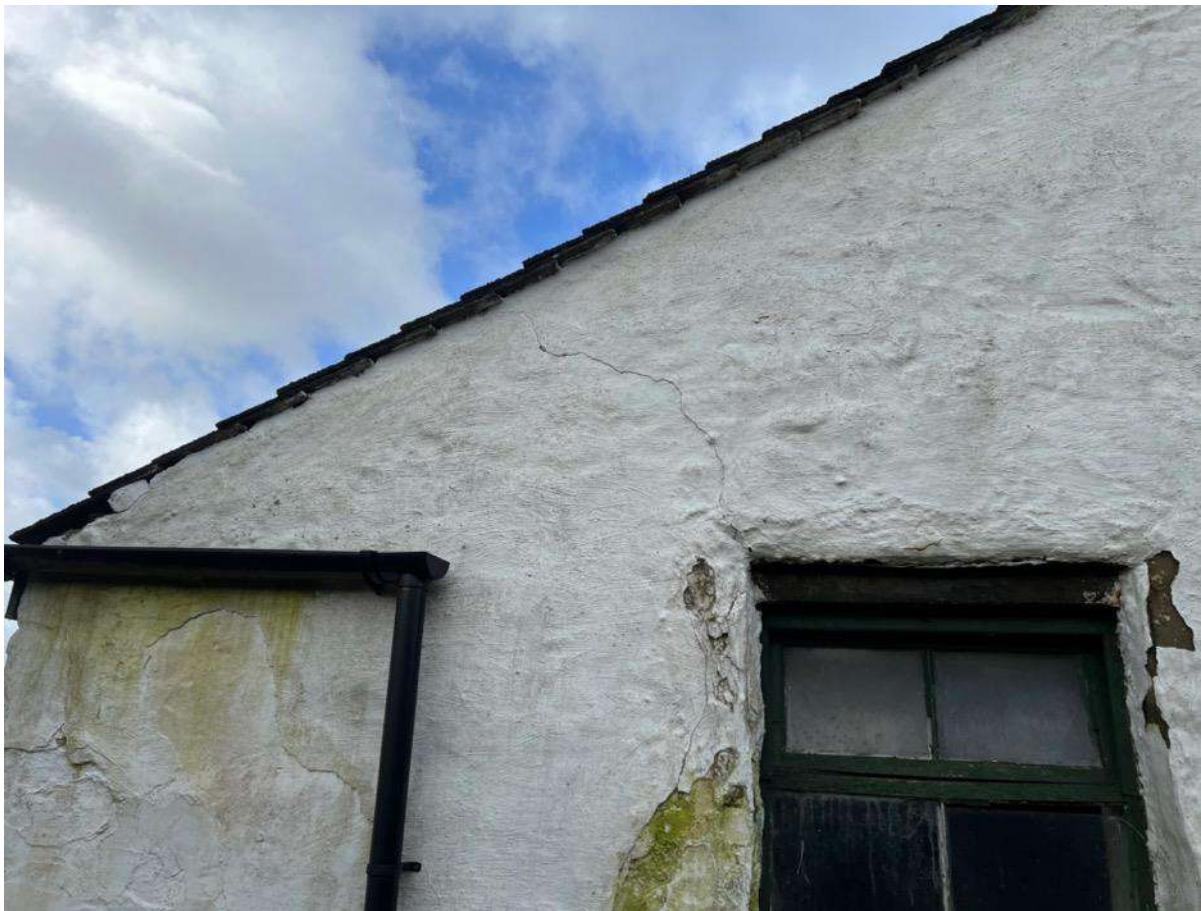
Photo 16 – East Elevation

This gable elevation is built in random sandstone and the wall is 500mm thick. The wall is in reasonable condition. It is reasonably plumb and reasonably pointed/painted. There are no signs of previous or ongoing movement. There are three window openings at ground floor level with a further opening to the loft or feed hopper above (photo 9). This section of the elevation has a short section of guttering and a downspout serving the outrigger roof (photo 16).

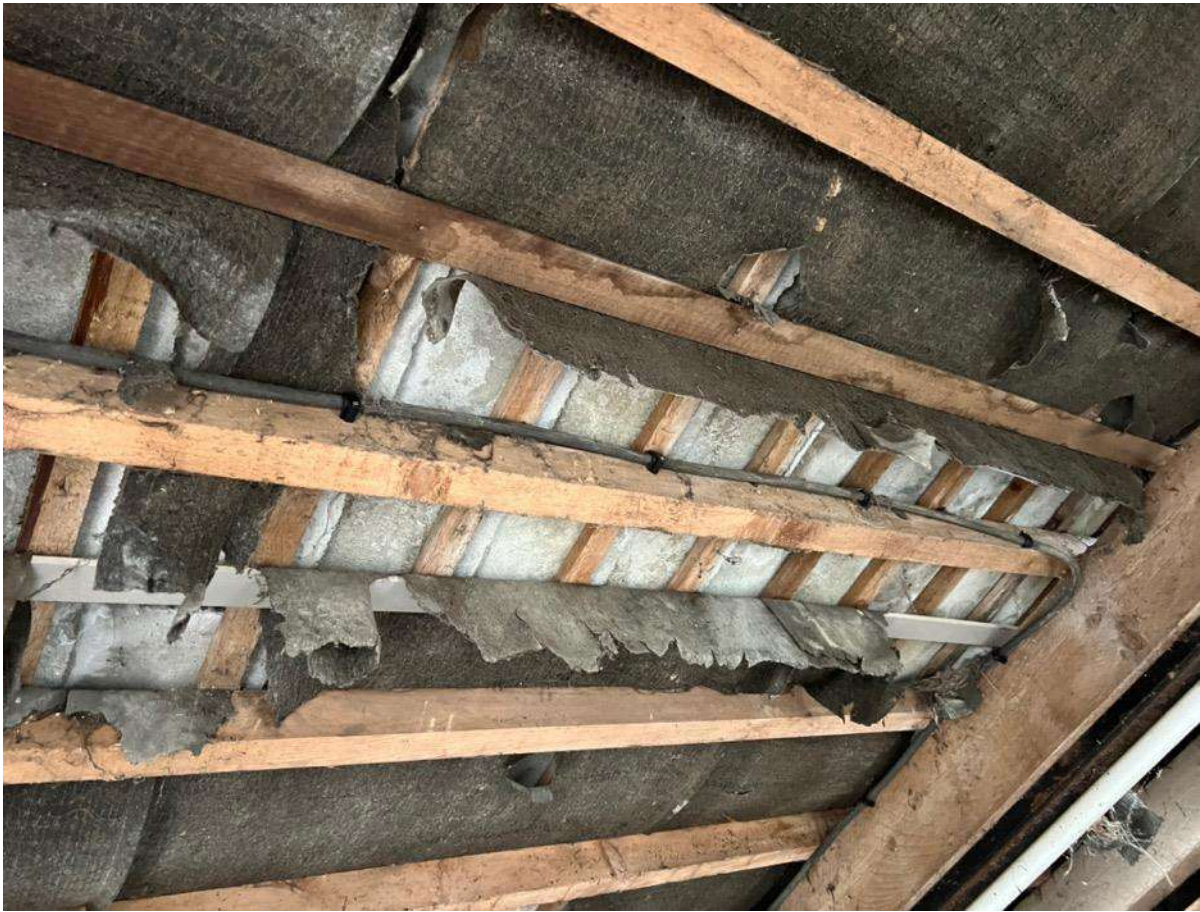
Photo 18 - Internal south outrigger

This building has a solid concrete floor and houses the base of a feed hopper. This area shows no sign of previous or ongoing movement to walls or floors. The roof has timber purlins and rafters which appear to be a replacement structure rather than original (photo 18). The roof has been felted but this is damaged (photo 18). The timber does not exhibit obvious signs of rot or infestation.

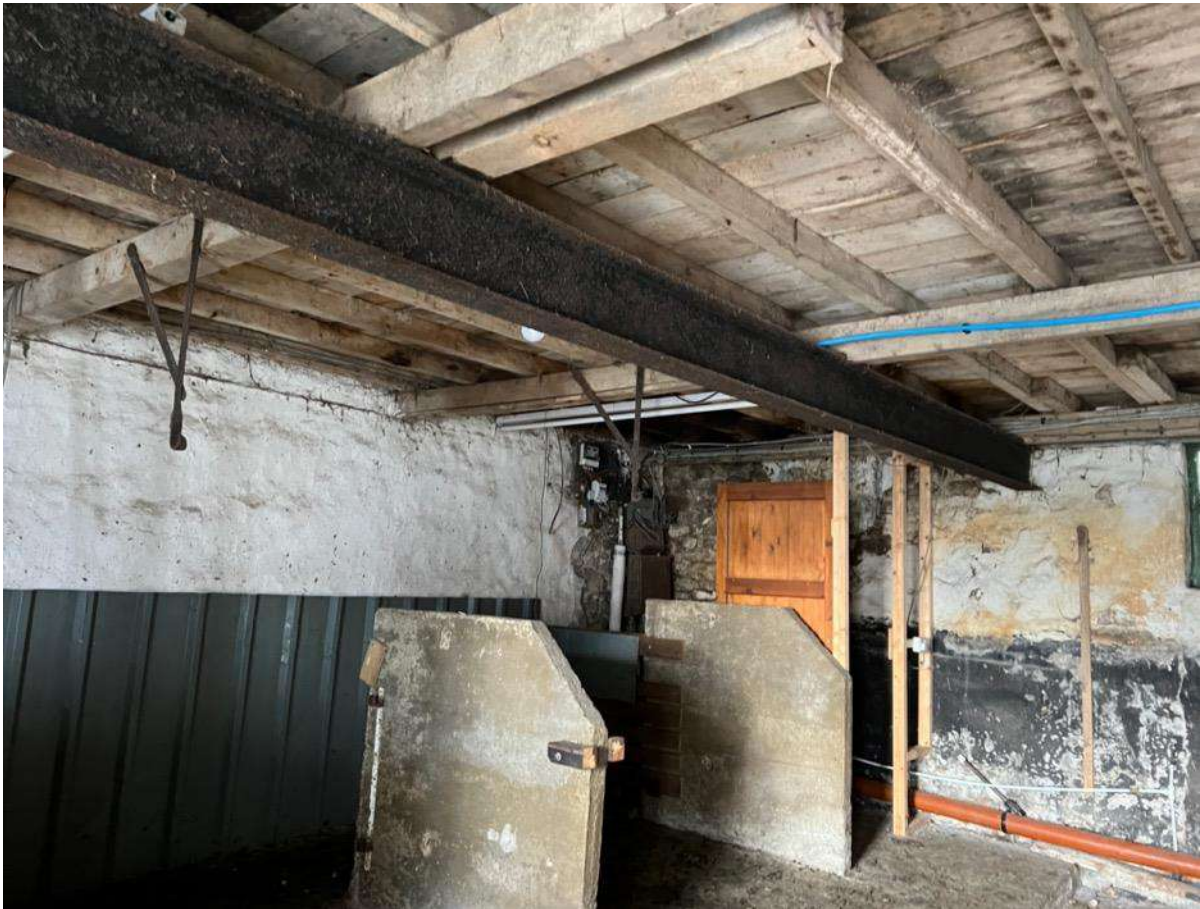
Photo 26 - Internal looking to gable with house and north elevation

Photos 26 and 42 show the west gable which forms the adjoining wall to the farmhouse. This is in good condition and well pointed at the higher levels with render to the ground floor area. Photos 45 and 46 show the area of the former large barn door which has been infilled with brick to form the smaller door and window. The original timber can be seen in photo 45 with the brickwork below.

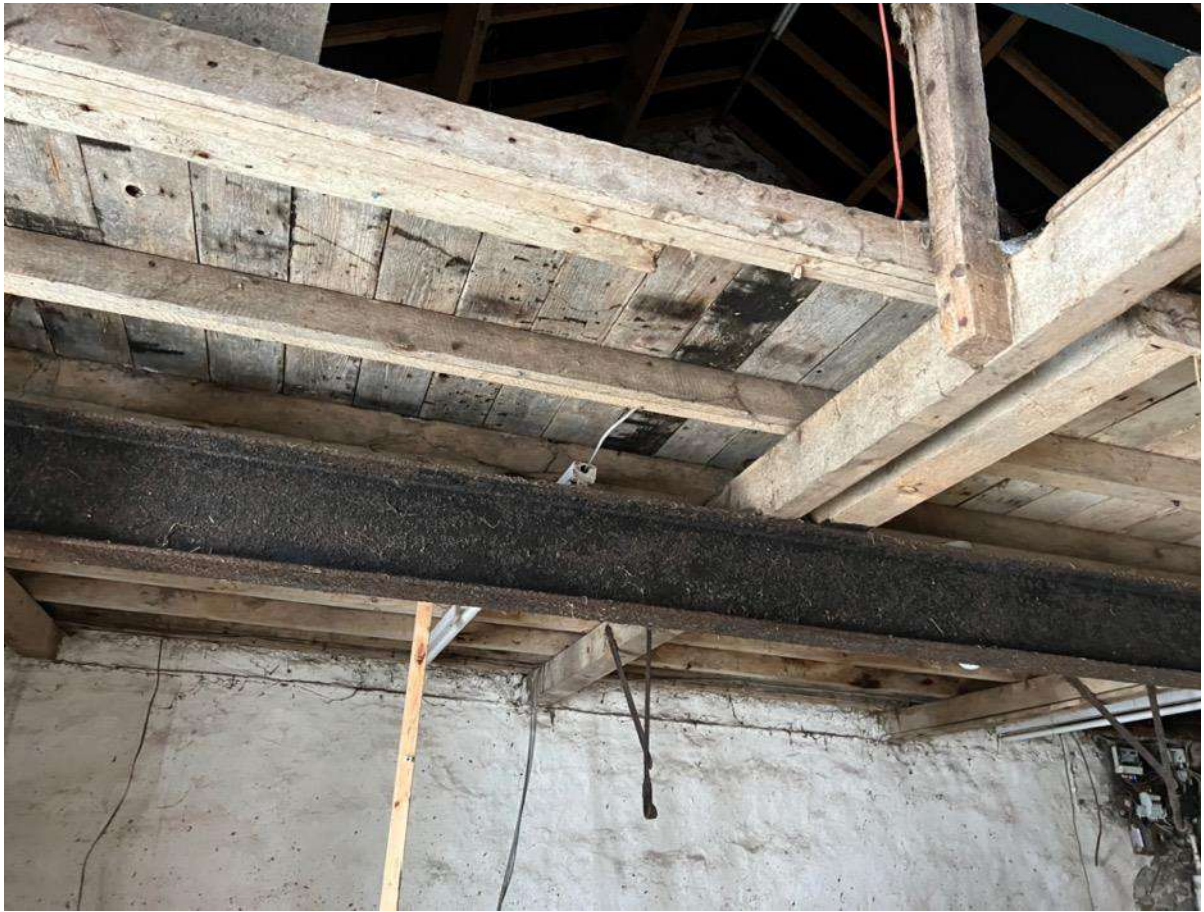
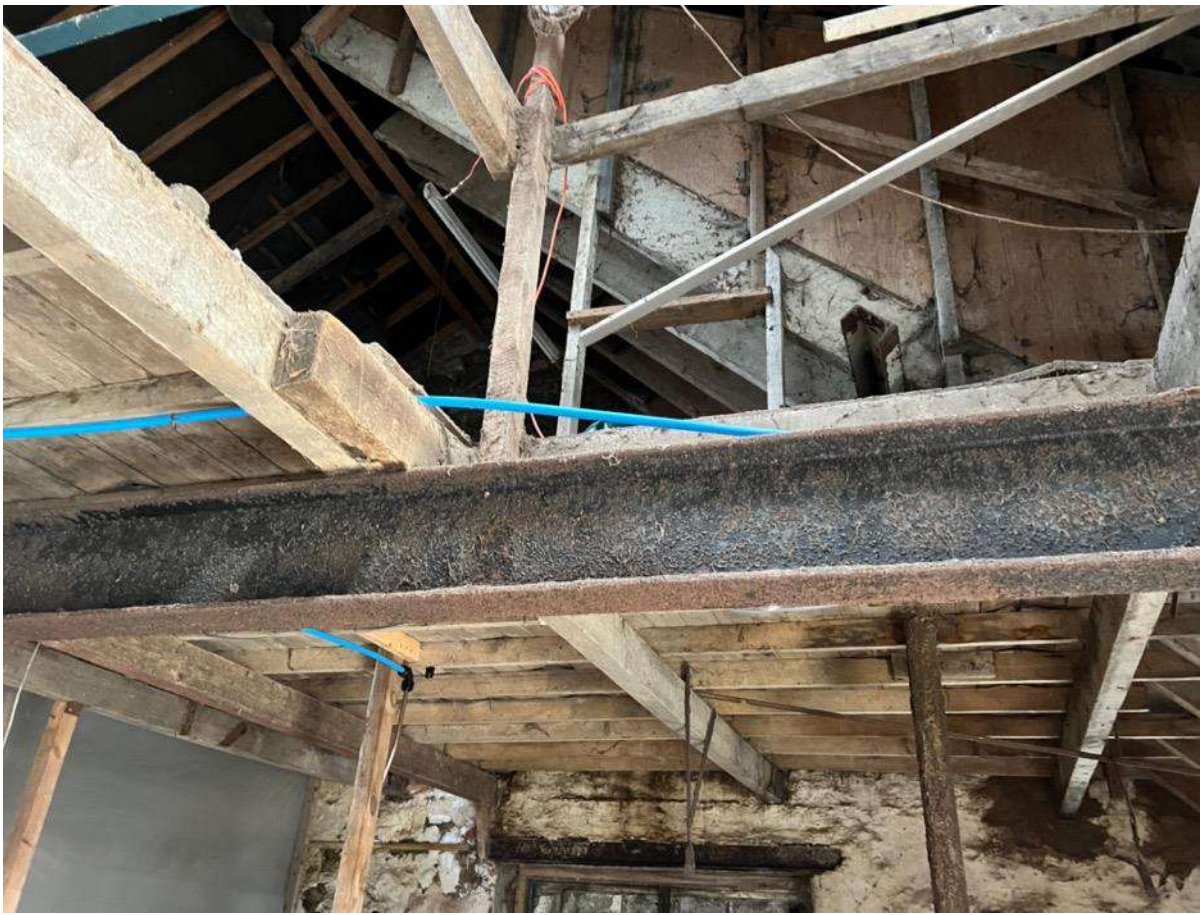
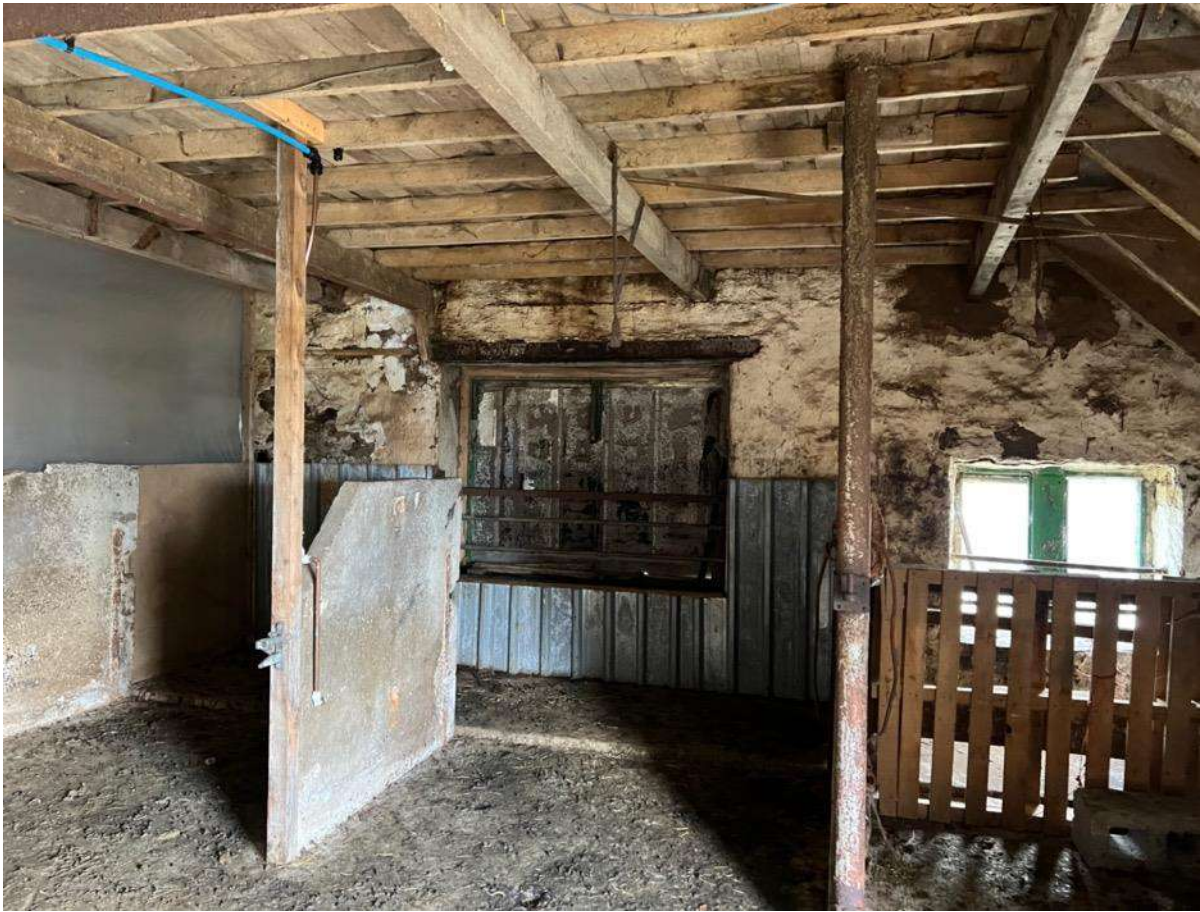
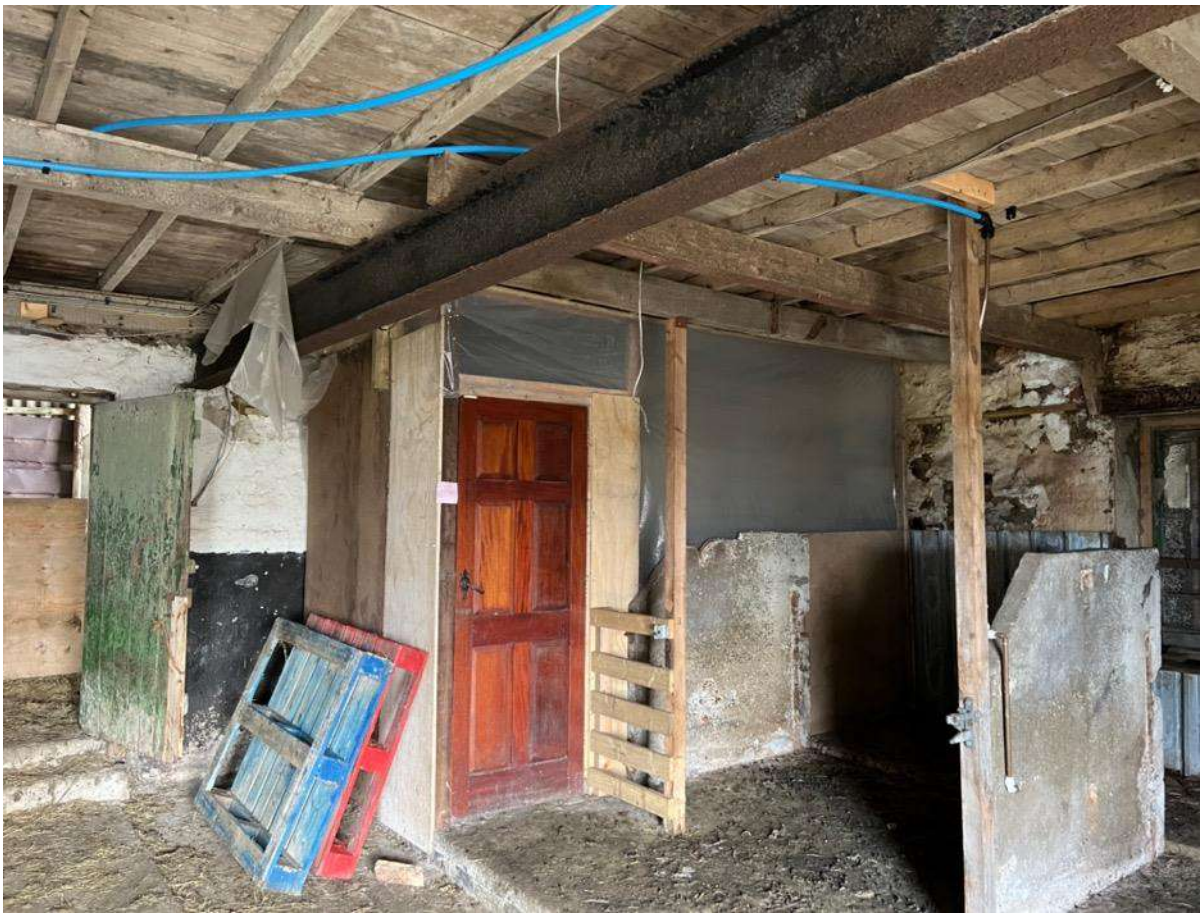
This section of the building has a shippon areas at ground floor level with a loft above. The building shows no sign of previous or ongoing movement to walls or floors. The ground floor is solid concrete (photos 33 & 34). The loft floor is of a timber construction supported by steel beams (photo 28 to 31). There is a feed hopper located against the east gable (photo 36). Photo 31 shows a small room formed in the north-east corner and photo 32 shows a toilet area formed in the north-west corner.

The upper loft is constructed in timber and appeared free of rot and infestation. The steel beams supporting this were heavily rusted but did appear to be under stress or exhibit excessive deflection.

The existing steel trusses, purlins and rafters appear to be in good or reasonable condition with little sign of rot or infestation. Any timber retained should be assessed by a timber specialist, with regard to rot and infestation. All retained timber should be treated against rot/infestation and an indication of residual section given for structural purposes. All retained timber to be used structurally should be checked for structural adequacy. Similarly, any retained steel should be thoroughly cleaned and re-painted to protect against corrosion.

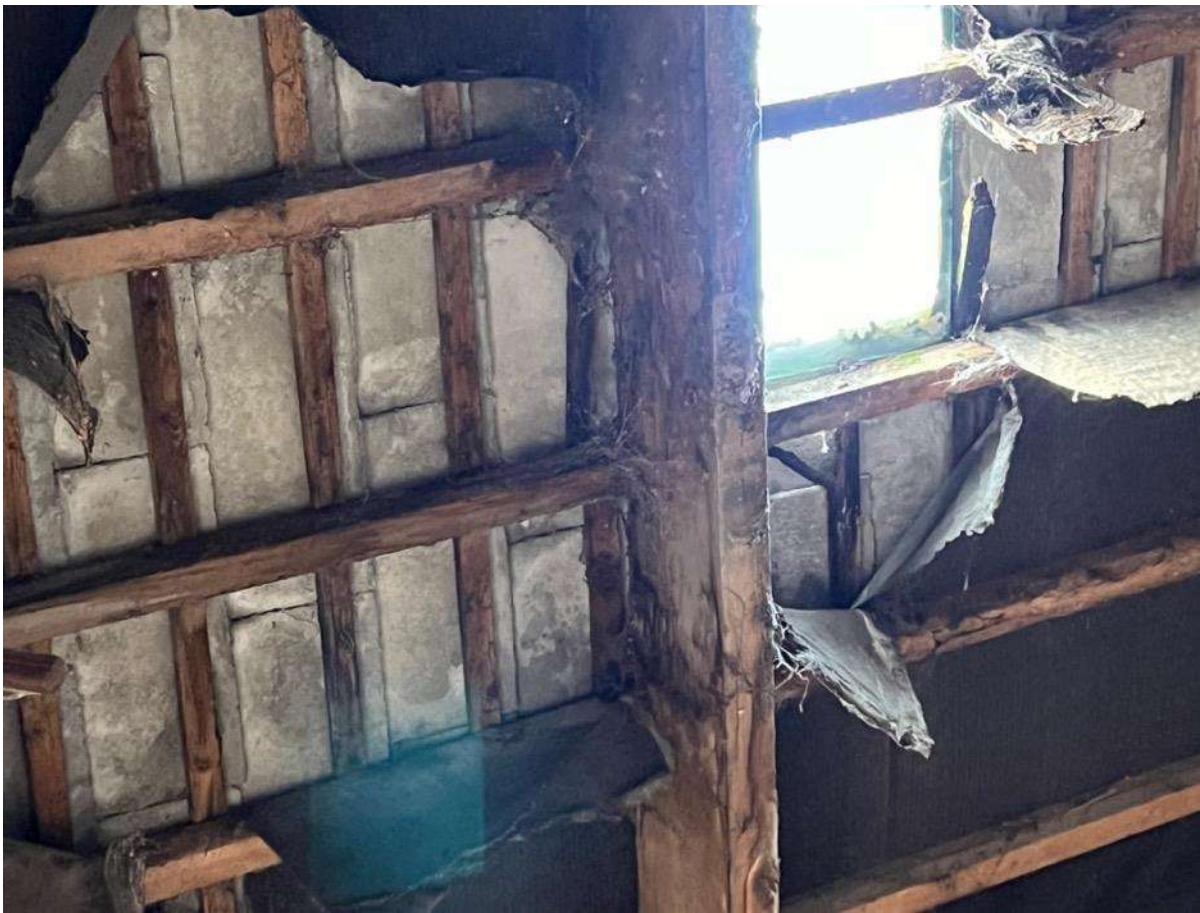
Photo 43 – Internal roof

As noted above, the roof to the barn has been recovered and has felt in place. The felt is damaged in several areas and there are signs of water ingress (photo 43). The roof structure appears to be a replacement structure consisting of lightweight steel trusses and timber purlins and rafters. The structure appears to be in a reasonable condition with no sign of excessive deflection or movement. The timber purlins and rafters appear in reasonable condition with no clear signs of extensive rot or infestation. As noted, there are areas of water ingress which may have damaged the timber.
