Barn 2 at Cuckoo Farm, Higher Road, Longridge, PR3 2YX

Structural Condition Survey for Conversion to Dwelling

PSC-872 – B2

April 2024

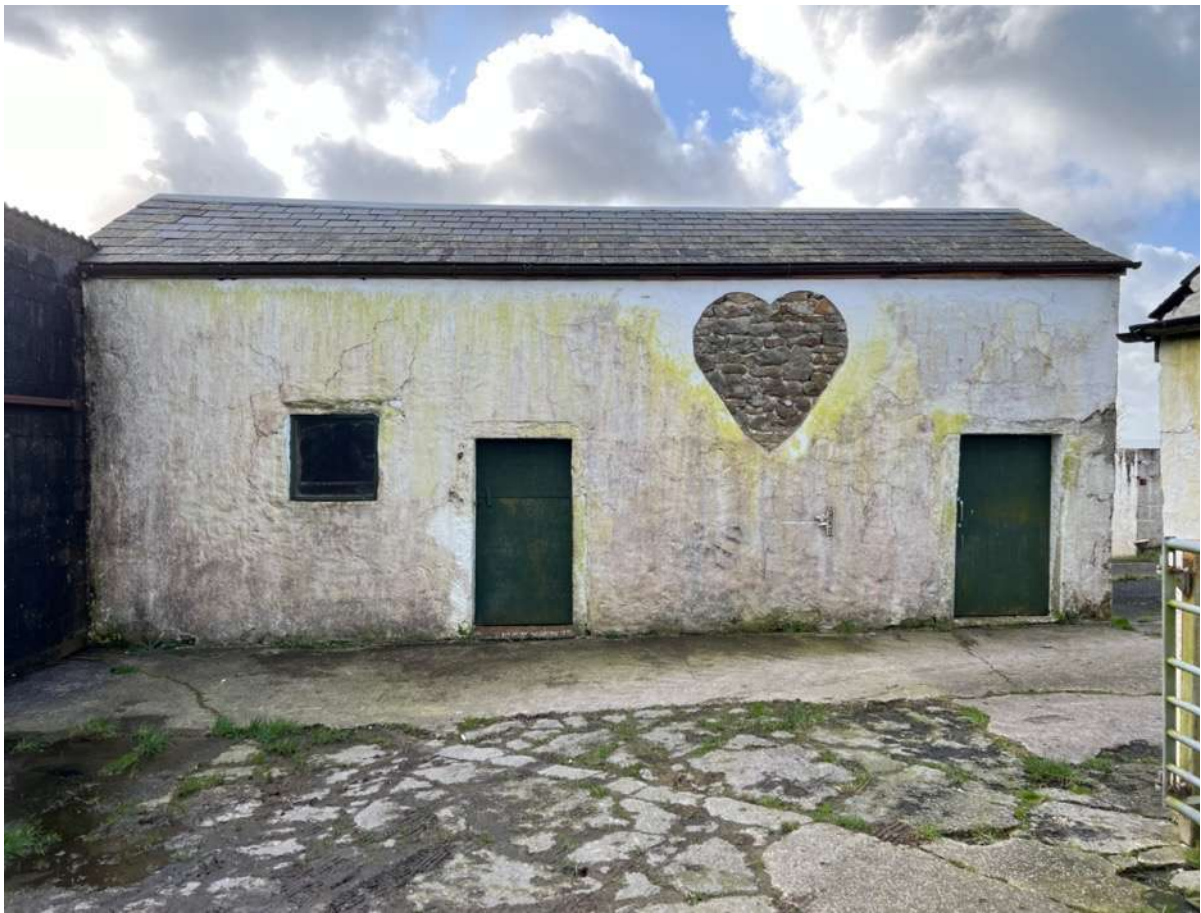
Photo 1 - North Elevation

This elevation is built in random sandstone, which has been rendered and painted white. The wall is 450mm thick. The wall is plumb and reasonably rendered/painted. There are no signs of previous or ongoing movement with minor cracking only to the render. There are three openings at ground floor level, one window and two doors. This elevation has the benefit of guttering and downspouts which are in reasonable condition.

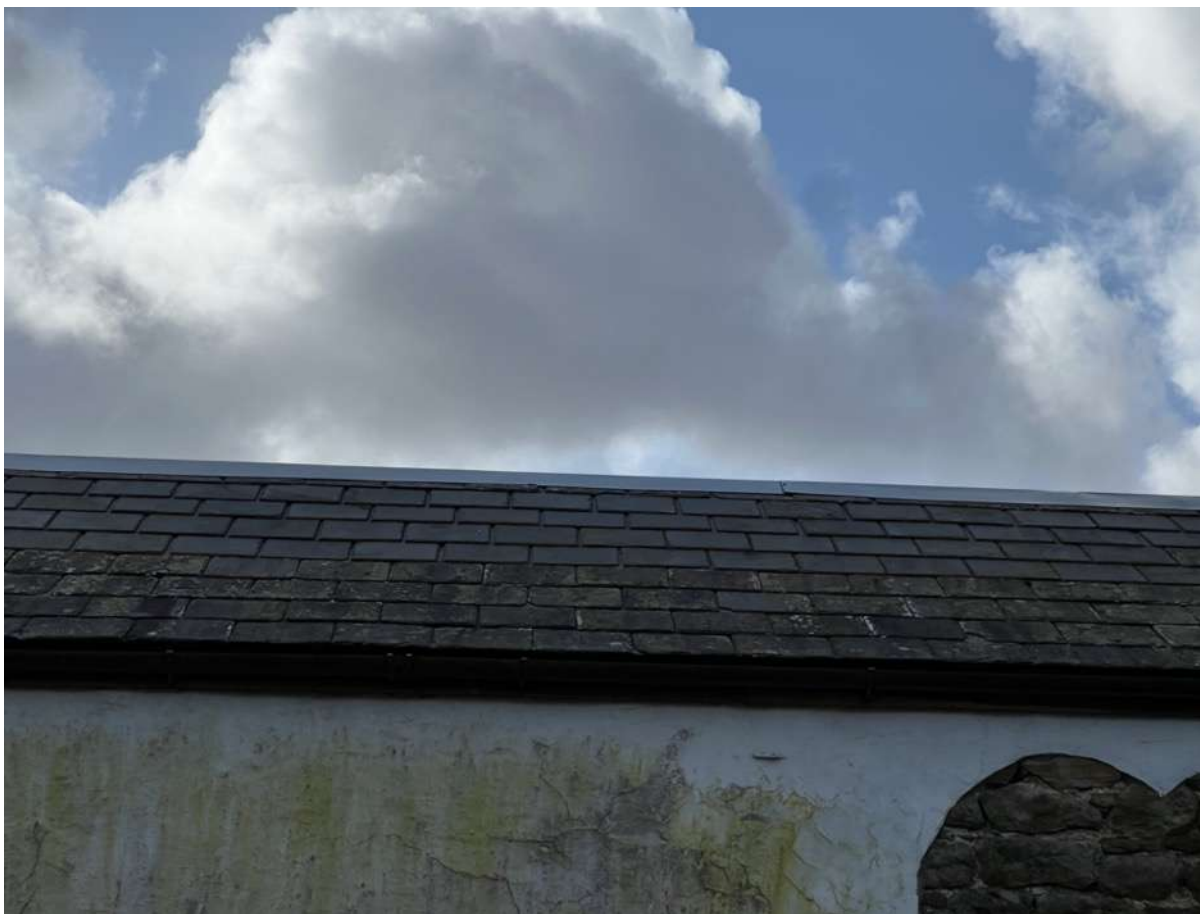
Photo 2 – North elevation roof

Viewed externally, the main barn roof appears in reasonable condition with no sign of major damage, slate/sheet loss, or deflection. The front (north facing) side of the roof is covered with slate. The rear (south facing) side is covered with metal or cement sheeting with rooflights. The internal inspection discussed below indicates that the barn has been re-covered including felt and the original timbers to the roof have been replaced with new rafters.

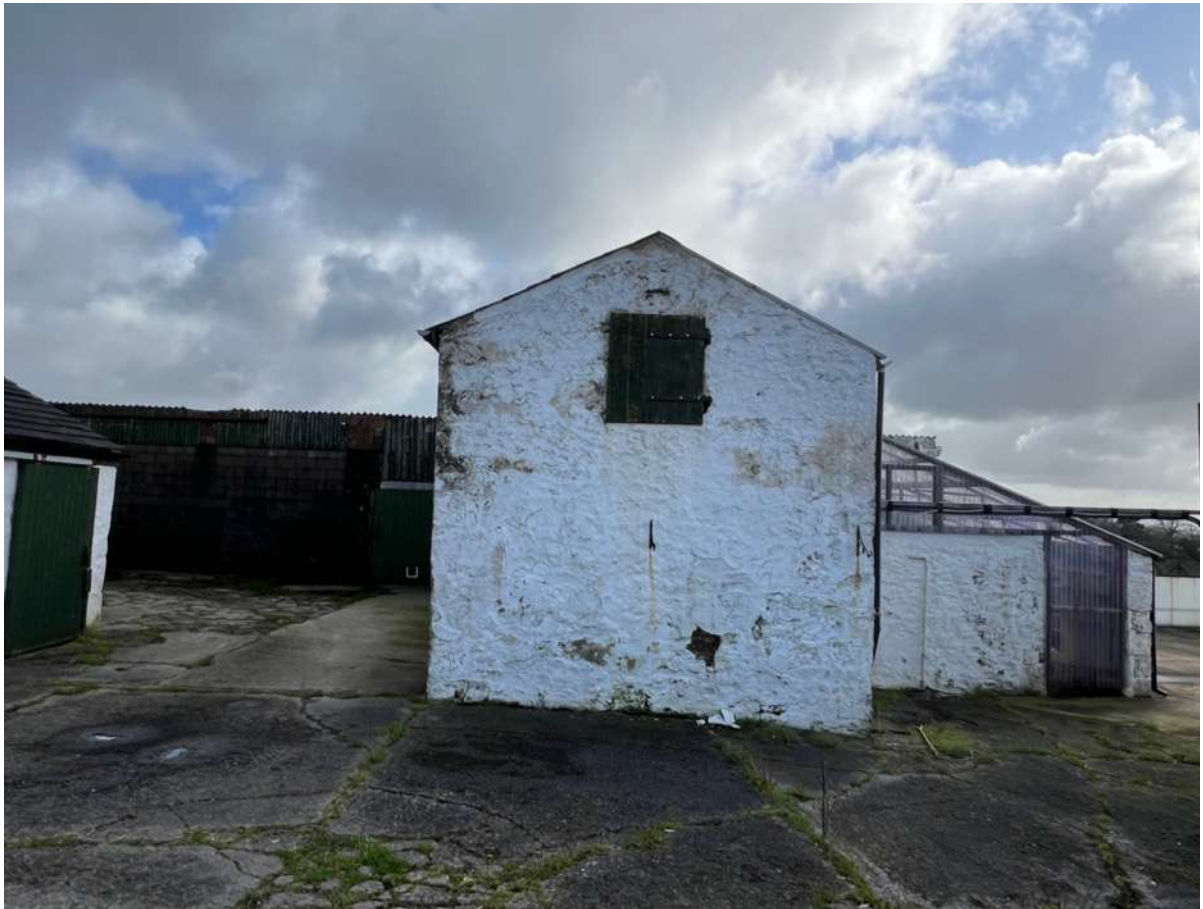
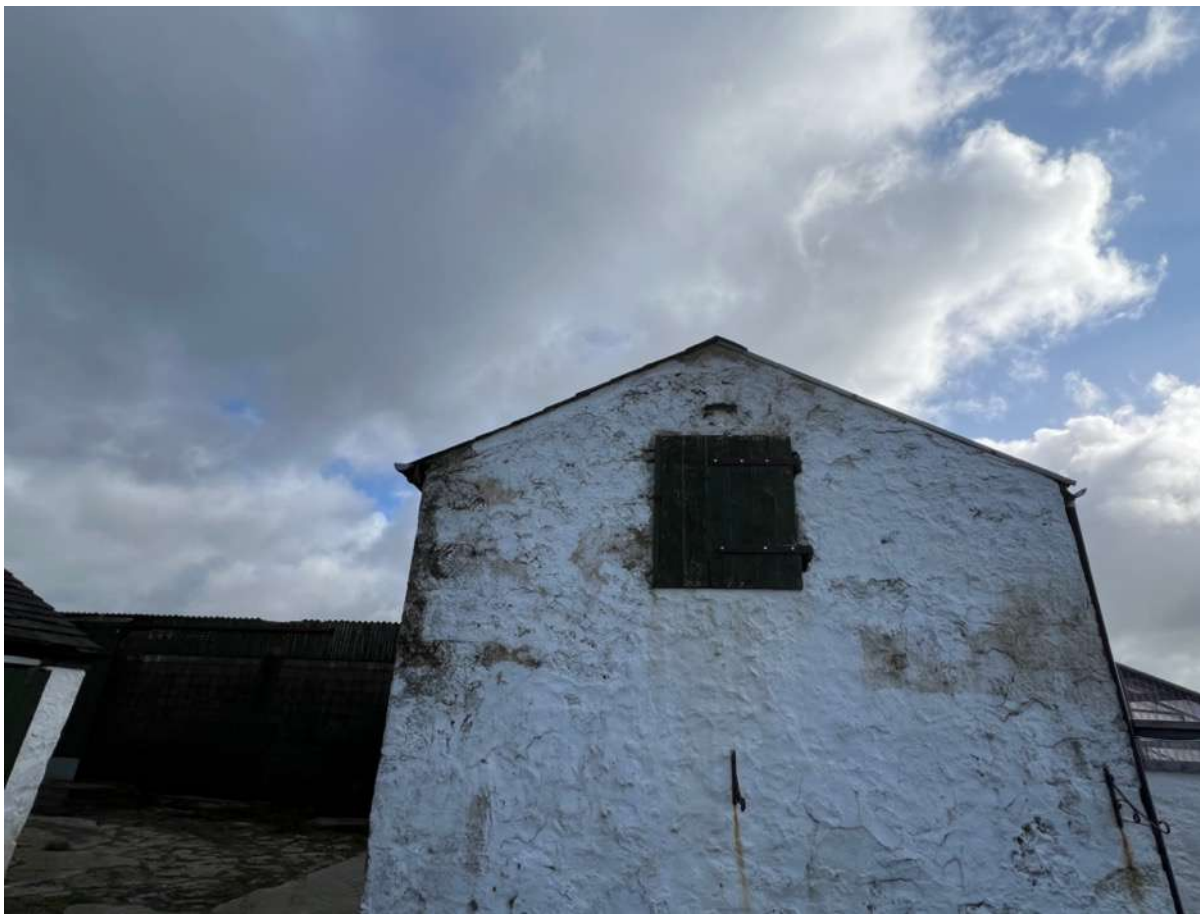
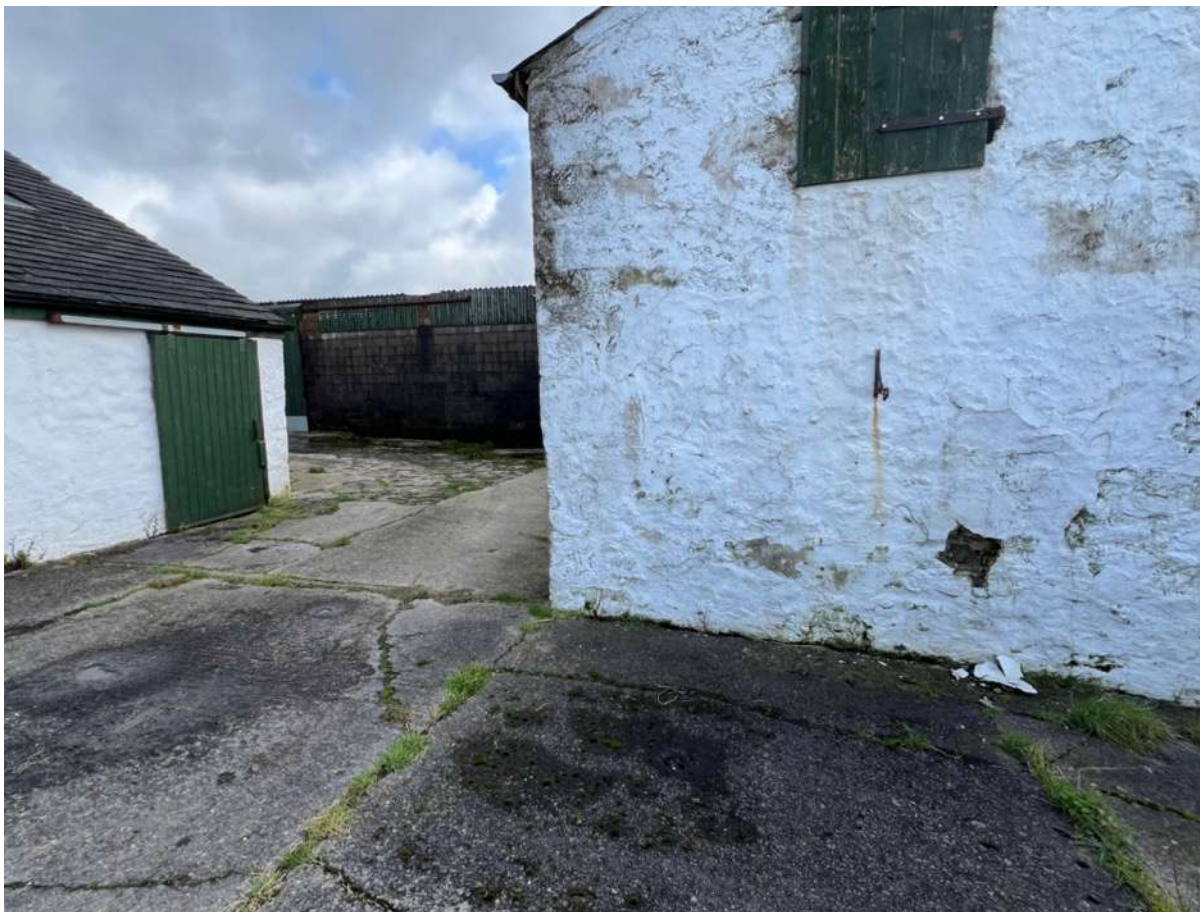
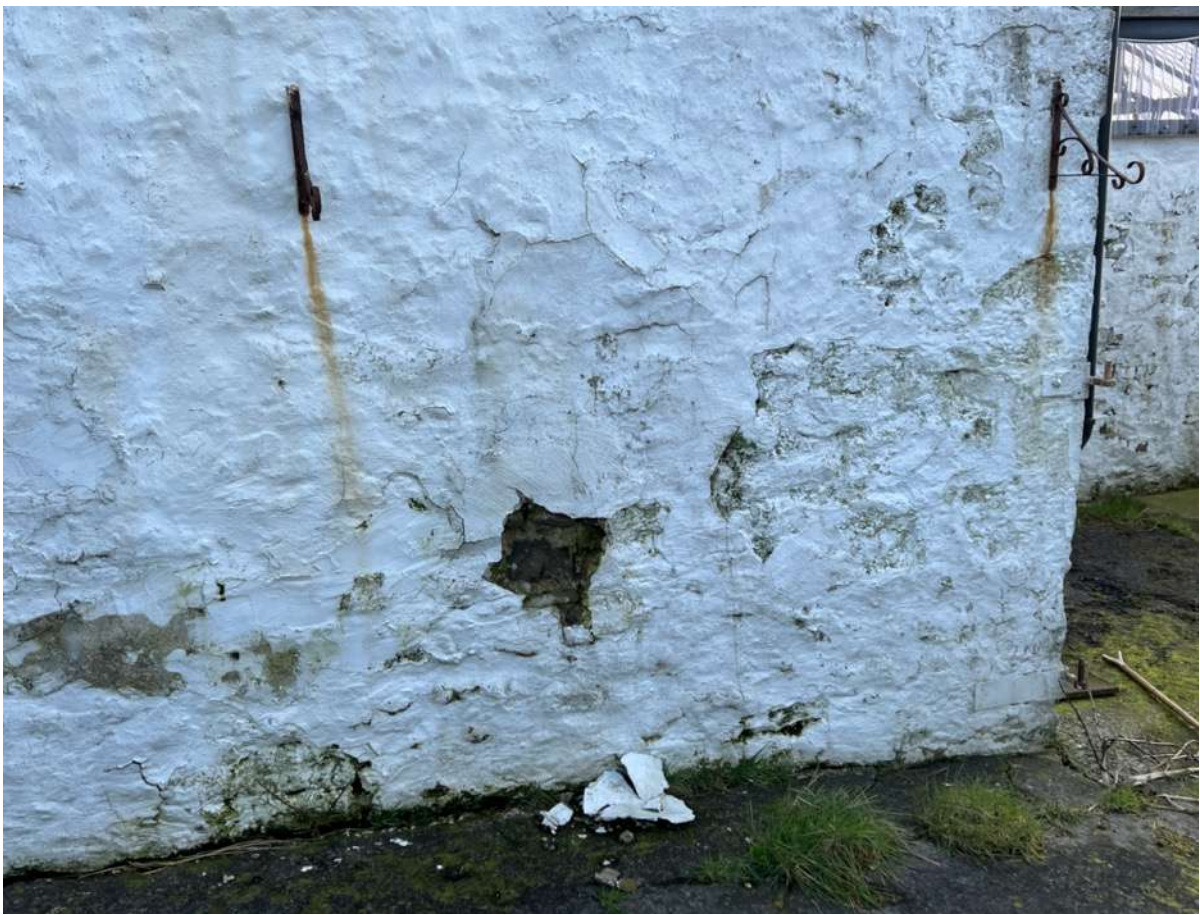
This gable elevation is built in random sandstone and the wall is 450mm thick. The wall is in reasonable condition. It is reasonably plumb and reasonably rendered/painted. There are no signs of previous or ongoing movement with minor loss of render only. There is one window/door opening at the upper floor level giving access to the loft.

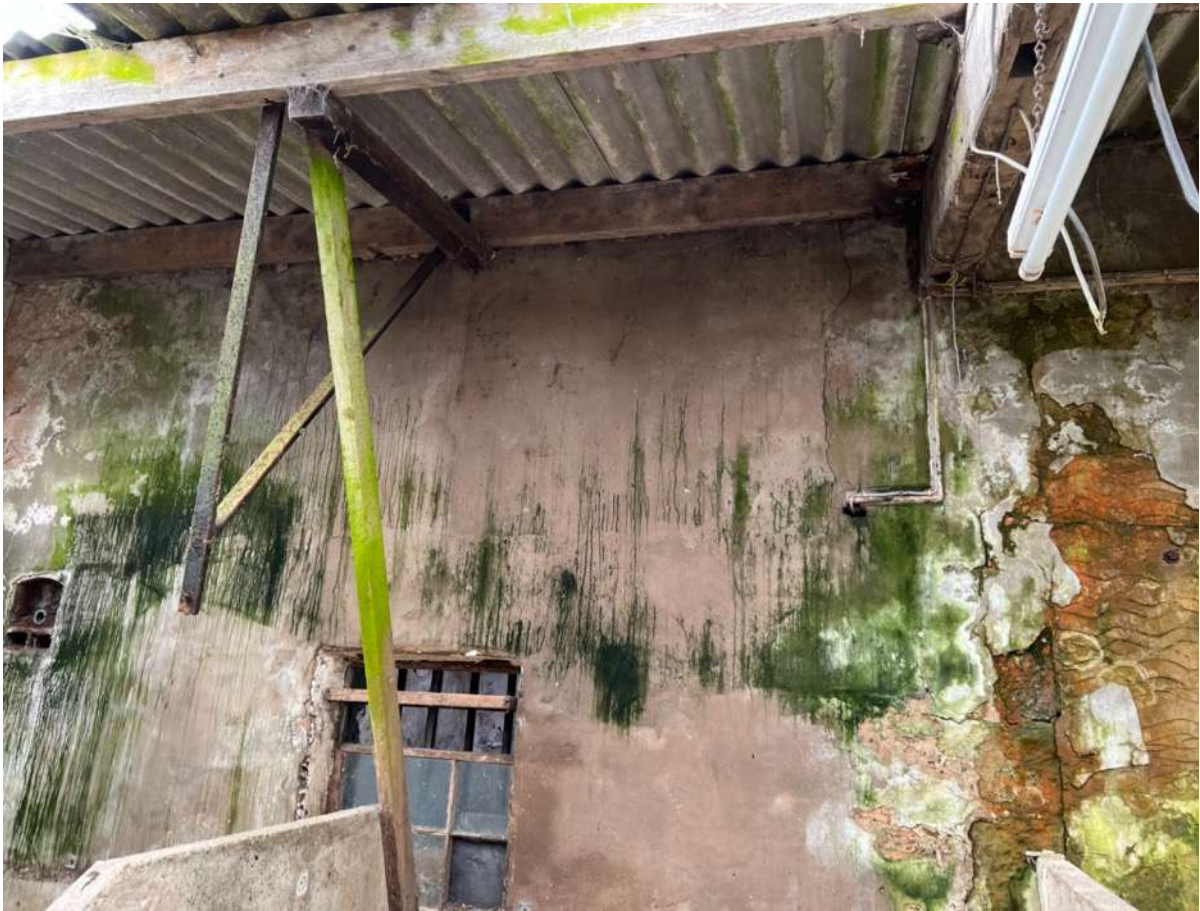
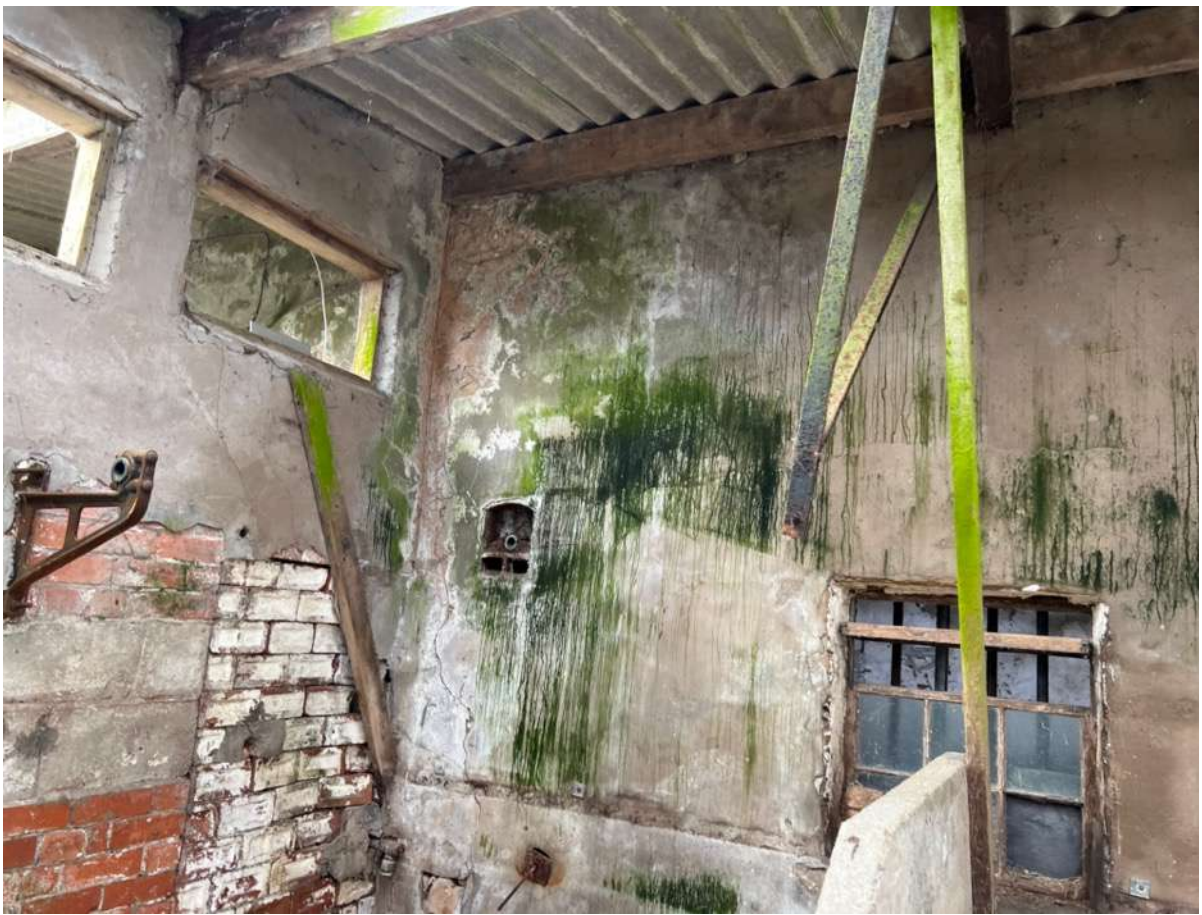
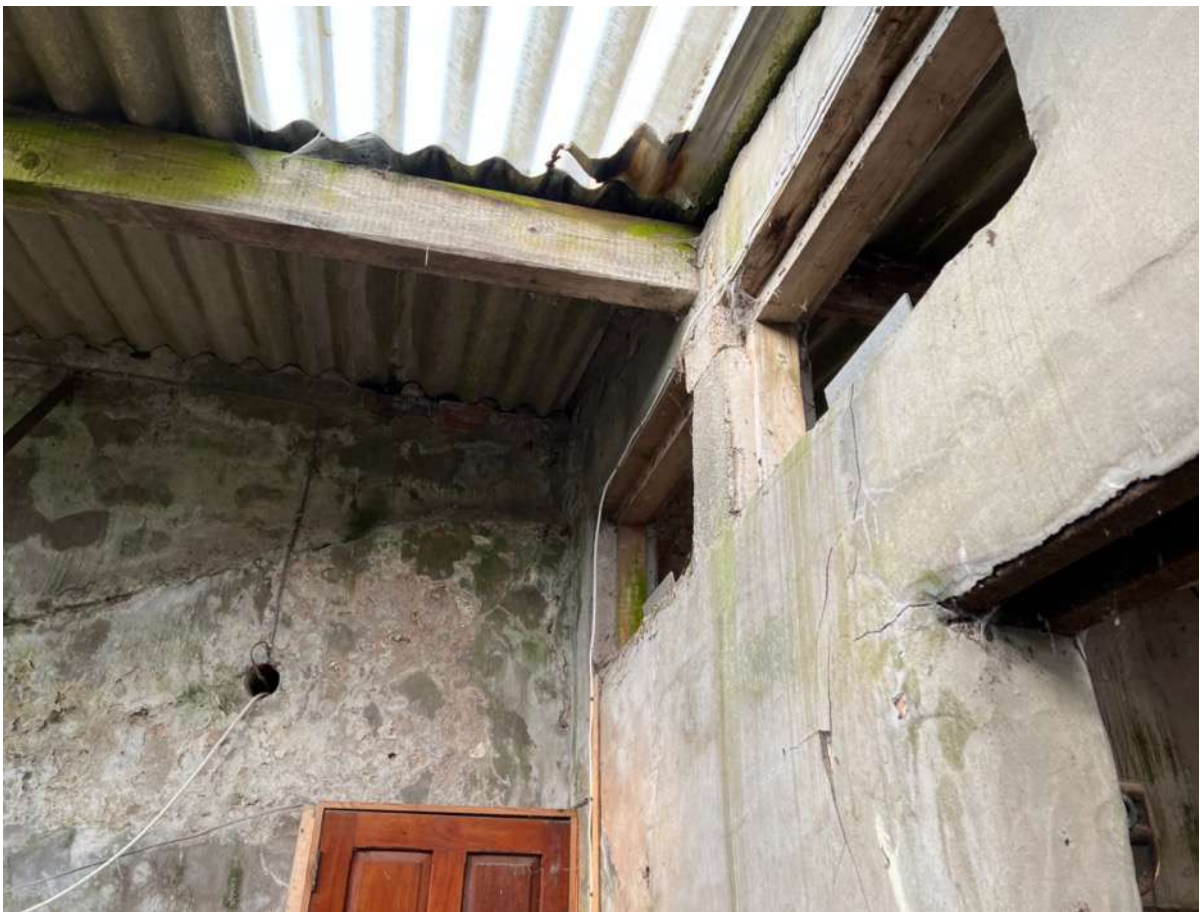
This gable elevation sits mainly within the adjoining building to the east and has a rendered wall, assumed to be 450mm thick random sandstone. From the area visible, the wall appears plumb and free from any previous or ongoing movement. The wall appears to suffer from damp caused by ingress of water from the adjacent roof.

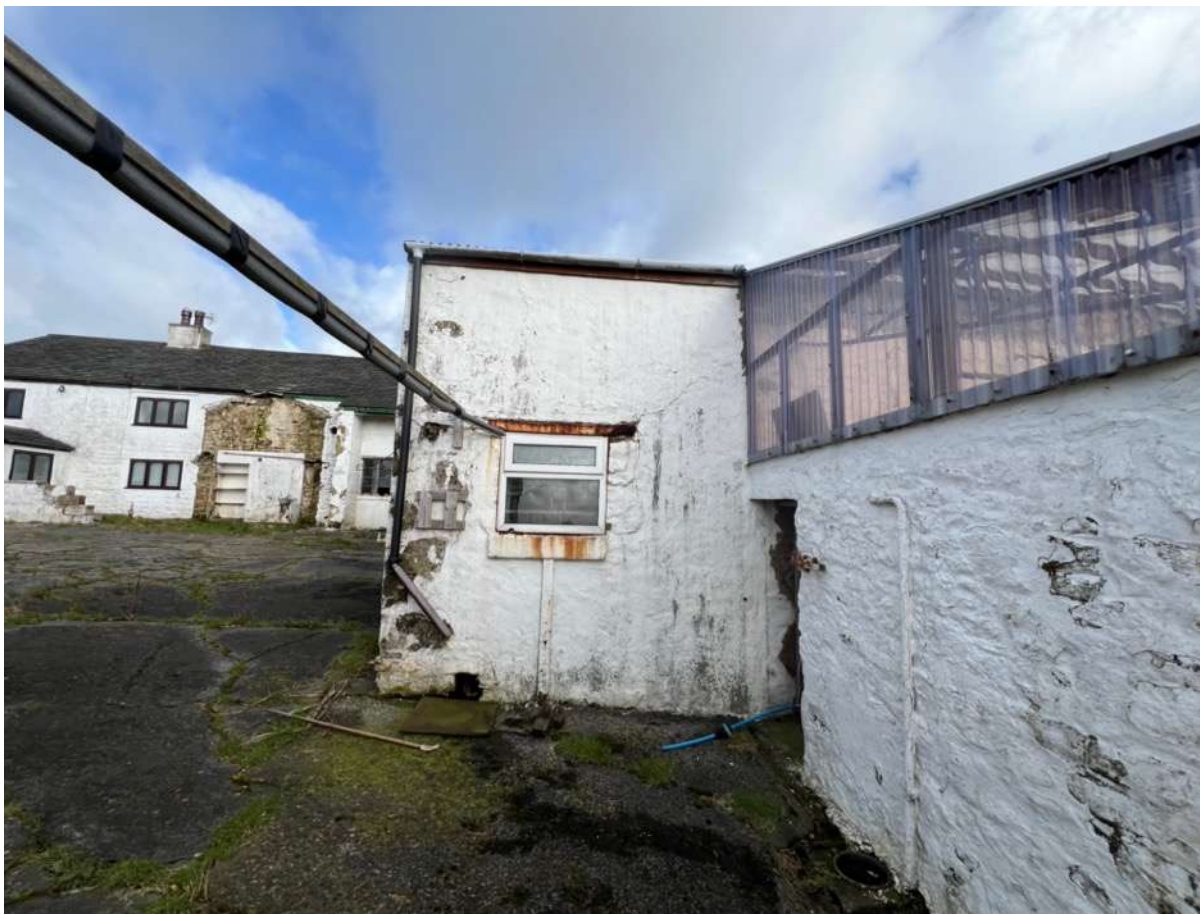
Photo 11 – South elevation

This elevation sits mainly within an adjoining lean-to structure (photos 12-15) with an area at the west end exposed (photo 11). The exposed area is rendered and painted. This elevation is plumb and free from previous or ongoing movement. There is one window opening to this elevation. This elevation has the benefit of guttering and downspouts which are in reasonable condition.

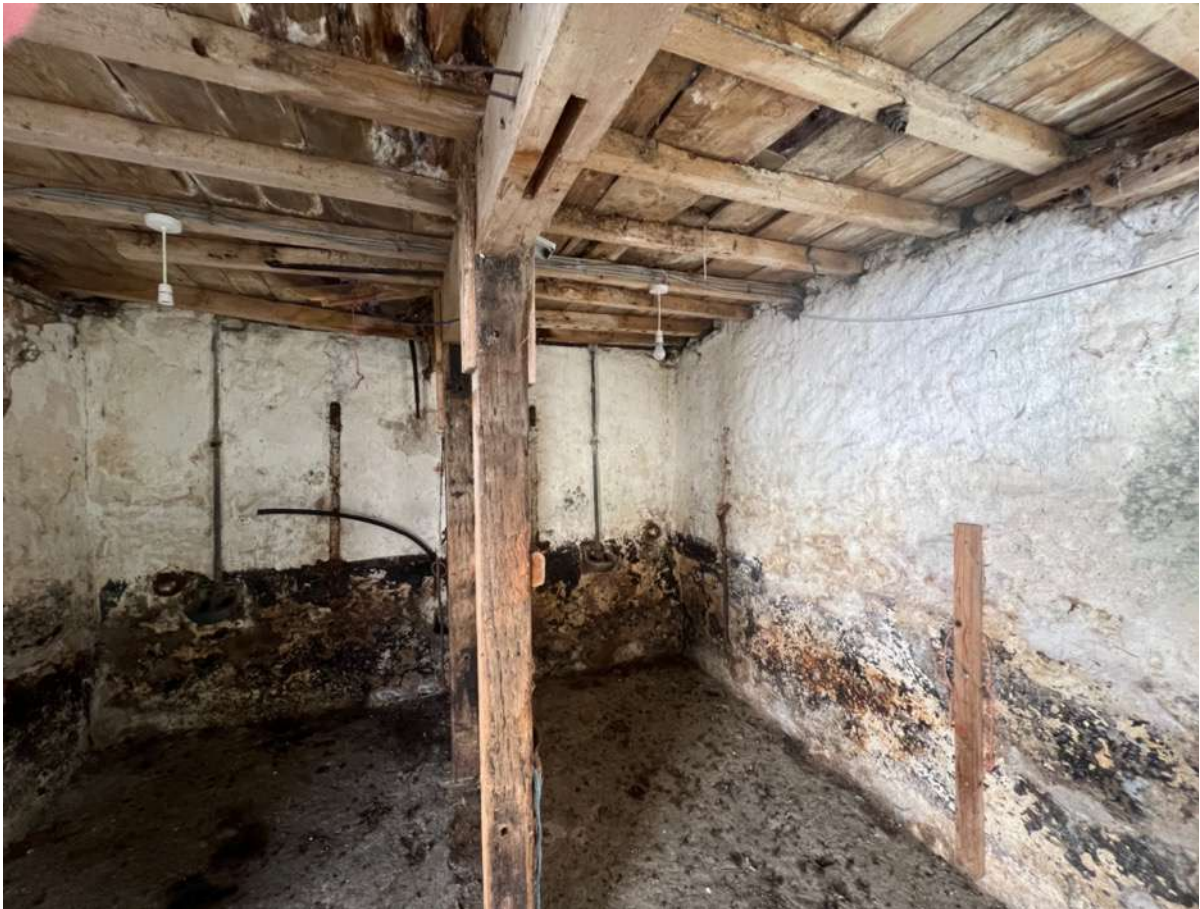
Photo 16 – Internal west end

The building is split into two sections with a 450mm sandstone wall at the centre. The west end of the building retains a timber boarded loft on timber joists, but the boards are incomplete at the east end. The west end has further timber beams and columns supporting the floor (photo 16). The floor joists at the east end appear older than those at the west end when compared in photos 22,23 and 18,19 & 21.

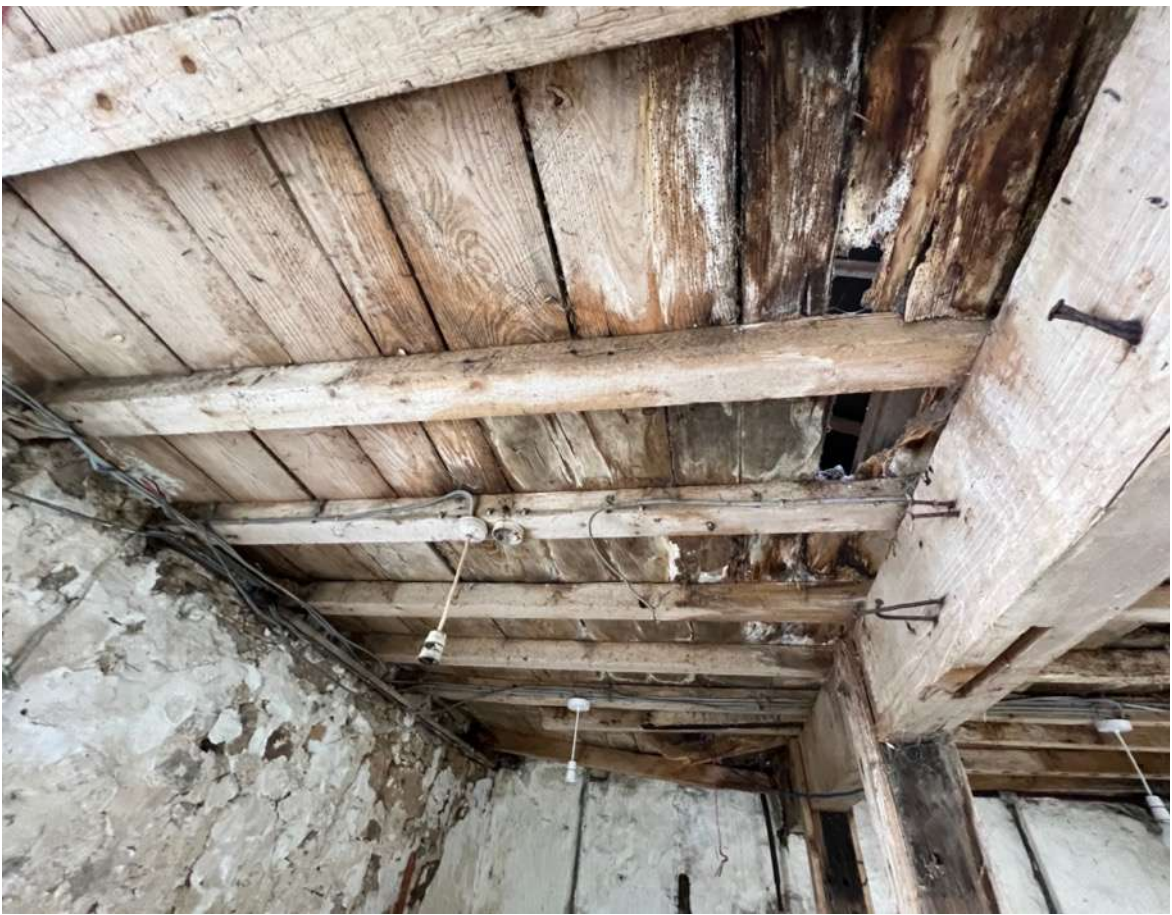
Photo 19 – Internal west end

The walls are all free from signs of movement but they exhibit areas of dampness. This dampness is also evident in the timbers (photos 19 and 20). There are signs of rot but no obvious signs of infestation.

The existing rafters appear to be in good or reasonable condition with little sign of rot or infestation. Any timber retained should be assessed by a timber specialist, with regard to rot and infestation. All retained timber should be treated against rot/infestation and an indication of residual section given for structural purposes. All retained timber to be used structurally should be checked for structural adequacy. The timbers to the existing first floor do not appear suitable for retention.
