Lancashire Tree Surgeons

Survey of Trees at ALDI
Whalley Road
Clitheroe
BB7 1HT

By
Daniel Howe MArborA
BSc (Hons)
Arboriculture and Urban Forestry
Lantra PTI (Professional Tree Inspector)
24th October 2023

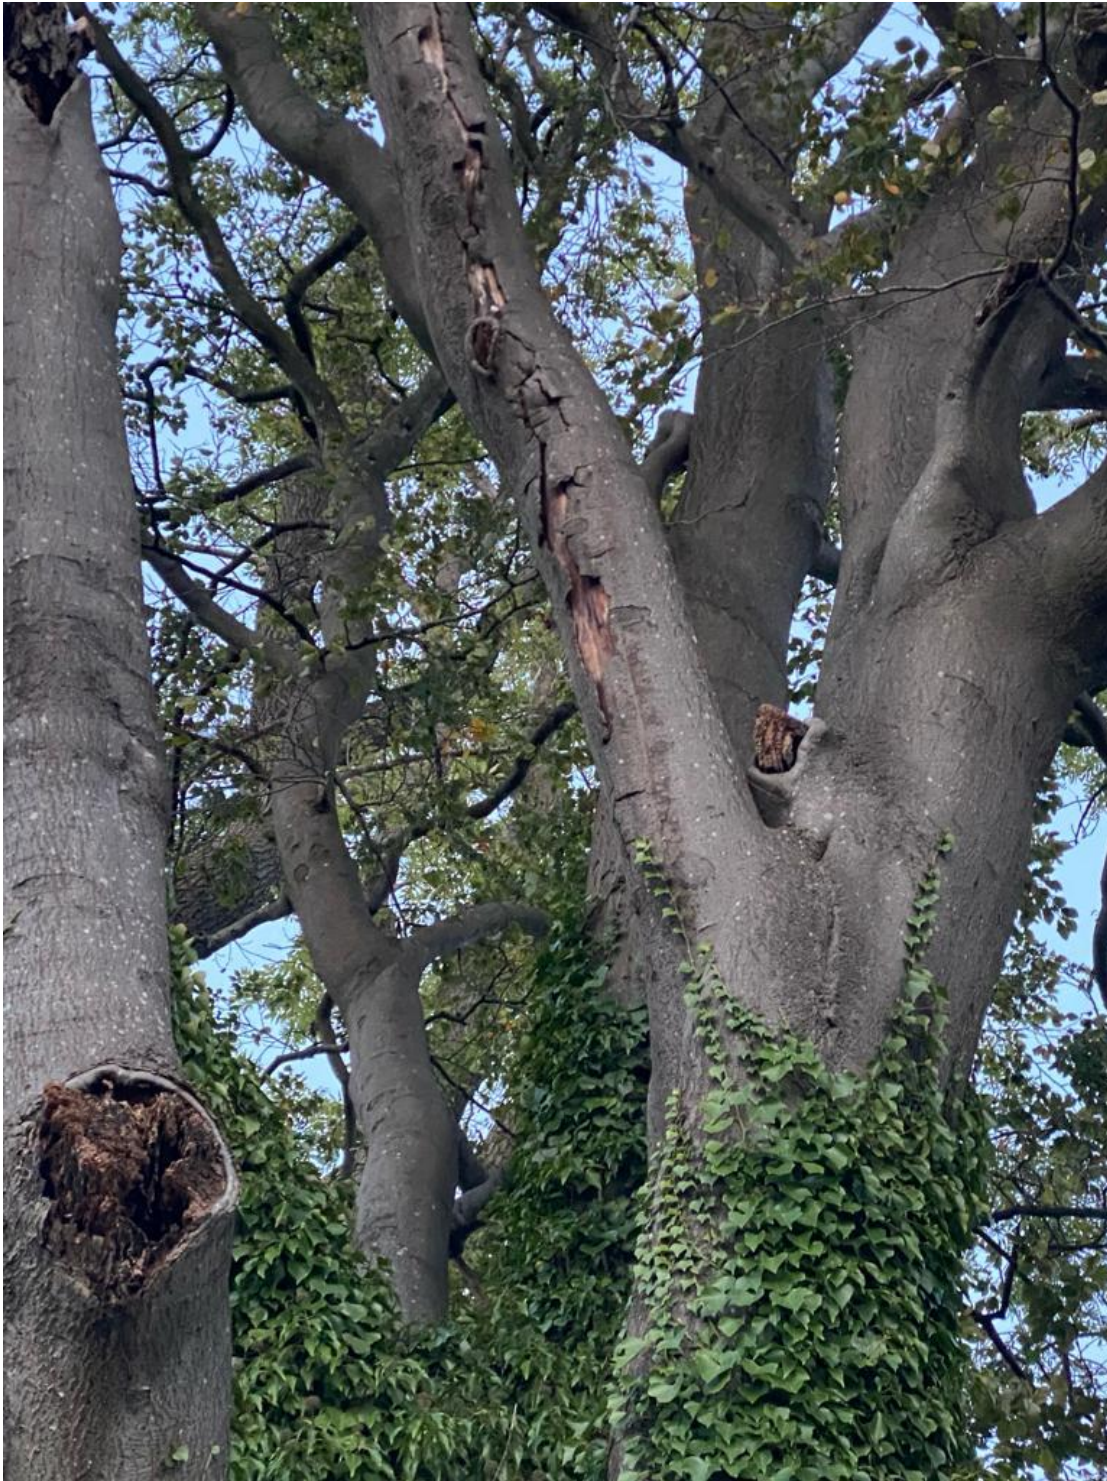
T2 Beach – Visually the tree is in poor vigour with a sparse canopy. Large areas of peeling bark can be seen, and the sap wood is exposed. (figure 2) There are several large pruning wounds (figure 3) which have badly decayed which would indicate that the decay and dysfunctional wood is more extensive throughout the tree. It would be my recommendation that the tree be removed as it poses an immediate threat to people and property in the area.

Figure 2 picture of the bark necrosis on T2

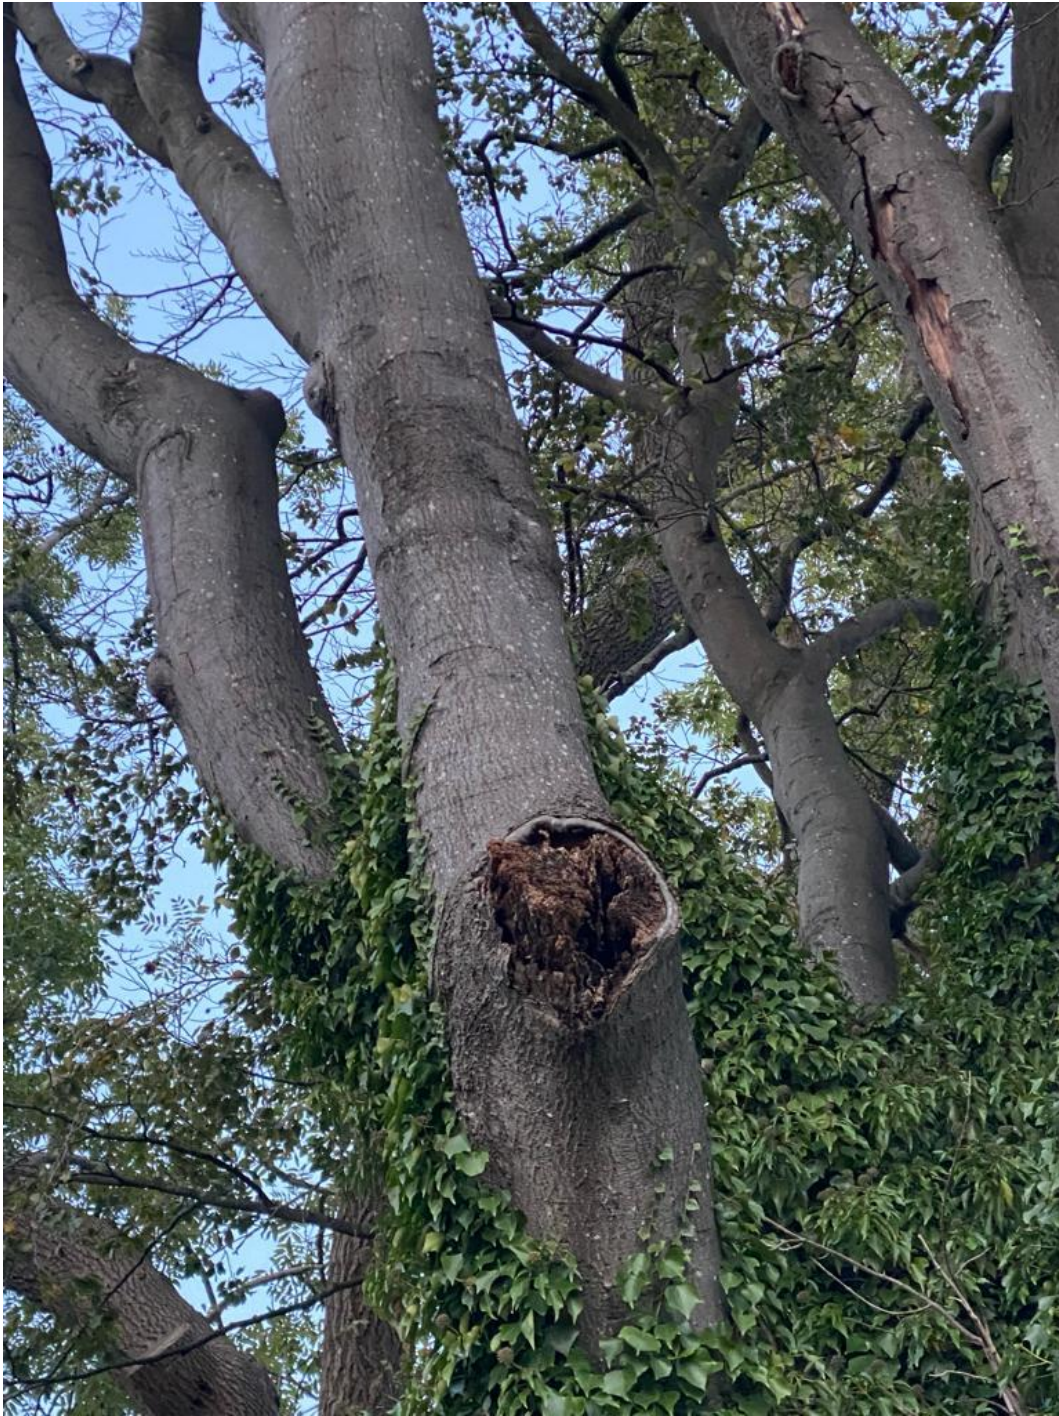
Figure 3 picture of the decayed pruning wounds
