North Elevation to be repaired  
(Rear view from Malt Kiln Lane)

Grove House - North Elevation

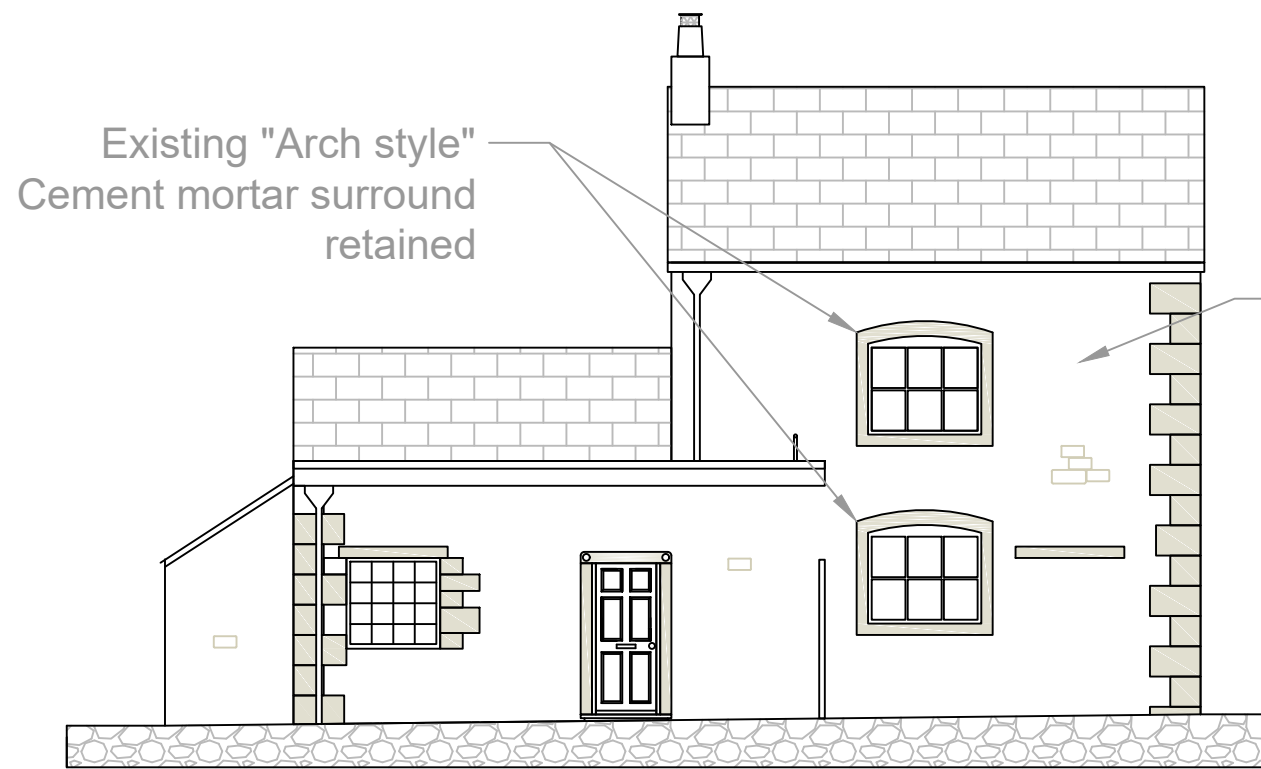
- Sandstone random stonework has become friable and damaged by cement based mortar repair work, completed circa 1990's.
- Old cement mortar has separated from friable sandstone and is encouraging water ingress and accelerating frost damage to exposed stone faces.

- All old cement mortar to be carefully picked out and removed manually with hand tools from North Elevation.
- Where stone faces have been covered, loose material to be carefully brushed away to expose stone face and allow building to "breathe".
- Existing cement mortar "Arch Style" window surrounds to be retained due to unknown condition of sandstone return and lack of ornate stone support. (like those found on front/side windows)
- All existing original lime based mortar to be retained and repaired as necessary with matching cream coloured traditional lime mortar.
