Preliminary Roost Assessment

14 The Dales

Langho

Gritstone Ecology

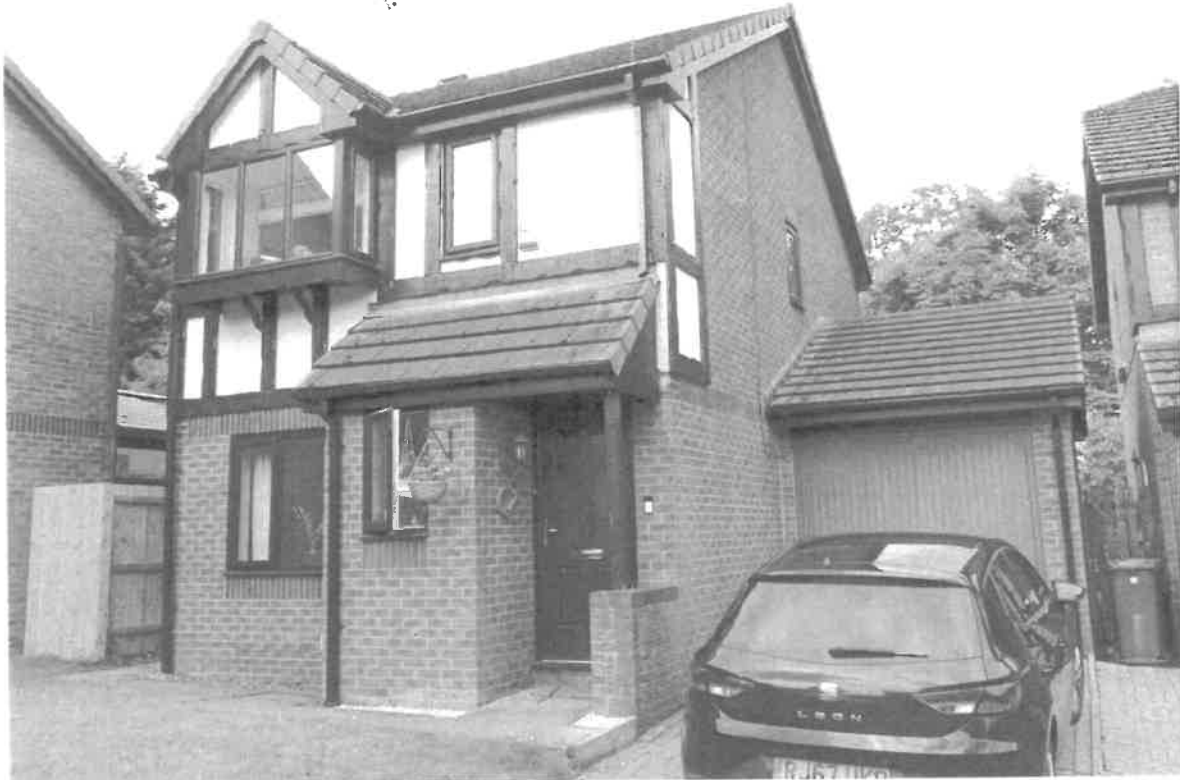
3.1a – The front of the house.

The building is relatively modern, well maintained, and in good condition. Ridge tiles are fixed tightly, there are no damaged or missing ridge tiles. There are no damaged, slipped, or missing roof tiles. Roof tiles are tightly fitted, with no gaps between tiles.

Fascia boards and boxed soffits are fitted tightly against the walls gaps are filled with sealant. Walls are in good condition, with no missing mortar or cracks.

There are no features externally which are likely be used by roosting bats, and no evidence of use by bats was present during the inspection.

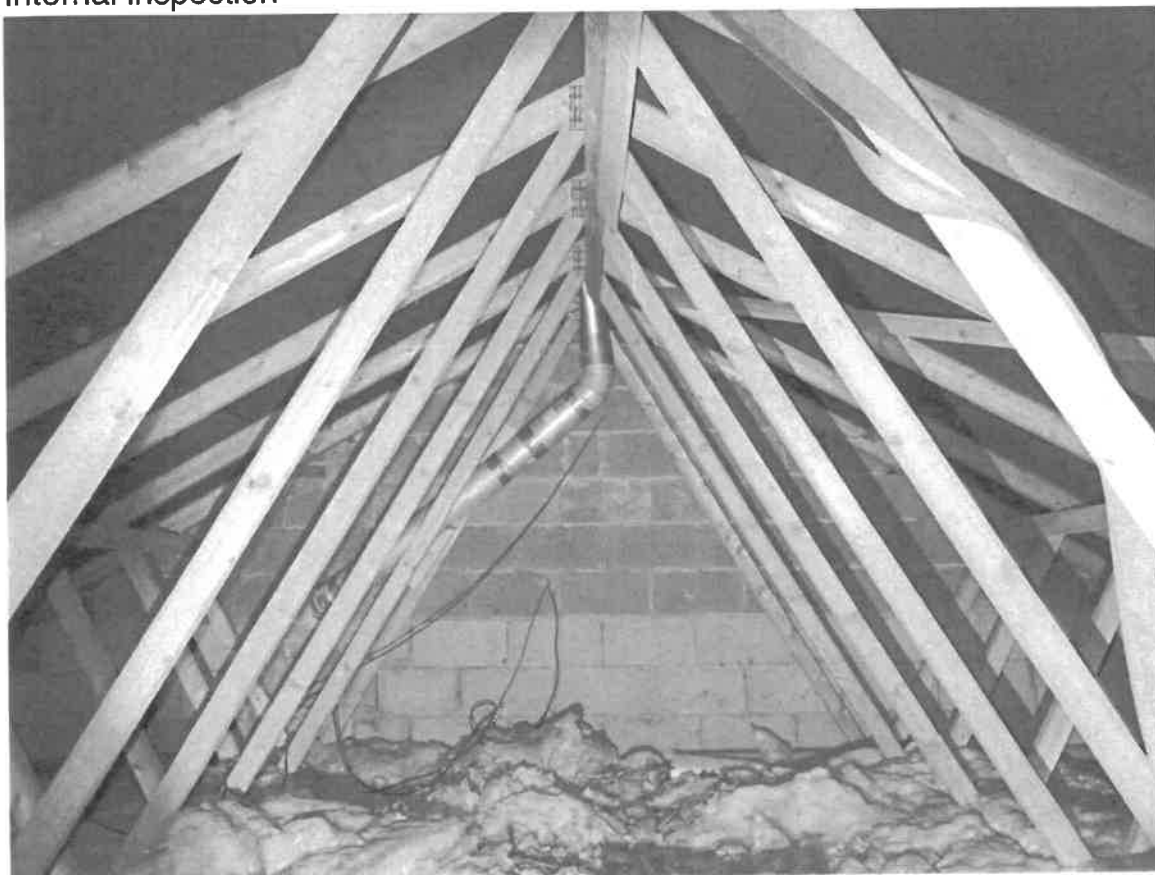
3.2a – The roof void.

The house has a single roof void, which is not used for storage, and accessed infrequently for essential maintenance.

The roof has a timber trussed rafter structure, lined with bitumen felt, and insulated with mineral wool between the ceiling joists. The roof lining is in good condition with no tears, or gaps.

The wall cavity was inspected at the wall plate and gables using an endoscope. There are no gaps at the wall-plate or gables; and there are no gaps which give direct access to the roof void from the outside. Boxed soffits open into the roof void and were inspected from above.

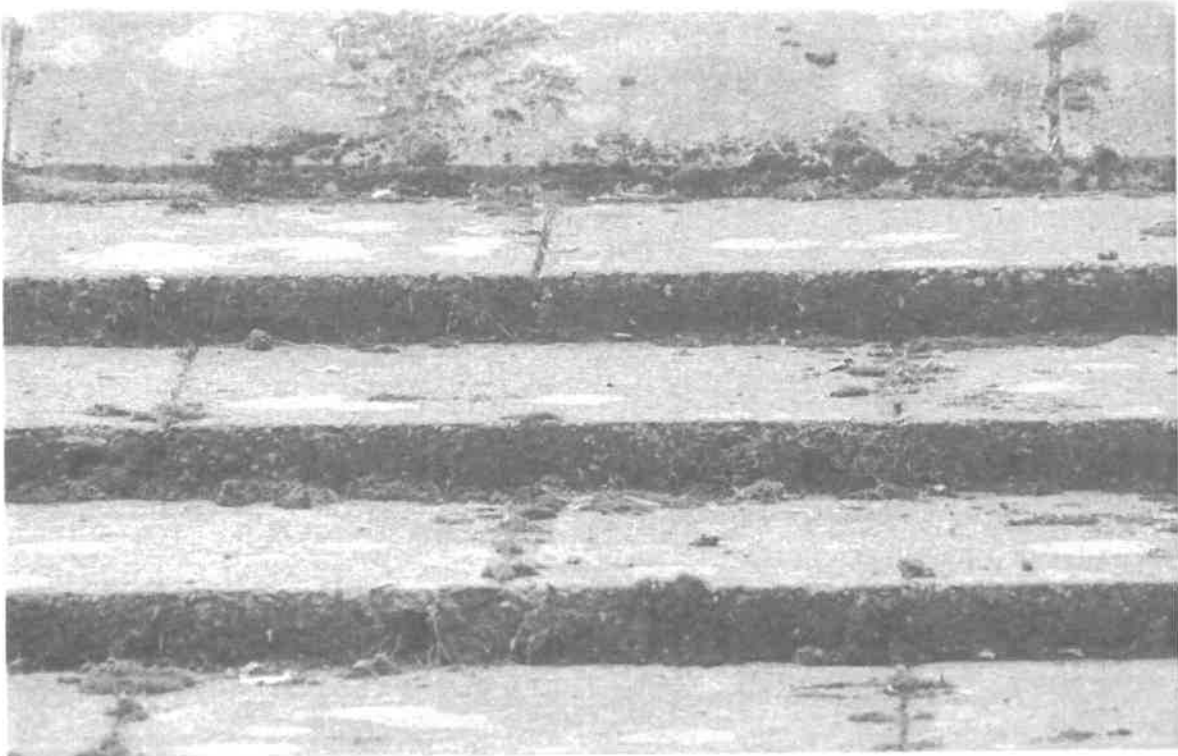
Roof and ridge tiles are in good condition; ridge tiles are sealed with cement. There are no gaps between roofing materials which could be used by roosting bats.

3 – Roof and ridge tiles are in good condition with no suitable gaps.

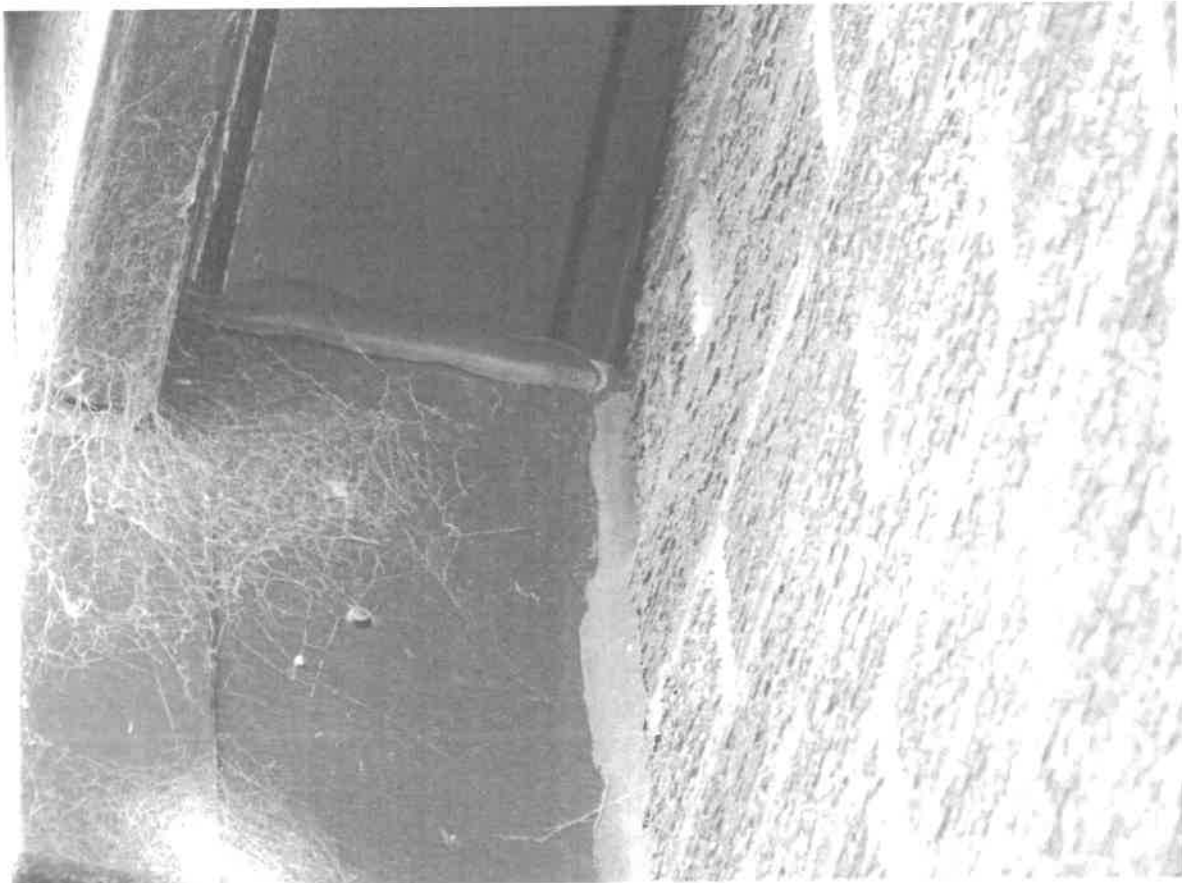
Fascia boards and boxed soffits at the eaves are fixed tightly against brickwork, with no suitable gaps; wall cavities and boxed soffits open into the roof void, and were inspected from above. Gable end verges are sealed with cement, and fitted with UPVC dry-verge covers.

4 – Fascia boards and soffits at the eaves and gables are fixed tightly against brickwork.

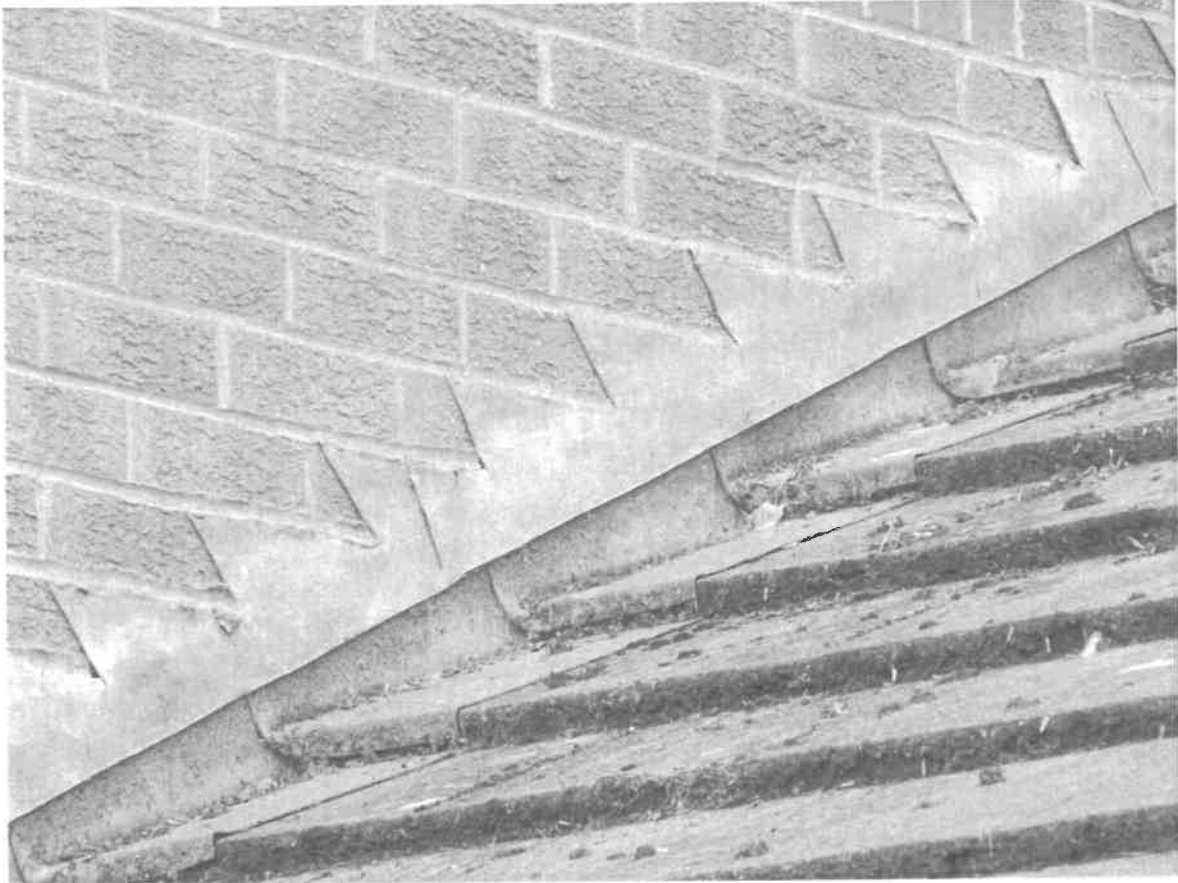
5 – Lead flashing is fitted tightly with no suitable gaps.

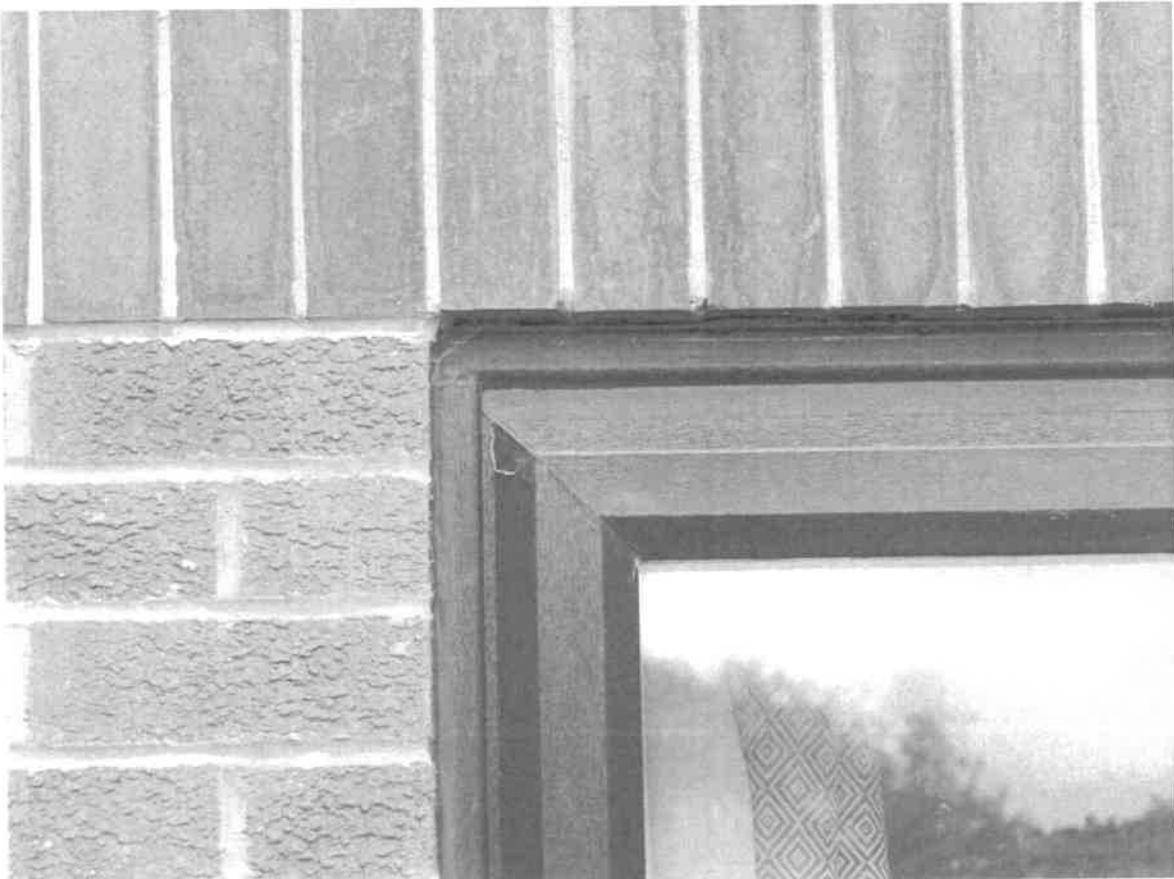
Walls are brick with an insulating cavity. Walls are in good condition, with no cracks, or missing mortar which could be used by crevice dwelling bats.

Window and door frames are fixed into the brickwork, gaps are filled with sealant, and offer no suitable roosting opportunities.

6 – Brickwork, mortar, and window frames are in good condition with no suitable gaps.

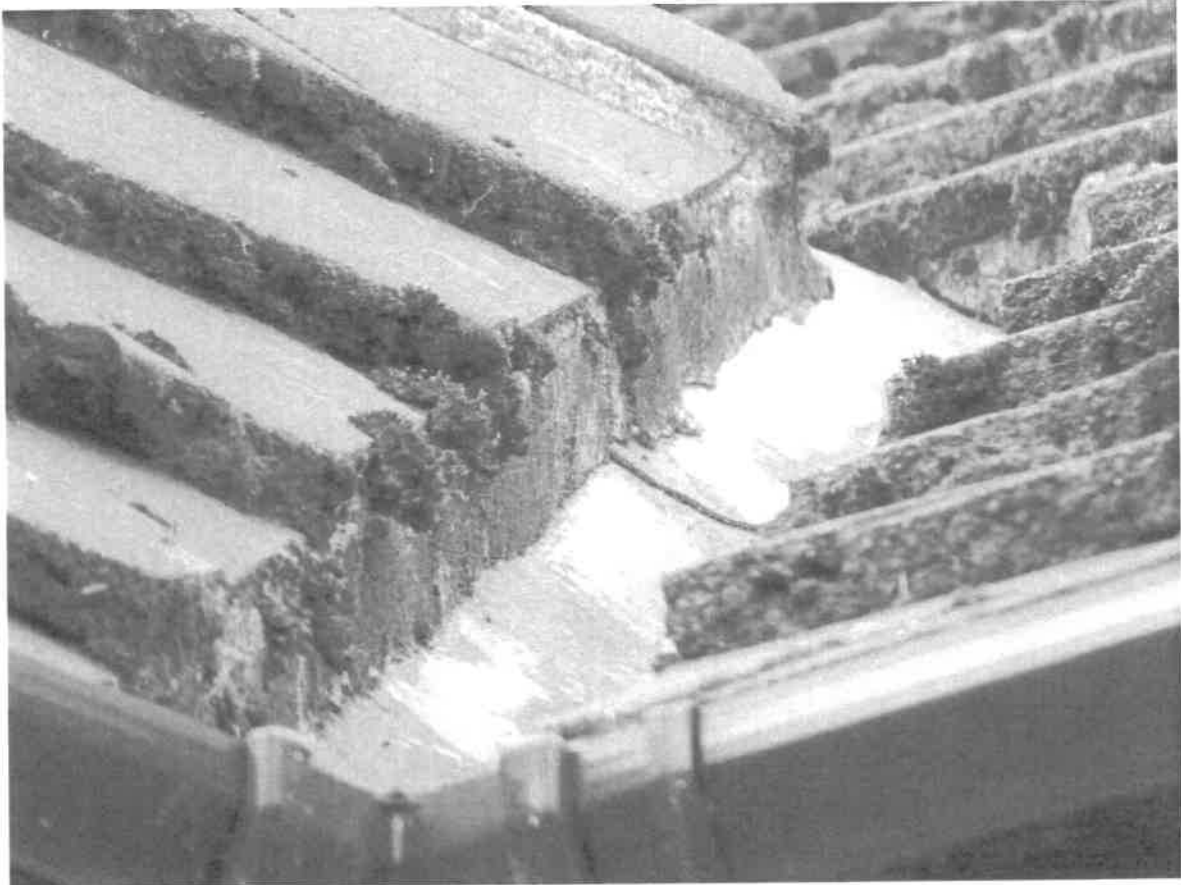
7 – Tiles and lead flashing in roof valleys are in good condition with no suitable gaps.

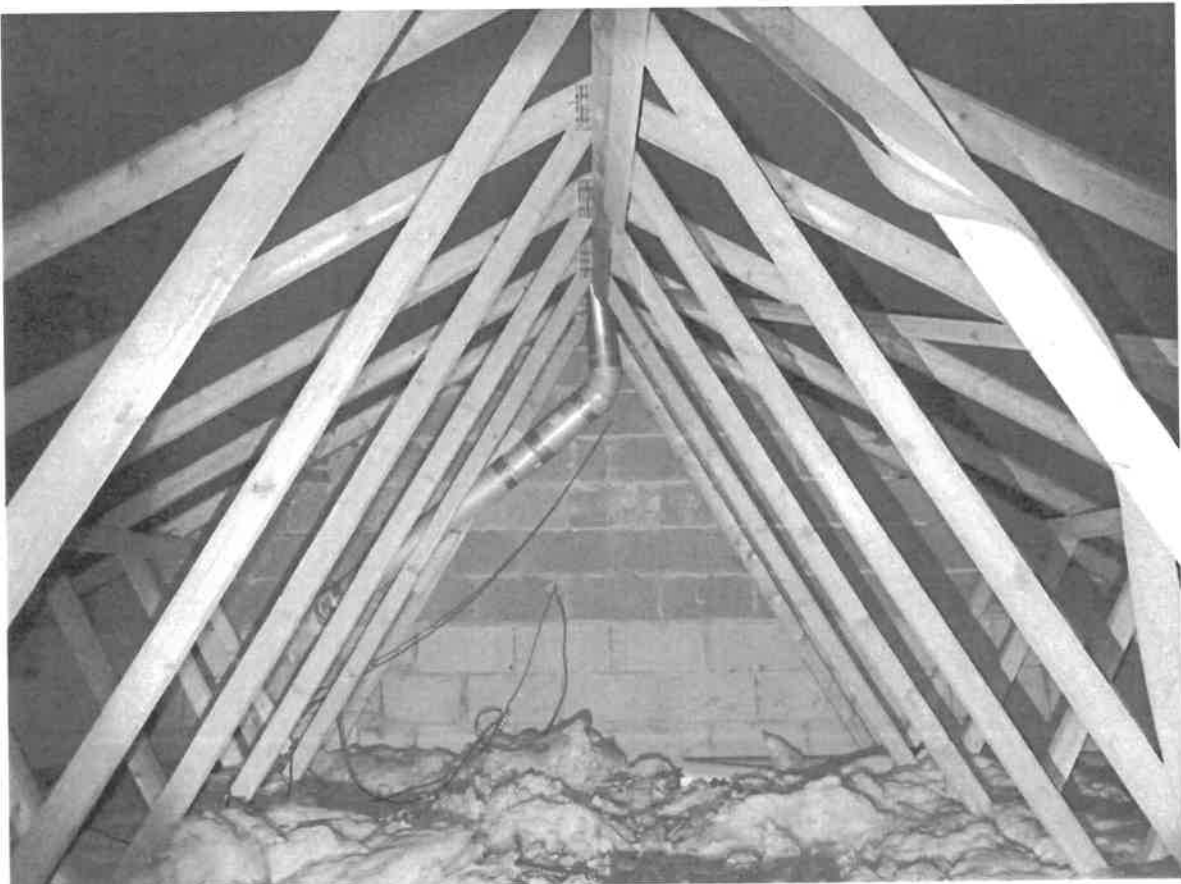
The small gaps between brickwork, roof timbers, and roofing materials, in the roof void were inspected in detail using an endoscope. No droppings were found, and no suitable gaps were present which could give access, or shelter to roosting bats.

8 – The house has a single enclosed roof void.
