Barn at 5 Talbot Street, Chipping

Historic Building Survey

October 2023

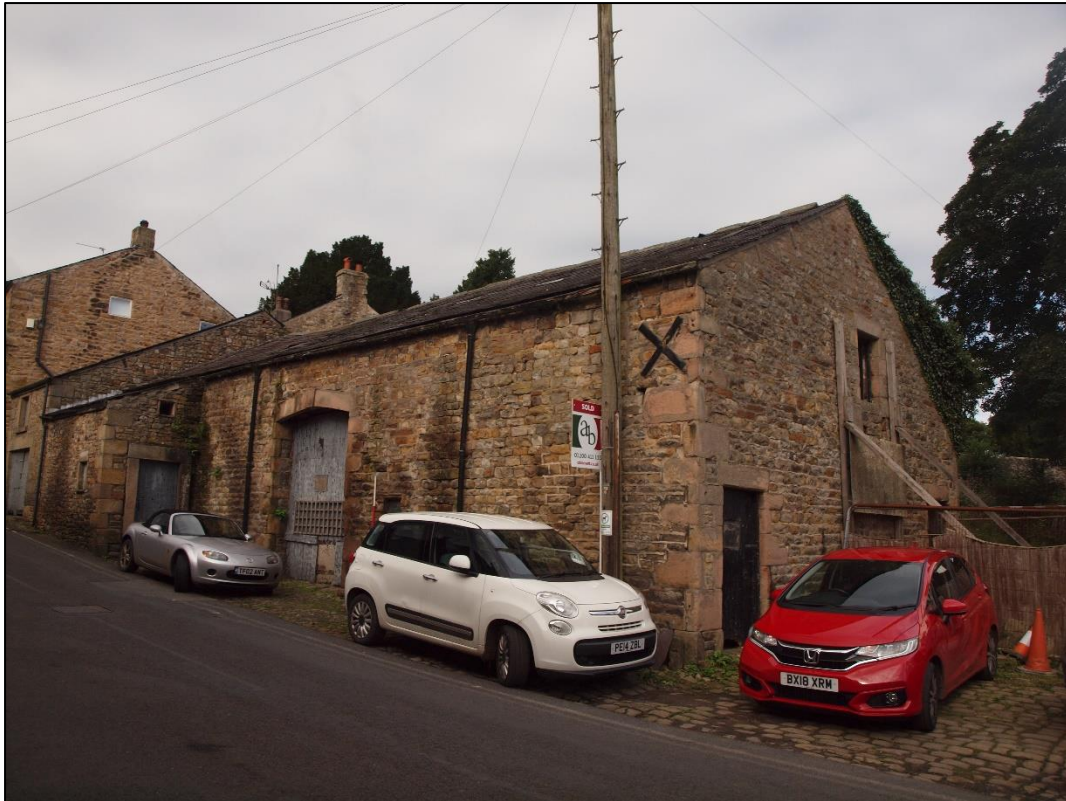
Plate 1: General shot of south elevation from Talbot Street

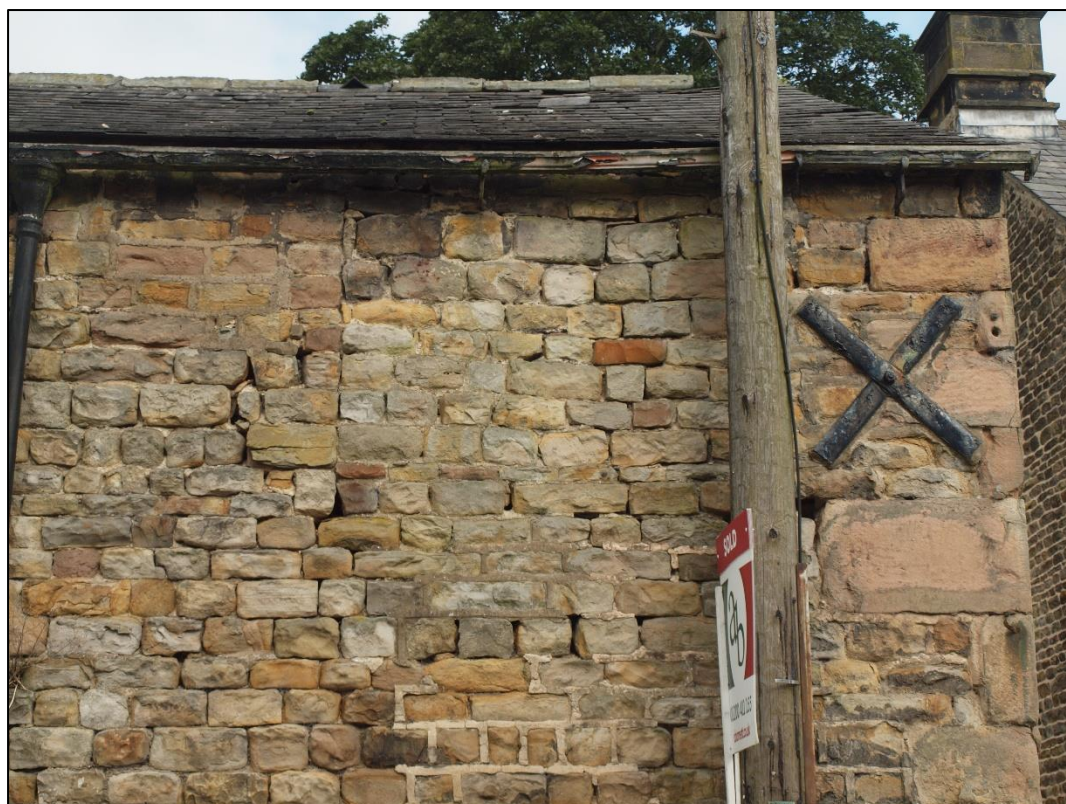
Plate 14: Blocked window at first floor level

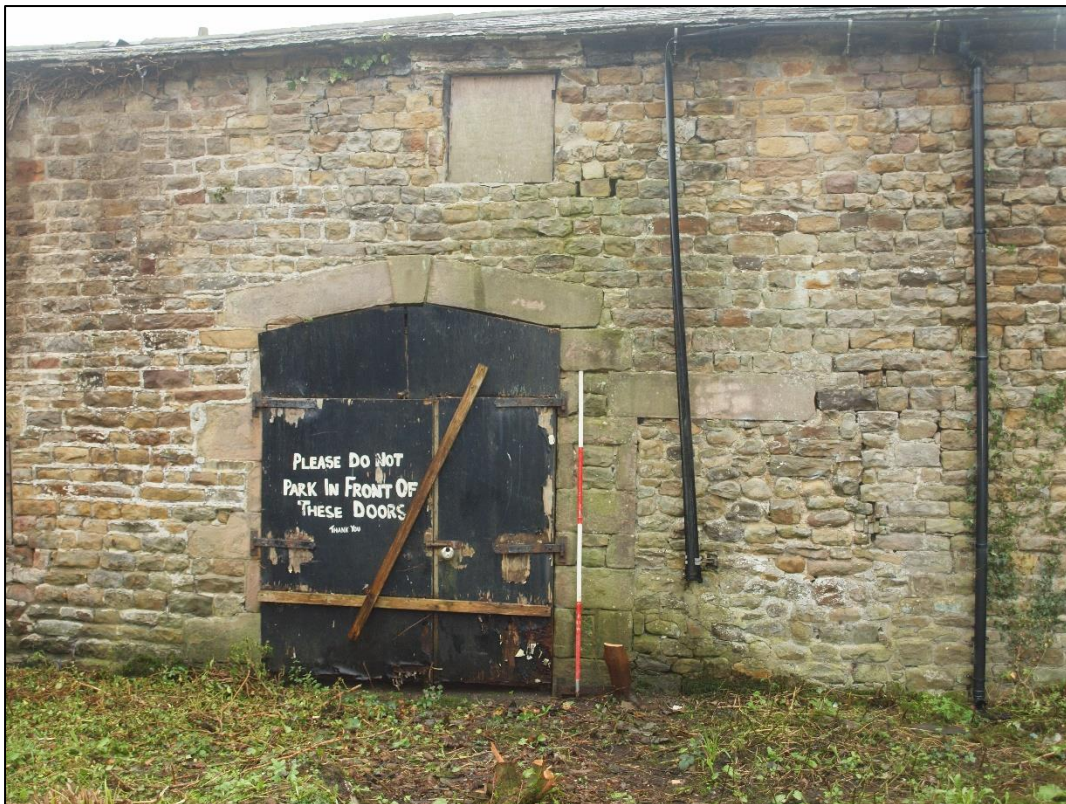
Plate 24: Barn door with pitching eye over and blocked doorway to the right

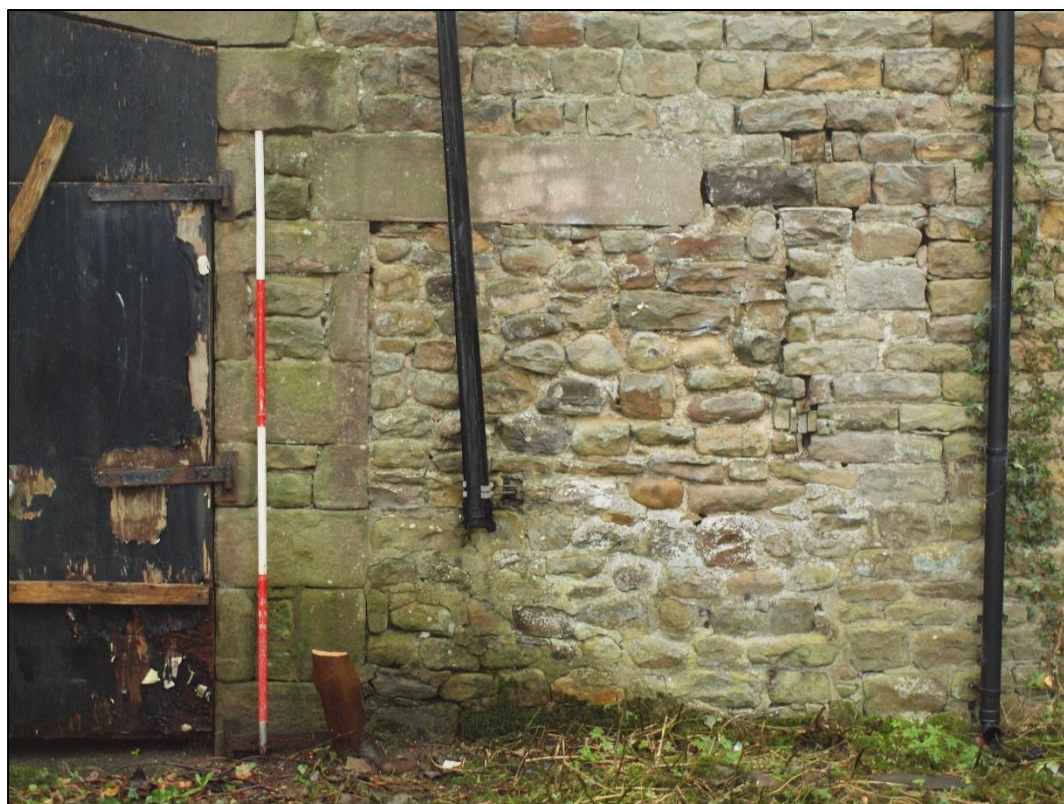
Plate 26: Detail of blocked doorway

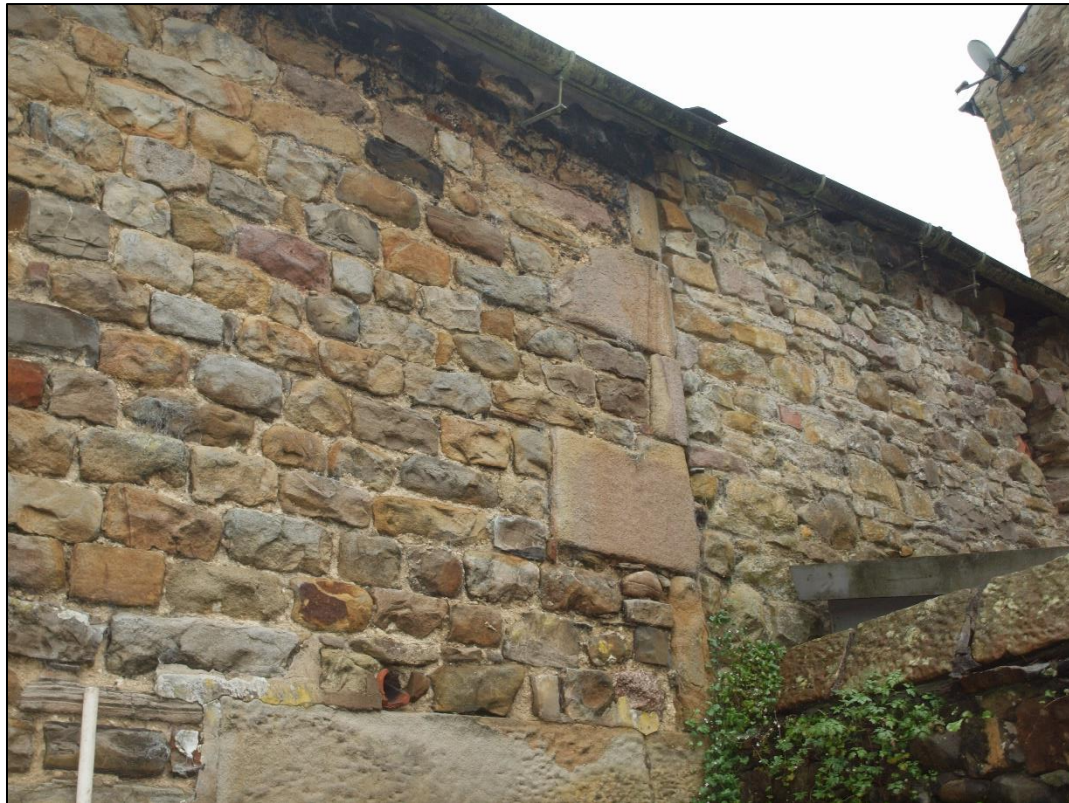
Plate 31: Straight joint with quoins marking end of original barn

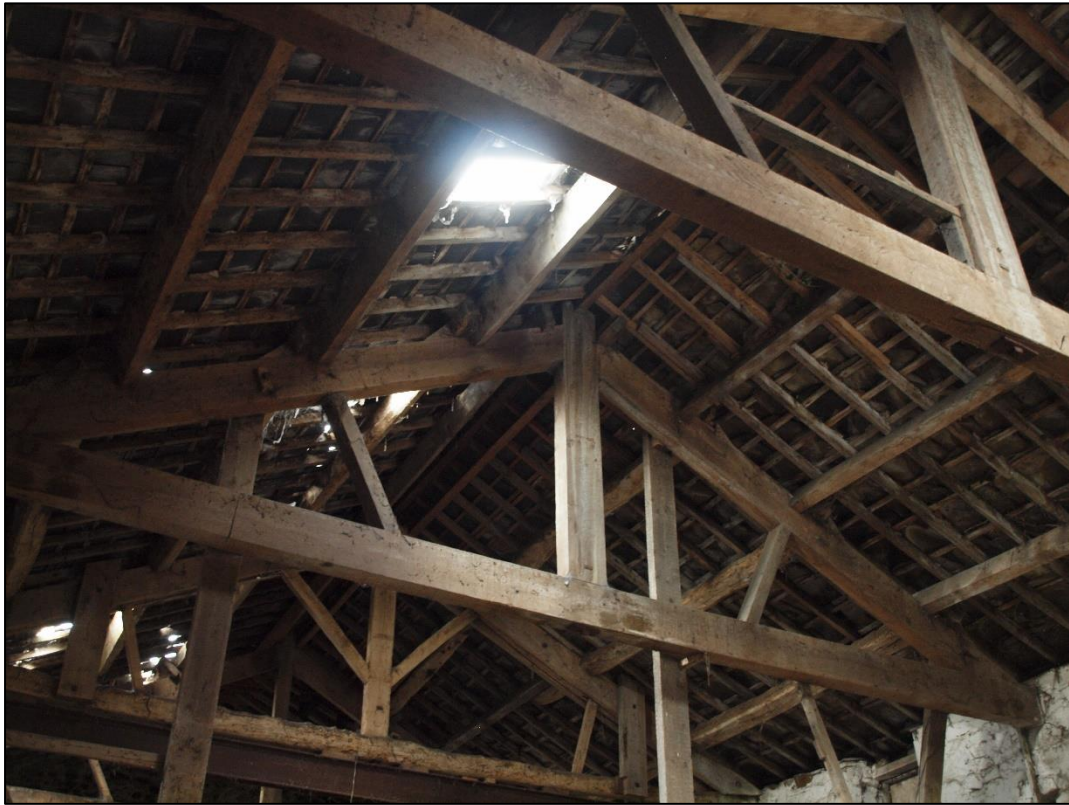
Plate 41: King post trusses

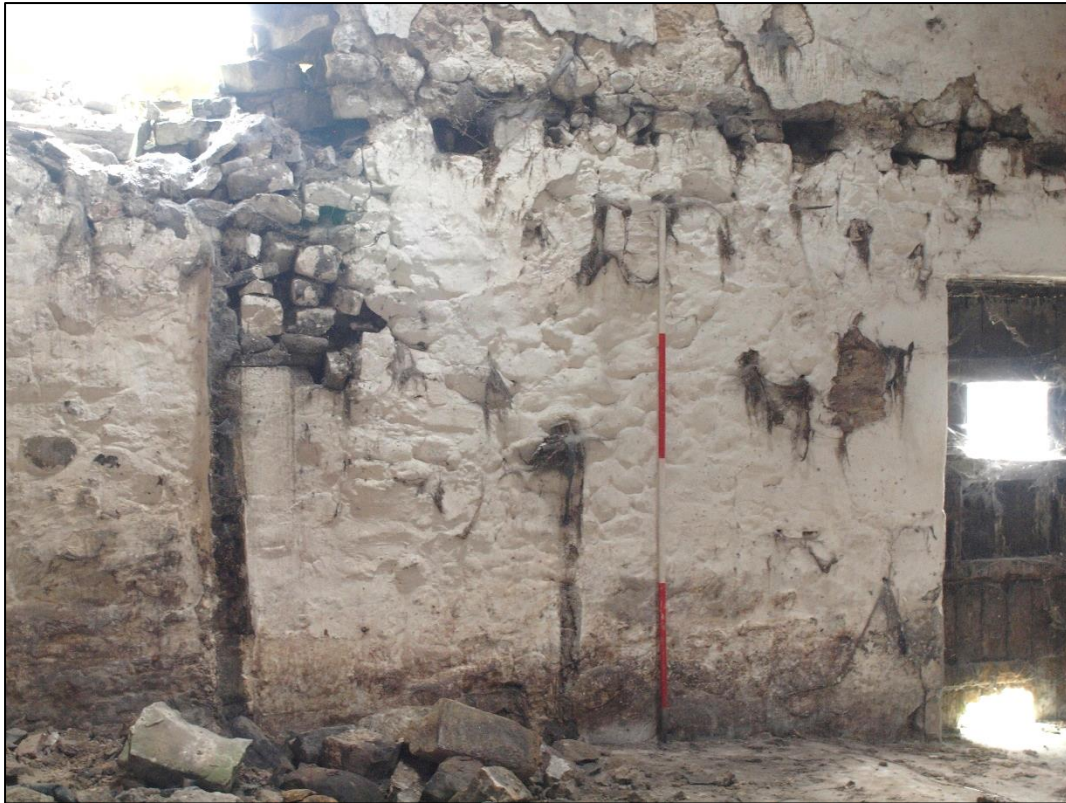
Plate 45: Scars of removed stalls in gable

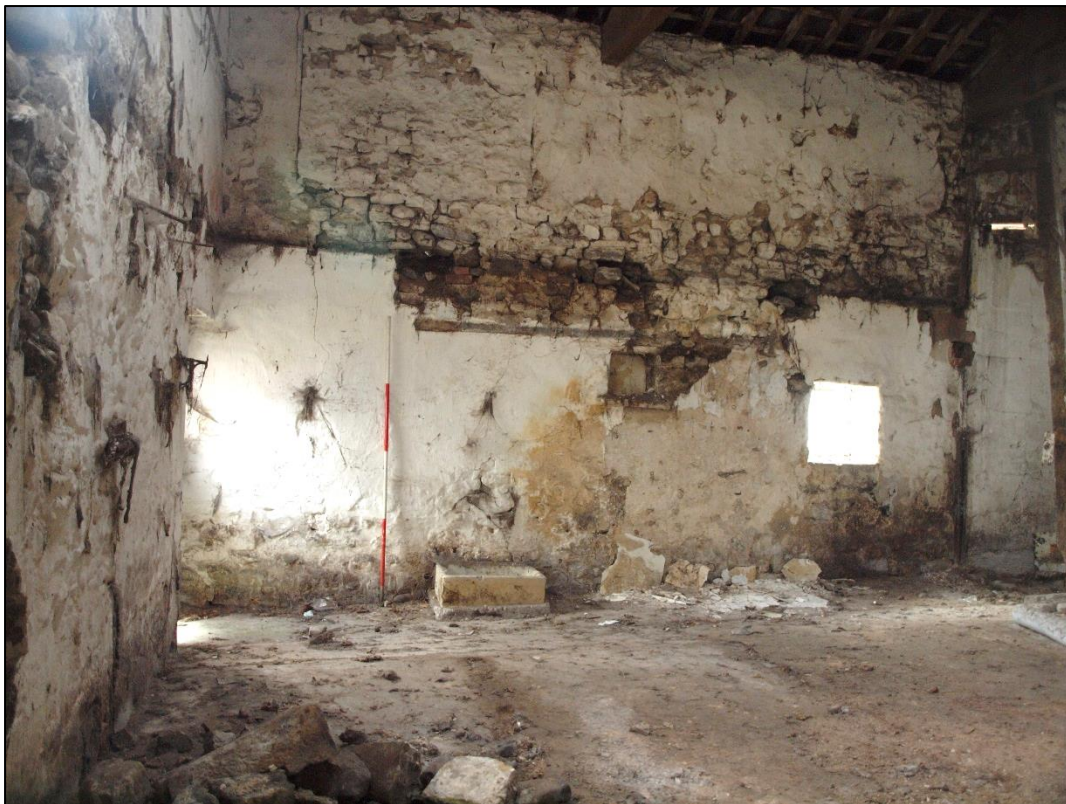
Plate 46: Eastern end of south wall showing blocked first floor window and ground floor niche

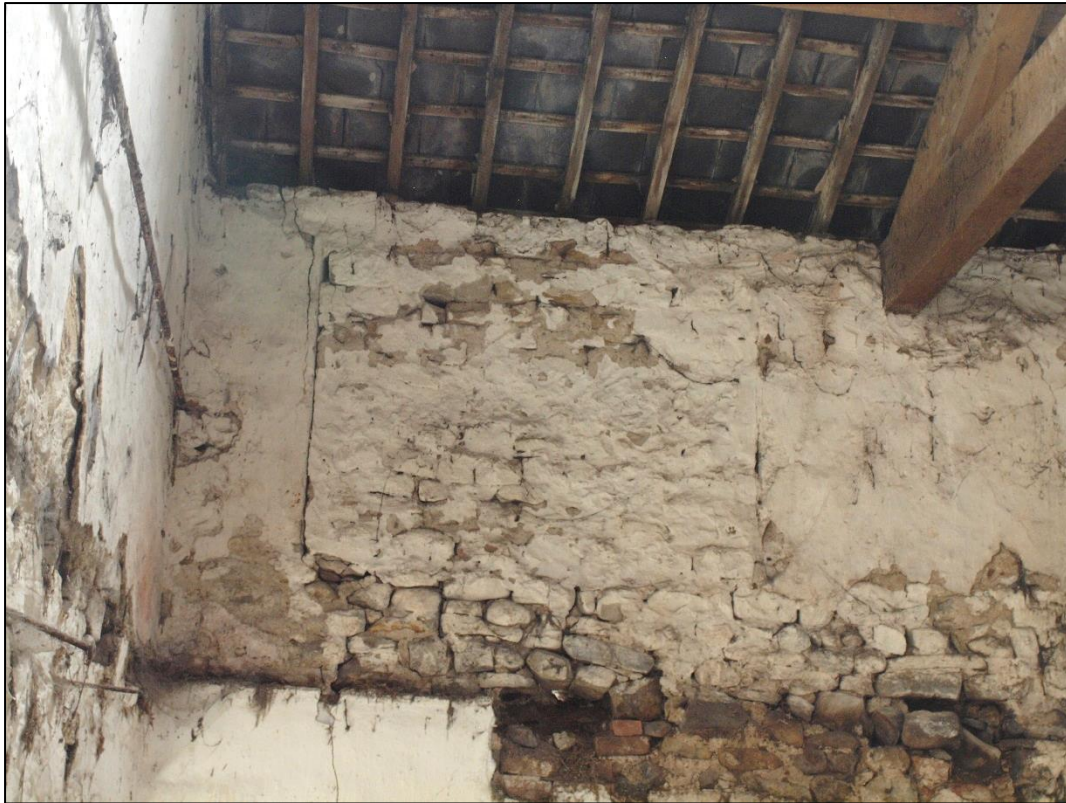
Plate 47: Blocked window shown above

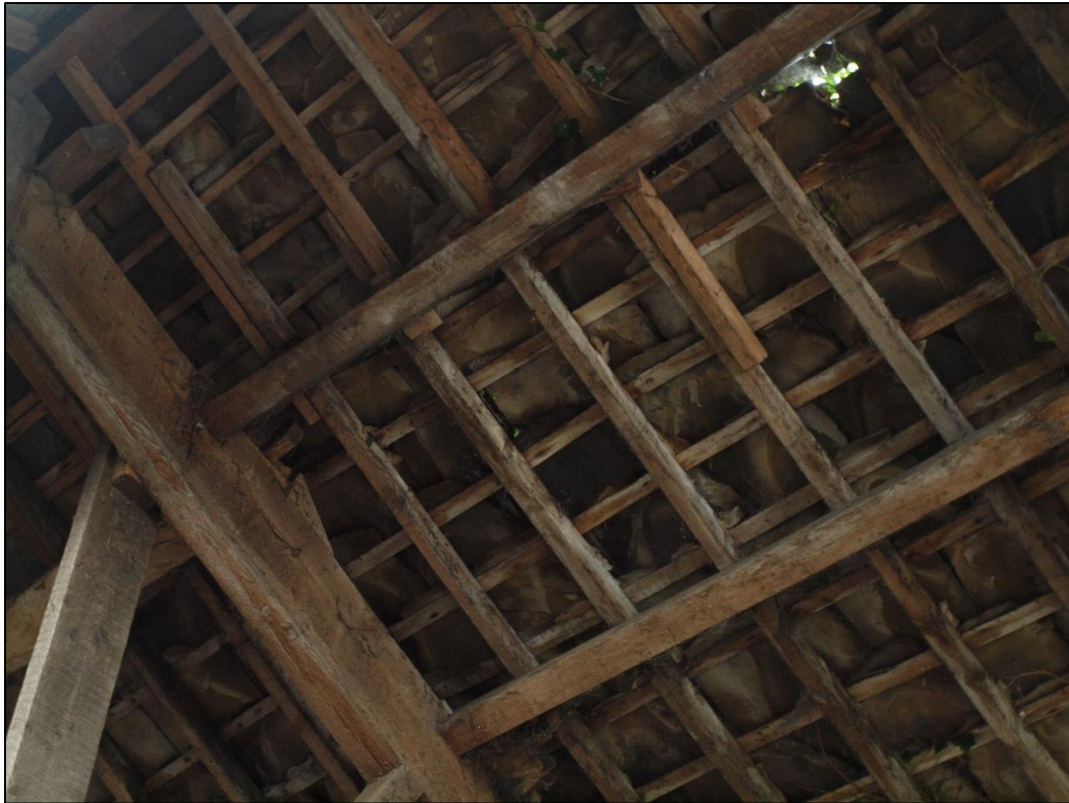
Plate 49: Detail of roof structure

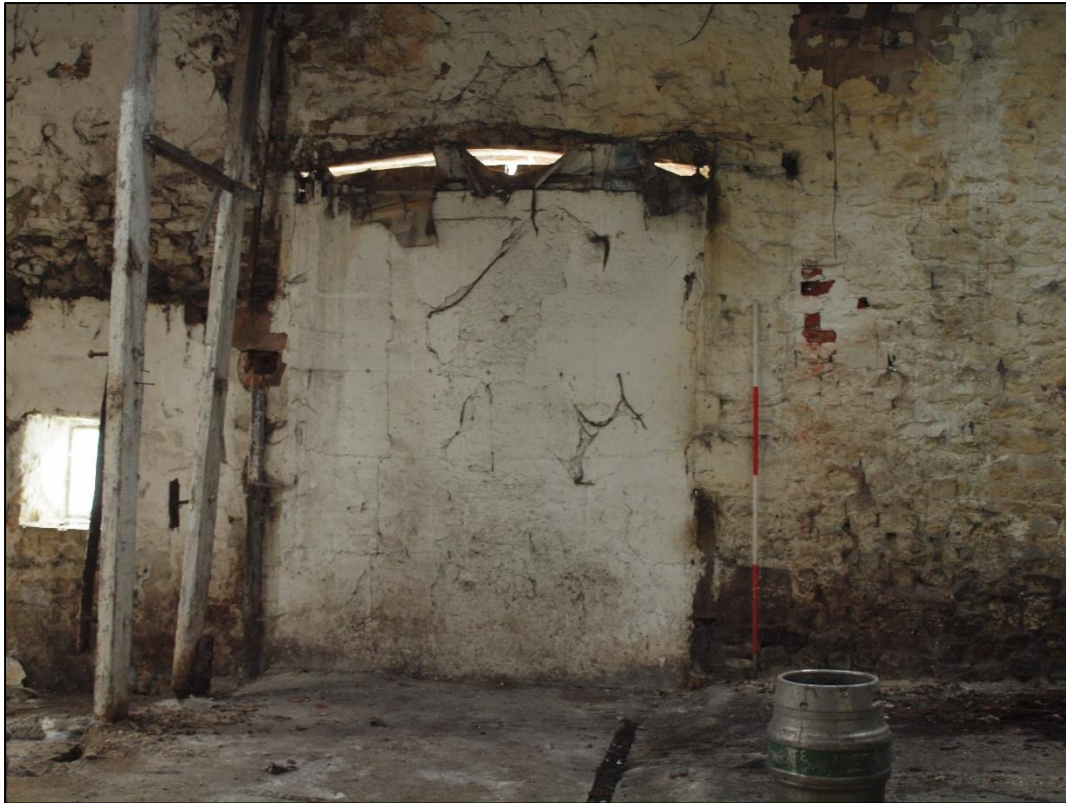
Plate 51: Southern barn door blocked with concrete block

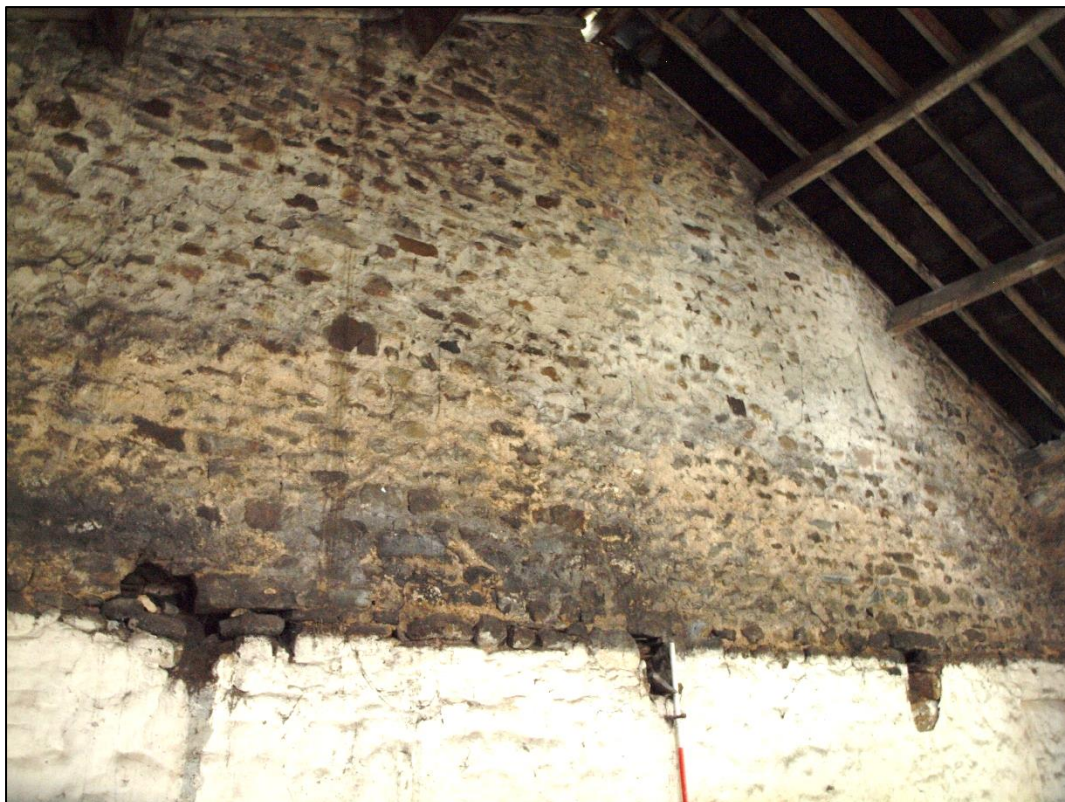
Plate 59: Detail of removed first floor joist holes an first floor of gable

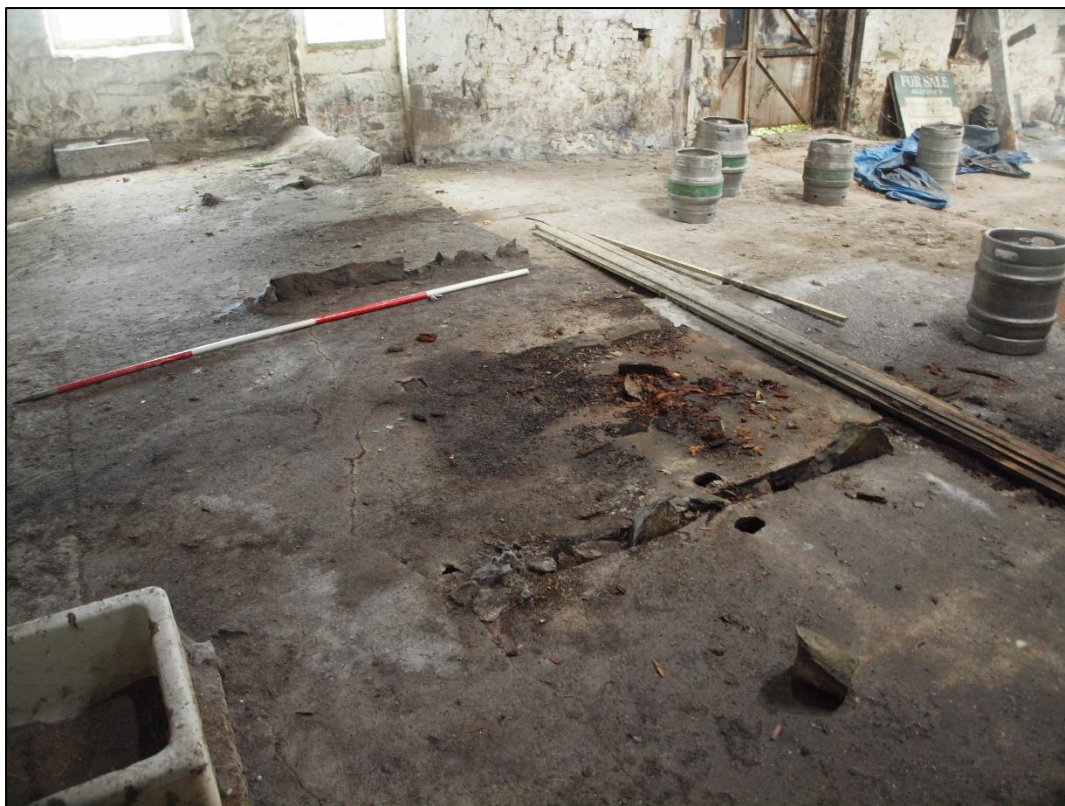
Plate 60: Scars or removed boskins in concrete floor

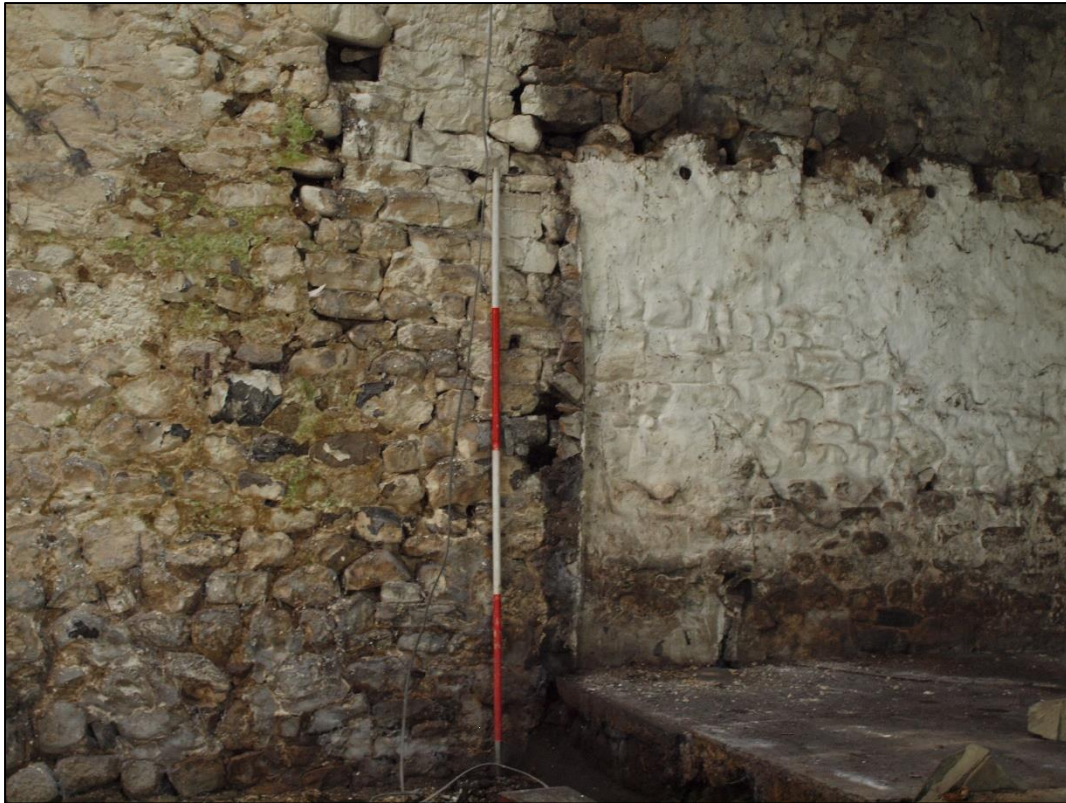
Plate 61: Scar of removed wall to western bay

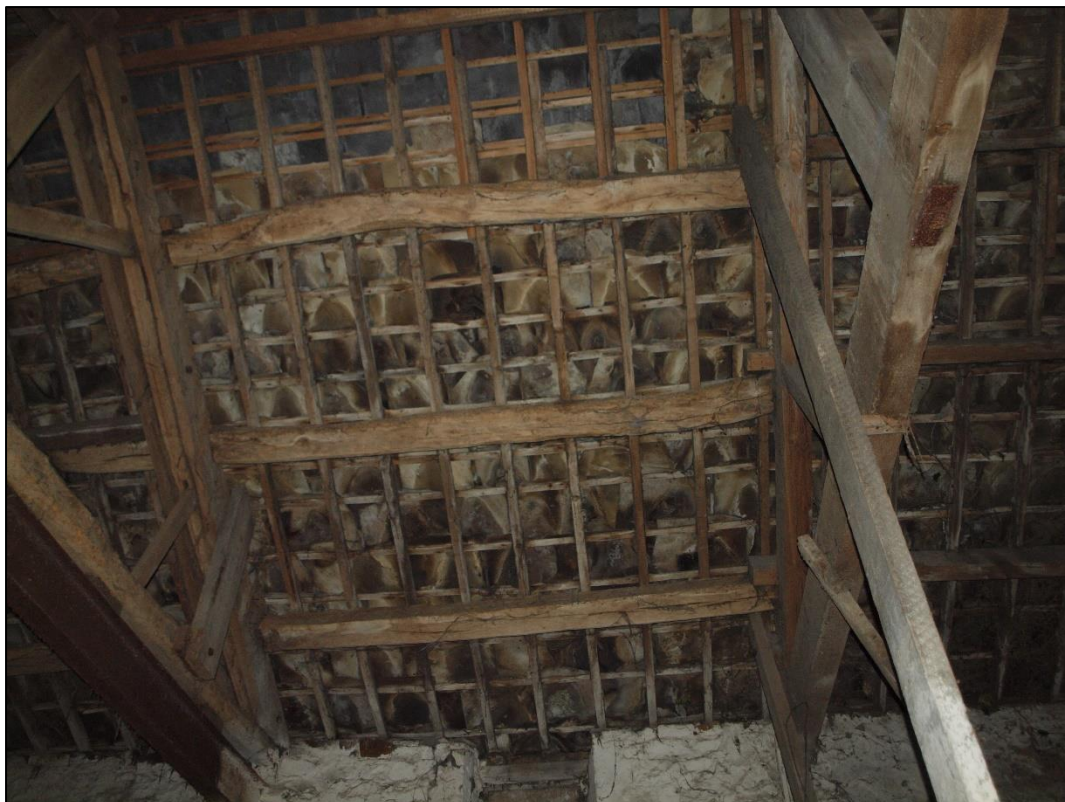
Plate 63: Roof showing remaining hand cut purlins

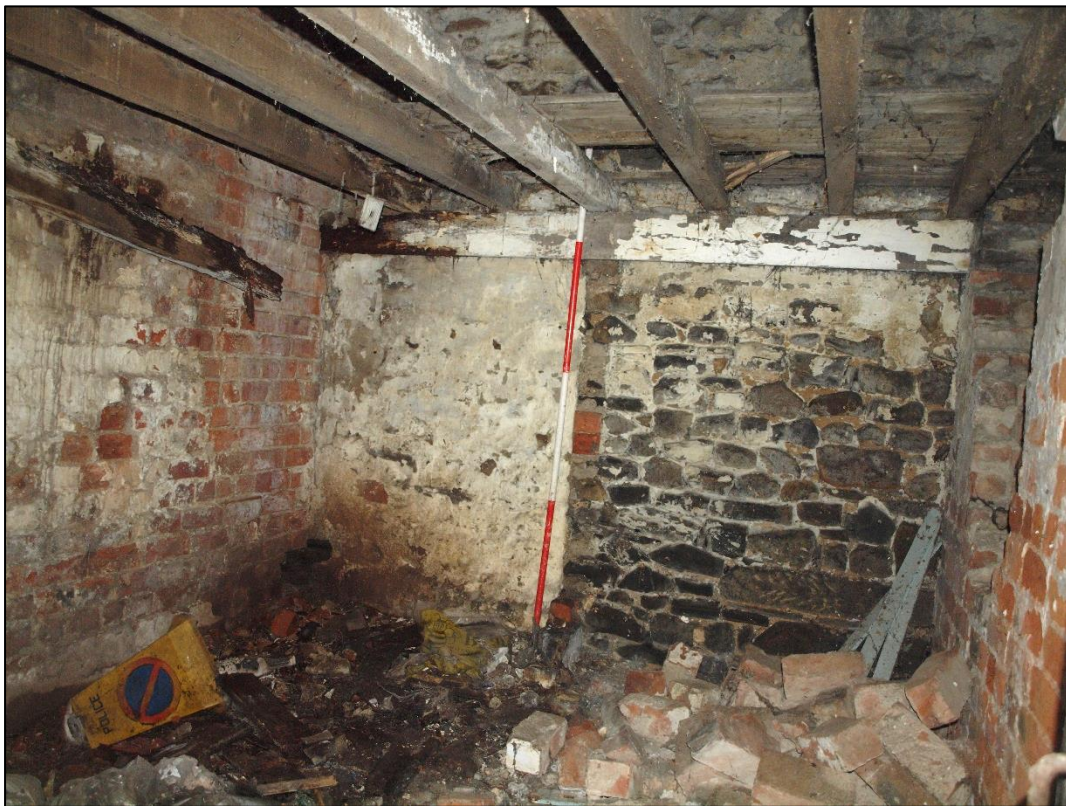
Plate 76: Central room of extension showing scar of removed brick wall
