**THE DUKE OF YORK, GRINDLETON  
STRUCTURAL REPORT**

**PROJECT NO. 7994**

**DATE: 8<sup>TH</sup> AUGUST, 2024**

## **THE DUKE OF YORK, GRINDLETON**

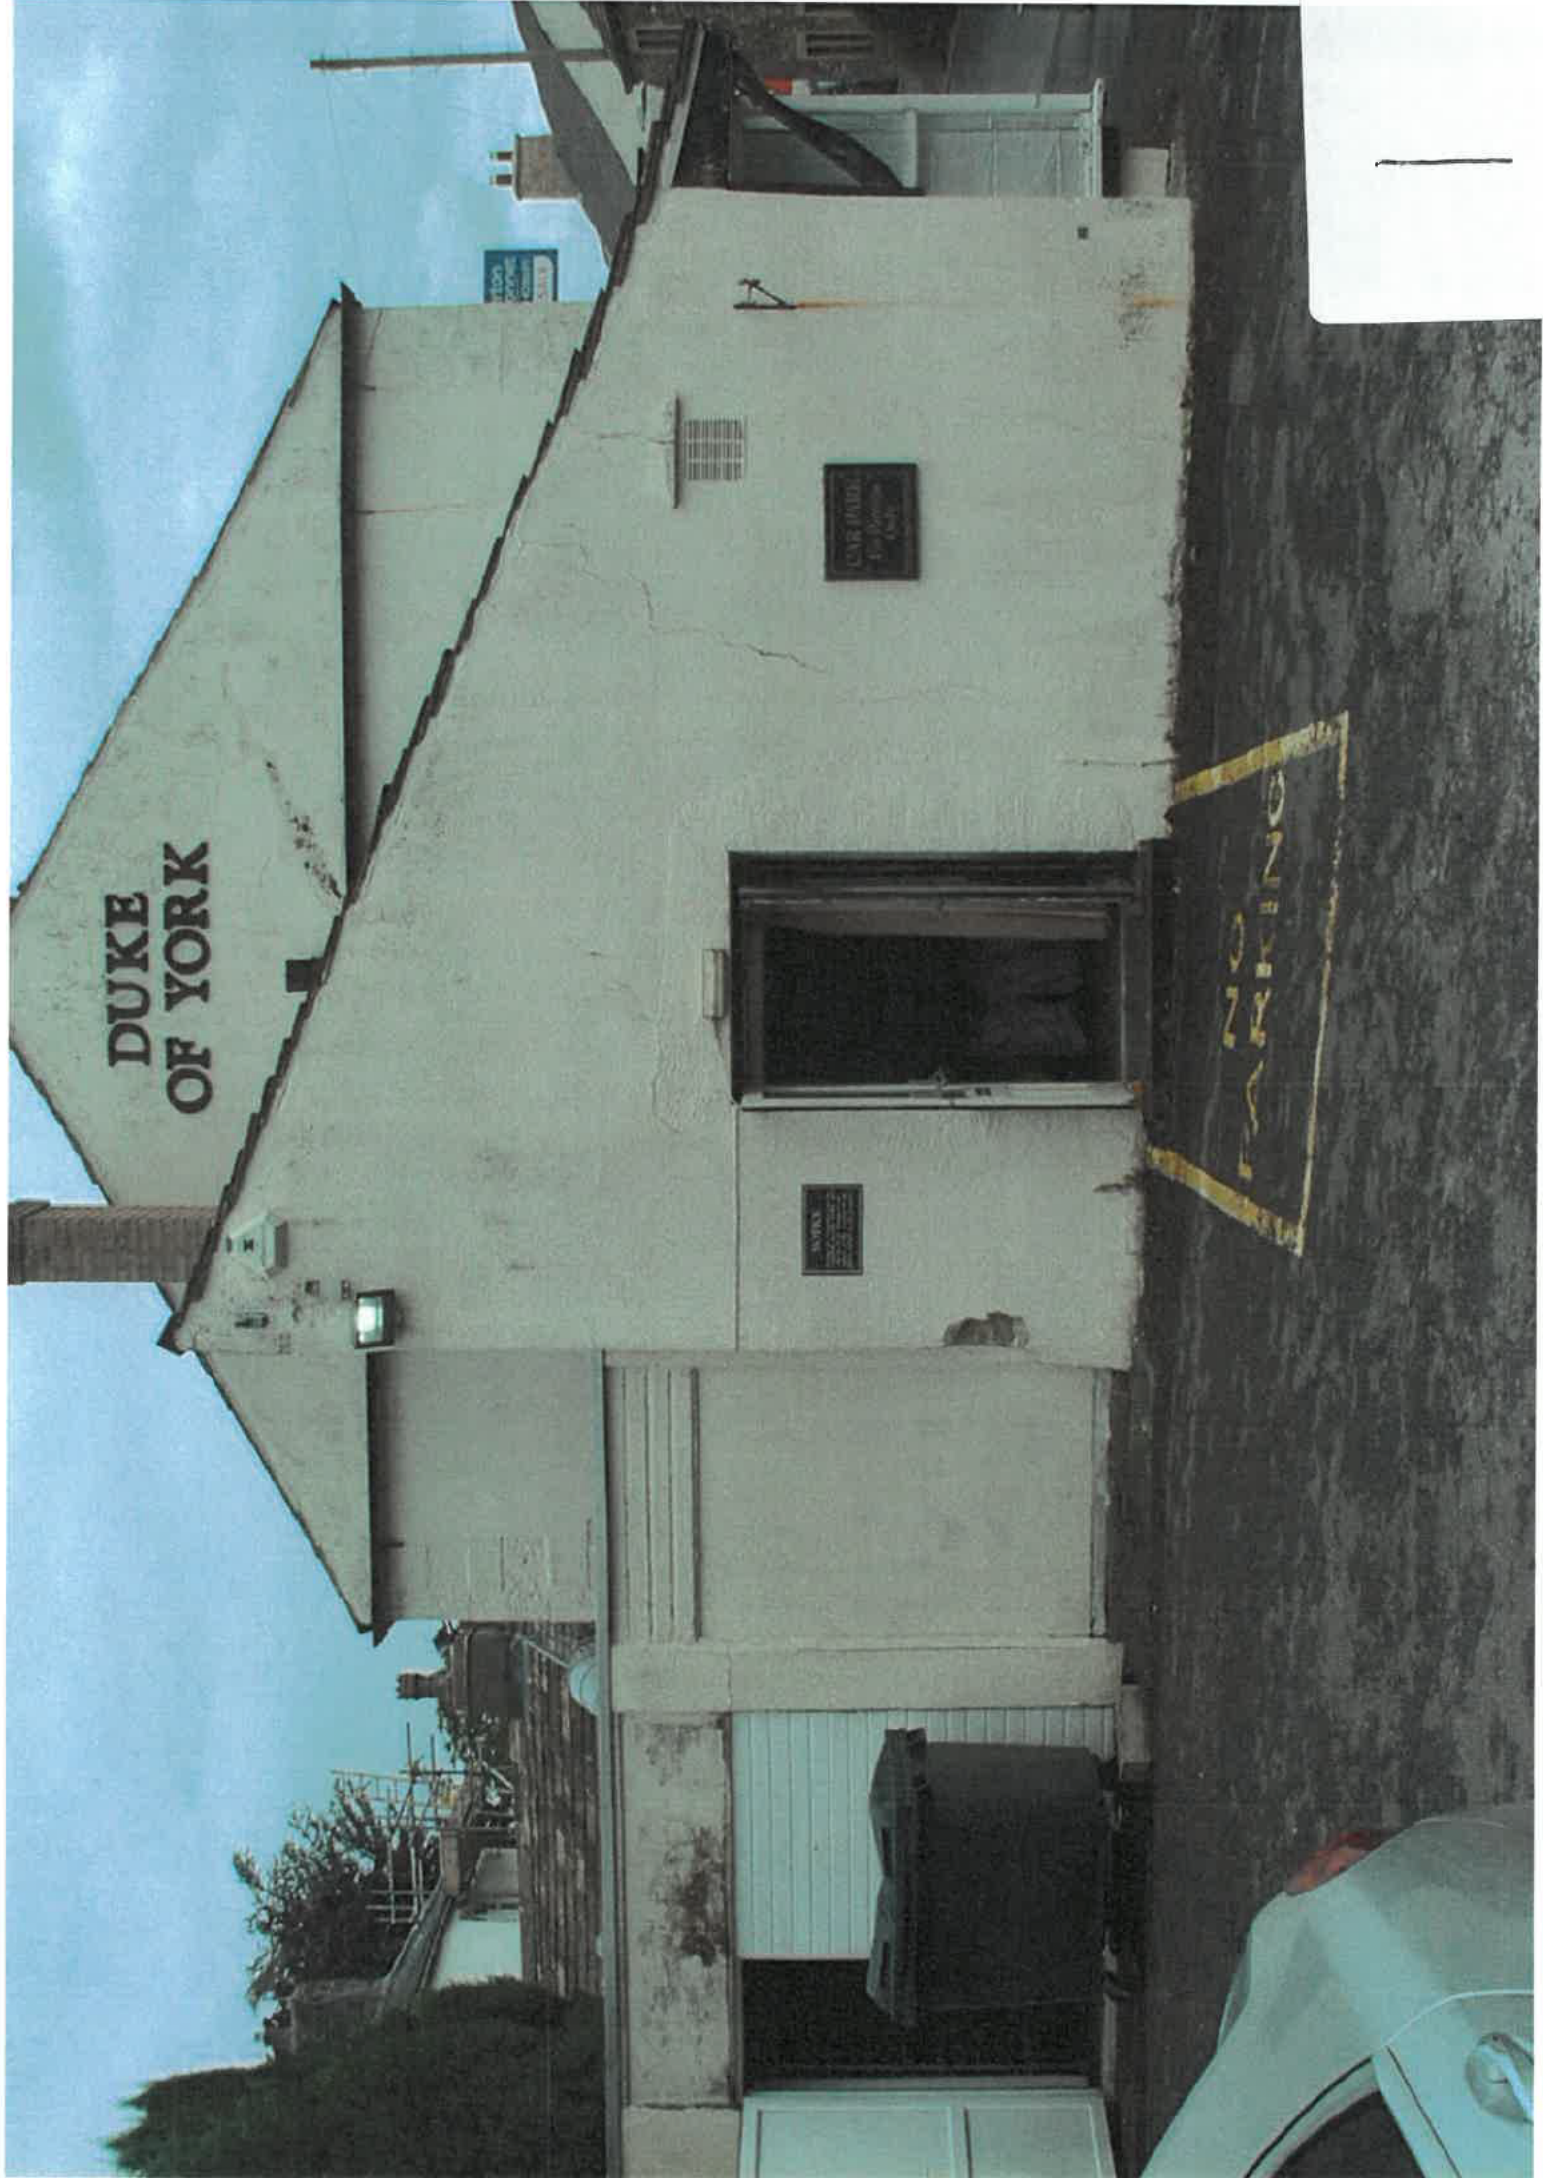
An external inspection of the westerly elevation showed diagonal shear cracks to the rendered finish of the flat extension side wall fronting the car park. Otherwise, walls were reasonably plumb with no evidence of significant recent movement (See Photograph 1).

The property is free from settlement related defects except to the westerly extension which is to be demolished and replaced with new in-character extension occupying the same footprint.

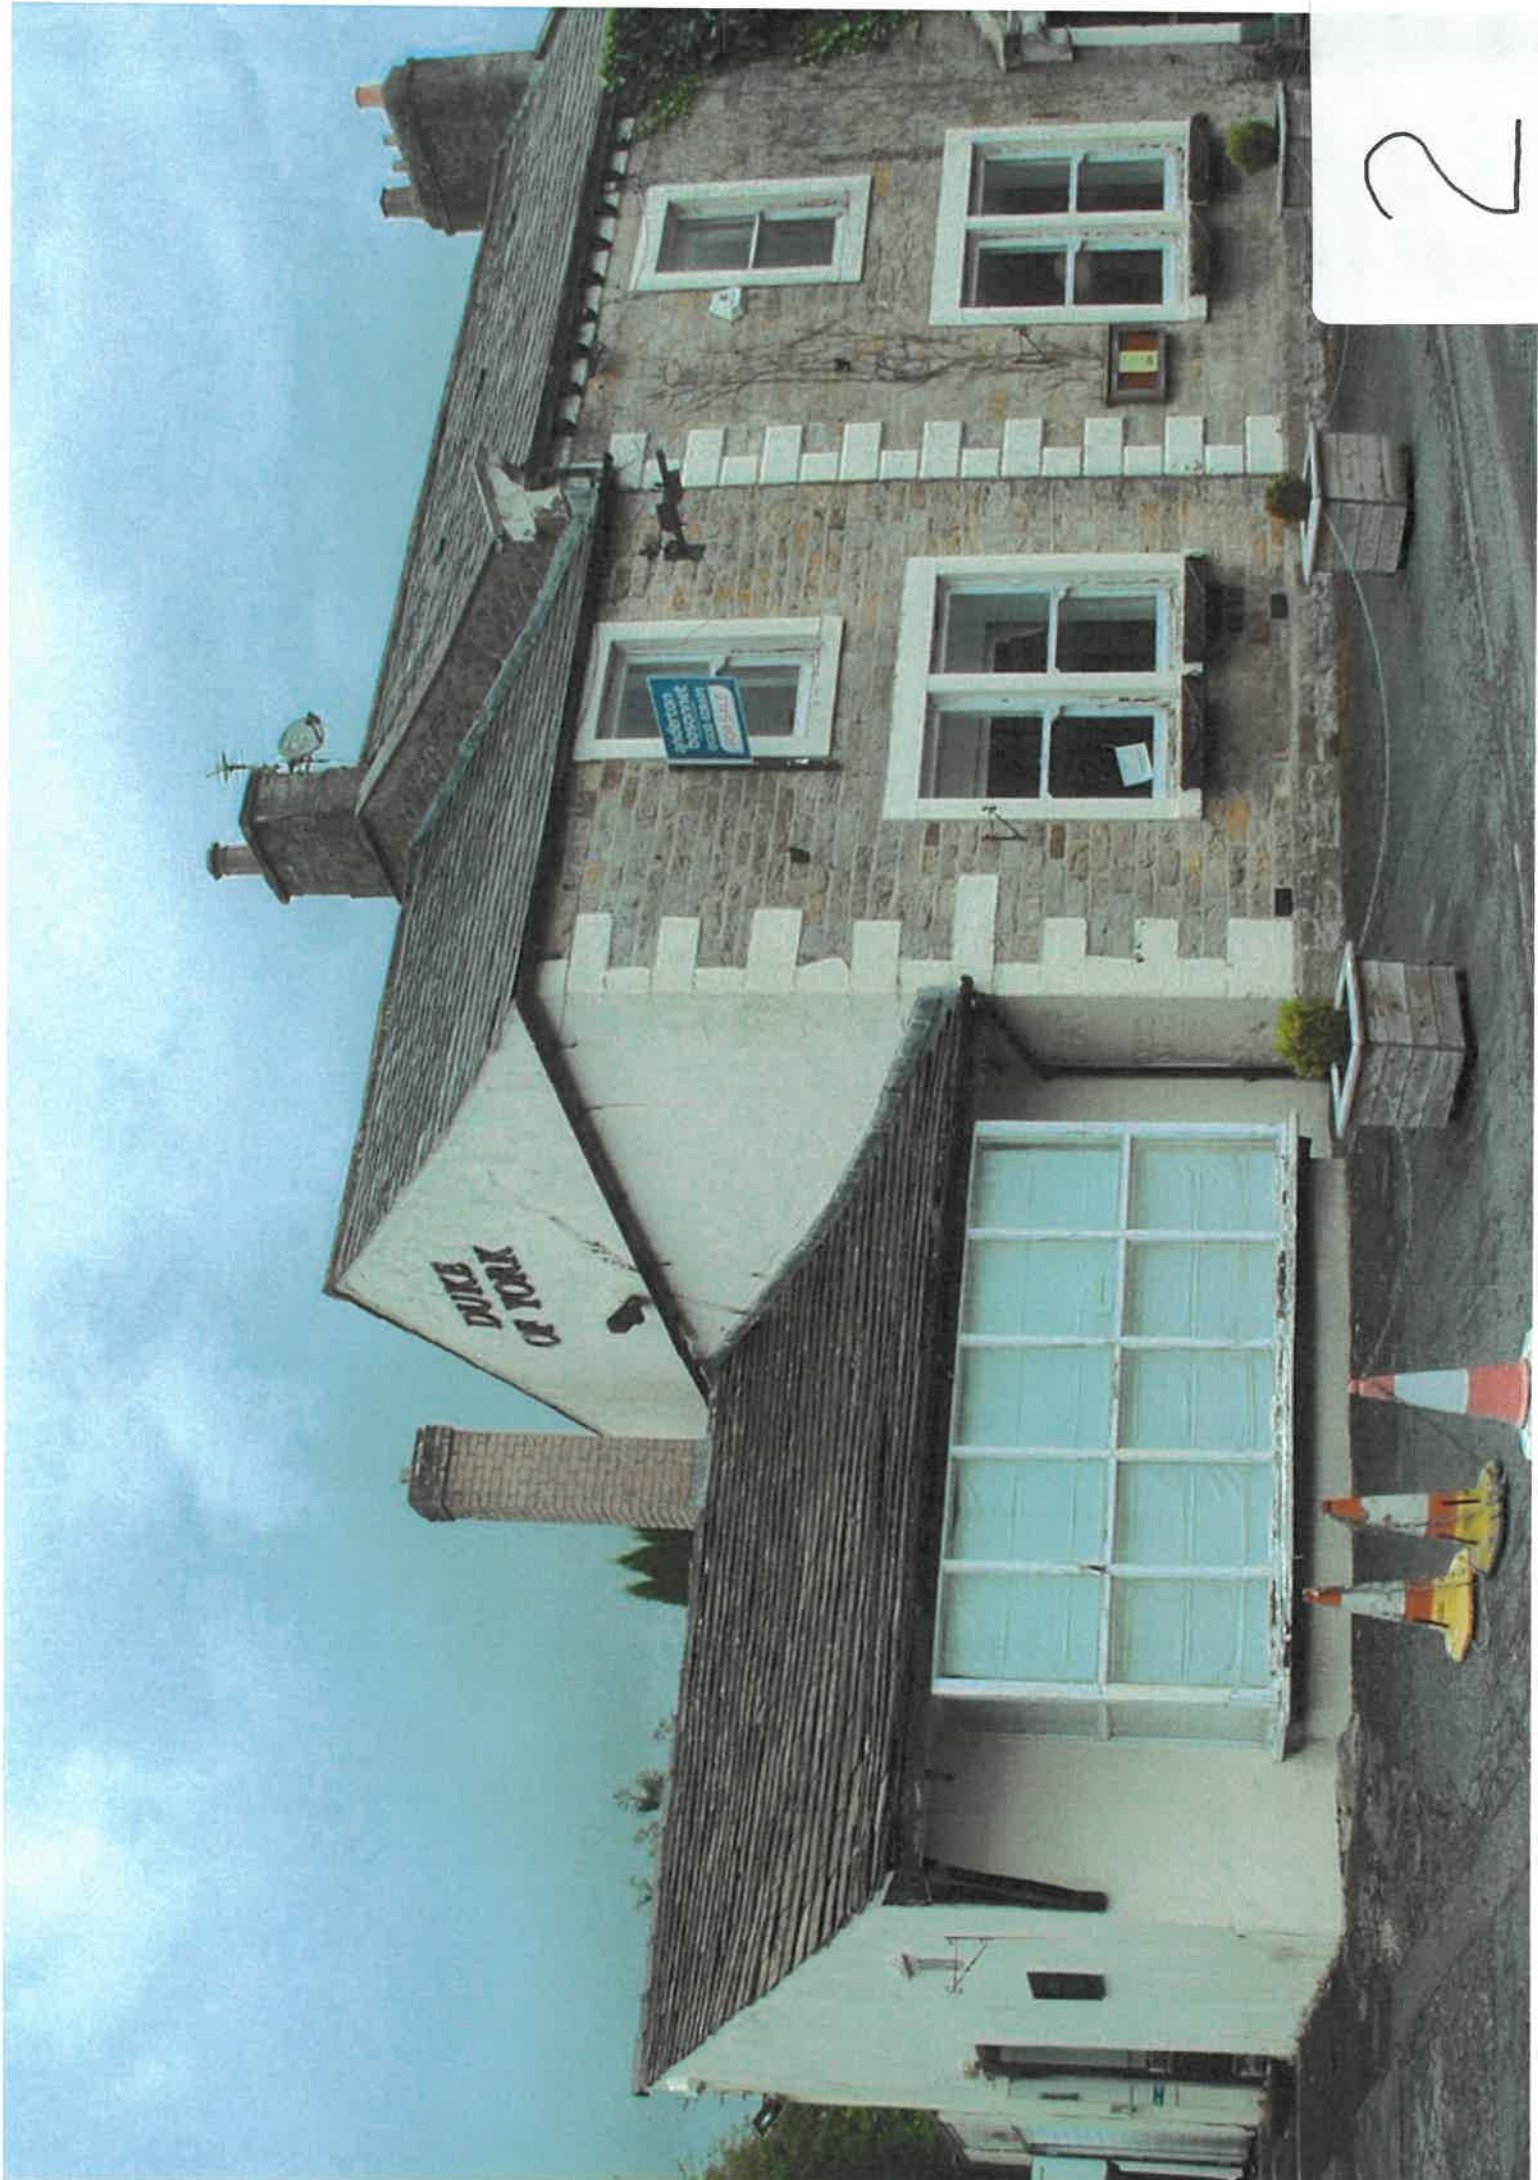
2

An external inspection of the southerly elevation showed walls to be reasonably plumb with only minor displacements and no evidence of significant recent movement (See Photographs 2-3). The blue slate roof coverings displayed reasonably good alignment

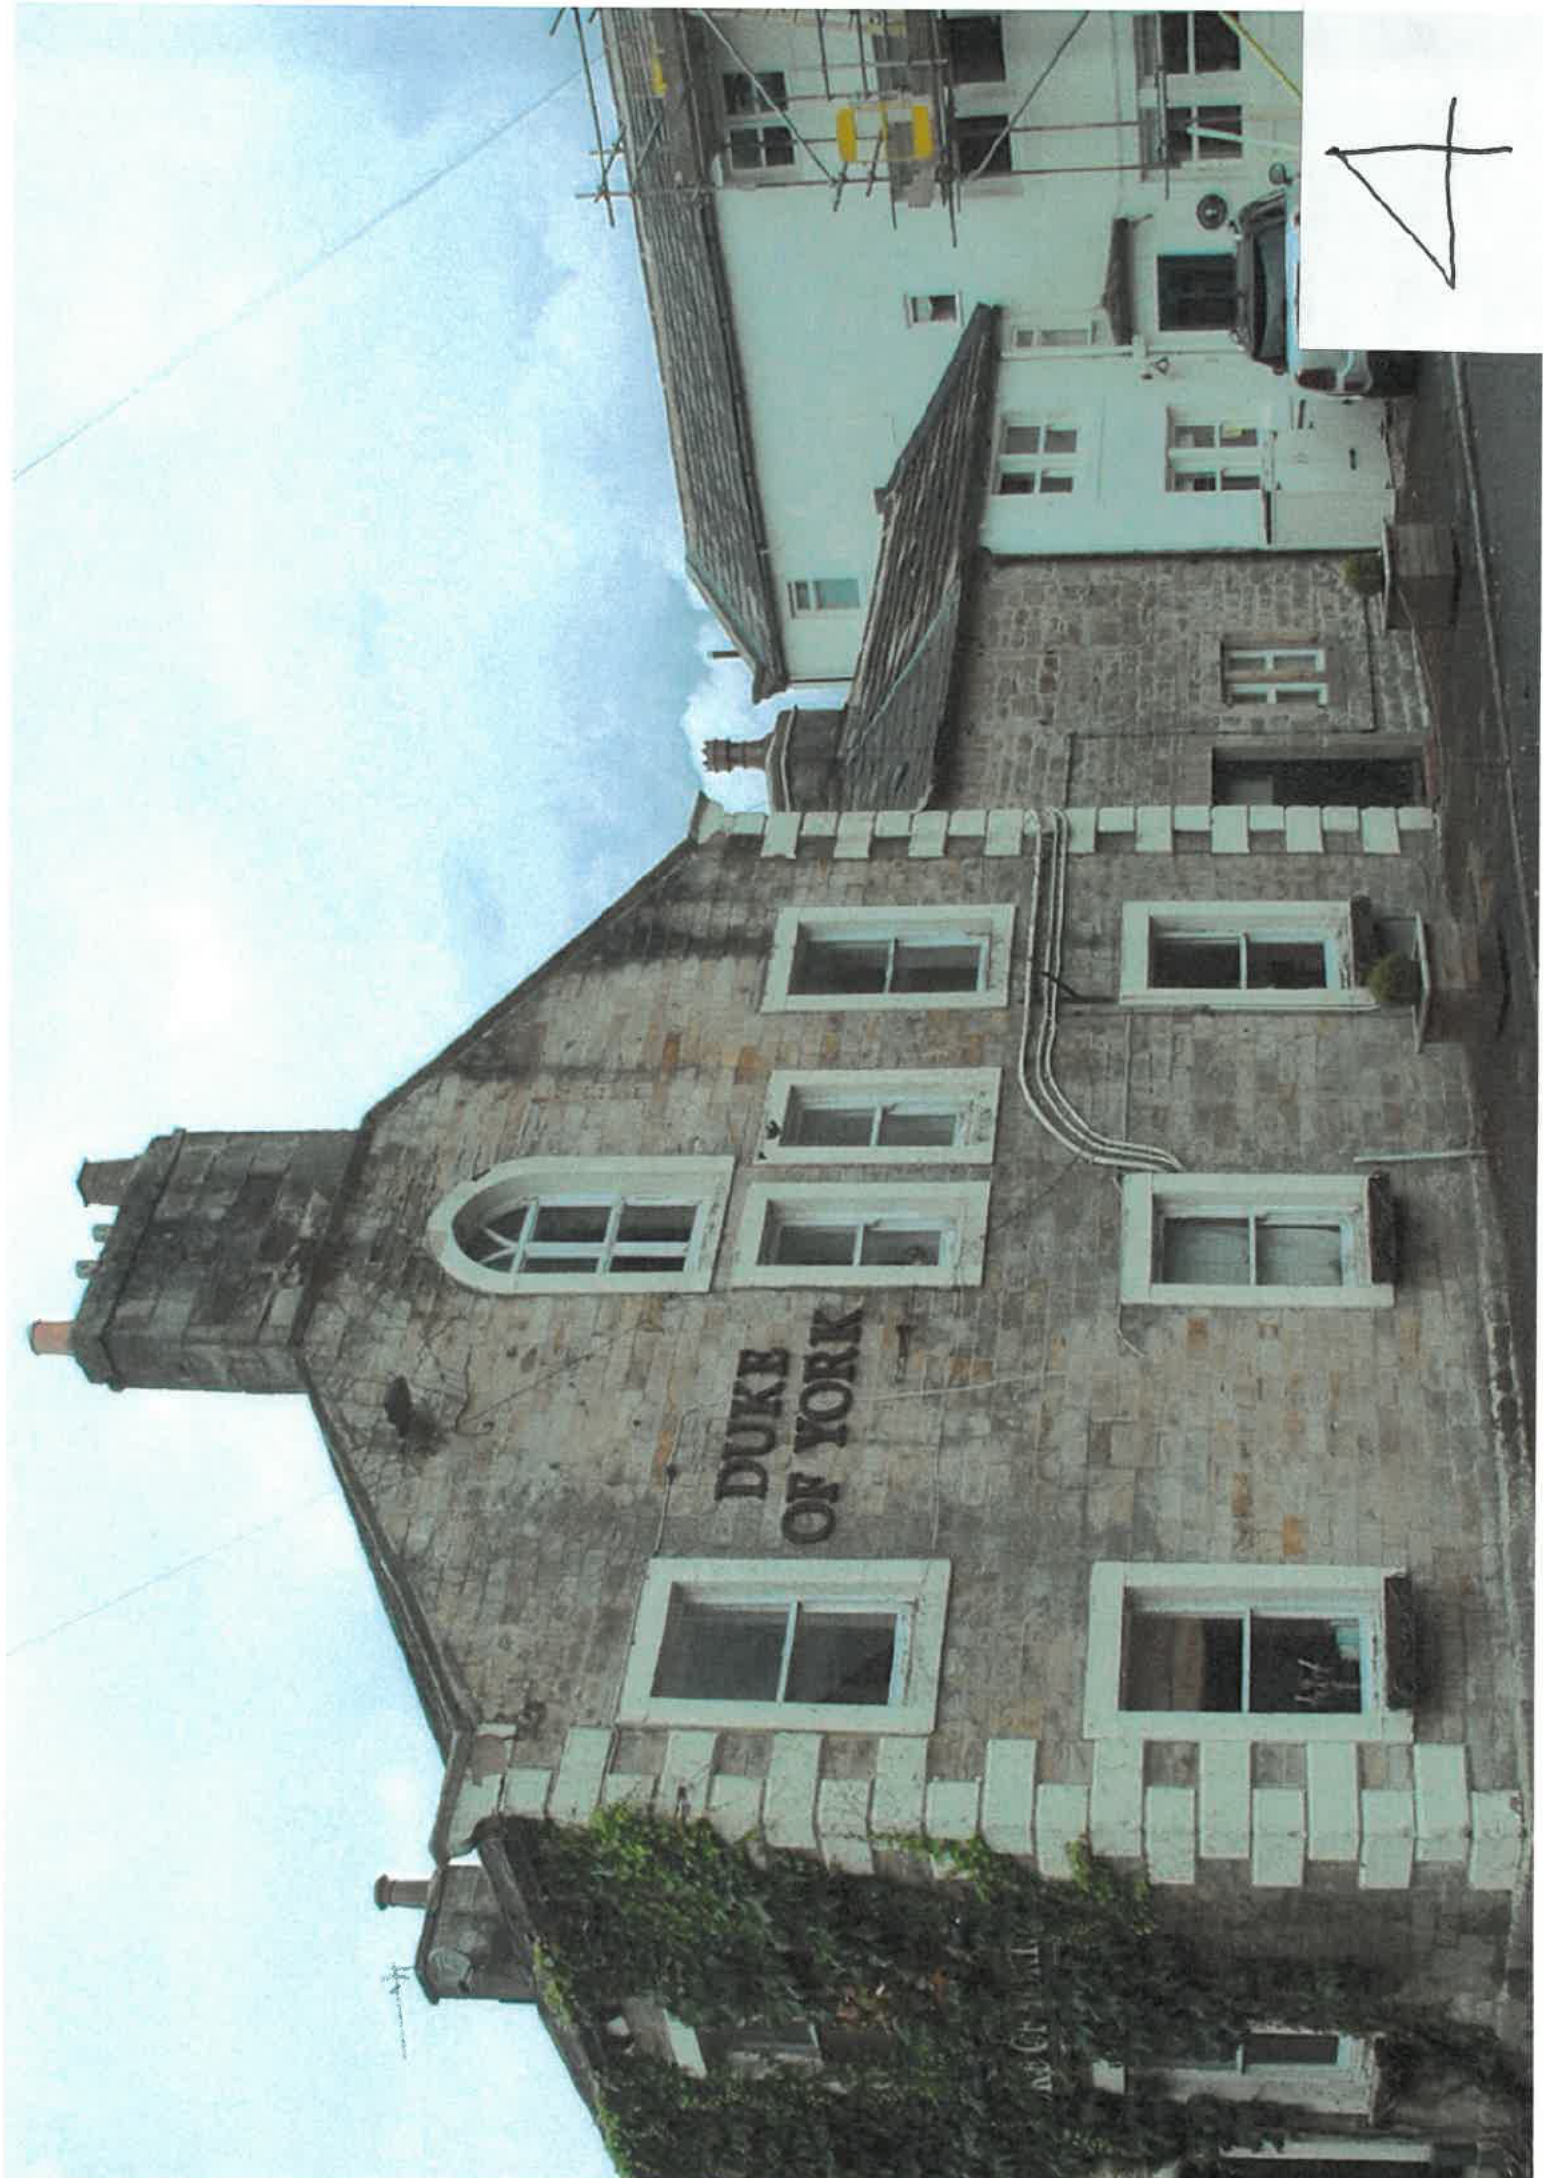
An external inspection of the easterly elevation showed walls to be reasonably plumb with only minor displacements and no evidence of significant recent movement (see Photograph 4).
