Huntroyde Estate  
c/o Ingham and Yorke  
Huntroyde Estate Office  
Padiham  
Burnley  
Lancs BB12 7QX

AD/EC/S1440/SR

- 1.1. The site comprises a two-storey detached barn.
- 1.2. I anticipate the building to be in the region of 200-250 years old with later extensions.
- 1.3. The exact date of construction may be confirmed by examination of the Title Deeds.
- 1.4. For ease of identification, all descriptions in the report will be as though facing the front (West).

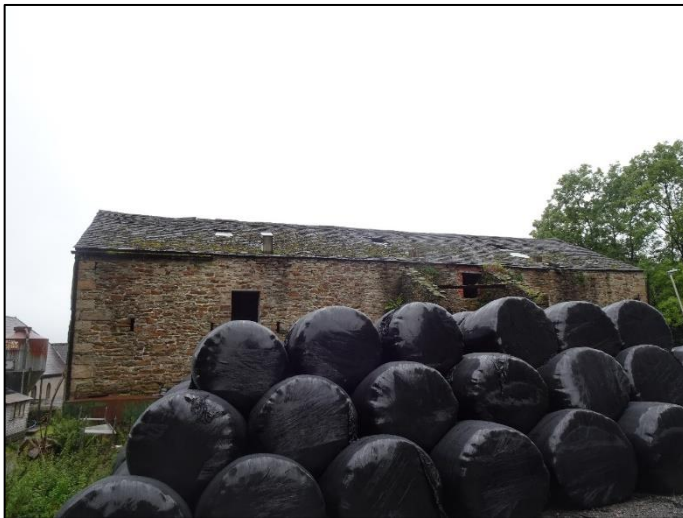
**Photograph 1**

- 2.1.1. The roofs have been viewed from ground level with the aid of a pair of binoculars where appropriate.
- 2.1.2. The roof is of duo-pitched construction with ridges running parallel to the front elevation covered with Hardrow (concrete) slates and mortar bedded and pointed concrete ridges.

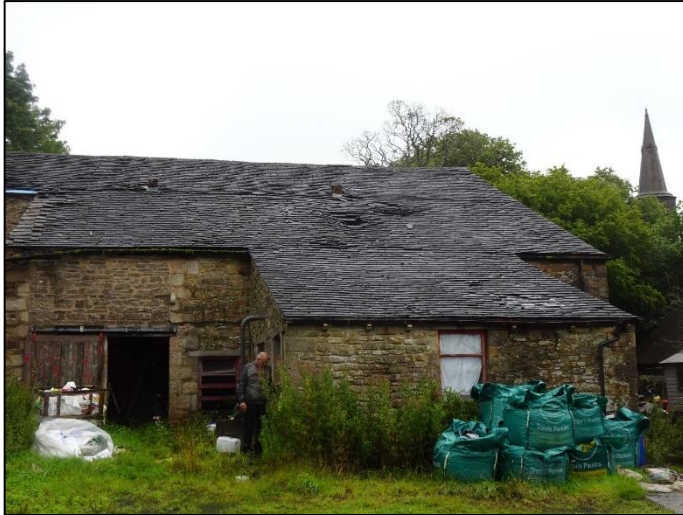
**Photograph 2**

- 2.1.3. There are glazed slates to the rear roof slope to provide natural light internally, two of which are missing.
- 2.1.4. There are catslide details over the front extended sections.

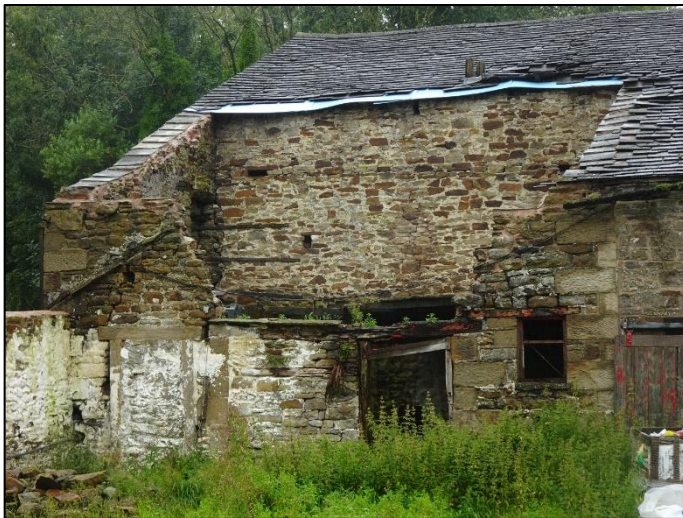
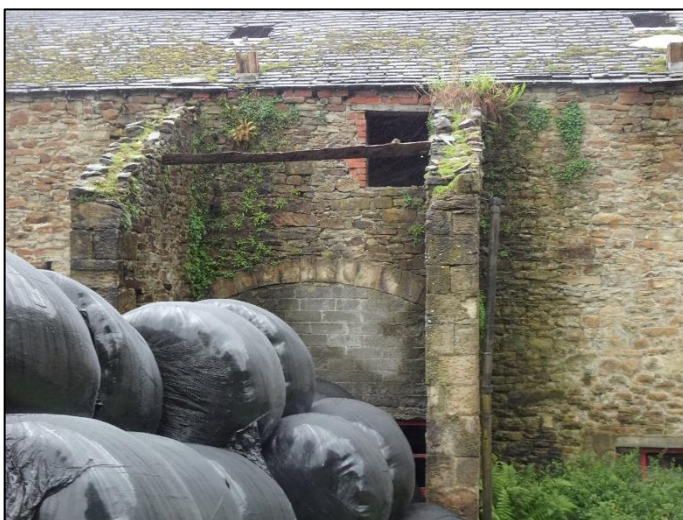
- 2.1.5. The roofs to the left side of the front, two-storey catslide and the rear offshoot have collapsed and these areas of the building are now open to the elements.

- 2.1.6. The roofs to these areas should be replaced.
- 2.1.7. The roof coverings elsewhere are in poor condition with numerous slipped, missing and displaced slates noted, resulting in water ingress.

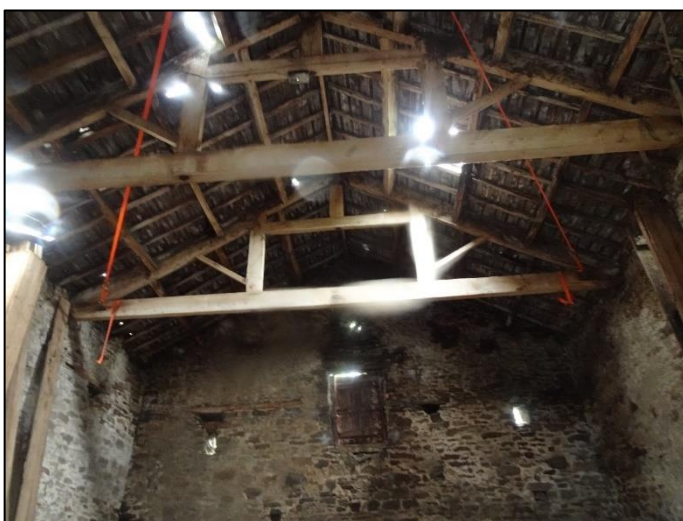
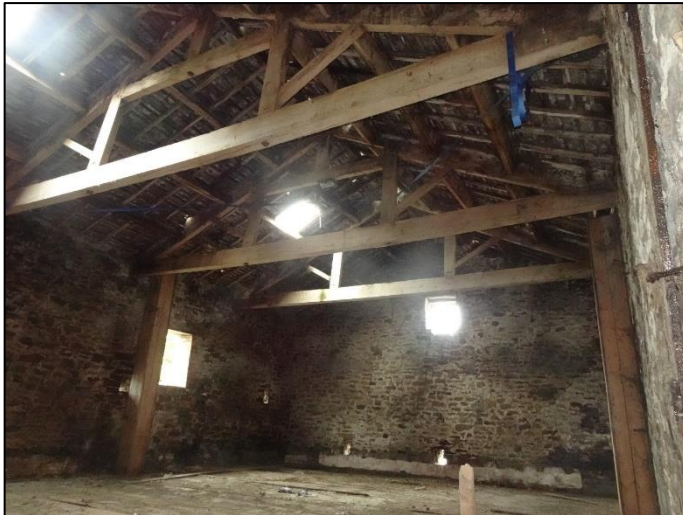
- 2.1.8. As part of any future refurbishment/conversion works, the roof should be stripped and re-covered.
- 2.1.9. There is some deflection noted to the roof slopes and ridge line. Internally purlins are noted to be deflected.
- 2.1.10. I anticipate that the deflection has occurred under the weight of a previous stone slate covering and is unlikely to become significantly worse.
- 2.1.11. The roof structure to the main two-storey section of the building comprises King post trusses supporting three rows of purlins to each roof slope, in turn supporting common rafters.

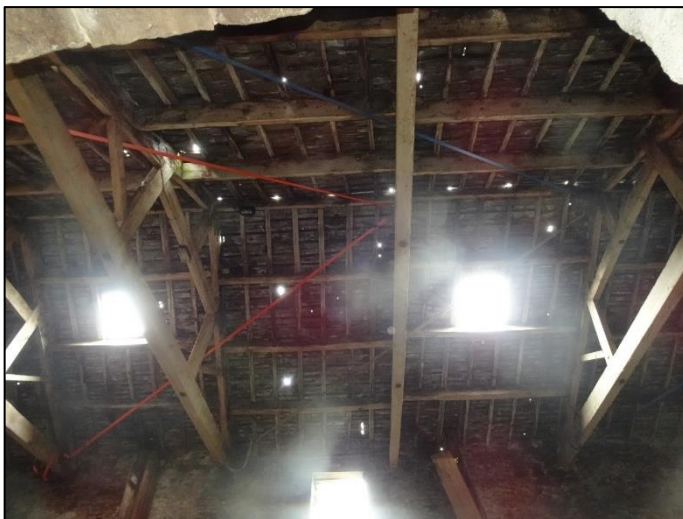
**Photograph 8**

- 2.1.12. Full examination of the structure was restricted due to a lack of safe access to the first floor.
- 2.1.13. There are isolated areas of damage/decayed rafters as a result of water penetration which will require replacement as necessary.
- 2.1.14. The trusses are noted to lean out of plumb which has resulted in movement to the gable apexes. Straps have been installed to provide restraint.

- 2.1.15. The trusses are sound and suitable for retention. The roof structure will require taking down and re-assembling.
- 2.1.16. Active woodworm infestation is noted to the first-floor timbers and therefore I would recommend that woodworm treatment is undertaken to the roof structure.
- 2.1.17. The roof structure to the front two-storey catslide roof comprises mono trusses supporting purlins, in turn supporting common rafters.

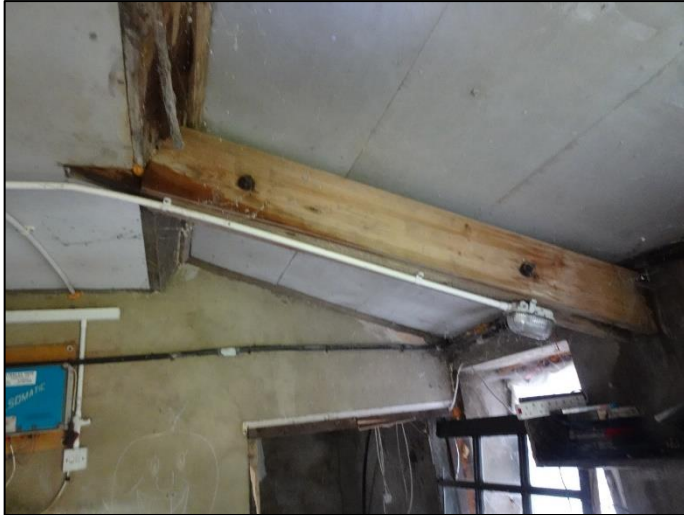
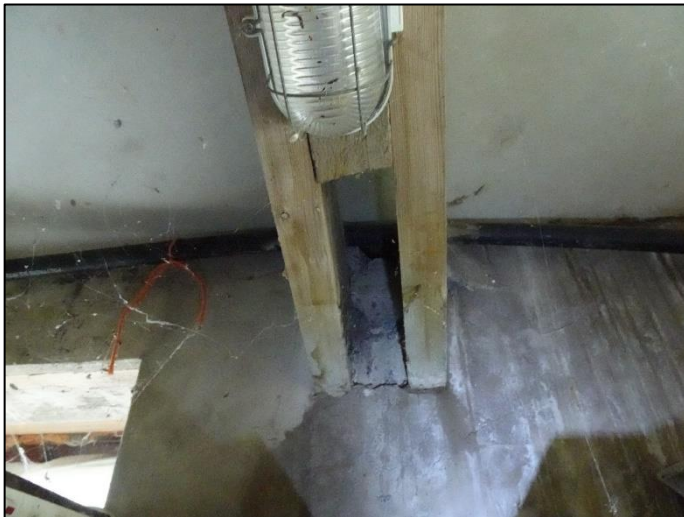
- 2.1.18. The roof structure to the front single-storey catslide roof comprises principal rafters supporting purlins, in turn supporting common rafters. The roof structure has been partially underlined which has obstructed examination.
- 2.1.19. Repairs have been undertaken to strengthen the left-side principal rafter where the rafter foot has decayed. The repair undertaken appears adequate.

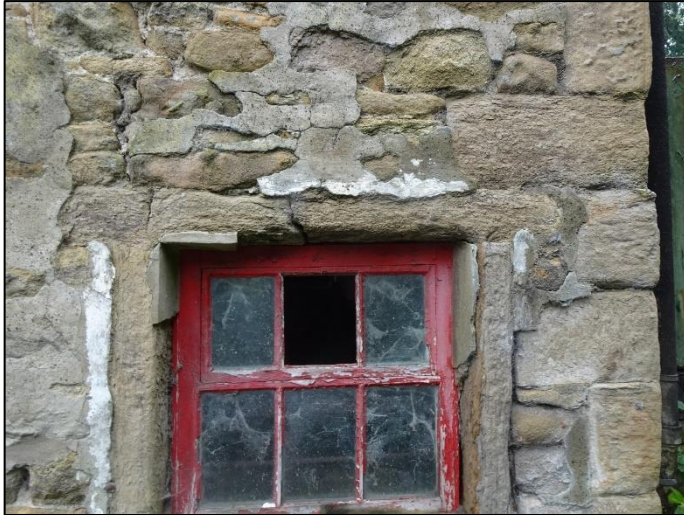
**Photograph 13**

- 2.1.20. There are areas of decay noted to the roof structures, primarily as a result of water ingress. Repairs will be required to the more significantly affected areas.
- 2.2. **Walls**
  - 2.2.1. Walls are of solid stone construction 400-500mm thick.
  - 2.2.2. There are a combination of stone, timber and steel lintels over window and door openings.
  - 2.2.3. Generally, all timber lintels are decayed and require replacement.
  - 2.2.4. There is a fracture to the rear-right, ground-floor window stone head which should be replaced.

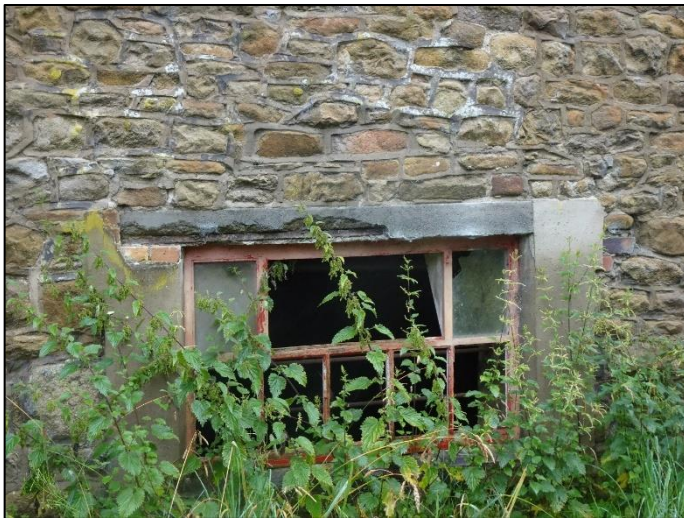
**Photograph 14**

- 2.2.5. The concrete lintel to the rear-left, ground-floor window head is defective and should be replaced.

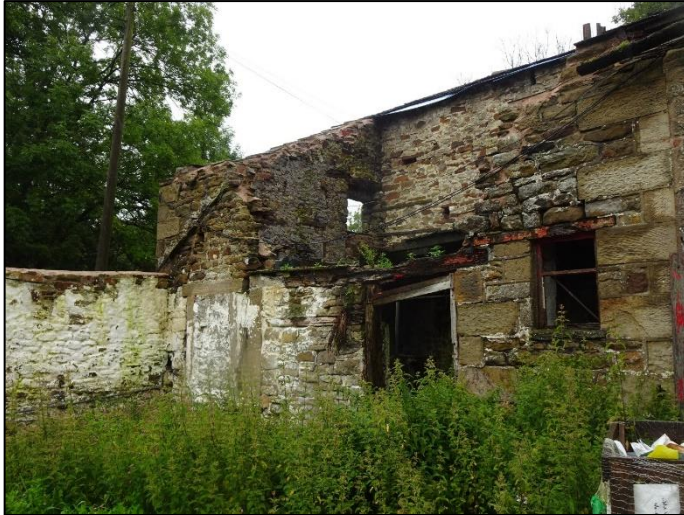
**Photograph 15**

- 2.2.6. Numerous alterations have been undertaken to original door openings to build in or partially build in to form window openings.
- 2.2.7. Alterations have been undertaken elsewhere to form new and widen original window openings.
- 2.2.8. The front left elevation has partially collapsed and should be re-built.

- 3.7. Walls to the front left have partially collapsed and should be re-built.
- 3.8. The front-right corner bulges outwards due a decayed timber lintel to the window opening, isolated re-building should be undertaken.

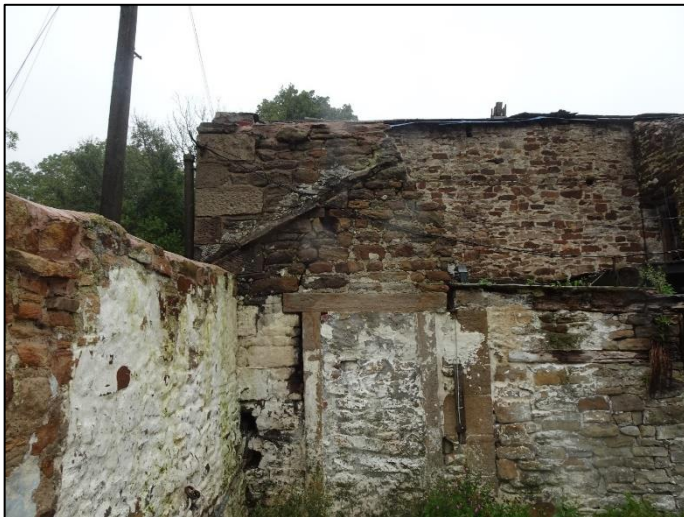
**Photograph 16**

- 2.2.9. The remaining left-side wall of this section leans slightly out of plumb. Re-building and tying in of the front elevation and a new first floor and roof structure will provide restraint to this section of wall.

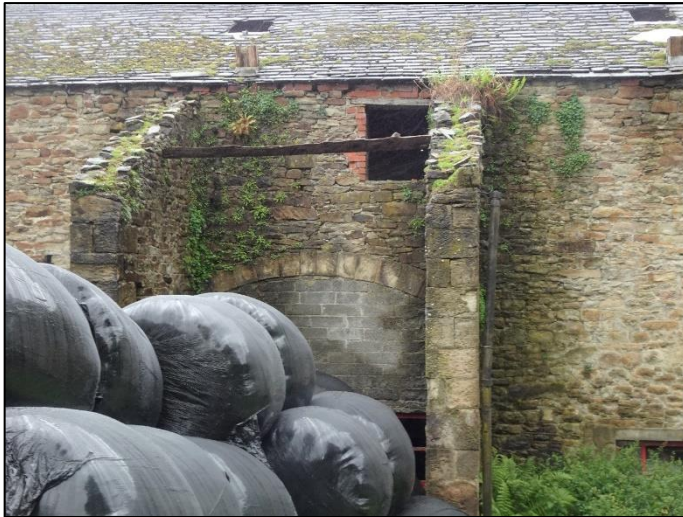
**Photograph 17**

- 2.2.10. Walls to the rear offshoot are generally in poor condition and are noted to lean out of plumb, however not to an extent requiring re-building and the addition of a roof structure will provide restraint to the walls.

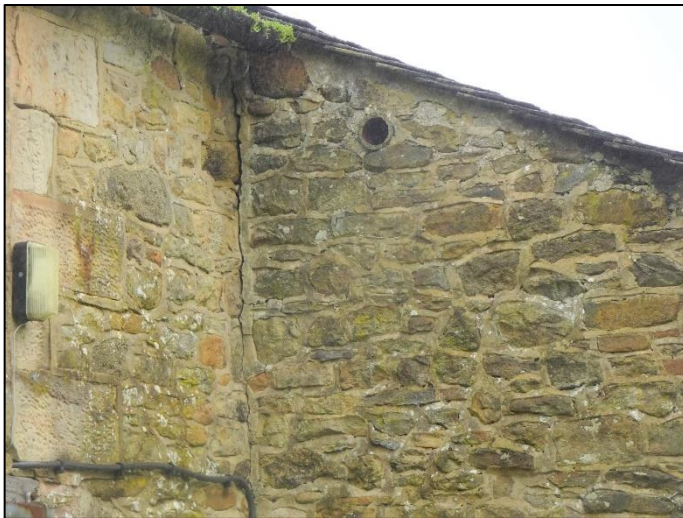
**Photograph 18**

- 2.2.11. There is tapered cracking noted at the abutment of the extended sections of wall to the front and rear elevations of the main two-storey part of the building.

- 2.2.12. Stitch repair works using a Helifix stainless steel system should be undertaken at the abutments.
- 2.2.13. Full examination of the rear elevation was slightly obstructed due to hay bales stored within this area.
- 2.2.14. The left and right-side gables of the main section of the building bulge outwards slightly at mid-level and lean out of plumb towards the apex.

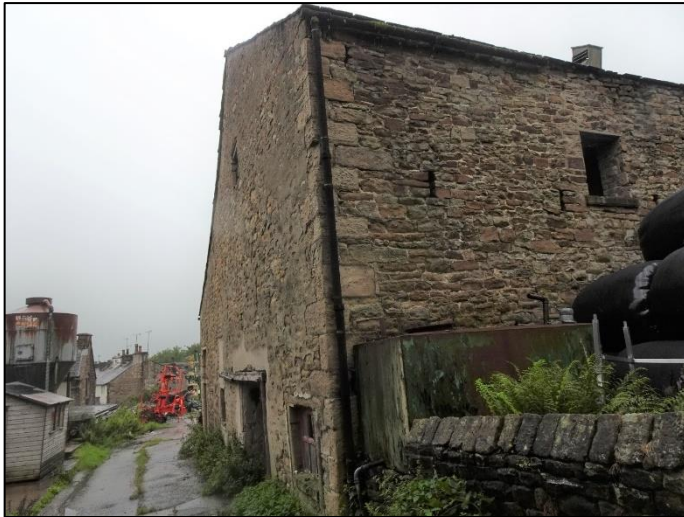
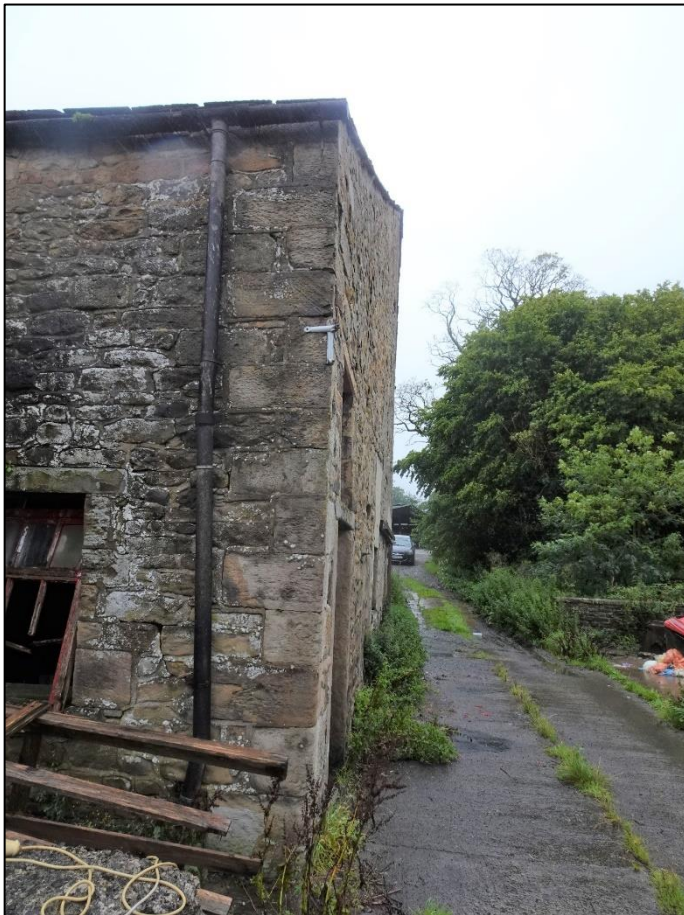
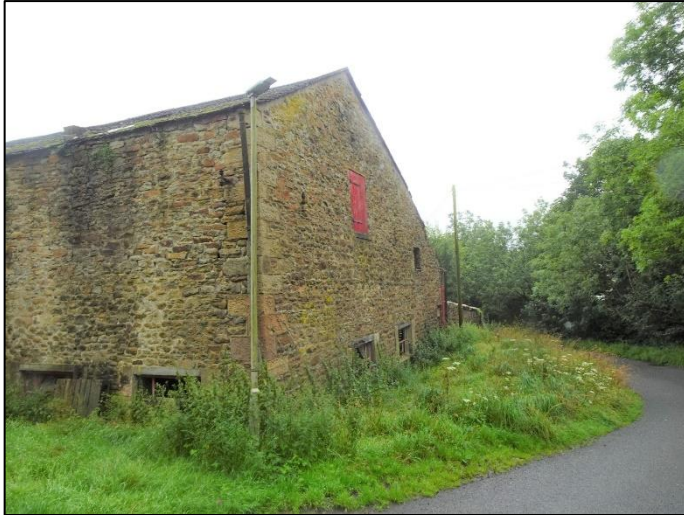
- 2.2.15. The left-side gable leans inwards, whilst the right-side gable leans outwards towards the apex.
- 2.2.16. Movement to the apexes is a result of horizontal movement of the main roof trusses.
- 2.2.17. Re-building of the upper gable apexes will be necessary.
- 2.2.18. There is bulging/bowing to the front-right corner of the main building.

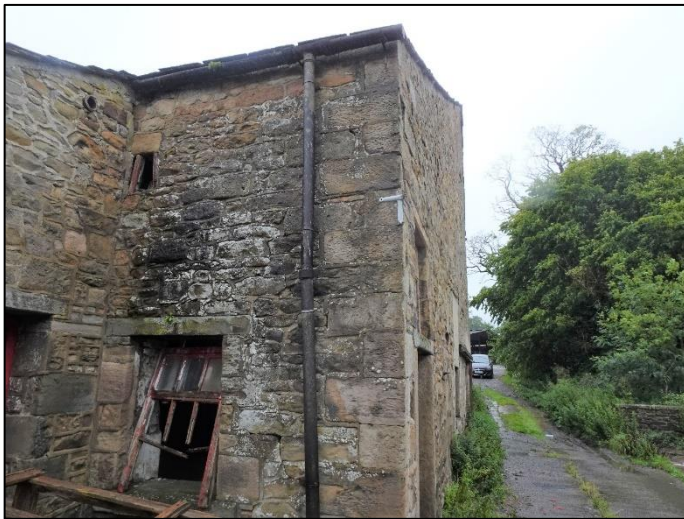
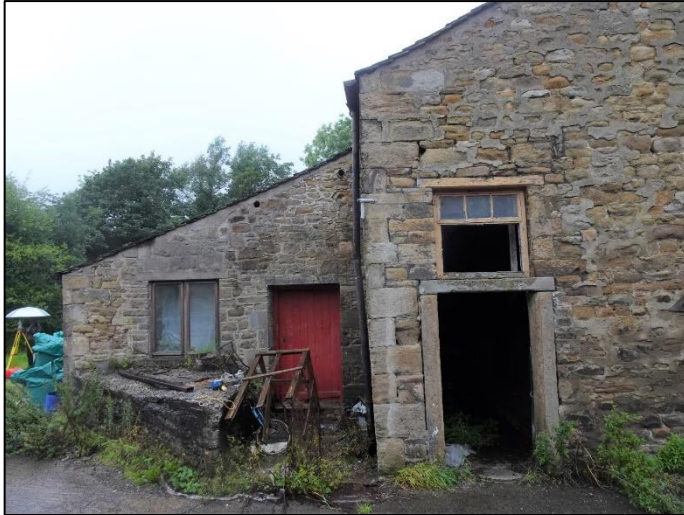
- 2.2.19. There is decay noted to the timber lintel over the window opening within this area and evidence of long-standing water ingress from the defective rainwater goods.
- 2.2.20. Replacement of the lintel and isolated re-building of the masonry above the opening will be necessary.
- 2.2.21. Both internally and externally, the walls have been re-pointed/rendered with cement-based mortars and renders.
- 2.2.22. I would recommend that as part of future refurbishment, all the external walls are re-pointed using a traditional lime mortar.
- 2.2.23. Rainwater goods are partially missing, leaking or blocked with vegetation and require replacement.

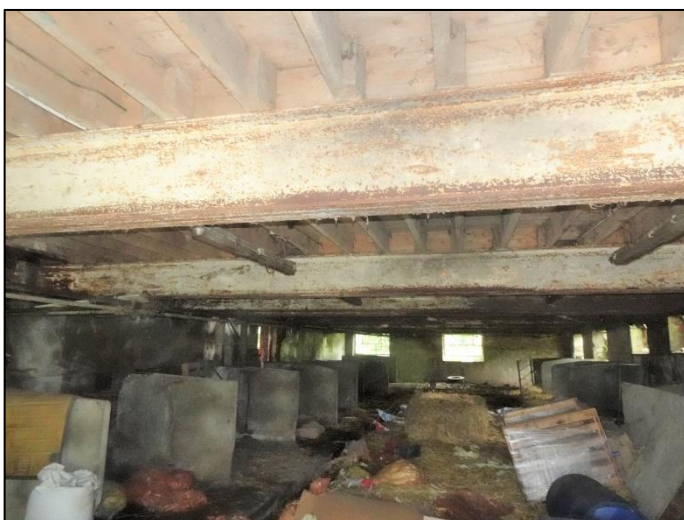
**Photograph 24**

- 2.3.1. First floors are of suspended timber construction. There are supporting steels to the main first-floor section.

- 2.3.2. The steels are in satisfactory condition although suffering surface corrosion.
- 2.3.3. The first floor to the front-left section has partially collapsed and requires replacement.

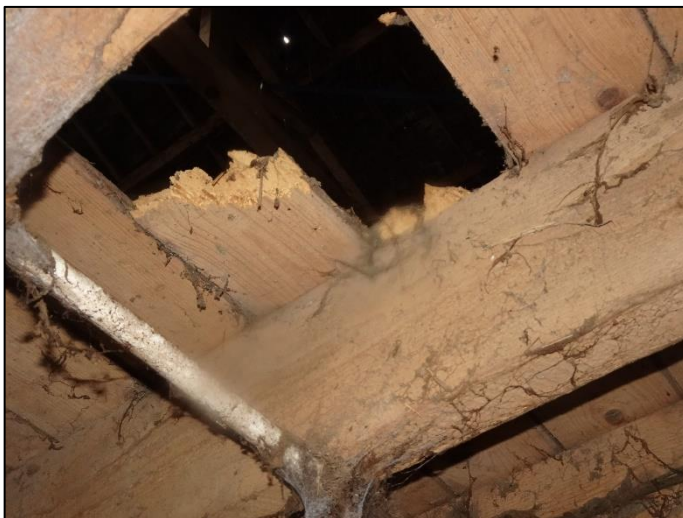
**Photograph 26**

- 2.3.4. Elsewhere, water ingress has resulted in isolated areas of decay to the first-floor floorboards and therefore safe access could not be gained to all of the first-floor areas.
- 2.3.5. There is active woodworm infestation noted to the floorboards to some areas.

- 2.3.6. As part of conversion works, I recommend that all first floorboards are replaced.
- 2.3.7. Ground floors are a combination of earth, cobbled and concrete. Examination was significantly restricted due to the amount of items stored within the buildings.
- 2.3.8. As part of conversion, the floors will be replaced.
