**HISTORIC BUILDING SURVEY REPORT:  
CROW TREES FARM, CROW TREES BROW, CHATBURN, LANCASHIRE**

Planning References: 3/2022/0966 and 3/2022/0967

Report prepared for Pringle Homes

By  
Allen Archaeology Ltd  
Report Number AAL2024035

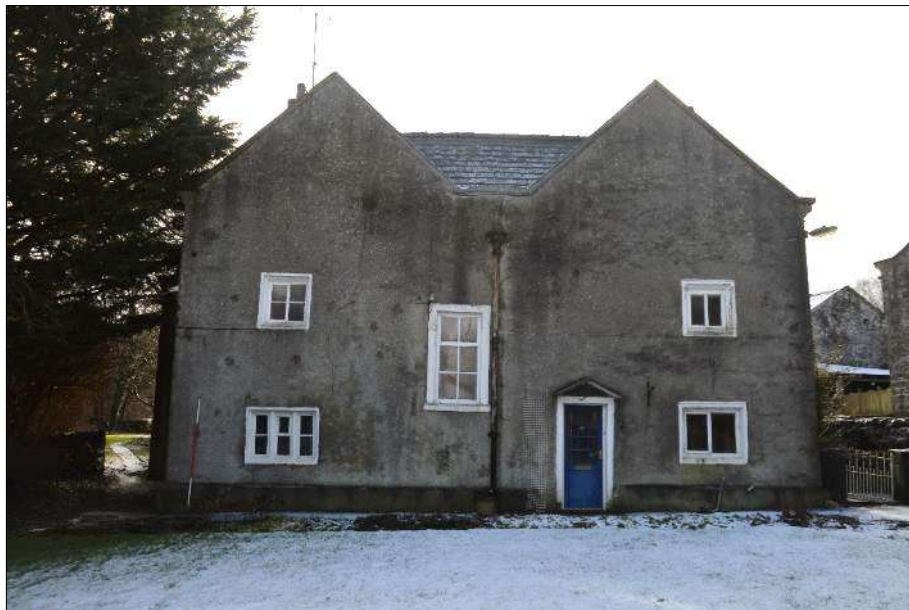
*Plate 1 (shot 94): Northwest elevation of the farmhouse, looking south-southeast, 2m scale*

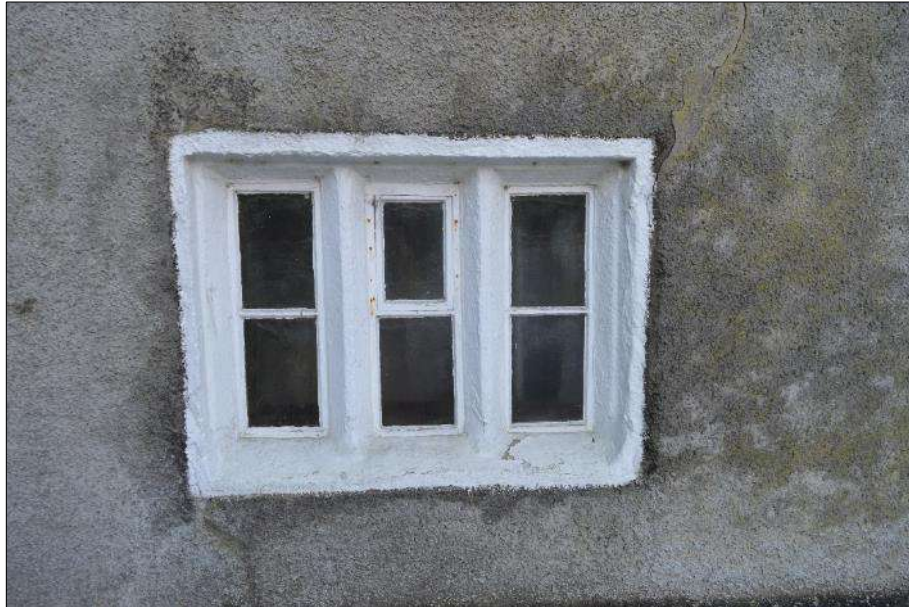
- 7.3 The small, mullioned window on the ground floor is likely to be original and has not been matched on the opposite side in the west bay (Plate 2). All other windows including the tall staircase window are fitted with wooden frames. The guttering varies and include modern replacements, the cast-iron downpipe and hopper draining the central valley from within the roof space is likely to be of late 19<sup>th</sup> century to early 20<sup>th</sup> century date (Plate 3). A plain stone canopy has been fitted above the main entrance which also holds a later door.

*Plate 2 (shot 95): Small ground floor, mullioned window on the northwest elevation, looking south*

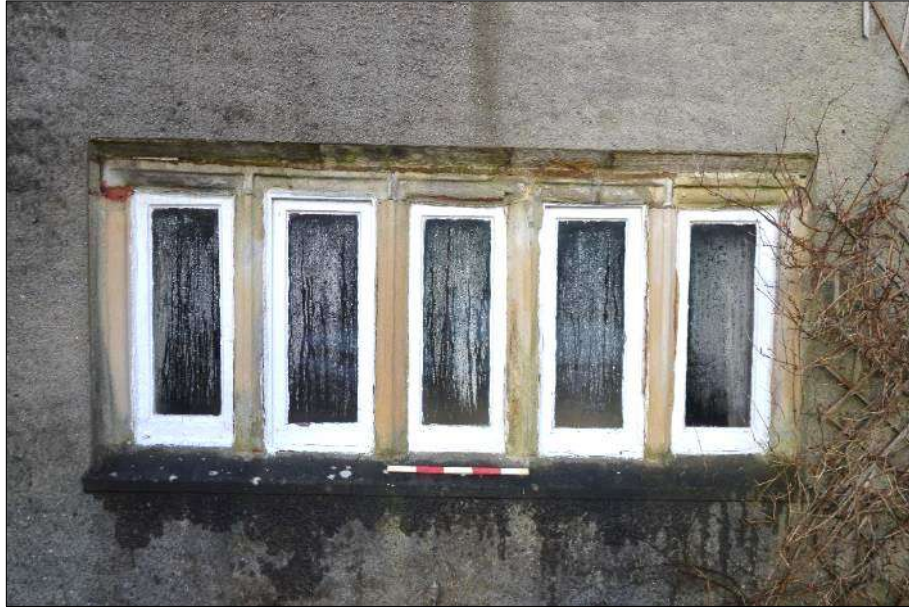
- 7.6 The wide, mullioned, ground floor stone window (Plate 8), in this case of five lights, is typical for the region. The size of the window in the 16<sup>th</sup> and 17<sup>th</sup> century often reflected the status of the room. The view from this window is offered from the extant living room and this may always have been the case, alternatively it may have doubled up as a dining room (Plate 9). The ovolo shaped mullions are very eroded.

*Plate 8 (shot 113): Mullioned 5-light window on the southeast elevation, looking north-northwest, 0.5m scale*

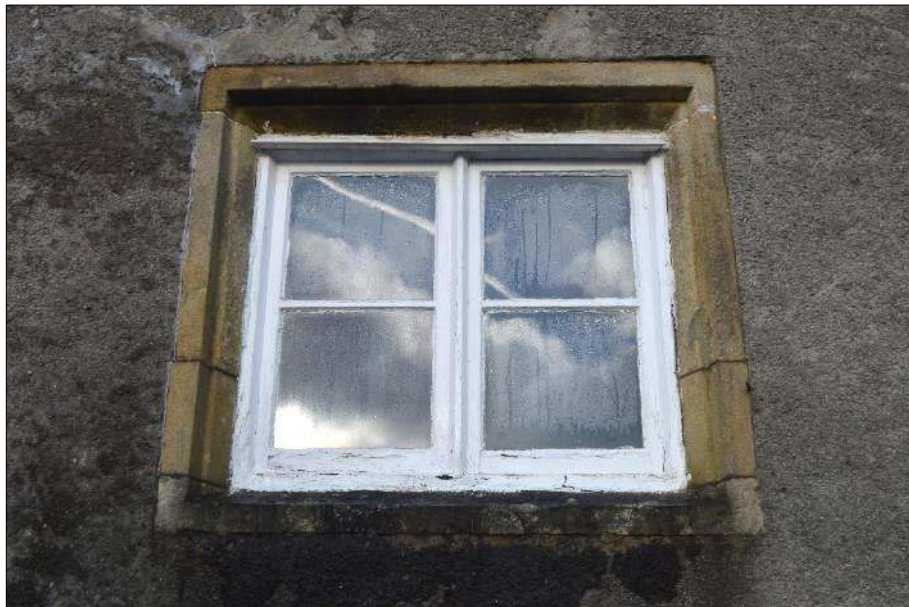
- 7.7 All other stone surrounds are plain and could reflect later instalments. The glass is all later, windows on the first floor and on the southwest half of the elevation are casements (Plate 9).

*Plate 9 (shot 109): Close up of first floor window with moulded surround, looking north-northwest*

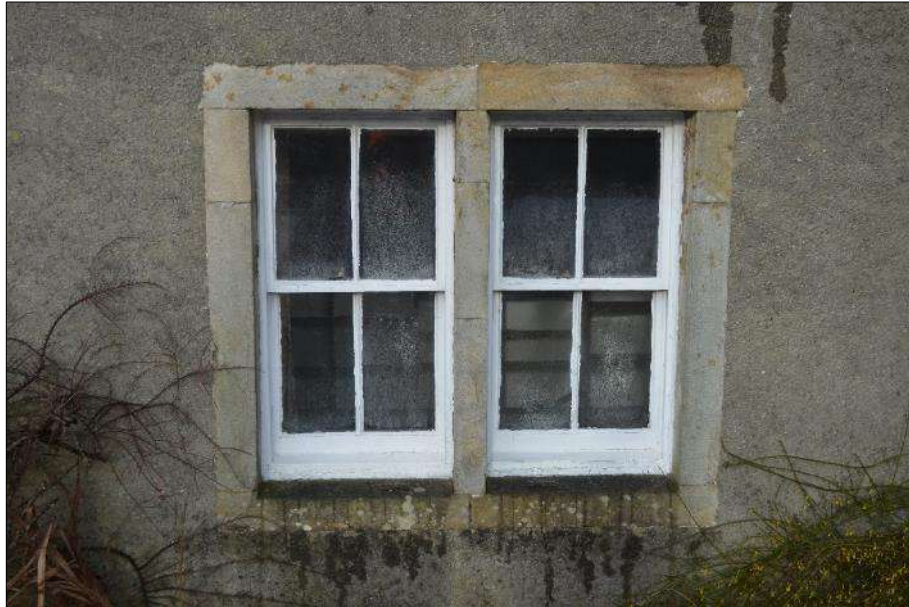
10). The four-light sash is a mid-Victorian feature but the lack of horns suggests a possible slightly earlier date. The paired sash windows were a feature in the late 18<sup>th</sup> century to overcome window tax. Finally, the second floor displays two horizontal (Yorkshire) sashes to the west and a casement window to the east. A central mullion has been added to each, possibly for extra support or remains from an earlier casement window and all are of different shapes (Plate 11).

*Plate 10 (shot 119): Close up of ground floor, recessed, sash window with glazing bars and no horn, looking north-northwest*

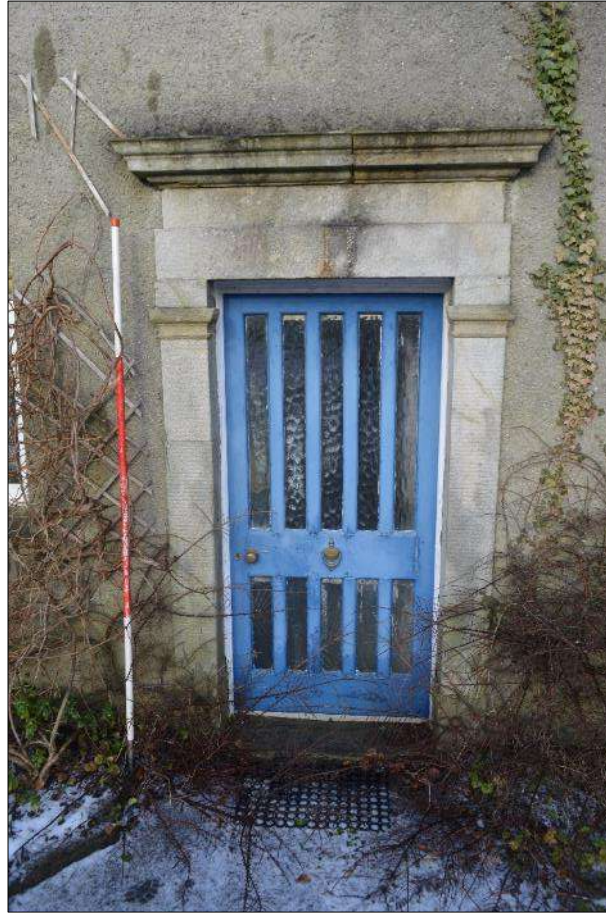
7.9 The doorway is surrounded by a plain neoclassical surround with mid-20<sup>th</sup> century door (Plate 12).

*Plate 12 (shot 112): Close up of modern door and neoclassical surround, looking north-northwest, 2m scale*

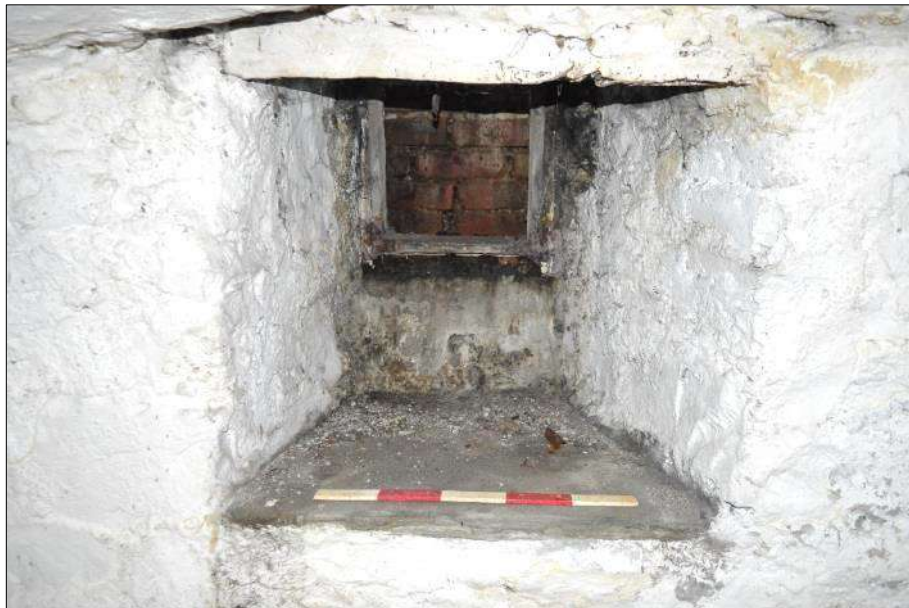
*Plate 16 (shot 234): Bricked up ventilation/window, looking east-northeast, 0.5m scale*

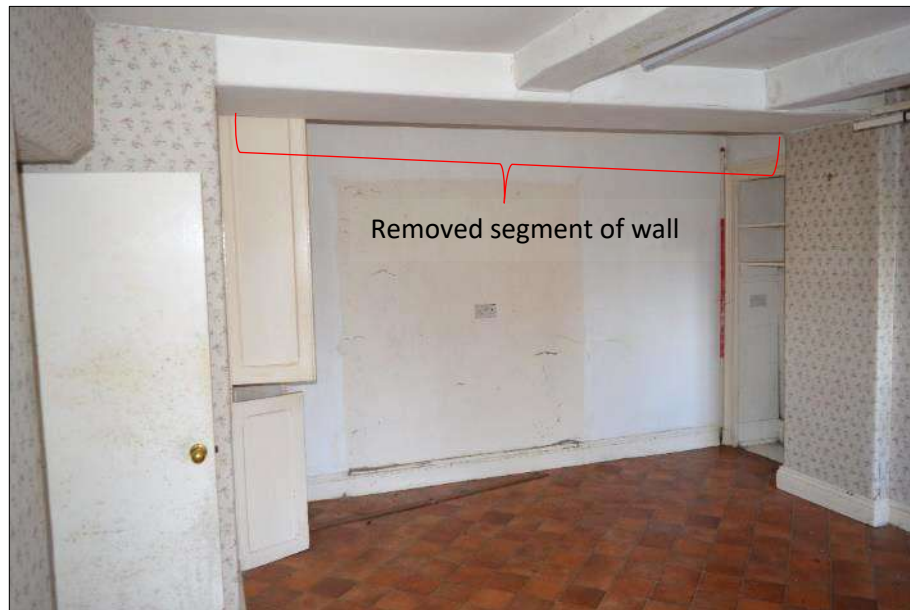
(Plate 17-Plate 19). It is possible a former staircase linking to the first-floor staircase was once positioned here and the built in cupboards are of later date.

*Plate 17 (shot 142): Segment of wall removed between pantry and extant kitchen (1.1), looking southwest, 2m scale*

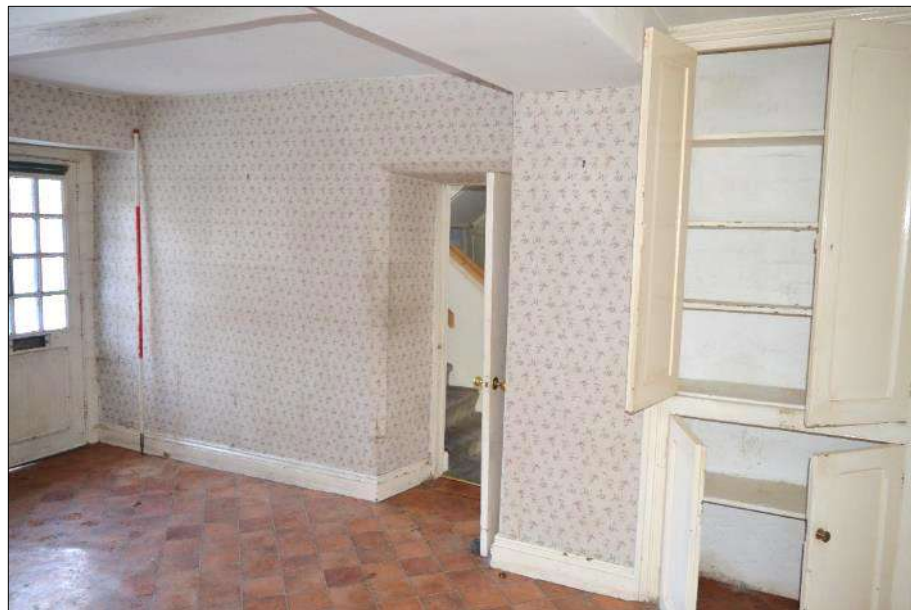
*Plate 18 (shot 144): View of altered wall between pantry and kitchen, looking east-northeast, 2m scale*

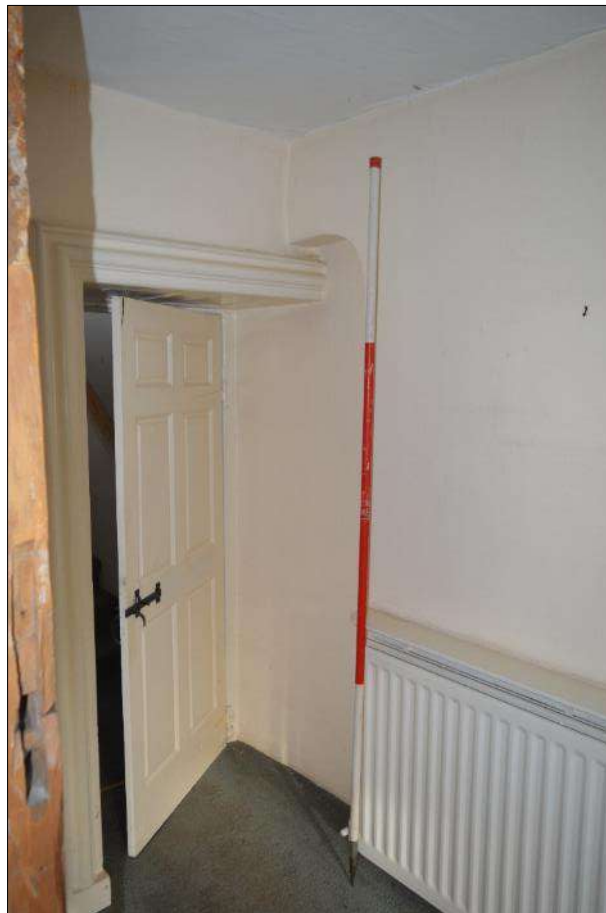
- 7.17 There were few historic and decorative features left in the house. The doorway between the corridor and the living room was the most ornate with a simple fielded panel above. Part of the central wall has had to be removed in order to accommodate the doorframe and panelling following an 18<sup>th</sup> century style (Plate 21). The style of panelling is also seen in the thin, Georgian style door hung on strap hinges with tapered ends.

*Plate 21 (shot 166): Doorway between the corridor and the living room (1.2), notice empty mortices for a possible strike plate on the post to the left, looking north-northeast, 2m scale*

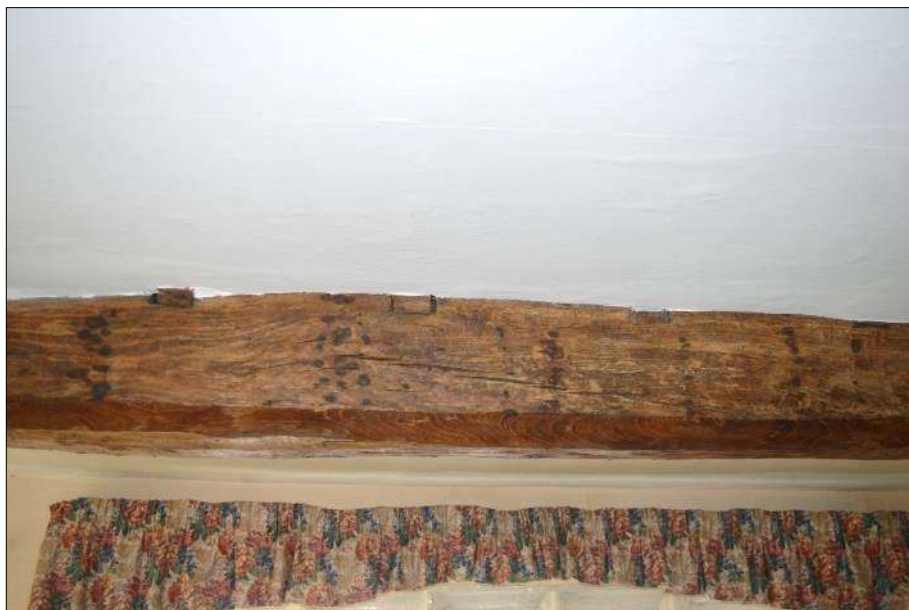
- 7.18 The living room measured c.4m by 5m. Two main beams (Plate 22) follow the length of the ceiling, one showing notches from former joists which could suggest the beam has been reused, or that the ceiling is later and is hiding notches on the opposing beam (Plate 23). Both beams show regular kerf marks suggesting they were sawn on a mechanical saw and then chamfered.

*Plate 23 (shot 167): Close up of main beam in living room with notches, looking south-southeast*

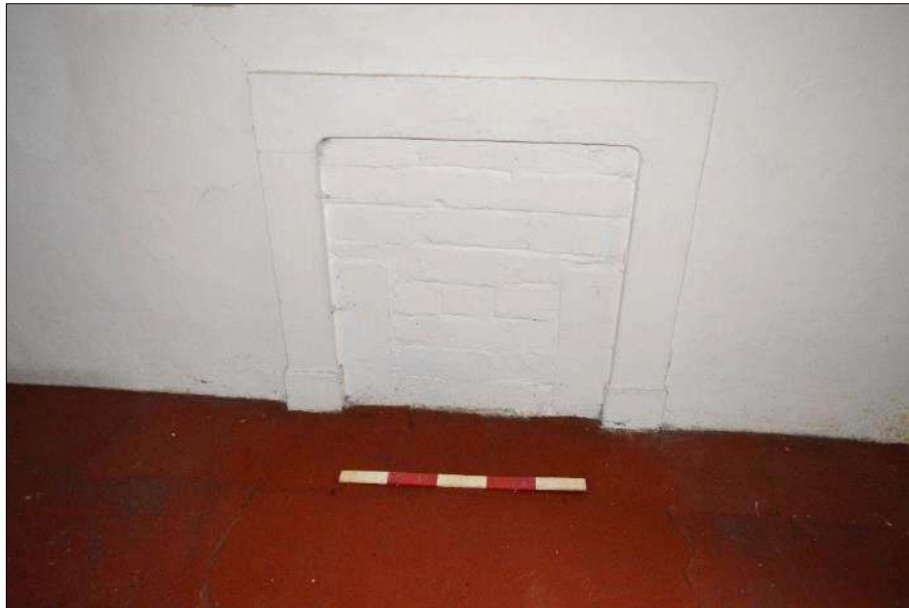
*Plate 28 (shot 182): Close up of bricked up opening, suggesting a former fireplace with a hob grate, looking north-northwest, 0.5m scale*

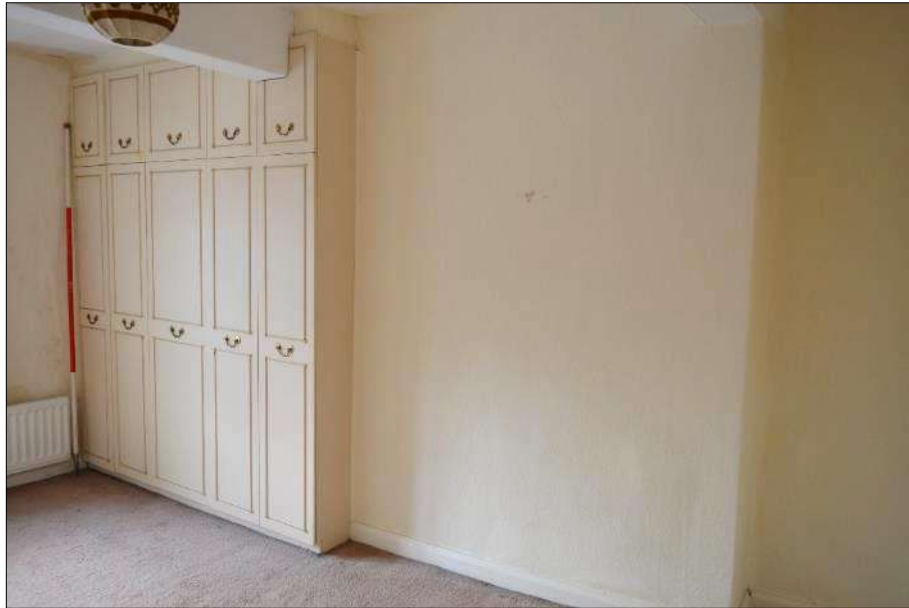
- 7.29 In all likelihood a fireplace has been blocked along the southwest wall. The skirting boards are of modern date, thus post-dating the blocking of the fireplace (Plate 34).

*Plate 34 (shot 199): Blocked up fireplace along the southwest wall of bedroom (2.2), looking south-southwest, 2m scale*

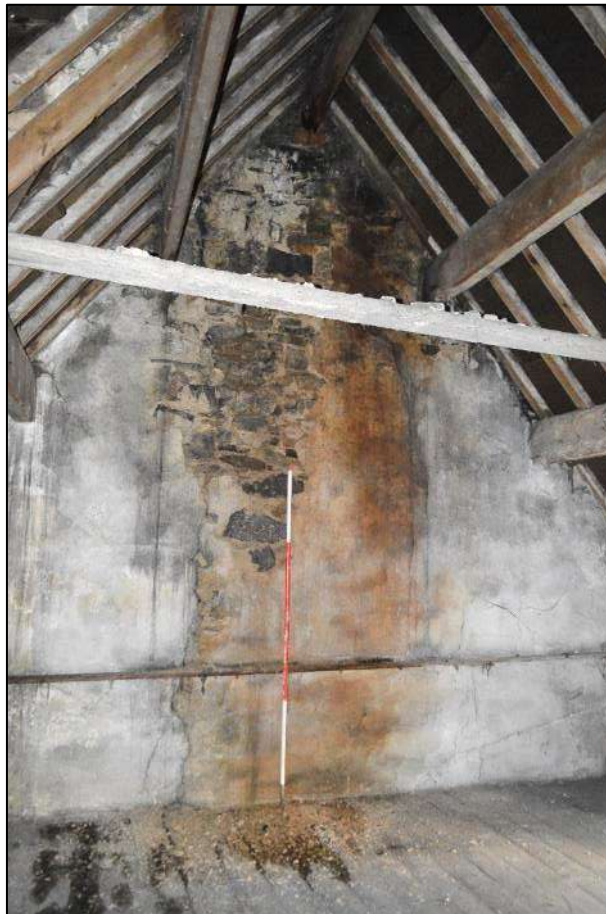
- 7.36 Room (3.2) was open to the roof. Unlike the visible chimneybreast in the adjacent room, stained plaster indicates the position of the chimney flue hidden within the wall (Plate 43). The floorboards are overall slimmer and more regular in size than in the adjacent room which suggests they are likely to be of later date.

*Plate 43 (shot 225): General view towards the northeast wall in room (3.2), looking east, 2m scale*

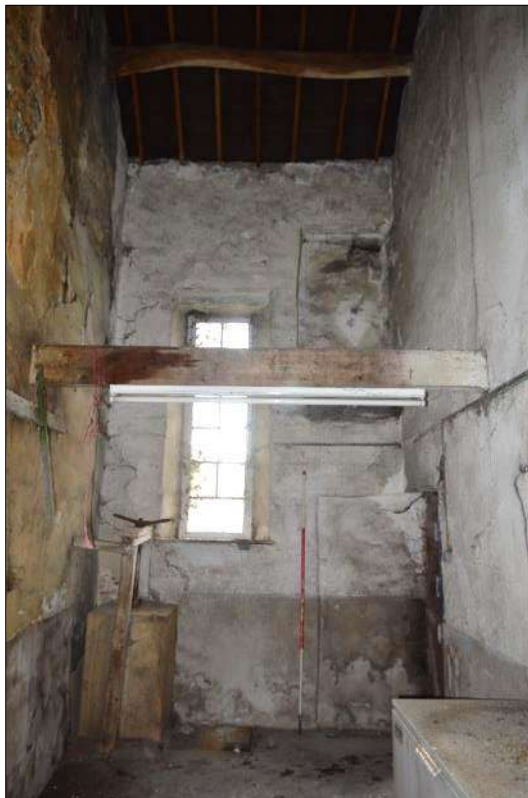
*Plate 54 (shot 130): General view towards the staircase window, looking south-southeast, 2m scale*

7.45 It is unfortunate that the exterior masonry could not be viewed which makes the interpretation more uncertain of the recess starting on first floor level and extending beyond the height of the staircase window (Plate 54). It may have accommodated storage shelves or be the remains of a shallow built-in cupboard. It is unlikely to represent a blocked window even with a lintel present. Likewise, a doorway seems unlikely with the bottom ledge tapering downwards, and not suited for a threshold. A similar feature but without the lintel was observed on ground floor which was created to accommodate the southwest door opening inwards (Plate 55-Plate 56). This recess, however, is shallower than that on the first floor. The possibility of a door opening inwards from the southwest corner also seem implausible as there is no adjoining building, and the first floor is not a loft over a traditional farm building such as a barn where once might expect a loft door.

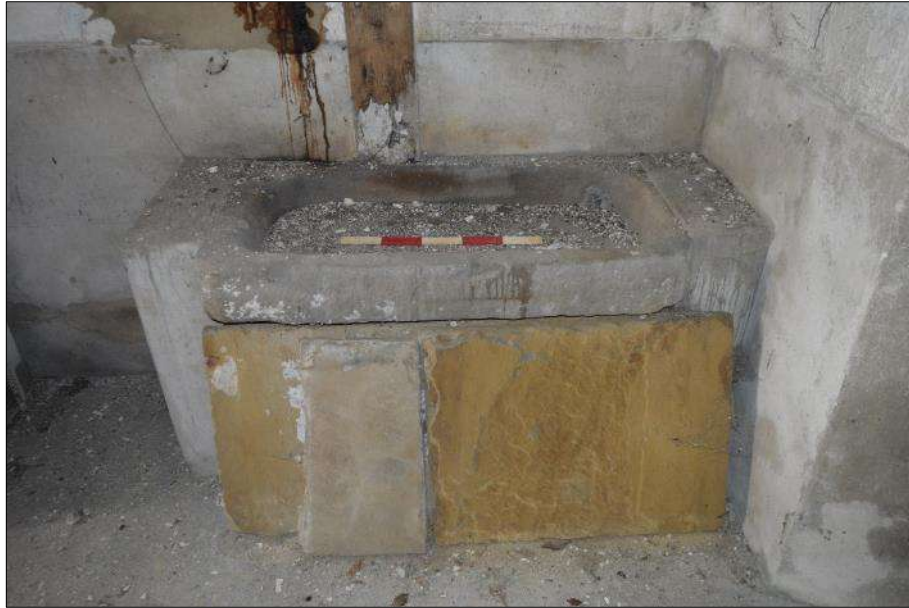
*Plate 59 (127): Sink or salting trough along the southwest wall, notice the cement on the lower half of the walls, looking southwest, 0.5m scale*

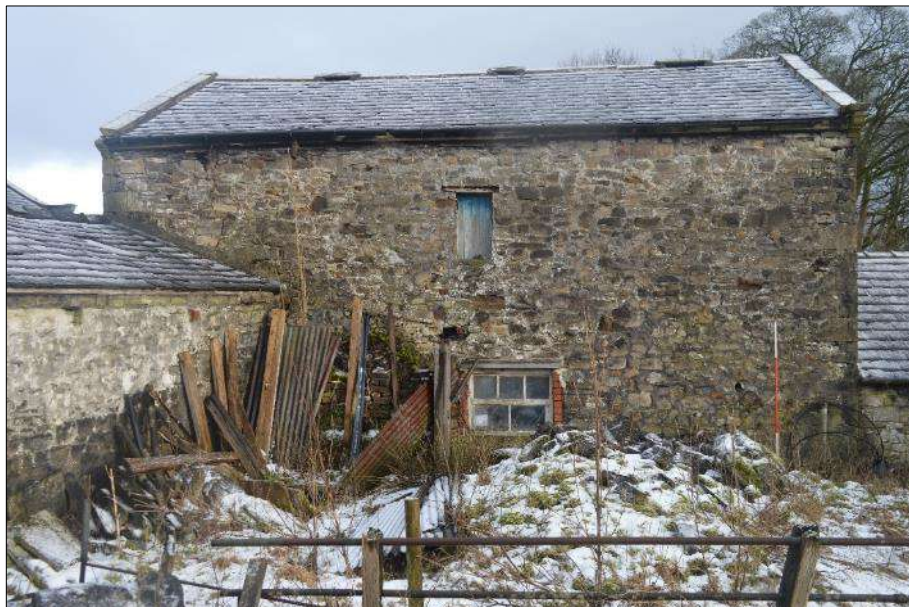
- 7.56 The southwest elevation facing away from the track has been repaired or partially rebuilt on several occasions. There are two extant openings (Plate 71); a repaired ground floor window with brick infill around the frame and a reduced first floor opening, with wooden plank door (Plate 72-Plate 73).

*Plate 71 (shot 48): Southwest elevation, looking northeast, 2m scale*

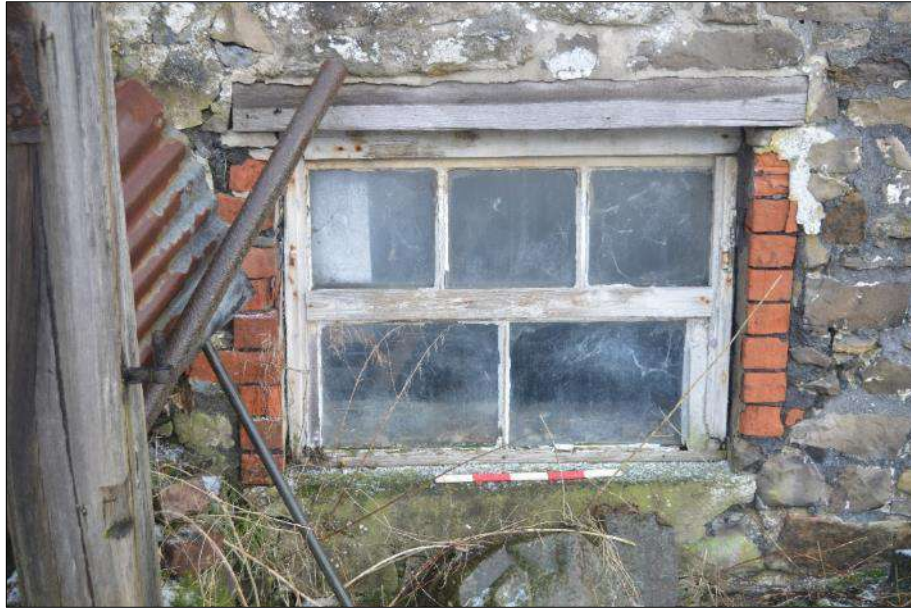
*Plate 72 (shot 49): Repaired ground floor window, looking northeast, 0.5m scale*

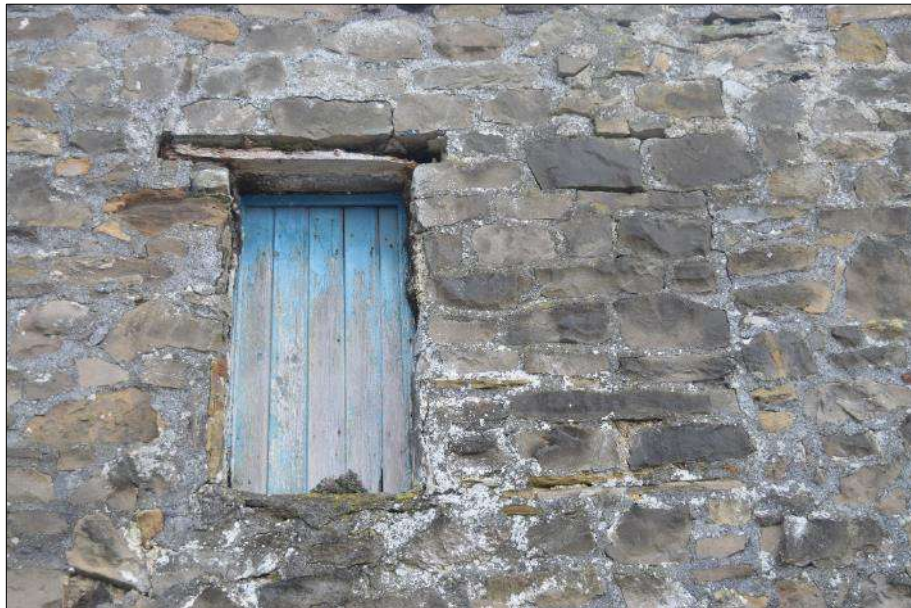
*Plate 73 (shot 51): Reduced first floor opening, looking northeast*

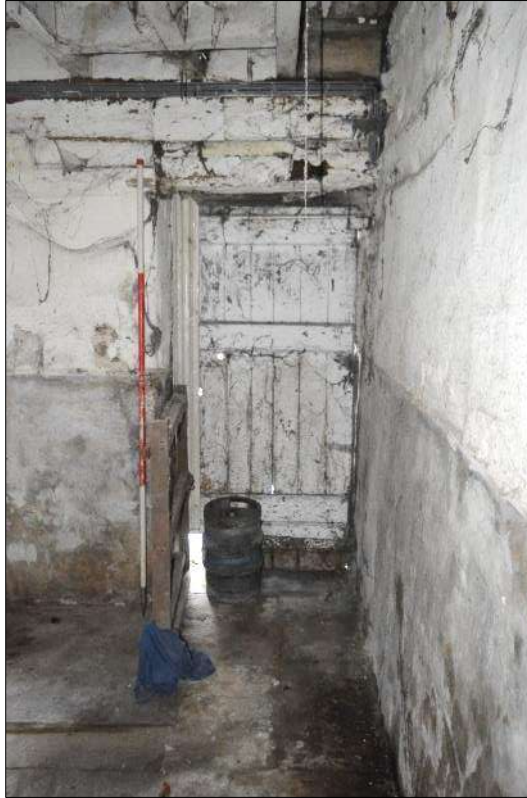
- 7.60 The door on the southeast corner has battens across narrow, beaded planks and may date to the early 19<sup>th</sup> century (Plate 78). The lower end has broken off in the past and has been repaired and a piece of ovolo moulded door frame has been attached to the opening side. It is hung on longer and wider, plain strap hinges. The stone flags on the floor in front of this door lead to the southwest feeding aisle. They are slightly sealed by the later cement floor and may represent surviving elements of an earlier floor.

*Plate 78 (shot 15): Early 19<sup>th</sup> century style plank and batten door with beaded narrow planks, looking northeast, 2m scale*

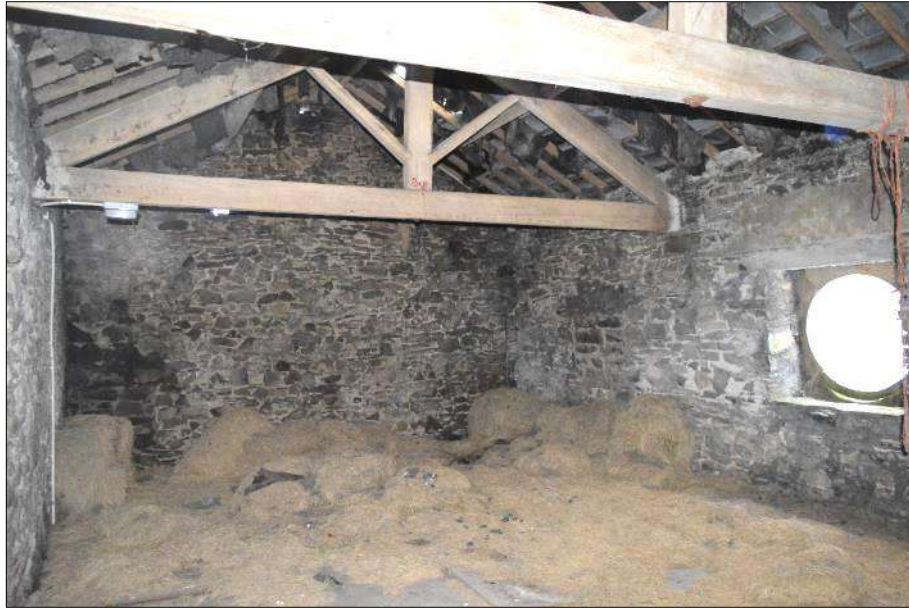
*Plate 79 (shot 26): General view of the north half of the loft, arrow points to blocked window*

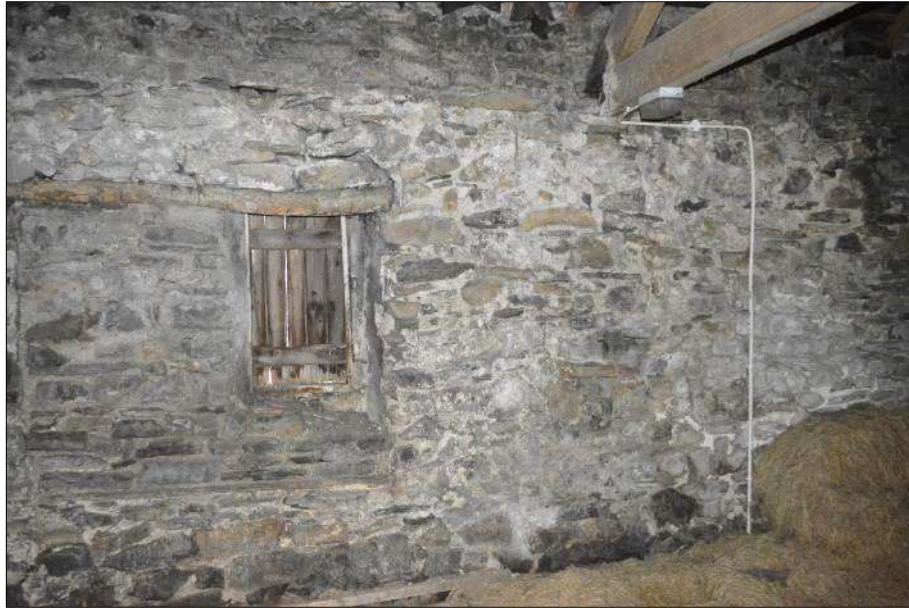
*Plate 81 (shot 29): Modified and reduced window/pitching hole, notice the horizontal line in the stonework on truss level, looking southwest, 2m scale*

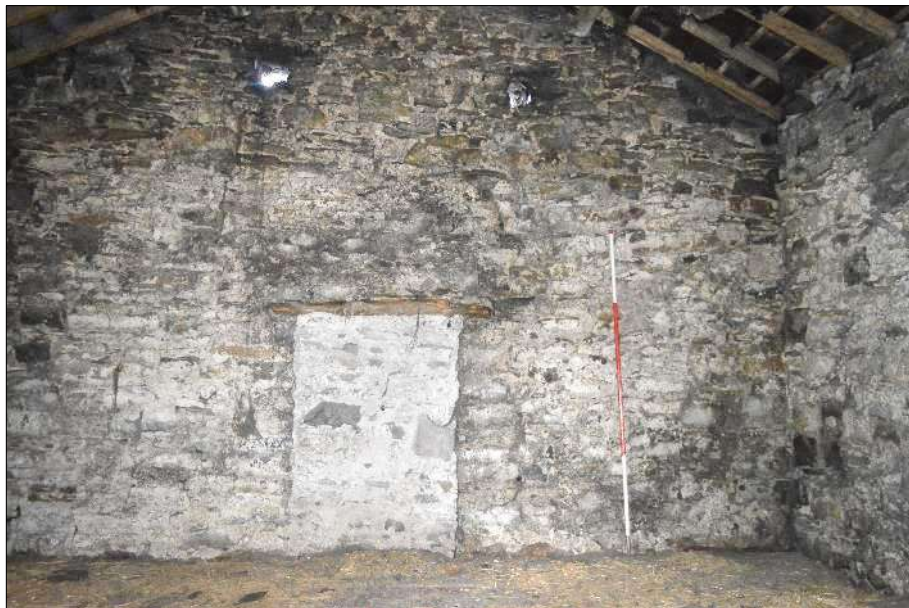
*Plate 82 (shot 22): Blocked loft door on the southeast wall, notice the horizontal line between the door and the two ventilation holes, looking southeast, 2m scale*
