**STRUCTURAL INVESTIGATION REPORT AT
HALL FARM BARN, WORSTON, BB7 1QA.**

Document Number	Revision	Description	Issue Date
8217	P1	-	25/03/24

Survey Date:	19 th March 2024 1pm. Weather overcast but dry.
Survey/ Report By:	Richard Lomax MIStructe BEng (Hons)
Client Name & Address:	Mr. Matthew Leyden

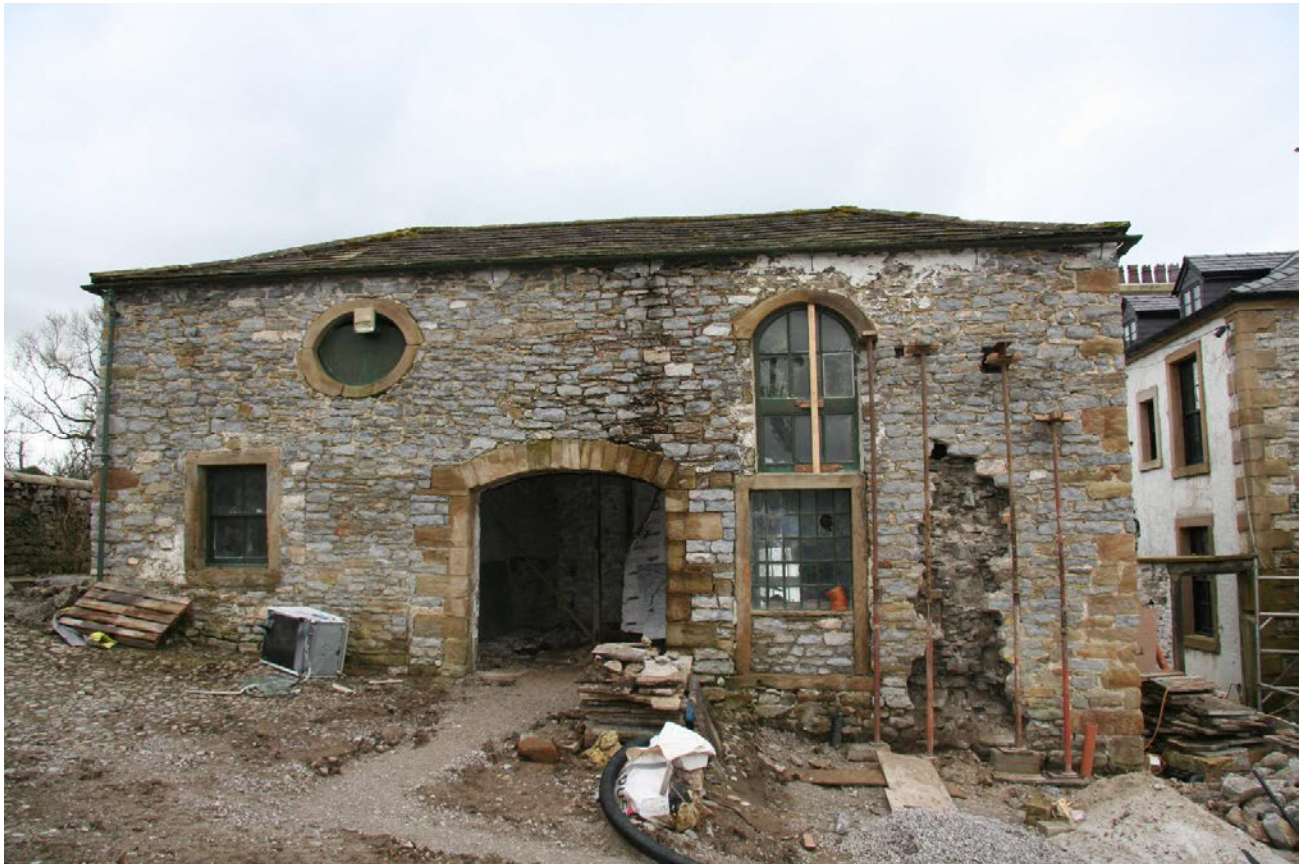
The structure is basically a detached traditional farm building built circa early 1900 set on a gently sloping site to the rear of Hall Foot, refer photograph P1 below.

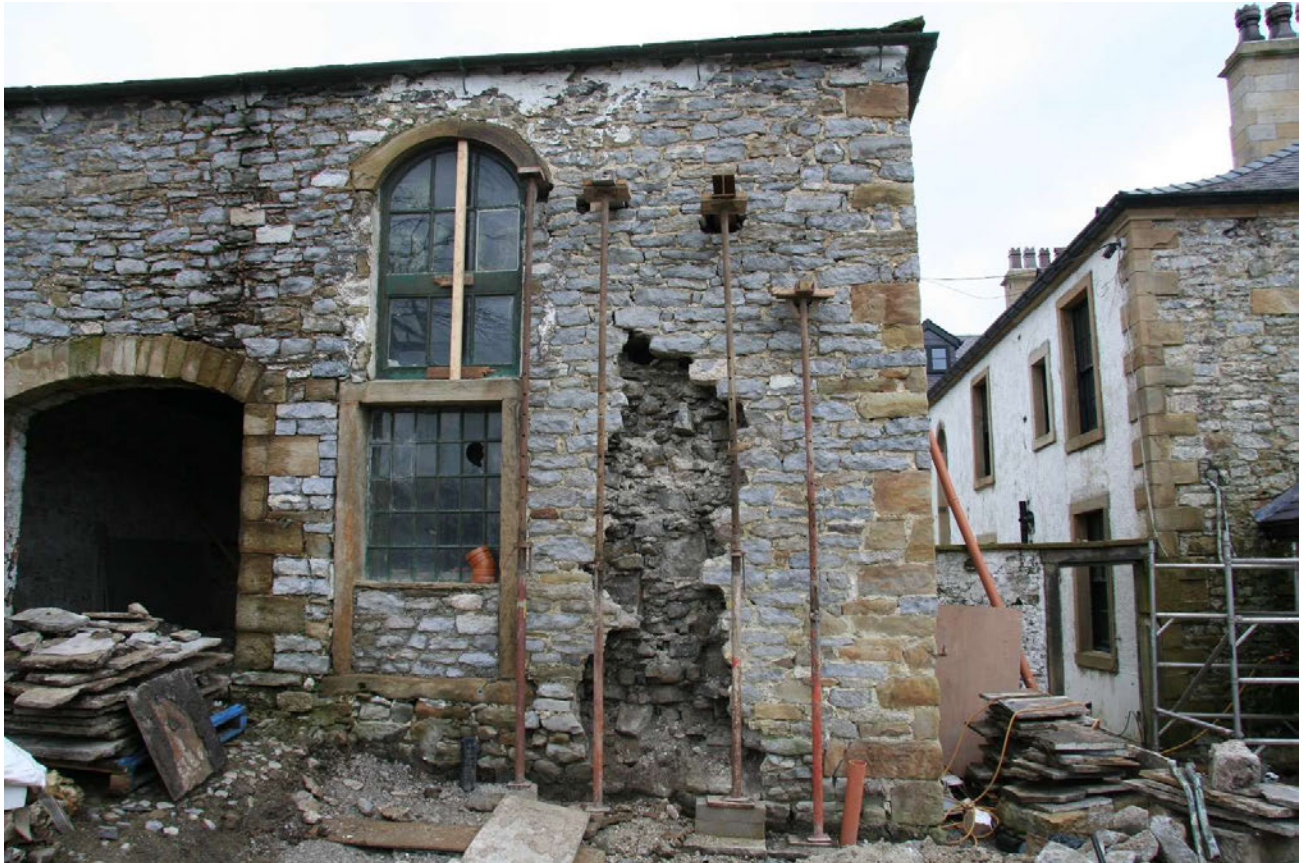
Inspection of the front elevation revealed part of the right hand elevation has been removed and temporarily propped above, refer photograph P2 below. This was carried out as the lower wall section had bulged out considerably according to operative on site.

Stone arch lintel (in two pieces) dropped one side requiring timber prop as shown in photograph P2 above.

The lack of masonry to the side of the main arch needs consideration such as a depth of masonry over the ground floor opening being introduced. The arch may need to be reset as well given its settlement on one side.

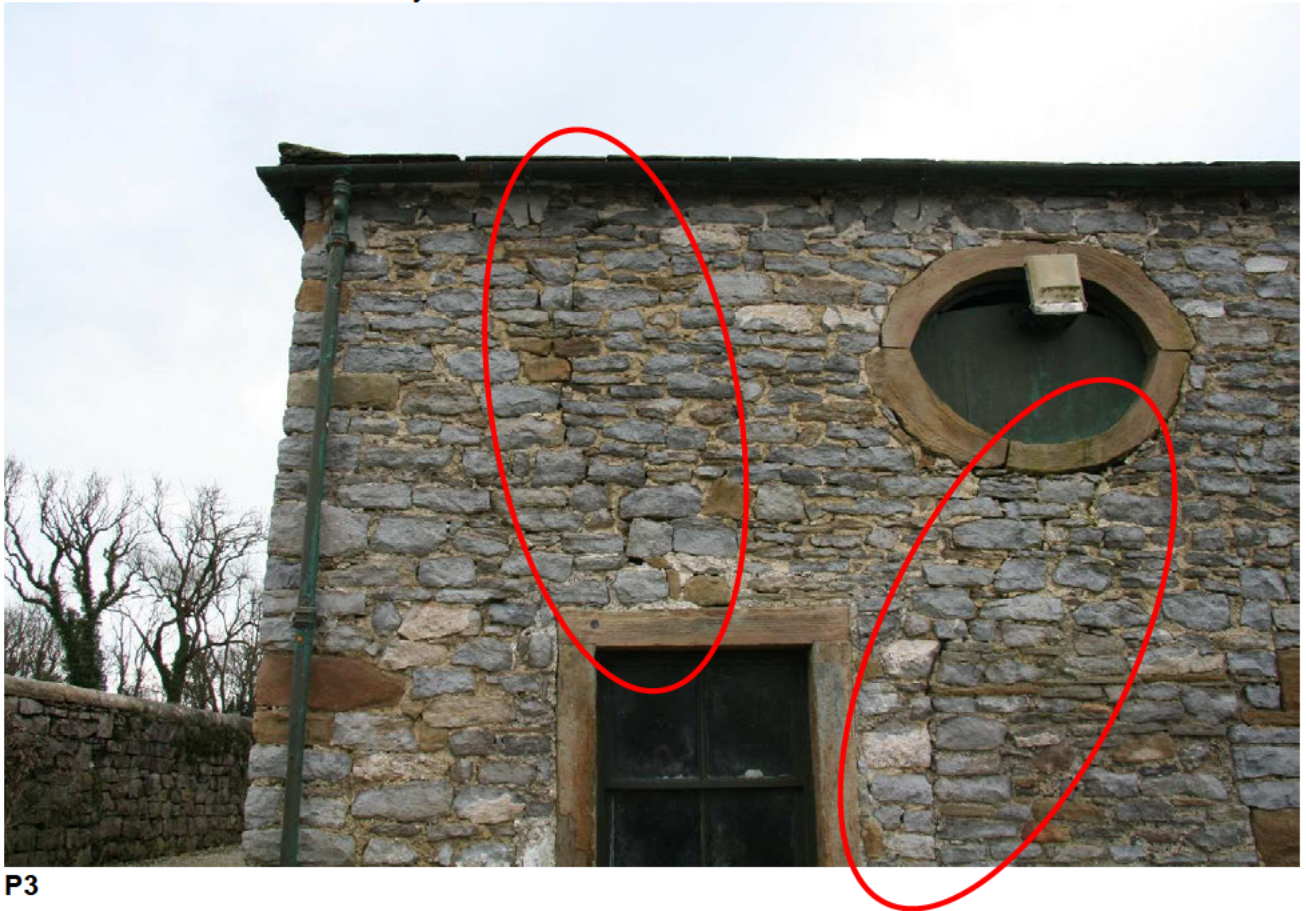
Inspection of the left hand side revealed vertical cracking over ground floor window and below circular window opening, refer photograph P3 below. Stone cill cracked.

Vertical cracking below circular window extends up from what appears to be a former opening that has not been toothed across correctly.

It is imperative the walls are strengthened especially at positions of weakness highlighted by the cracking. The Author would recommend modern crack stitching techniques using stainless steel helical bars and minor wall repair, replacing small stone units with longer units by competent stone mason – both techniques to span across cracks to provide a stronger and better bond. Tying of the two leaves should be further investigated and mortar raked and repointed throughout.

Replace internal window/ door timber lintels with more modern robust materials such as steelwork or precast concrete. Replace cracked stone lintels.

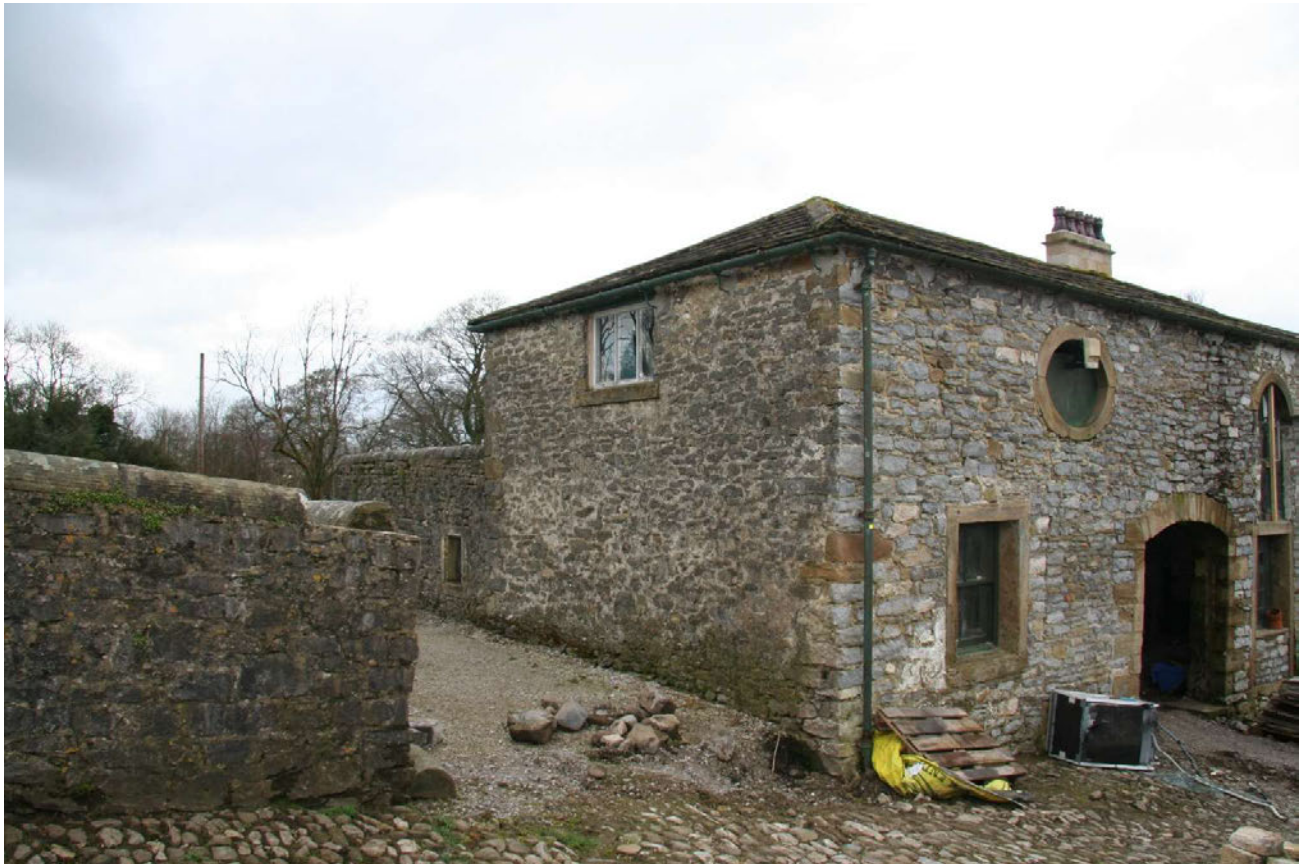
Inspection of the left hand end gable revealed no significant cracking indicative of structural movement, refer photograph P4 below.

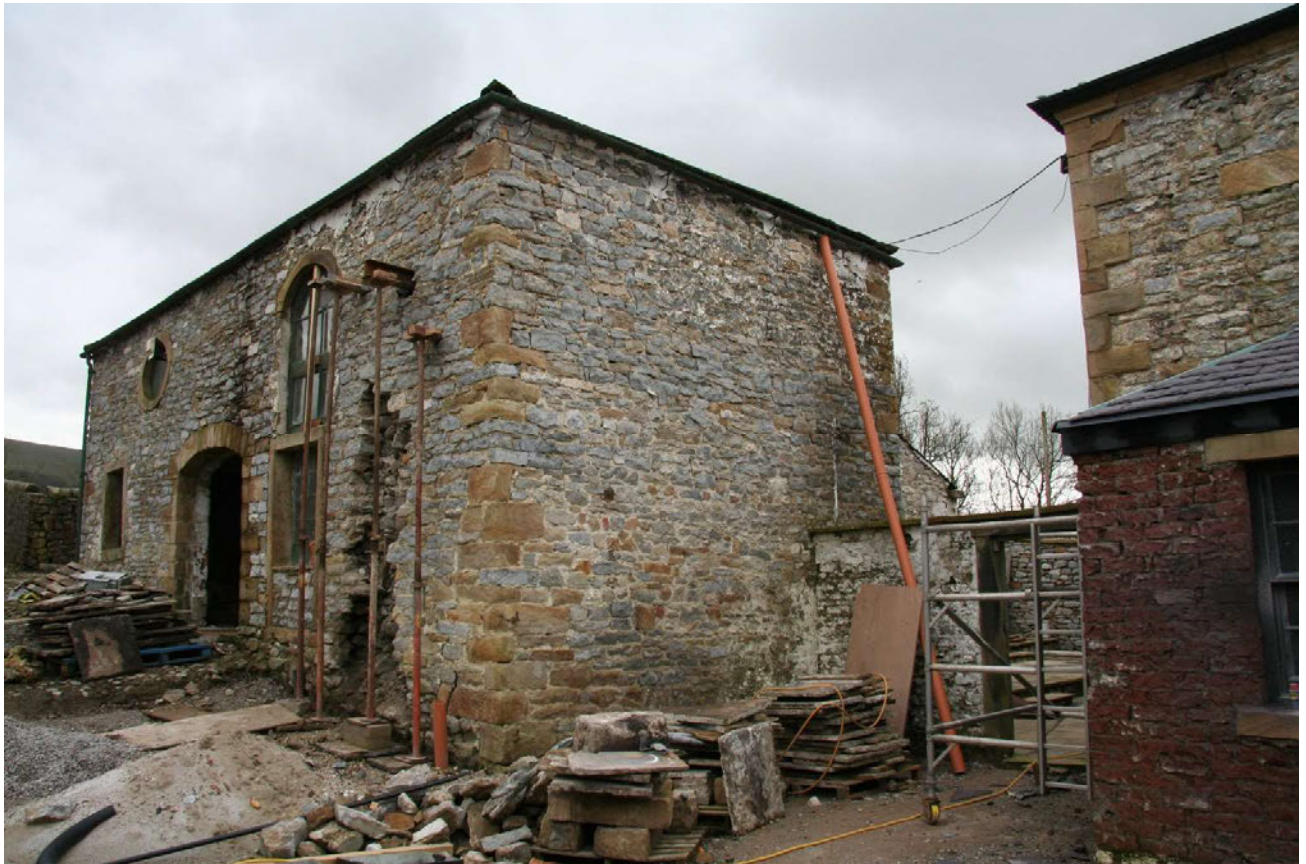
Inspection of the right hand end gable revealed no significant cracking indicative of structural movement, refer photograph P5 below.

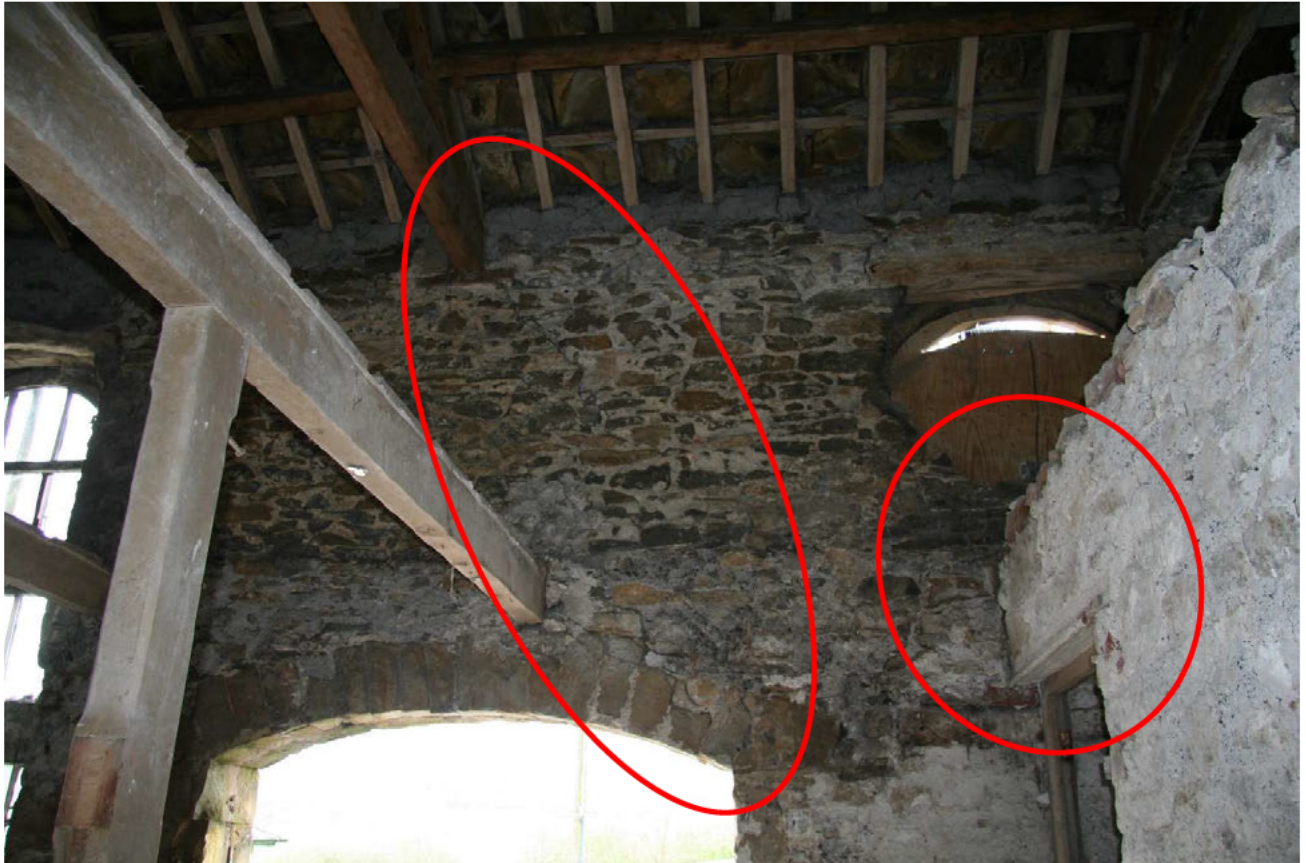
Inspection internally revealed the left hand side of the arch has dropped nominally with resulting diagonally cracking extending past the first floor primary beam up to the truss bearing, refer photograph P6 below. This is less pronounced externally.

First floor primary beam poorly located closely to arch centre – refer photograph P6 above.

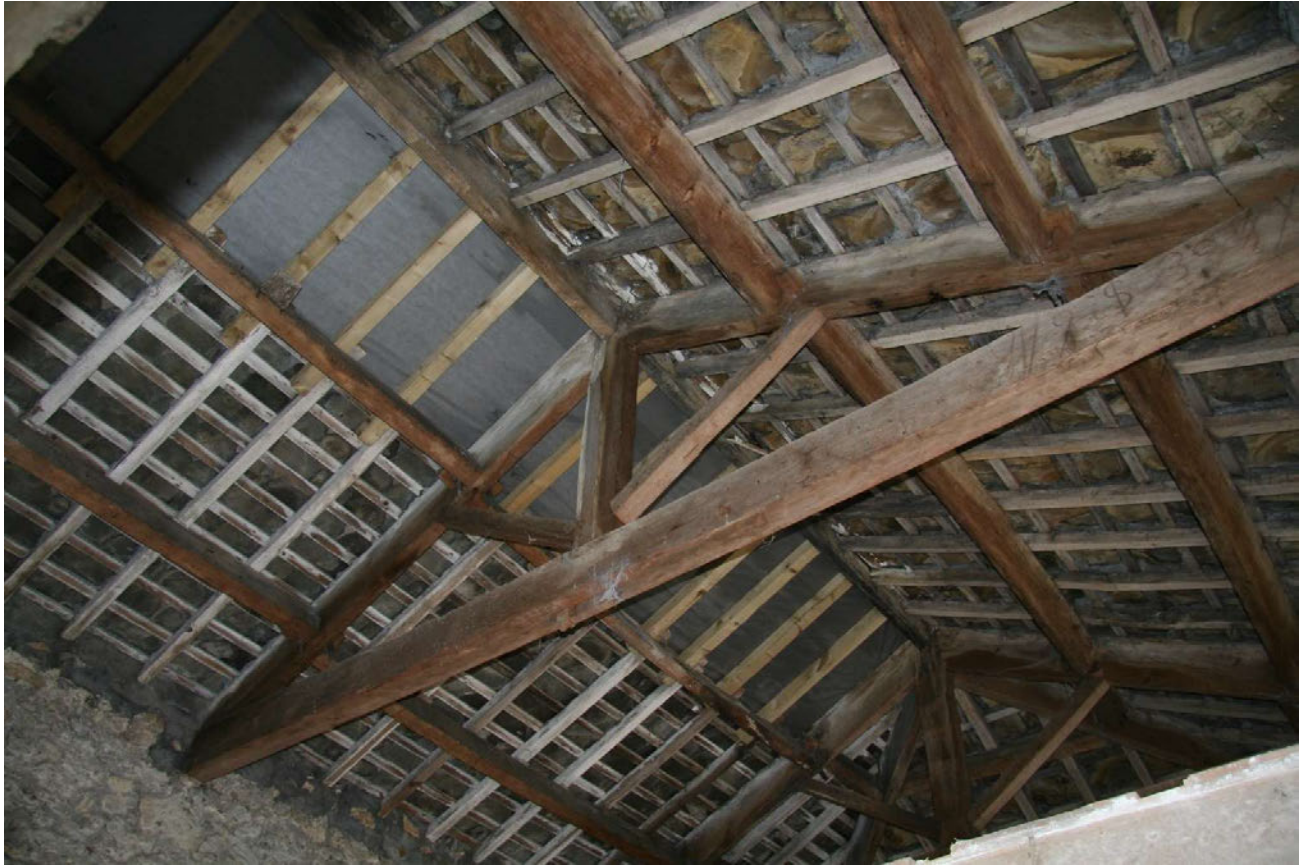
Kingspan roof trusses appeared in relatively good condition when inspected from ground floor level, refer photograph P7 below.

Rafter replacement evident to area adjacent rear slope/ ridge – refer photograph P7 above.

Appoint timber specialist to inspect at high level and intrusively investigate the timber truss/ purlin/ rafter/ lintel elements and check for rot infestation – locally repair/ strengthen, where applicable.

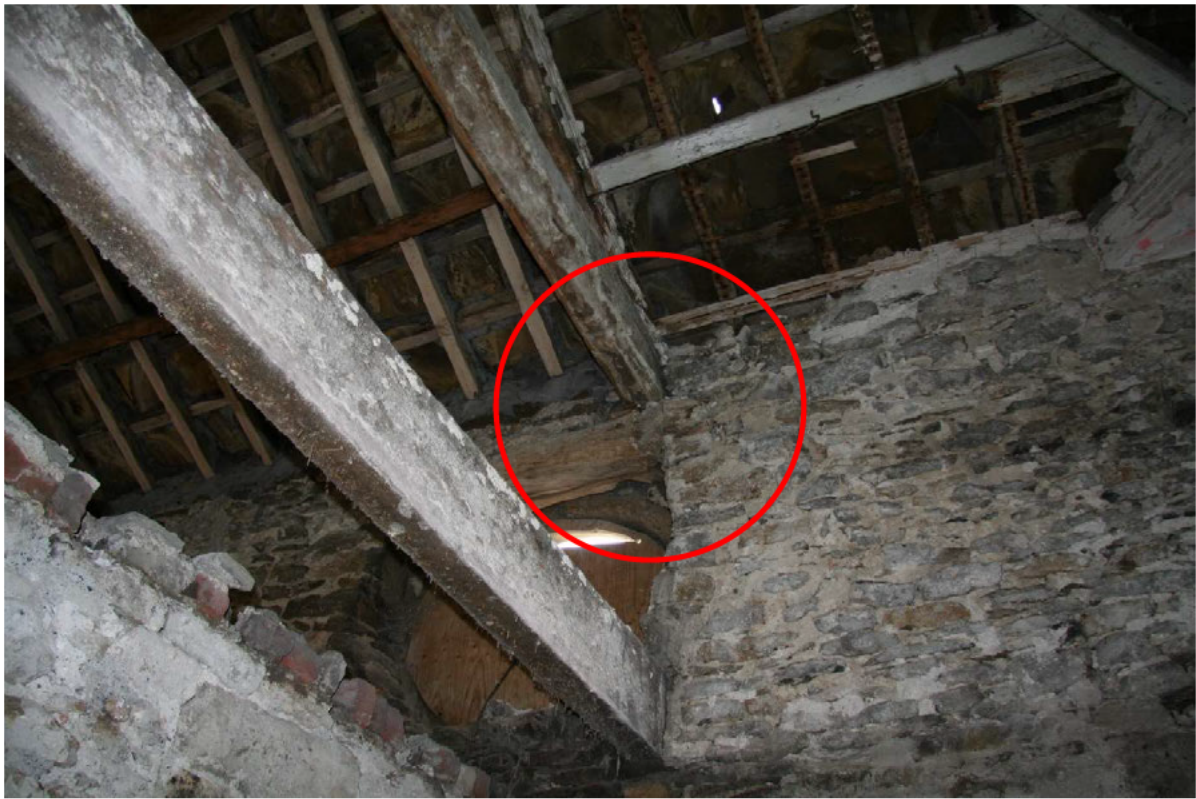
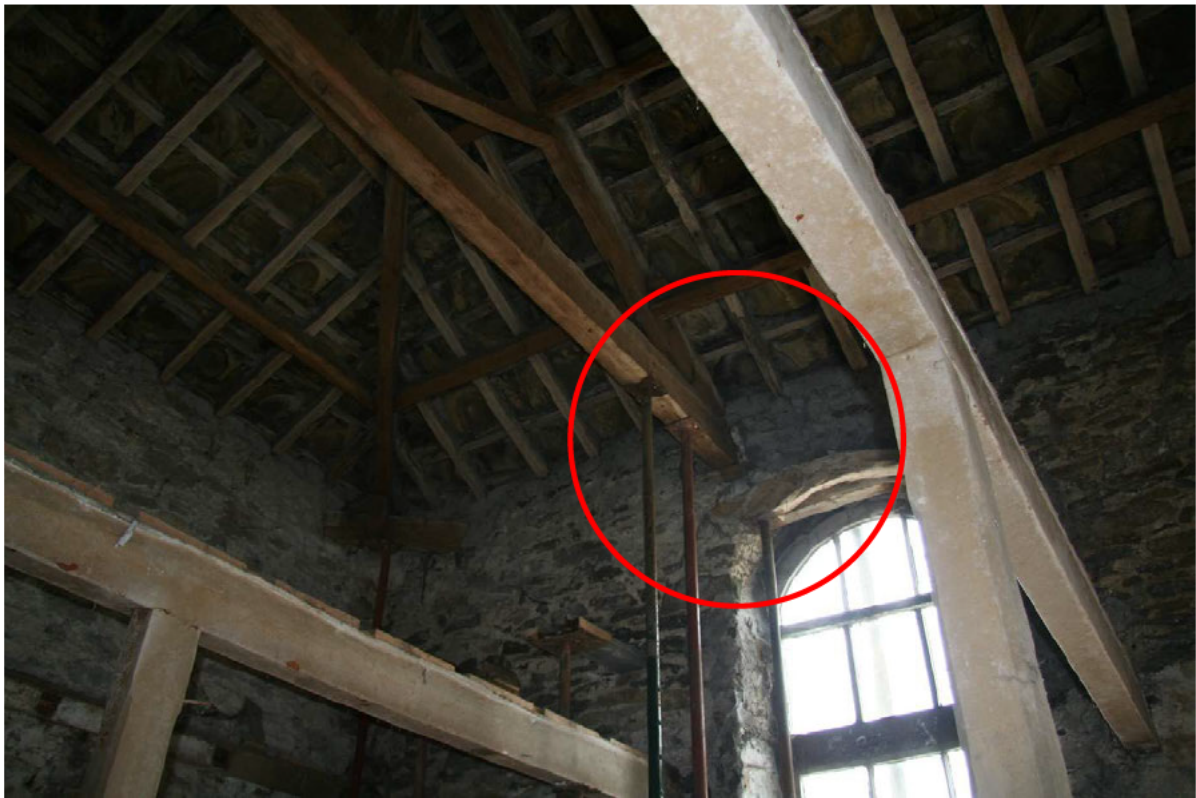
Poor positioning of first floor windows in relation to the truss bearings, refer photographs P8 and P9 on the following page.

Ground floor openings to the front elevation have been poorly positioned at strategic load-bearing points below truss and first floor primary beam bearings contributing to the walls weakness and how it performs when it settles under variable soil stratum. Ideally, proposed openings shall be positioned away from load-bearing points or suitable lintels incorporated.

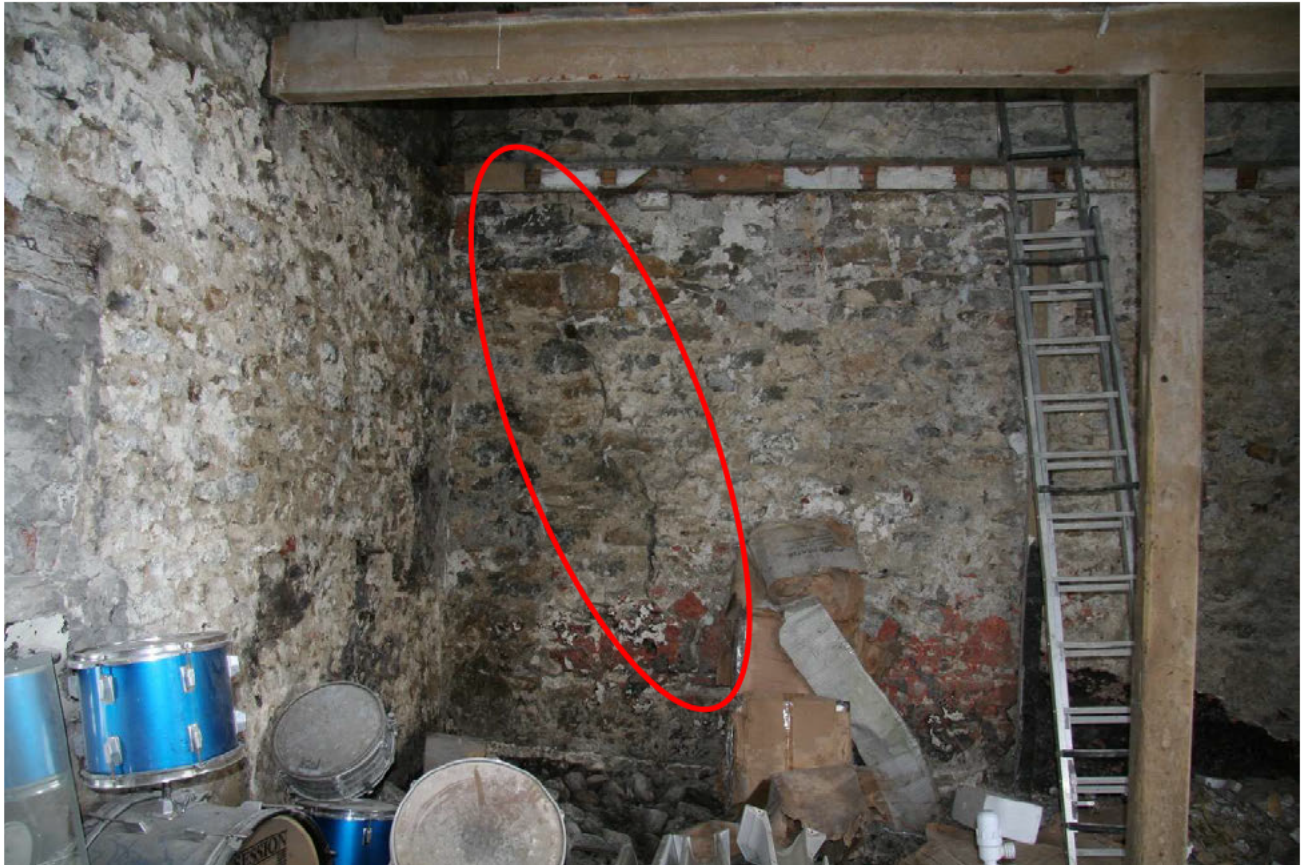
Relatively large vertical cracking evident to left hand gable, refer photograph P10 below. Not prominent to external elevation.

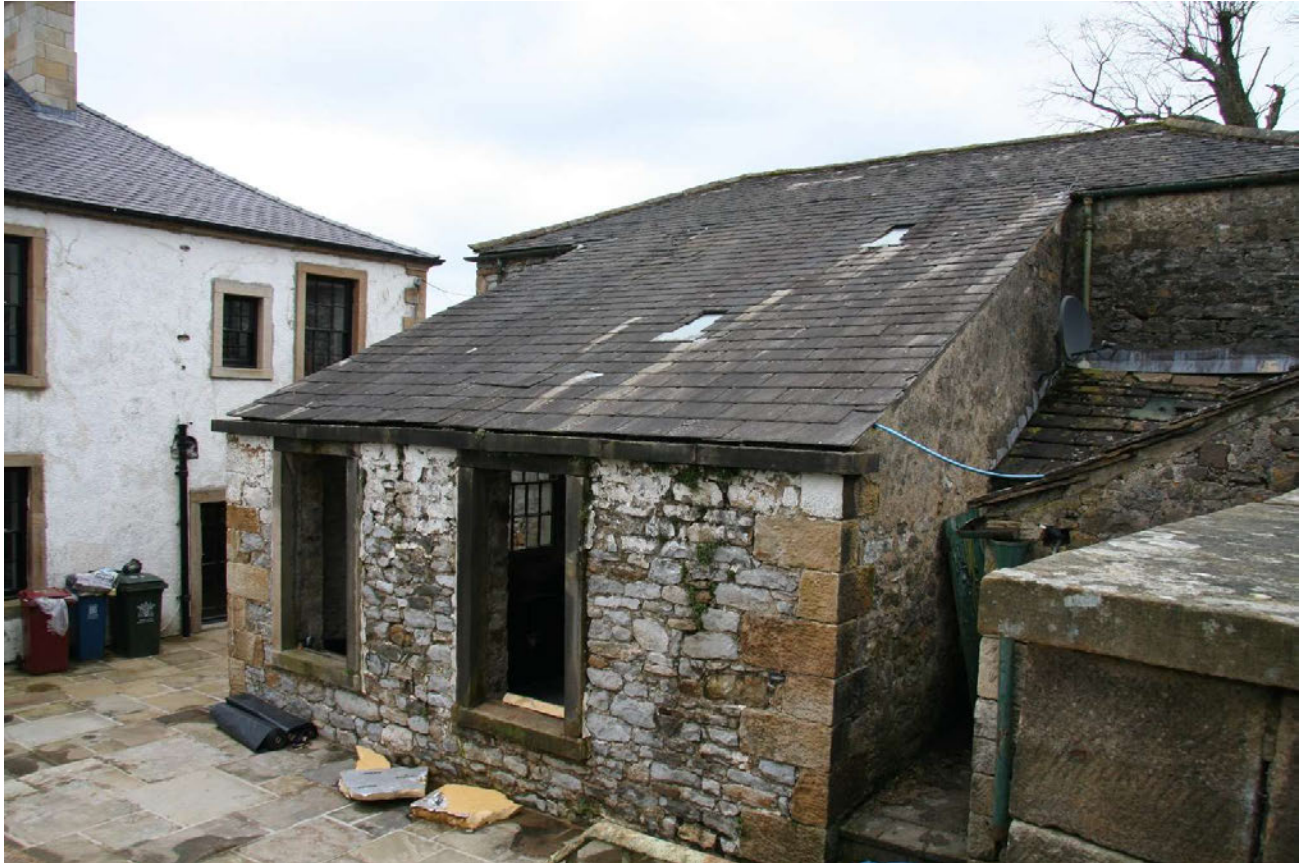
Rear annex of similar construction with timber purlin construction, refer photograph P11 below.

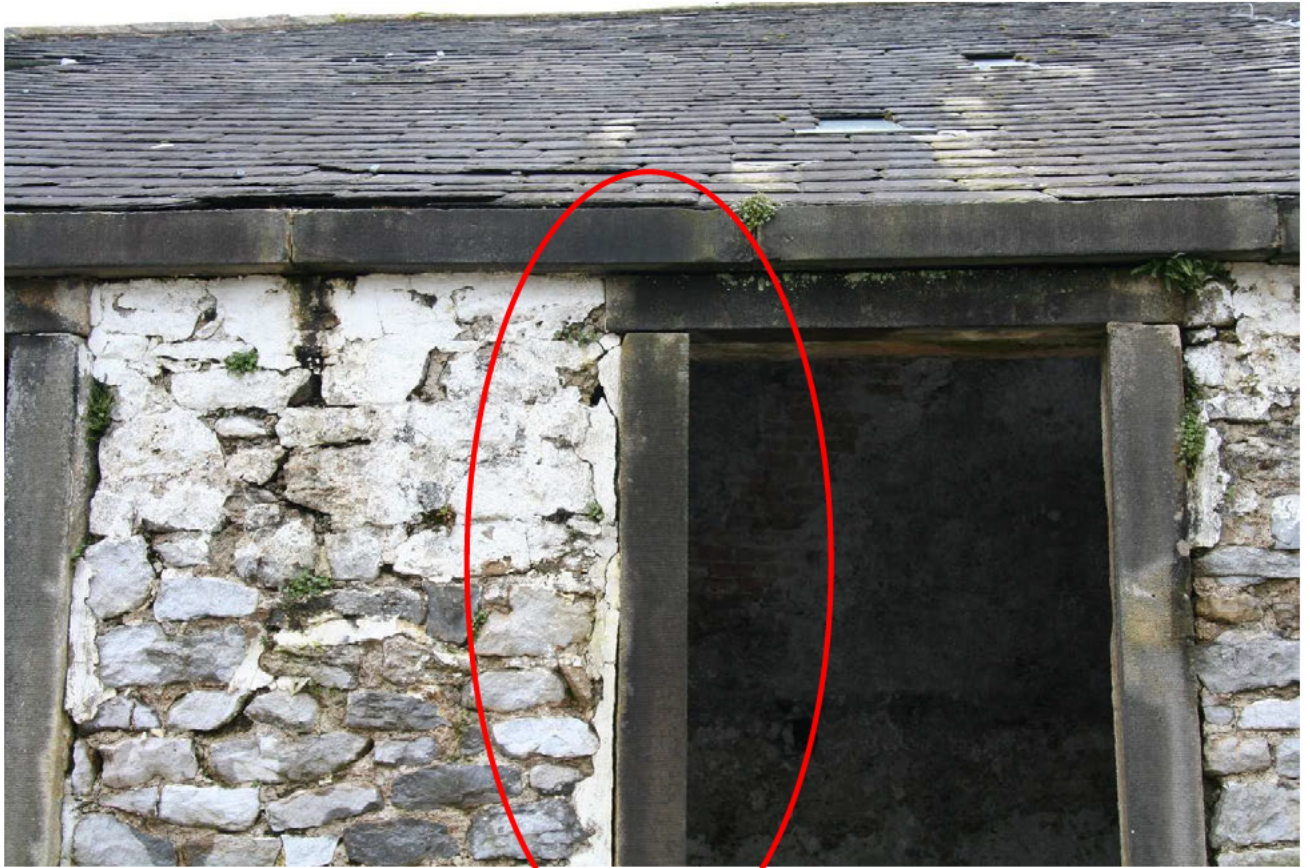
Stone jamb movement evident to window opening, refer photograph P12 below.

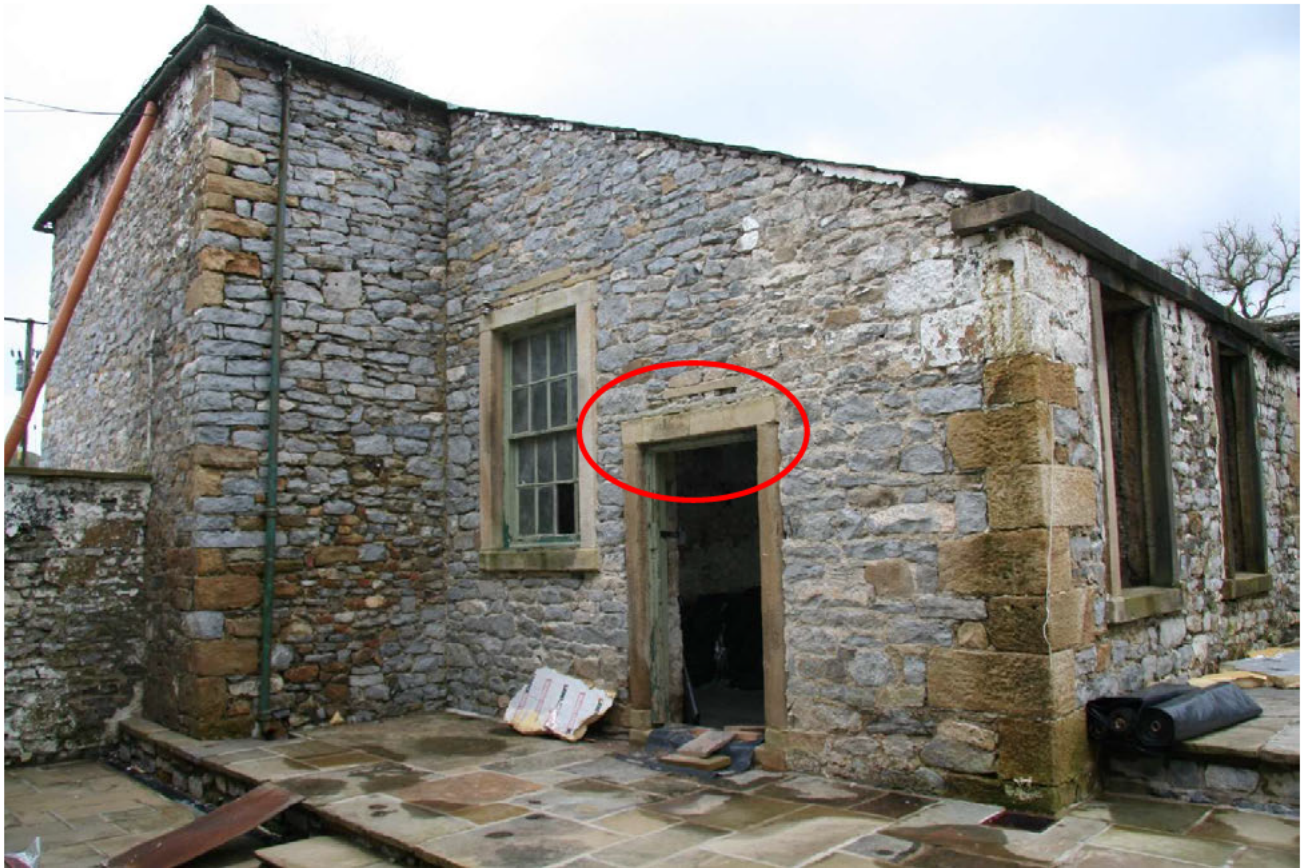
Inspection of the annex side elevation revealed no significant cracking indicative of structural movement, refer photograph P13 below.

Stone lintel to door opening snapped, refer photograph P13 above and P14 below.

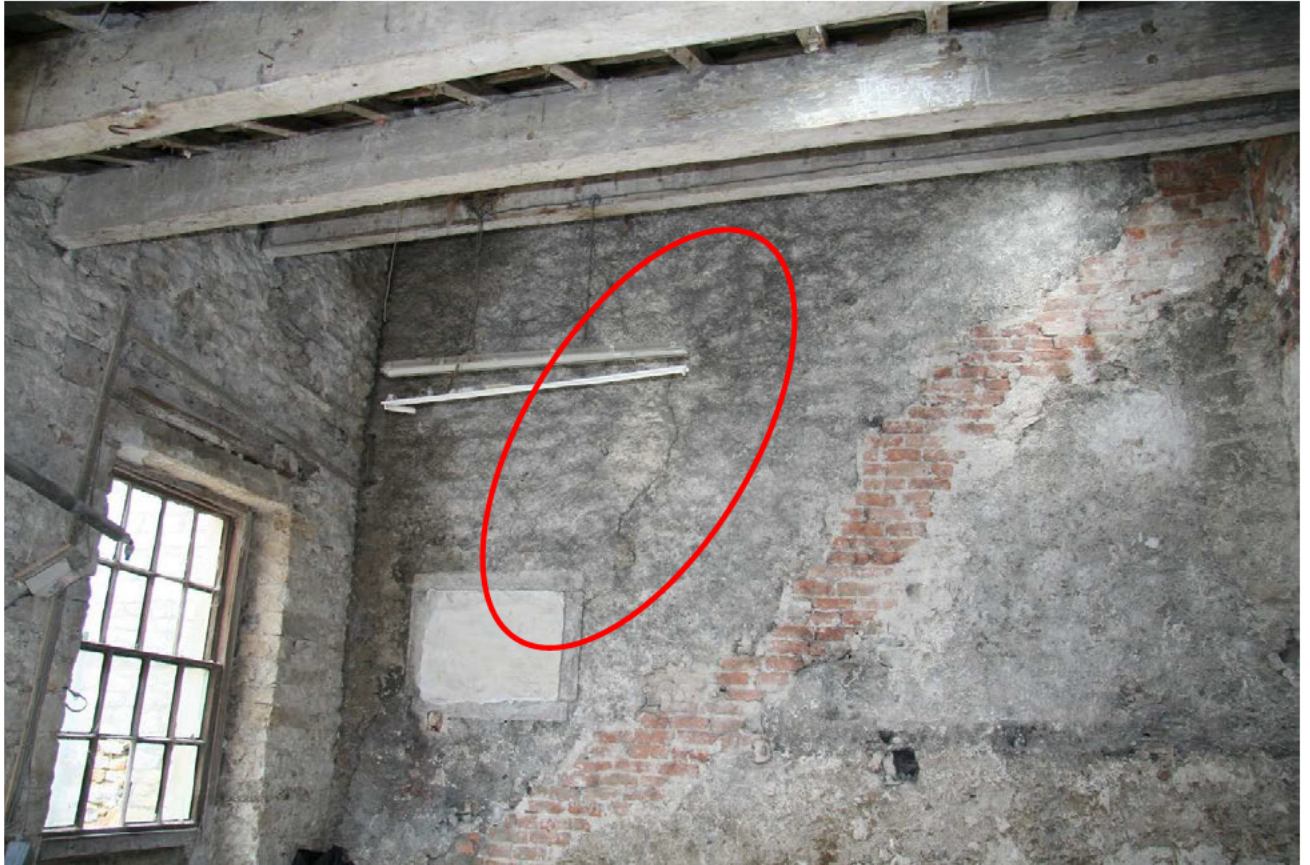
Relatively large vertical diagonal cracking evident to main barn rear elevation wall, refer photograph P15 below. Not prominent within main barn.
