ENGINEERING REPORT 9682

**GARAGE CONVERSION
1 STRAITS LANE
READ
BURNLEY
BB12 7PE**

CLIENT: ROGER HINDLE FINANCIAL SERVICES LTD

04.10.2024 MP/CH

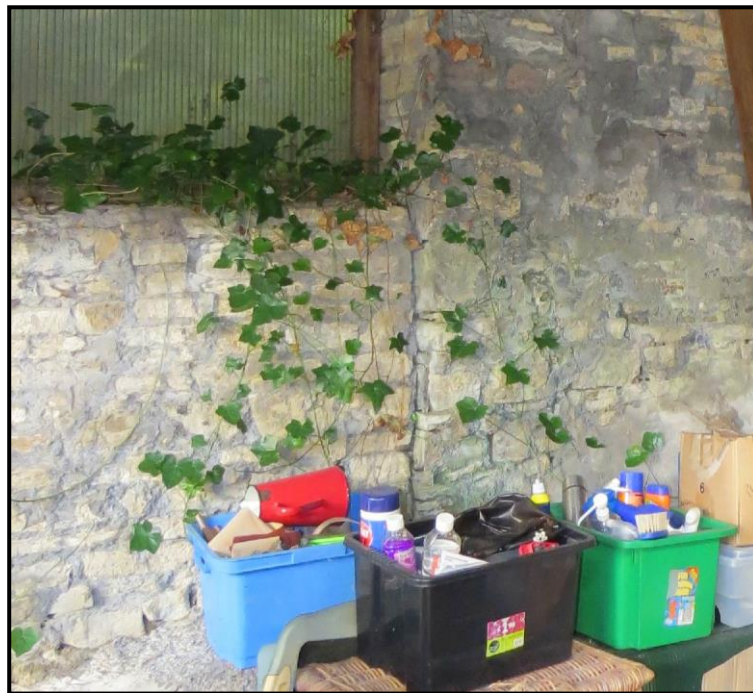
- 2.1 The garage is constructed as a back to earth structure the exterior footprint in the order of 9 metres x 7 metres wide, aligned on an approximate North/South orientation with the front entrance on Turner Fold having a predominantly Southern aspect.
- 2.2 The rear section of the unit is constructed on a back to earth structure as a solid wall construction probably in excess of 100 years old and appears to have been an original barn or outbuilding. The current structure incorporates a full height vertical construction joint to both the Western (left) and Eastern (right) flank walls. (Photographs 007, 008).

Photograph 007 West elevation vertical joint to original stone barn

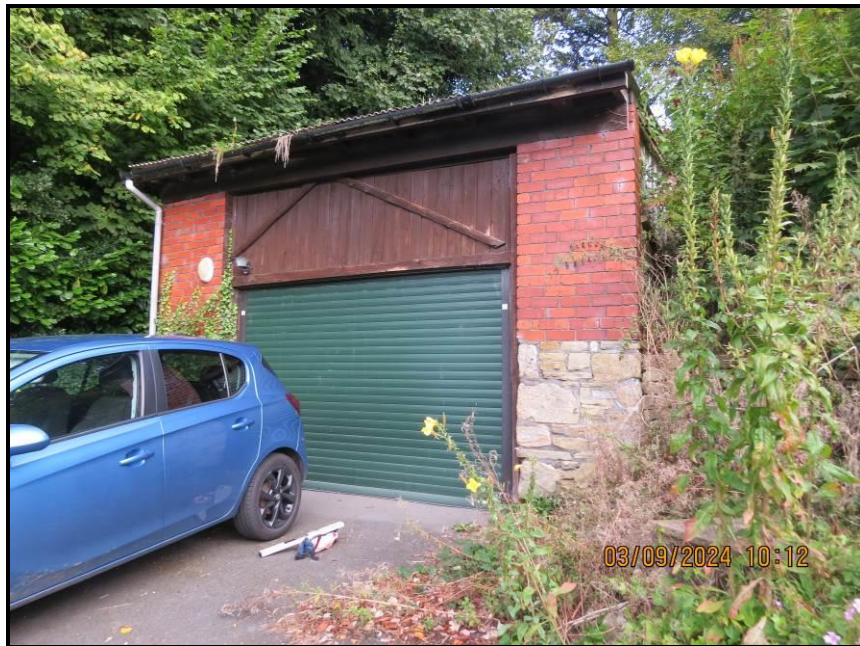
- 3.1 The garage extends for a width in the order of 8 metres incorporating 1 metre wide pillars on either side of the roller shutter doorway, the pillars incorporate natural stone plinths 1200mm high with upper brickwork panels in garden wall bond for a further 1.8 metres to eaves level. (Photographs 001, 004).

Photograph 004 Front elevation

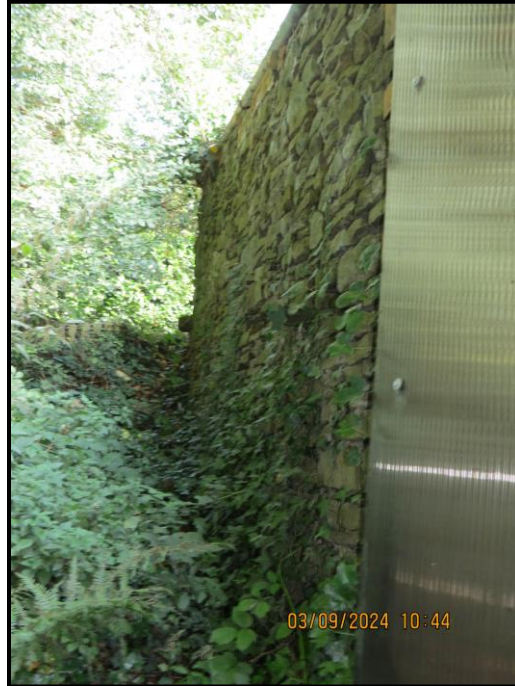
- 4.1 On the rear North West corner of the Western flank wall localised irregular coursing is evident (possibly resulting in the internal 1200mm x 1200mm brickwork buttress evident internally on the North West corner). (Photographs 005, 030, 031, 032).

Photograph 031 North West flank, localised disturbance to outer leaf

- 5.2 The vertical profile of the wall is satisfactory, there is no evidence of any movement or separation between the original stone flank of the external front section to the garage. (Photograph 007).
- 5.3 The original stone section extends from chainage 3 metres to 9 metres with a wall thickness in the order of 450mm, with a generally satisfactory vertical profile to inner stonework.
- 5.4 In the North West corner (approximately chainage 7 – 9 metres) there is a 1200mm square x 2 metres high Accrington brick pillar, possibly added to provide additional lateral support to the external stonework on the North Western corner where some misalignment has occurred to the outer facing stone. (Photograph 031).

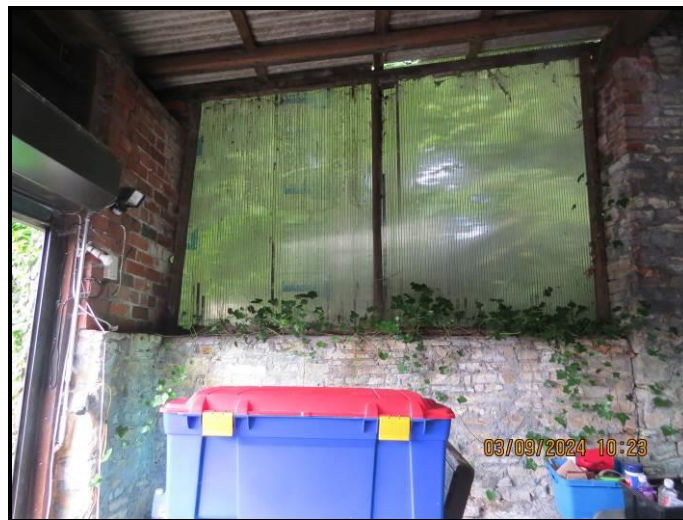
Photograph 005 Double panel window, Western flank wall

- 5.1 The South West corner is constructed with a stone plinth approximately 1.8 metres high to the underside of the cill level of the double panelled Perspex window. The stone wall is seated on a variable section concrete plinth approximately 400mm – 500mm high x 600mm wide. (Photographs 005, 006, 027).

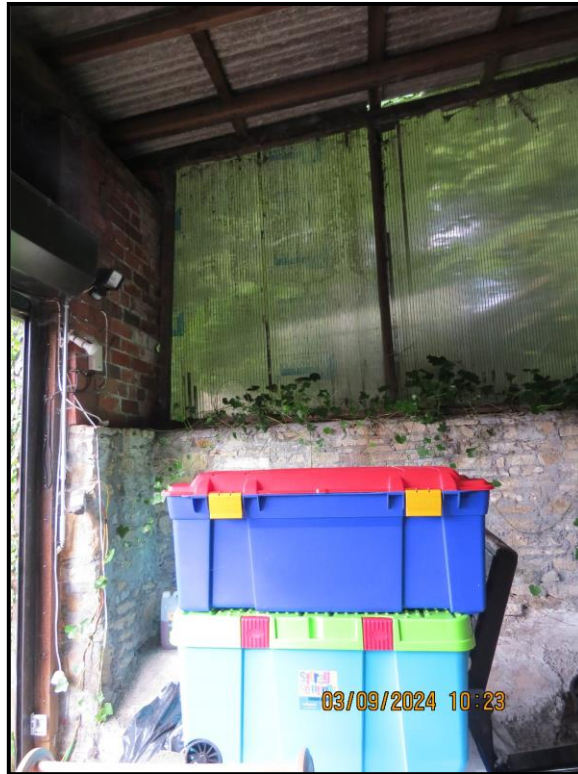
Photograph 006 Western flank wall, chainage 0 – 3 metres

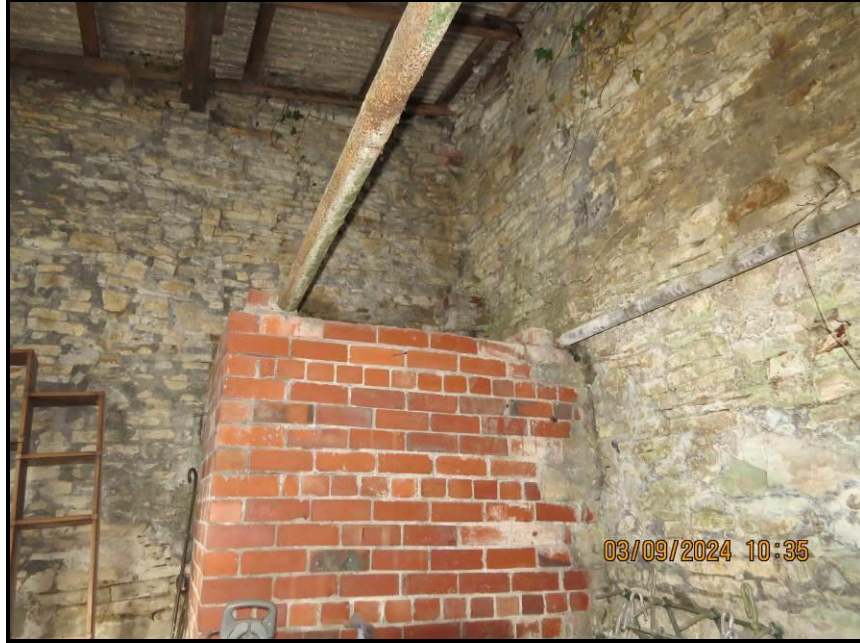
- 5.5 The buttress also provides support with 75mm diameter metal struts spanning between both flank walls. (Photographs 024, 032, 034, 035).

Photograph 024 Buttress support to steel struts

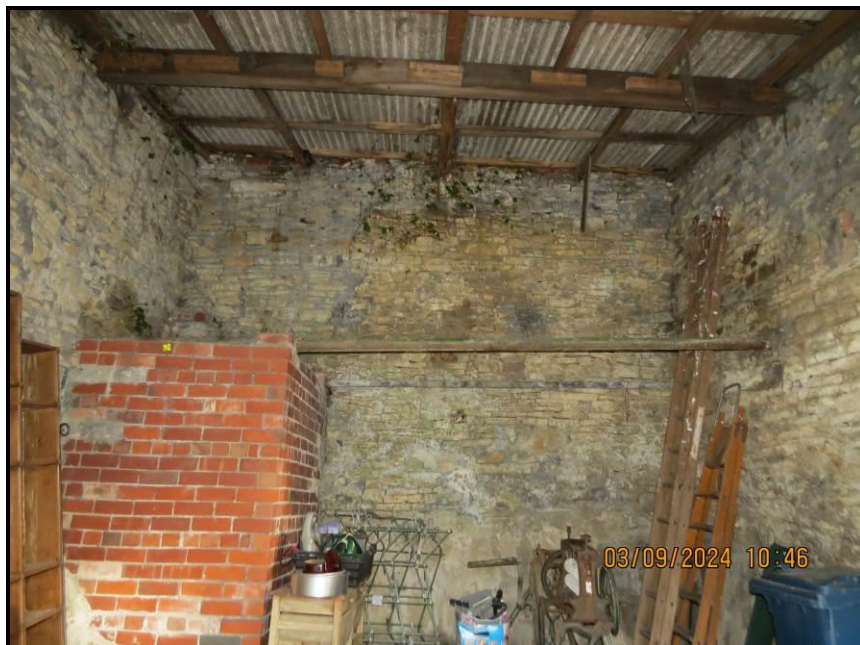
Photograph 035 Rear wall and return flanks

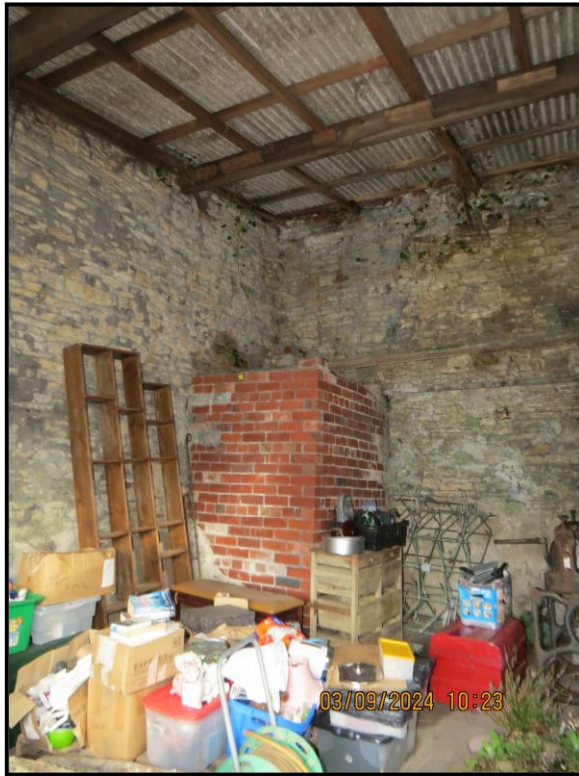
- 6.1 The rear wall extends for a width in the order of 8 metres and a height of 9 metres, constructed in random coursed stonework with evidence of historical crack repairs, but no evidence of any recent structural movement. (Photographs 008, 009).

Photograph 008 Western flank and North West corner, original construction

- 6.2 There are no visual signs of any separation or lateral movement between the rear wall and the return Western and Eastern flanks. (Photographs 008, 010, 011).

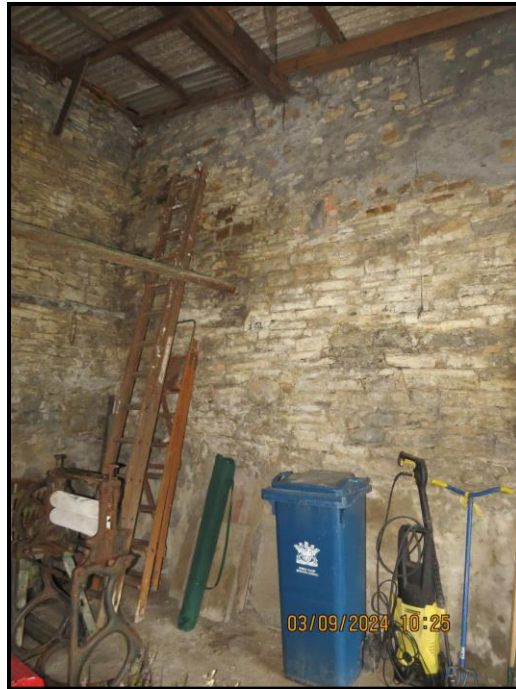
- 7.1 The Eastern flank extends to the left hand window reveal, the window reveal (repaired) is a mixture of stone and brickwork. The overall profile of the wall is reasonable with some historic minor internal bowing, evident where the steel struts have been provided to give lateral bracing between the Eastern and Western flanks, at a height of around 2 metres above floor level. (Photographs 011, 012, 015, 023).

Photograph 012 Eastern flank wall lateral restraint

- 9.5 In the conversion adequate bracing will be incorporated within the floor construction, providing full width lateral restraint to both Eastern and Western flank walls and also to the rear back to earth retaining wall.

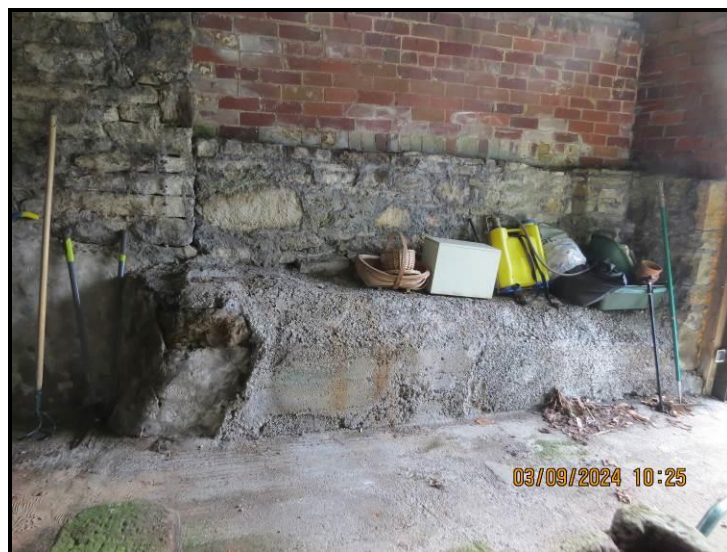
Photograph 015 Mixed plinth construction, chainage 0 – 3 metres (East)

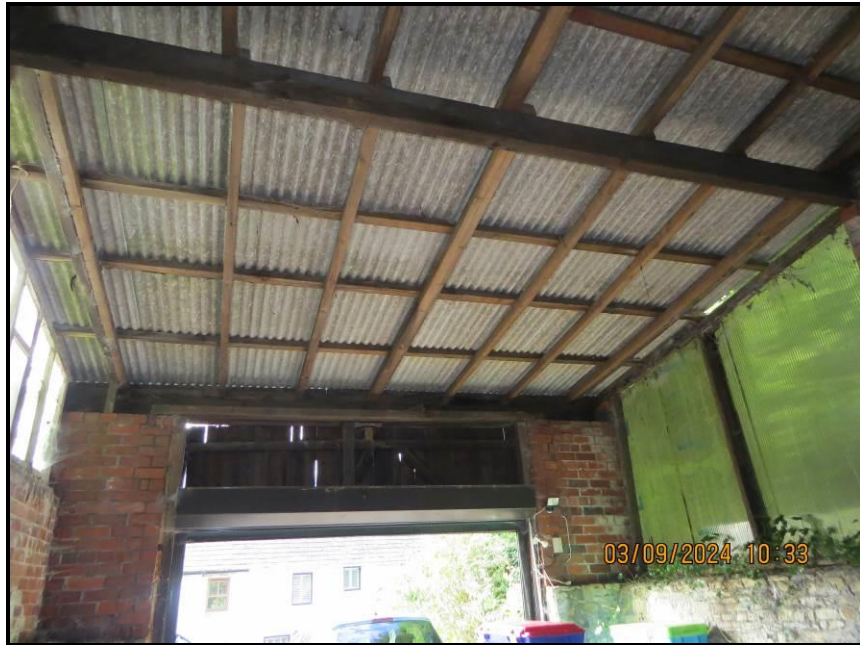
- 8.1 The roof to the unit is completed in small 6 Asbestos cement supported on a purlin/rafter roof construction with satisfactory profiles for the current loading. (Photographs 021, 022, 026).

Photograph 021 Roof – general arrangement

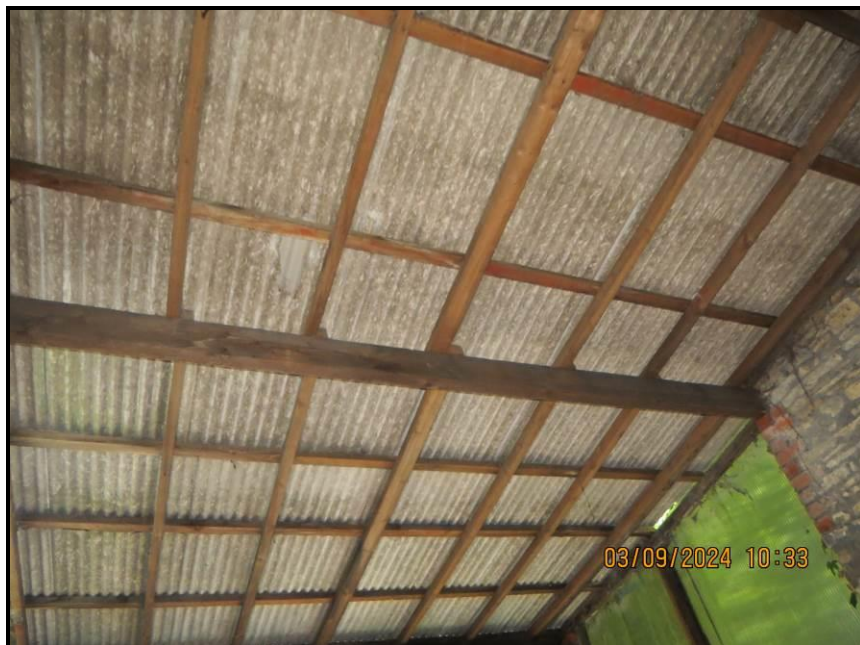
Photograph 022 Roof – general arrangement

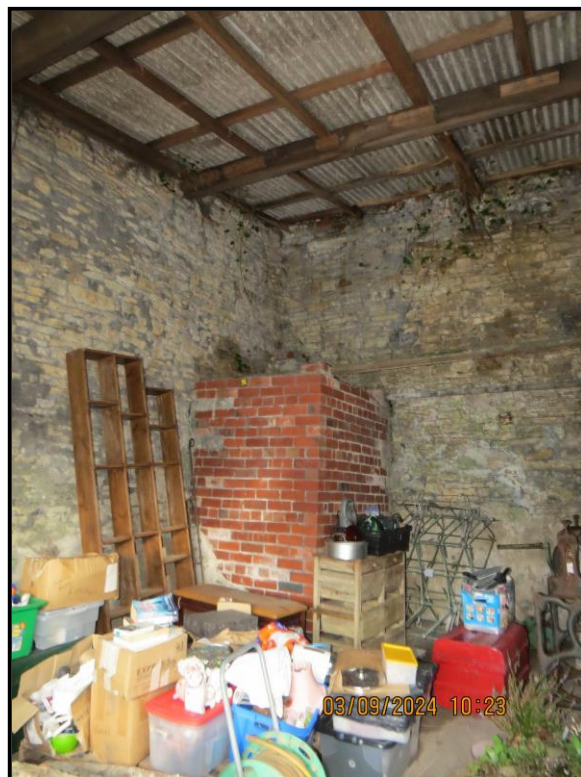
008 Western flank and North West corner, original construction

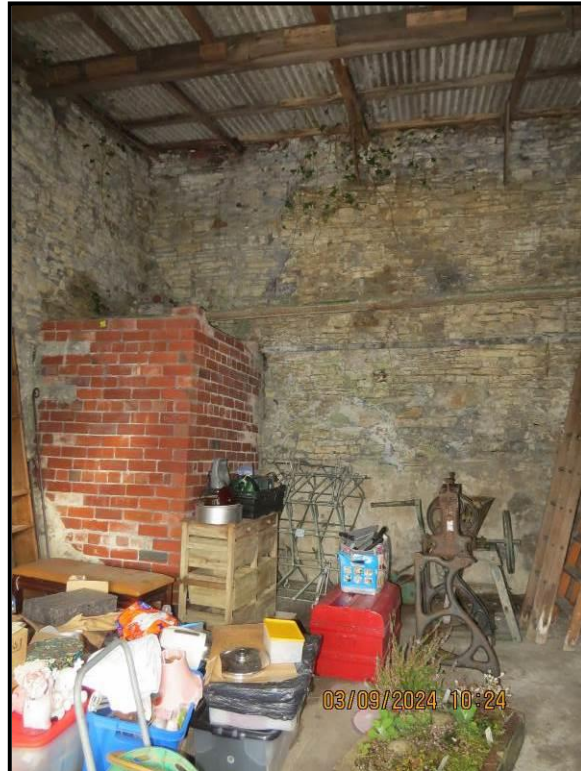
009 Masonry buttress, North West corner

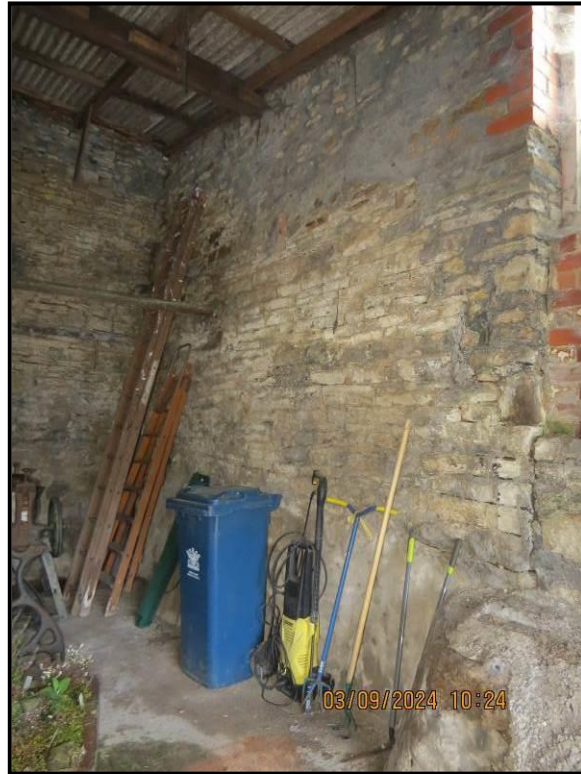
011 Eastern flank wall, lateral restraint

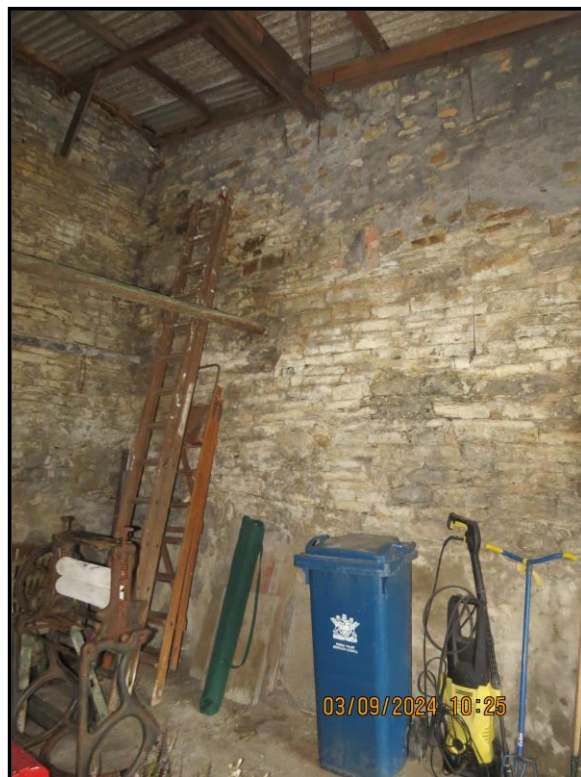
012 Eastern flank wall, lateral restraint

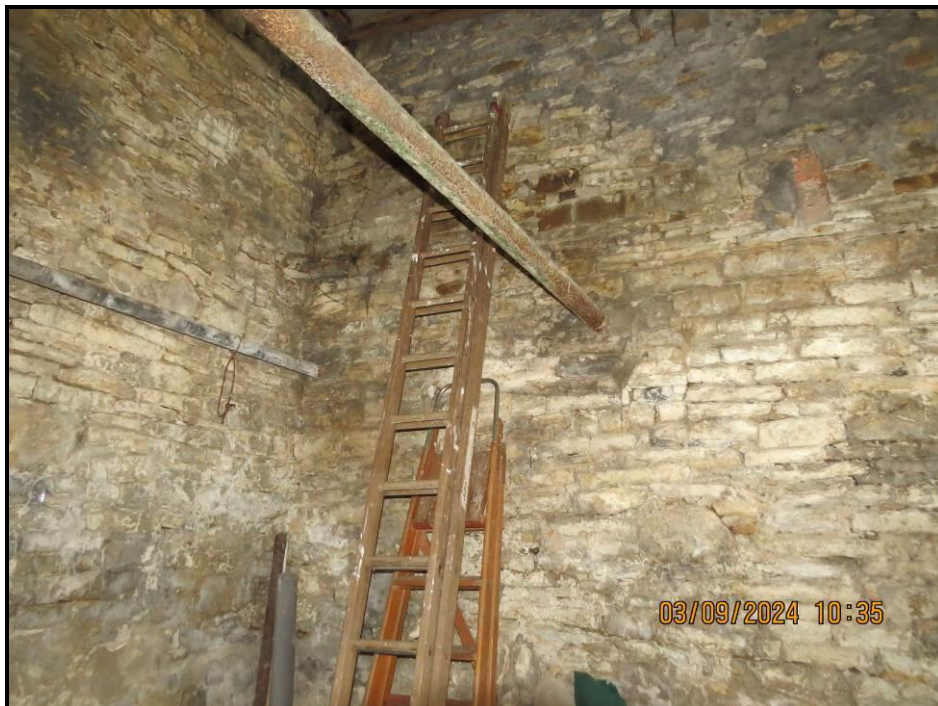
023 Lateral strut support to Eastern wall

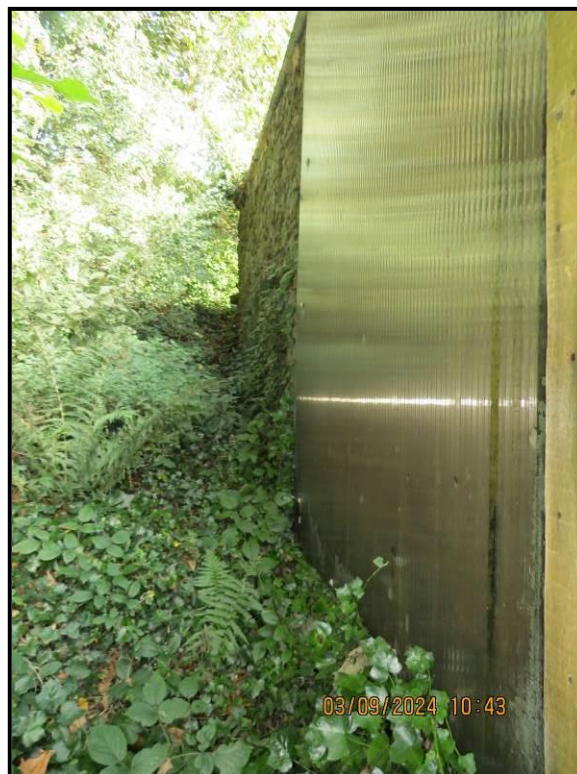
030 North Western flank, localised disturbance to outer leaf

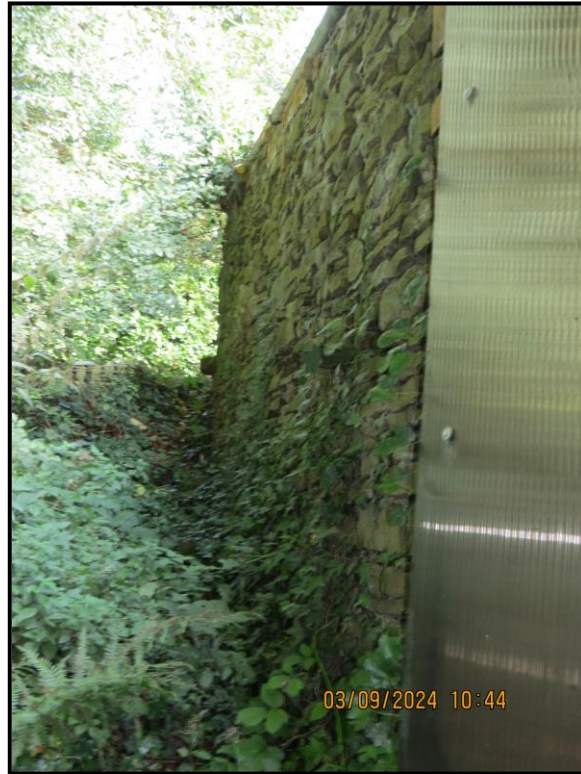
031 North Western flank, localised disturbance to outer leaf

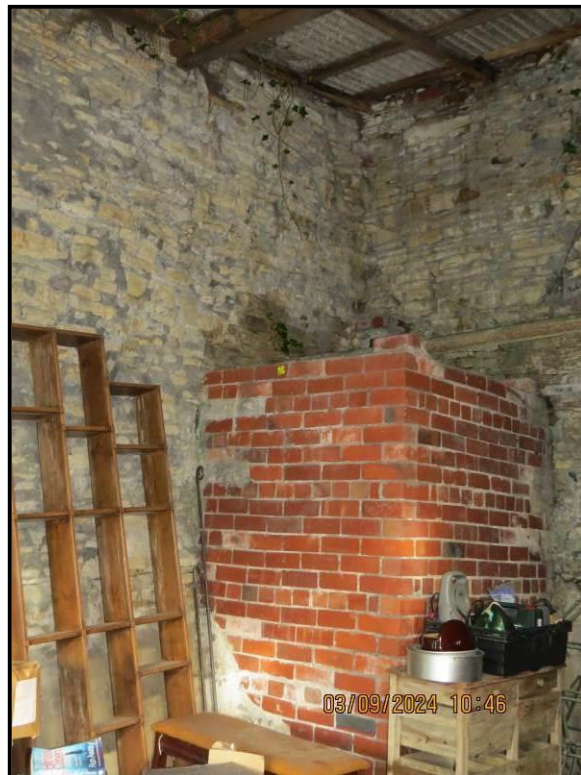
032 Internal buttress, North West corner
