## **Barn 1 at Writtenstone Farm, Writtenstone Lane, Longridge, PR3 2ZN**

### **Structural Condition Survey for Conversion to Dwelling**

PSC-859 – B1

February 2024

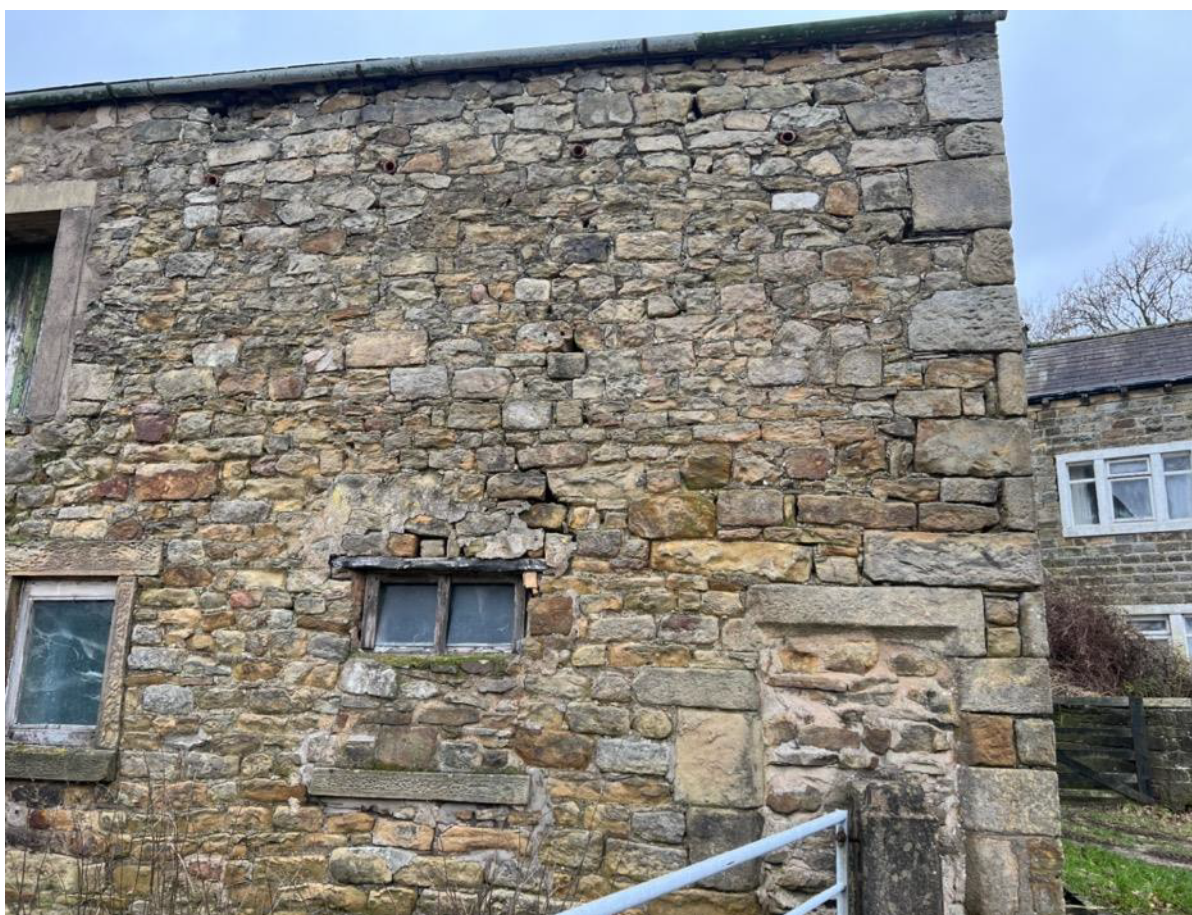
level together with the large main barn door (photos 1 to 6). A further door opening at the north east end has been blocked up (photo 2). There are 2 further openings at a higher level, giving access to the loft areas of the barn. The main barn door has a recessed area of stone to accommodate the sliding doors (photos 4 to 6). This section of the elevation has the benefit of guttering and downspouts which are in a poor condition.

Photo 2 – South East Elevation

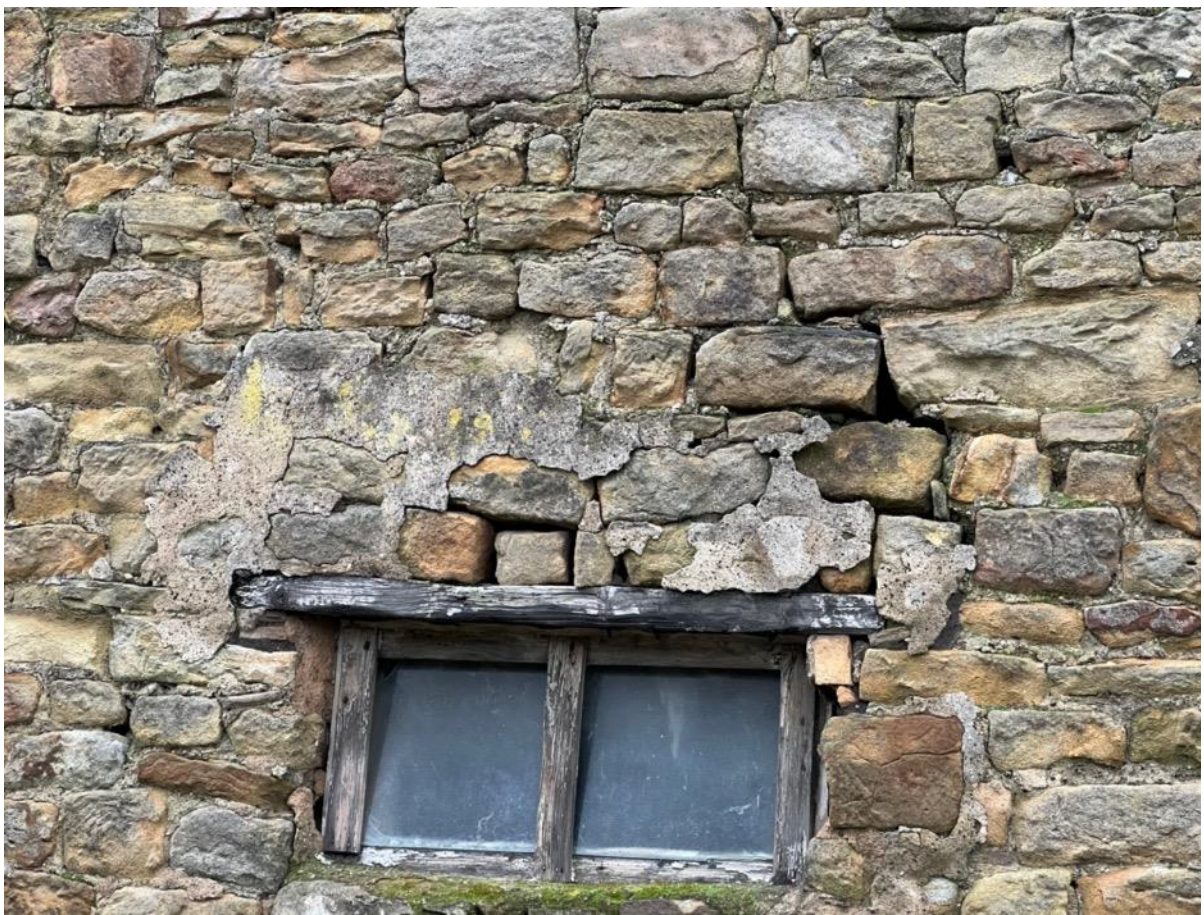
This elevation is in two sections covering the older barn to the south west with the more recent main barn to the north east. The walls are built in random sandstone and are 500mm thick. The walls are in reasonable condition. They are plumb and reasonably pointed. There are no signs of previous or ongoing movement except for minor issues where timber lintels have rotted or deflected (photo 3). The main barn section has three window openings at ground floor

Photo 3- South East Elevation

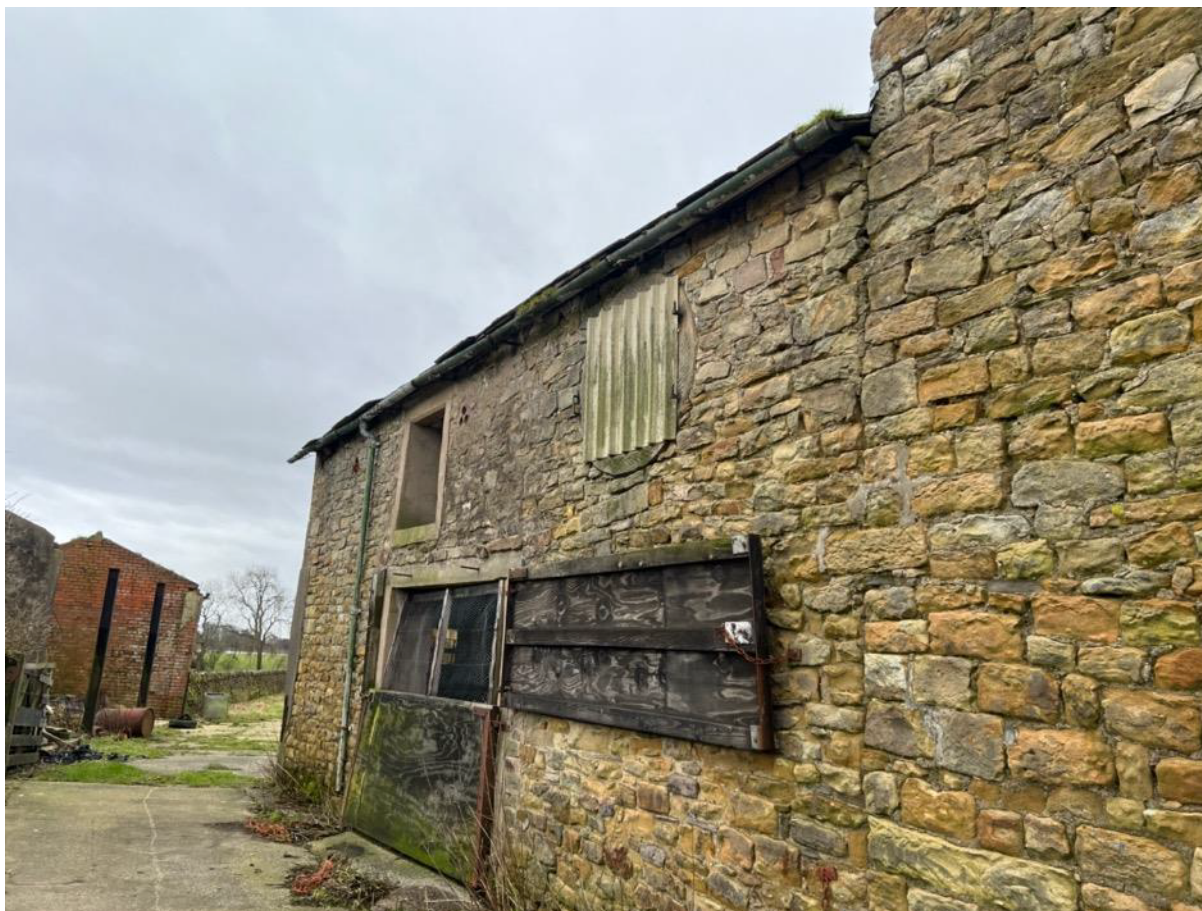
The smaller section of barn to the south west has a single large door opening at ground floor level and 2 further openings at a higher level giving access to the loft areas of the barn (photo 10). There are also further vents at a high level formed by field tiles (photos 10 to 12 & 14). The south west corner of the elevation has been rendered at the lower levels and this may indicate some previous damage underneath caused by vehicular collisions (photo 14). This section of the elevation has the benefit of guttering and downspouts which are in a poor condition.

Photo 10 – South East Elevation – west extension

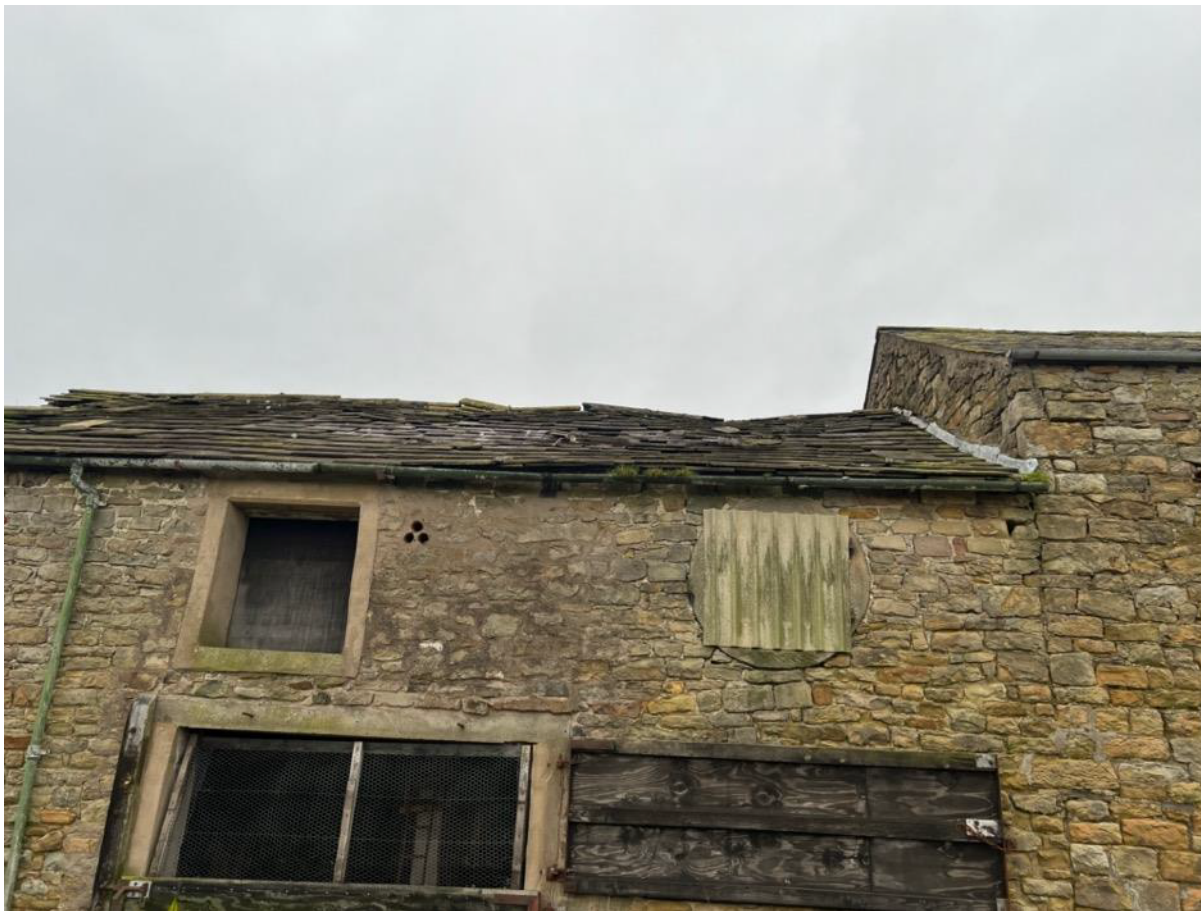
Viewed externally, the main barn roof appears in good condition with no sign of damage, slate loss, or excessive deflection. The stone flagged roof to the south west section is in poor condition with damage and missing or displaced flags. The flagged roof has excessive deflection to the purlins at the north east end (photo 17). The cement asbestos roof to the rear shippon is in good condition with no missing/damaged sheets and no sign of excessive deflection.

Photo 12 - South East Elevation – west section showing flags to roof

against rot/infestation and an indication of residual section given for structural purposes. All retained timber to be used structurally should be checked for structural adequacy. The roof to the south west section is currently covered with heavy stone flags and if these are retained then the design of any new roof timbers must take account of this heavier covering. The roof to the rear shippon is currently covered with cement sheets or asbestos cement sheets. These should be investigated further to ascertain the exact material. If this is found to be asbestos sheeting it should be removed and disposed of to current Health & Safety Guidelines.

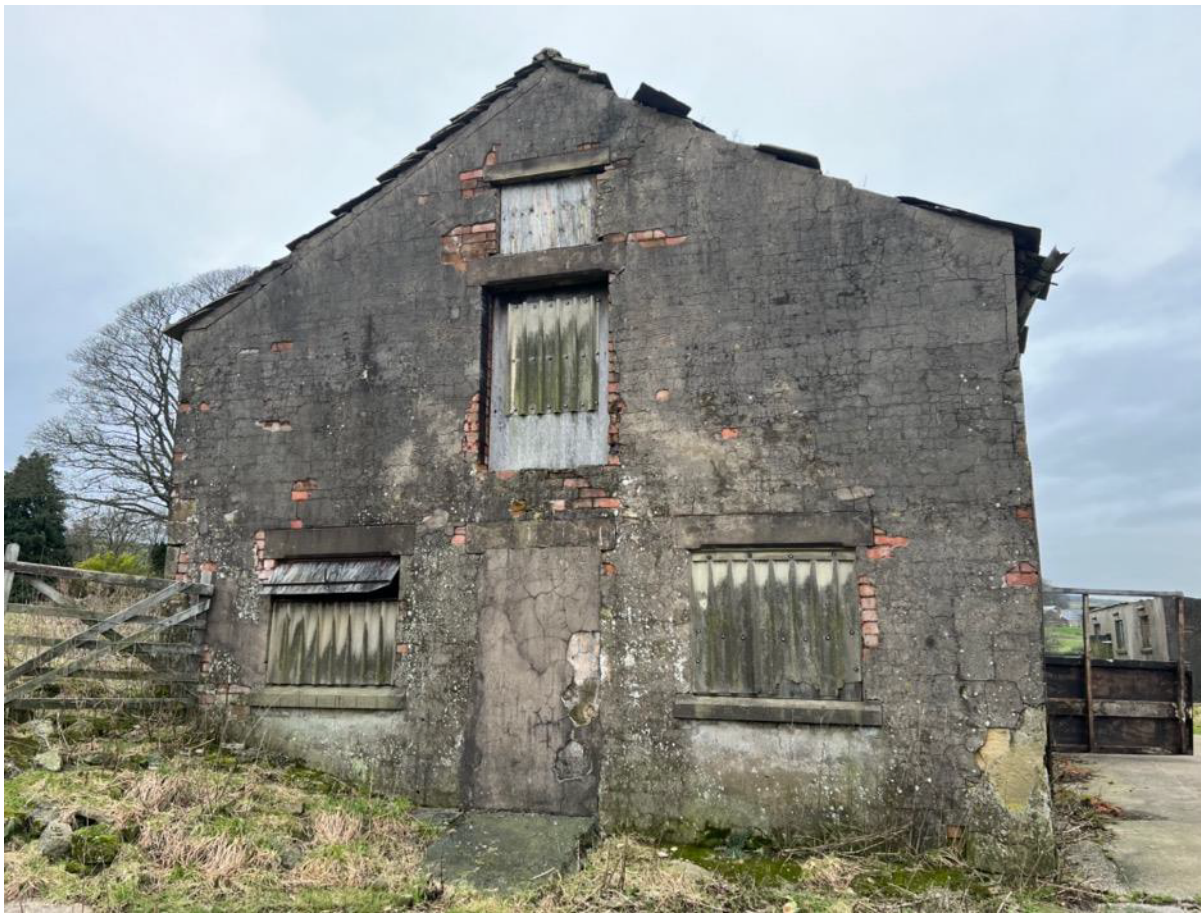
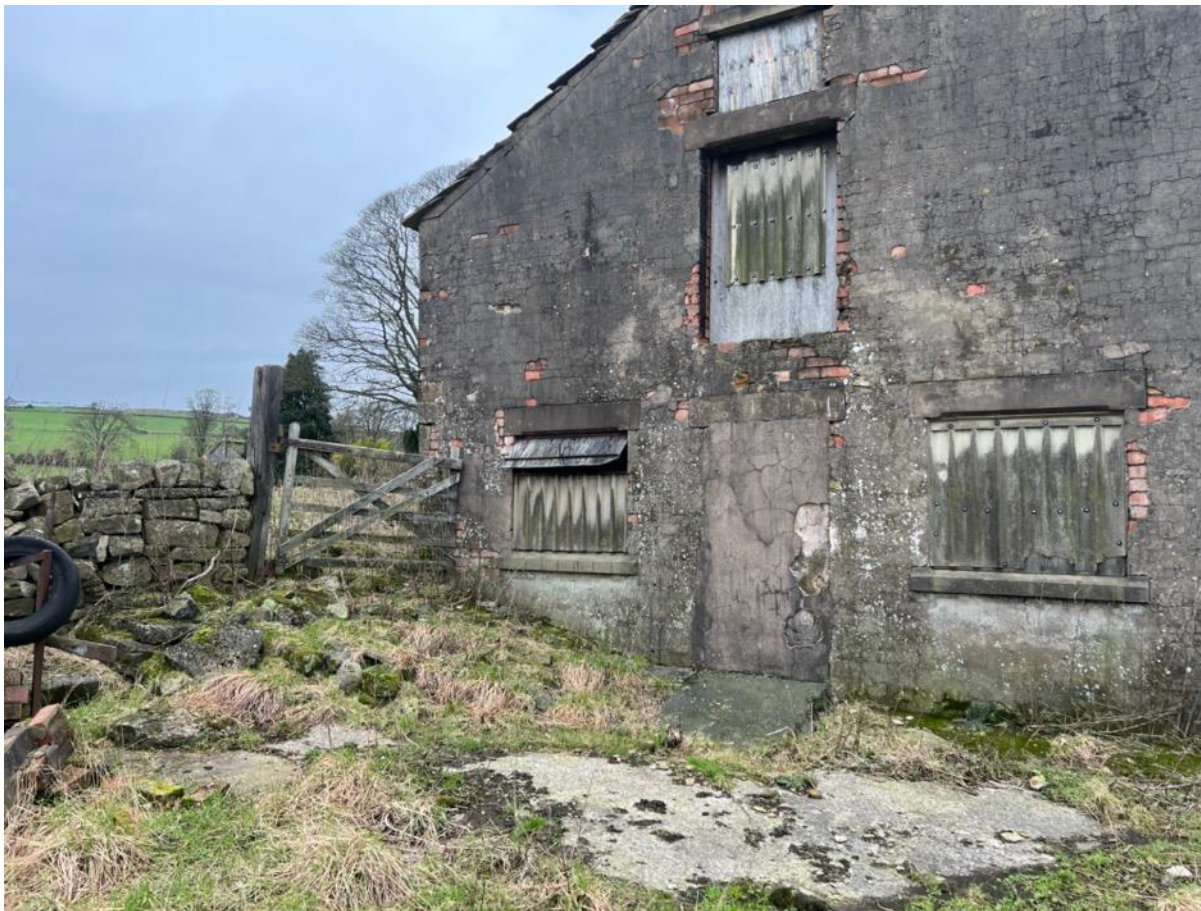
This elevation is the gable to the south west section of the barn and appears to have been re-built in clay brick, forming a solid 250mm thick wall. The wall has been rendered. The wall looks poor visually but there are no signs of previous or ongoing movement and it is reasonably plumb. There are two window openings at ground floor level with a former doorway which has been blocked up. There are two further openings above the former doorway giving access to the loft area. The photos indicate that the ground level rises to the rear of the building along this elevation.

Photo 15 - South West Elevation

Photo 16 - South West Elevation

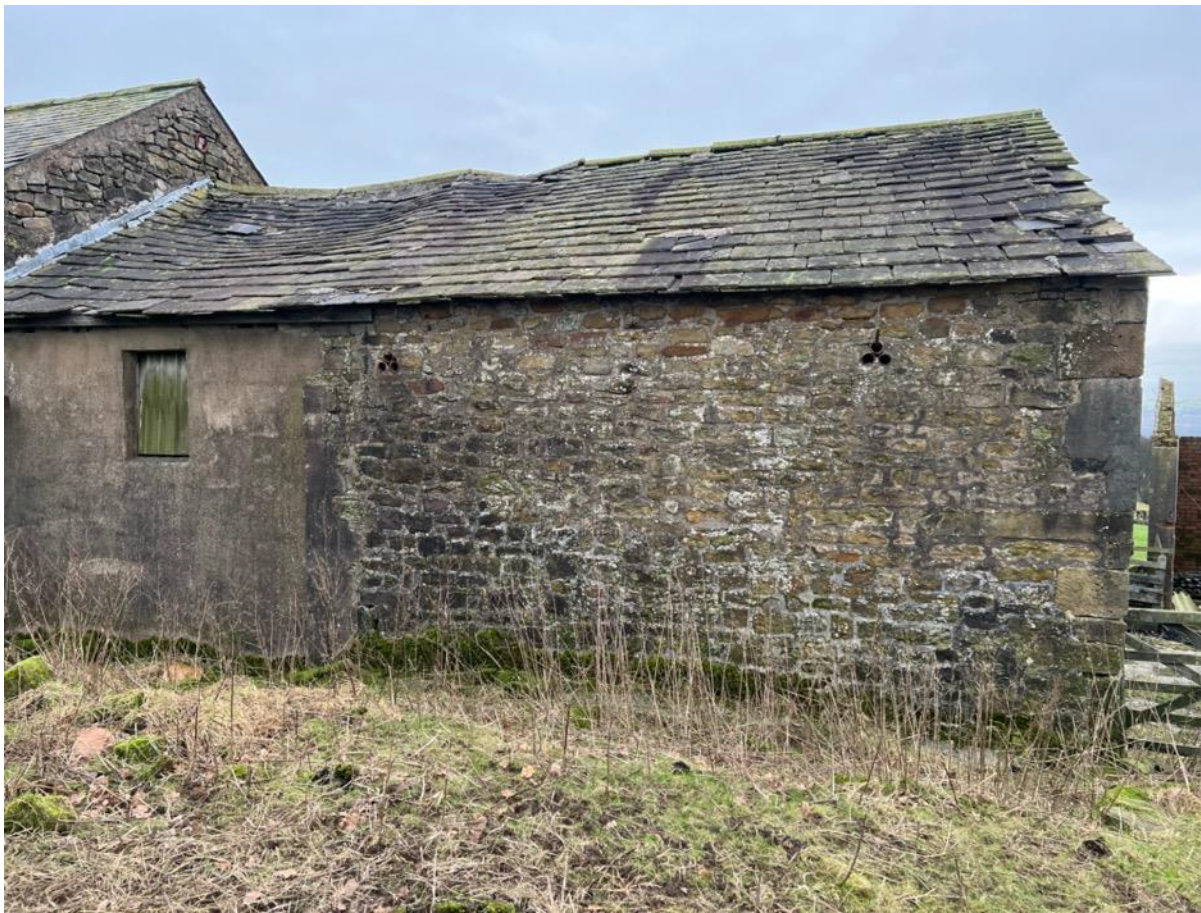
This elevation is a 500mm thick random stone with a single opening at the upper level. The north east section of wall is rendered and this indicates a former large opening in this barn which appears to have been blocked up. This is evidenced in the internal inspection. The wall is plumb, reasonably well pointed/rendered and free from signs of movement. There are no gutters or downspouts to this section of wall.

Photo 17 – North West Elevation to west section

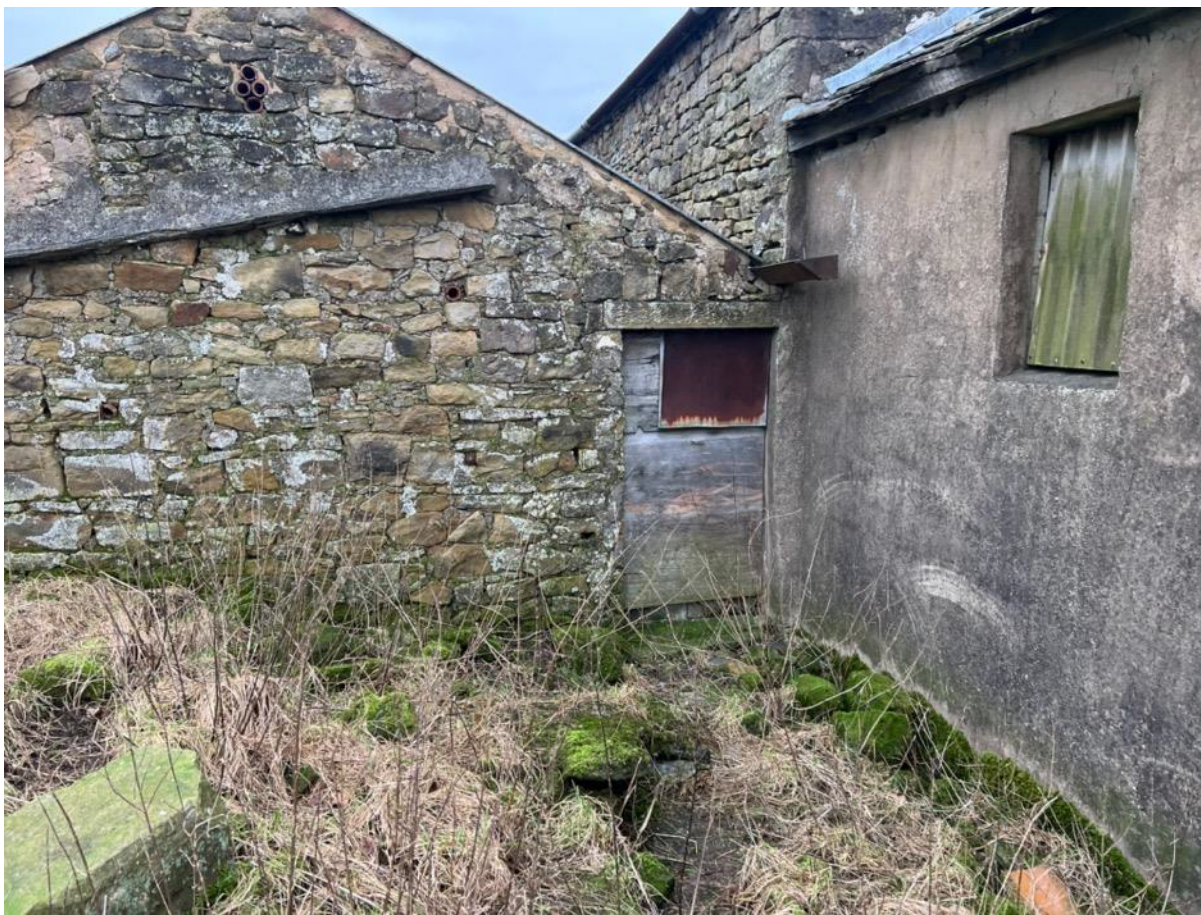
This wall is a 500mm thick random stone wall with a single doorway at the junction with the main barn (photo 21). There is a vent at the apex formed by field tiles. The wall is plumb, reasonably well pointed and free from signs of movement. This elevation does not have a gutter or downspout but there is a line of sloping solid mortar indicating there may have been a further building at this location.

Photo 21 – North West Elevation – junction of 3 sections

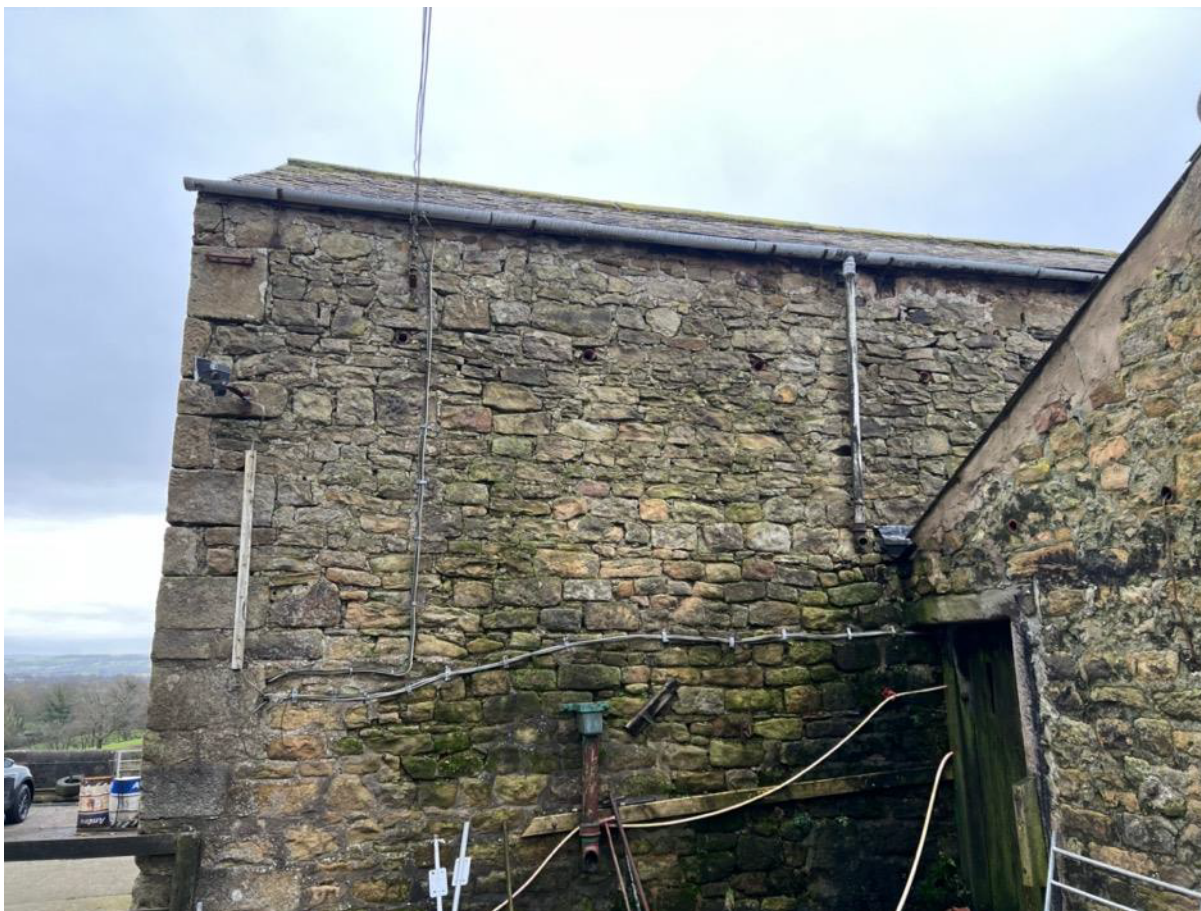
This elevation is a 500mm thick random stone wall with no openings externally. The majority of the wall is only visible at a higher level due to the adjacent rear shippon. The wall is plumb, reasonably well pointed and free from signs of movement. This section of the elevation has the benefit of guttering and downspouts which are in poor condition and discharging onto the wall (photo 26).

Photo 26 – North West Elevation

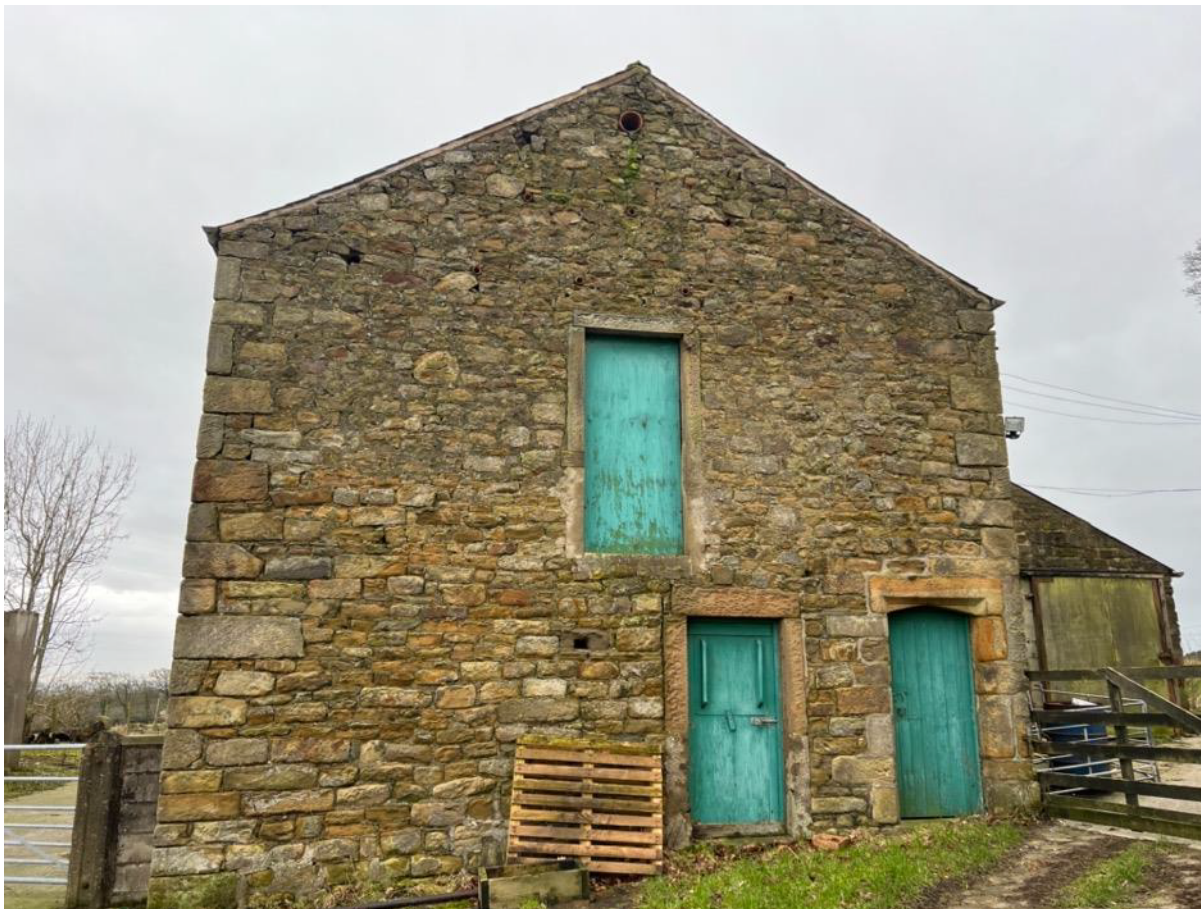
This wall is a 500mm thick random stone wall with two door openings at ground floor level and an upper door opening to the loft area (photo 28). There are several vents at a high level formed by field tiles (photo 28). The wall is plumb, reasonably well pointed and free from signs of movement. As with the south west gable it can be seen that the ground rises along this elevation towards the rear.

Photo 28 - North East Elevation

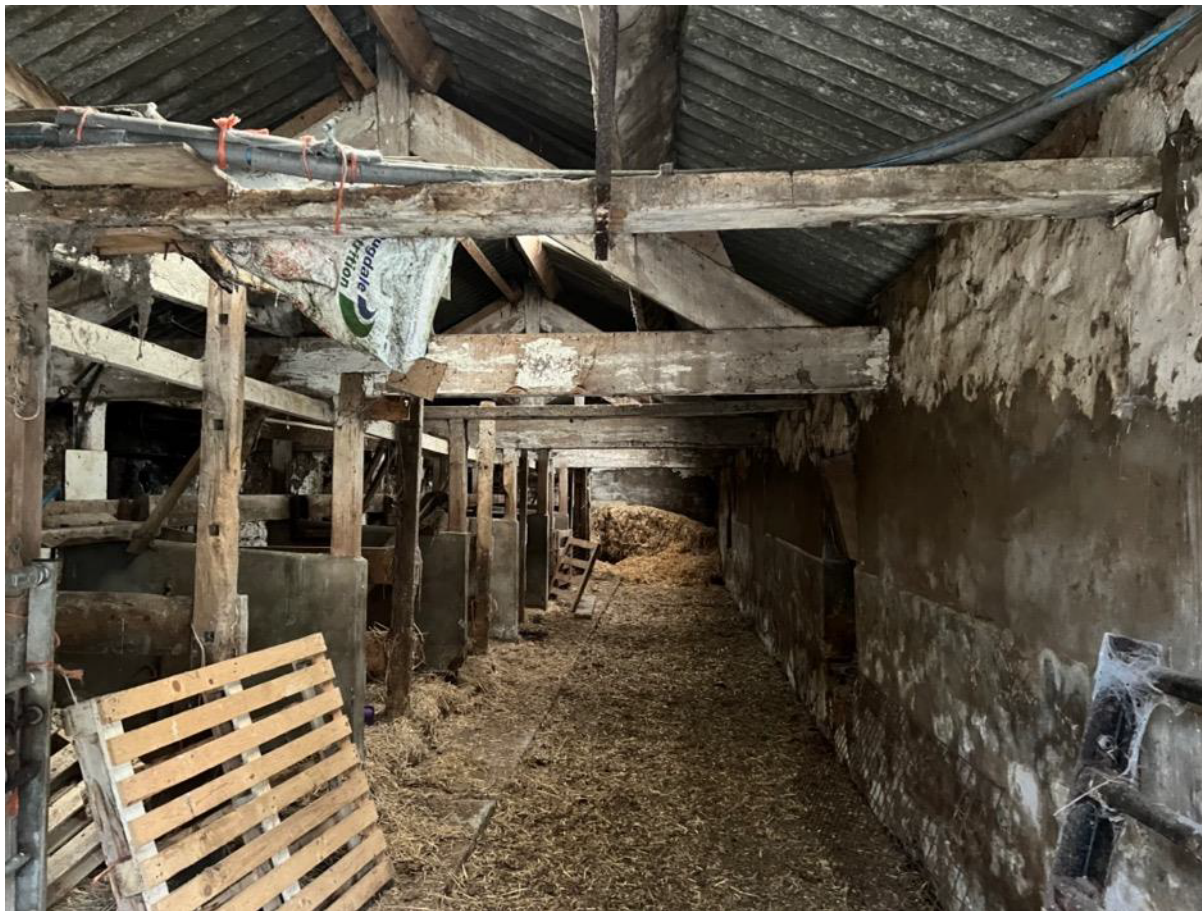
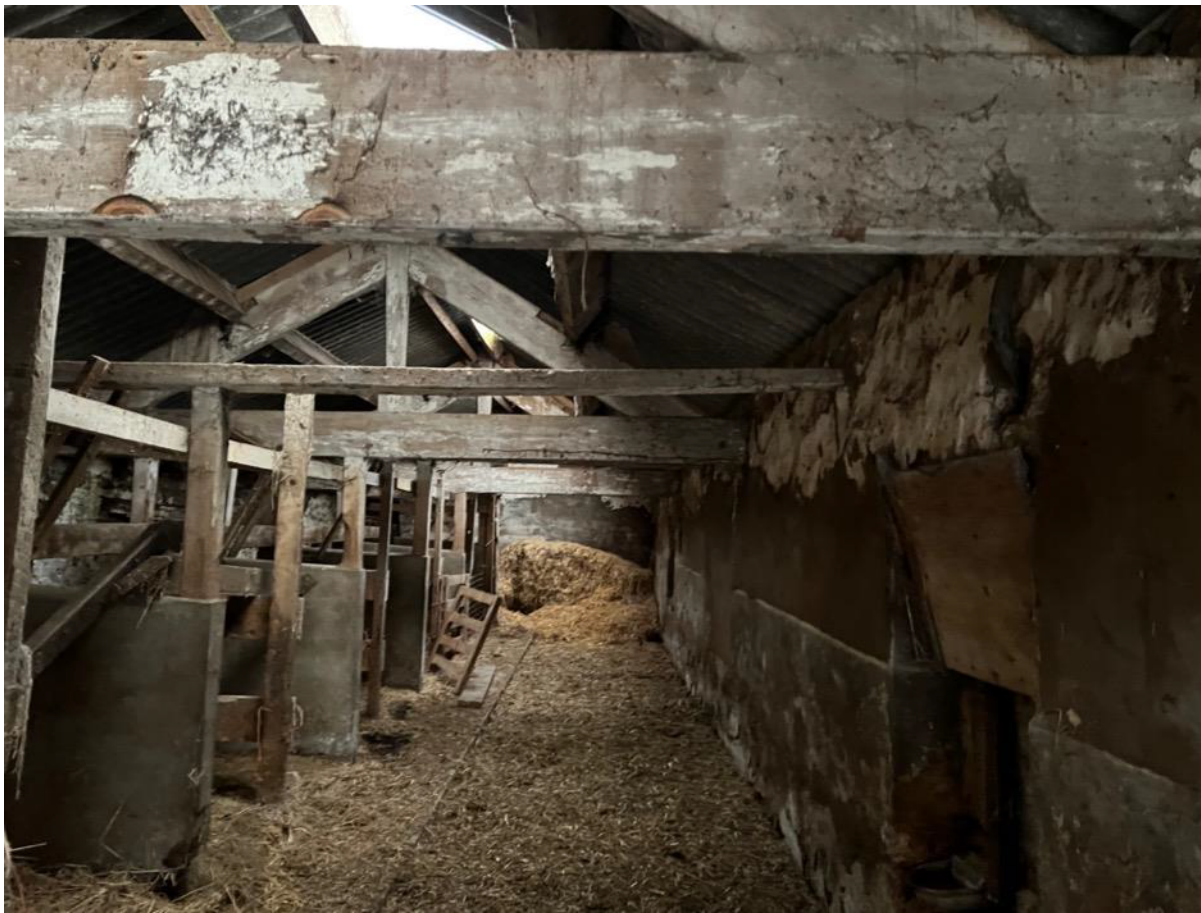
This section of the building is a full length shippon with a solid concrete floor (photos 32 & 35). The building shows no sign of previous or ongoing movement to walls or floors. The roof structure is of a timber construction with timber purlins and trusses (photos 32 to 35). There is evidence of damp/rot to the structural timbers but this is not extensive and likely to be treatable. Photo 37 shows an internal opening made in the rear wall of the main barn to provide access. The lintels are steel universal beam sections and these are in reasonable condition.

Photo 32 – Internal rear shippon

Photo 35 - Internal rear shippon

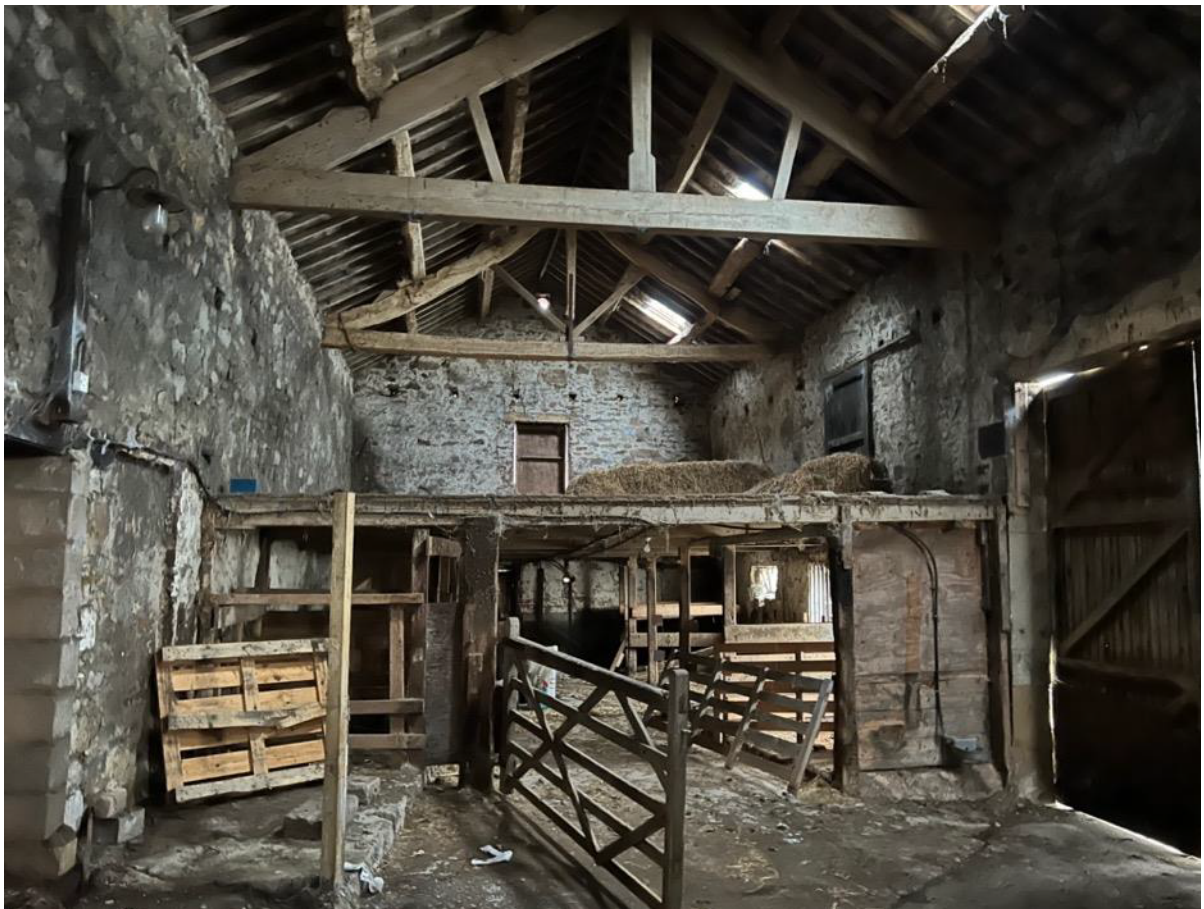
This largest area of the barn is full height at the south west end (photo 38) and has a loft area at the north east end (photo 42). The ground floor is concrete with the loft area constructed in timber. Internally, there is little or no sign of previous or ongoing movement to the walls or floor. The timber trusses are generally in a reasonable condition with little sign of rot or infestation (photos 44 & 45). The truss to the north east end appears to be older and has some signs of

rot and/or infestation (photo 42). The slate roof can be seen to be under boarded (photo 45). The timber loft structure is in a reasonable condition with no major signs of rot or infestation.

Photo 42 - main barn east

The existing trusses and purlins vary in condition, with some having little sign of rot or infestation but others have definitely suffered damage. Any timber retained should be assessed by a timber specialist, with regard to rot and infestation. All retained timber should be treated

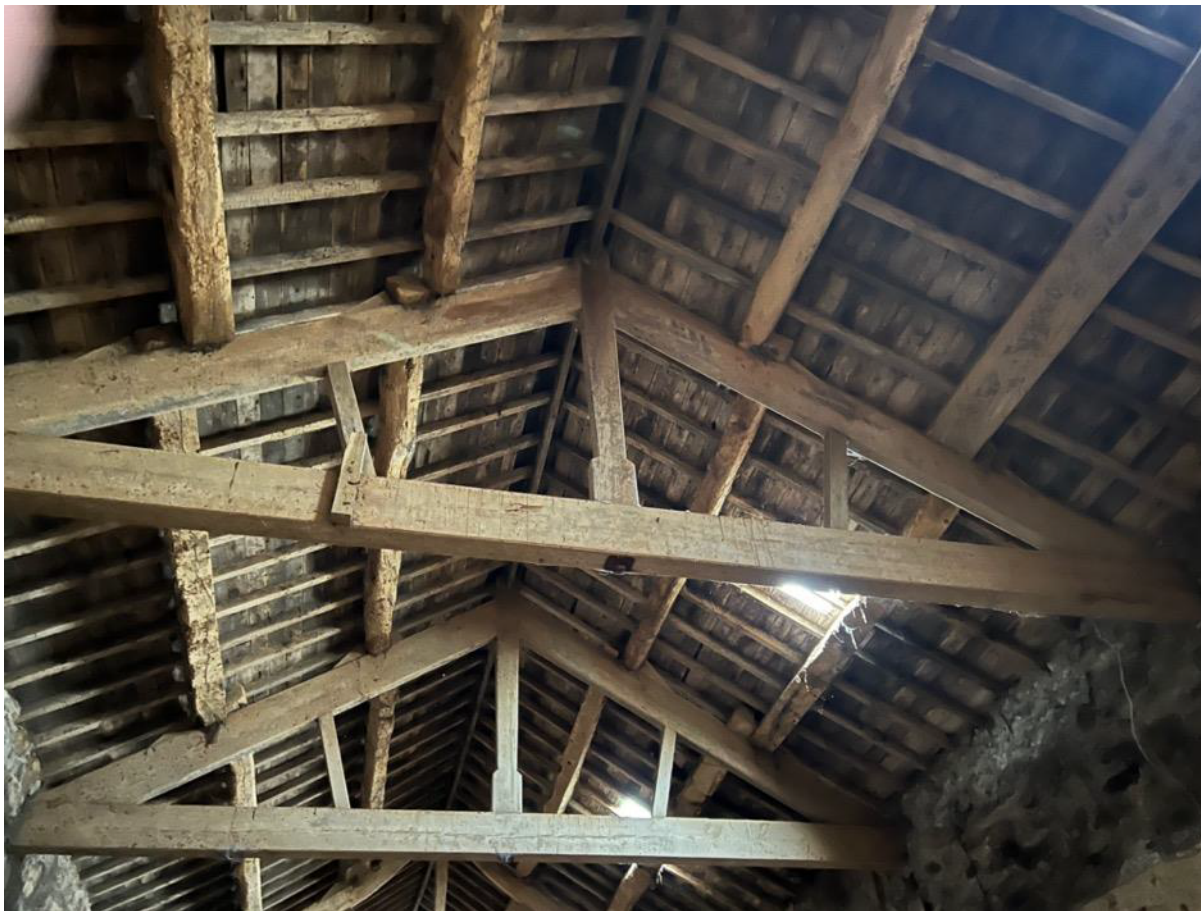
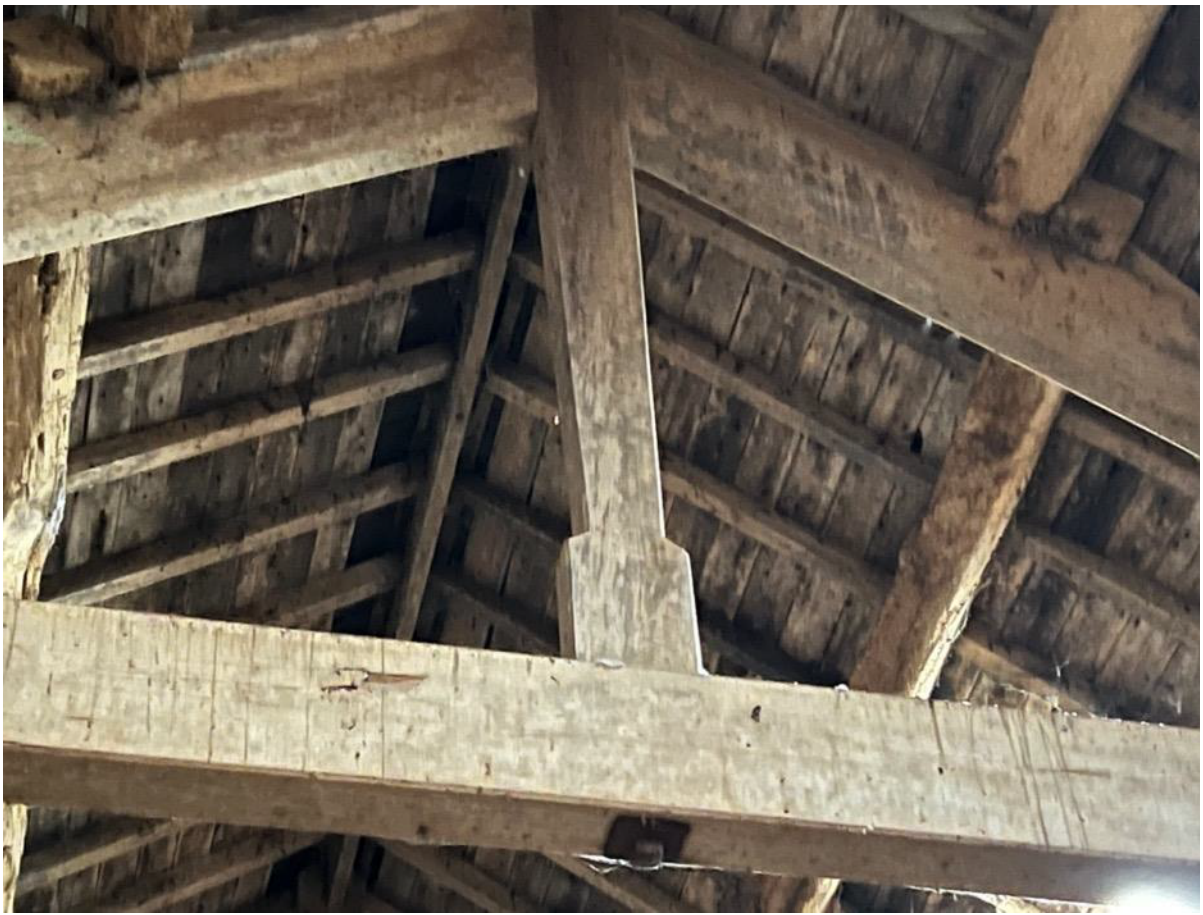
Photo 44 - main barn east

Photo 45 - main barn east – truss detail

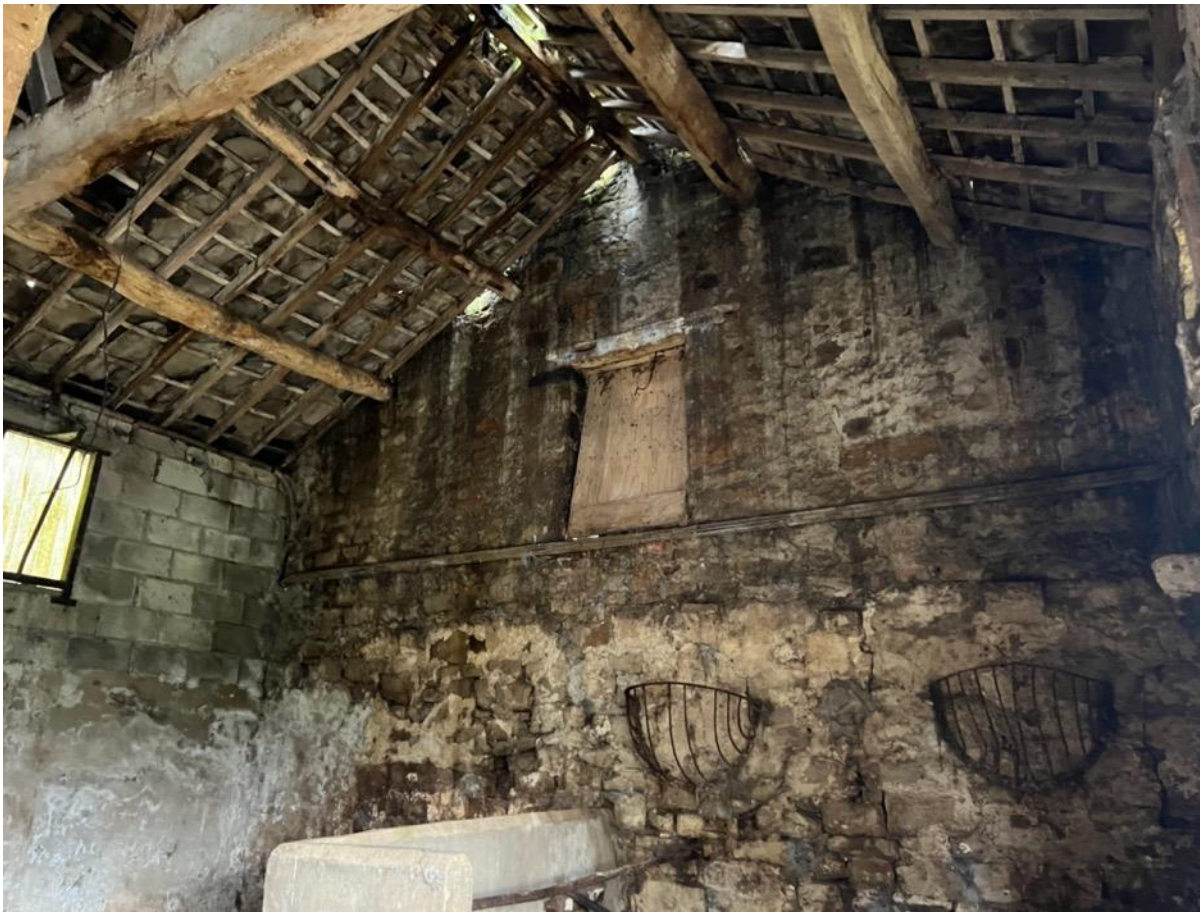
As noted above, this section of the barn appears older than the rest of the structure. The gable wall has been reconstructed in clay brick (photos 49 and 50) and a large opening in the rear wall has been infilled (photo 47). The ground floor is concrete with the loft area constructed in timber supported by steelwork (photo 49). Internally, there is little or no sign of previous or ongoing movement to the walls or floor. The roof structure is in poor condition as evidenced in photos 48 and 51 to 53. There are areas of rot, damp and infestation. The purlins at the north east end have deflected excessively (photo 48). There are large areas of daylight visible in the roof where flags are missing or have been displaced. The loft floor has been renewed as can be seen in photo 49 and these timbers are in a reasonable condition.

Photo 47 - main barn west section

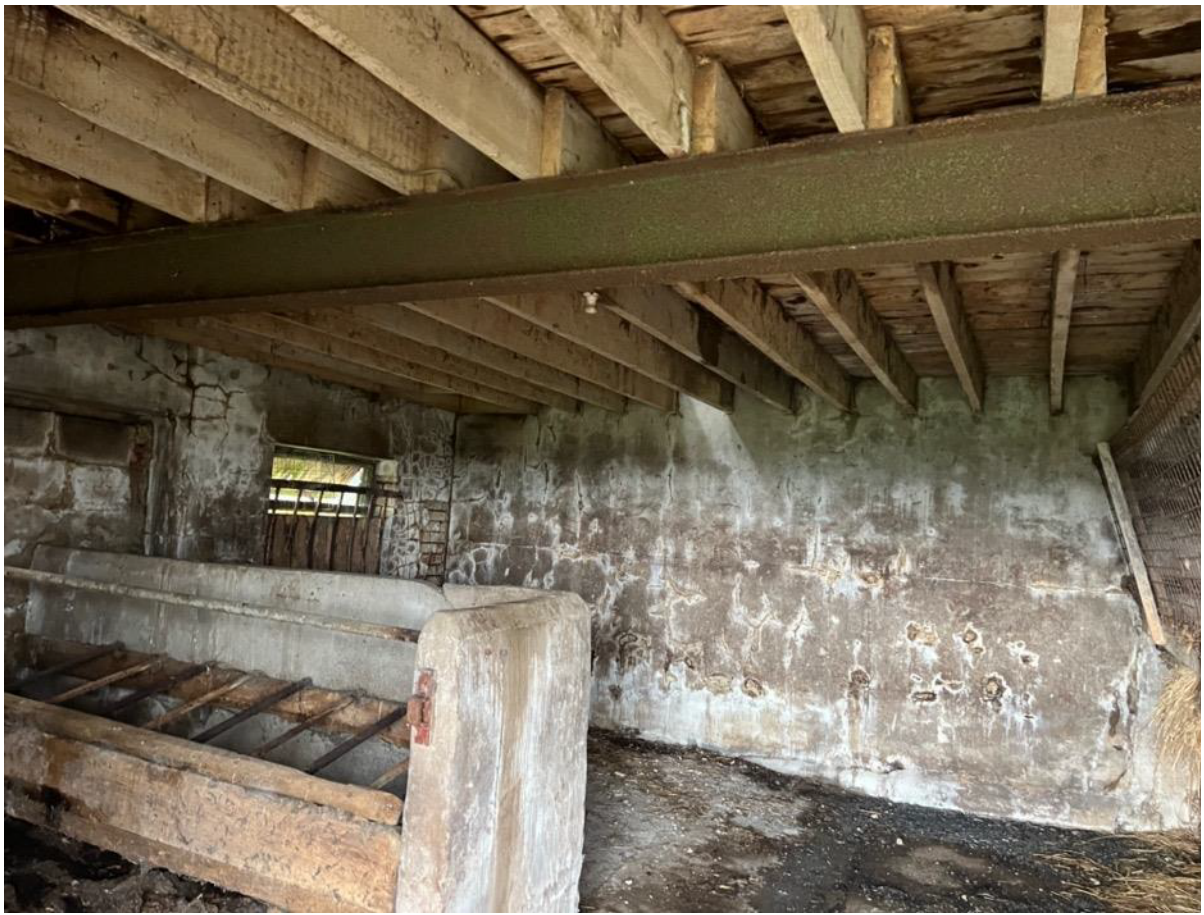
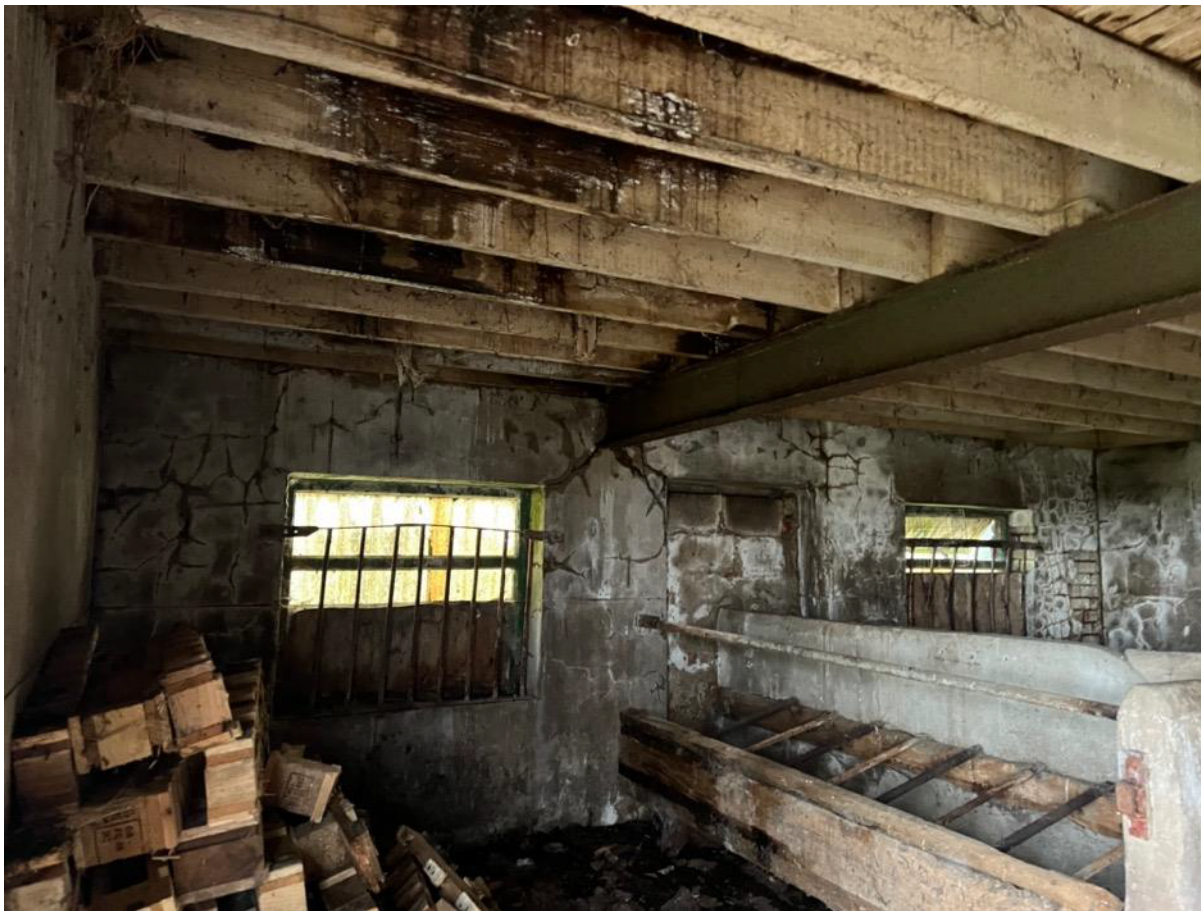
Photo 49 - main barn west section

Photo 50 - main barn west section
