Complete Property Management

**Outbuilding 1 at Writtenstone Farm,
Writtenstone Lane, Longridge, PR3 2ZN**

Structural Condition Survey

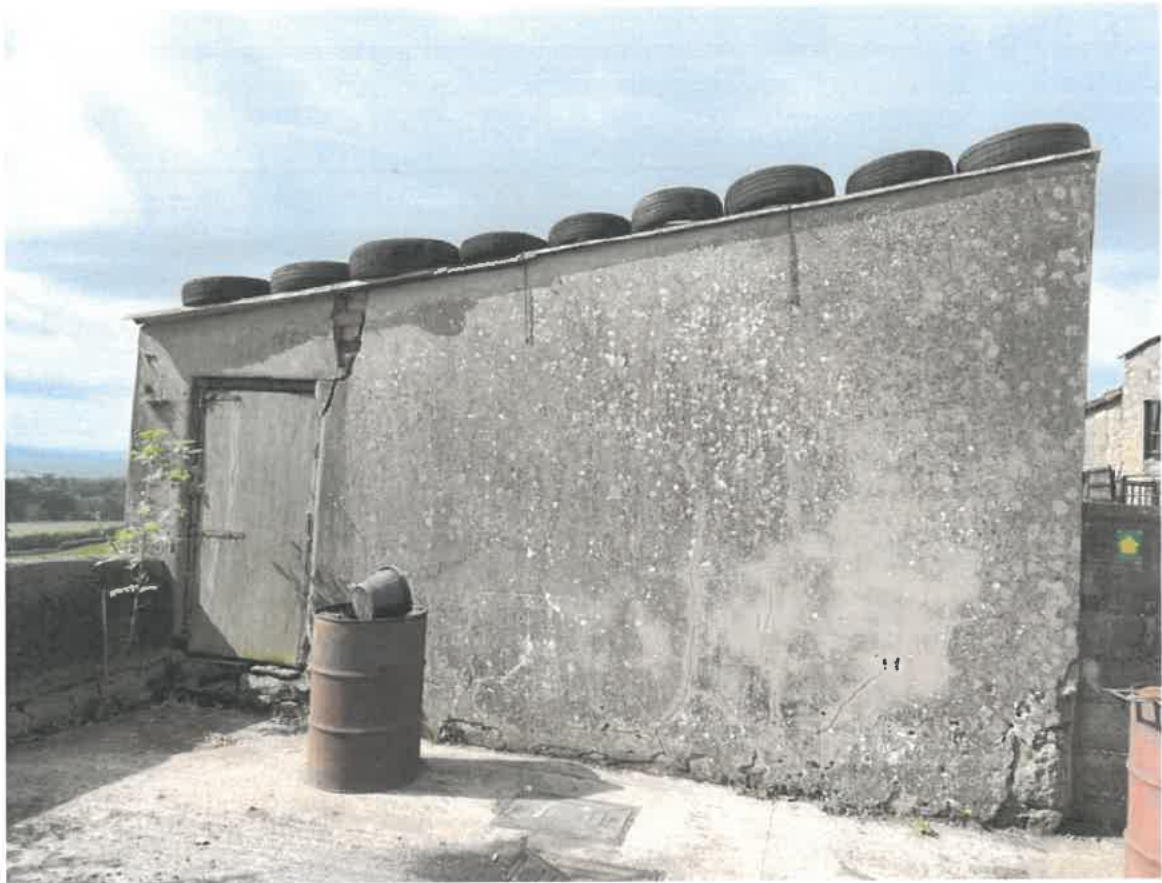
Photo 1 - North East Elevation

This elevation is built in solid brick 225mm thick and rendered on the outside, with one doorway opening. The wall is reasonably plumb with the majority of the render in place with minor crazing (photo 2). Photos 1 & 2 show a large crack at the top right of the door on this elevation. This is due to movement of the rear (south east) elevation which is pulling this corner with it.

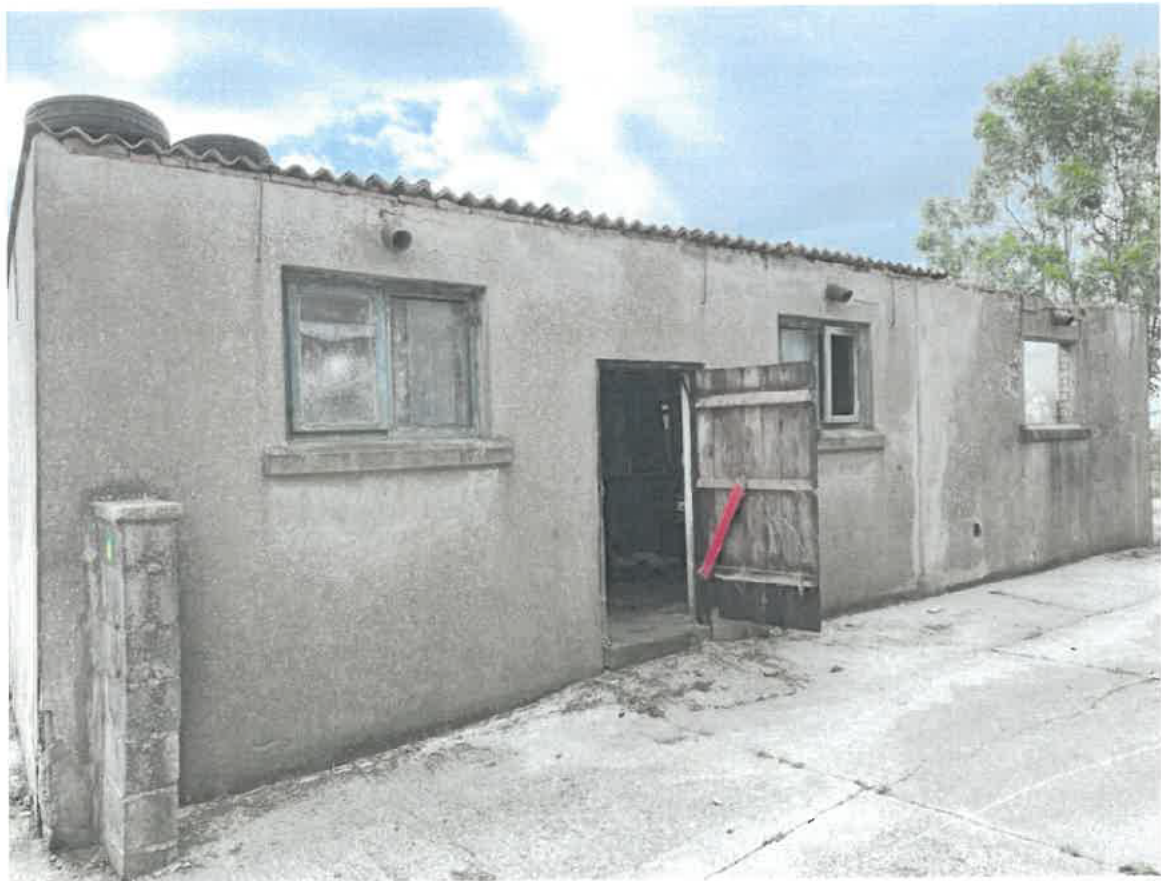
Photo 4 – North West Elevation

This elevation is of the same construction as above and is also rendered. There are 3 window openings and a doorway to this elevation. The wall is reasonably plumb with the majority of the render in place. Photos 5 & 6 show a distinct line in the render and this would suggest that the building was extended to form the additional section to the south west. It can be seen that the roof to this extension has been lost.

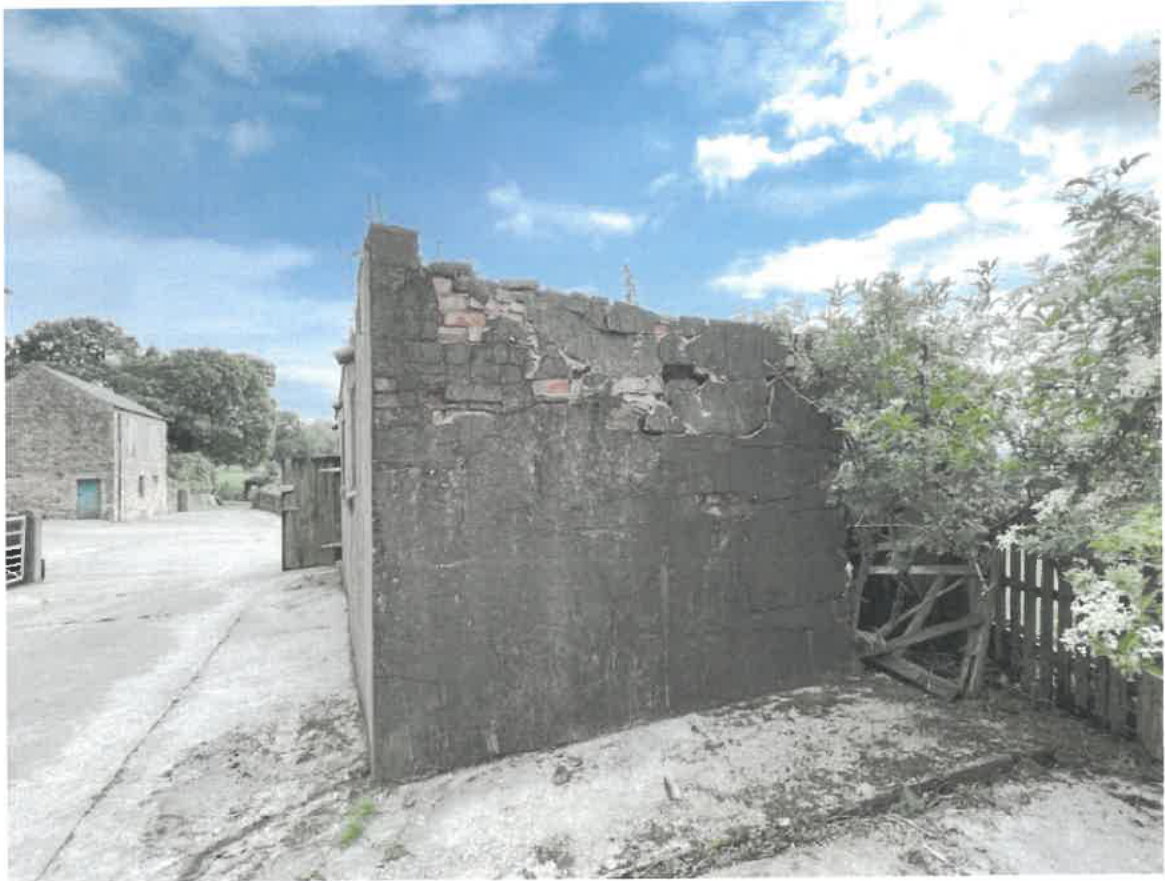
Photo 7 –South West Elevation

This gable elevation is a 225mm thick brick wall with render. There is one doorway opening. The wall has been seriously damaged possibly by the roof falling in or from a collision by a vehicle. Photo 8 shows the damage at the upper level and the impact/movement has caused further damage lower down (photo 9).

It can be seen from the survey detailed above that this outbuilding has suffered serious damage to the south west gable and this will need re-building. The rear south east elevation is suffering from rotational movement and this is also damaging the adjacent gable and mid walls. The rear elevation retains the floor area and the movement is likely to be due to inadequate or damaged foundations, together with an inadequate section for the earth and floor area

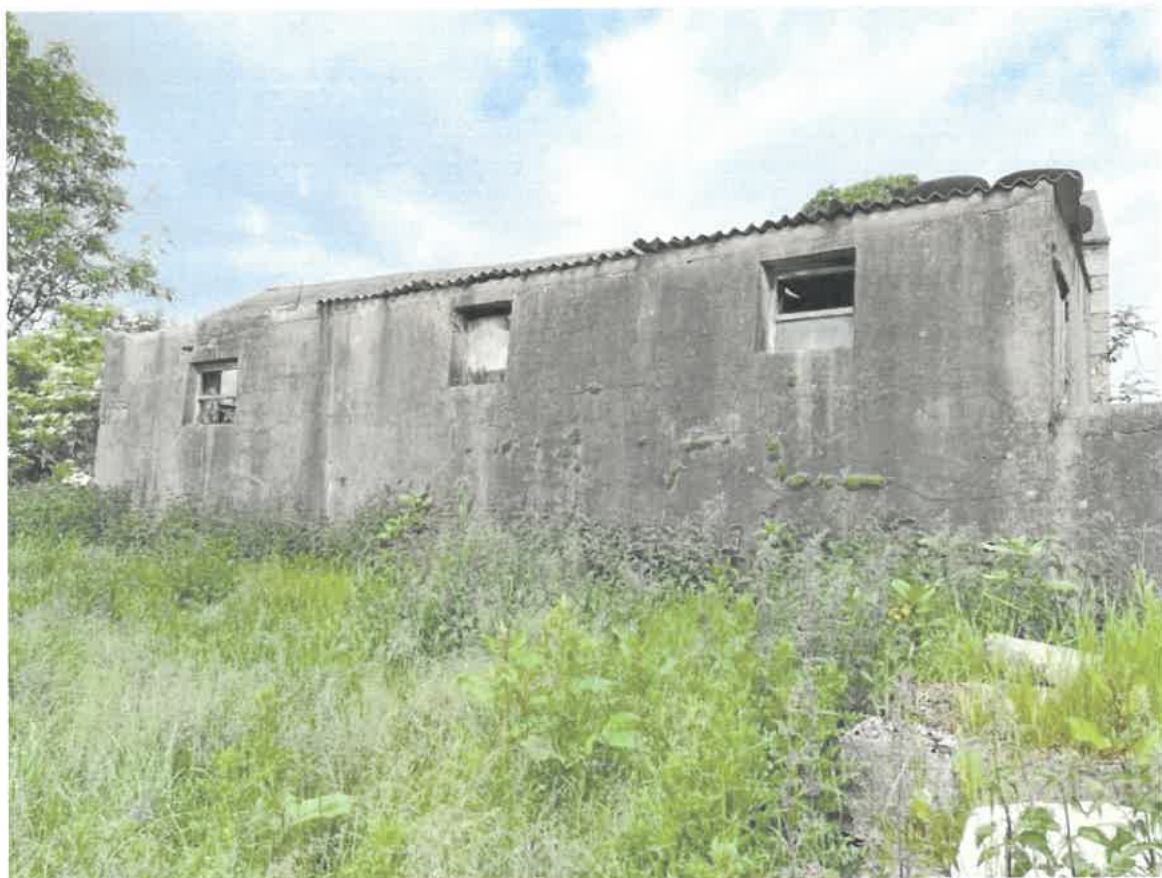
Photo 10 – South East Elevation

This elevation is of the same construction as above and is also rendered. There are 3 window openings to this elevation. The wall is not plumb and is leaning out at the top, due to previous and possibly ongoing movement. As with the north west elevation there is a distinct line in the render and this would suggest that the building was extended to form the additional section to the south west. Photo 10 shows the twist in the roof caused by partial collapse and structural movement.

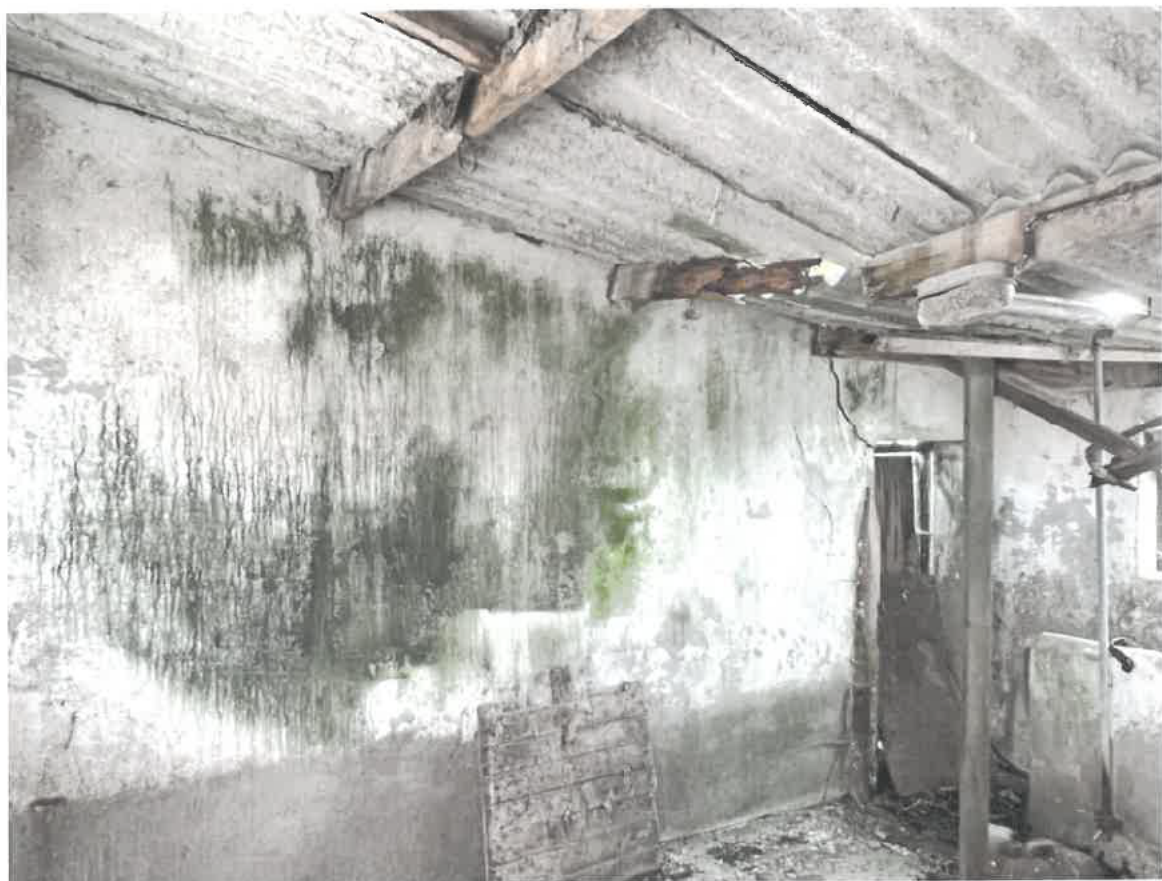
Photo 14 - Internal North East end

Internal inspection shows the movement noted externally to the north east corner reflected internally (photo 14). Similar movement can be seen in the mid wall where it abuts the rear wall (photo 17). The rear wall has numerous cracks in the plaster, extending into the brickwork and this confirms the movement in this wall. The photos indicate the rot to the timbers and partial collapse of the roof to this section.

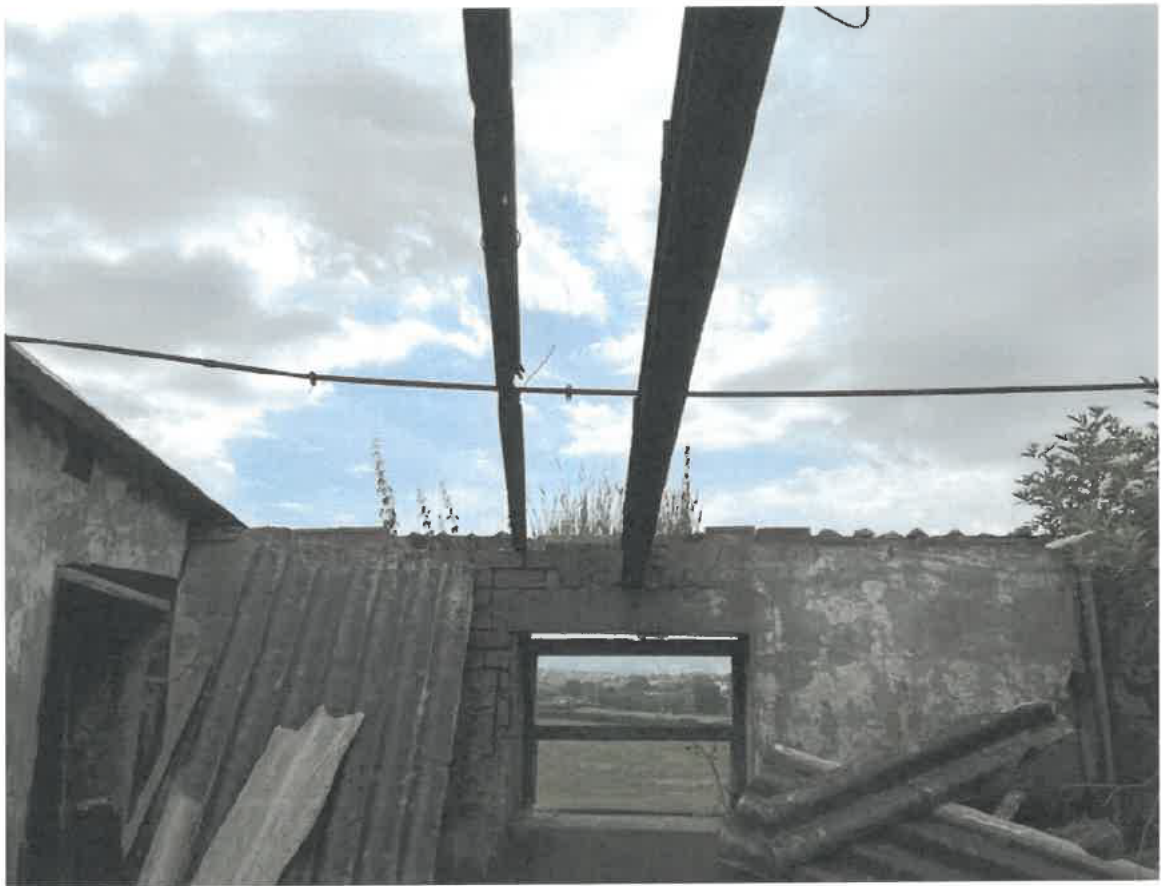
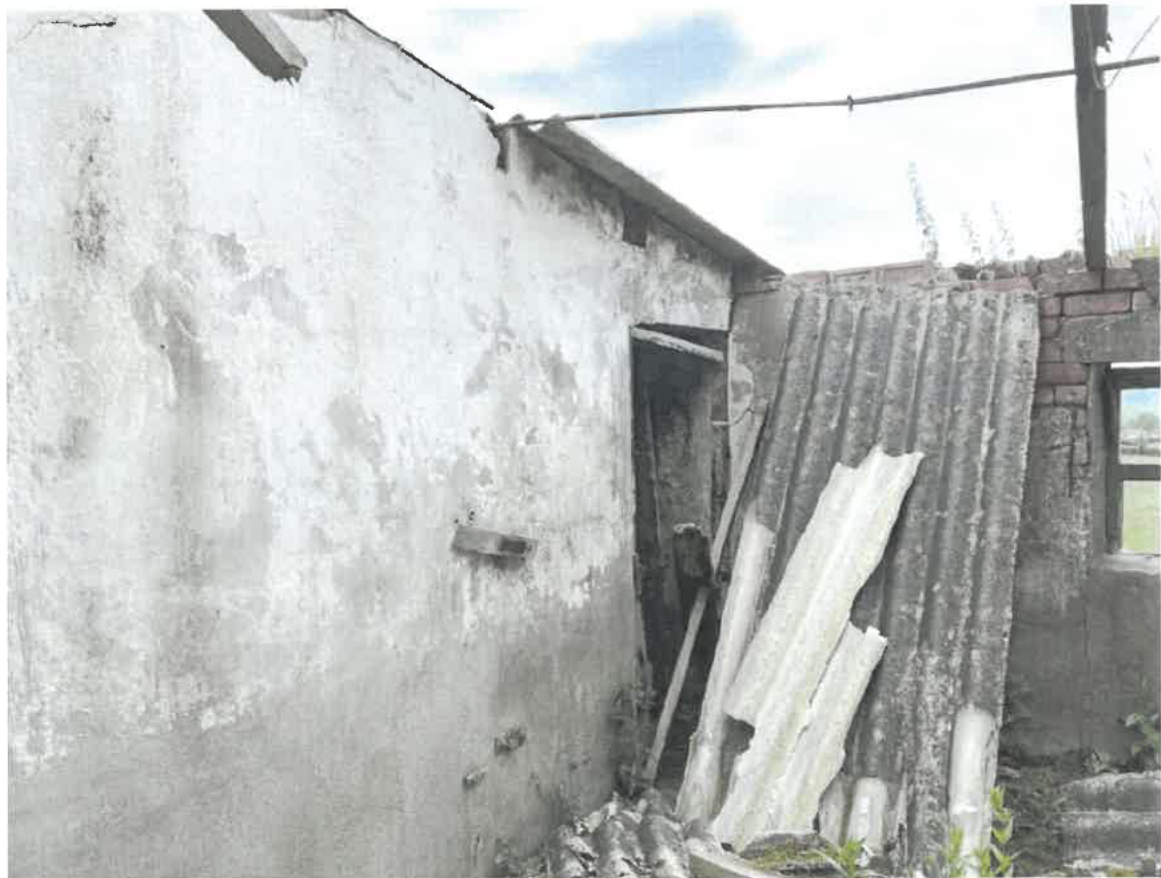
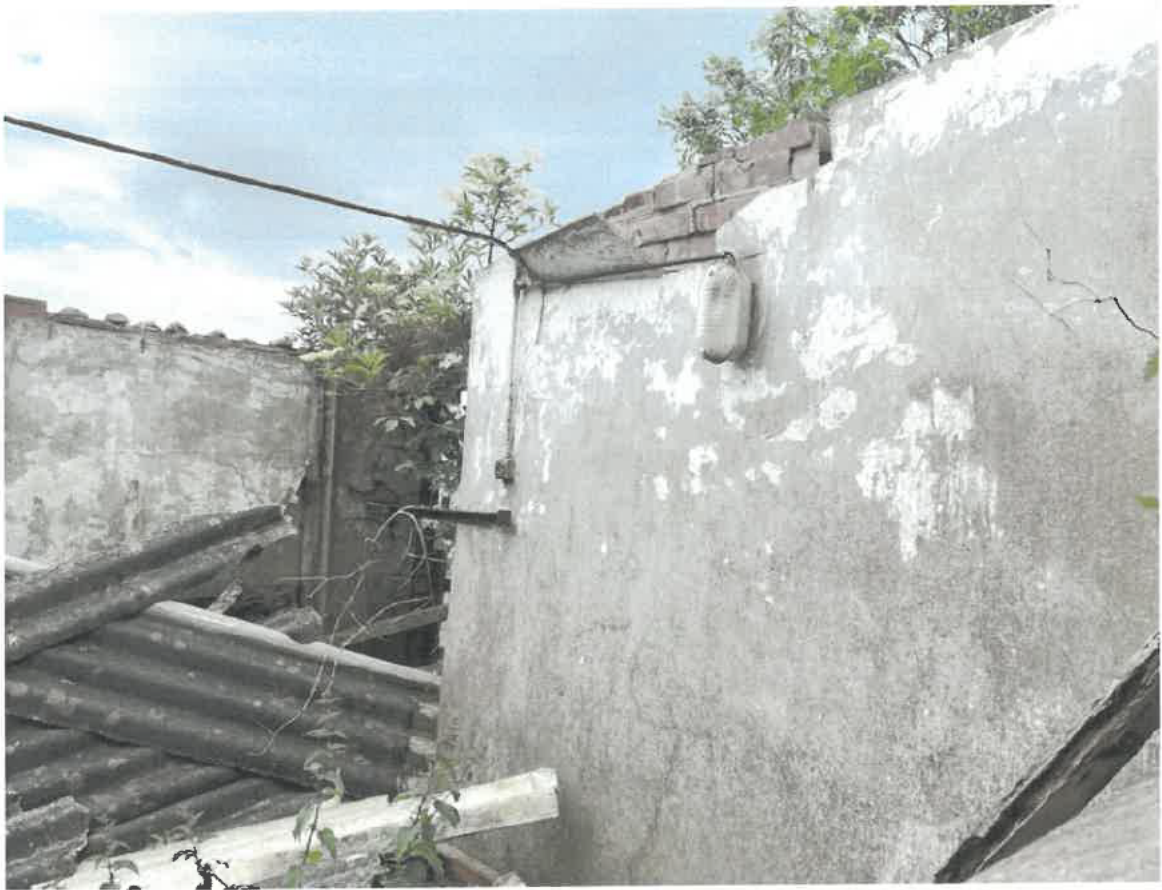
This section has lost its roof and has been exposed to the weather.
