Complete Property Management

Outbuilding 2 at Writtenstone Farm, Writtenstone Lane, Longridge, PR3 2ZN

Structural Condition Survey

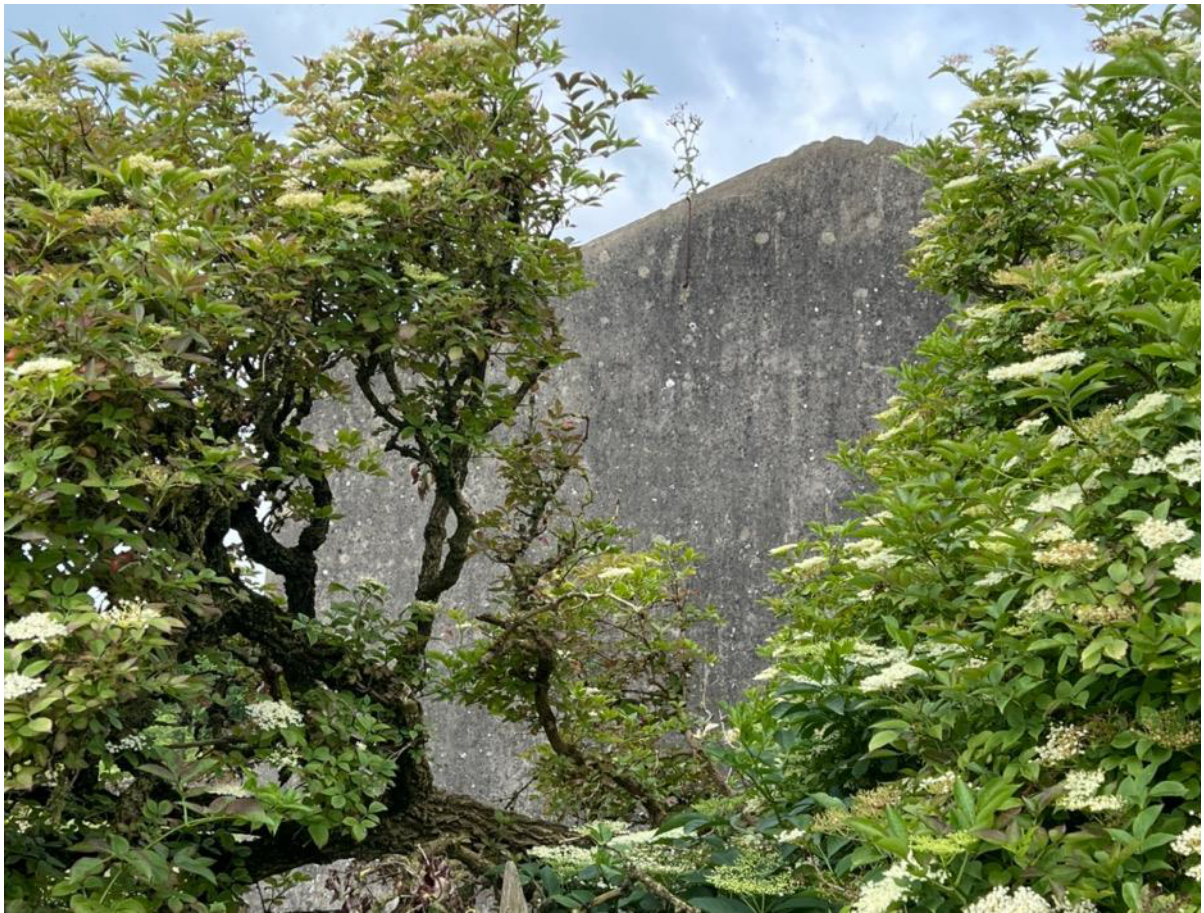
Photo 1 - North East Elevation

This elevation is built in solid brick 225mm thick and rendered on the outside, with no openings. The wall is reasonably plumb with the majority of the render in place with minor crazing only. The corner with the front elevation has a solid 360mm square pier (photo 3). There are no signs of previous or ongoing movement.

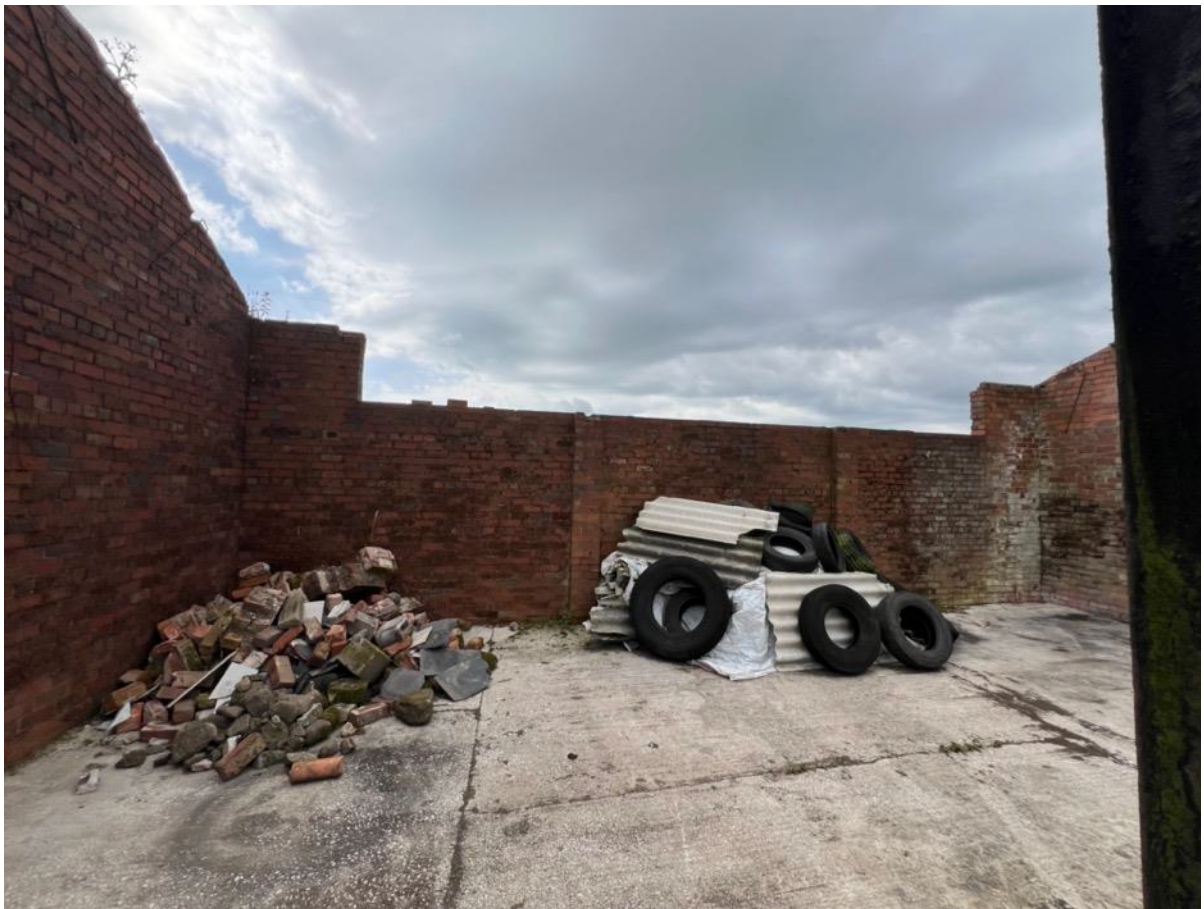
Photo 4 – Internal looking at South East Elevation

This elevation is of the same construction as above and is also rendered externally. There is large high level window running practically the whole length (photos 4 & 12). The wall is reasonably plumb with the majority of the render in place (photo 10). There are 340mm square piers in the brickwork (photos 5 & 6) and as well as providing stiffness to the brickwork, these probably supported trusses spanning to the columns on the opposite elevation. There are no signs of previous or ongoing movement.

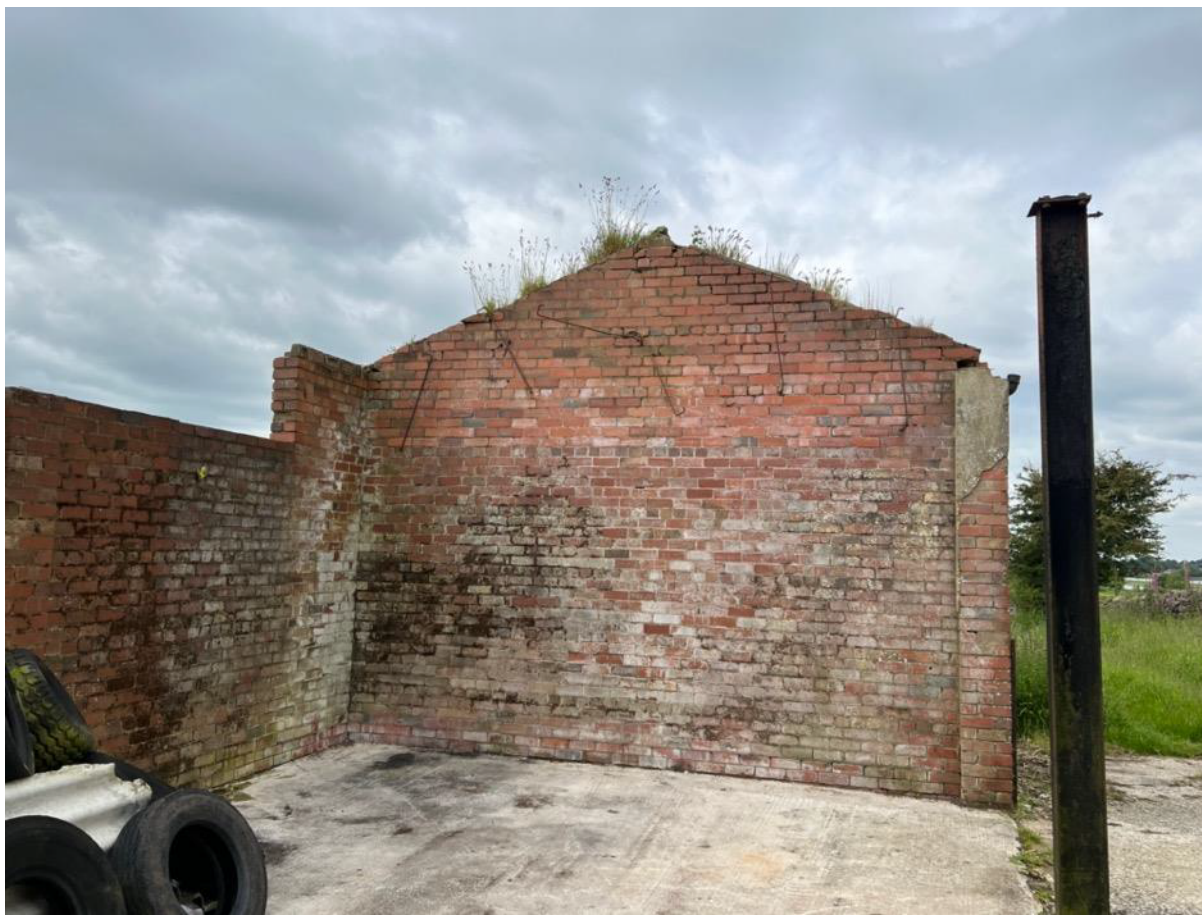
Photo 7 – South West gable Internal

This gable elevation is a 225mm thick brick wall with render applied externally. There are no openings. The wall is plumb and the render is 70% in place. There is a pier at the corner with the front elevation which measures 350mm square. There are no signs of previous or ongoing movement.

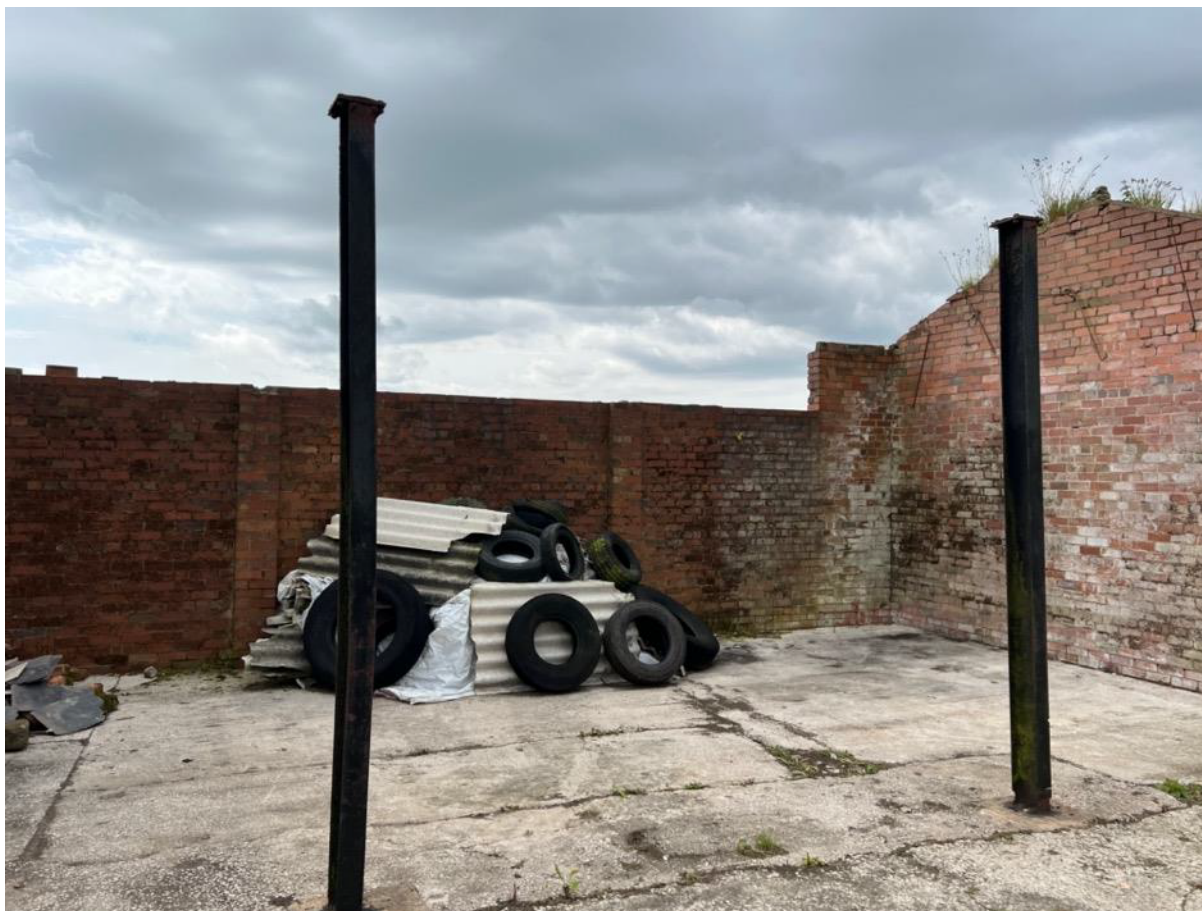
Photo 8 – Columns to North West Elevation

This elevation is open and has two steel columns in place which previously supported roof trusses.

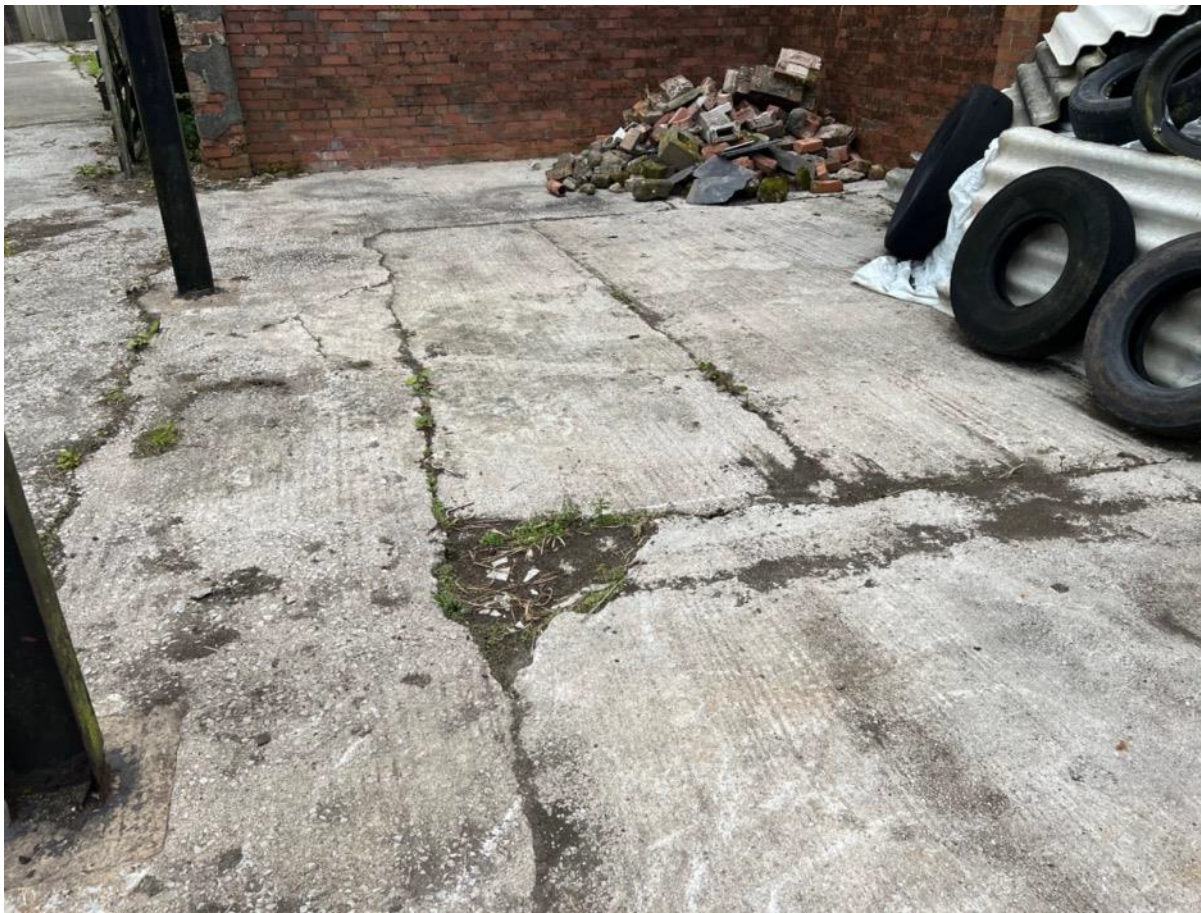
Photo 11 – Concrete Floor

Internal inspection shows a concrete floor in place which is in reasonable condition.
