Barn at Park Farm, Whalley Road, Barrow, Clitheroe, BB7 9YS

Structural Condition Survey for Conversion to Dwellings

PSC-891

June 2024

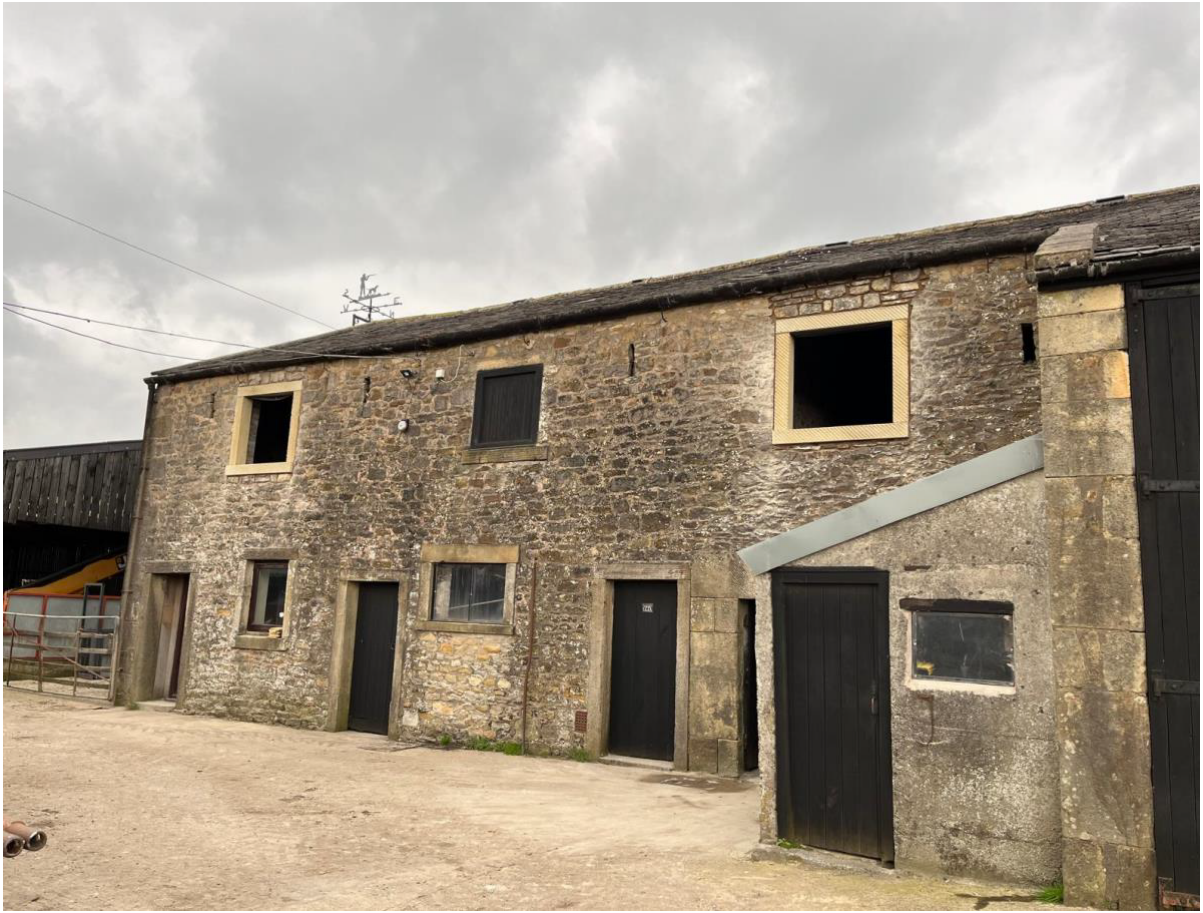
Photo 1 - South West Elevation

This elevation is built in random sandstone and the wall is 450mm thick. The wall is in good condition. It is plumb and well pointed. There are no signs of previous or ongoing movement. There are 5 standard door openings, 3 window openings and the main barn door at ground level. There are 3 openings to the loft area together with vents at first floor level (photo 6).

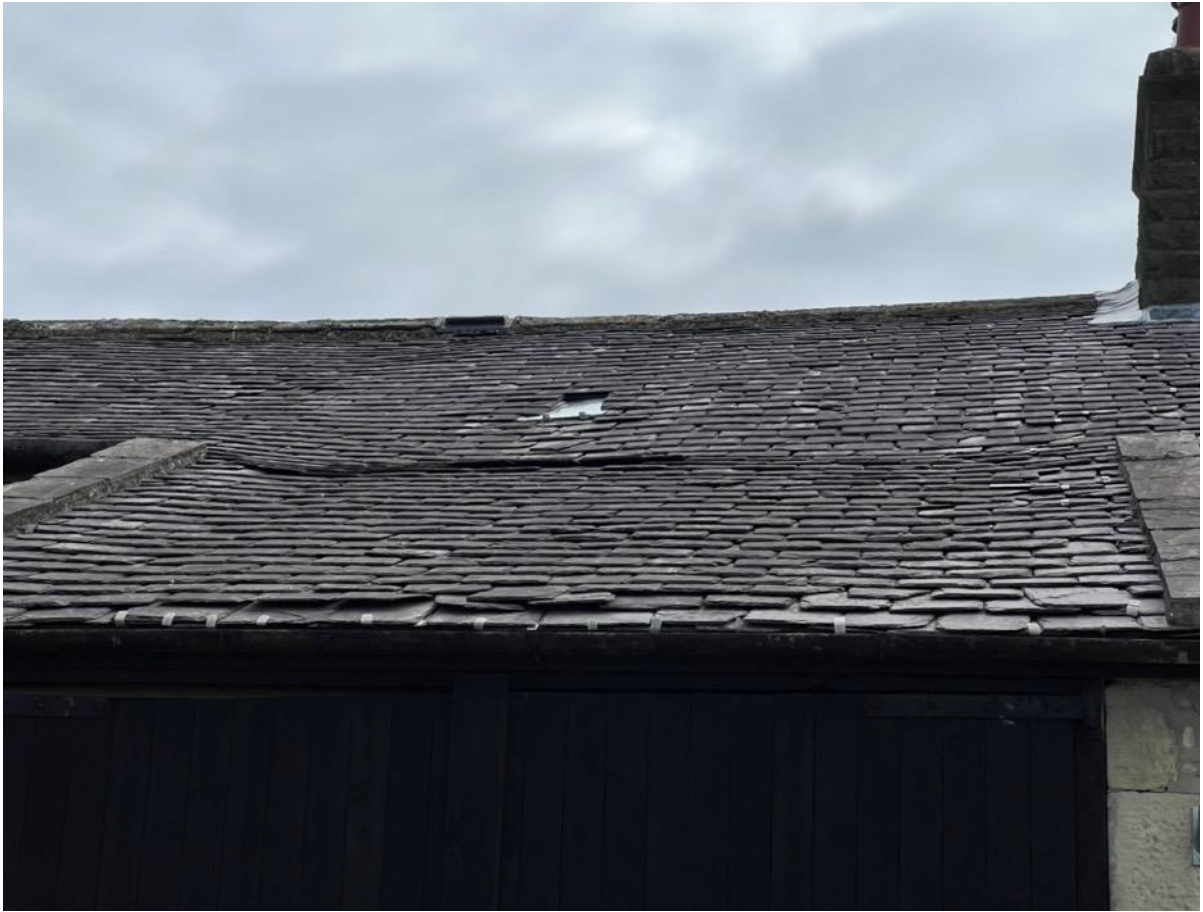
Photo 2 – Roof South West

Viewed externally, the main barn roof appears in reasonable condition little sign of damage, slate loss, or excessive deflection (photos 2 to 4). The ridge tiles are sandstone and there are edging flags in place to the gable wall (photo 4). The rear single storey section has metal sheets in place, and these are in good condition (photo 17). As noted above the lean to at the front of the building has cement-asbestos sheeting to the roof which is in a reasonable condition (photo 13).

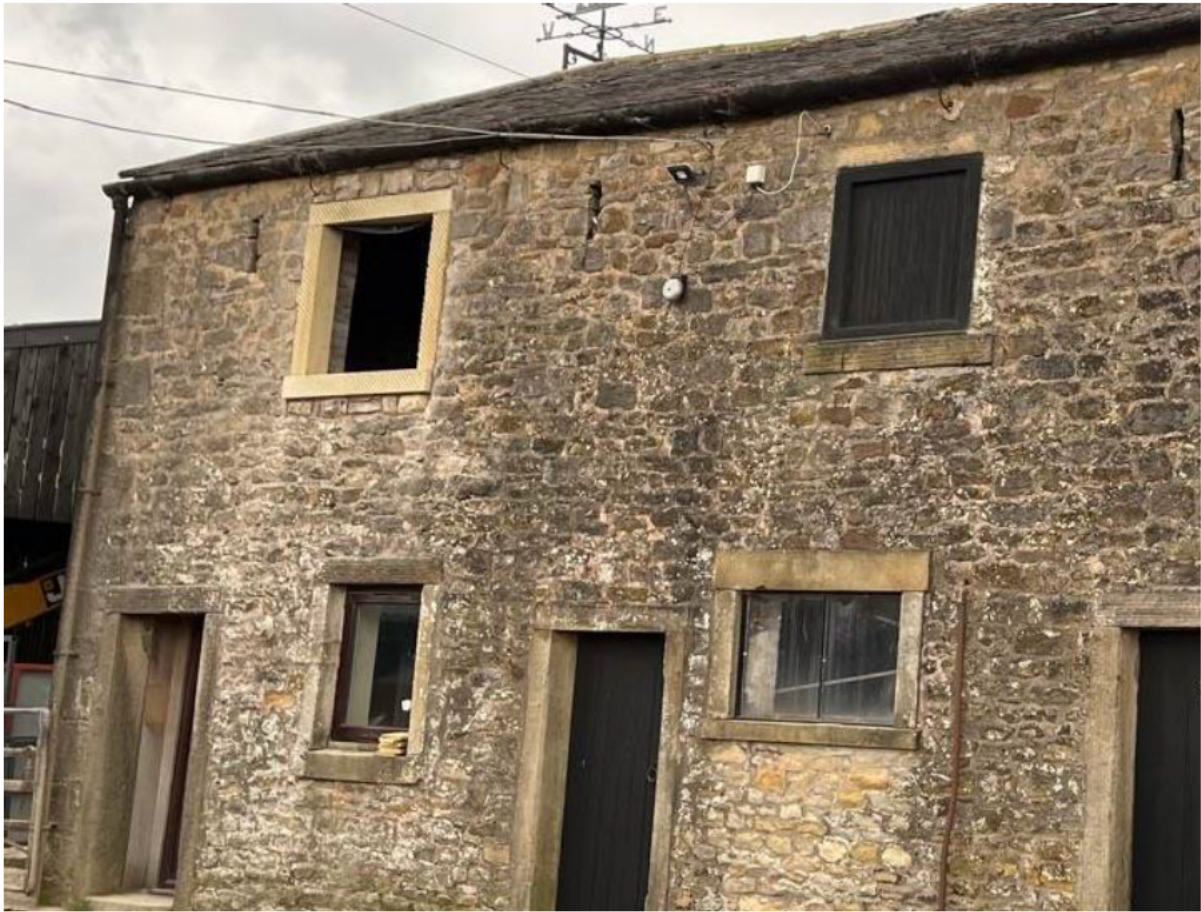
Photo 8 – South West Elevation

is in good condition. Photo 14 indicates the outrigger with the main barn door which can also be seen in Photo 13 above the lean to. Again, this section is in good condition, well pointed and has no sign of movement. This elevation has the benefit of guttering and downspouts which are in reasonable condition (photos 8 & 14).

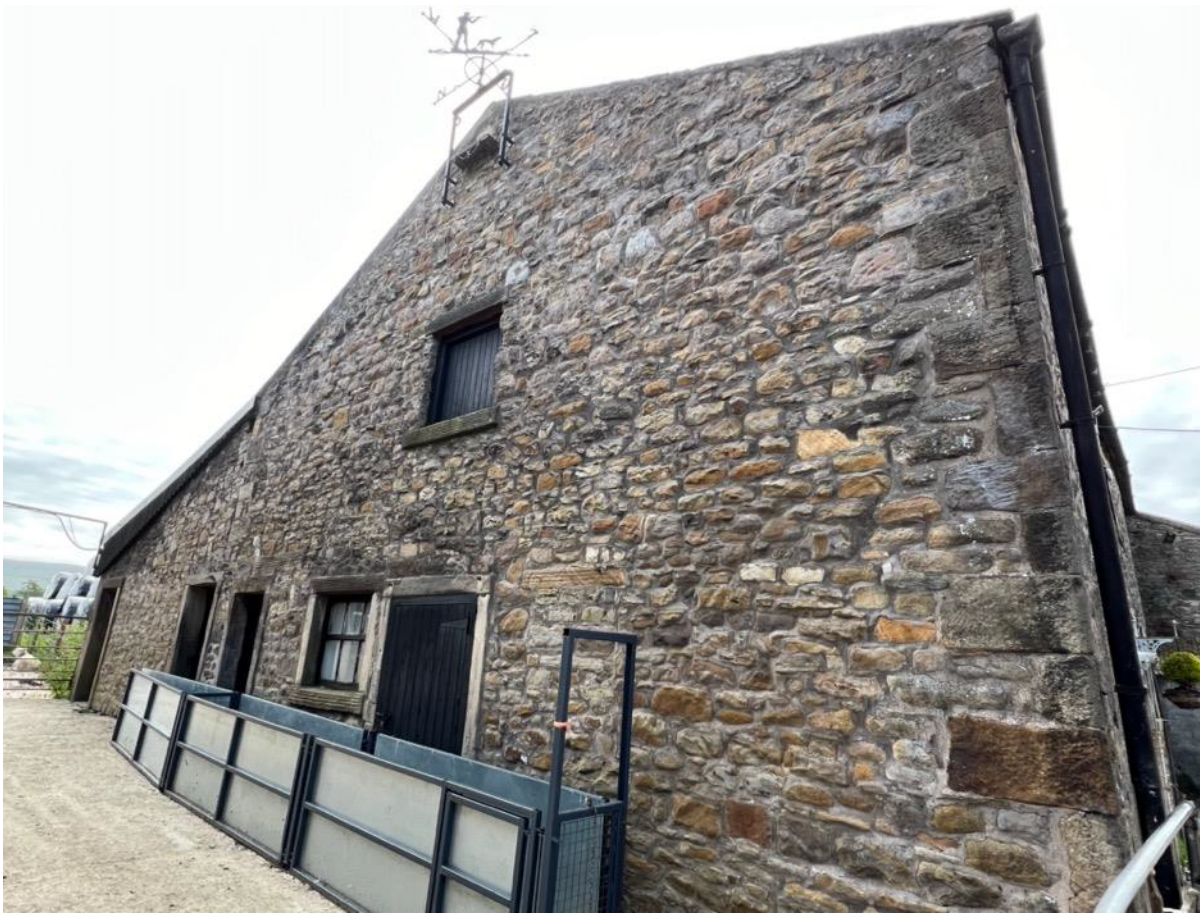
Photo 9 – North West Elevation

This elevation includes the gable to the main barn and the single storey outrigger to the rear of the barn (photo 9). The gable is built in random sandstone and the wall is 450mm thick. The wall is in good condition. It is plumb and well pointed. There are no signs of previous or ongoing movement. There are four door openings at ground floor level and one window. There is a further opening to the loft level above. Photo 11 shows the raised roof with the section of timber cladding above the stonework. The timber is in good condition with no sign of rot or infestation.

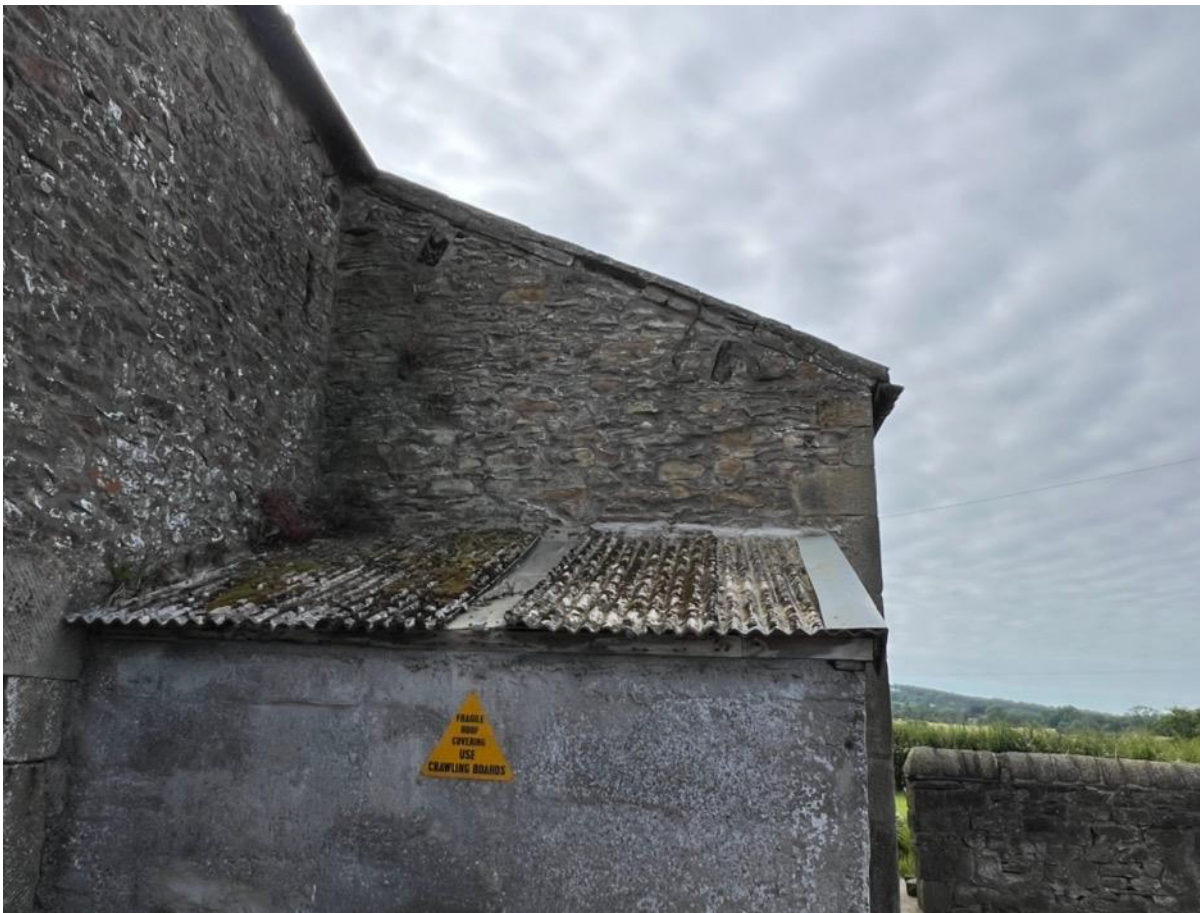
Photo 13 – Lean to on South West Elevation

Photo 13 illustrates a small lean to, built in concrete block with a cement asbestos sheet roof, which has been added at some point. This has no sign of previous or ongoing movement and

It is noted that the small brick/block lean-to on the front (south west) elevation is to be removed.

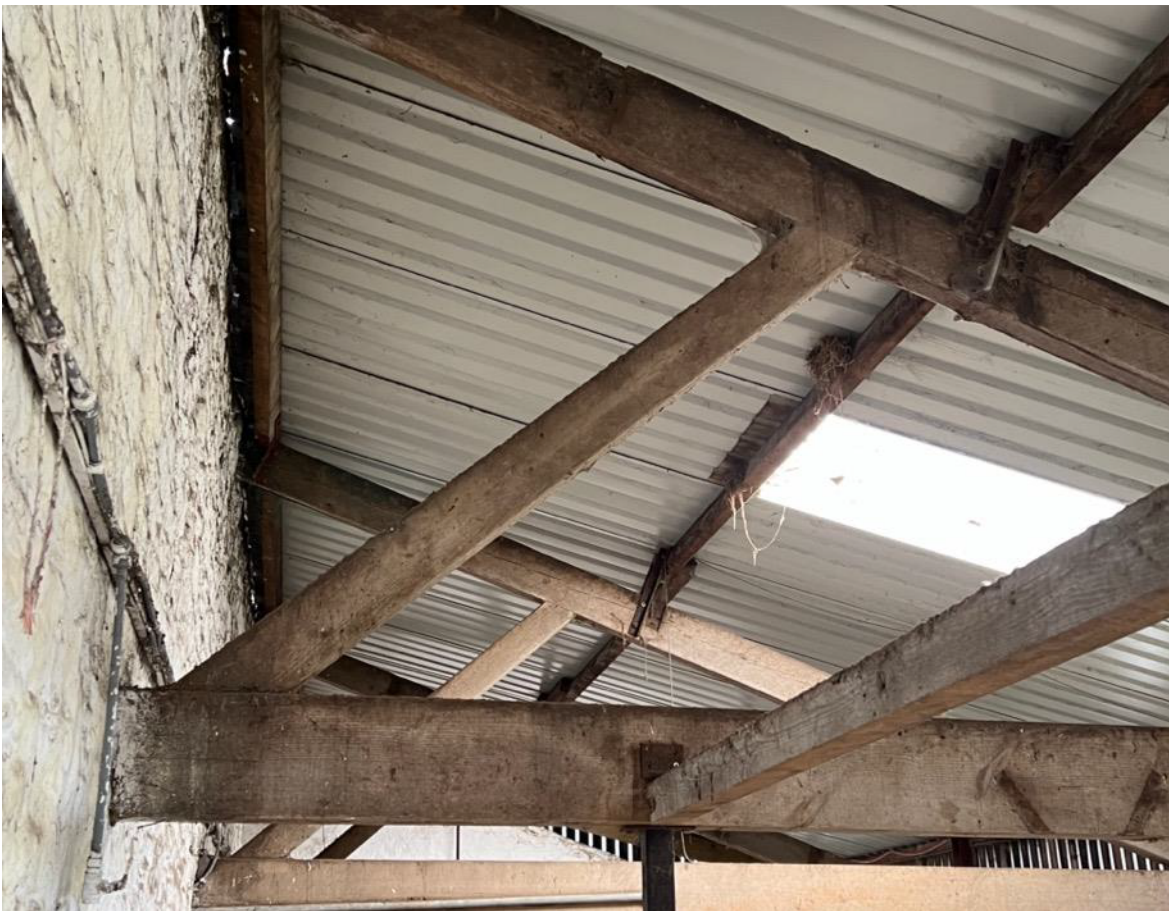
Photo 20 - Internal to rear single storey section – roof timbers

Main section – This section of the building is a shippon area with mono pitch timber trusses carrying the roof above (photo 20). This area, including the wall with the main barn, shows no sign of previous or ongoing movement to walls or floors. The ground floor is solid concrete (photo 23). The timber trusses, purlins and rafters appear in reasonable condition with no clear signs of extensive rot or infestation.

The existing truss and purlins appear to be in good condition with little sign of rot or infestation. Any timber retained should be assessed by a timber specialist, with regard to rot and infestation. All retained timber should be treated against rot/infestation and an indication of residual section given for structural purposes. All retained timber to be used structurally should be checked for structural adequacy.

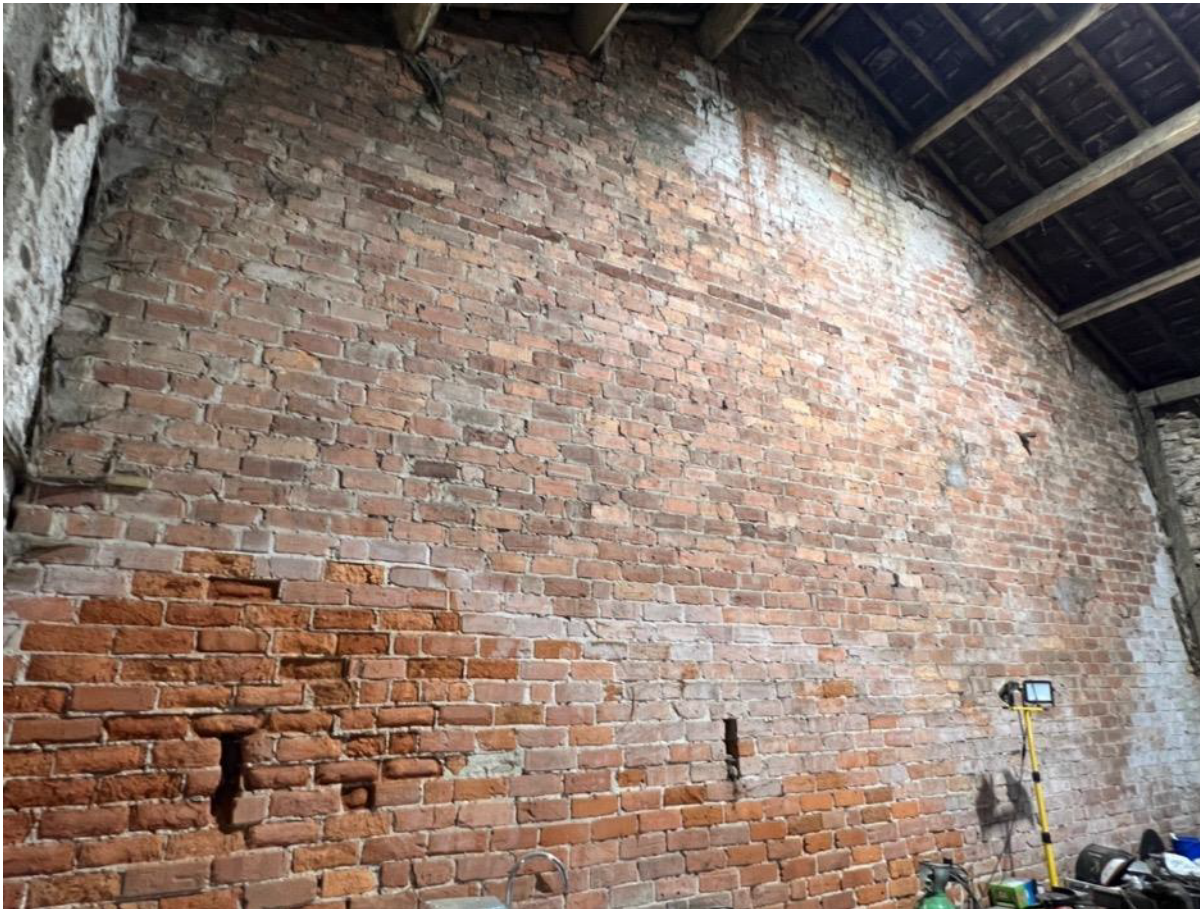
Photo 24 – Internal main barn – gable to house (south east)

The hay barn area is shown in photos 24 to 27 and at ground floor this is split between the access area (photo 25) and a shippon (photos 26 & 27). Photo 24 shows that the gable wall to the adjoining house is built with clay bricks. The wall is plumb and in good condition. The majority of it is well pointed but photo 24 shows an area where some bricks have spalled. It may be that the brickwork above this has been replaced at some point or that the whole gable was rebuilt in brick having previously been stone. The floor to the access area is stone flags (photo 25). The shippon area has a concrete floor and stalls with a timber floor above to the hay loft (photo 27). The internal walls are all in good condition, plumb and well pointed. There is no evidence of previous or ongoing movement.

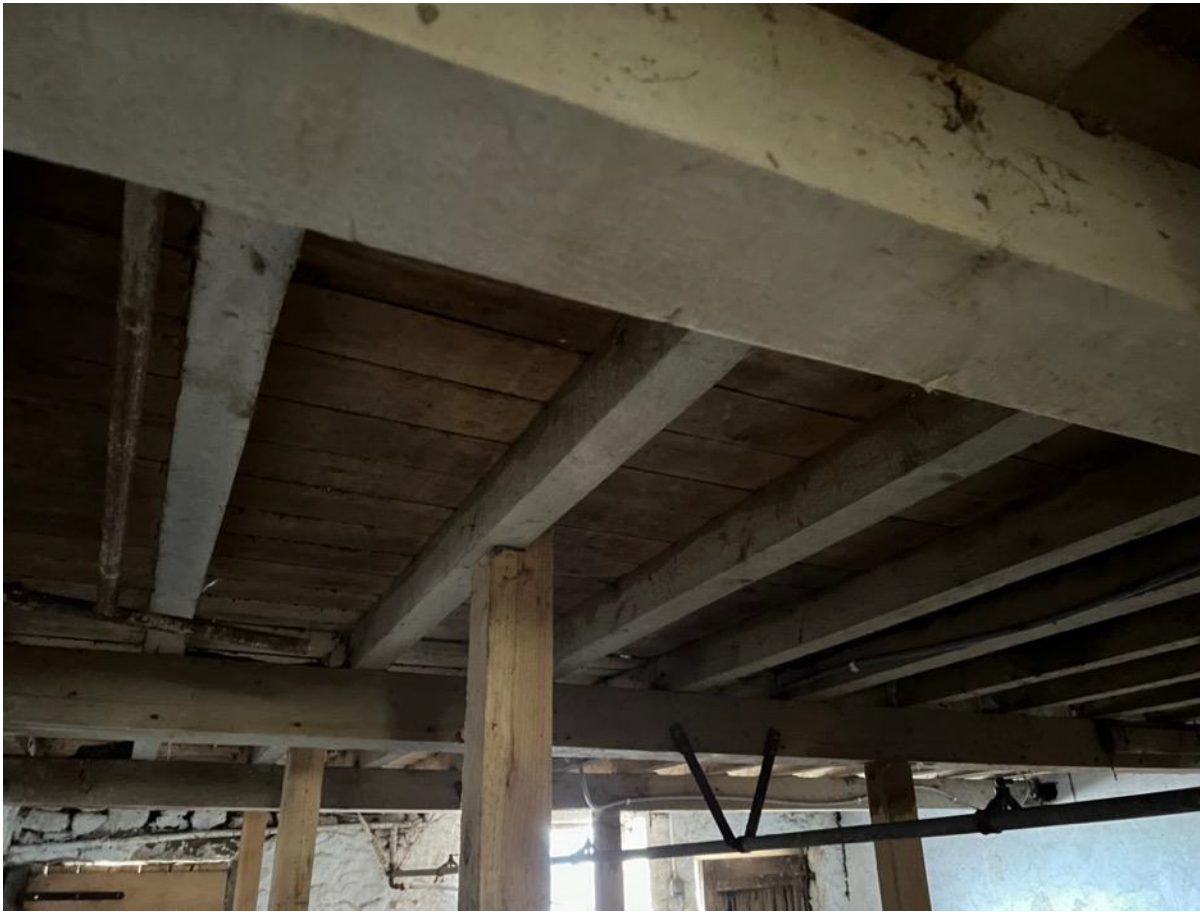
Photo 38 - Internal main barn – mid section – Floor to loft above

The cow parlour is shown in photos 36 to 39 and this too has concrete floors and stalls, with a timber floor to the loft above supported by timber posts (photo 38). The internal walls are all in good condition, plumb and well pointed/rendered. There is no evidence of previous or ongoing movement. The timber is in good condition with little or no sign of rot or infestation.

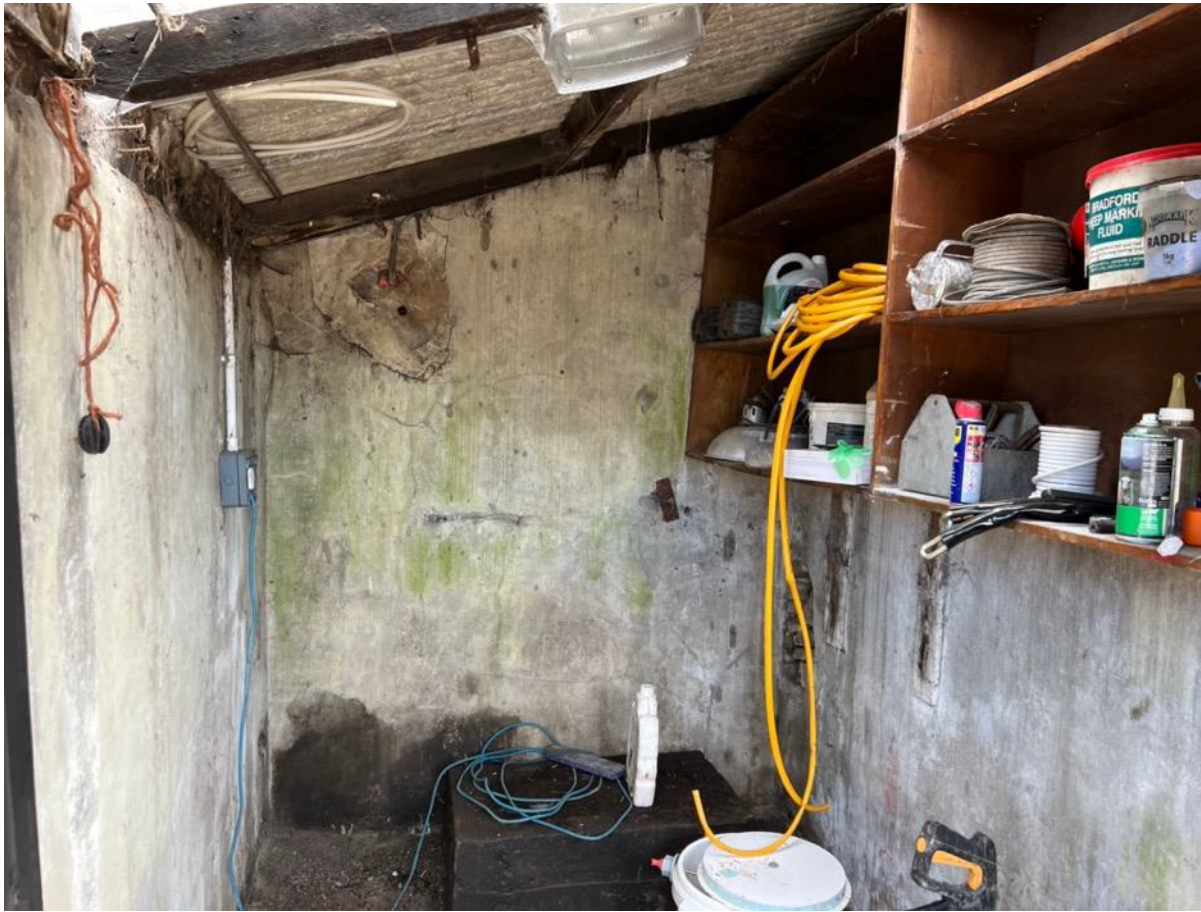
Photo 44 – Lean to on south west elevation - internal

Photo 44 shows the internal area of this small building which has a solid concrete floor and plastered walls. The building is in reasonable condition but there are signs of some water ingress and damp. There is no sign of previous or ongoing movement.
