Photographic Record (1.5m graded staff for scale)

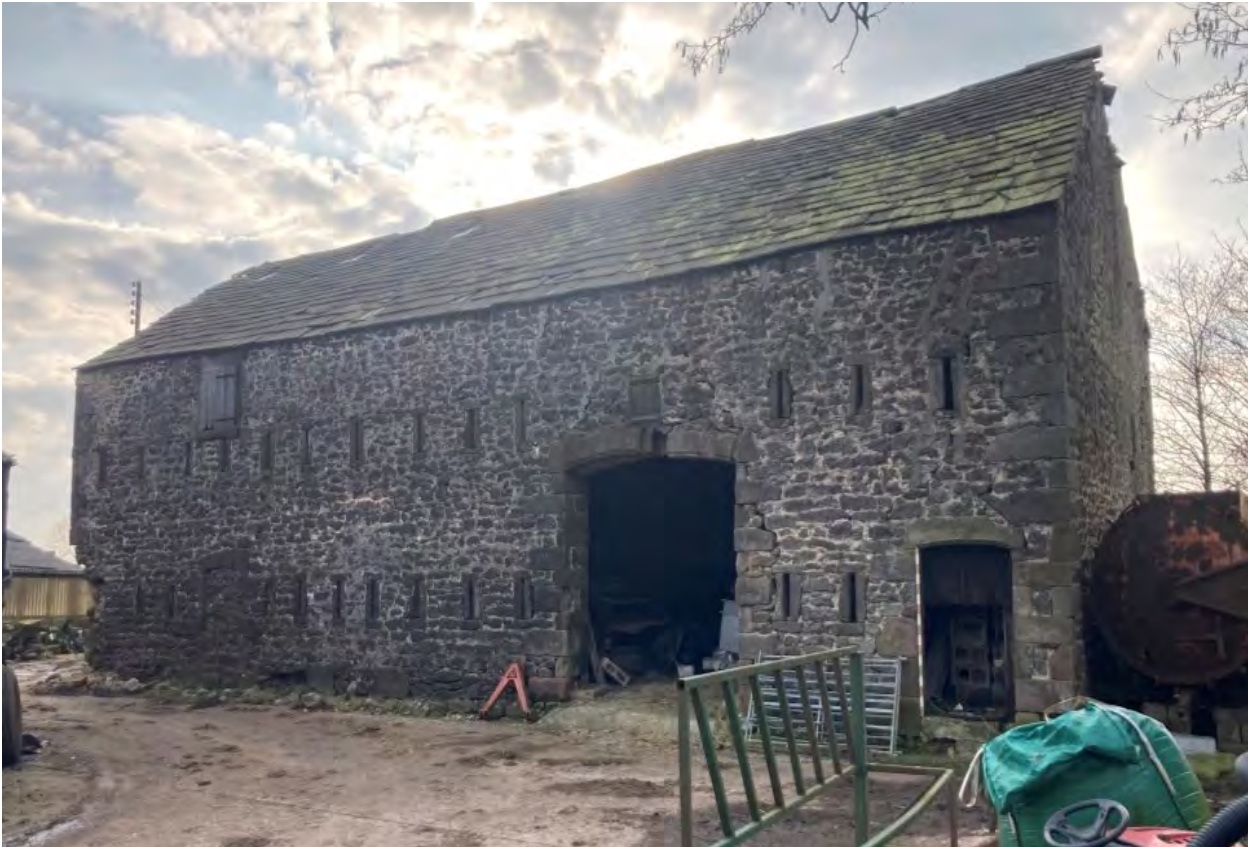
Main east elevation of barn

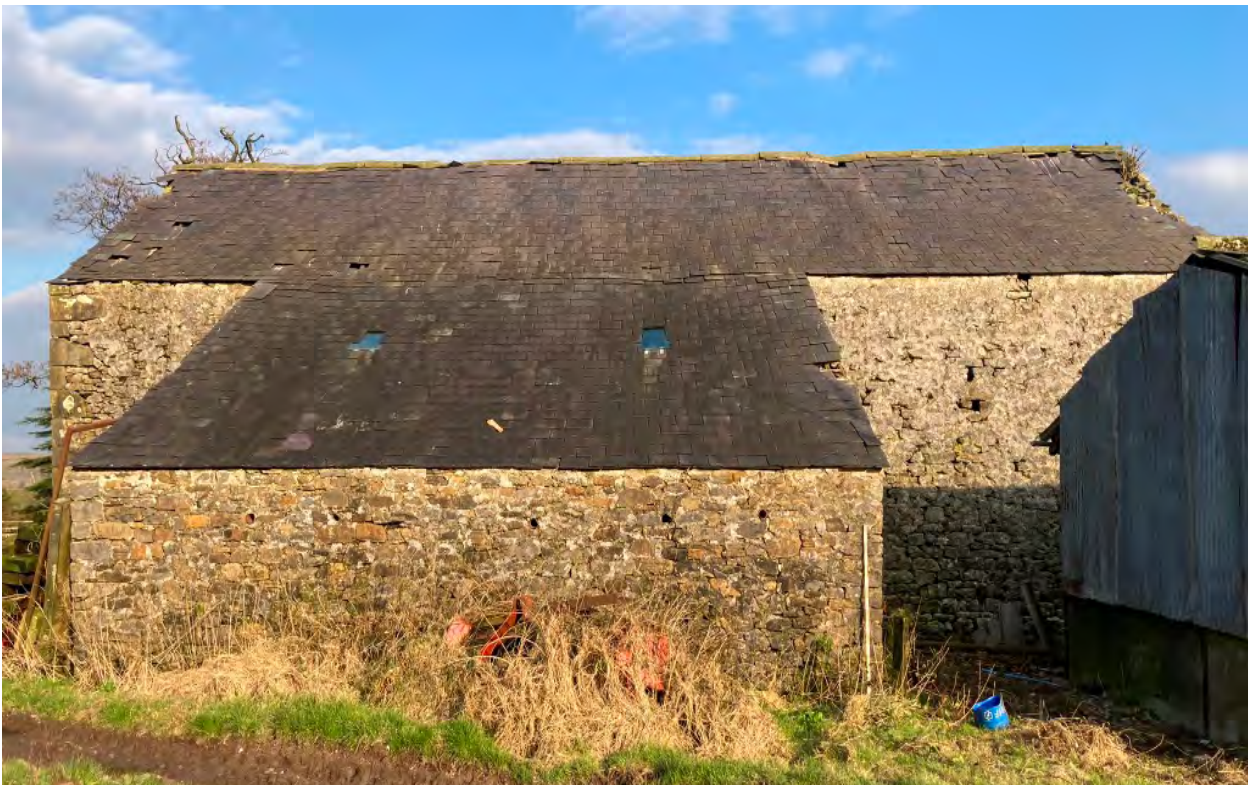
Rear west elevation of barn

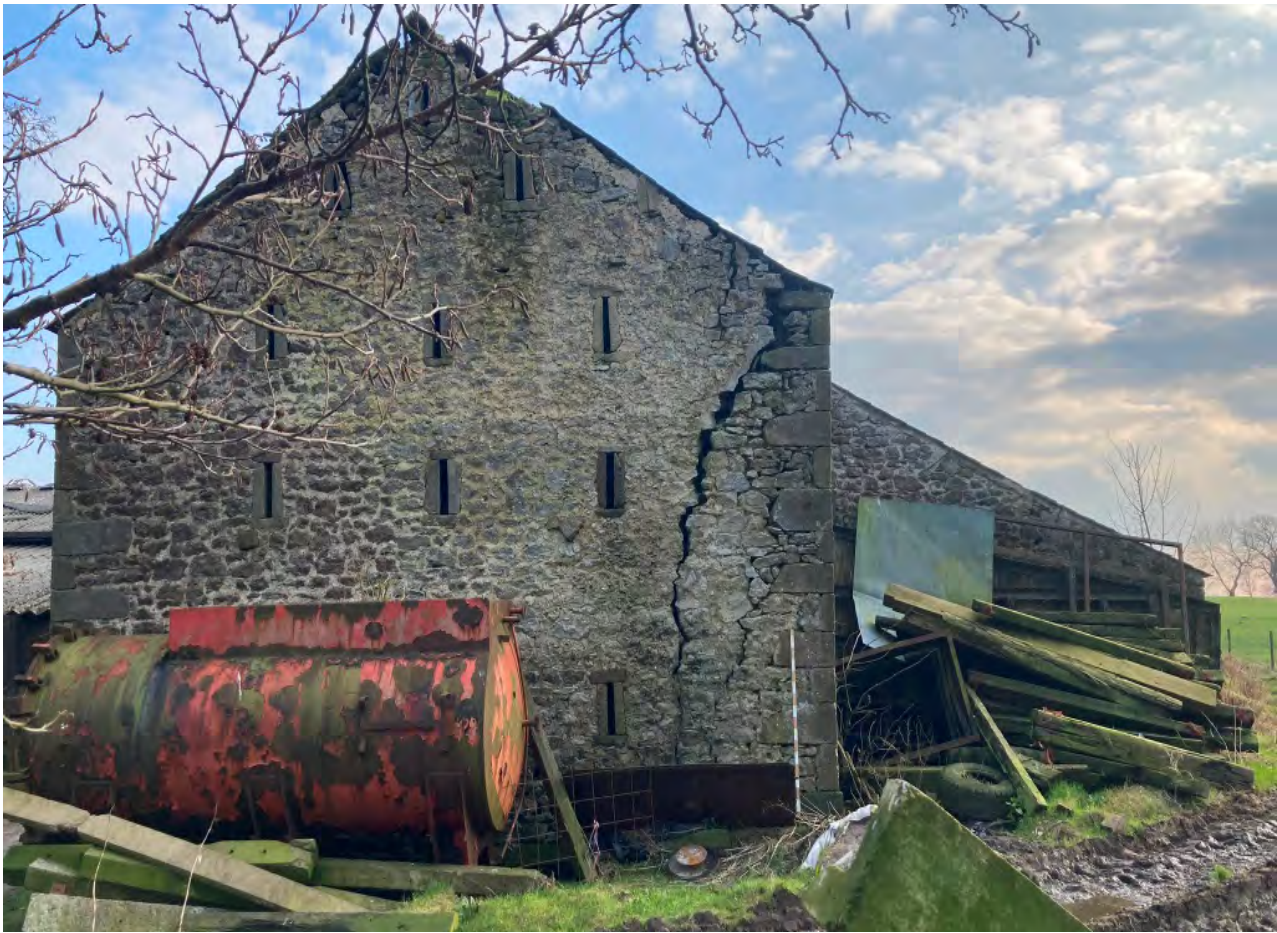
North gable of barn showing tear crack to east corner washed out walltops to main barn.

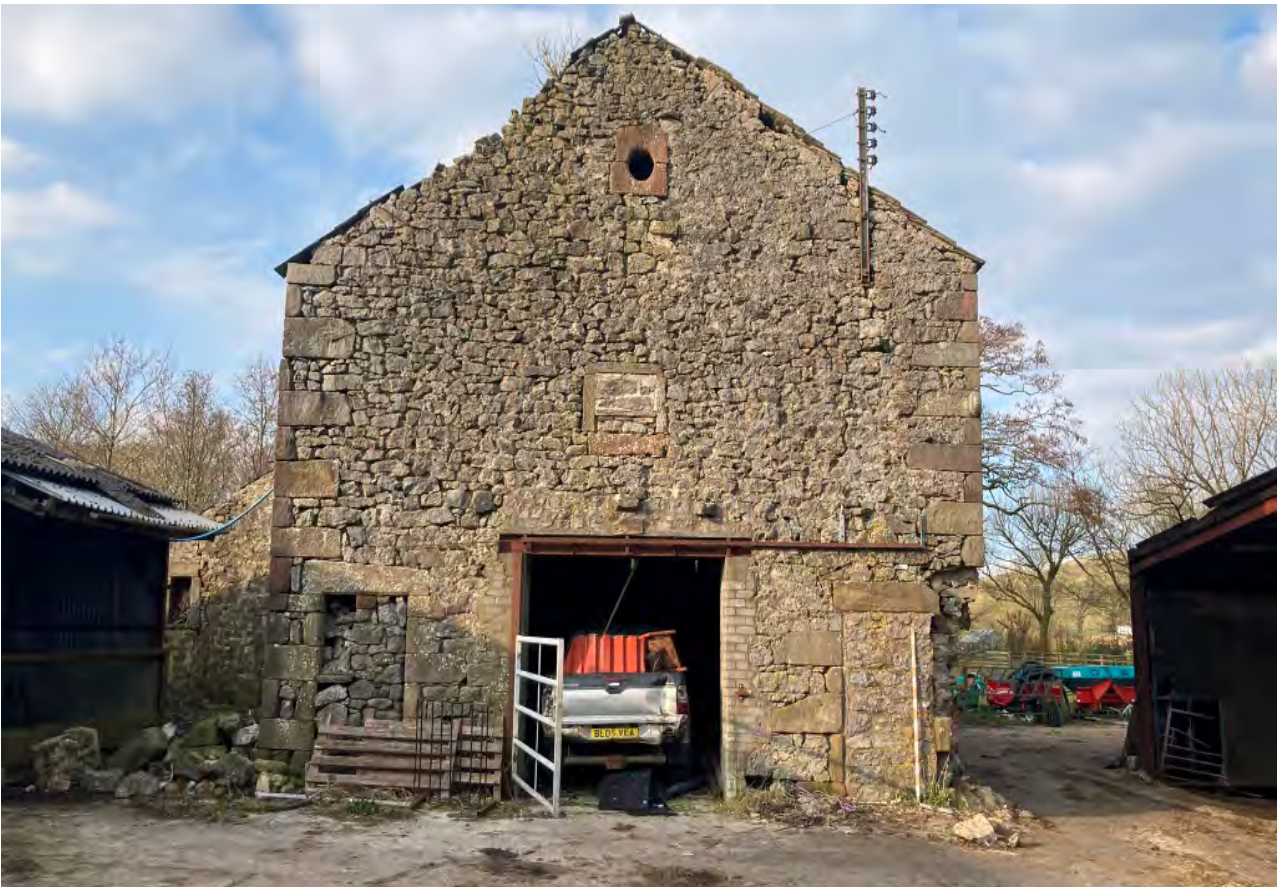
South gable of barn showing more recent central doorway, with blockwork jambs. Also note blocked pitching window above and blocked shippon doorways either side, lost southeast corner and washed out walltops.

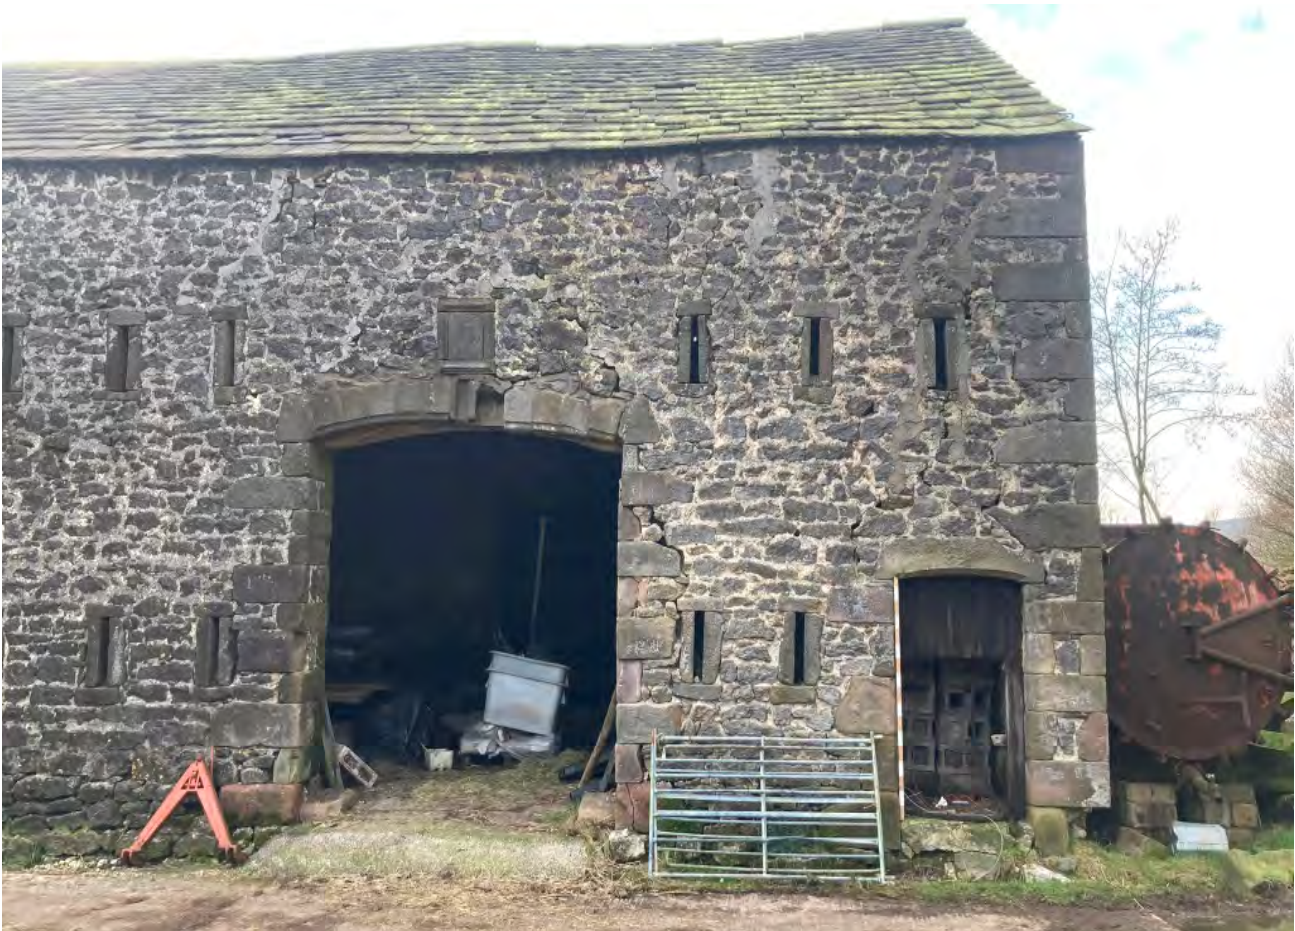
North end of east elevation showing vent slits to both floors and threshing doorway with lost voussoir to arched lintel and diagonal crack across the corner. Also note previously repointed cracking to high level.

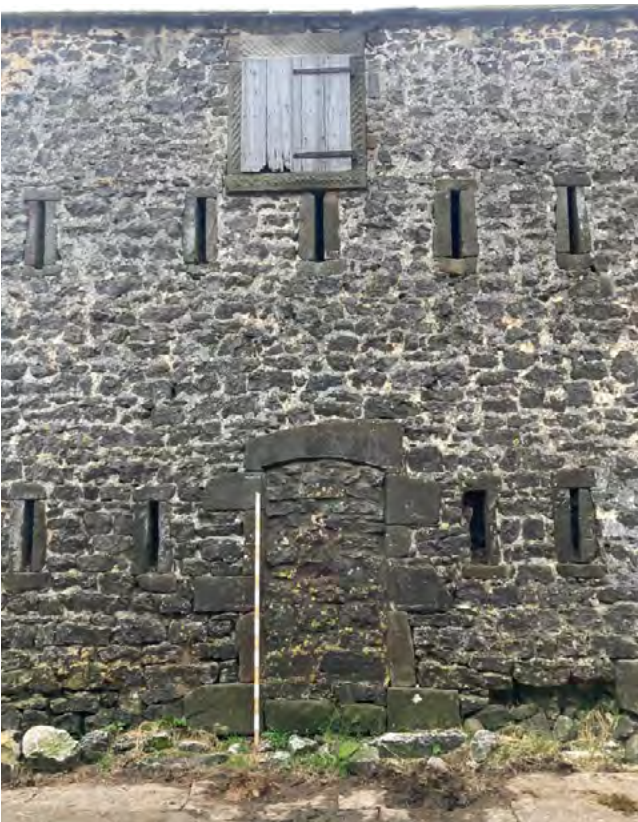
South end of east elevation showing blocked doorway and pitching window above. Also note missing masonry and washed out pointing at ground level.

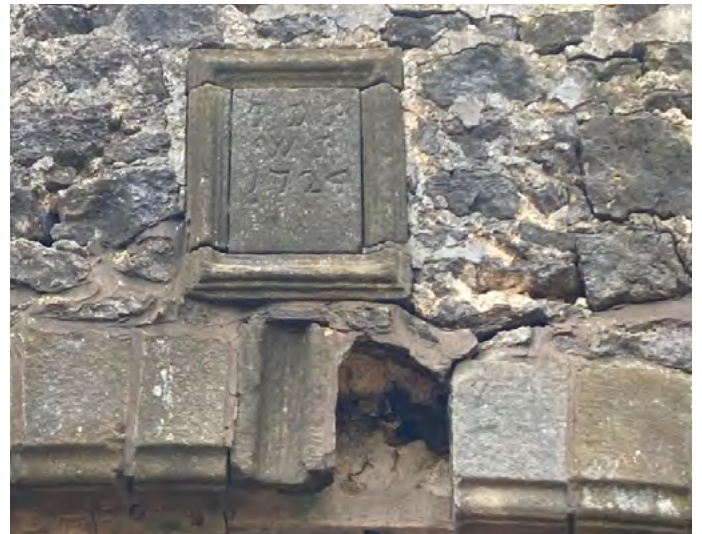
Missing stone voussoir to arched lintel and date stone above.

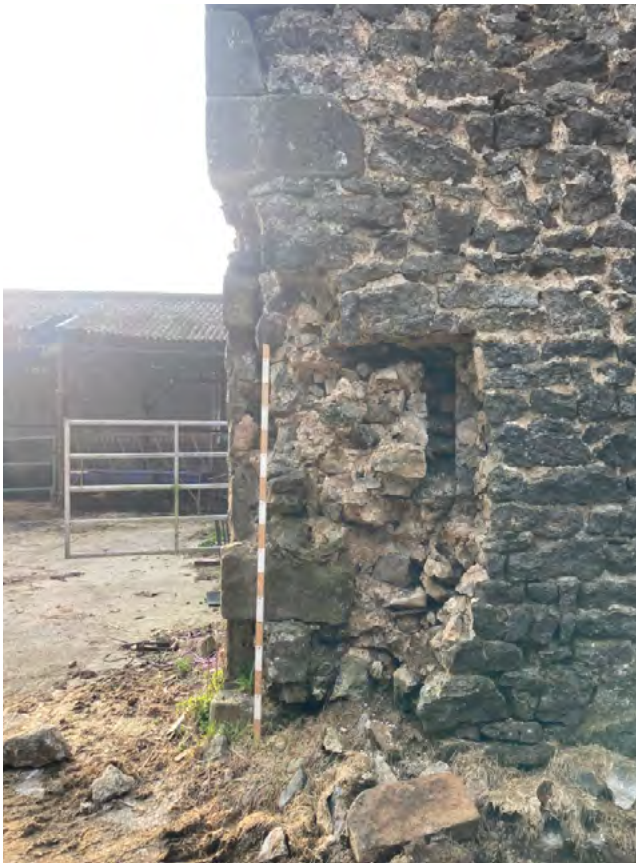
Lost masonry to southeast corner of the barn, viewed from the east side

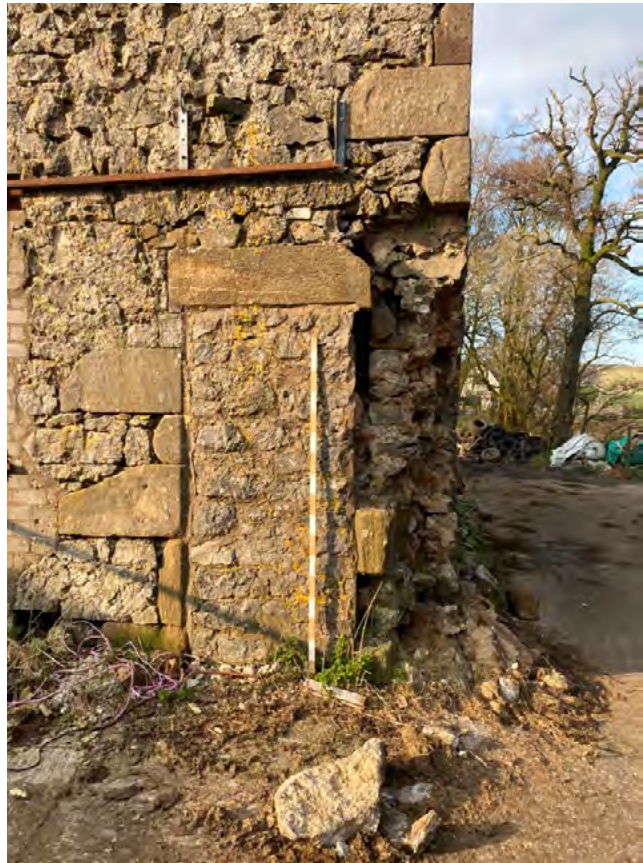
Lost masonry to southeast corner of the barn, viewed from the south side. Also not previously blocked doorway to shippon.

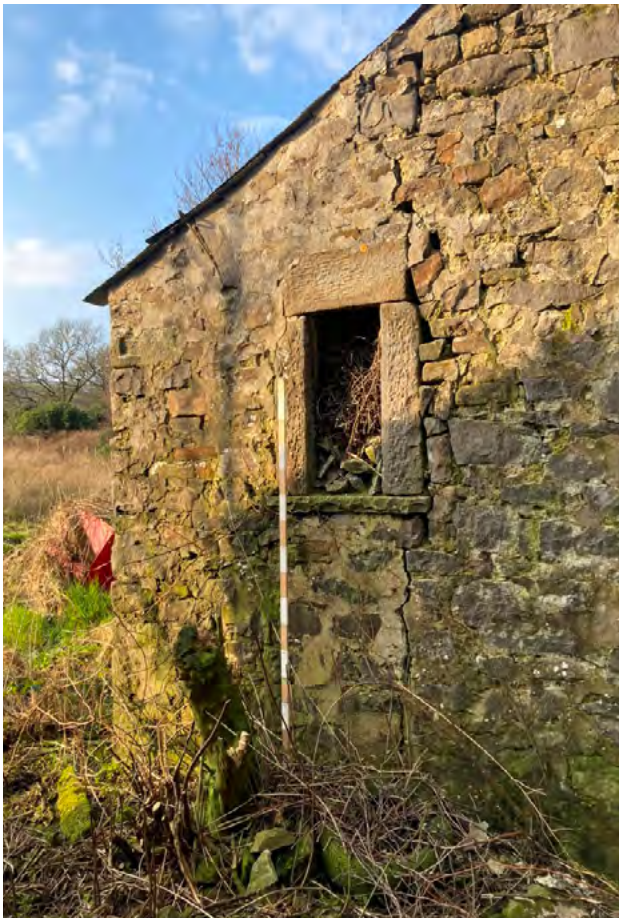
Southwest corner of outshut showing crack to the right of partially blocked window on south return wall.

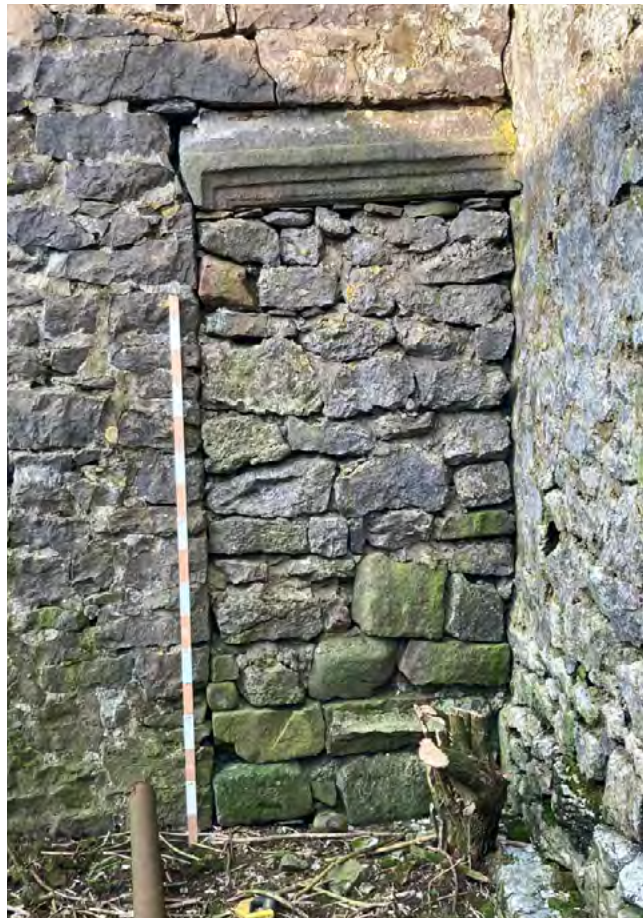
East return wall of oushut at abutment with the west wall of the main barn, showing crack at abutment and blocked doorway with reused lintel to head.

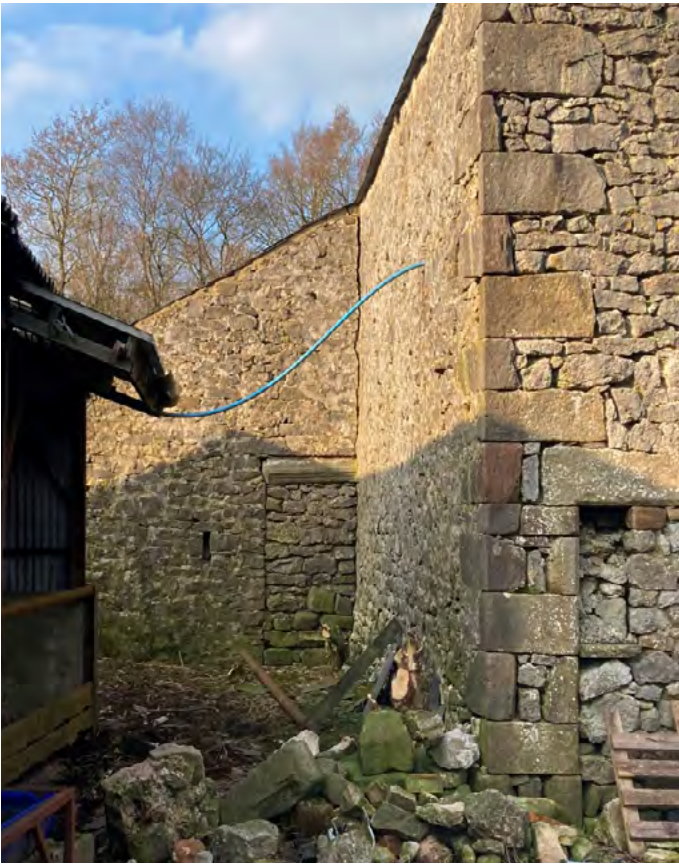
View of south west corner of main barn and south return of oushut. Note crack to unbonded masonry at abutment.

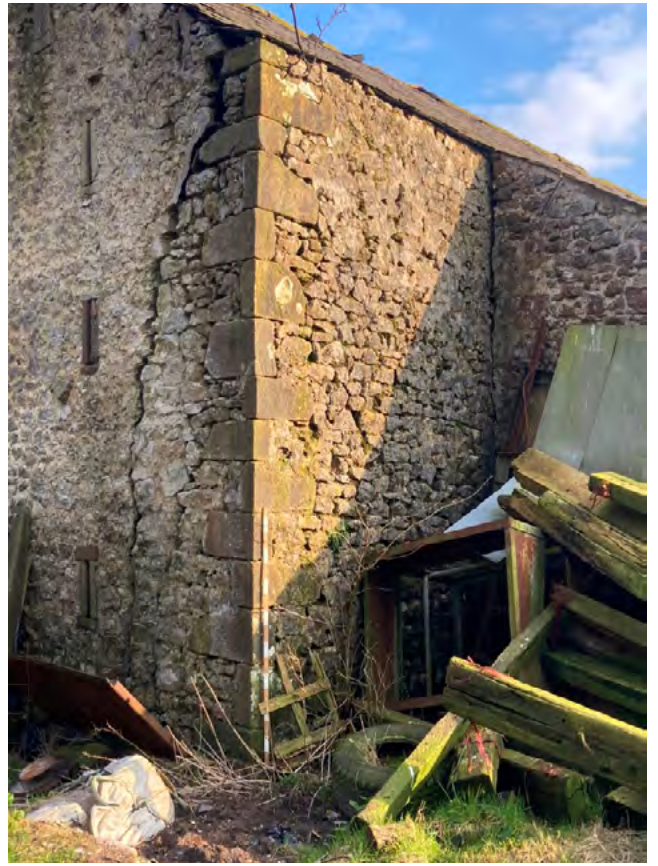
View of northwest corner of main barn and abutment with north return to oushut showing cracking to main barn and at unbonded abutment with oushut.

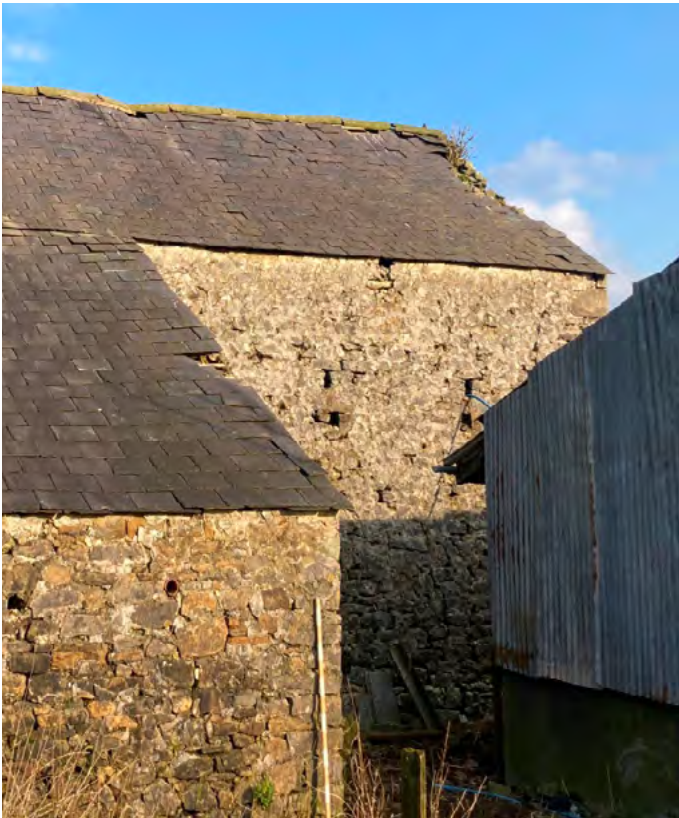
South end of oushut and main barn showing slipped and missing slates at verge and ridge including plant growing out of the wall top to main barn. Also note hairline cracking at high level to both walls.

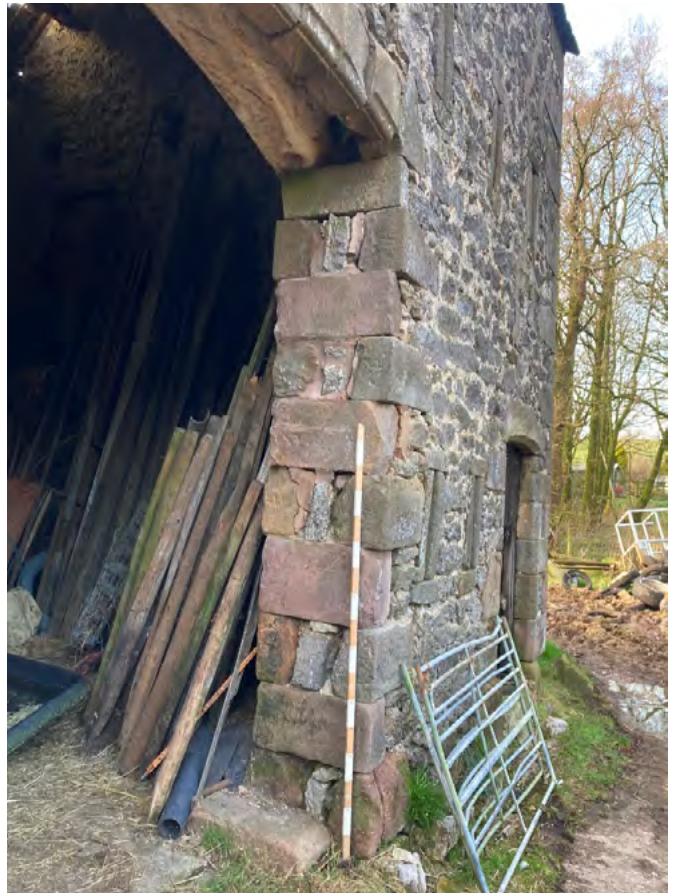
View of north jamb of threshing doorway . Note footing for lost threshing doors.

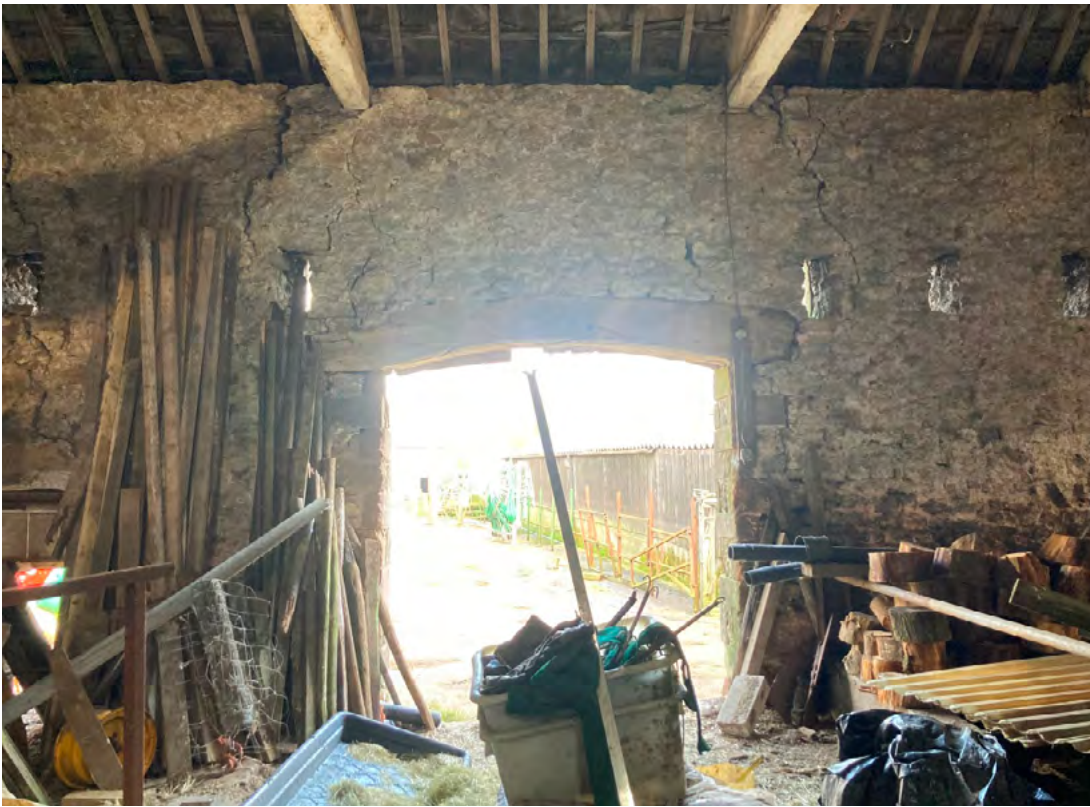
North end of east wall to main barn internally. Showing cracking from wall head to either side of the doorway.

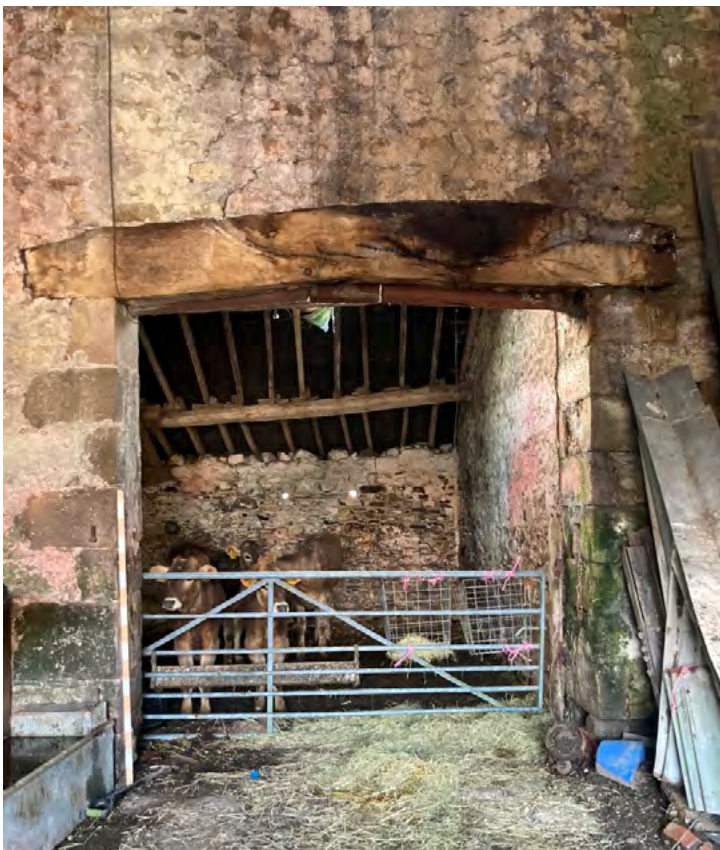
Arched timber lintel to doorway in west wall opposite threshing doorway through into outshut. Note hairline cracking the masonry above,

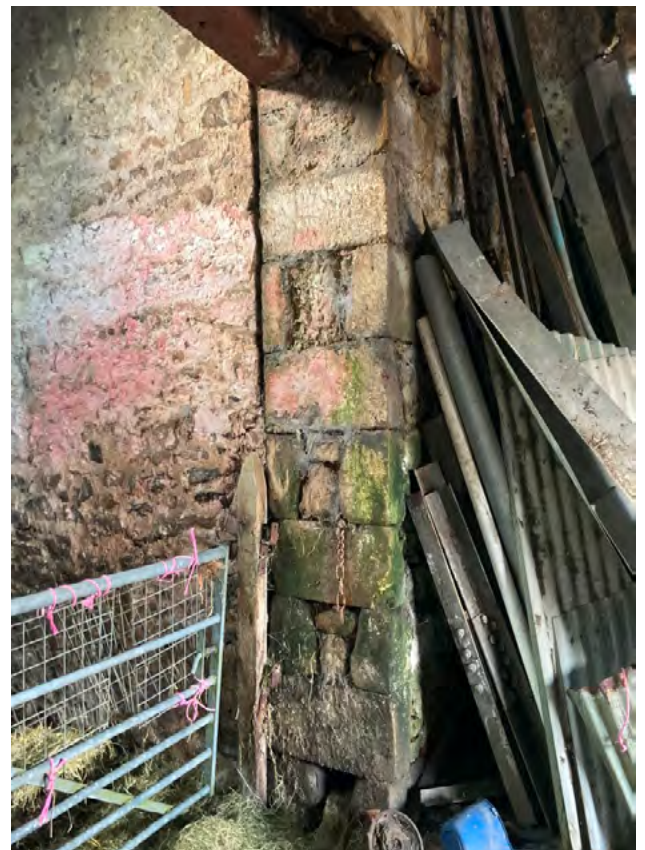
North side of doorway into outshut showing crack at abutment of main barn and outshut and fixing at head for lost doors.

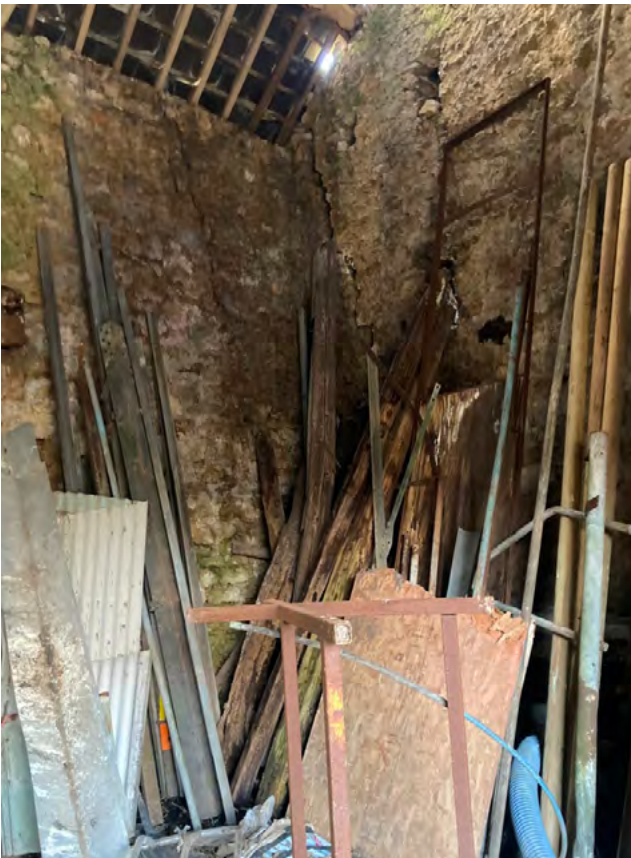
Cracking to northwest corner of main barn hidden behind stored items.

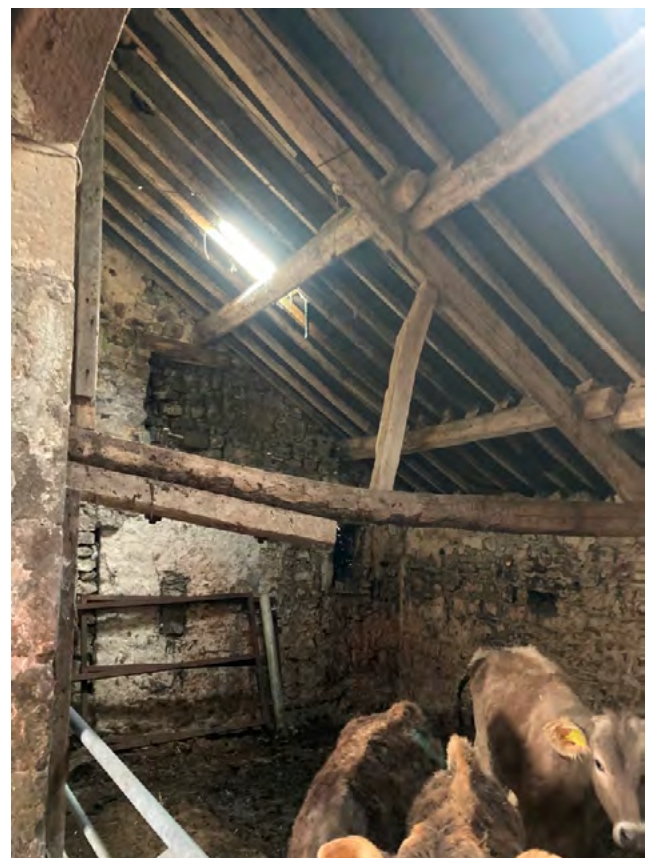
Outshut looking to southwest corner showing failed and partially supported half truss. Also note blocked openings to south wall beyond.

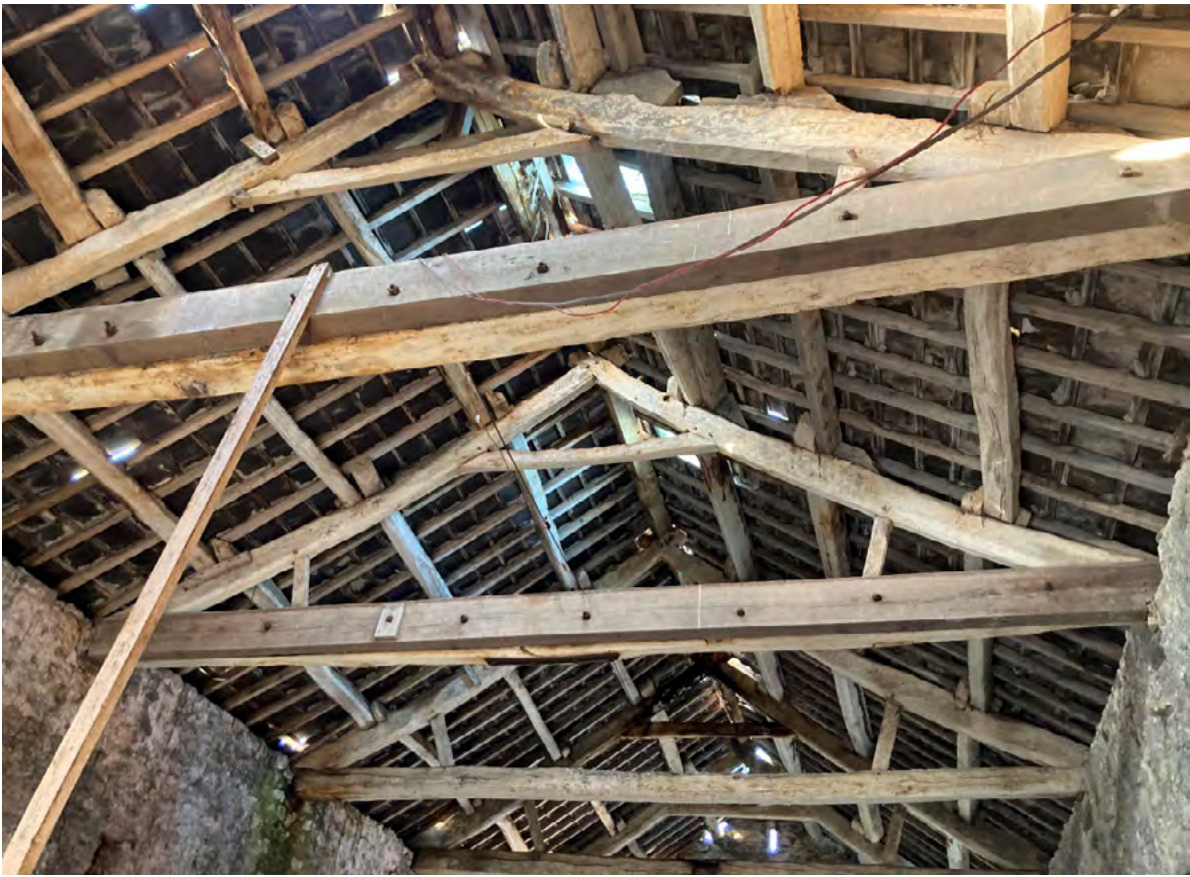
View of roof structure looking north, showing additional support to ties of end two trusses and decay from water ingress to head of truss beyond.

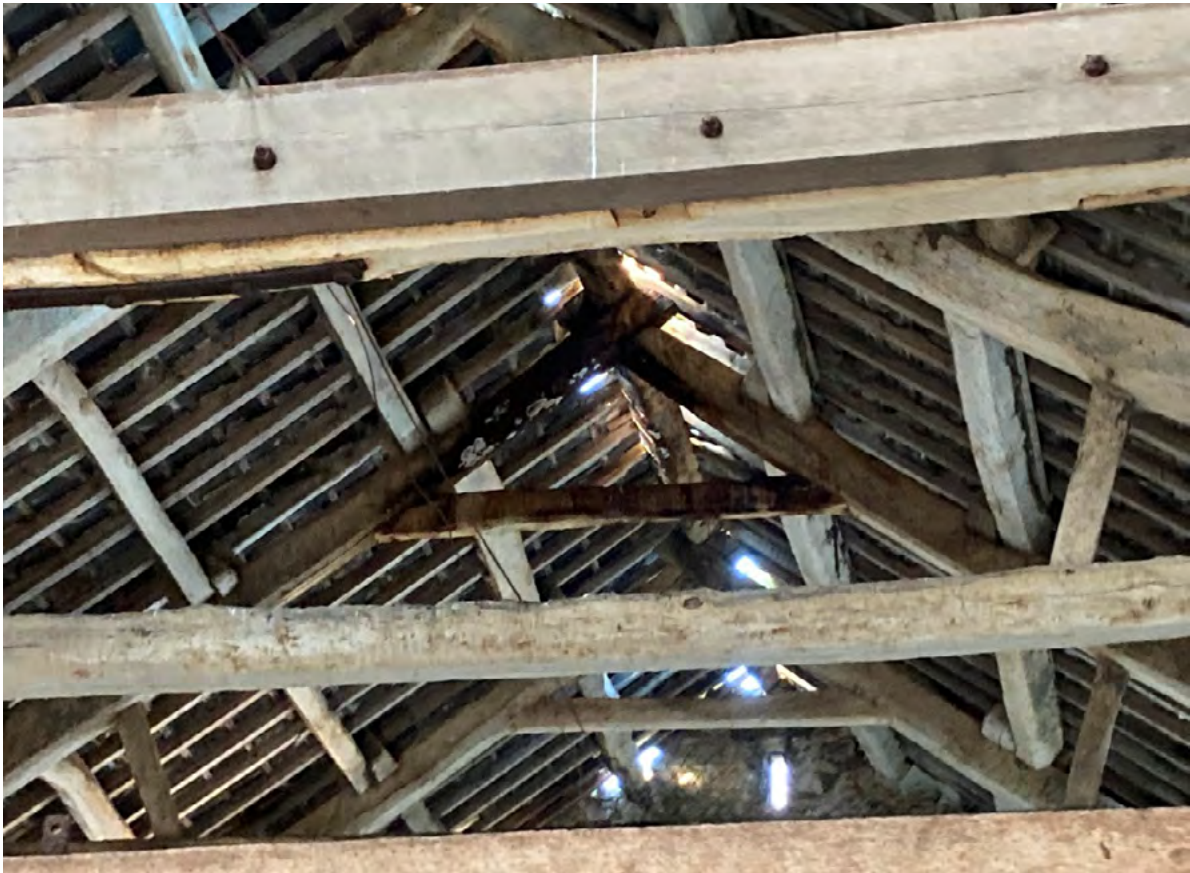
Viewed of decayed head to truss as a result of loss of ridge stones.
