# **Structural Appraisal**

## **Fair Oak Barn**

**John West**

**Ref: A18**

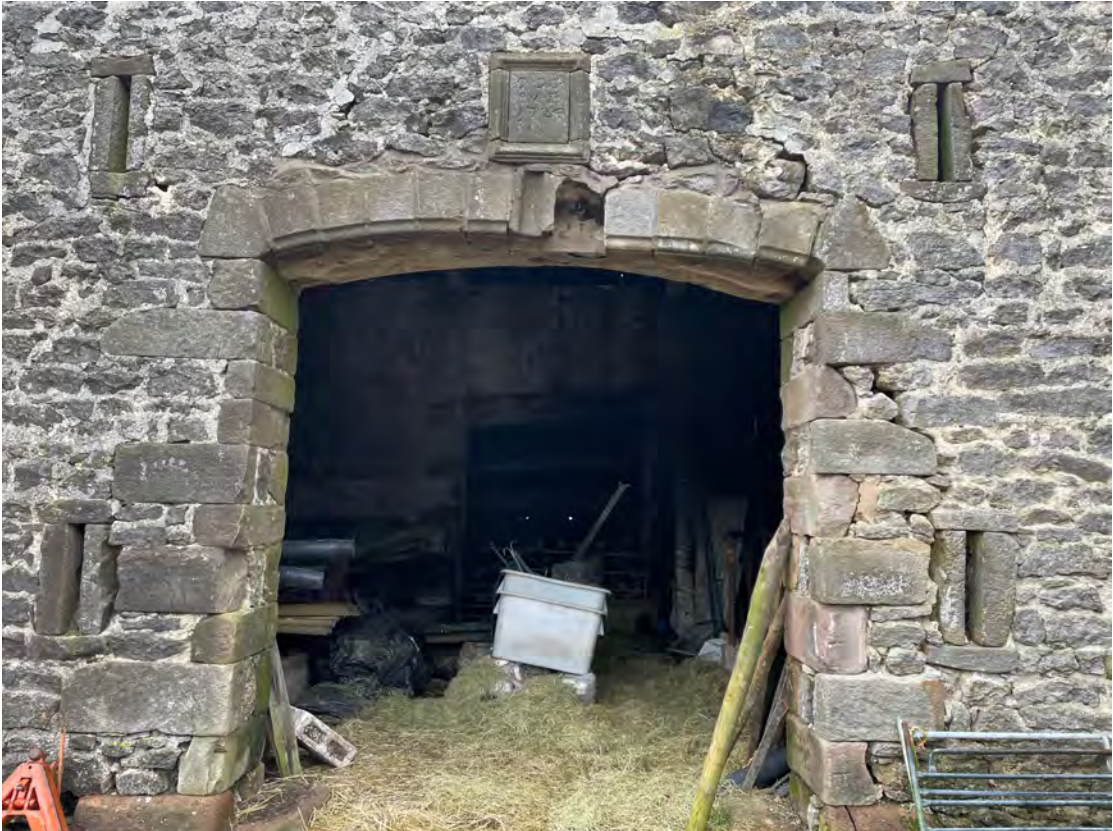
The arch over the cart entrance is missing a voussoir stone, and the masonry above has dropped as a result. The inner half of the wall over the opening is carried on a curved timber beam.

Photo 1: Main Cart Entrance

The rear extension should be tied on to the west wall as shown on the drawing. The entrance arch should have its missing voussoir replaced.

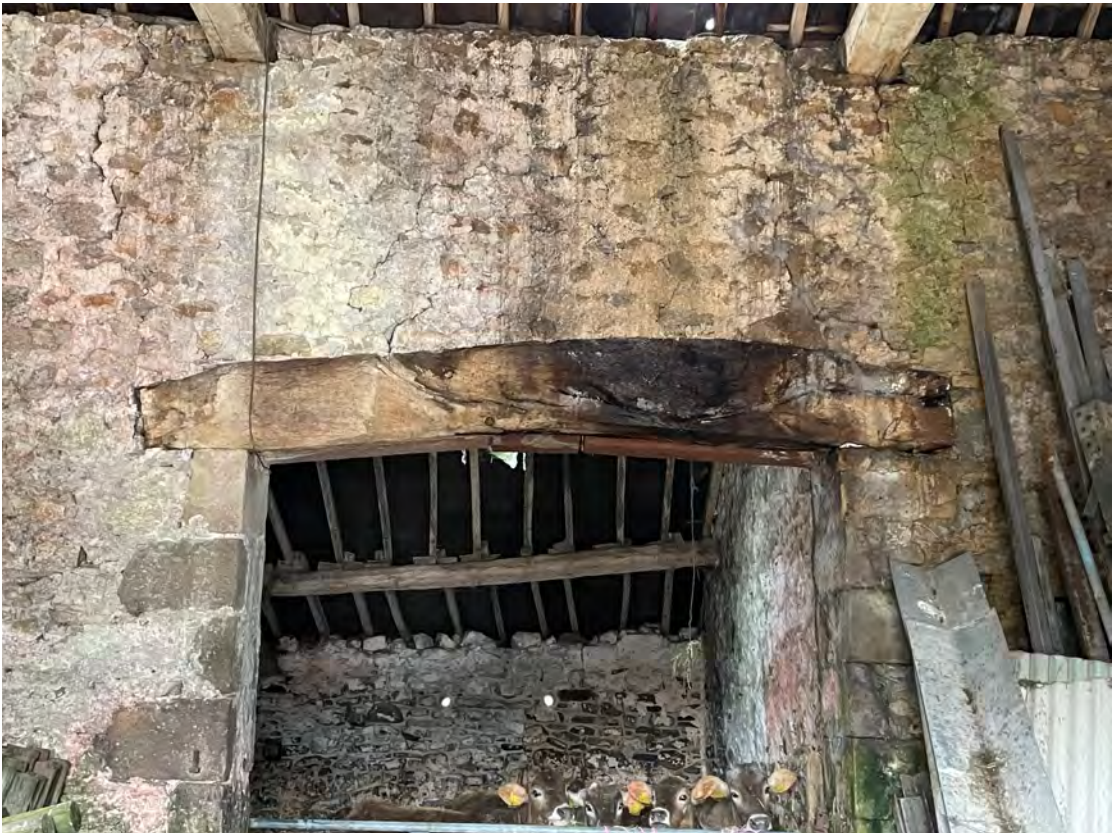
Both of the main walls of the barn are leaning to the east. The east wall by up to 100mm, and the west wall by 150mm adjacent to the opening to the rear extension. This movement has opened up the junction between the rear extension and the west barn wall, which is not bonded in.

Photo 2: Cart Entrance to Rear Outshut

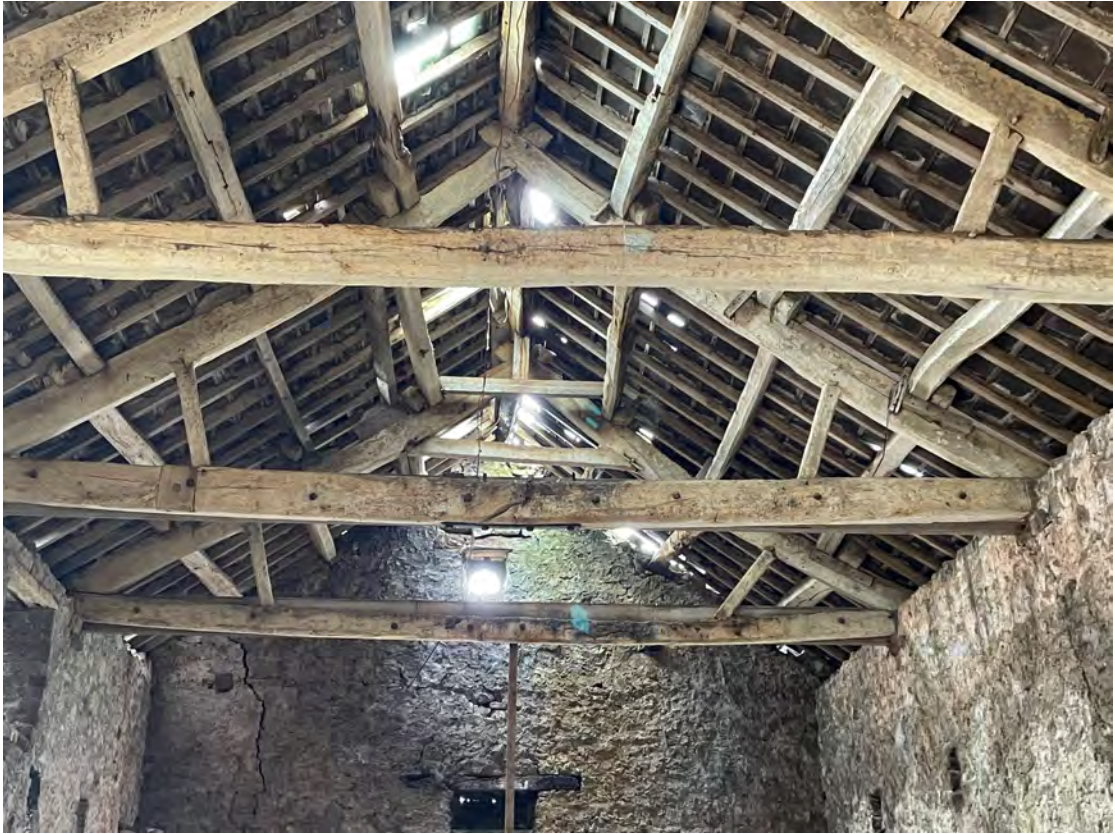
The roof of the main barn is carried on five collared and tie trusses. The two at the south end have had their ties reinforced with additional timber. The central truss has a rotten tie beam where its west end bears on the wall. The second truss from the north has wet rot at its apex, affecting the principals, and the adjacent ridge pieces. The north end ridge too has been affected by wet rot. Otherwise, the purlins appear to be sound, but this can only be confirmed after the slating has been stripped and the tops of the purlins can be inspected.

Photo 3: Roof Looking South

The two roof trusses that need repairing are shown on the drawings. In addition, two ridge pieces should be like for like replaced.

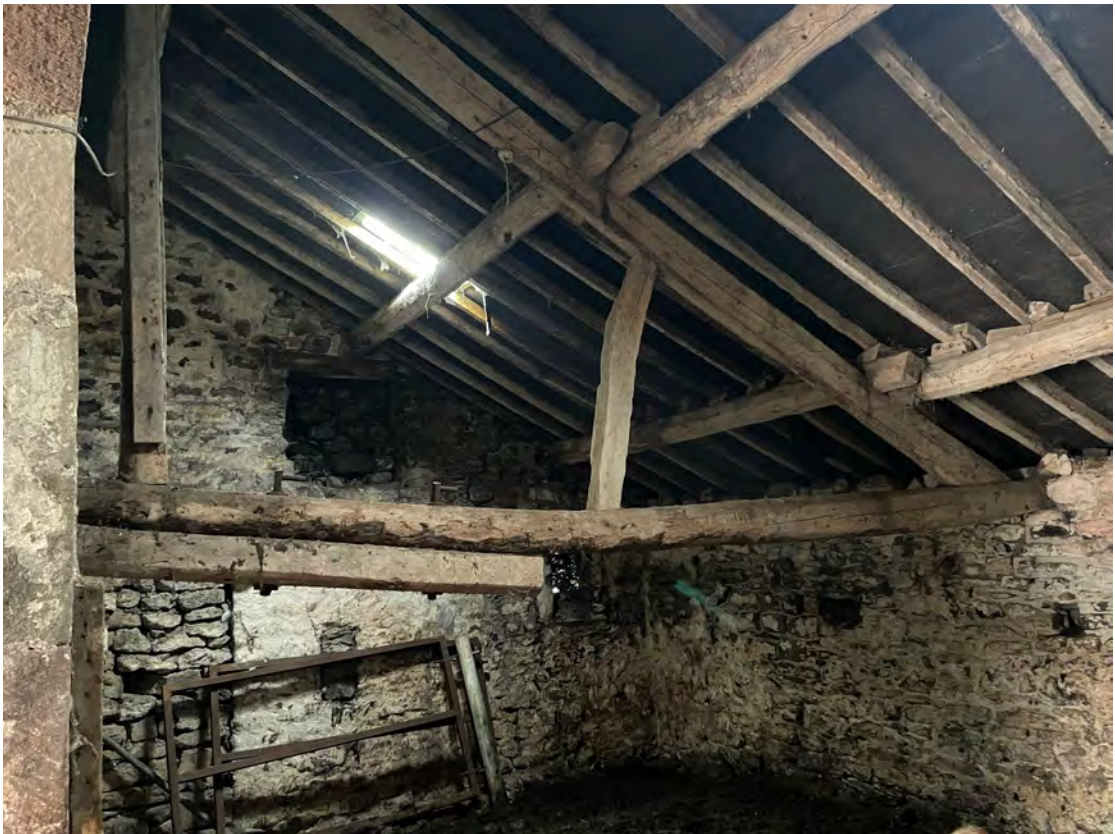
The truss in the outshut is suffering from rot and the tie beam has deflected excessively.

Photo 4: Roof of Outshut

The truss in the extension should be replaced.

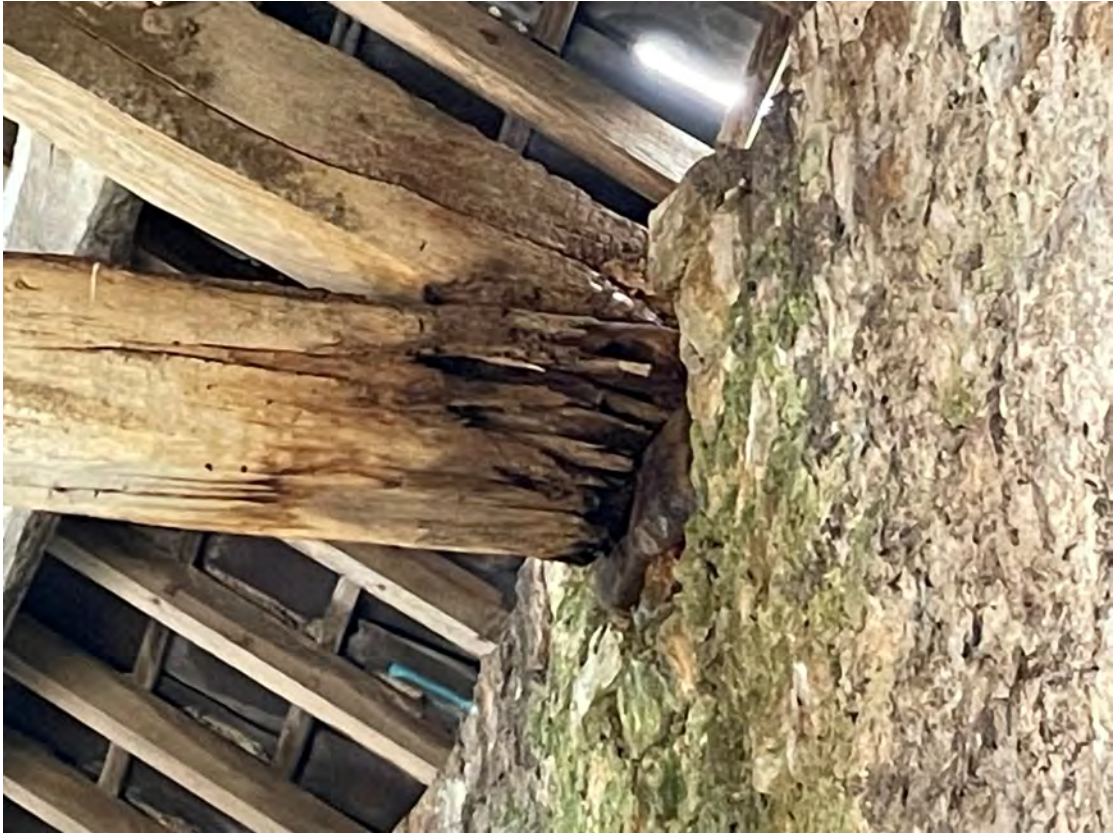
Photo 5: Central Truss End Failure

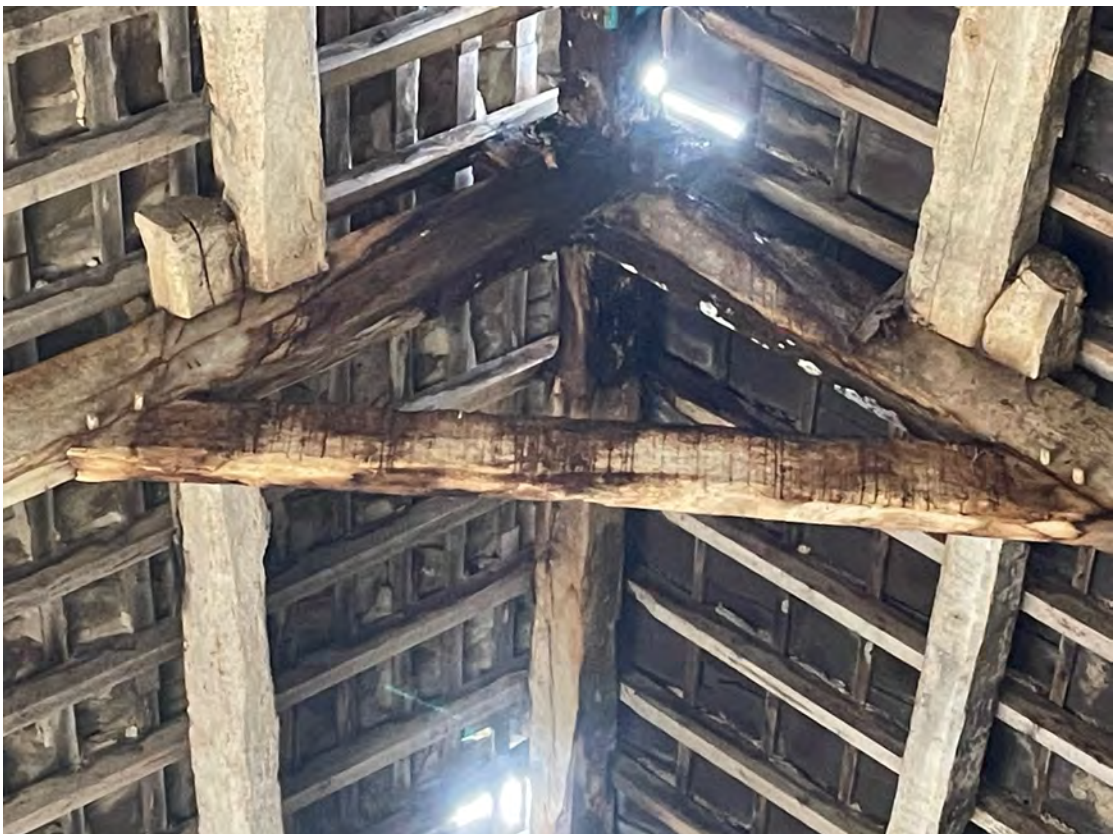
Photo 6: Truss No. 4 - Apex Timber Rot

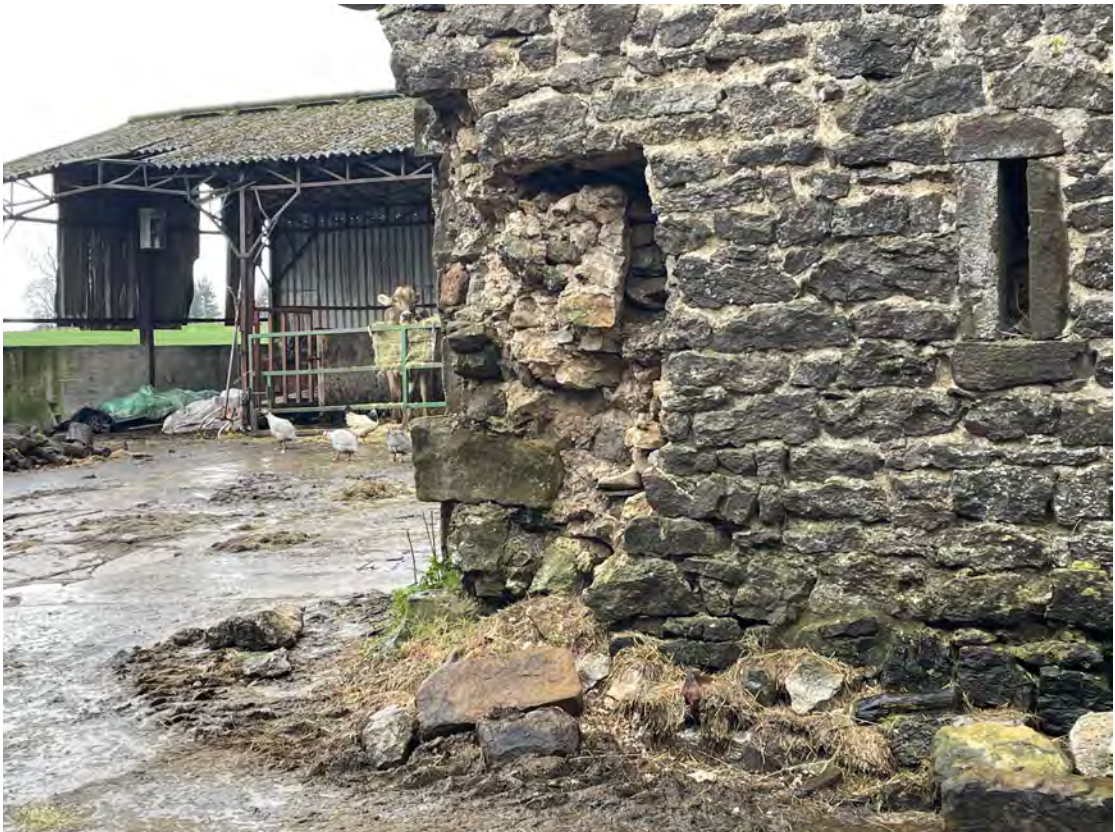
The south-east corner of the main barn has been damaged by vehicles. The collapsed area should be rebuilt, and a kerb introduced to keep vehicles away from the wall at this point.

Photo 8: Collapsed South-East Corner

The south-east corner of the main barn should be re-built, and a kerb introduced to keep vehicles away from the corner.

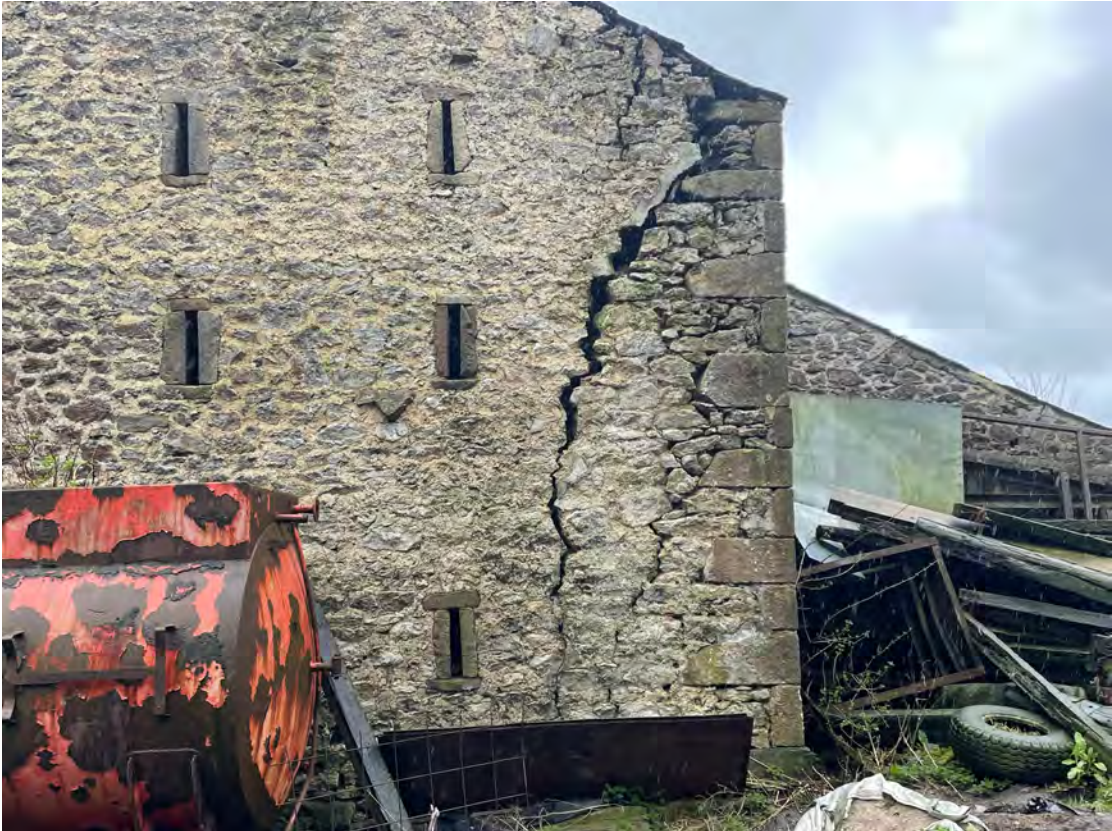
The foundations have not been exposed or inspected, but some subsidence has occurred on the north-west corner of the main barn. The ground is very wet in this area, which could be the cause of the problem. The area should be drained and allowed to dry out. Steel ties should be introduced as mentioned below.

Photo 9: North Gable Wall

The cracking in the north wall should be pointed up and steels introduced across the gable wall to prevent further movement.

The area around the west and north sides of the barn should be drained.
