## **Barn at Parsonage Farm, Church Street, Ribchester, PR3 3YE**

### **Structural Condition Survey for Conversion to Dwelling**

PSC-690-CAR1 – Rev B

August 2024

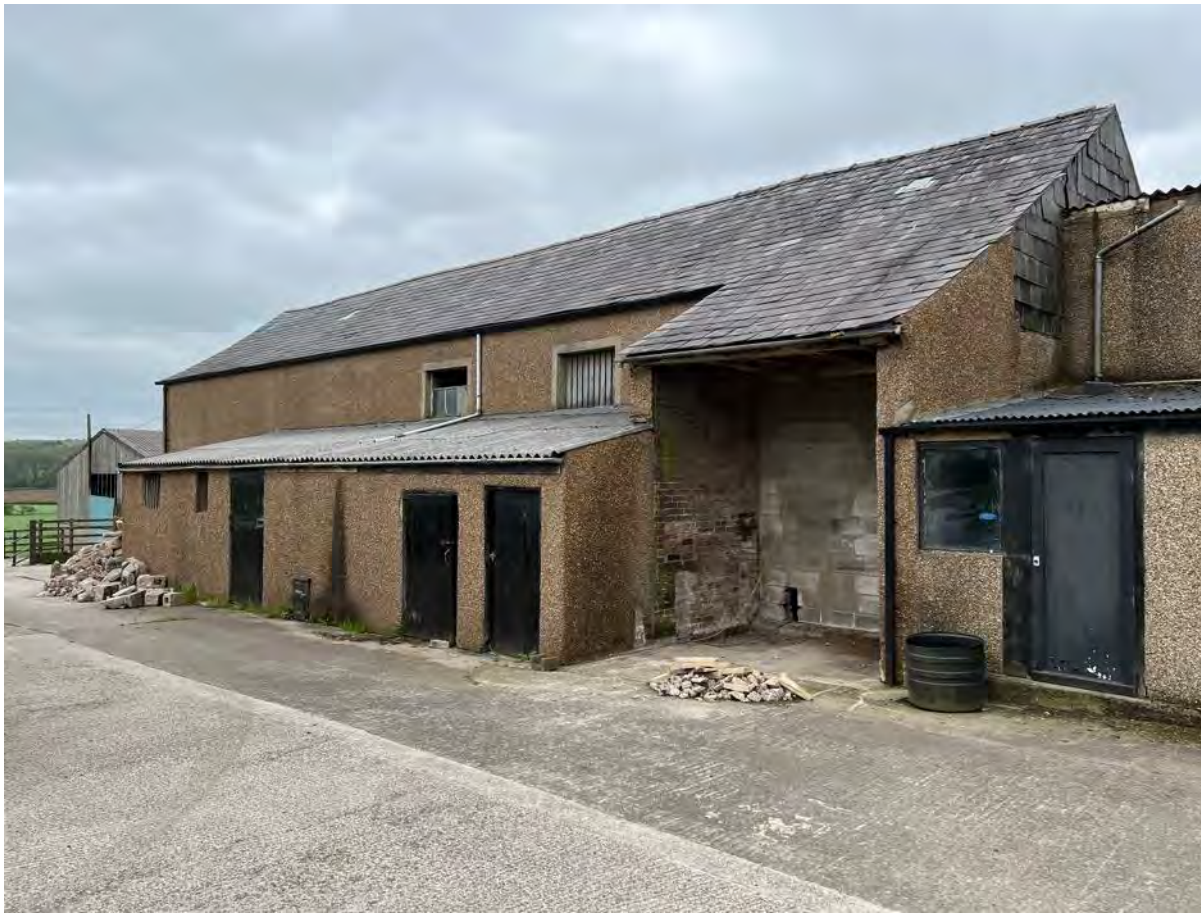
Photo 1 - North East Elevation

The original brick wall to this elevation is constructed with clay brick and is approximately 400mm thick. The wall has a pebble dashed render. Single storey extensions have been added to this elevation as can be seen in Photo 1. In addition, the original barn has been extended to the northwest with a blockwork extension which has also been pebble dashed (photo 2). This extension appears to have replaced two original bays of the brick barn as evidenced by internal inspection and exploratory excavations externally. The walls to this elevation are generally plumb, the render is in reasonable condition and free from signs of movement. The elevation benefits from guttering and downspouts.

Photo 1 indicates slates to the gable where the extension abuts to the original barn.

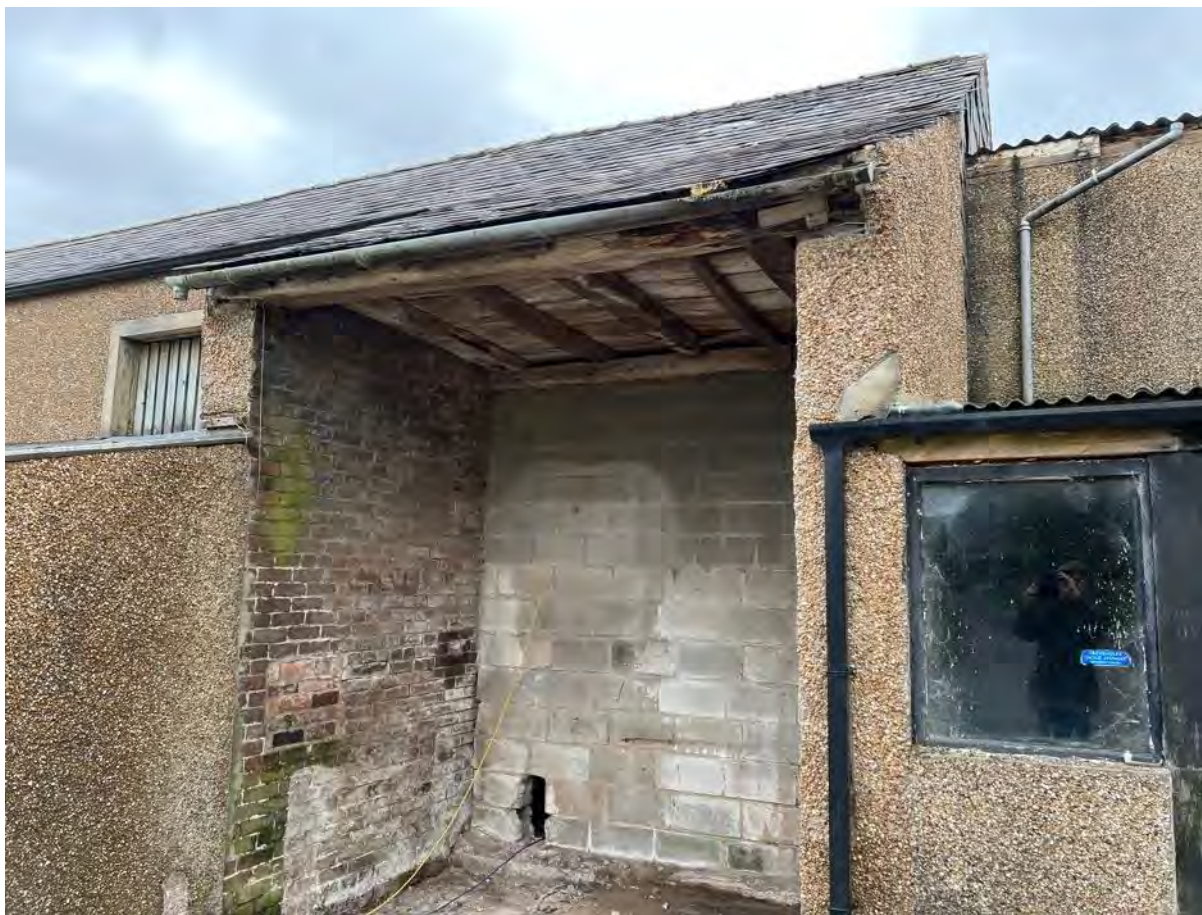
Photo 5 – North East Elevation – Original Barn Entrance

The original barn door (photo 5) has been blocked up with concrete blocks. Photos 5 to 7 show the original unrendered brickwork and the timber to the roof/overhang. The brickwork is in good condition, reasonably pointed and generally plumb. There are two high level window openings in the original wall, above the single storey extension (photo 9). At the eastern end there is a further window opening at ground floor level (photo 14). The original brickwork can also be seen in photo 15 which shows an area adjacent to the gable where the render has been removed at a low level. Again, the brickwork appears in good condition given the age of the building.

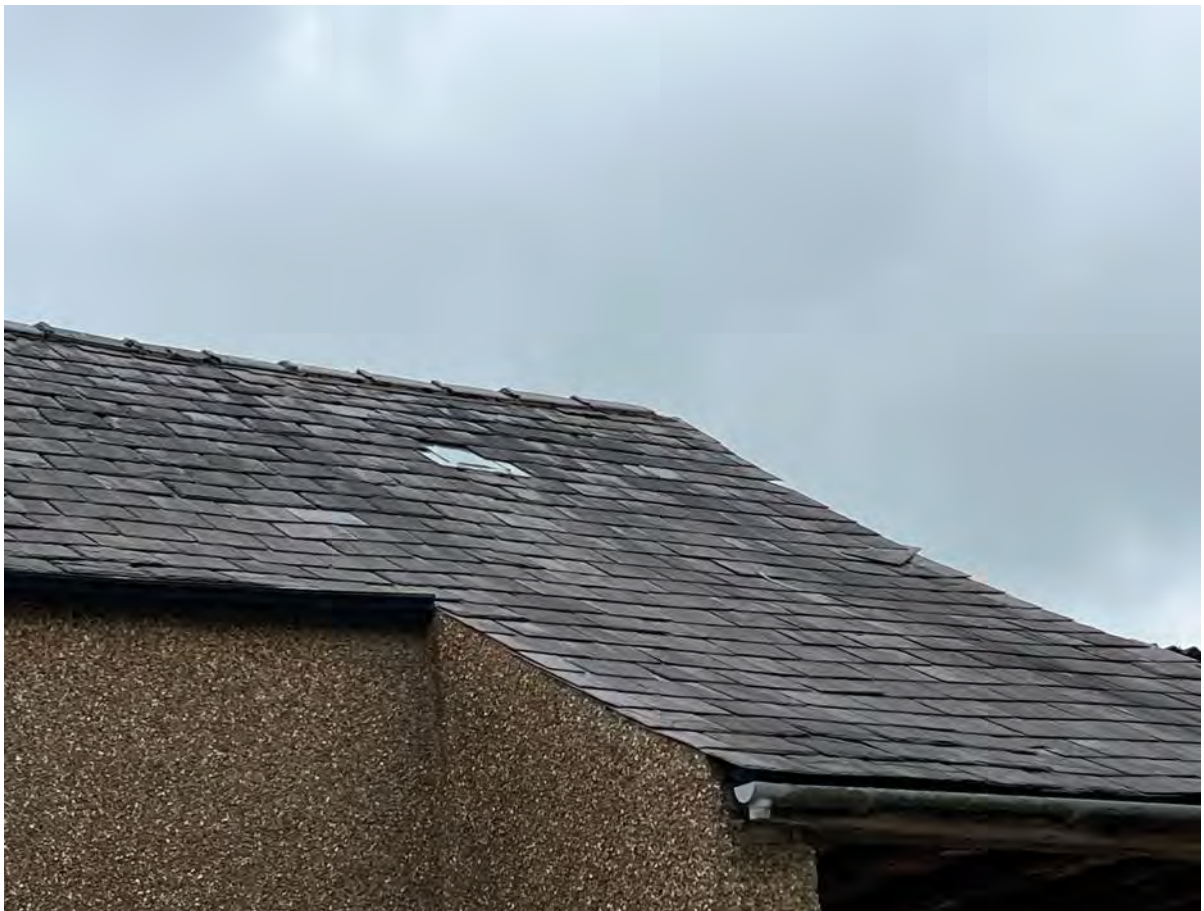
Photo 10 – North East Elevation Roof

The main roof is slate on traditional rafters, purlins and trusses which are discussed further below. The external views indicate the slates to be in good condition with no loss or damage. The roof appears not to have suffered from any major movement or deflection when viewed externally.

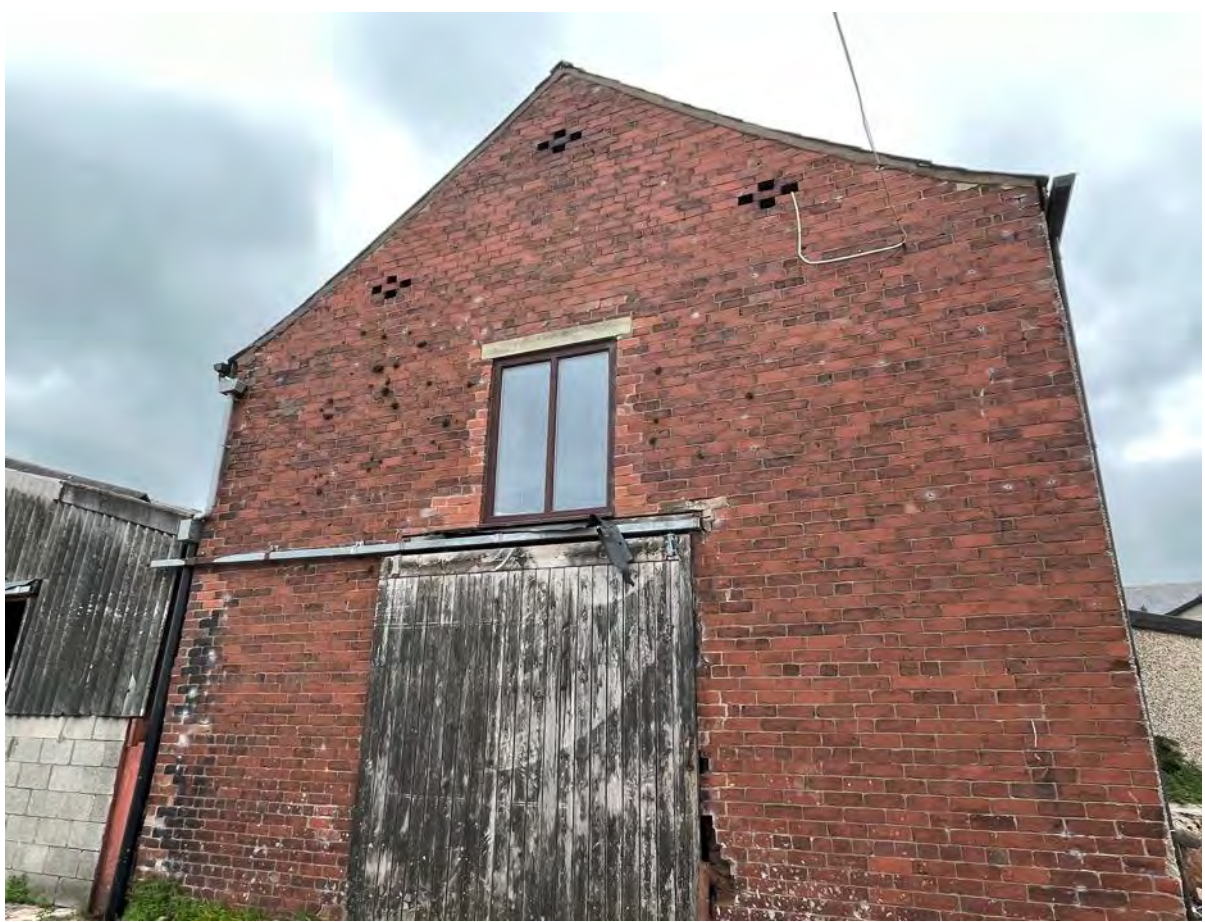
Photo 17 – South East gable

The elevation is a 500mm thick brick wall. It appears to have had an extra skin of brickwork added externally using Accrington Brick. The wall is in good condition, plumb and well pointed. There is no sign of structural movement. The elevation has a large door opening with a window above (photo 17). There are 3 vents in the brickwork above the window (photo 20). Photo 21 shows the steel column to the large steel framed extension to the south.

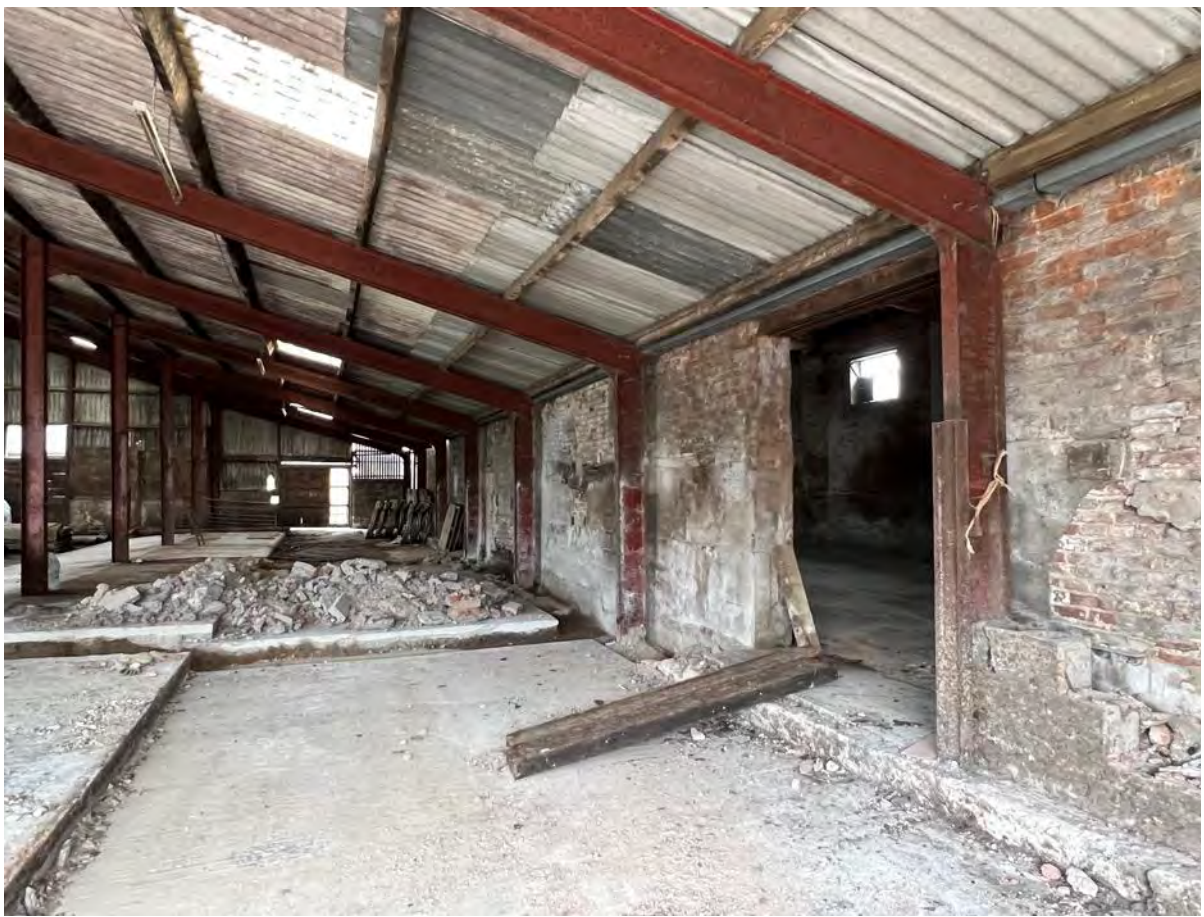
Photo 23 – South West Elevation

The south elevation of the brick barn sits within the large steel framed extension to the south as can be seen in photo 23. The brick walls are 400mm thick and the photographs illustrate that the wall has been repaired or had sections blocked up with concrete blocks (photos 29 to 31). There is a large opening in place at the eastern end (photos 23 & 24). A further window opening is in place at a high level towards the western end and this can be seen in photo 49. The walls are plumb and generally well pointed. There is no sign of movement to the wall.

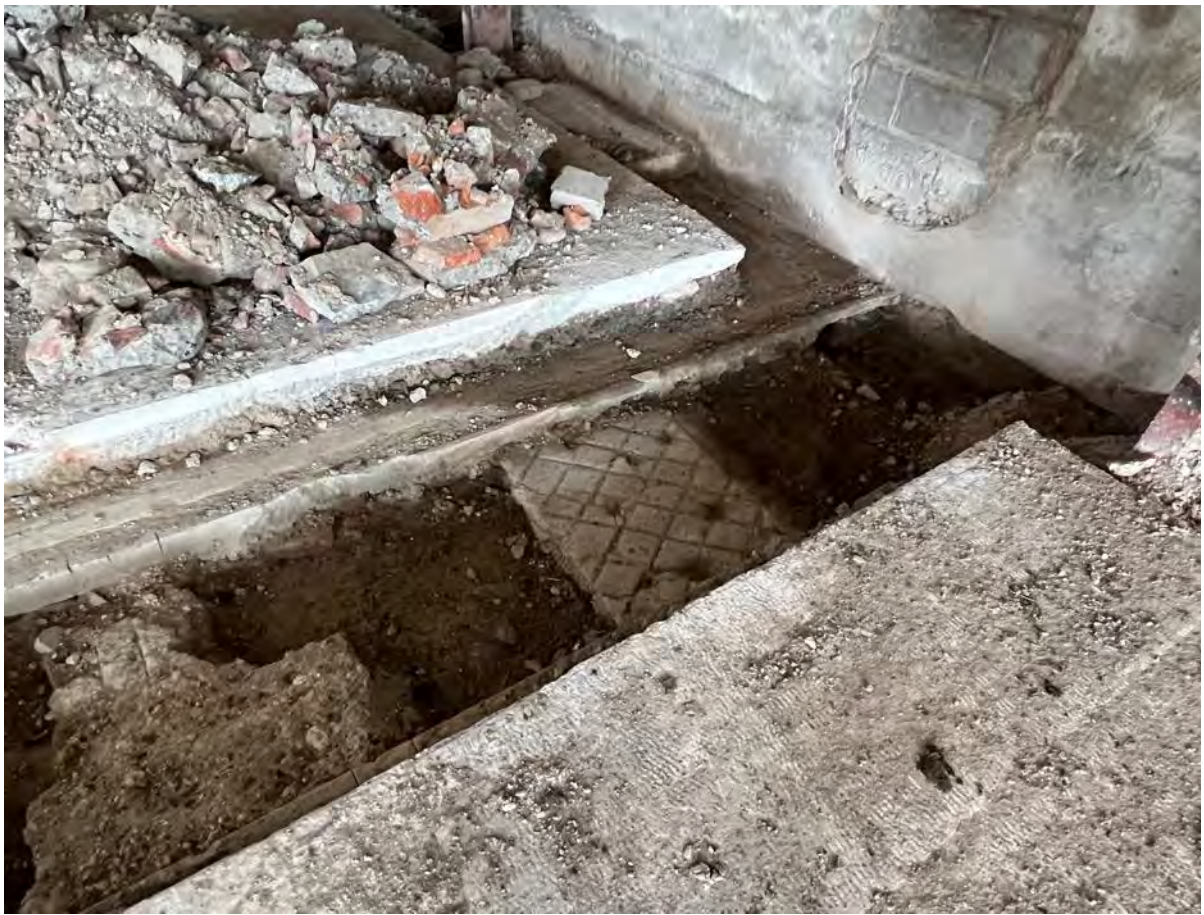
Photos 27 and 28 show excavations below the current floor which indicate that the large steel framed building to the south of the brick barn probably replaced a traditional rear section of a Lancashire barn. The excavations indicate footings to such a building in place below the existing floor.

Photo 27 - South West Elevation – excavations to reveal former lean-to section

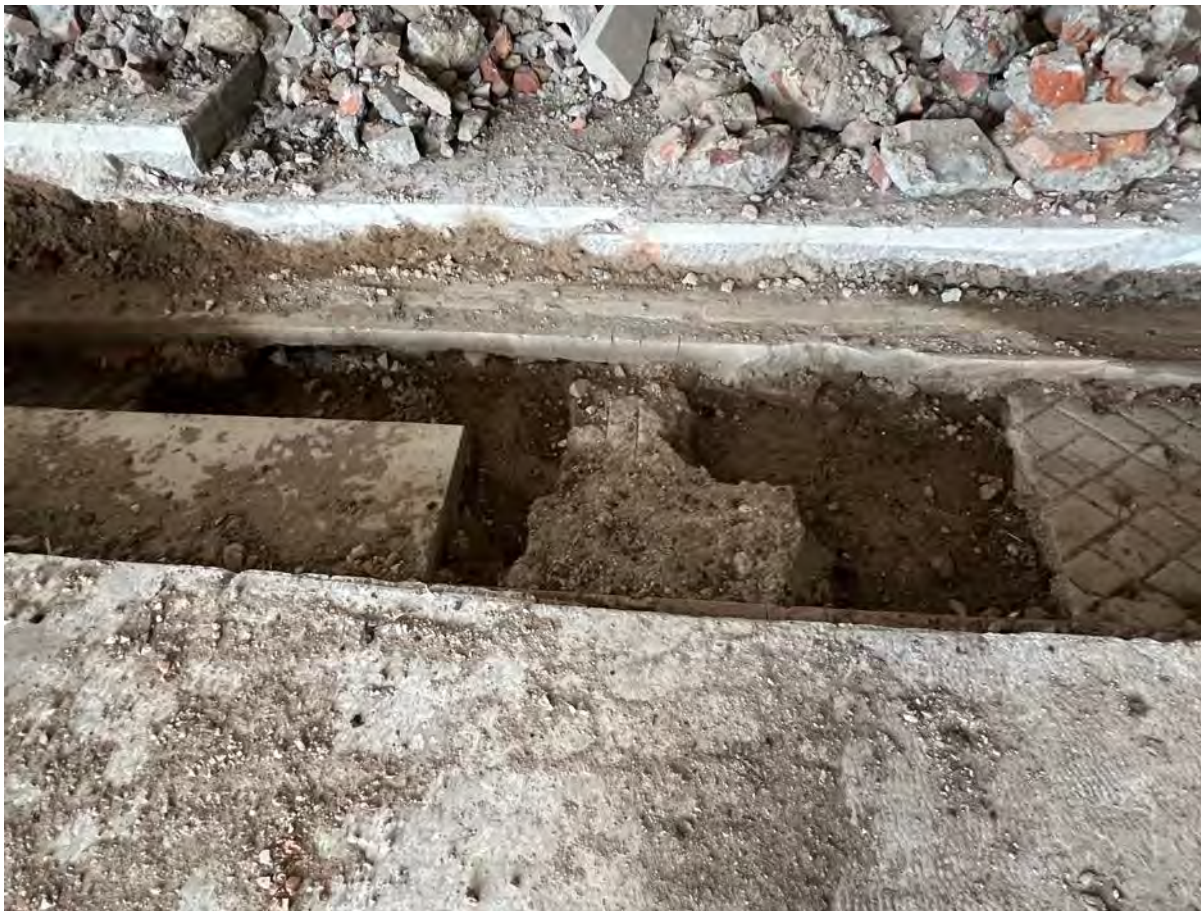
Photo 28 - South West Elevation – excavations to reveal former lean-to section

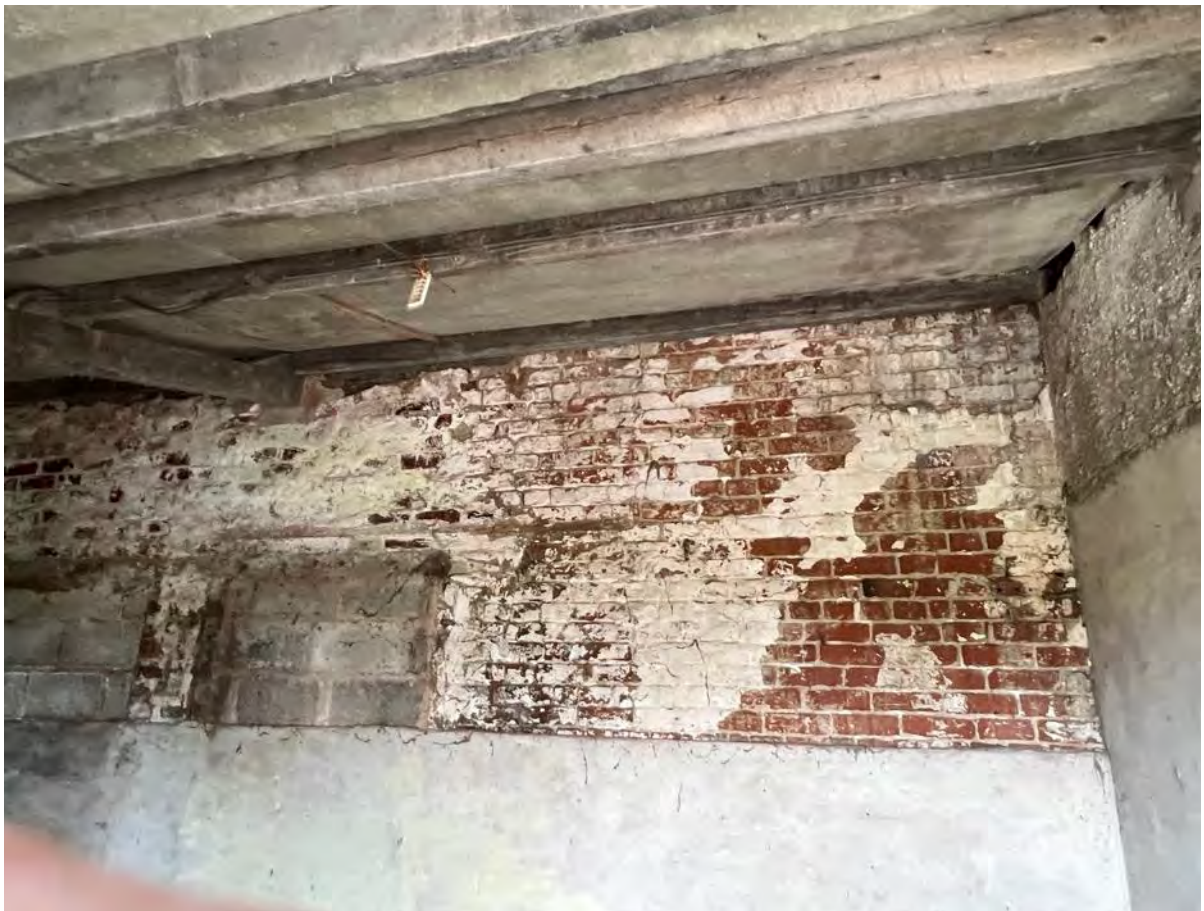
Photo 38 - Internal – extensions to north east elevation

These areas are in a reasonable condition and also inspection of this area gives an indication of the state of the original brick walls to the main barn. This has been rendered at lower levels and areas have been infilled with block (photo 38). The original brick wall and the newer block walls are all free from structural movement and plumb.

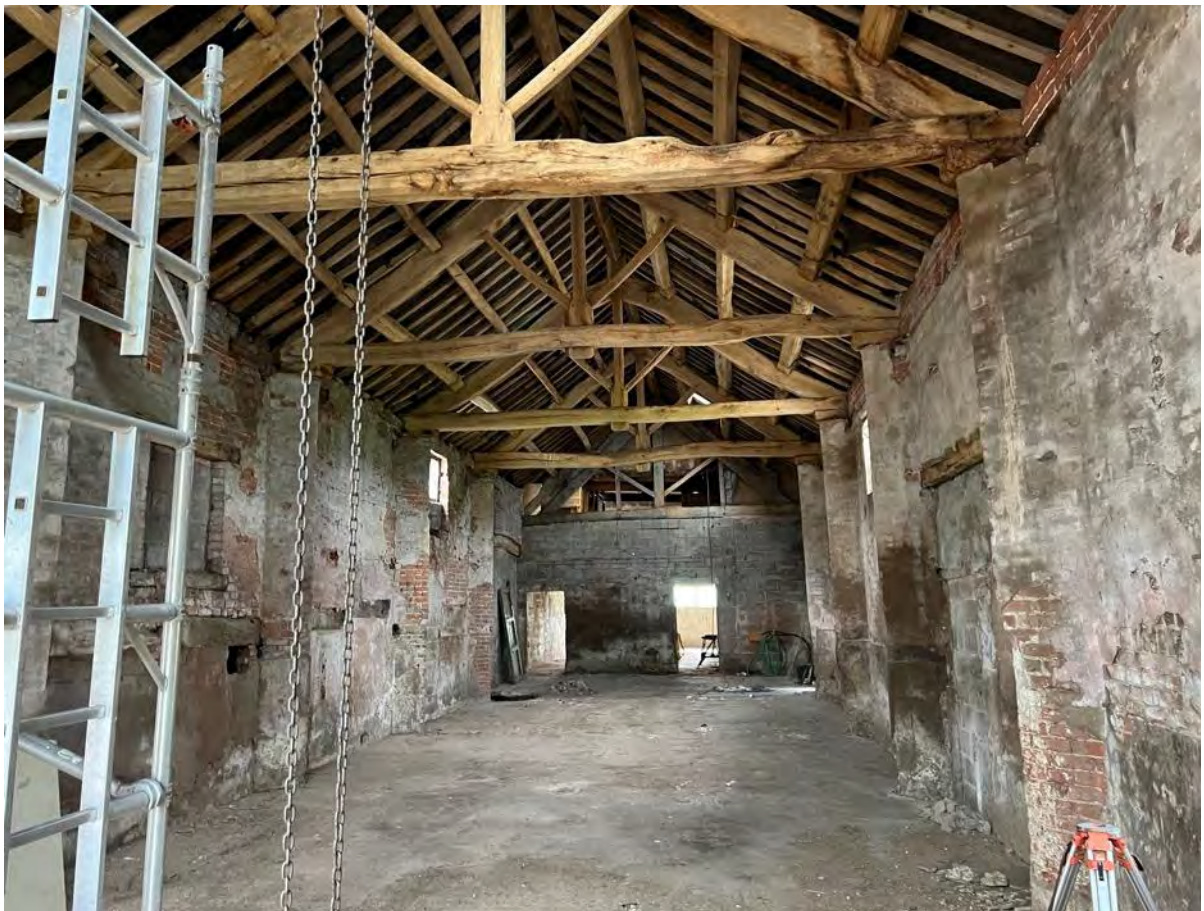
Photo 40 – Internal – main barn

The main barn is an open building to full height as can be seen in photo 40. The brick walls have triangular piers set at regular intervals (approx. 12 feet or 3.7m). These piers are 500mm long on each triangular side. They carry the king post roof trusses above. The brickwork is in reasonable condition but there are some areas of damage and lots of areas where openings have been infilled with blockwork or damage repaired. There is no indication of any structural movement or issues. Photos 46 and 52 show areas of damage to the piers but this is not due to structural movement and can be repaired.

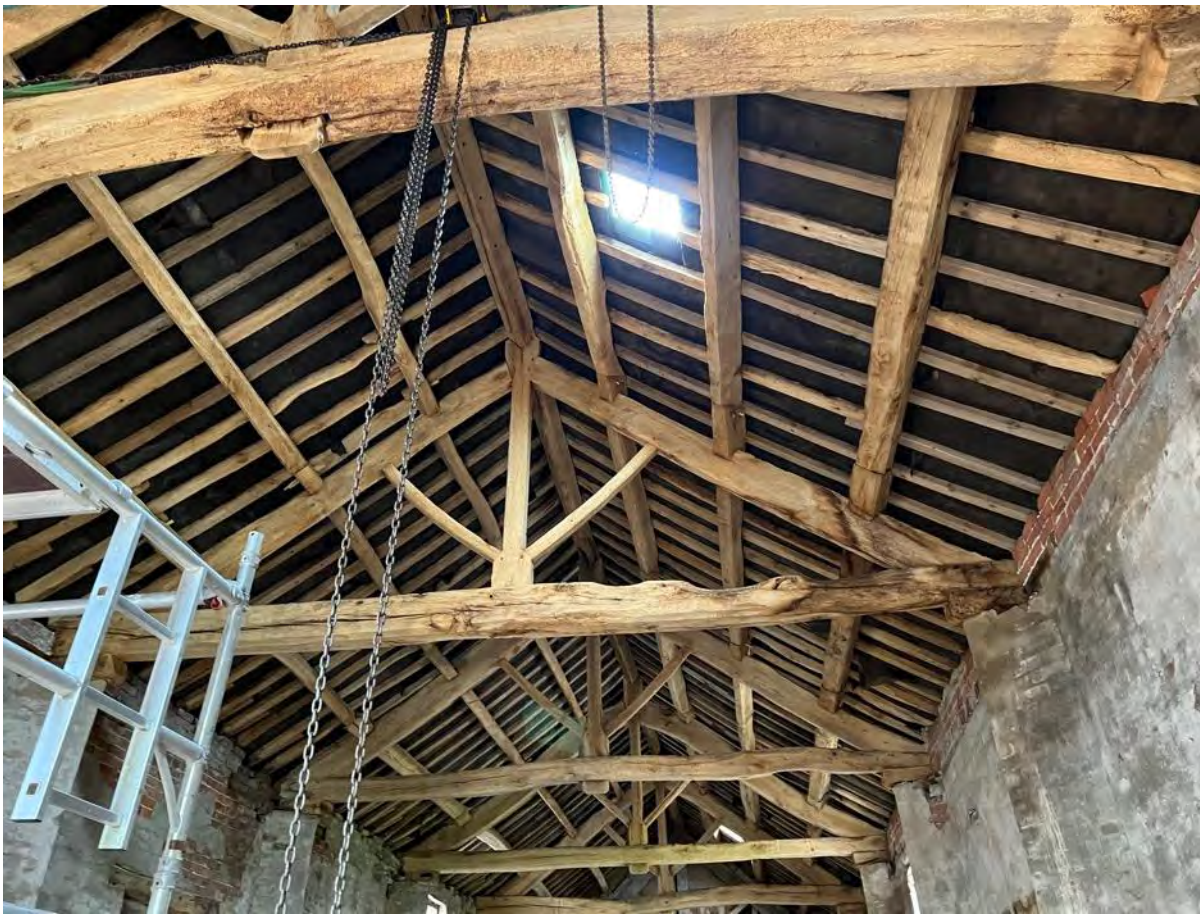
Photo 41 - Internal – main barn

The roof structure can be seen in photos 41 to 43 with the bearing detail of the trusses illustrated in photo 47. The trusses, purlins and rafters appear to be original and are generally in good condition. There are some issues with the trusses including spread and water ingress as indicated on photos 41 & 42. The standard of workmanship and quality of timber used is very high. The roof has been felted and re-slatted over the years.

The existing trusses and purlins appear to be in good condition with little sign of rot or infestation. There are some areas that need assessment and repair as noted above but the structure appears adequate for the loadings anticipated. All the timber retained should be assessed by a timber specialist, with regard to rot and infestation. All retained timber should be treated against rot/infestation and an indication of residual section given for structural purposes. All retained timber to be used structurally should be checked for structural adequacy.

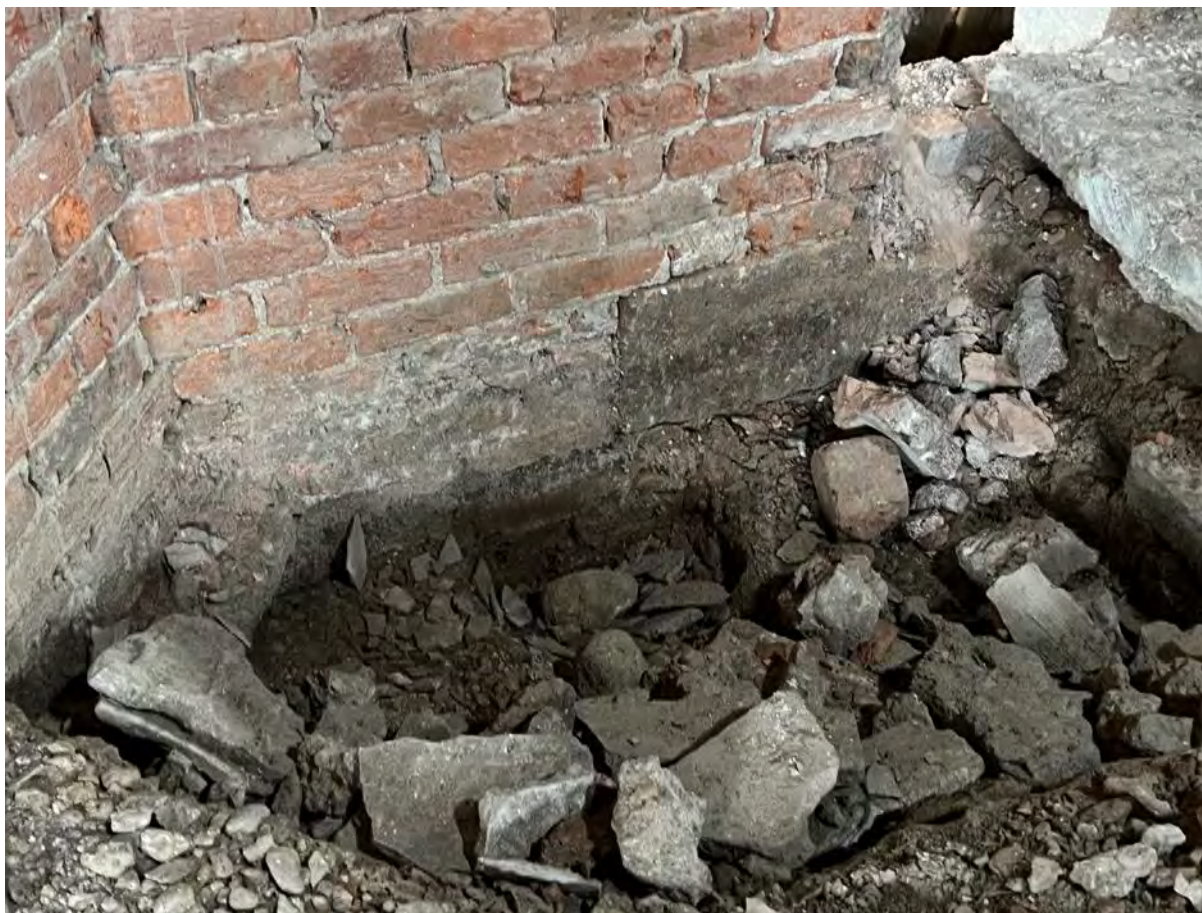
The barn has a concrete floor which is in reasonable condition. Photo 56 shows an excavation through the floor to expose the founding stones. These are located at a reasonable depth on a suitable bearing strata.

Photo 56 - Internal – main barn – excavation to founding stones

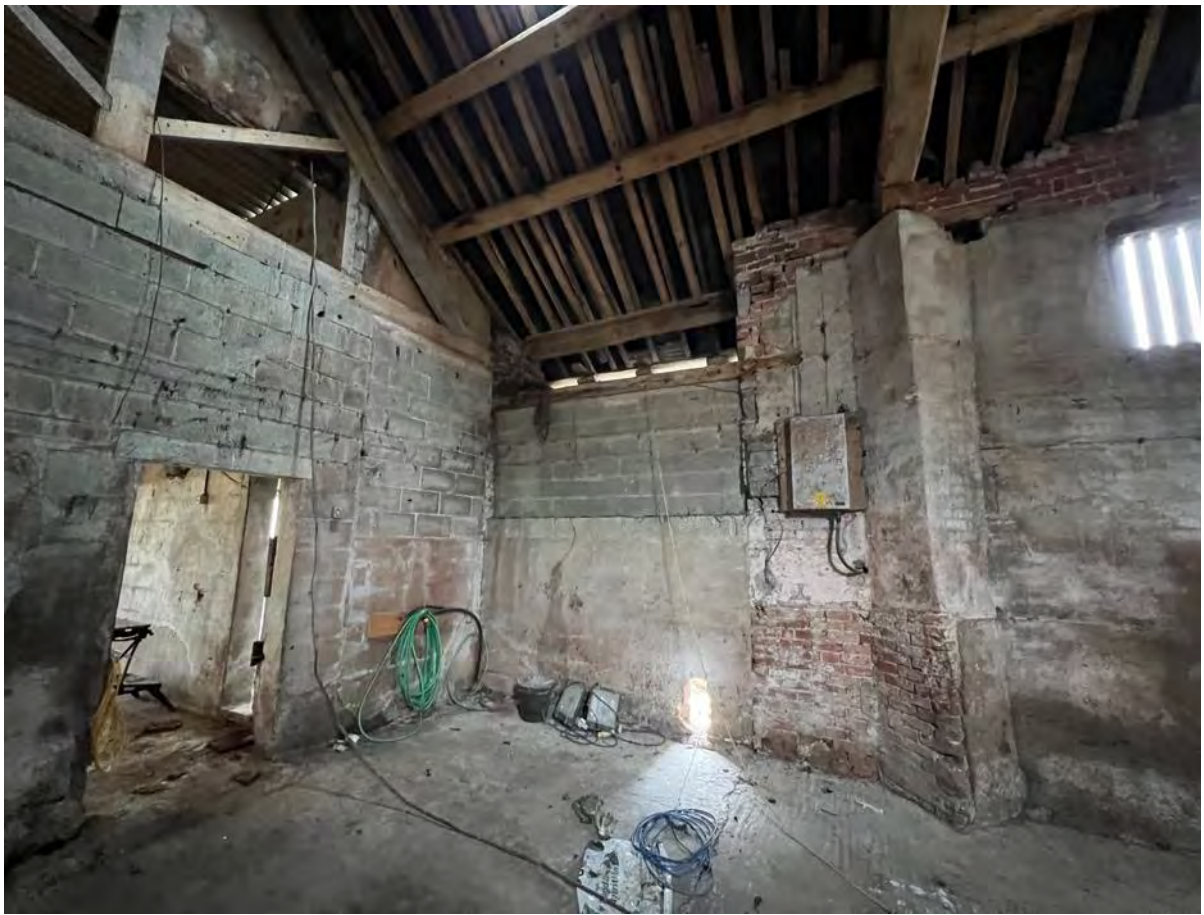
Photo 57 - Internal – main barn

As noted above, the brick barn appears to have originally extended by a further two bays to the west. These bays appear to have been replaced by the blockwork extension at the west end. This is further evidenced on photos 57 & 58 by the presence of a block wall constructed immediately adjacent to the barn door and located directly below a truss. This is clearly not original, and a truss would not have been located at the gable. This block wall is constructed with 200mm blockwork and is plumb and free from movement. There are two openings at ground floor through to the extension. The truss has been left open as can be seen on Photo 58.

As noted above, a new block gable wall has been installed under the westernmost truss (photos 57 & 58). This is at the junction of the original barn and the extension to the north west which is thought to have replaced two more bays of the original barn.

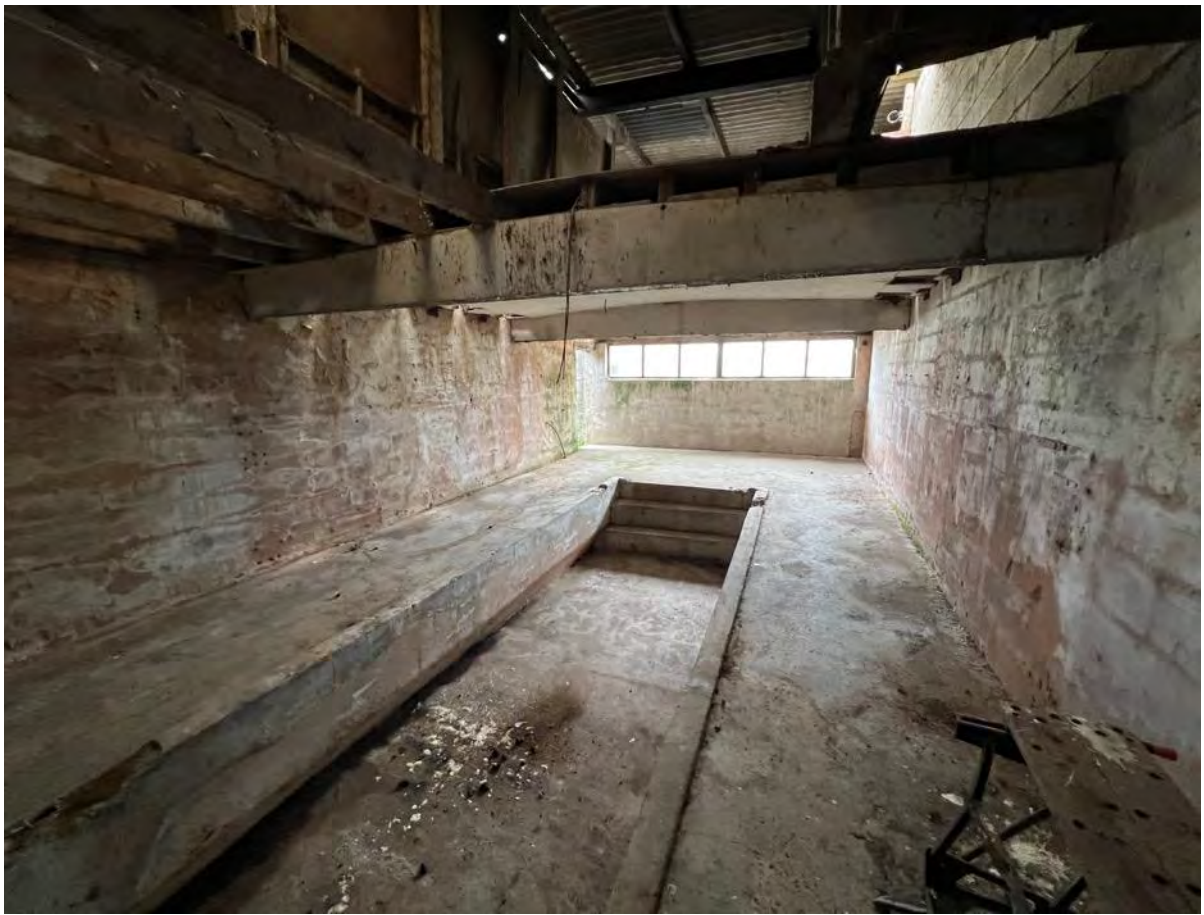
Photo 59 – Extension at north west end

The extension to the west forms a milking parlour (photo 59) plus an adjacent room (photo 61). The milking parlour has a loft above (photo 60). The extension is in good condition and free from movement.

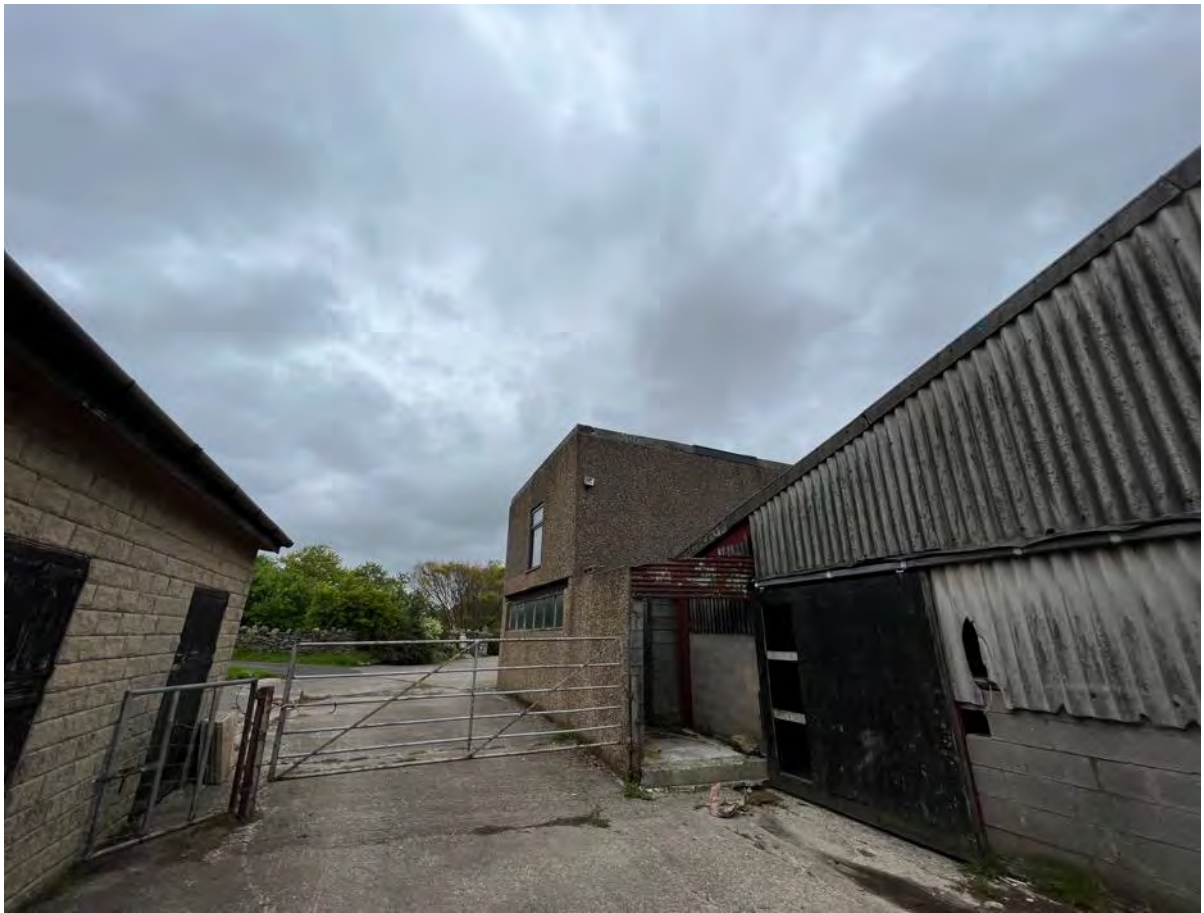
Photo 65 – North West elevation of extension

The section of wall on the south elevation of the extension at the west end can be seen in Photo 65. This is a block wall with pebble dashed render. The wall appears free from movement and in reasonable condition.

The new gable wall to the extension is shown on photos 32 and 65. This is a rendered block wall, it is plumb and is free from movement. The elevation has a long window opening at ground floor level and a single window above. The longer window has a steel beam supporting the blockwork which is in reasonable condition.
