Job No. 6880

BUILDING STRUCTURAL SURVEY

PROPOSED CONVERSION OF
BARN AT VICARAGE FARM, TALBOT BRIDGE ROAD
BASHALL EAVES
CLITHEROE
BB7 3DB

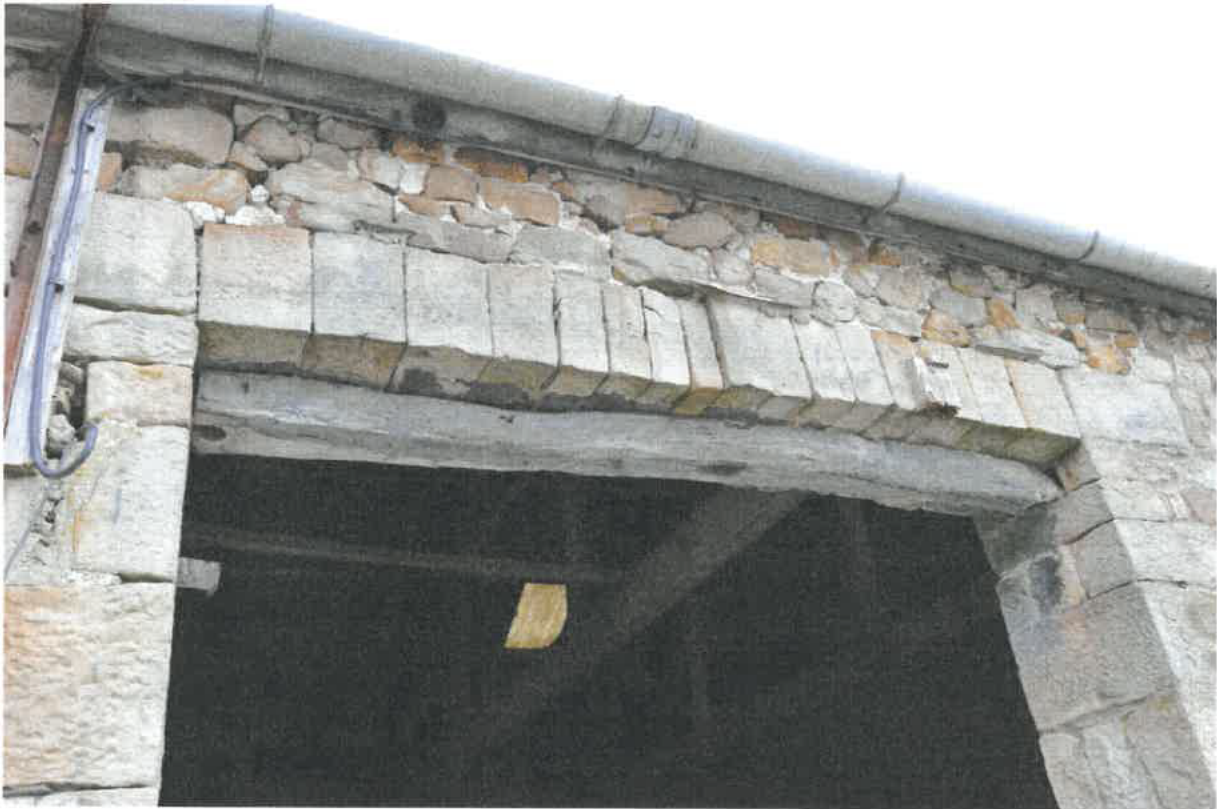
PL06: Internal photo of Vicarage Farm Barn – Large Entry doorway with reclaimed lintel over

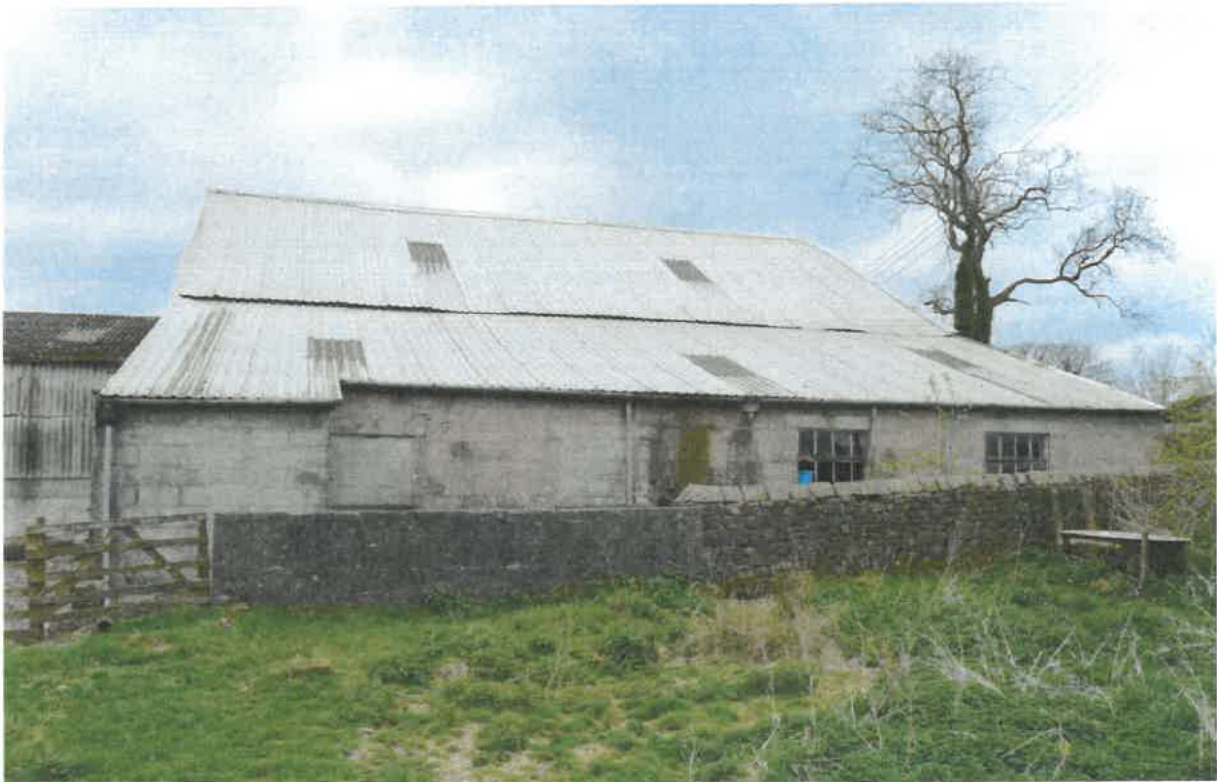
PLO7: Photo showing metal roof sheeting to barn in average to poor condition. The rear blackwork and rendered add on extension is proposed to be removed.

The metal profiled roof covering to the barn appears to be in fair condition at the time of inspection. Some minor breaches as well as loose cover flashings, repair is required.

It is proposed that the roof to the barn is re-roofed, with new underlays and battens and re roofed completely in new / reclaimed blue/grey slates in keeping with the local area.

- Re-roofing works with reclaimed / new blue / grey slate, along with an underlay and new treated timber battens are also required to replace the profiled metal roof cladding.

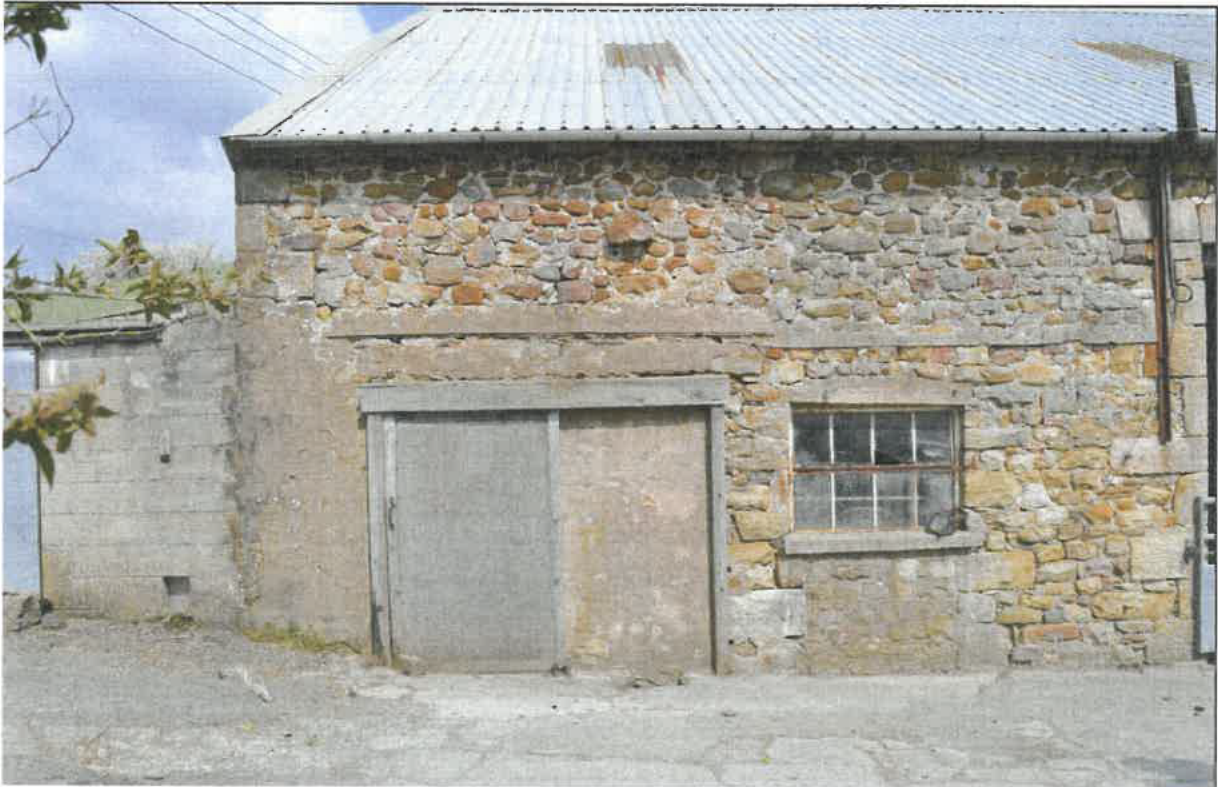
PL08: Photo showing metal roof sheeting to barn on front elevation and grey half round pvcu gutters

Externally, no safe working platform was present at eaves level which prevented full access to various areas of the roofing and rainwater goods, meaning that only a visual record using a camera could be undertaken from ground level. From ground level it was clear to see that the roof gutters were blocked and the rainwater pipes were damaged or missing. New gutters and rainwater pipes are recommended.

The existing pvcu grey half round rainwater gutters and grey and black rainwater pipes were in fair to poor condition or absent. New gutters and rainwater pipes to be provided throughout. Recommended for rise and fall powder coated black aluminium gutters and rainwater pipes throughout. It is proposed to replace with black powder coated aluminium gutters and rainwater pipes.

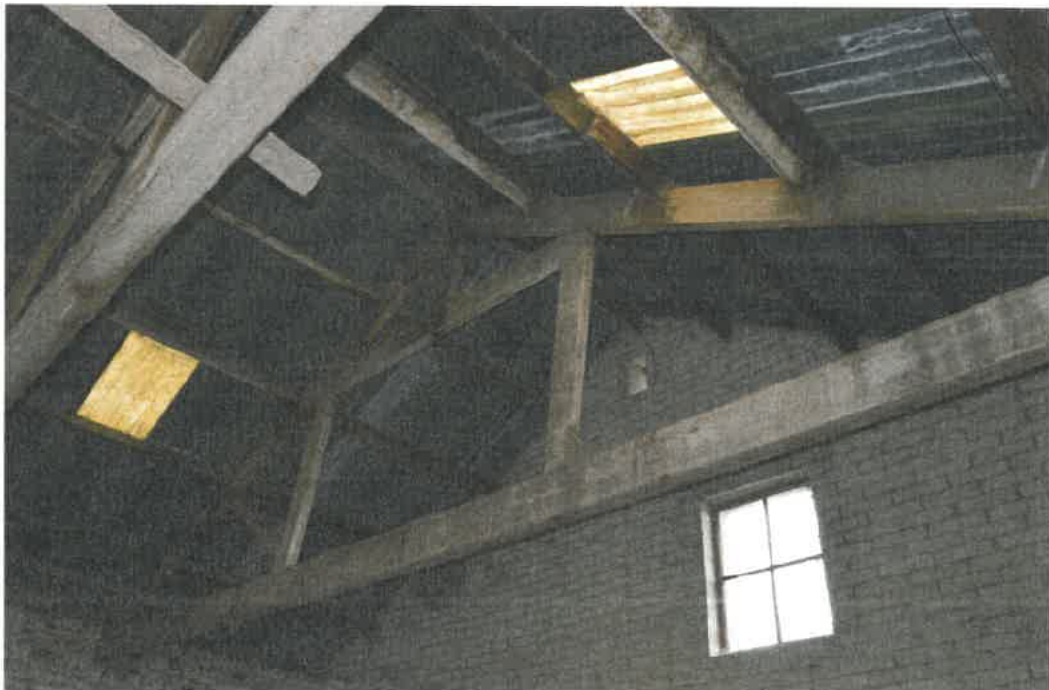
PL09: Photo showing roof structure, comprising of queen post sawn trusses, sawn purlins and rafters.

The roof structure to the barn appeared to be in good condition at the time of inspection and free of obvious decay. The trusses and purlins were built into the existing external walls and is considered to be traditional practice. However, where there is localised moisture penetration / water ingress, this can leave the timbers susceptible to decay. However, there was no significant evidence of decaying timber noted to the ends of the trusses or purlins (built into walls) at the time of inspection. However, a closer inspection on erection of a safe working platform should be undertaken to confirm the exact condition of the roof structure. This should also provide an opportunity to assess for evidence of wood boring insect attack to the roof timbers. It may also be prudent to treat the existing roof timbers to increase their longevity.

- Remedial works should be carried out to the timber roof structures where required to address issues identified. This should also consist of the treating of all timber components that are to be retained i.e., trusses, purlins and rafters to protect against rot and insect attack.

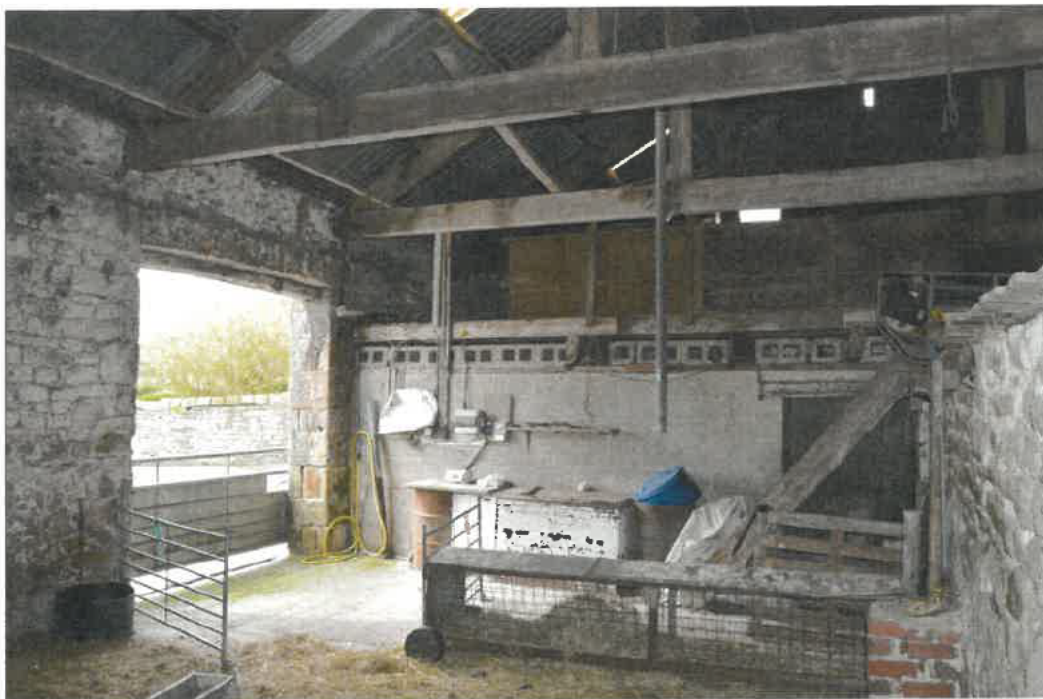
PL10: Photo showing internal roof structure with queen post trusses either side of large barn door opening. Underside of profiled metal sheeting visible over treated rafters.

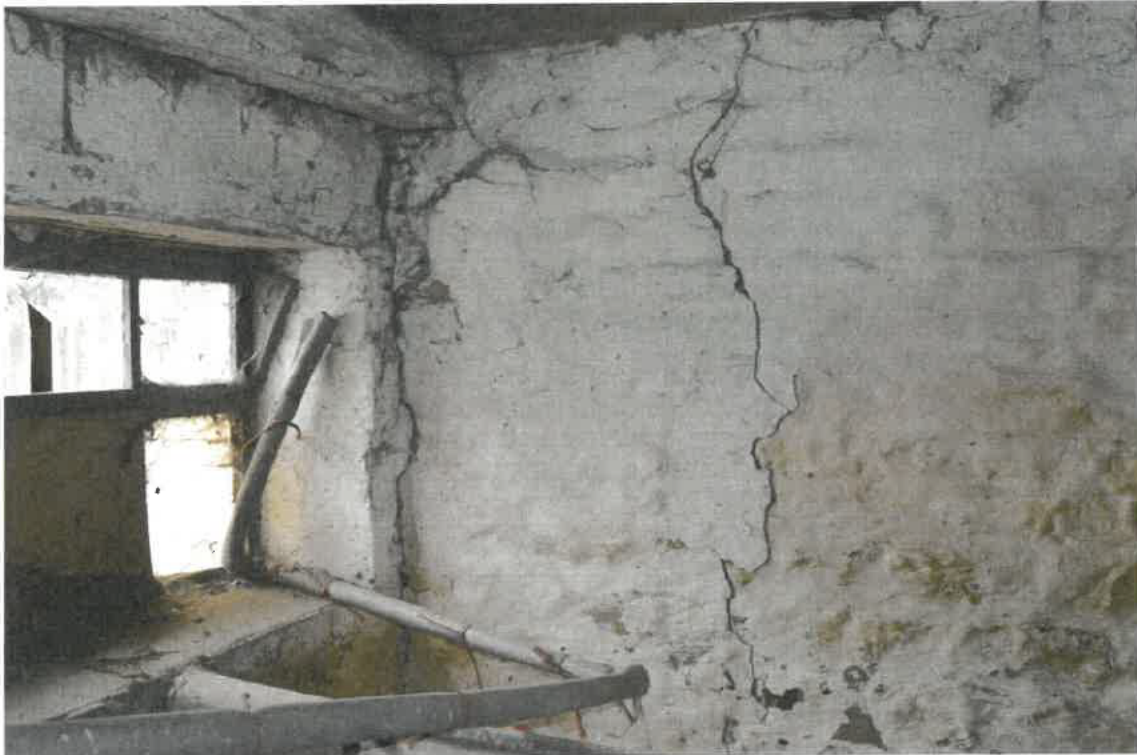
In general the walls appeared to be relatively sound with a true vertical alignment and with no obvious significant evidence of structural movement, settlement or significant cracking to the external walls. Some isolated cracking was noted to the barn walls but was not considered to be significant at the time of construction, and should be repaired with crack stitch repairs to be advised by Structural Engineer. All stone work should be pointed with lime mortar and monitored for any further changes.

The cracking is likely as a result of past structural movement / settlement as a result of shallow / inadequate foundations; however, this is deemed to be longstanding in nature. This area of walling requires isolated areas of structural repair through a mixture of 'cracking stitching' and repointing as required which are recommended to be carried out in accordance with Structural Engineers / specialist contractor's recommendations.

Cracks to be reviewed by Structural Engineer and crack stitch repairs proposed to be carried out.
