Barn at Lower Hud Lee Farm, Longridge Road, Hurst Green, BB7 9QP

Structural Condition Survey for Conversion to Dwelling

PSC-907

August 2024

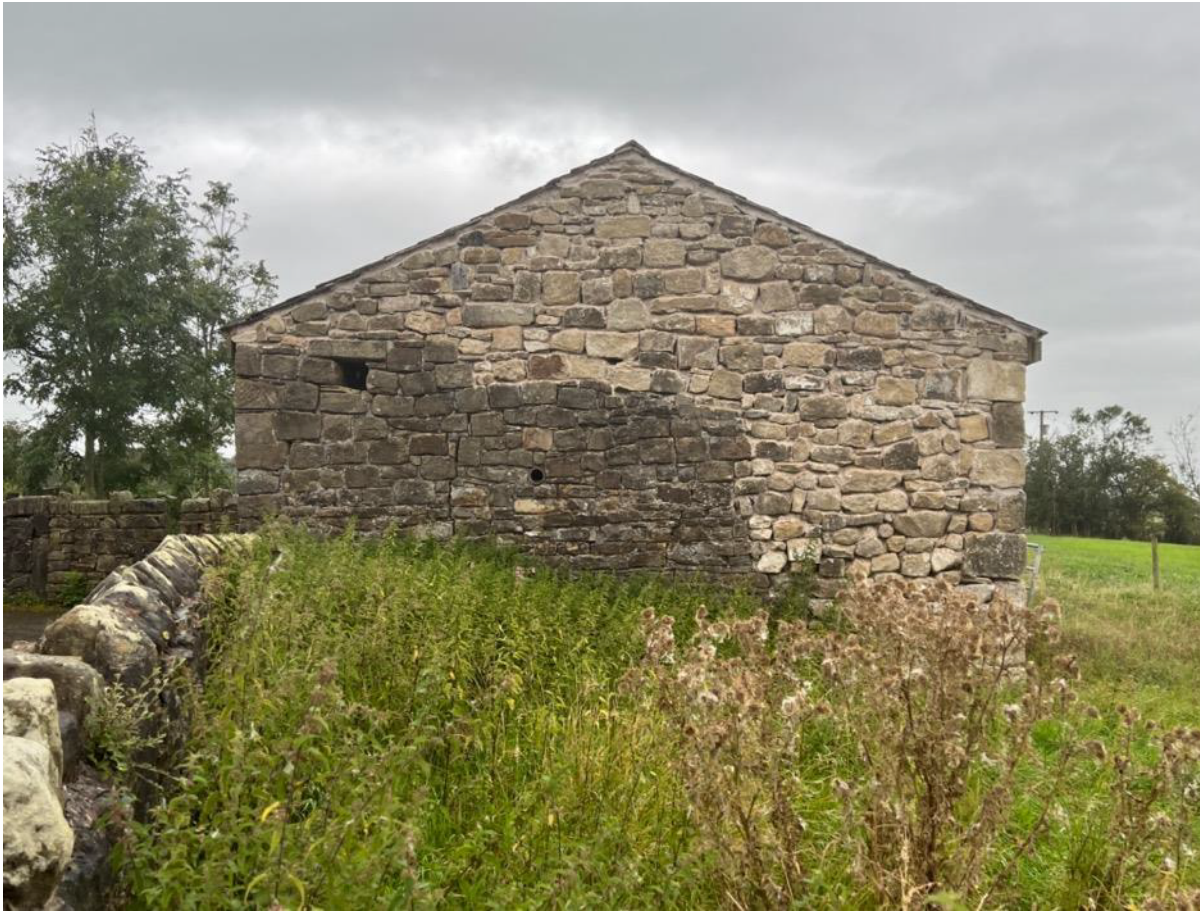
Photo 1 - West Gable

West Gable (Photo 1)

This elevation is built in random sandstone and the wall is 500mm thick. The wall is in good condition. It is plumb and well pointed. There are no signs of previous or ongoing movement. The only opening is a small vent opening to the upper north end.

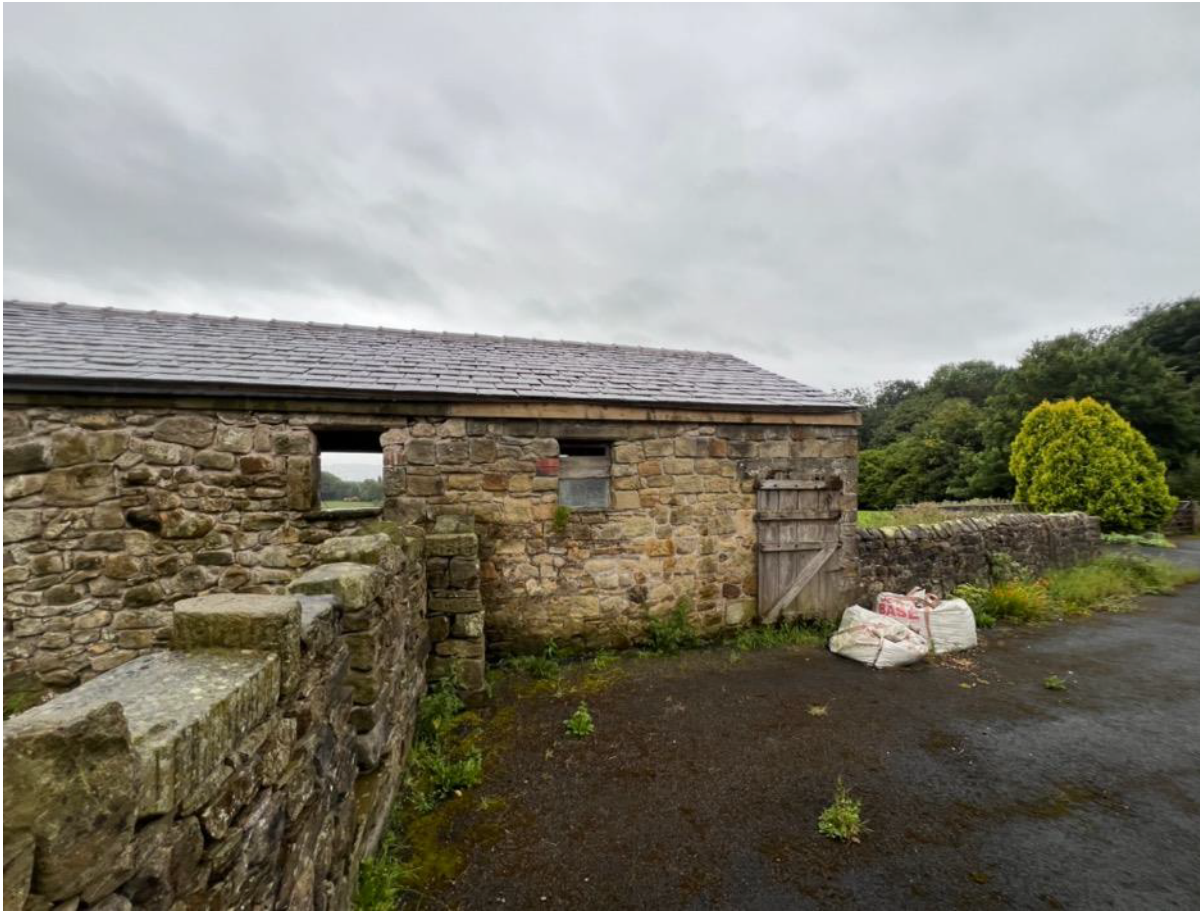
Photo 2 – North Elevation – west end

North Elevation (photos 2 to 6)

This elevation is random stone wall with some patches of clay brick (photo 5) and is 500mm thick at the west end, reducing to 350mm at the eastern end where it has a block inner leaf. A boundary wall to the adjacent property meets this wall along its length (Photos 4 & 5). The wall is in good condition. It is plumb and well pointed and there are no signs of previous or ongoing

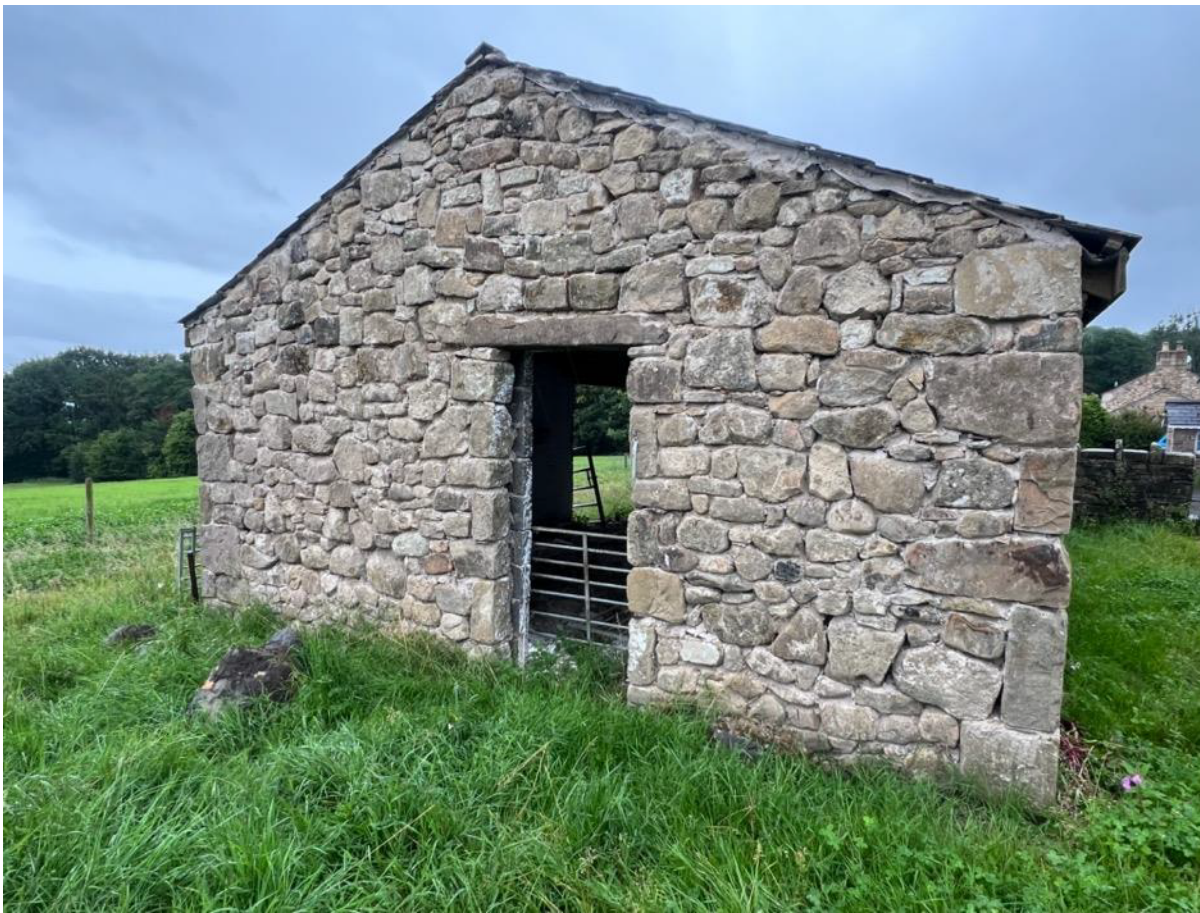
Photo 7 – East Gable

East Gable (Photo 7)

This elevation is built in random sandstone with a block inner leaf and the wall is 350mm thick. The wall is in good condition. It is plumb and well pointed. There are no signs of previous or ongoing movement. There is a single door opening at the centre.

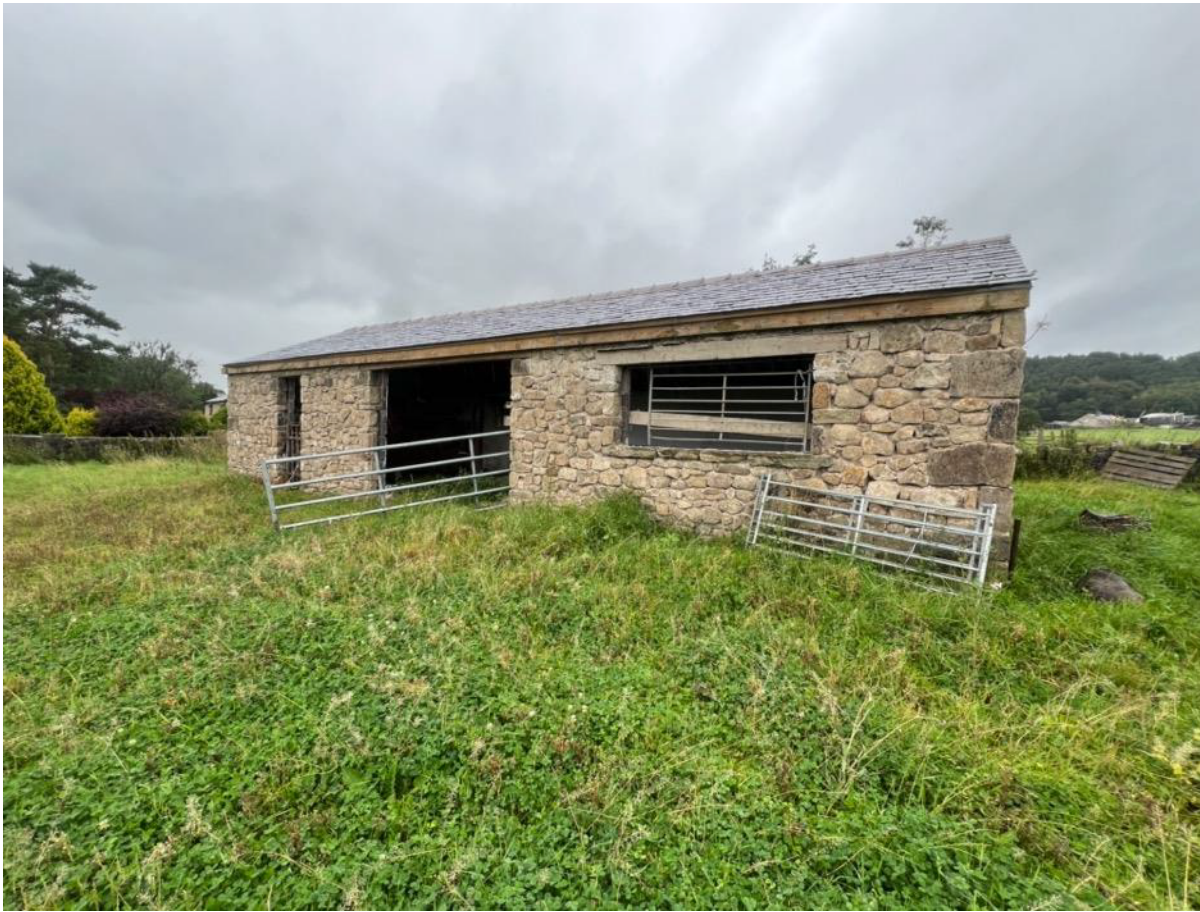
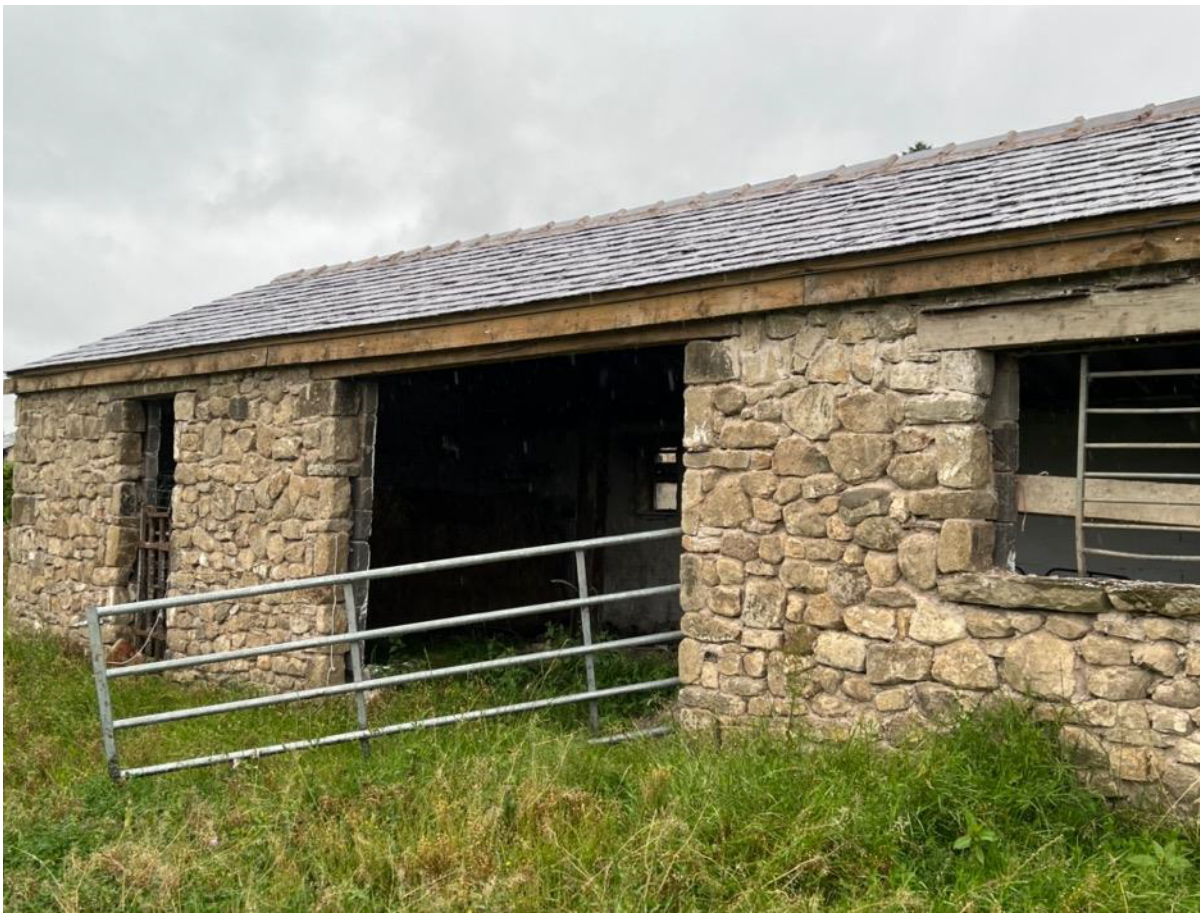
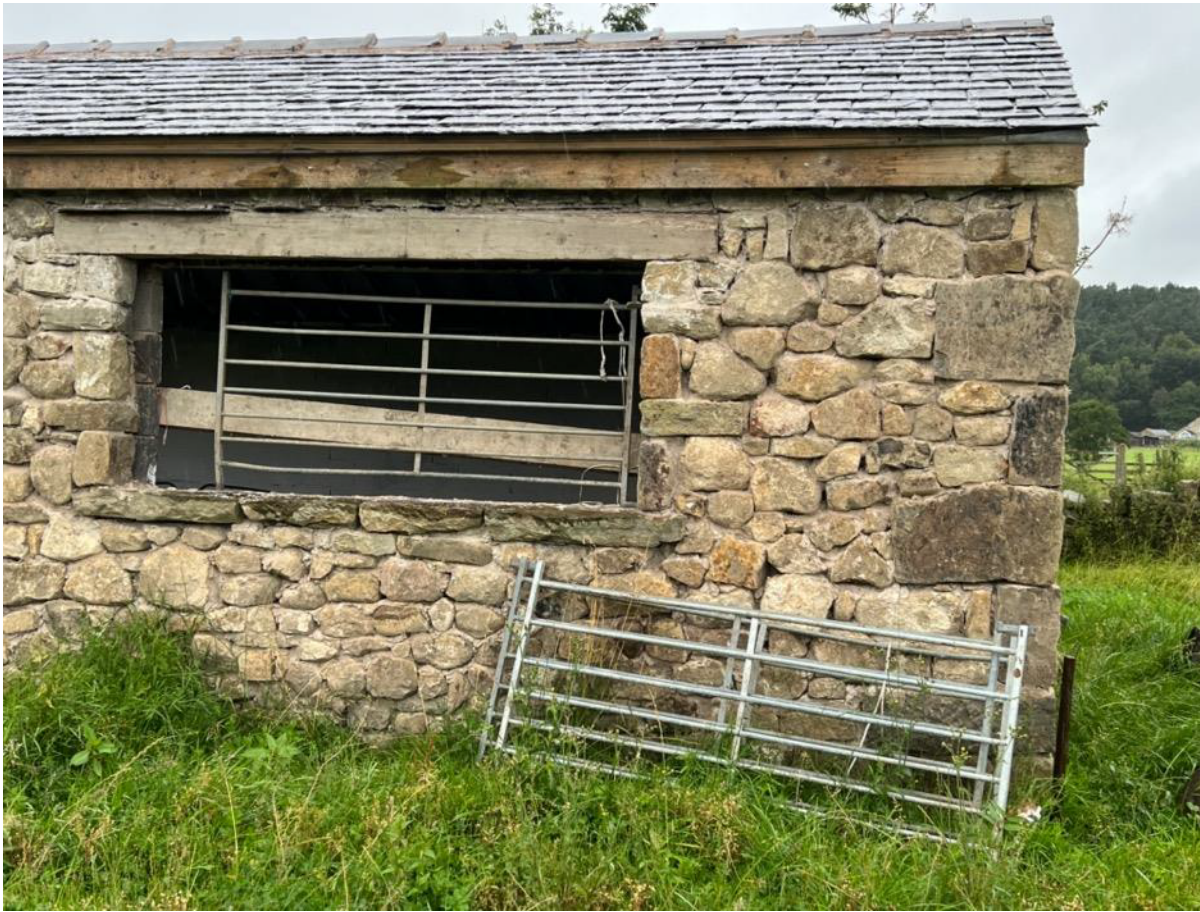
South Elevation (Photos 8 to 10)

This elevation is a 350mm thick random stone wall with a block inner leaf. The wall is plumb, reasonably well pointed and free from signs of movement. The elevation has a large central opening with a standard door to the west end and a large window to the east end.

Photo 8 – South Elevation

Photo 9 – South Elevation

Photo 10 – South Elevation

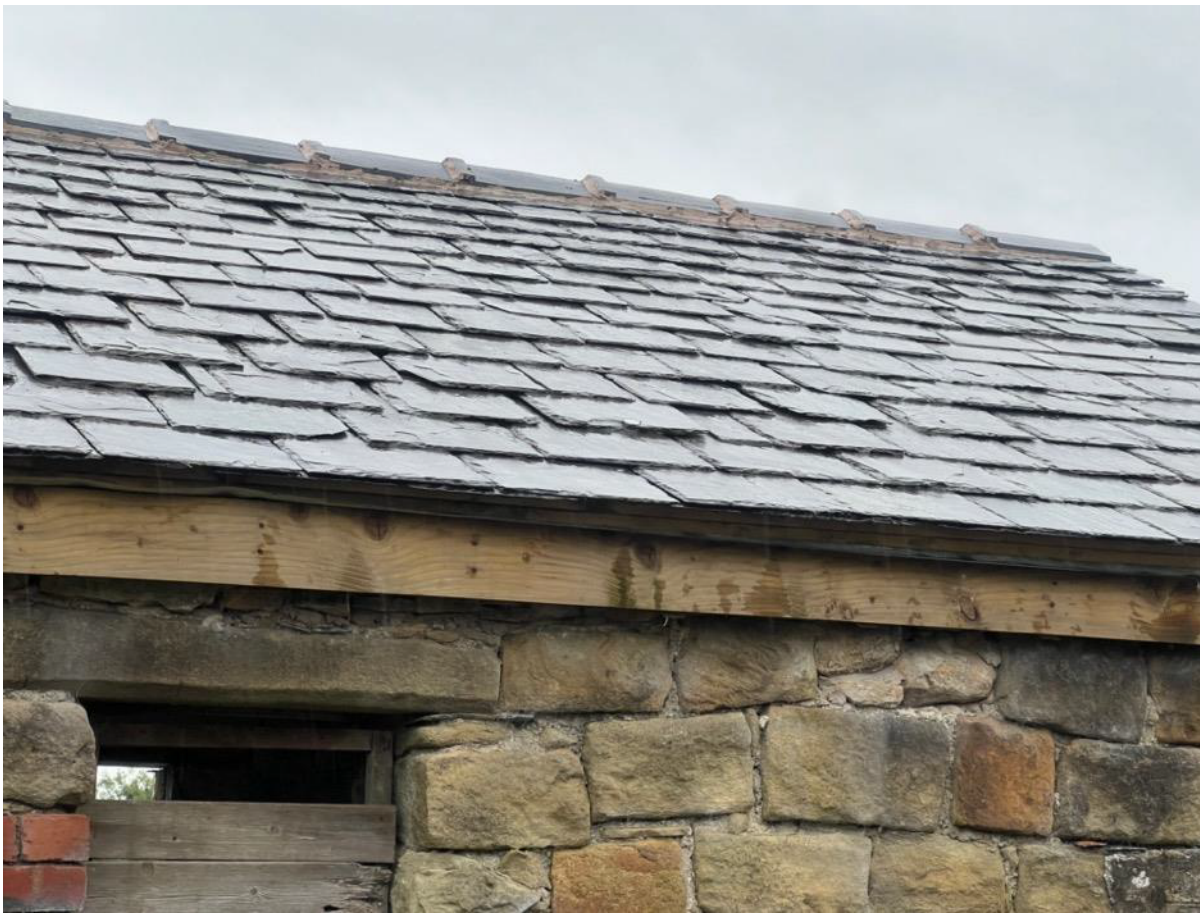
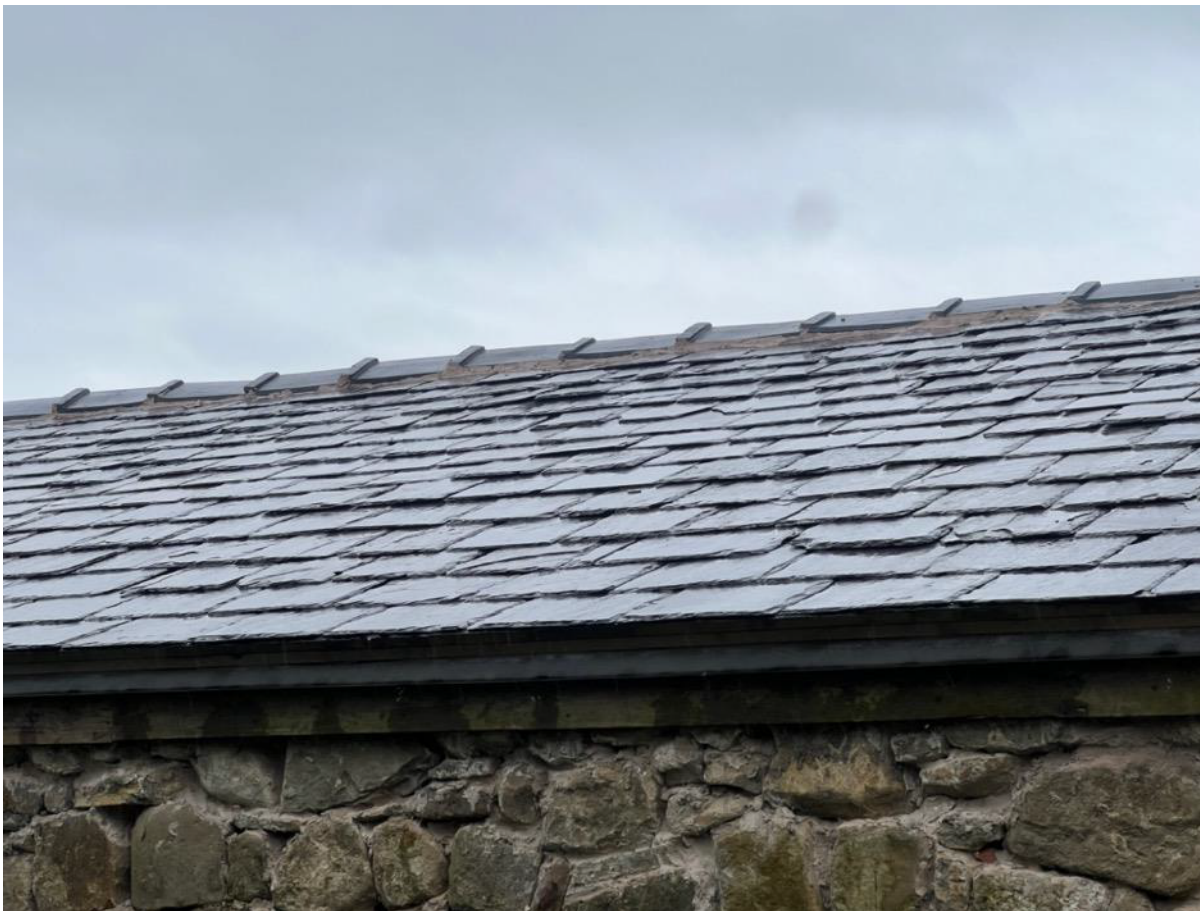
Roof (Photos – External – photos 11 & 12)

Viewed externally, the main barn roof appears in very good condition with no sign of damage, slate loss, or deflection.

Photo 11 – Roof to North

Photo 12 – Roof to south

It is recommended that the new internal skin is in place and the internal walls, ground and first floor are put in place prior to any works to the roof although the roof. This will add stability to the existing walls. The barn currently has a good standard of roof and works to this area will be limited.

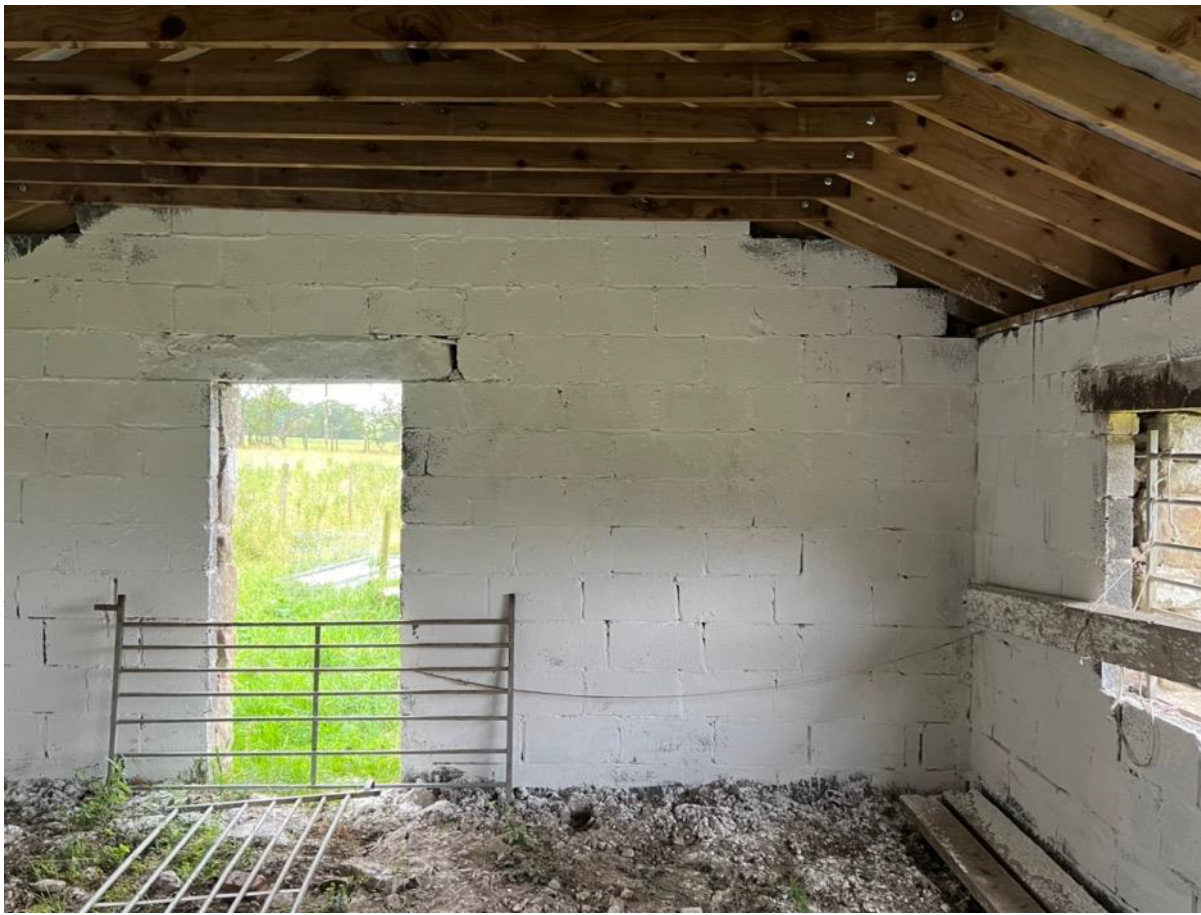
Photo 13 – Internal looking east

(Photos 13 to 20)

Internal inspection indicates that all the walls are free from signs of previous or ongoing movement. The majority of the barn has 350mm thick walls with a 100mm block inner leaf plus 250mm of stone to the exterior (photo 14). The west gable and a short section of the north elevation are built in solid 500mm thick stone (photos 15 & 16). The interior is whitewashed.

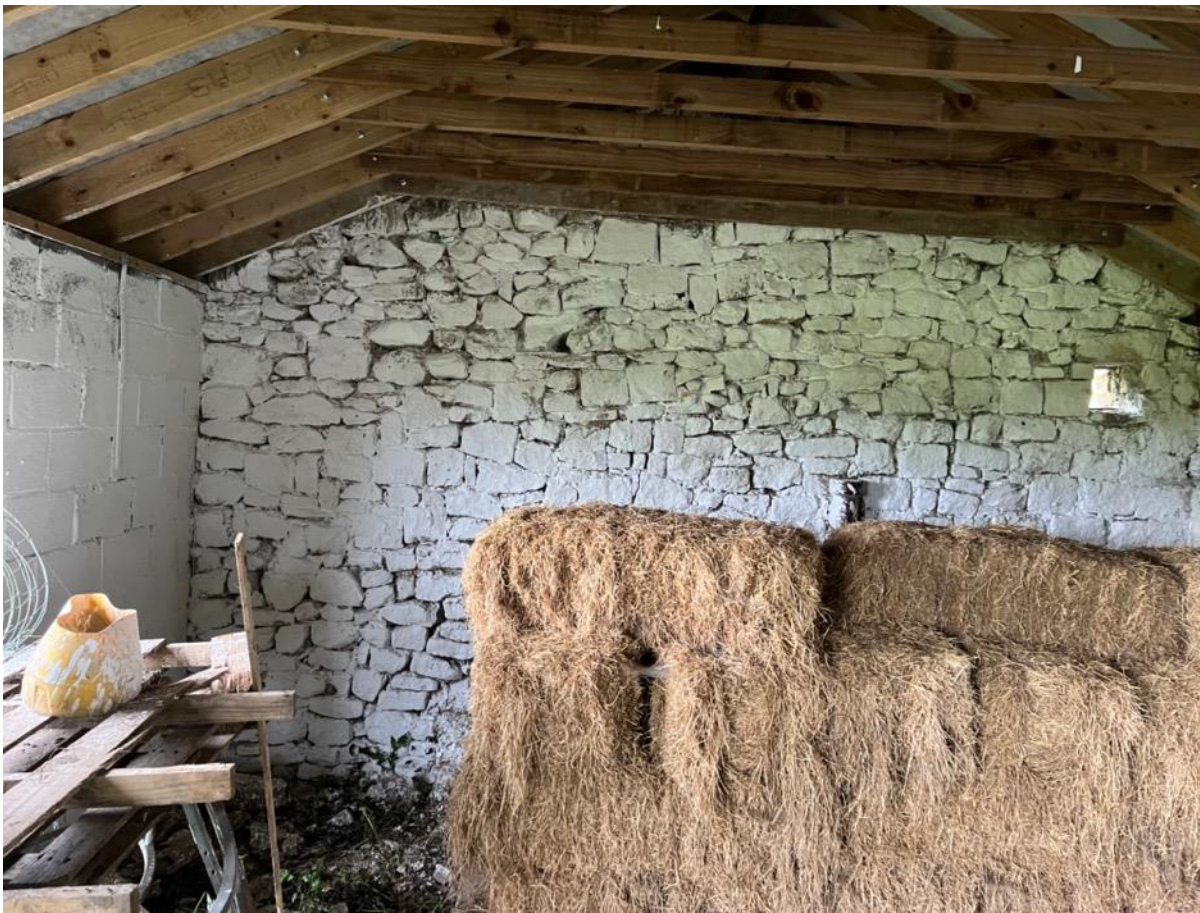
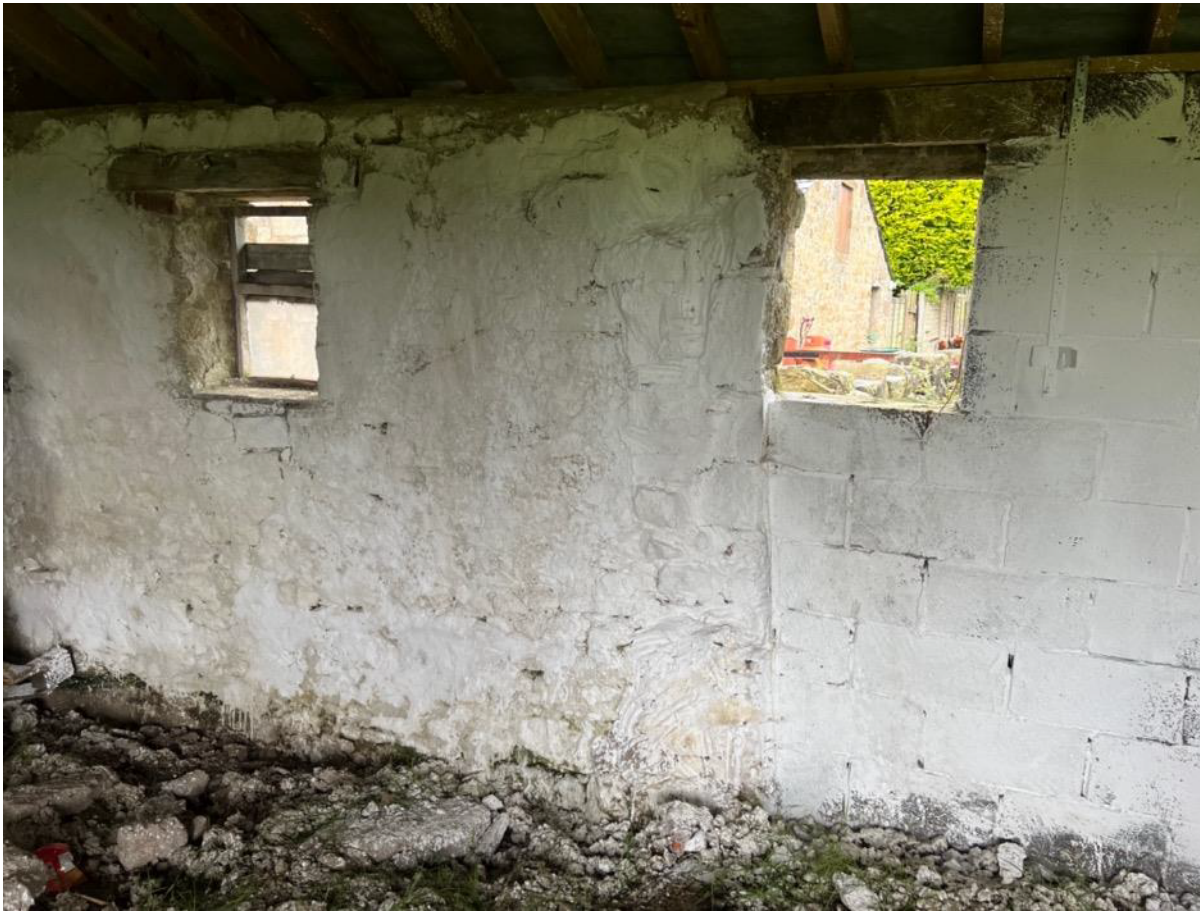
Photo 15 - Internal looking west

Photo 16 – Internal looking north

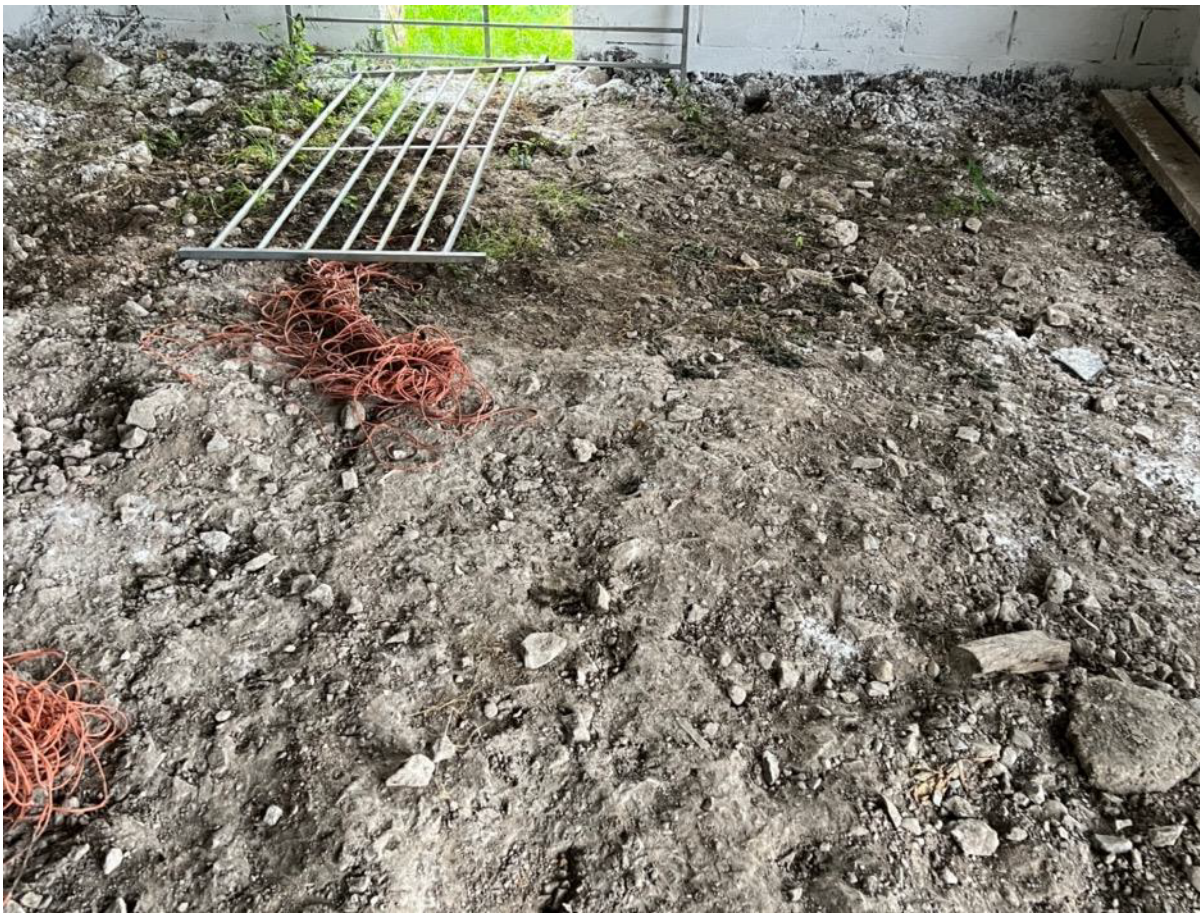
Photo 17 – Internal floor

The barn has an earth floor only (photo 17).

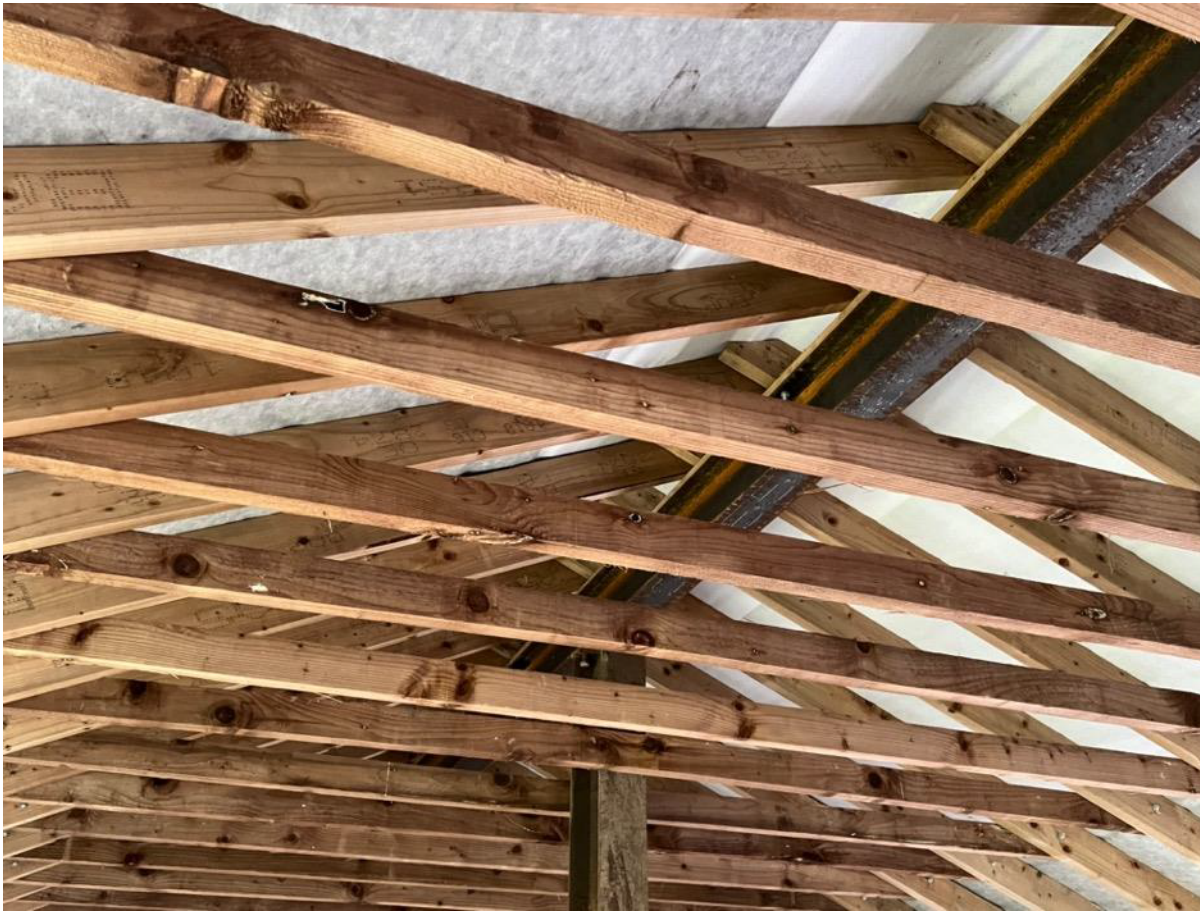
Photo 18 – Internal – roof structure

The roof to the barn has timber rafters spanning from the steel (structural) ridge to the wall plates, with timber ties to restrain spread (photo 18). The wall plates are strapped to the walls (photo 20). The ridge has a steel column towards the west end which has a concrete pad foundation (photos 18 and 19). The timber rafters are 140x43 mm sections and the steel sections are 254x146 UB sections. The roof is felted and all the timber is in good condition, free from any sign of rot or infestation. The steel sections have surface rust only and are in good condition.

The existing rafters and ties appear to be in good condition with no sign of rot or infestation. Any timber retained should be assessed by a timber specialist, with regard to rot and infestation. All retained timber should be treated against rot/infestation and an indication of residual section given for structural purposes. All retained timber to be used structurally should be checked for structural adequacy. The ridge and column steel sections should be cleaned and painted with an appropriate paint to inhibit corrosion. They should also be checked against the final design details for structural adequacy but they appear to be suitable for purpose.
