Preliminary Roost Assessment

2 Lane Ends

Sabden

Gritstone Ecology

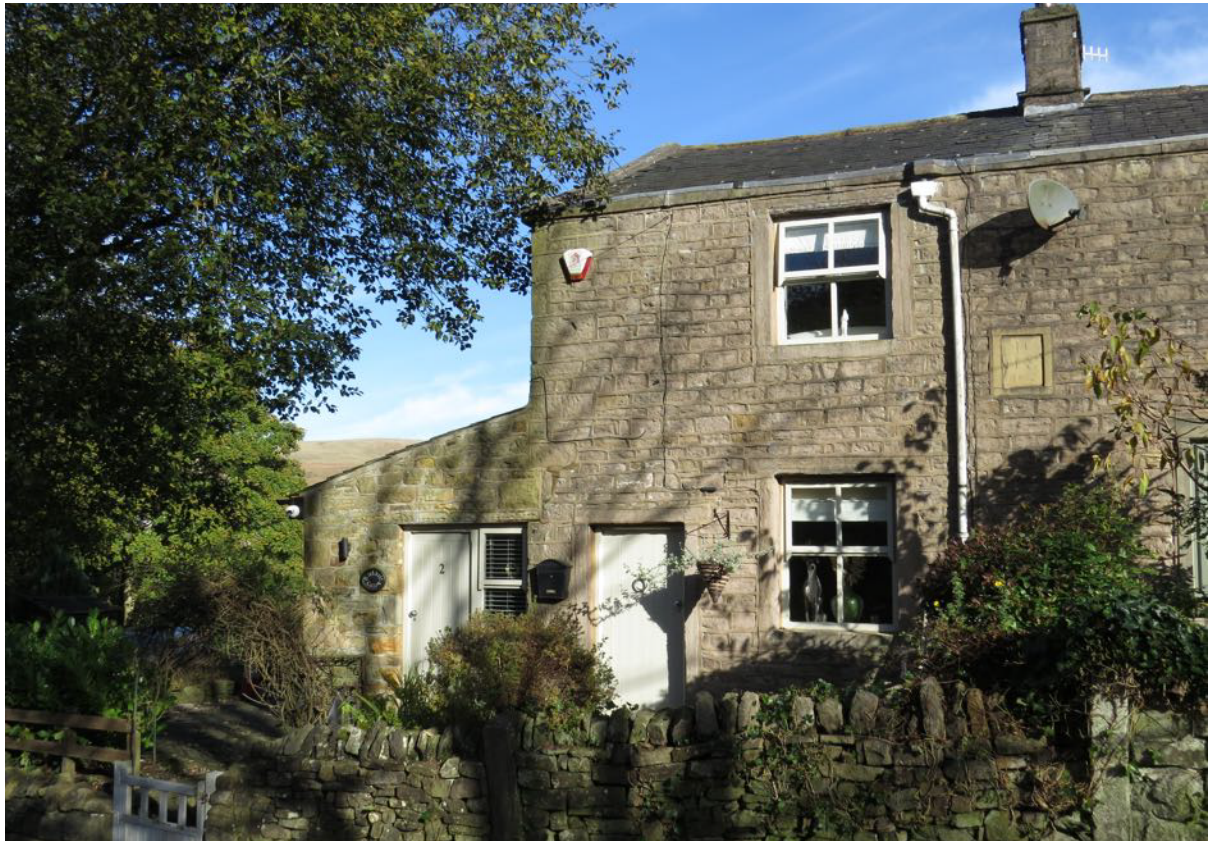
3.1a – The front of the house.

The building is well maintained, and in good condition. Ridge tiles are fixed tightly, there are no damaged or missing ridge tiles. There are no damaged, slipped, or missing roof tiles. Roof tiles are tightly fitted, with no gaps between tiles.

Fascia boards and boxed soffits are fitted tightly against the walls gaps are filled with expanding foam sealant. Walls are in good condition, with no missing mortar or cracks.

There are no features externally which are likely be used by roosting bats, and no evidence of use by bats was present during the inspection.

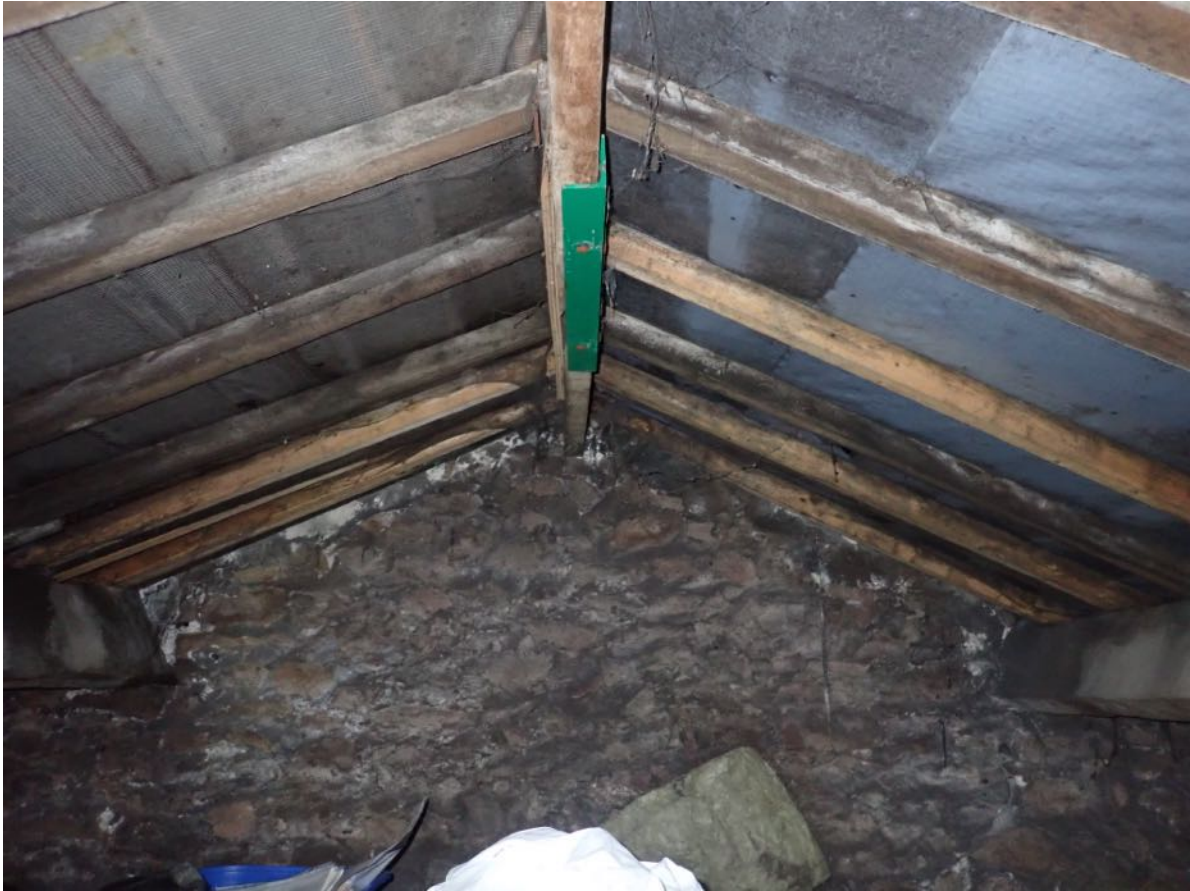
3.2a – The roof void.

The roof has a timber rafter and purlin structure, lined with a modern non-breathable membrane, and insulated with mineral wool between the ceiling joists. The roof lining is in good condition with no tears, or gaps.

The eaves and wall plate were inspected using an endoscope. There are no gaps at the eaves; and there are no gaps which give direct access to the roof void from the outside. Boxed soffits on the extension open into the roof void and were inspected from above.

The roof voids in general, and in particular the roof timbers and gables are filled with dusty cobwebs, and were undisturbed prior to the inspection.

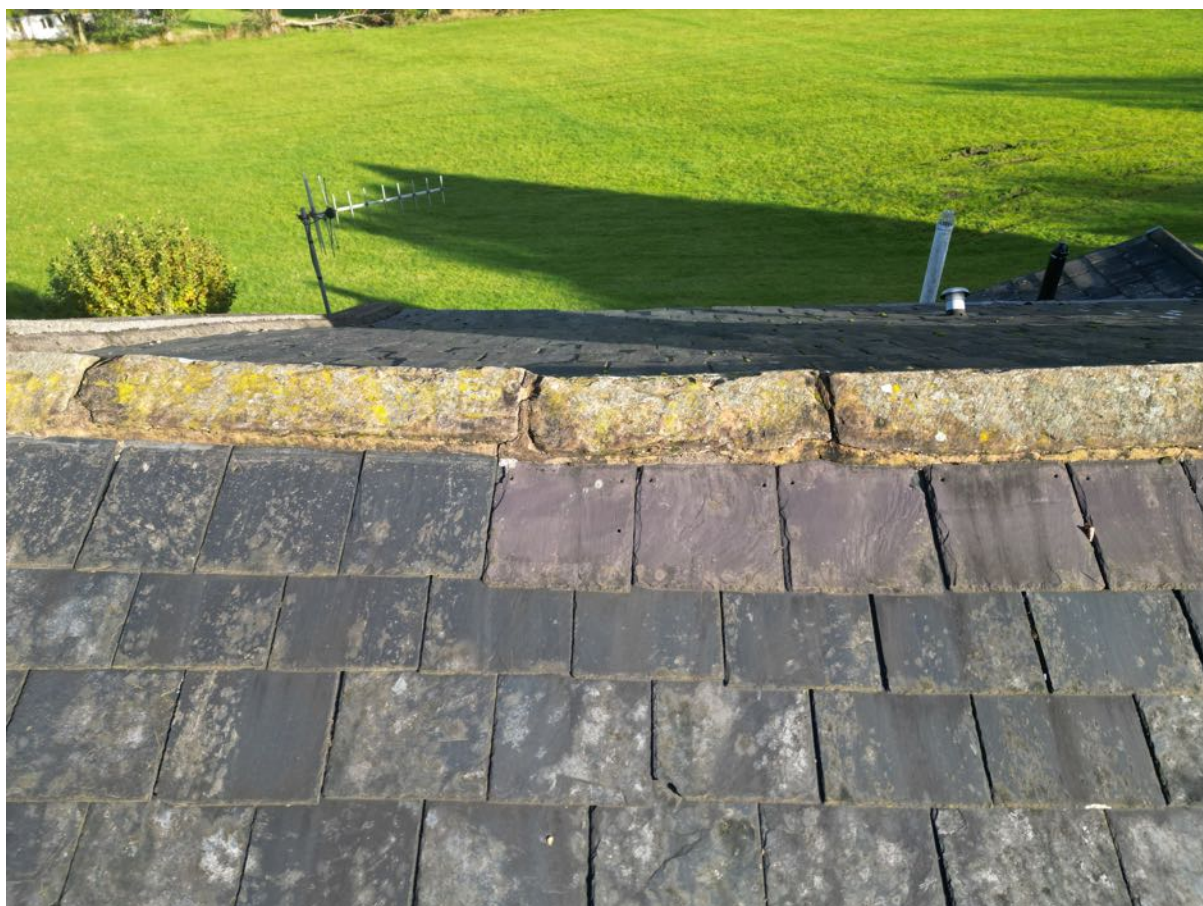
Roof and ridge tiles are in good condition; ridge tiles are sealed with cement. There are no gaps between roofing materials which are likely to be used by roosting bats.

3 – Roof and ridge tiles are in good condition with no suitable gaps.

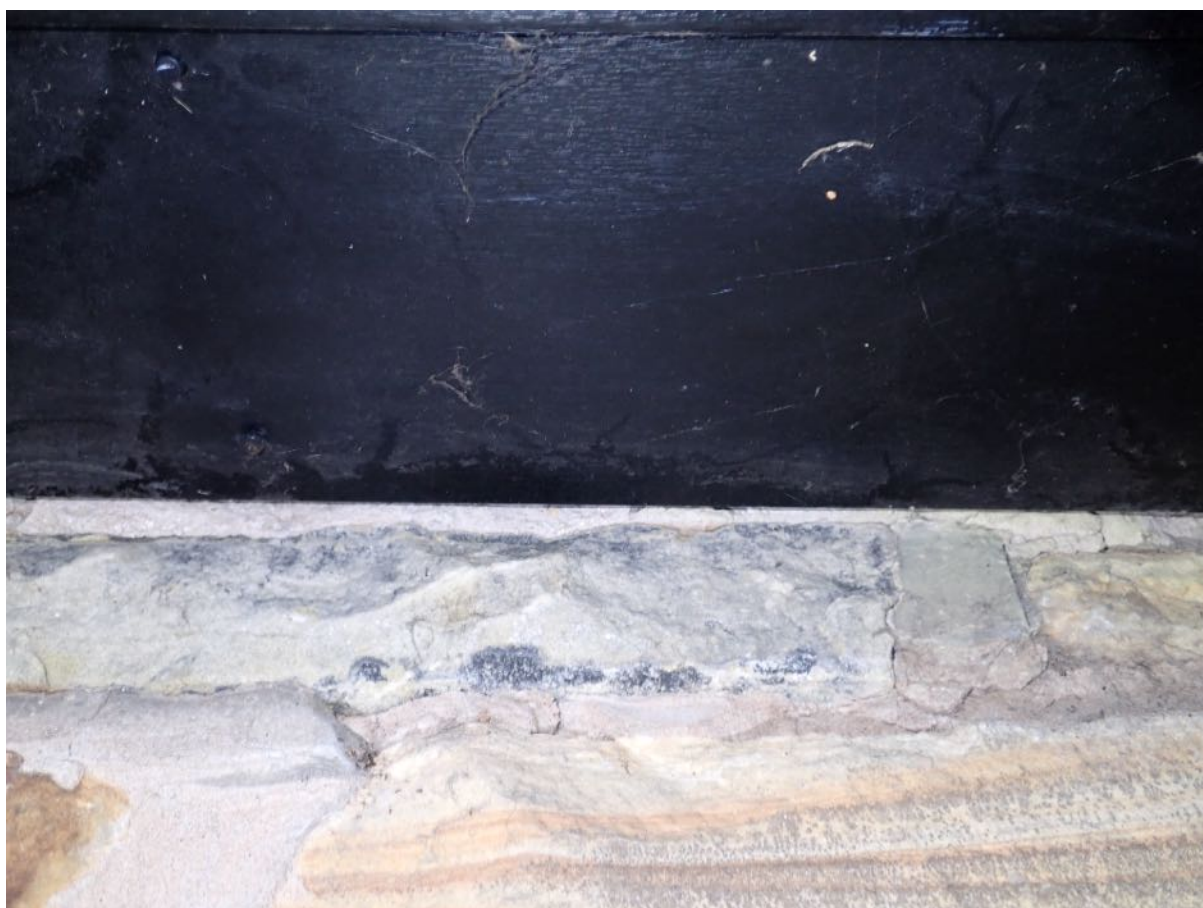
Fascia boards and boxed soffits at the eaves of the extension are fixed tightly against stonework, with no suitable gaps.

4 – Soffits at the eaves of the extension are fixed tightly against brickwork.

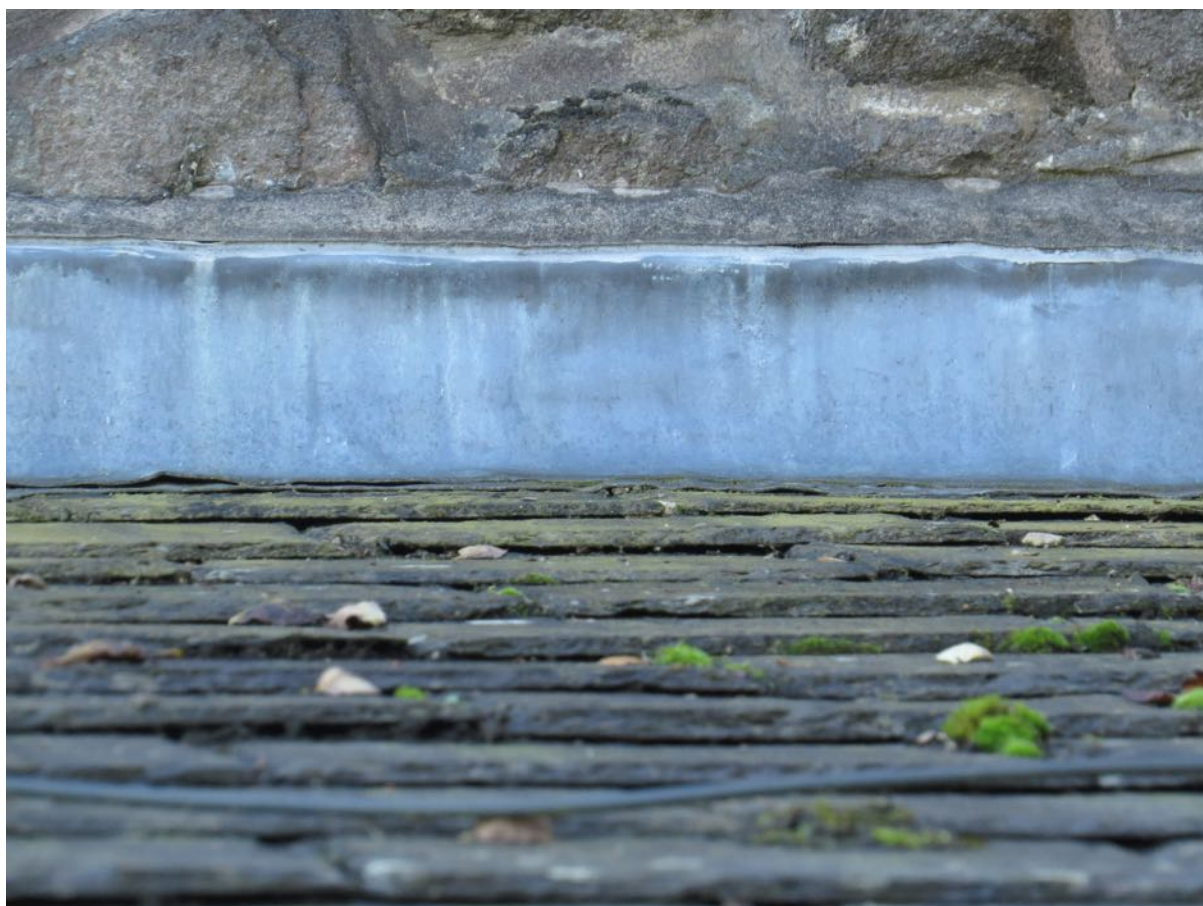
5 – Lead flashing is fitted tightly with no suitable gaps.

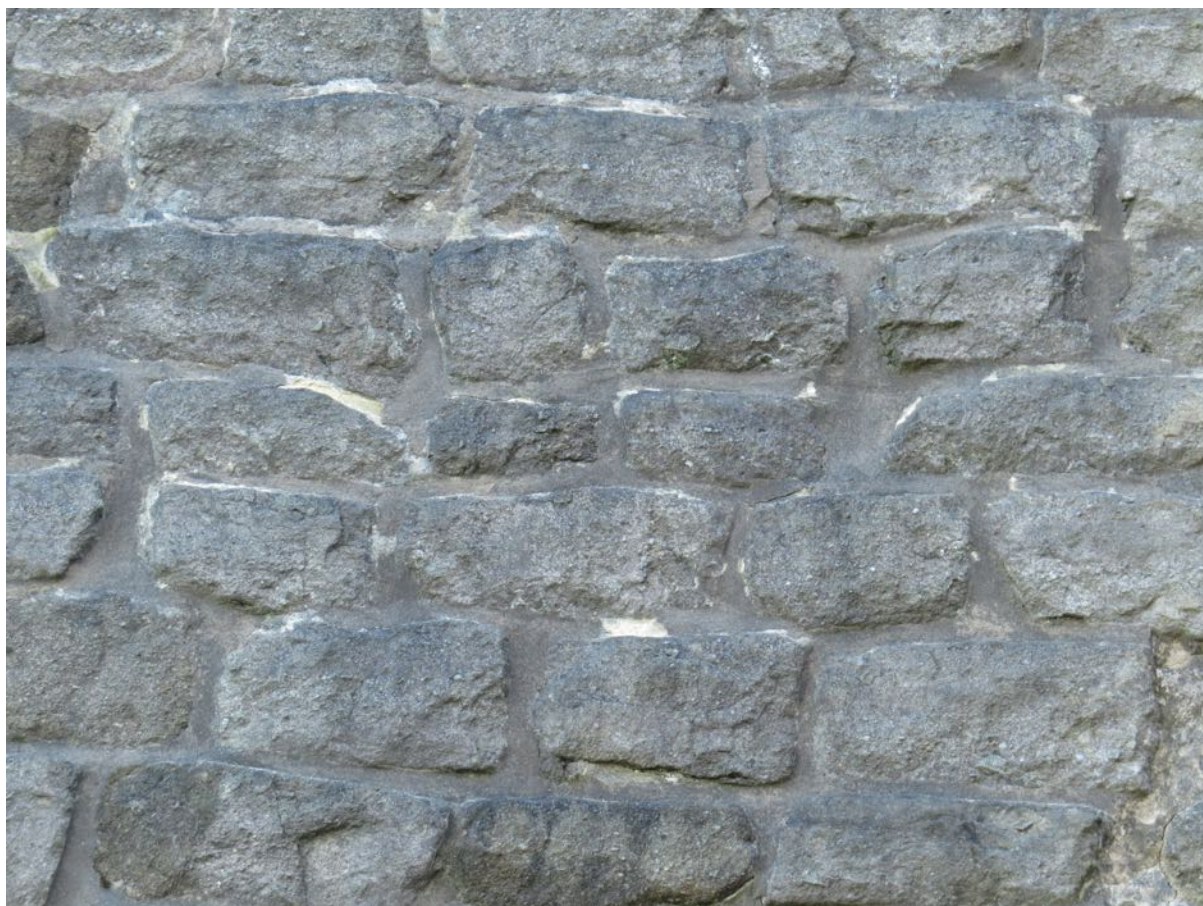
Walls are solid stone with no insulating cavity. Walls are in good condition, with no cracks, or missing mortar which could be used by crevice dwelling bats.

6 – Stonework and mortar are in good condition with no suitable gaps.

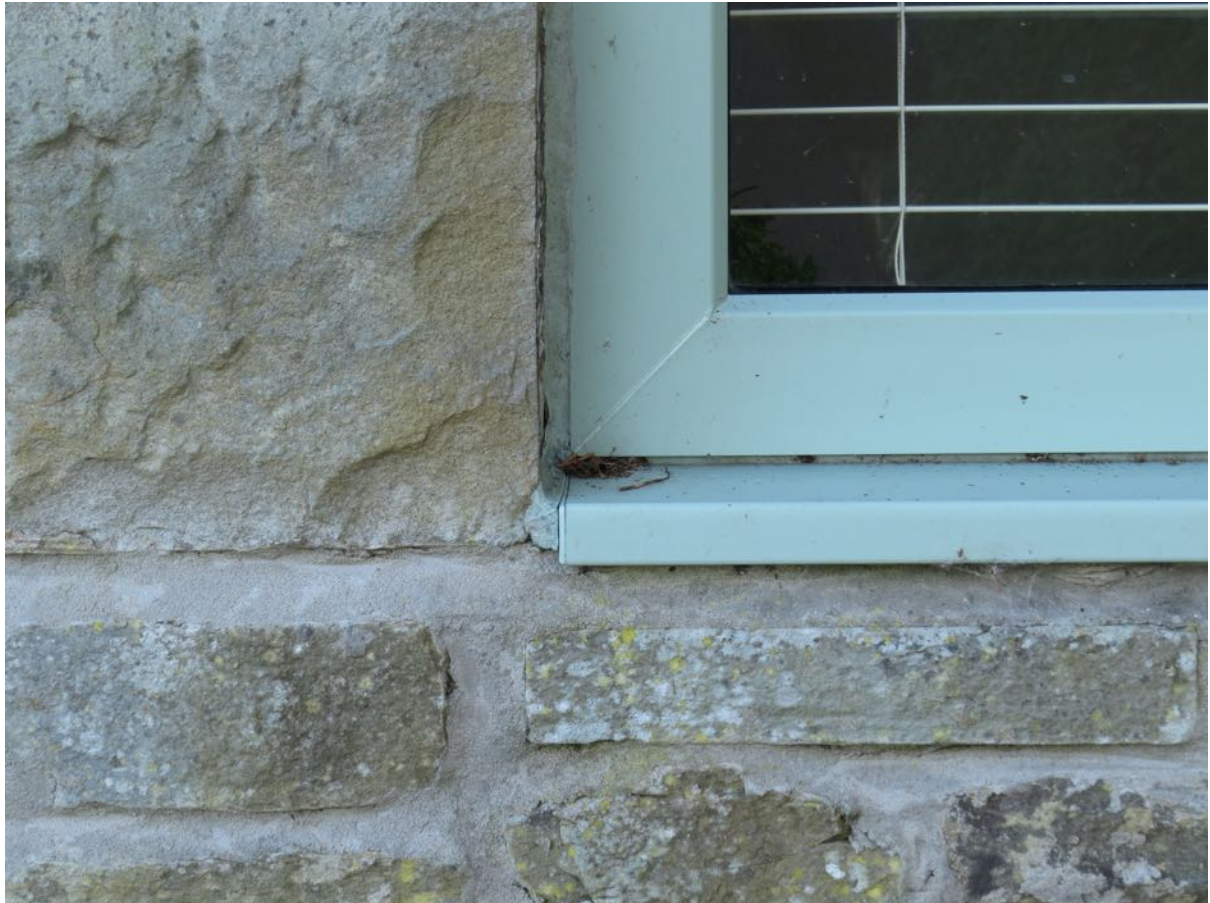
Window and door frames are fixed into the brickwork, gaps are filled with sealant, and offer no suitable roosting opportunities.

7 – Window and door frames are tightly sealed into brickwork with no suitable gaps.

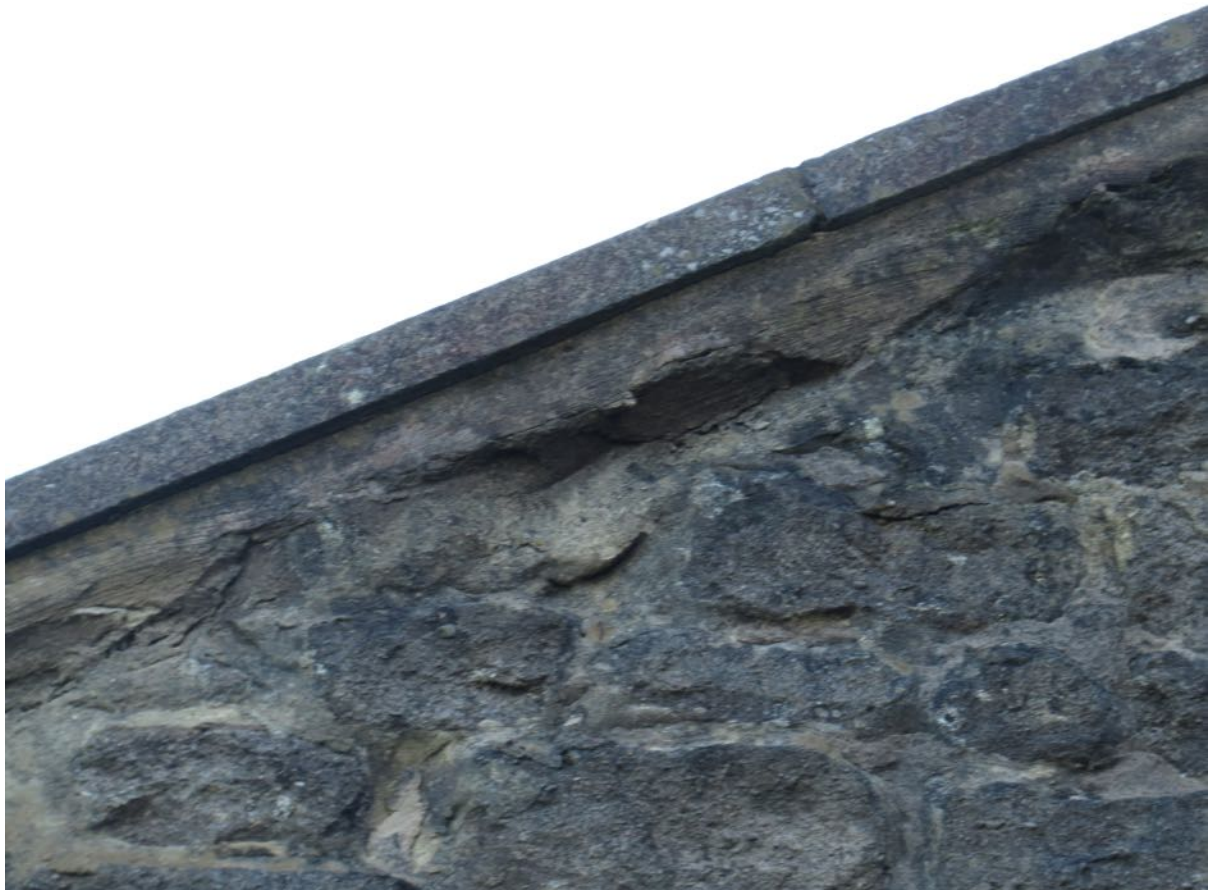
8 – Capping stones at the gable end are fitted tightly with no suitable gaps.

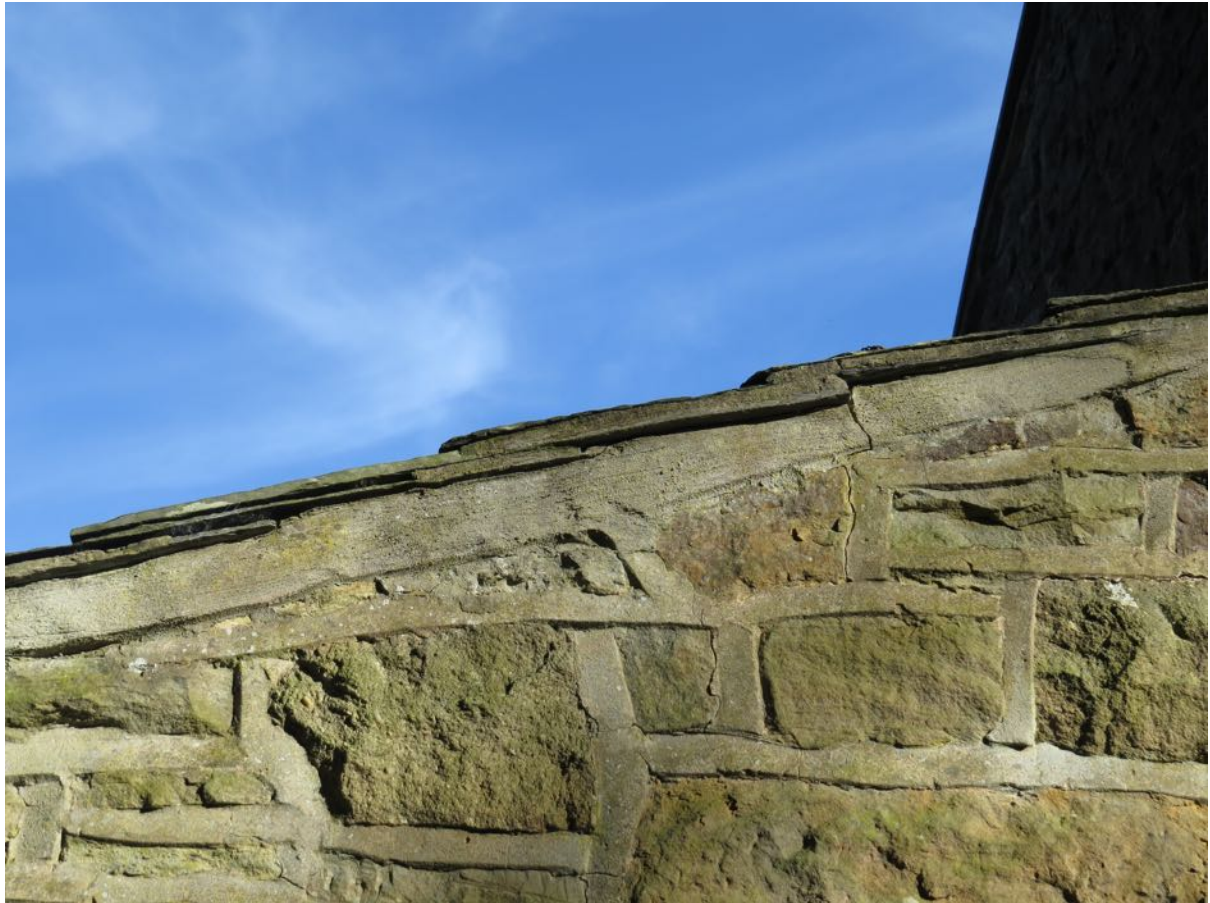
9 – Cement at the verges is intact with no viable gaps.

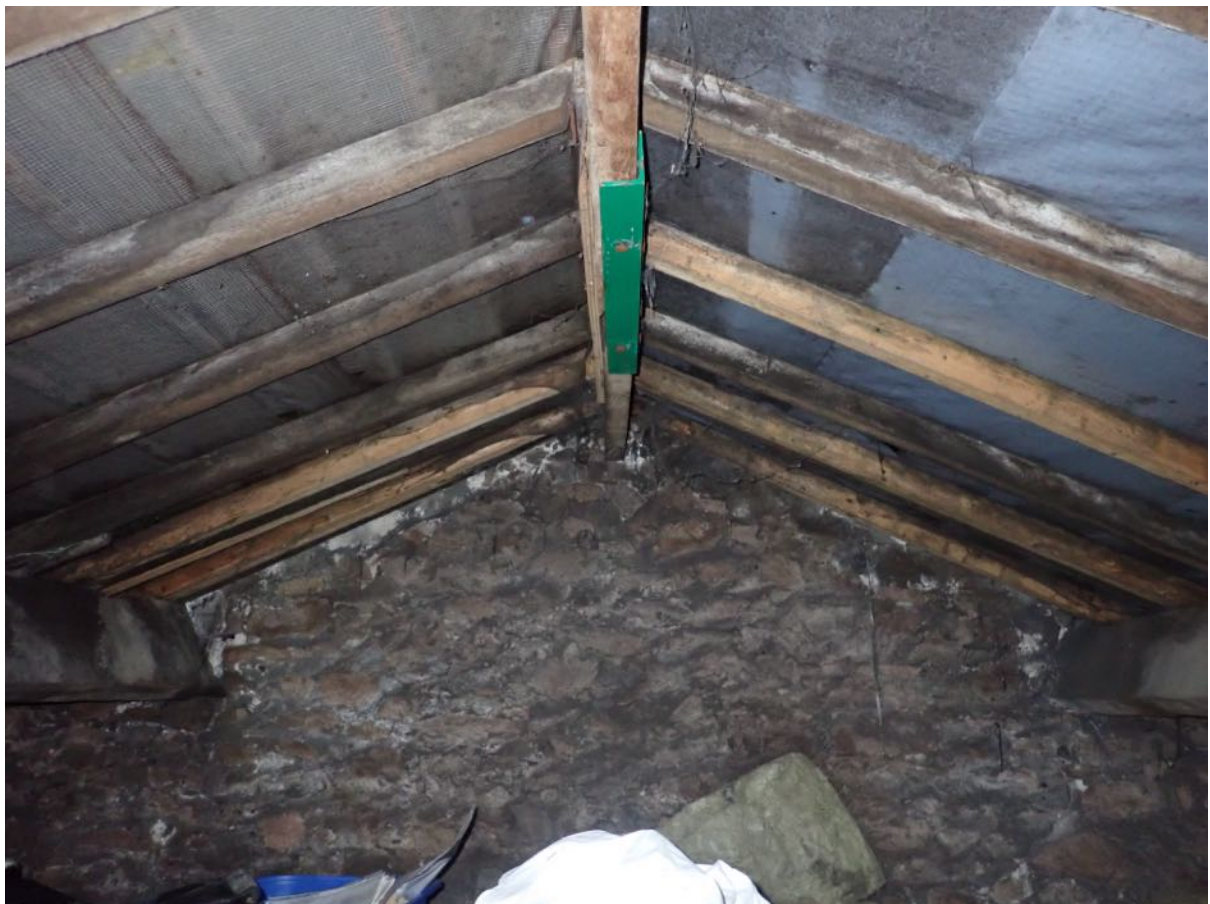
10 – The main loft void.

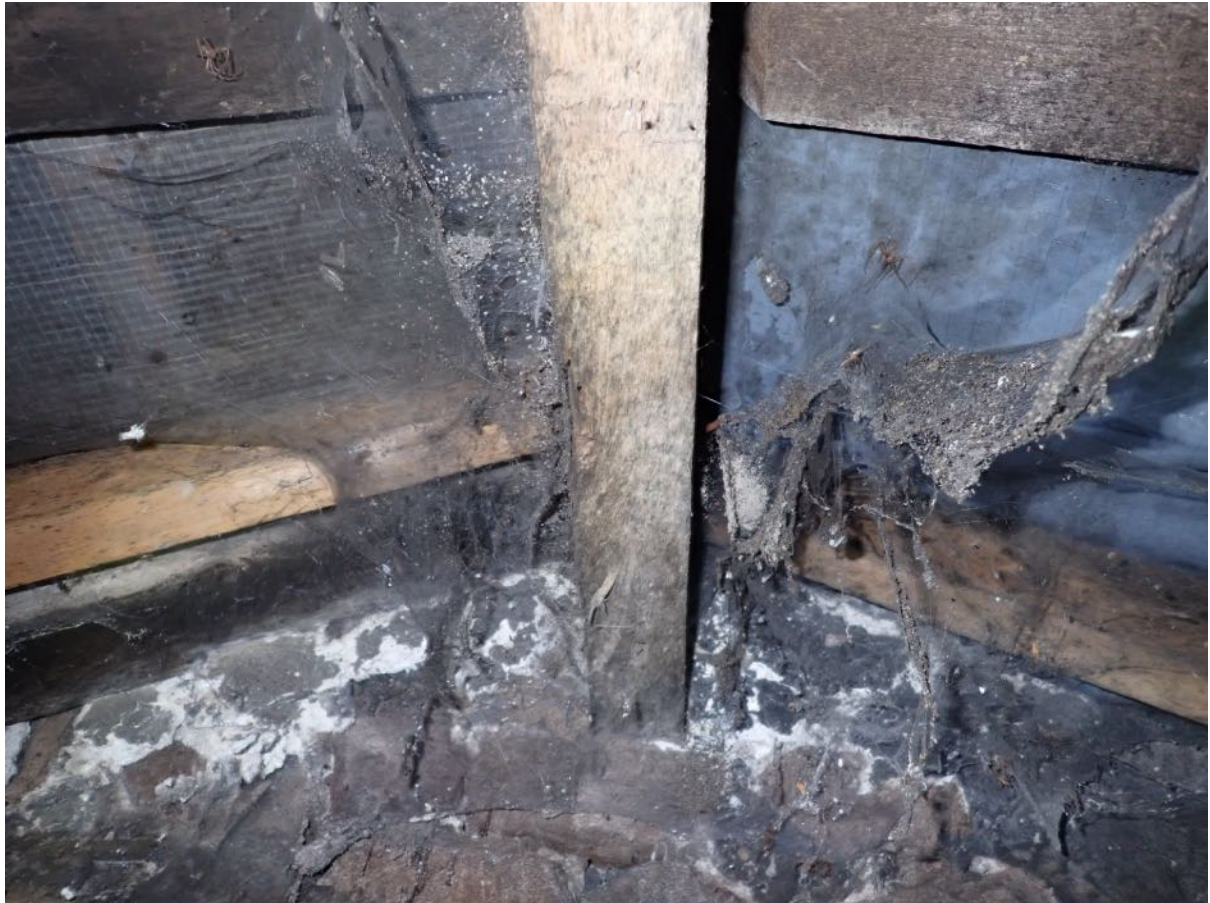
11 – Timbers are covered with dusty cobwebs.

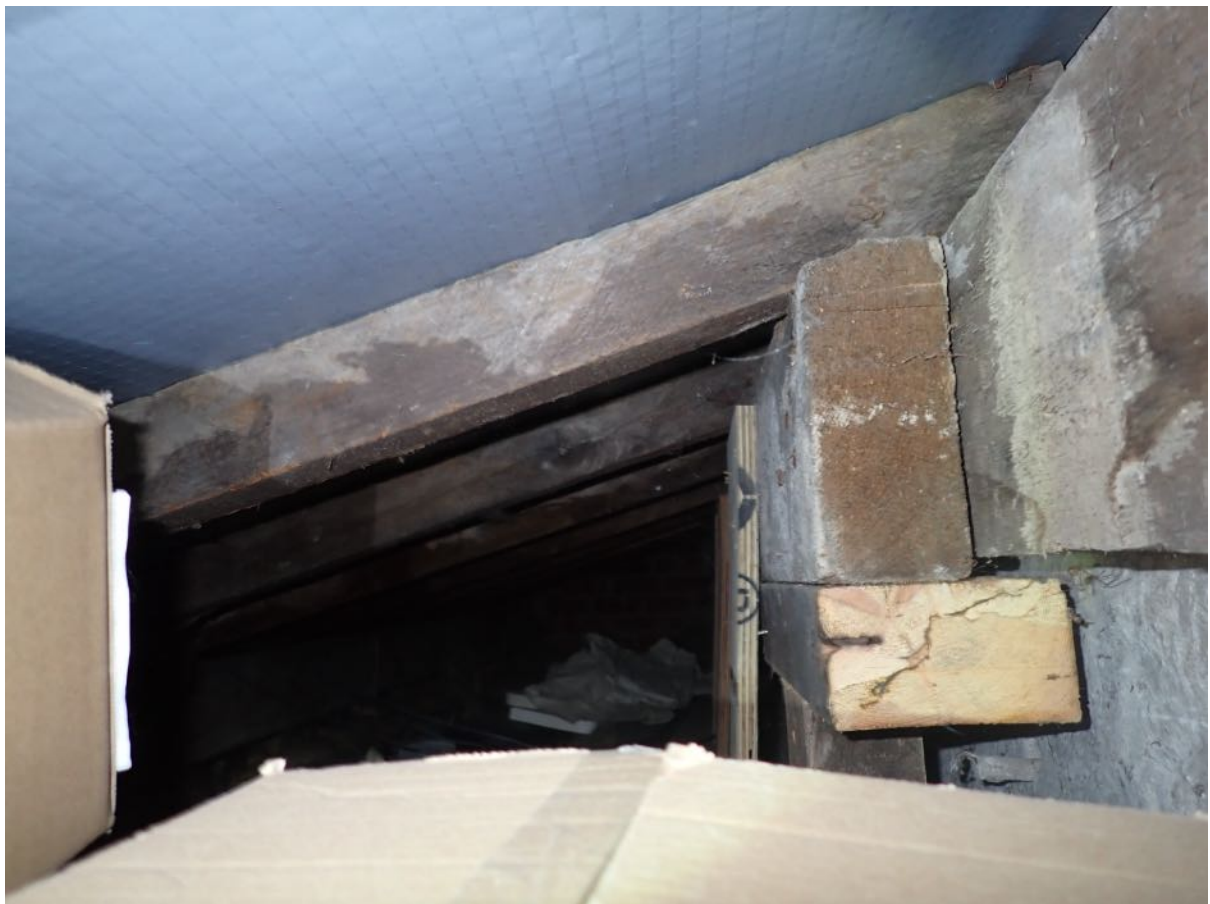
12 – The loft void in the extension is small and cluttered.

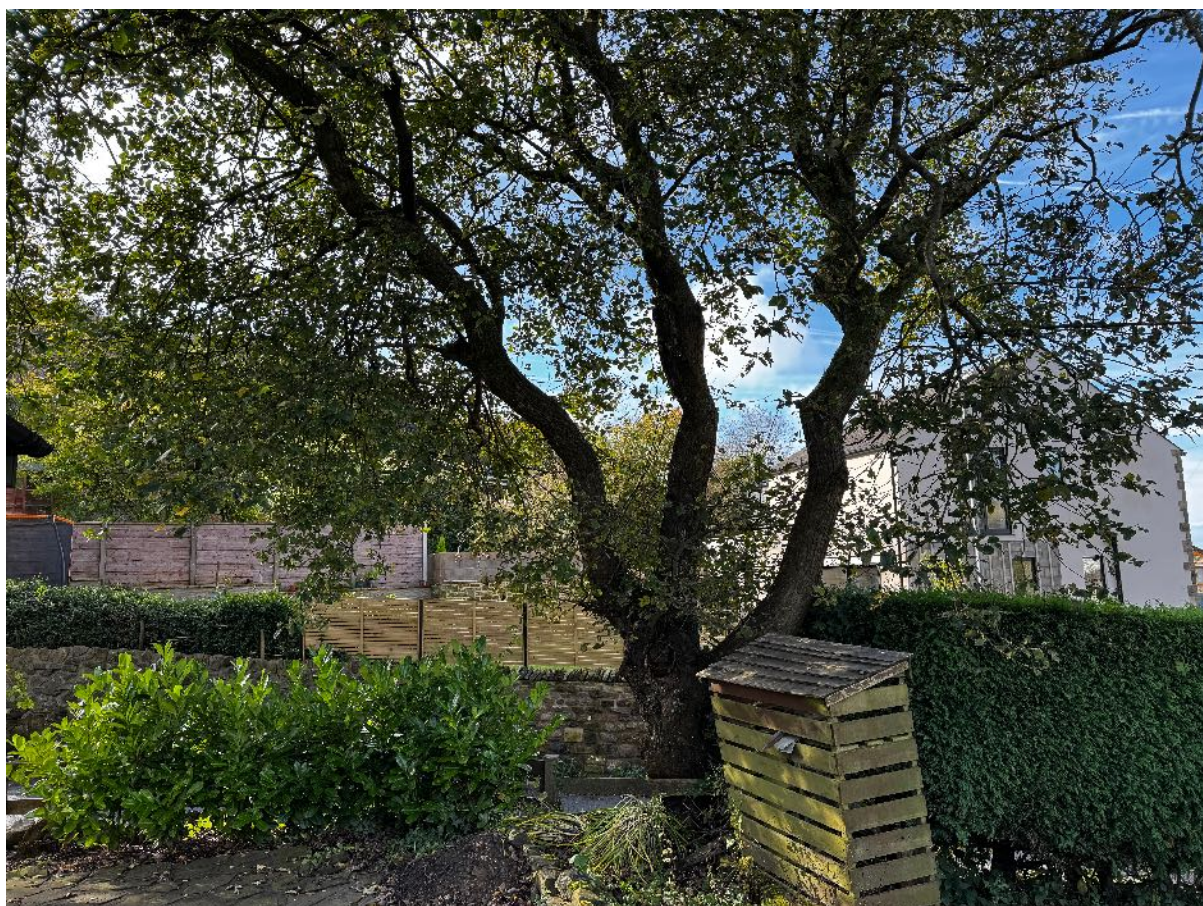
A willow tree to the front of the house will be removed to accommodate the new extension. The tree is approximately 6m in height, and multi-stemmed, with an average stem diameter of 20cm. There are a number of pruning wounds on the main stem, however these are healing, and there are no features suitable for use by roosting bats.

13 – A willow tree will be removed to facilitate the works.

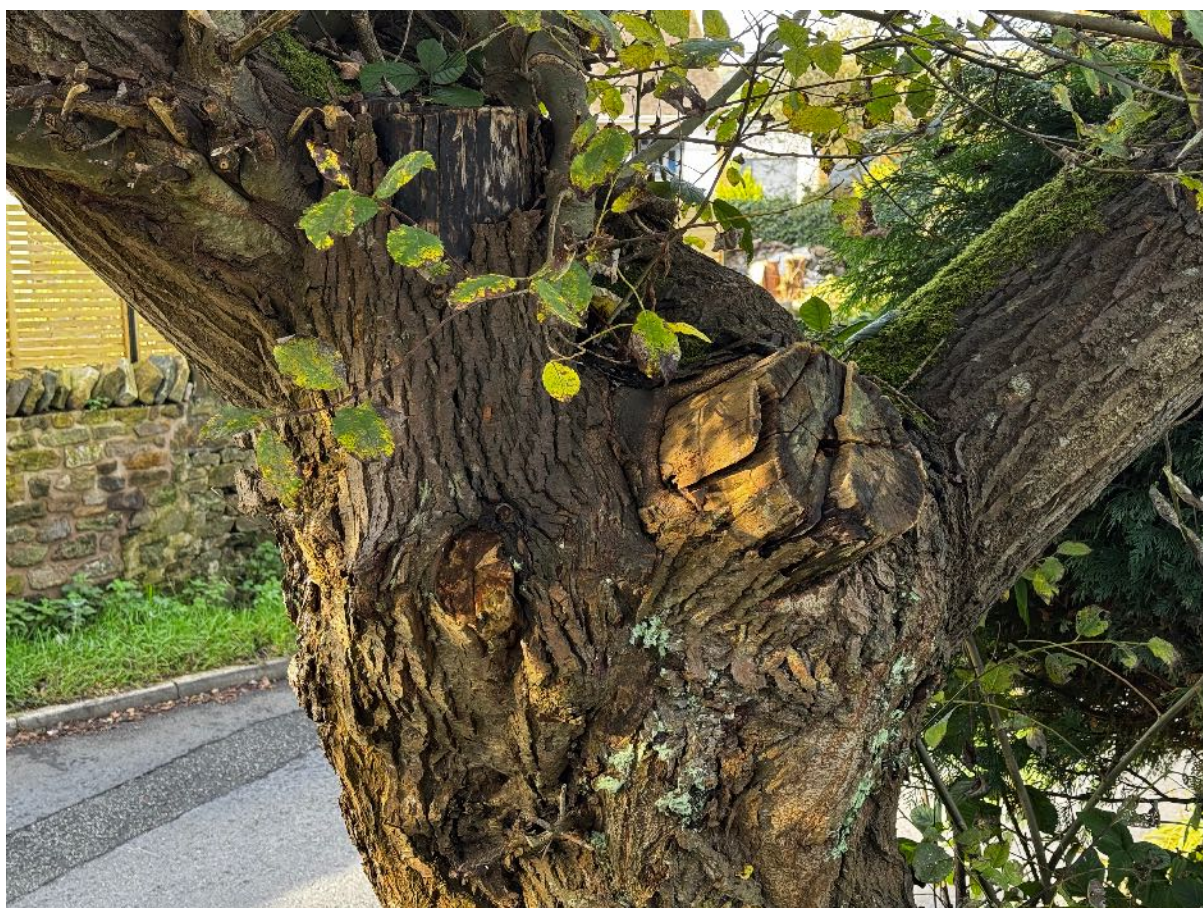
14 – The tree has pruning wounds but no suitable cavities for roosting bats.
