Tree Hazard Evaluation Report

Group of 3x Mature Sycamores *Acer pseudoplatanus*

**Cross House
Broad Lane
Whalley
Clitheroe
BB7 9TW**

Ref:NSTS2021/3

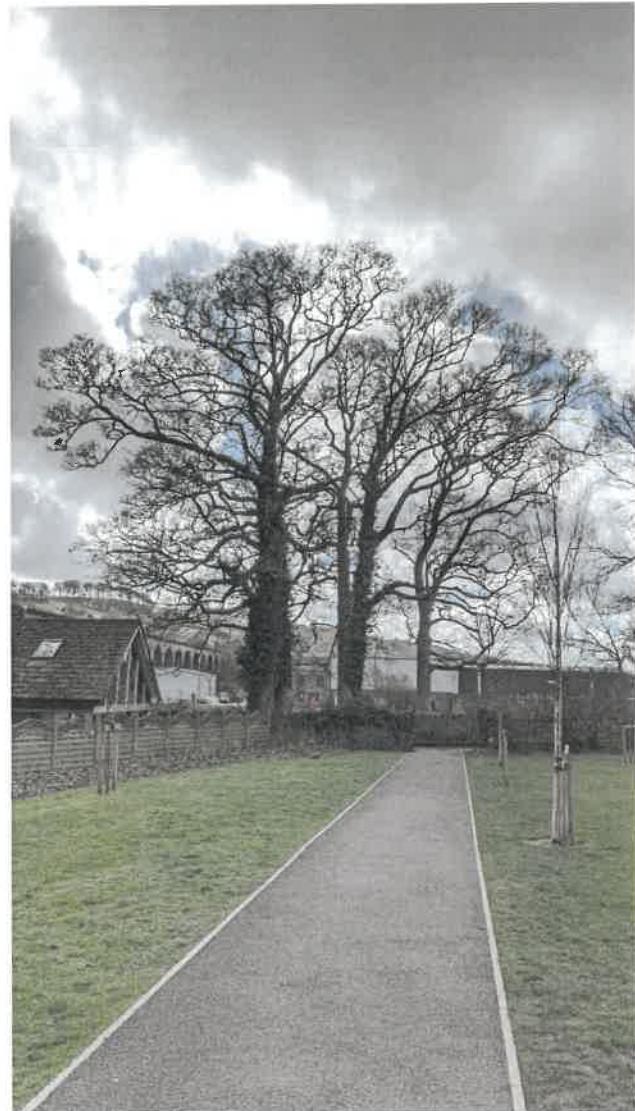
Fig 2.

Image of T1 T2 T3 group of Sycamore on the day of the survey. Taken from the North, Cross house on the left of the image.

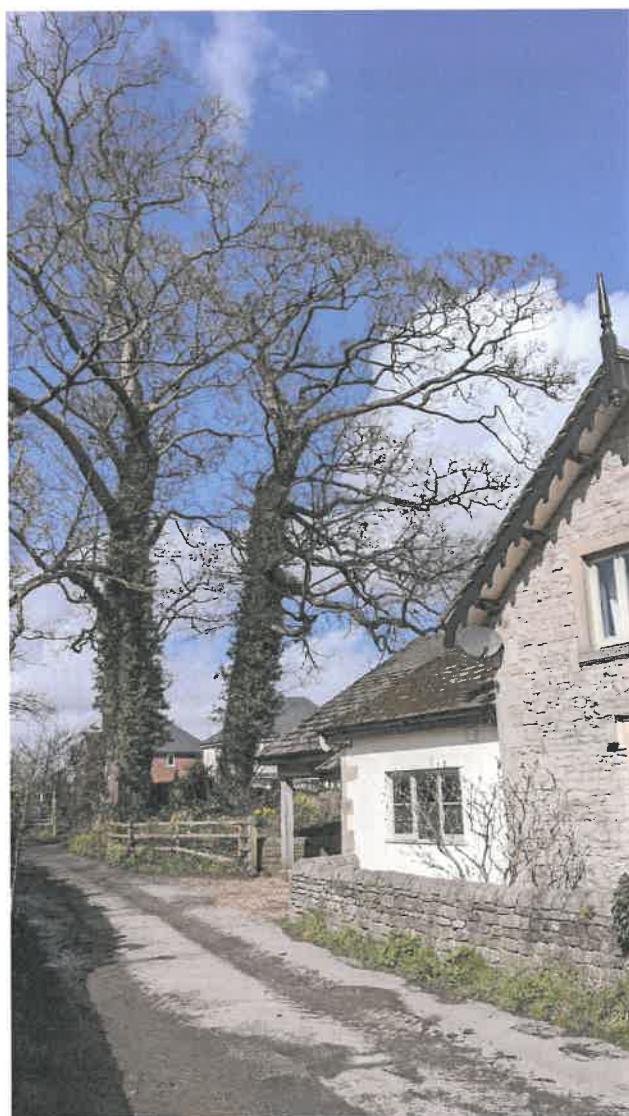
Fig 3

Image of T1 T2 T3 group of Sycamore on the day of the survey. Taken from the East.

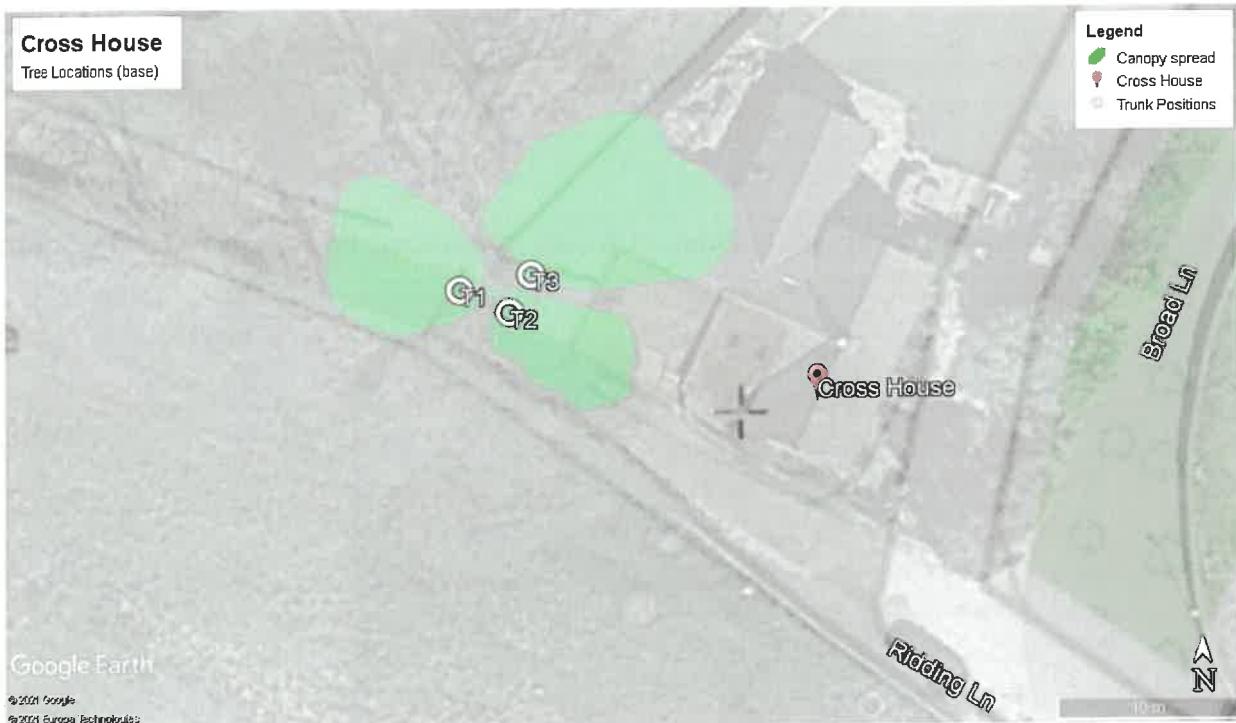
Fig 4. Tree canopies in relation to trunk positions at ground level. Image illustrates major asymmetry in canopy shape due to codominant suppression from the proximity of neighbouring tree/s.

Canopy disengagement/ shyness is visible on all three trees as a result of trunk proximity. The three tree stems also lean heavily away from each other.

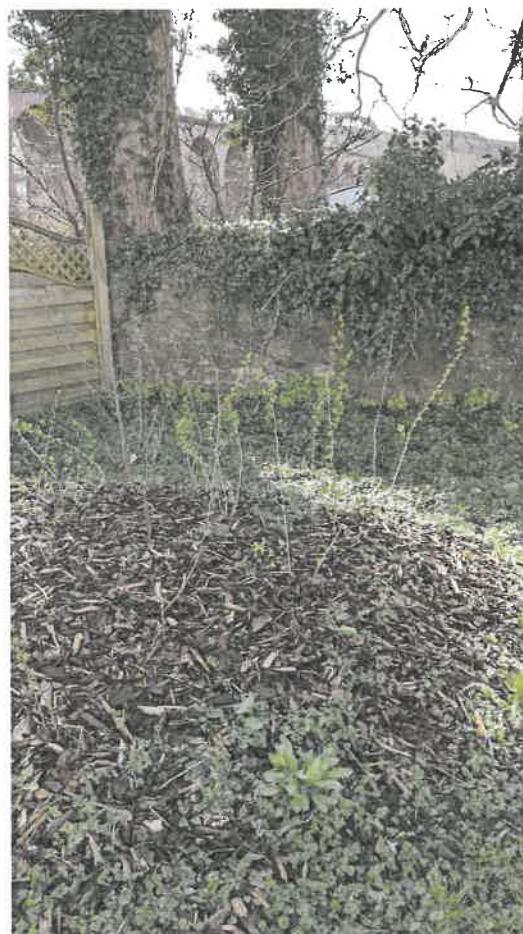
A freshly planted area with a large pile of bark chippings has been established from 6m to the north of the boundary wall, which is not ideal for the health of the tree group due to the risk of introduced pathogens and pests.

Fig 5. Image shows proximity and volume of freshly introduced bark mulch and depth of excavation on North side of trees.

The ground conditions surrounding these trees is not ideal for the health or structural integrity of Sycamores of this size and maturity. The root plate area for this given species would normally be around the canopy drip line of a naturally, open grown specimen with a symmetrical crown. The canopy disengagement and stem lean along with the road, recent footpath, excavation of the driveway and excavation of the housing estate leads one to fairly assume that the root distribution of these trees is not normal. The roots will have almost certainly been subject to damage and compaction on all sides of the root distribution area.

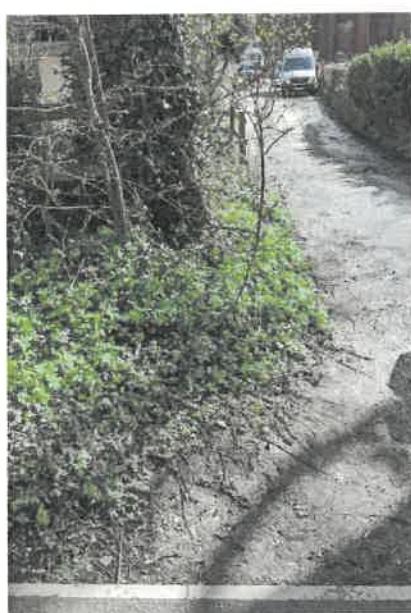
The base of T1 is 1m from the road which runs the length of the tree’s root plate from East to West on the South side of the trunk.

Fig 6. Image illustrates the proximity of the road to T1/T2 and also the proximity to T1 of recently installed tarmac footpath.

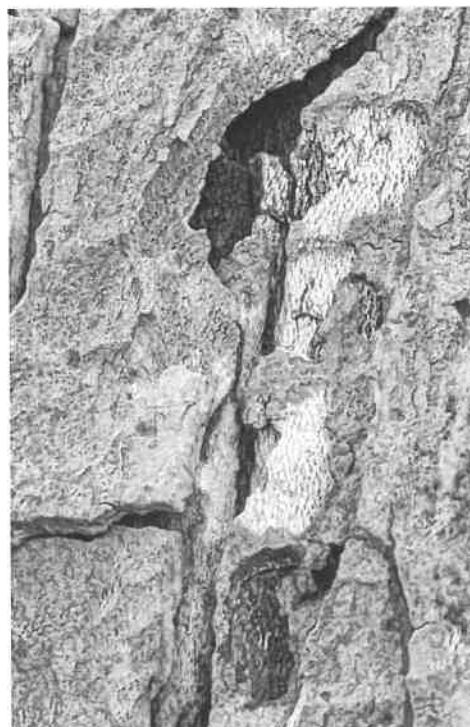
Small bark lesions were observed on the stem at 1m with patches of sooty spores present under the bark, most likely *Cryptostroma corticale*. Black lesions were also observed on several branches from ground level.

Fig 7. Image shows the presence of sooty spores beneath the bark on T2.

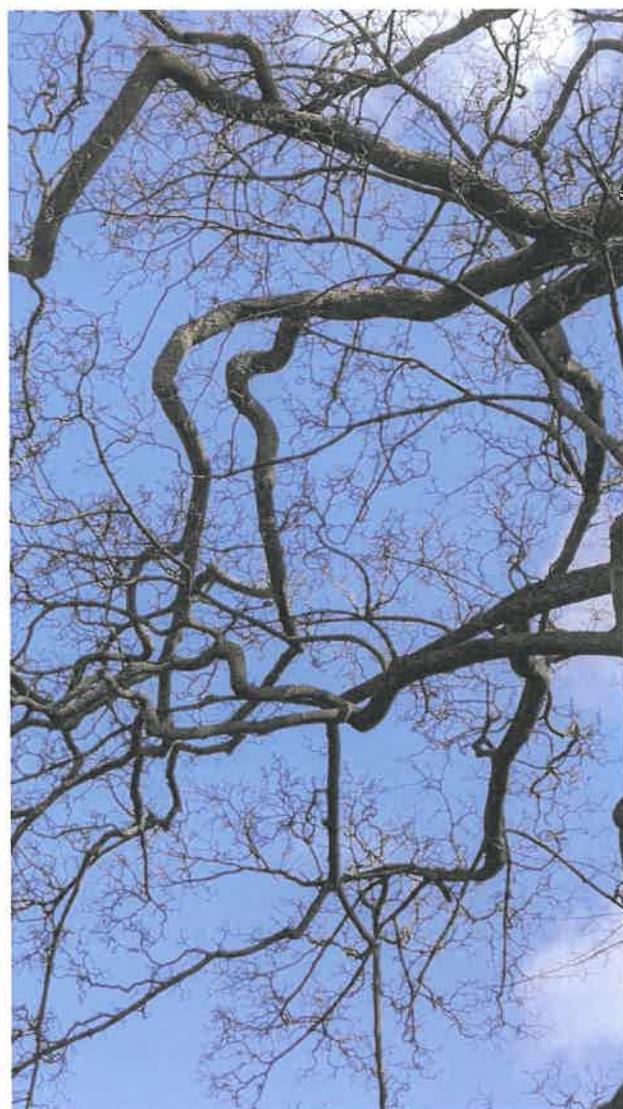
Main limbs throughout the canopy show twisting, dog-legged growth and direction changes at pruning cavities, creating major hazard beams. Included unions are present on the lowest, trifurcated Northward limbs. The inner canopy has been excessively thinned and lion-tailed, resulting in over elongated limbs. Necrotic lesions are visible on the first limb at 3m from the stem and on the adjacent branch. Bark stress fractures caused by transverse tension are visible on the Western most limb at 5m beyond the 90 degree change of direction. A fruiting body was noted at 16m on the westernmost leader, 4m from the stem. Fruiting bodies were observed on the Easternmost limb over the building on the end branches. Major branch cavities caused by poor pruning are also visible on the same limb 7.5m from the stem. Deadwood is present at <3%.

Fig 8. Image shows trifurcated, dog-legged limbs on NE side of T3.

The over elongation of limbs from over thinning have created a high risk of branch sheer failure.

In conclusion to this survey/ report it is recommended that all three trees be felled to ground level to remove all risk of structural failure.

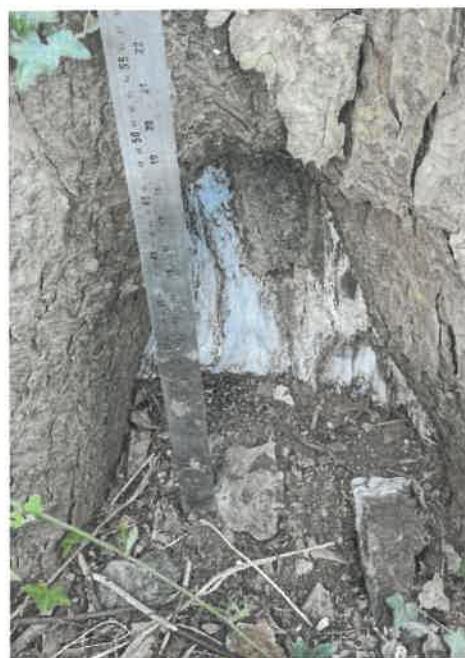
A basal cavity wound is present at the base on the North side of the trunk between two buttresses. The cavity measures 35cm wide at ground level and tapers up to 47cm from ground level. The cavity has been filled with concrete at ground level. White, dry and decayed wet-wood (acer heartwood) is present with black/orange oozing sap at the very top of the cavity. The presence of a *Pseudomonas* bacterial infection is suspected. At the time of the survey, it was possible to penetrate the wet-wood by 8cm with a 3.5mm probe. It is suspected the decay within the cavity extends below ground level. A Sonic Tomograph would be required to ascertain the extent of decay. The buttresses either side of the cavity appear to be truncating in reaction to compartmentalize the cavity.

Fig 9. Basal cavity on North side of T3 trunk.

The lean direction of T3, excavation of root plate, the basal cavity and decay along with the weighting of the over-extended limbs coupled with numerous pruning wound cavities create a high risk of branch drop or failure at base towards the building.

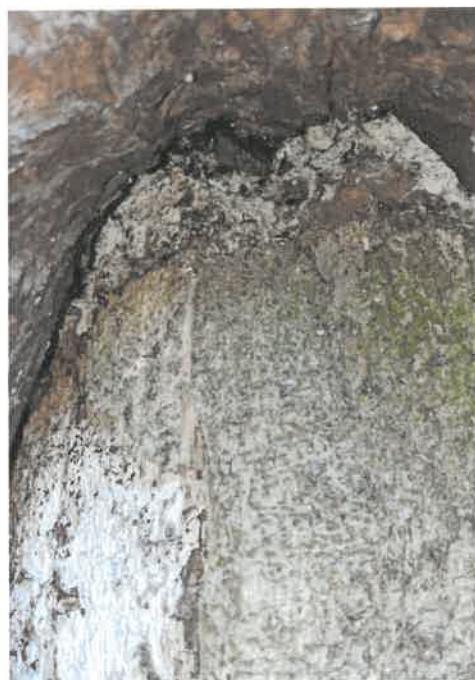
Fig 10. Black/ orange oozing sap at top of cavity suspected to be caused by *Pseudomonas* infection.
