**The Barn, Springwood,  
Hurst Green**

**Level 2-3 Historic  
Building Recording**

AB Heritage Project No: 63086

Date: 03/09/2024

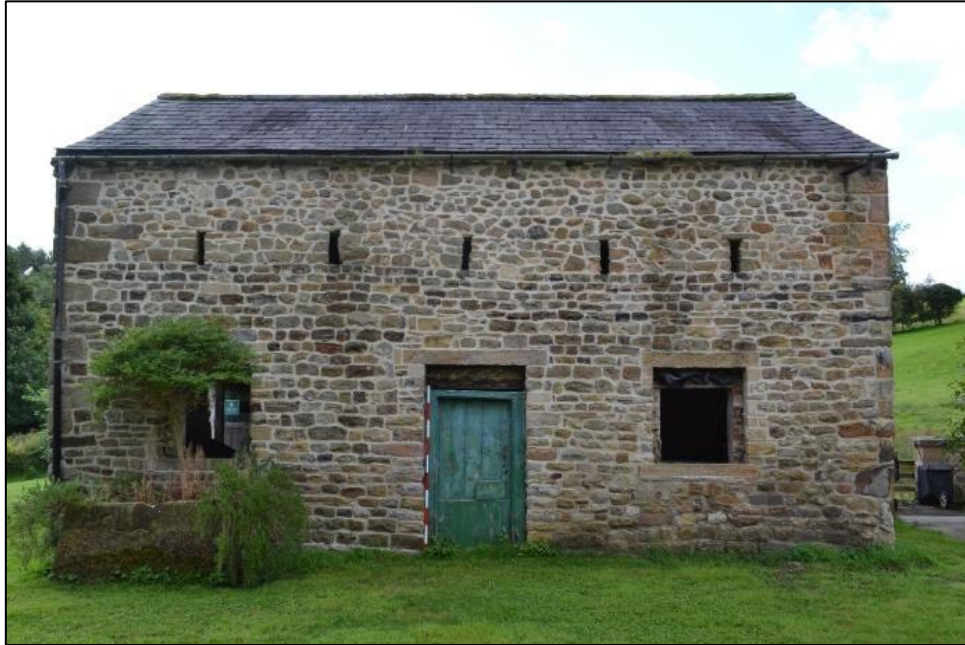
**Plate 8. The north elevation (scale 2m)**

- 4.2.5 The stonework appears to have been recently repointed with lime mortar. The timber batten door is not original and does not fully fit the portal, which has a stone lintel. The window on the west has stone cill and lintel, while the east window has only a stone cill and no lintel. There is small iron tethering ring under the west window, and a stone trough in front of the east window.

- 4.2.6 This elevation does show subtle evidence of alterations. The door has clearly been changed, and it is apparent on Plate 8 that the windows on the ground floor have been reduced in size, note the bricks and render inside the window openings that would have housed smaller frames and glazing. The quoins on the east and west returns of the north elevation also show where the height of the building has been raised, note the size and type of quoins from the level of the base of the ventilation slits. These correspond with changes on the gables which more clearly show a change in build that evidences the historic work to the roof. A building break on the north elevation is discernible from the base of the ventilation slits which indicates the original eaves height of the building.

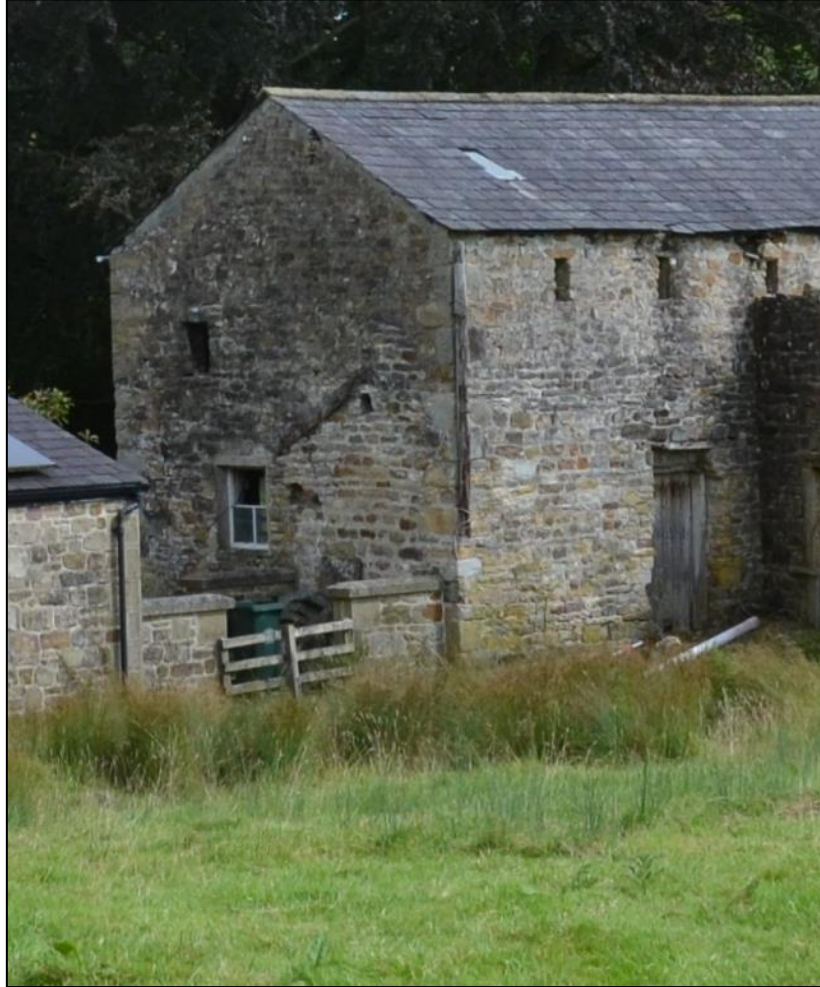
**Plate 10. The west elevation**

- 4.2.14 The west elevation shows evidence of several interventions to the original appearance and build. On the ground floor there is a small sash window, the location of which strongly suggests that it belongs to the dairy phase of the building. The window is broken with the upper sash missing. The inside edges of the portal are finished with concrete and there is a stone lintel.
- 4.2.15 South of the window, also on the ground floor is a building scar and a possibly a putlog hole that evidences the former small building that is shown on Plate 4 from 1888. The scar indicates that the building was a porch or similar, and there is evidence on the interior face of the west elevation for a blocked door (see Plate 16, below). This smaller building clearly had a pitch roof (Plate 11, below). The two protruding dwarf walls are modern, this area now being in use as a refuse store.

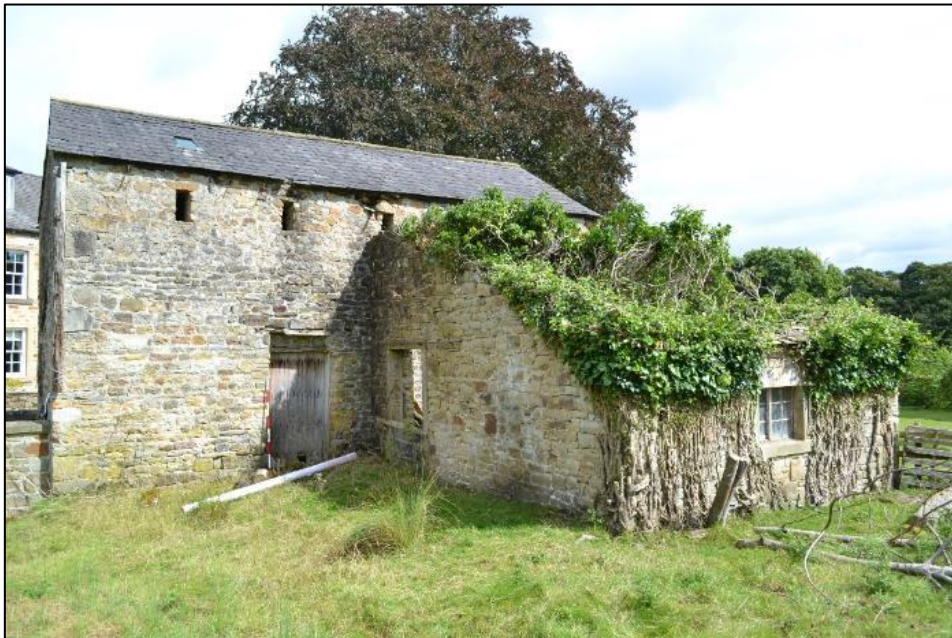
**Plate 13. The south elevation (scale 1.6m)**

- 4.2.18 The south elevation (Plate 13, below) shows the part of the building not screened by the ruined building, as well as the west and south elevation of the ruined building. It was not possible to achieve a clear shot of the remainder of the south elevation of the Barn, but examination showed no features of note. This correlates with evidence in the interior.

- 4.2.19 The south elevation is simpler than the opposing north elevation. The south has only a single, off-centre door at ground floor. As with the portal on the north elevation, the door is timber batten in style and is smaller than the original opening, which has stone packing beneath the rotten timber lintel and above the door.
- 4.2.20 At first floor are five ventilation slits that correspond with those on the north elevation. Together these features represent the ventilation required for fodder storage on the first floor, most probably associated with the later dairy phase of the Barn.

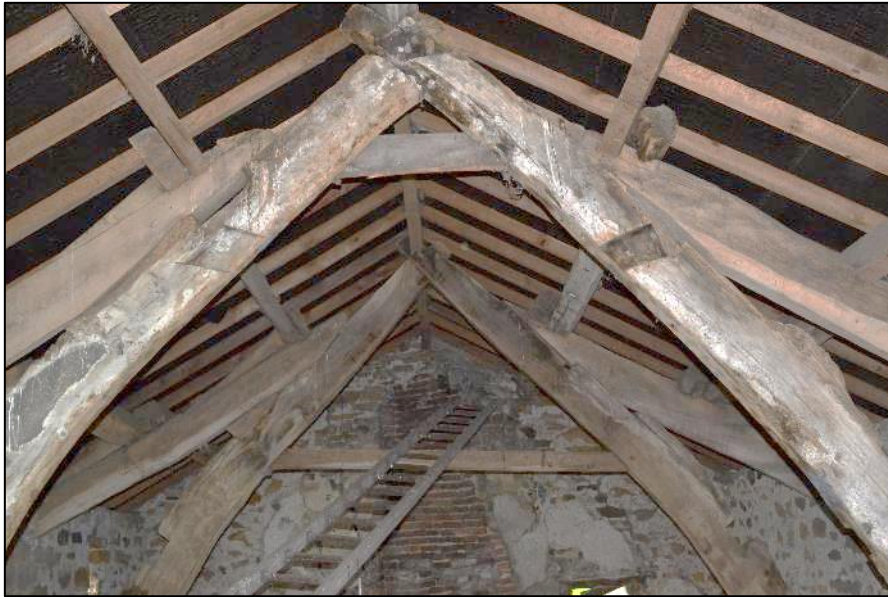
**Plate 21. Detail of crucks and other roof timbers**

- 4.2.33 Plates 21 & 22 below show in some detail the original crucks, including how they are pegged at the apex and how the purlins run along the backs of the crucks.

- 4.2.34 It was clear that the original crucks included evidence that the roof may have been repaired several times, for example the notches on the 'inside' of the crucks on Plate 21 show a downward inclination, which would accommodate a structural use in the roof as it is presently (note the horizontal tie beam above and on the cruck behind). Furthermore, the raised roof has required the later timbers to be integrated into the masonry and it is these that take the weight of the roof, with some merely piggy backing on the original crucks (Plates 21 & 22).
- 4.2.35 Close examination of the original timbers revealed no personalised joiner's marks beyond the rather unexplained notches already described. What was abundantly apparent, however, was that the original timbers were, or had been, heavily infested with woodworm and a good degree of deterioration from rot.

- 4.2.36 In summary, the roof is very interesting but in a poor and potentially deteriorating condition. It is entirely possible that the original crucks are not actually *in-situ* and that the curiously located notches were perhaps from an earlier phase of the structure, after which they were moved when the roof was raised.

- 5.1.7 Due to obstacles present on the first floor and its unknown stability, a decision was made to not attempt the measured recording of the cruck beams. Instead, it is recommended that measurements of the crucks are taken these once they are removed.

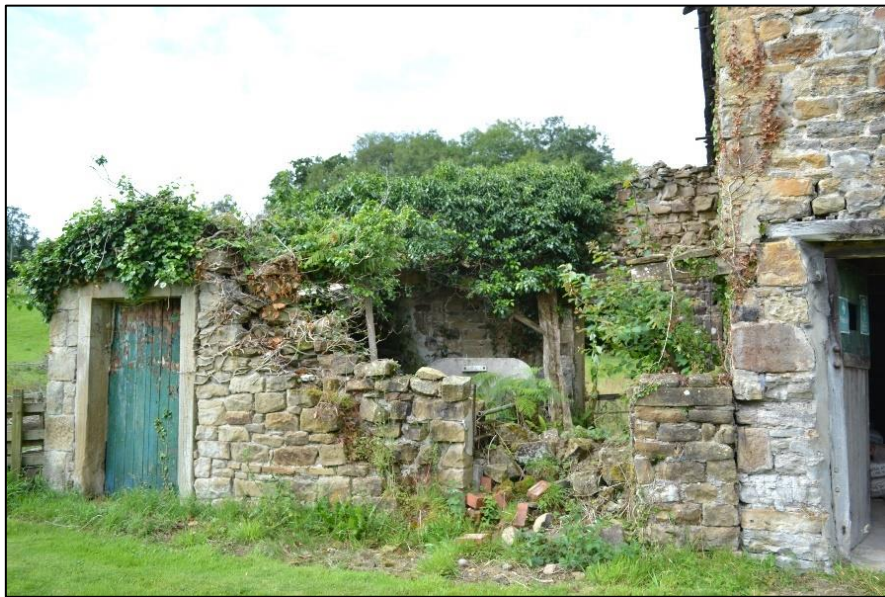
**Plate 23. The ruin from the east**

- 4.3.1 Abutting the Barn on the east side of the south elevation, is the ruined building shown on the 25 Inch OS map of 1932 (Plate 6) so we can assume that the building very much post-dates the original construction of the Barn. The building is almost square in plan, and is a single storey, built of sandstone blocks. The roof was slate and mono-pitched, sloping down from the adjoining Barn (Plate 23).

- 4.3.2 Plate 23 shows the state and condition of the building in 2024. However, it is possible to identify certain key features and to identify the function of building in the past. Plates 13 & 23 show the east and west elevation of the ruin, and they show that the building had opposing doors close to the back of the Barn.
