Tree Work Recommendations

3 Hollowhead Lane, Wilpshire, BB1 9JX

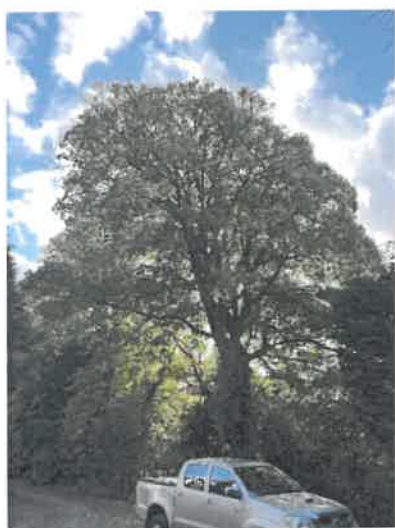
Image 1 – T1
Sycamore

T1 – Sycamore *Acer psuedoplatanus*

Sycamore recommended at the left hand side of the driveway. to be felled due to the raised driveway over the buttress and lower stem of tree causing die back in the right side of the crown. This has been caused by high root compaction and bad design of driveway installed by previous owners. The tree is in a high target area adjacent to the driveway and garden and is in close proximity to the house. See pictures attached.

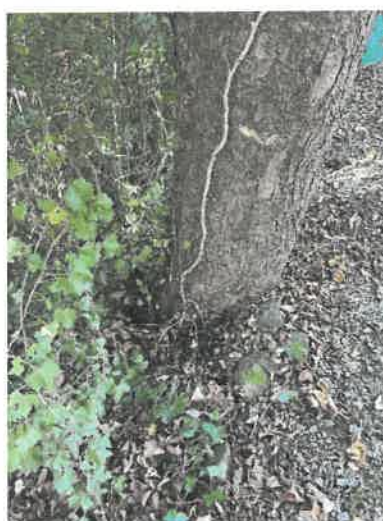
Image 2 – Image showing driveway built up over buttress.

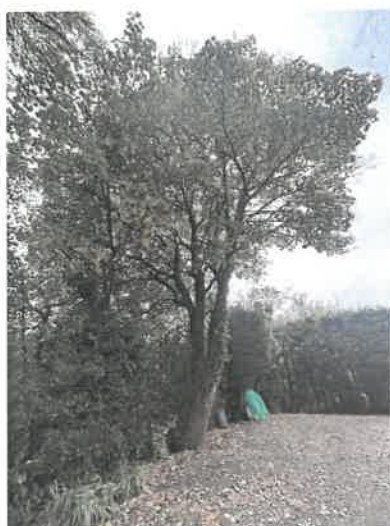
Image 3 – Tree adjacent to driveway.

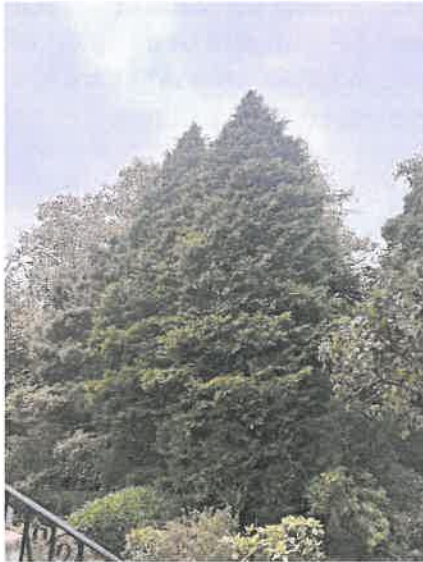
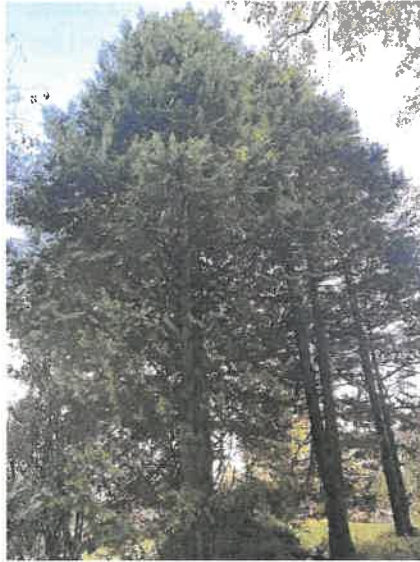
Image 1 & 2 - Group of Cypress

G1 Leyland cypress *Cupress x leylandii*

Group of Cypress at the right hand side of the driveway recommended to be reduced in height by approximately 3m or one third to reduce the windsail of the trees as they are in close proximity to the house. The trees are to be reduced to an even height all along.

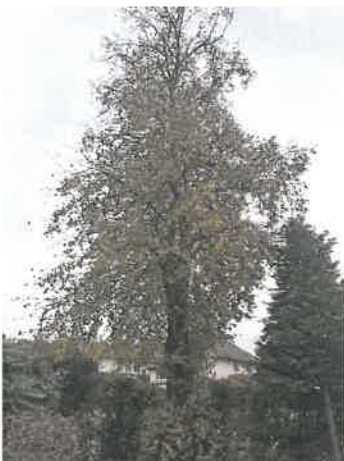
Image 1 – Lime tree

T2 Lime *Tilia Cordata*

Lime recommended at the front of the property to be felled and remove the stump due to root system causing extensive damage and trip hazard to the customers footpath. Removing the tree will allow the customer to get a new footpath installed without damaging the root system of the tree. See pictures attached.

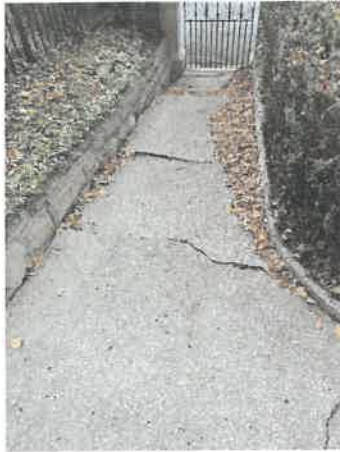
Image 2 (T2)

Image 2 & 3 – Pathway to house damaged by root system of T2 Lime tree. (PTO)
