Heritage Statement

Barn 2, Dinkling Green, Little Bowland Road

Whitewell, BB7 3BN

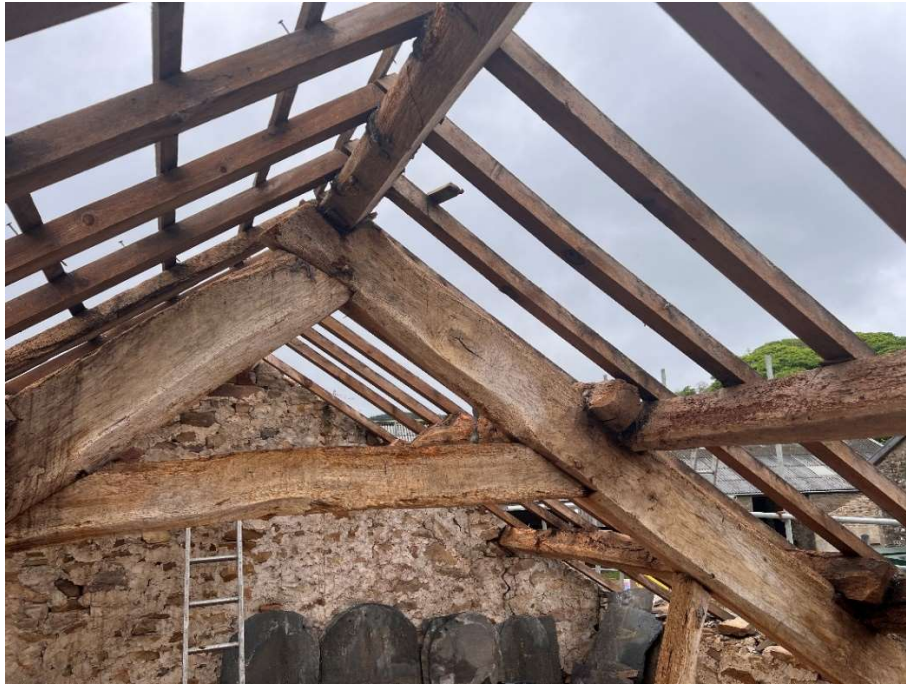
1. Details of existing trusses before removal

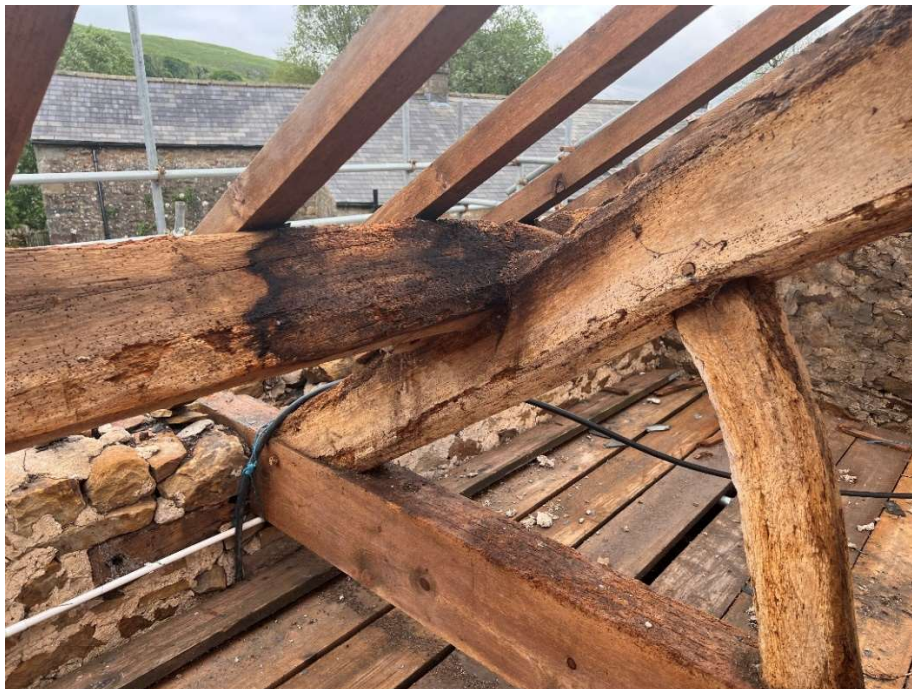
The works to replace the trusses and purlins has been carried out to ensure the continued use and safety of the barn for the future. Wood rot and beetle attack was significant, and the structural integrity of the timbers could not be guaranteed.

2. Rot and beetle attack to timbers

The trusses and purlins have been designed and constructed in a like for like basis with the use of green oak and traditional jointing methods to replicate the trusses as they previously were built.

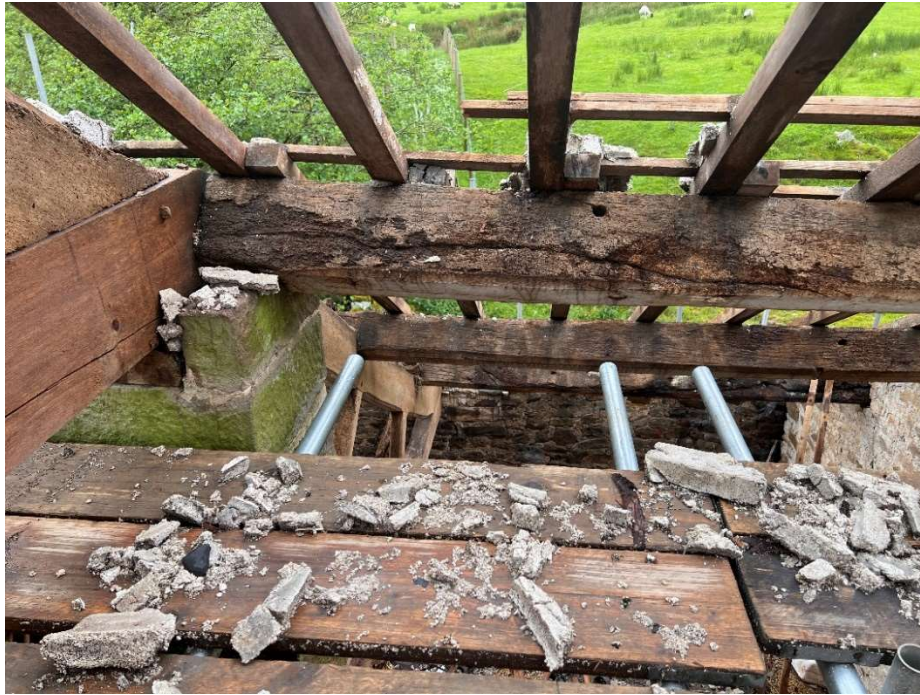
3. Significant rot to purlin on rear slope

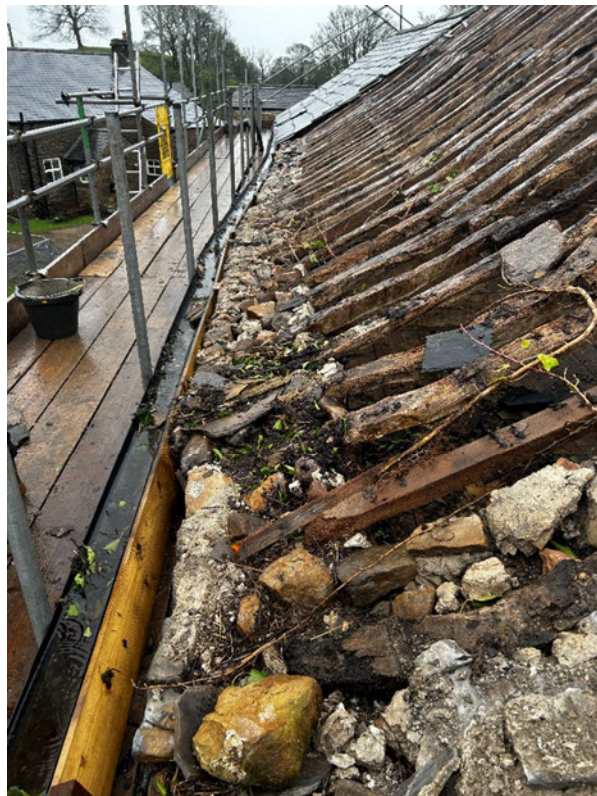
4. Rot visible to rafters

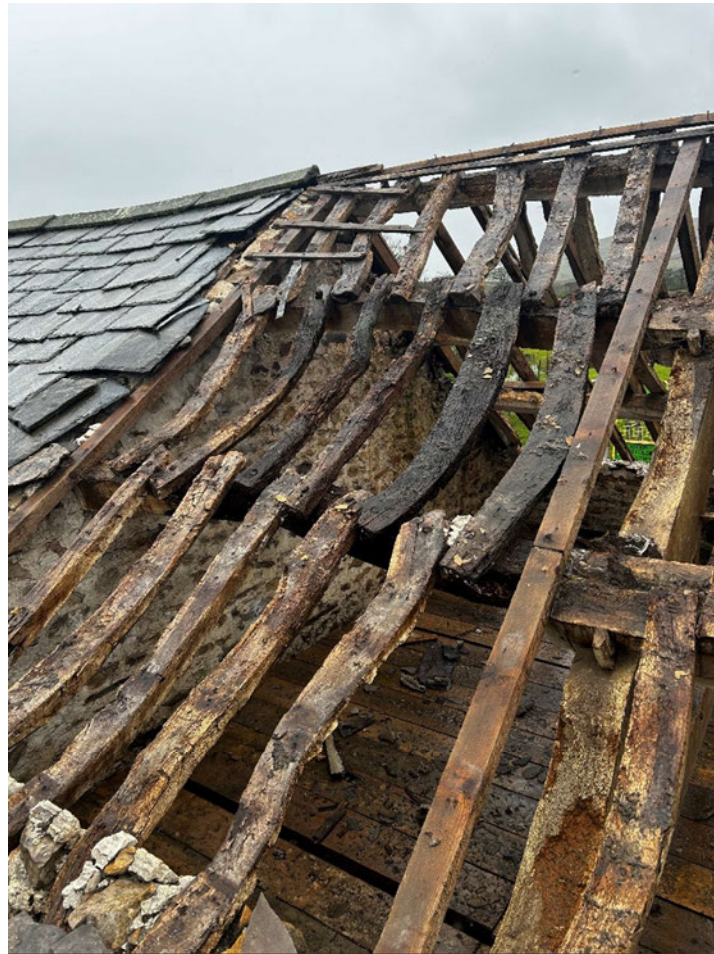
5. Original rafters in very poor condition

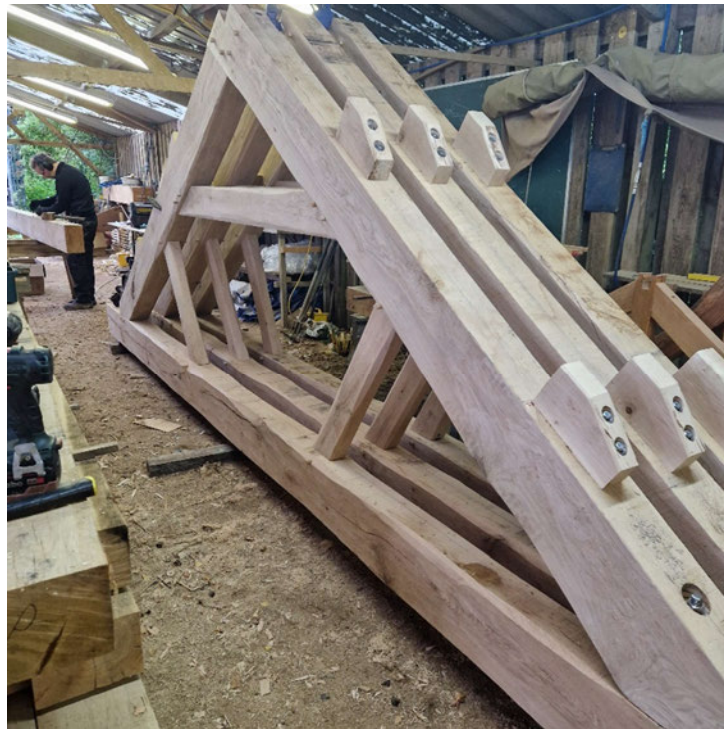
6. New trusses made to replicate old

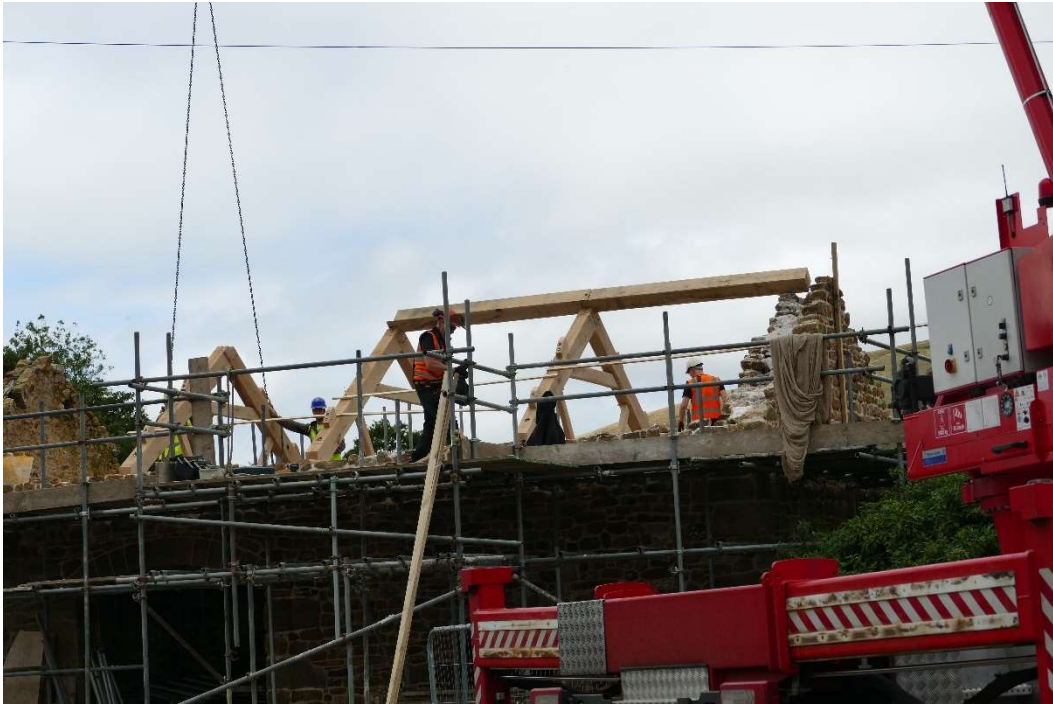
7. New trusses during installation
