**BAT PRESENCE / ABSENCE SURVEY**

**Black Moss Farm**

Elmridge Lane  
Chipping  
Preston  
Lancashire  
PR3 2NY

Date: 9<sup>th</sup> September 2024  
UES reference: UES03941/08

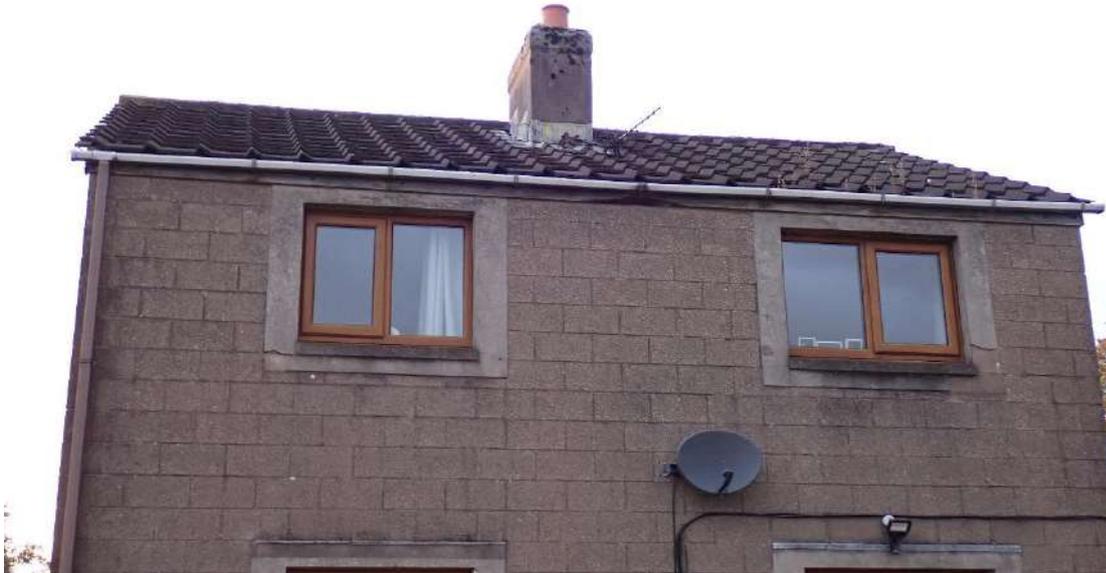
Photograph 2 – View of the pitched roof and western gable end of Building 1.

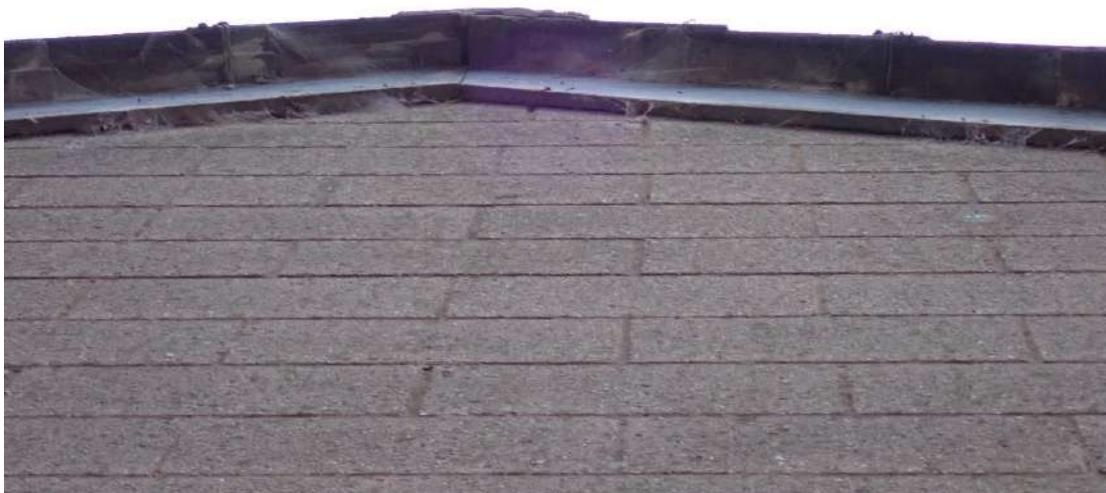
**Roost 1** – Three common pipistrelles were recorded emerging from underneath the fascia boards on the southern aspect of Building 1 during the first survey and two were observed using the same roost during the second survey. This is considered to be a day roost used by a low number of bats.

Photograph 3 – View of the PRFs formed from damaged fascia boards on the southern aspect of Building 1.

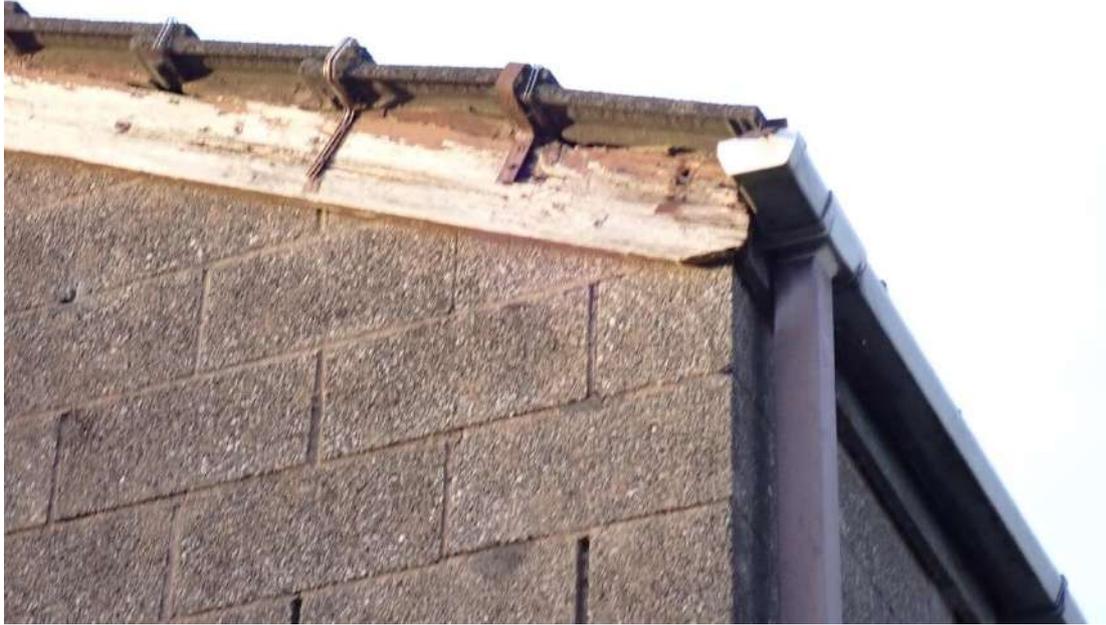
Photograph 4 – View of the gaps under the bargeboards on the eastern aspect of Building 1.

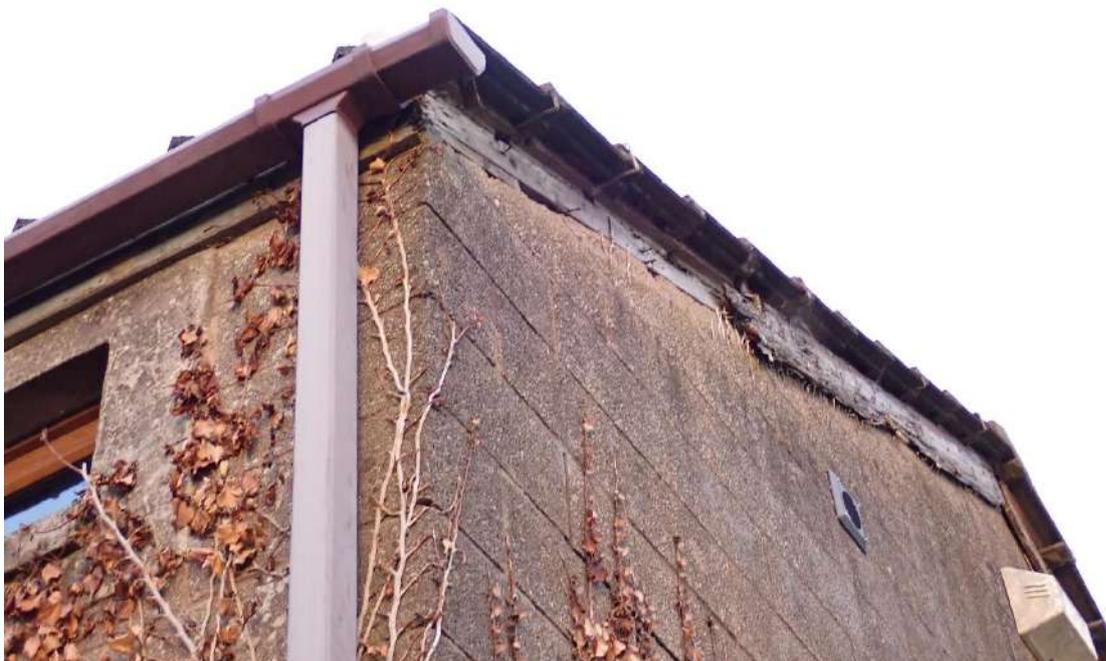
Photograph 5 – View of a damaged section of bargeboard on the western aspect of Building 1.

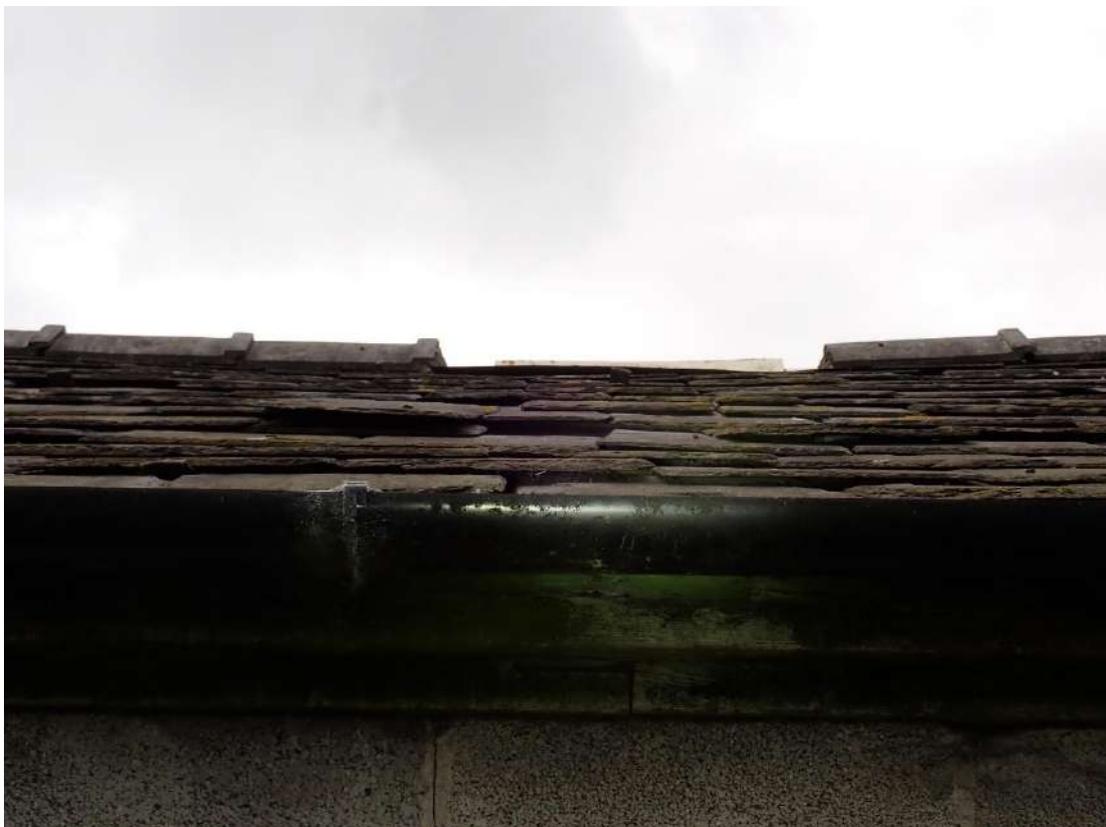
Photograph 11 – View of PRFs formed from raised roof tiles on the eastern section of Building 2.

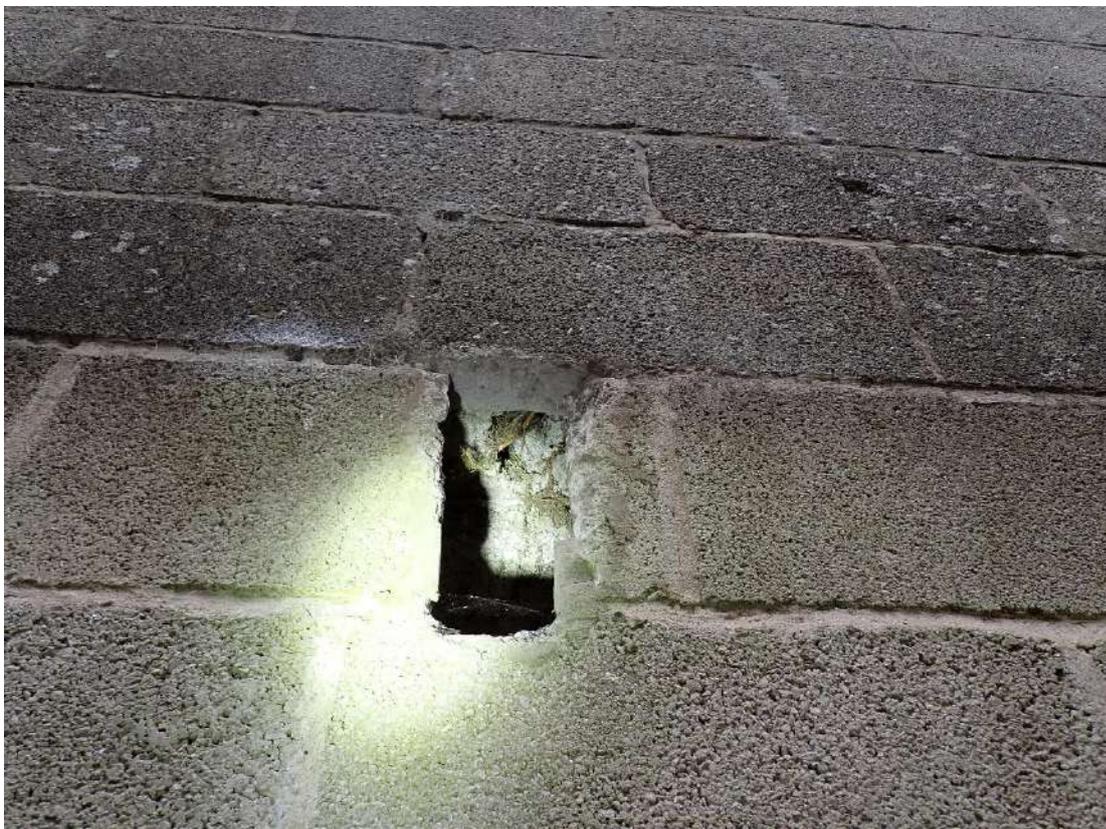
Photograph 15 – View of access points into the wall cavities of Building 2 via areas of damaged brickwork at the eastern gable end.

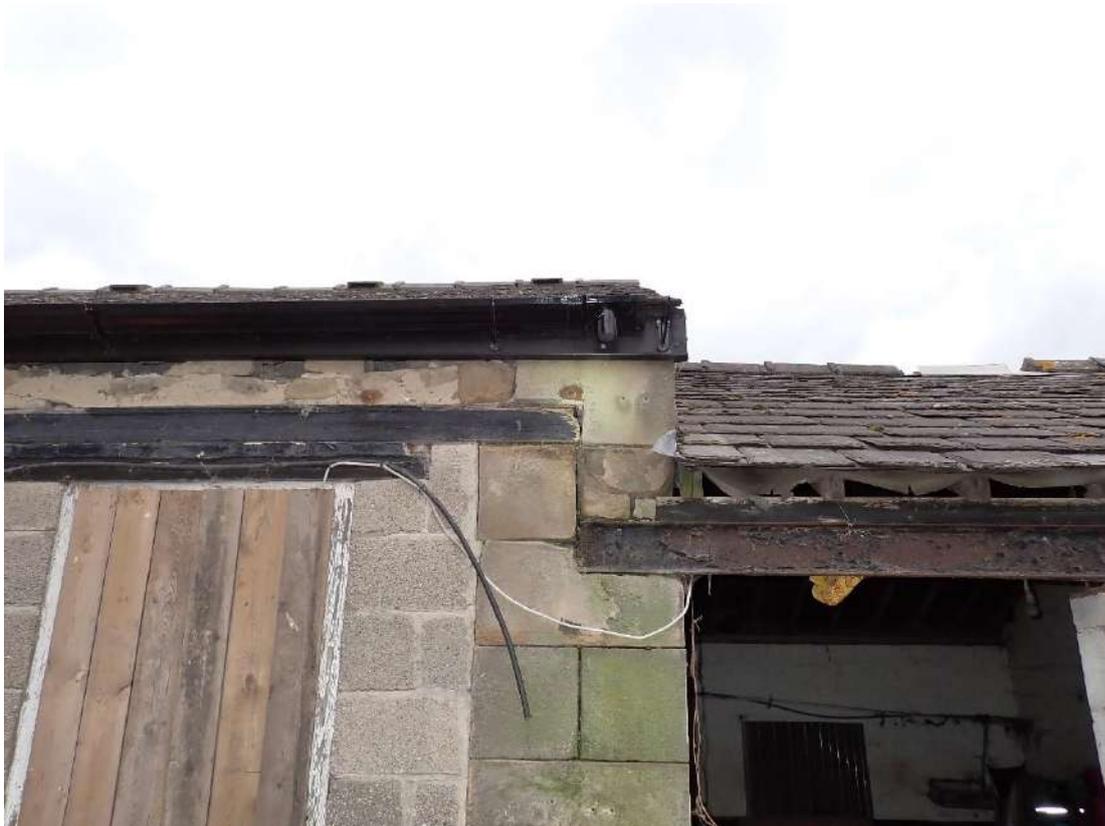
Photograph 16 – View of an access point into the wall cavity in the eastern section of Building 2. located on the eastern gable end.

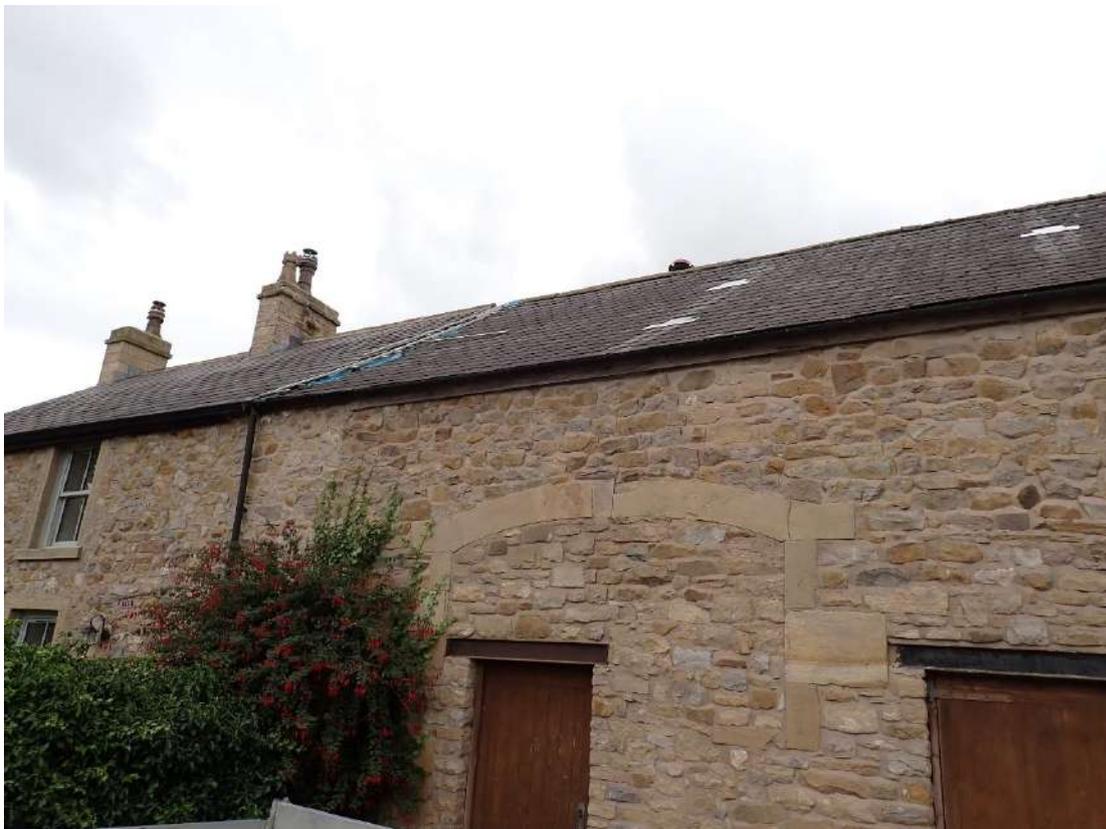
Photograph 21 - View of the raised tiles on the southern aspect of Building 3, forming PRFs.

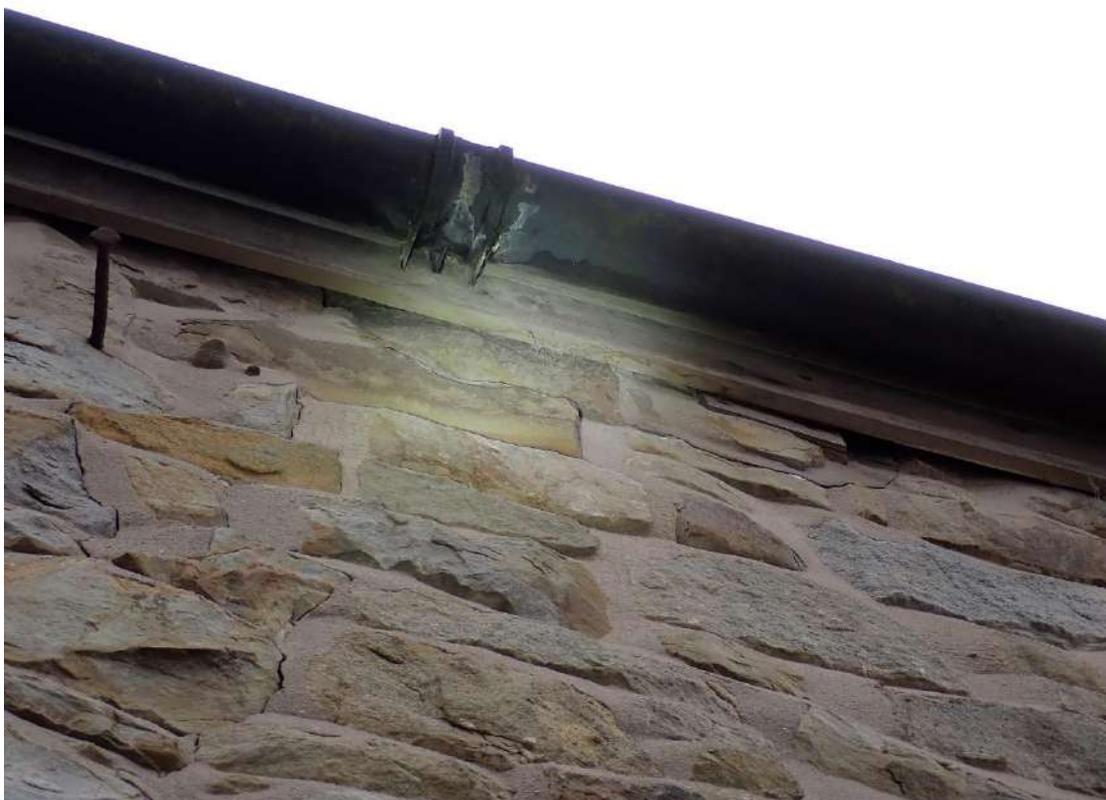
Photograph 23 – View of the gaps behind the fascia board on the southern aspect of Building 3.

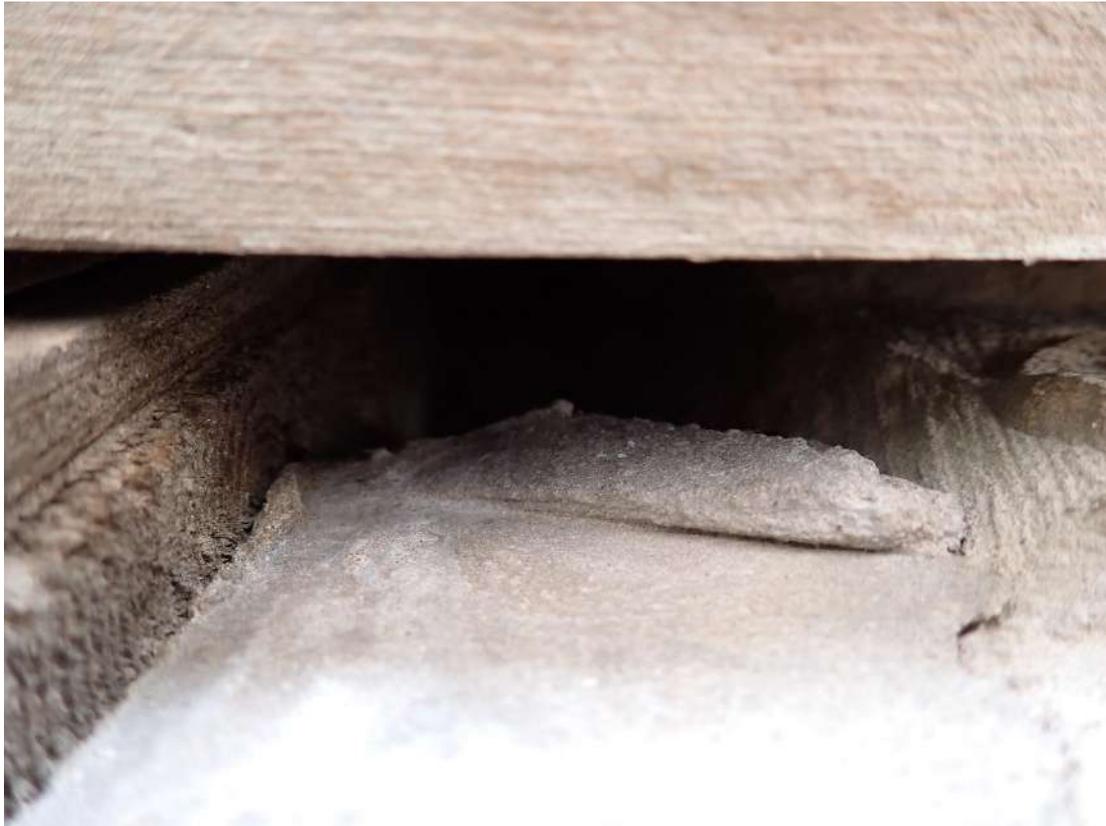
Photograph 24 – Close in view of the gaps between the fascia boards on the southern aspect of Building 3.

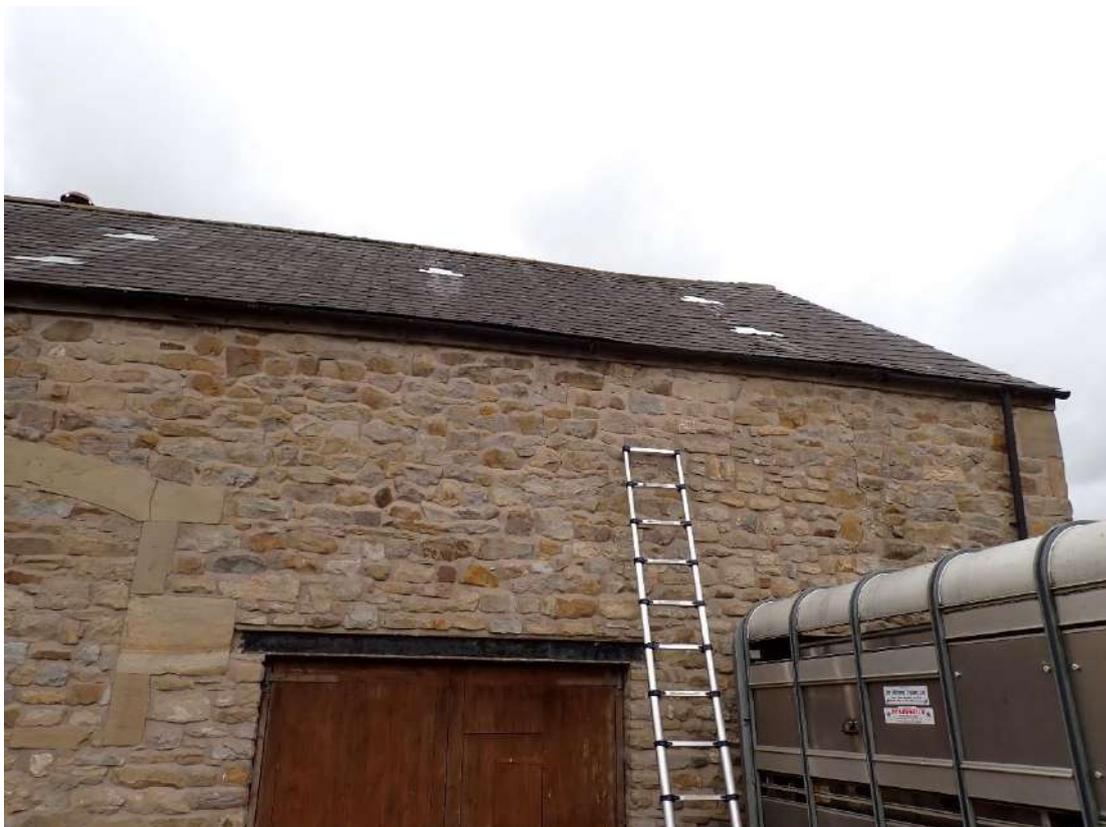
Photograph 25 – View of the cavity extending up to the wall plate, located behind the fascia board on the southern aspect of Building 3.

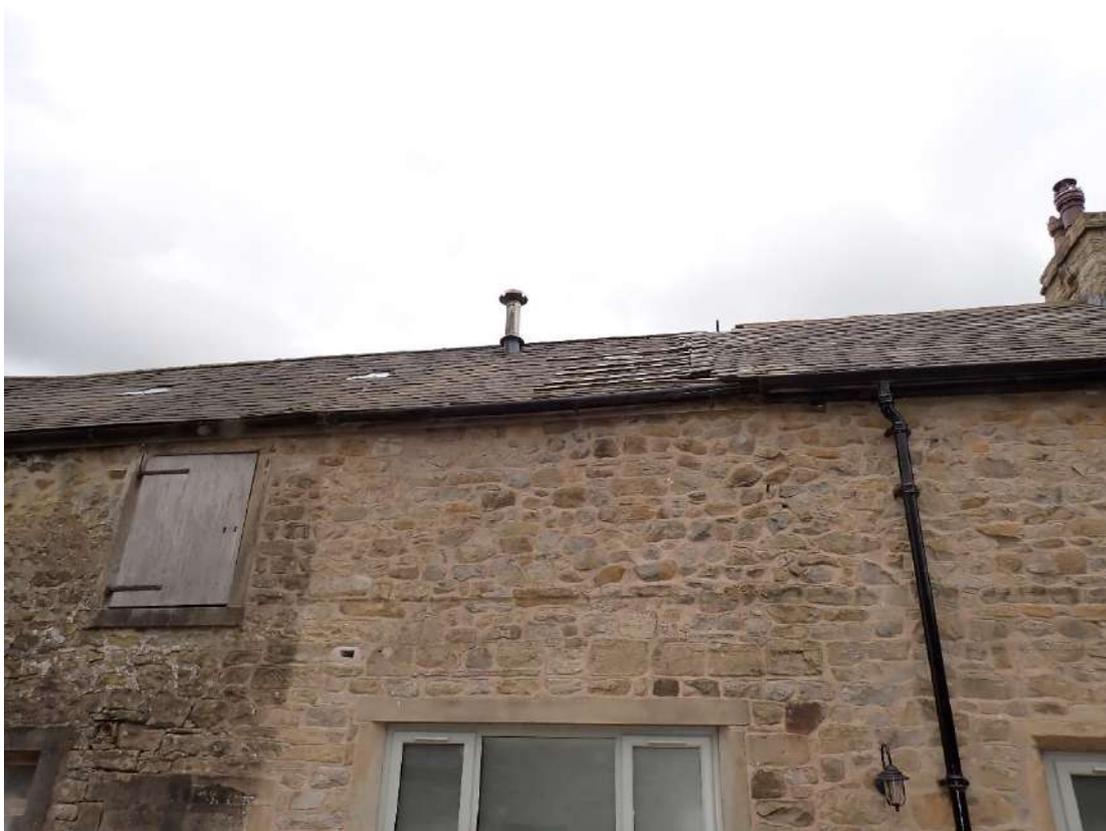
Photograph 26 – View of the location where droppings were observed on the southern aspect of Building 3.

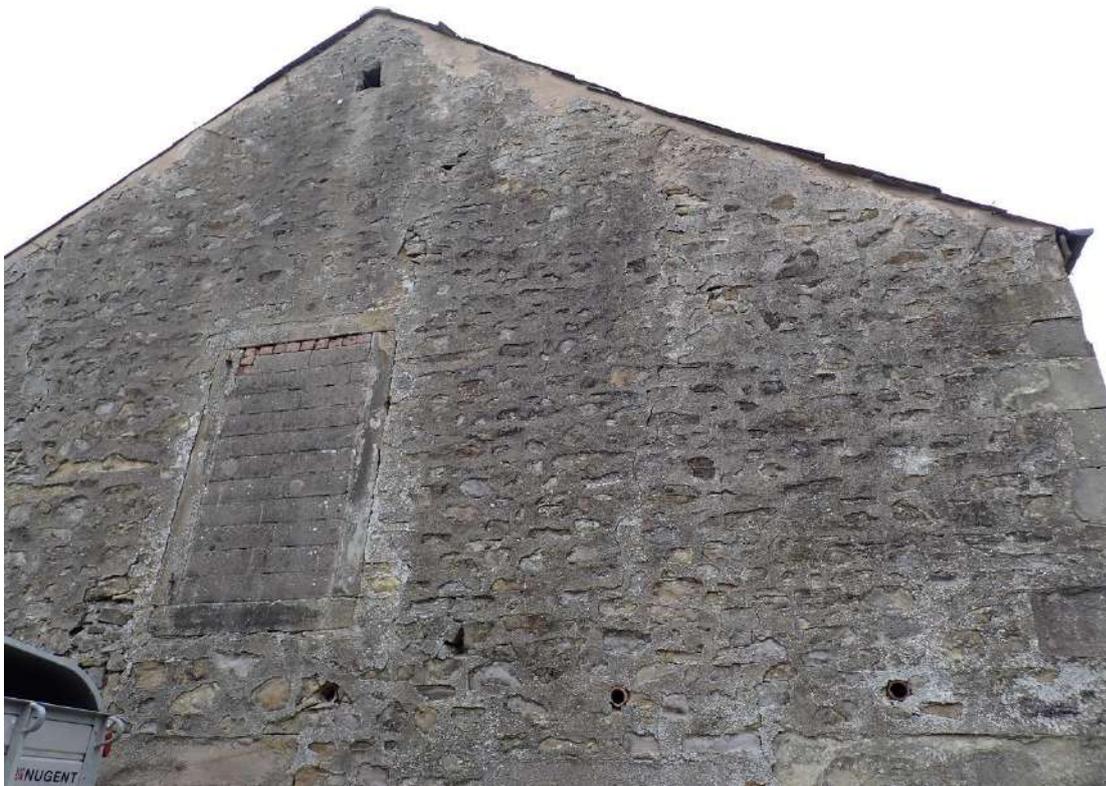
Photograph 27 – View of the PRF formed by cracks in the brickwork on the northern aspect of Building 3, where the newer extension meets the older barn.

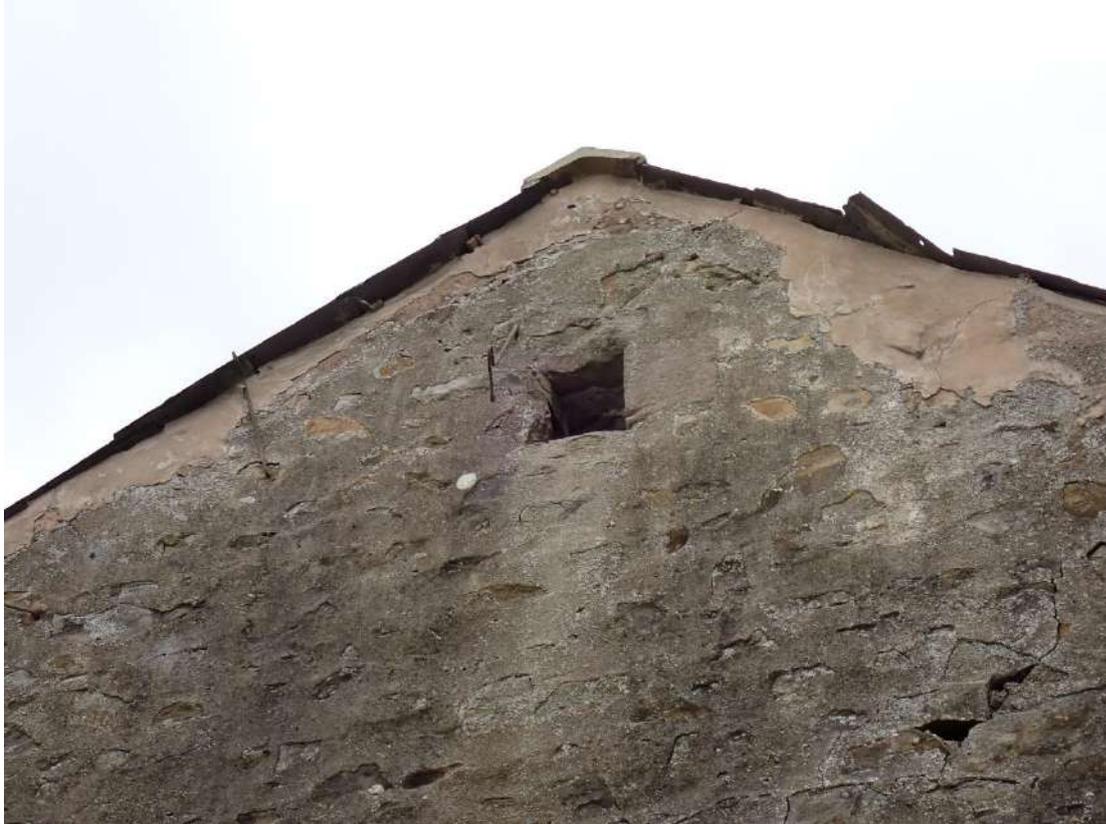
Photograph 28 – View of the PRFs formed from ventilation gaps on the eastern gable end of Building 3.

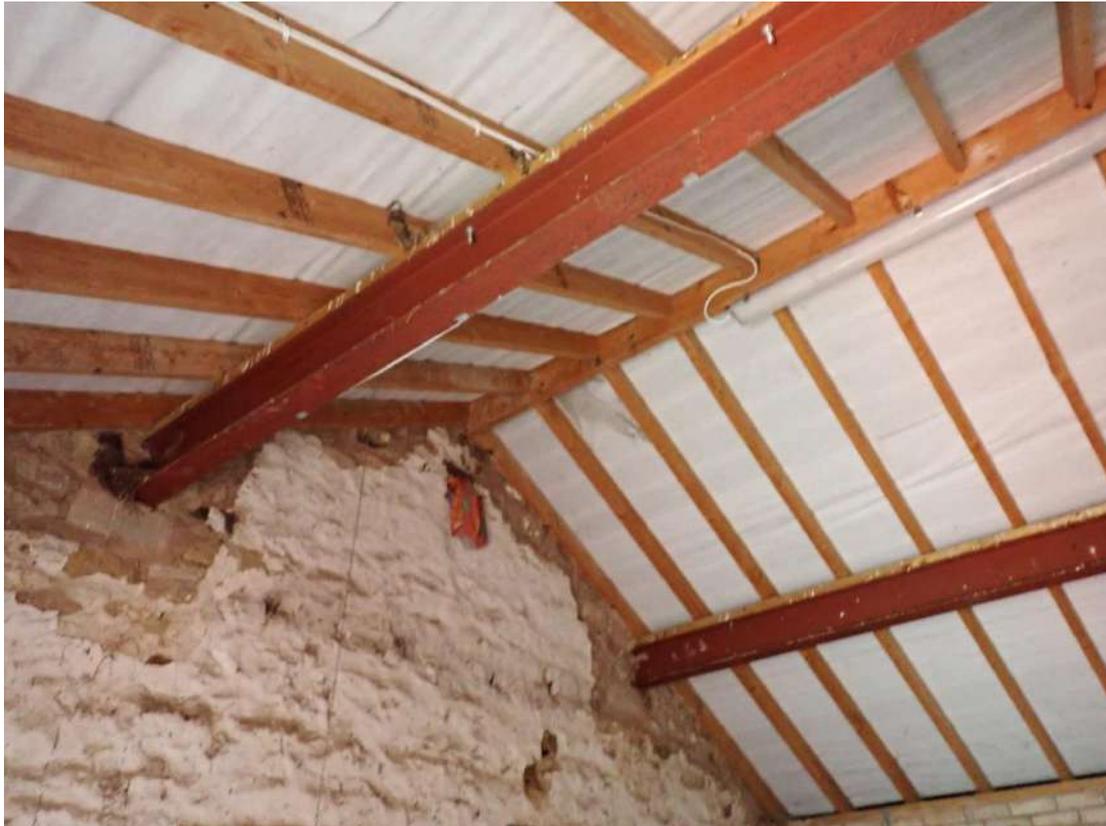
**Roost 2** – Bat droppings were observed within the loft void of Building 2 and were later confirmed to be from common pipistrelles through DNA analysis. Bats were not observed to be using the roost during the presence / absence surveys and so the access points could not be identified. However, due to the location of the droppings within the loft space and the presence of a cavity at the eaves on the southern aspect, this is considered to likely be the access point. Due to the low number of droppings, this is considered to be a day roost used on an occasional basis by a low number of bats.

Photograph 38 - View of bat droppings located on the walls at the gable ends of loft void of Building 2.

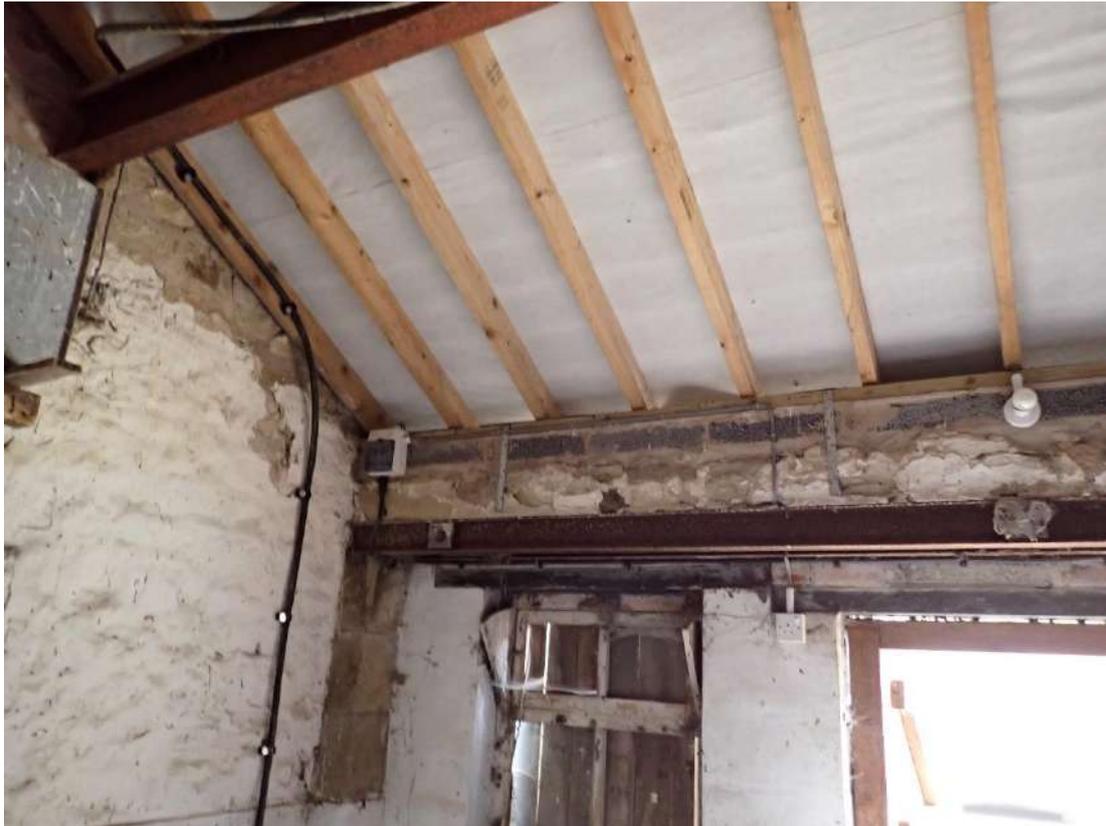
Photograph 40 – View of the PRFs in the gable ends where the timber of the roof ends.

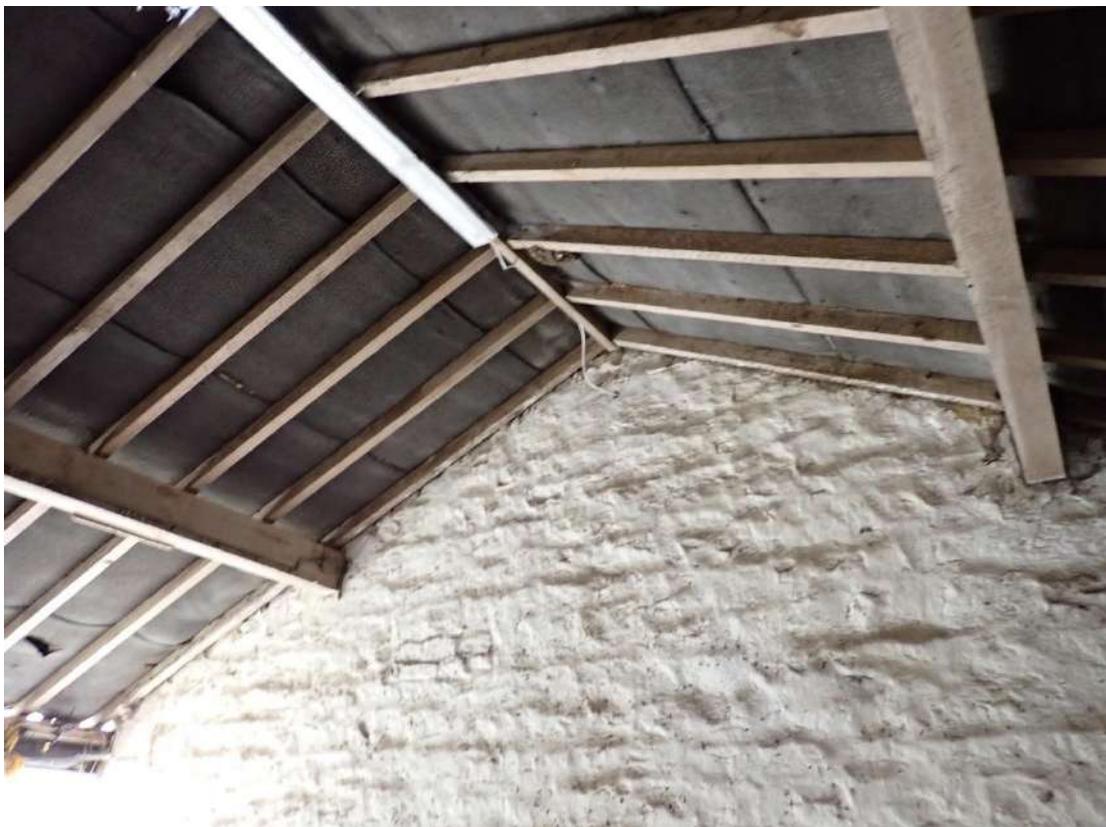
Photograph 41 - View of the gaps above the wall plate in the western room of the pig styes of Building 2.

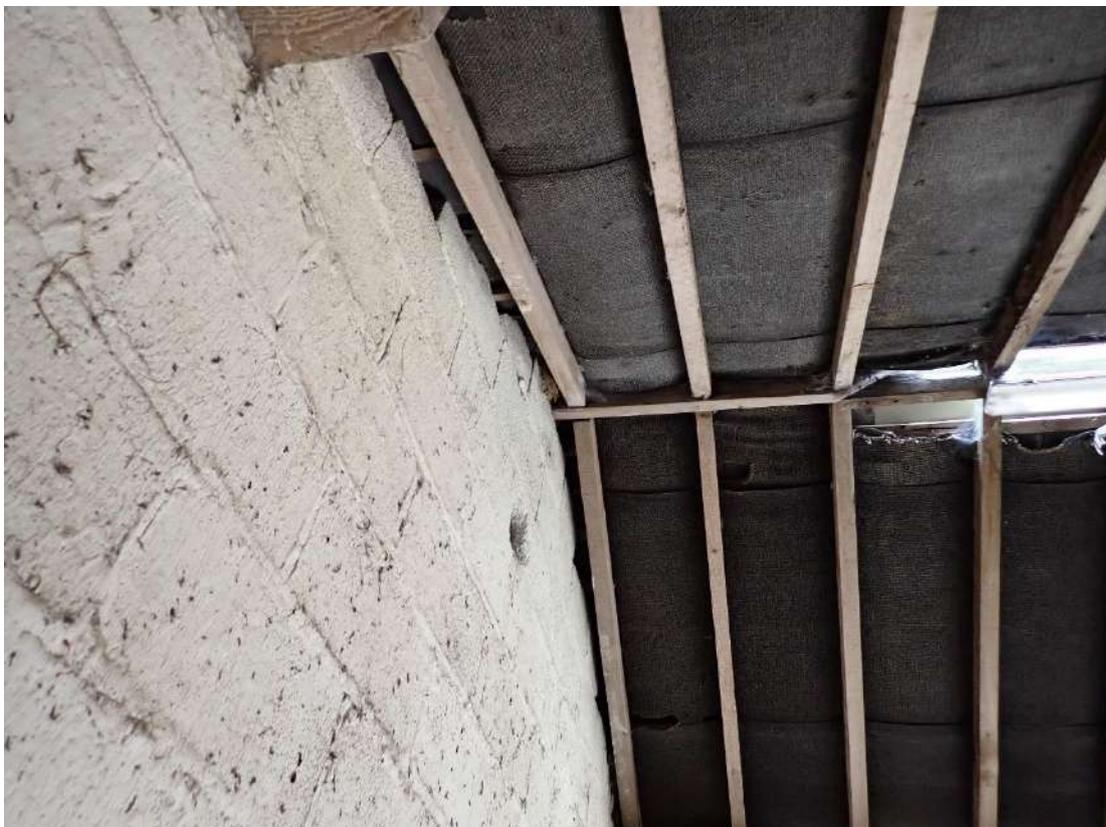
Photograph 43 - View of the damaged section of the bitumen lining of the middle room of the pig styes in Building 2.

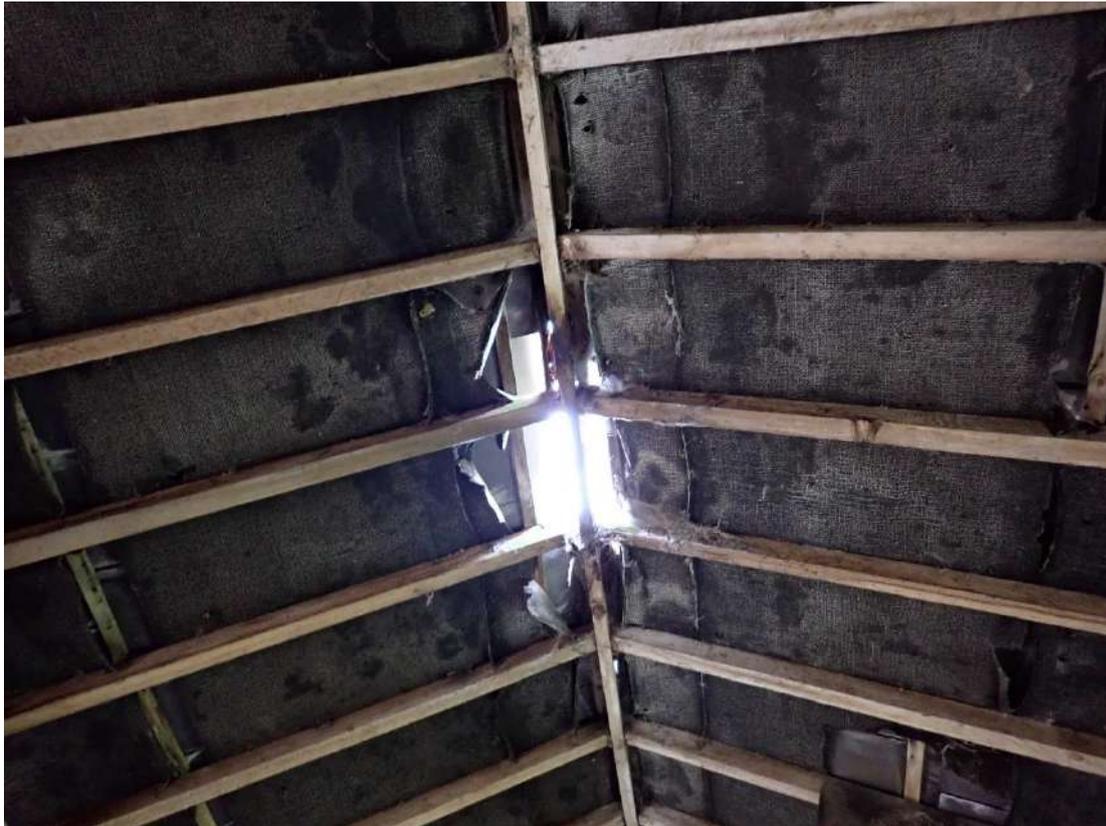
Photograph 44 – View of the gaps between the tiles and the bitumen lining forming PRFs in the middle room of the pig sty section of Building 2.

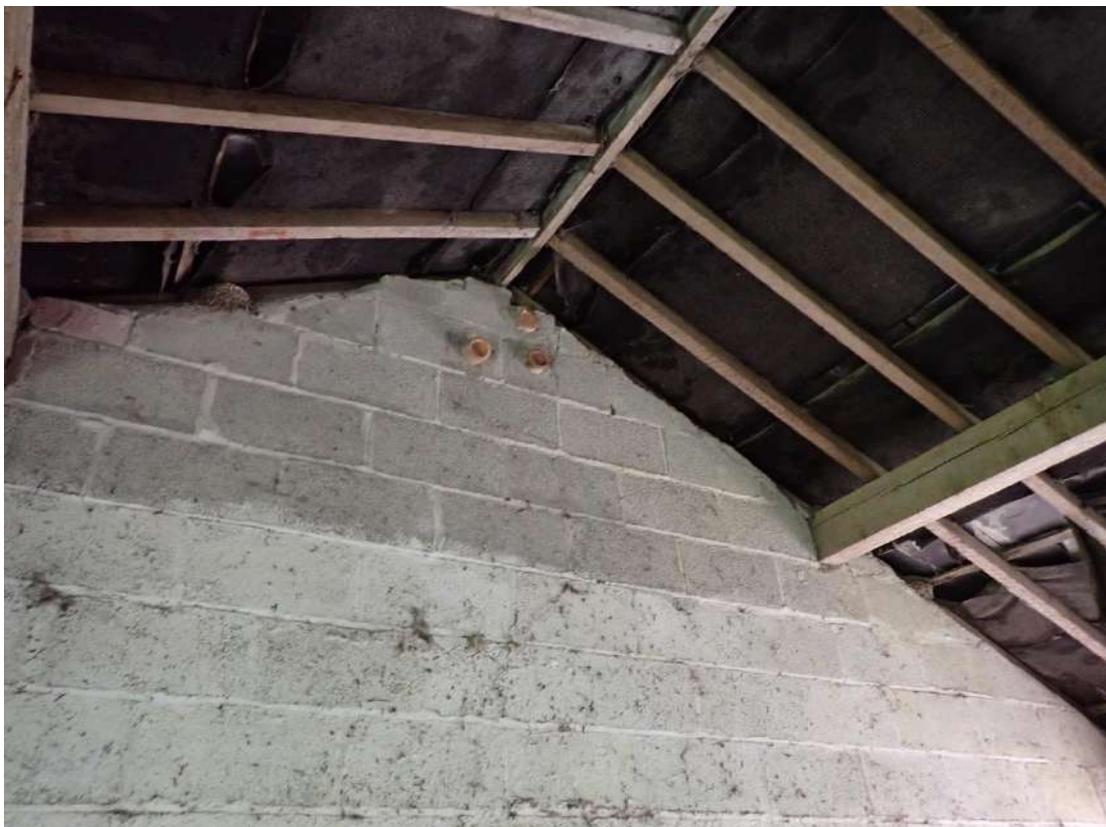
Photograph 45 – View of the damaged bitumen lining in the eastern room of the pig sty section of Building 2.

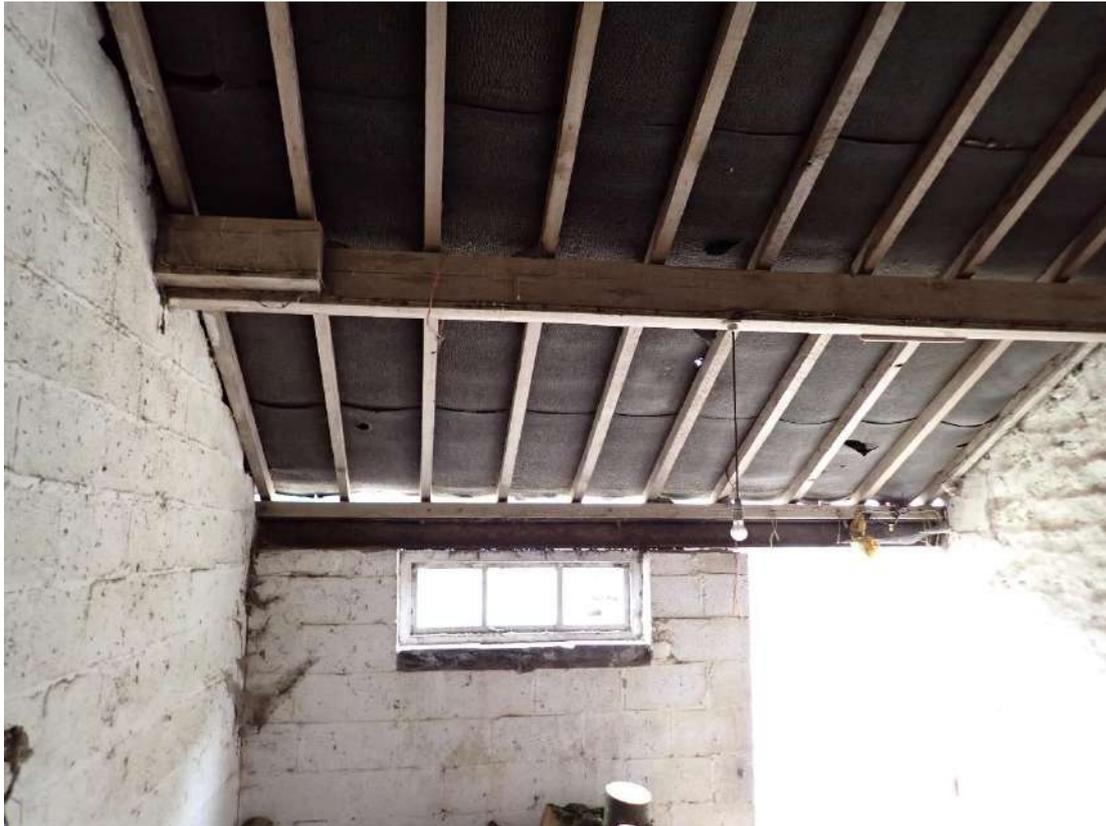
Photograph 46 - View of the damaged sections of the brickwork in the internal walls of the pig sty section of Building 2 leading to the wall cavity.

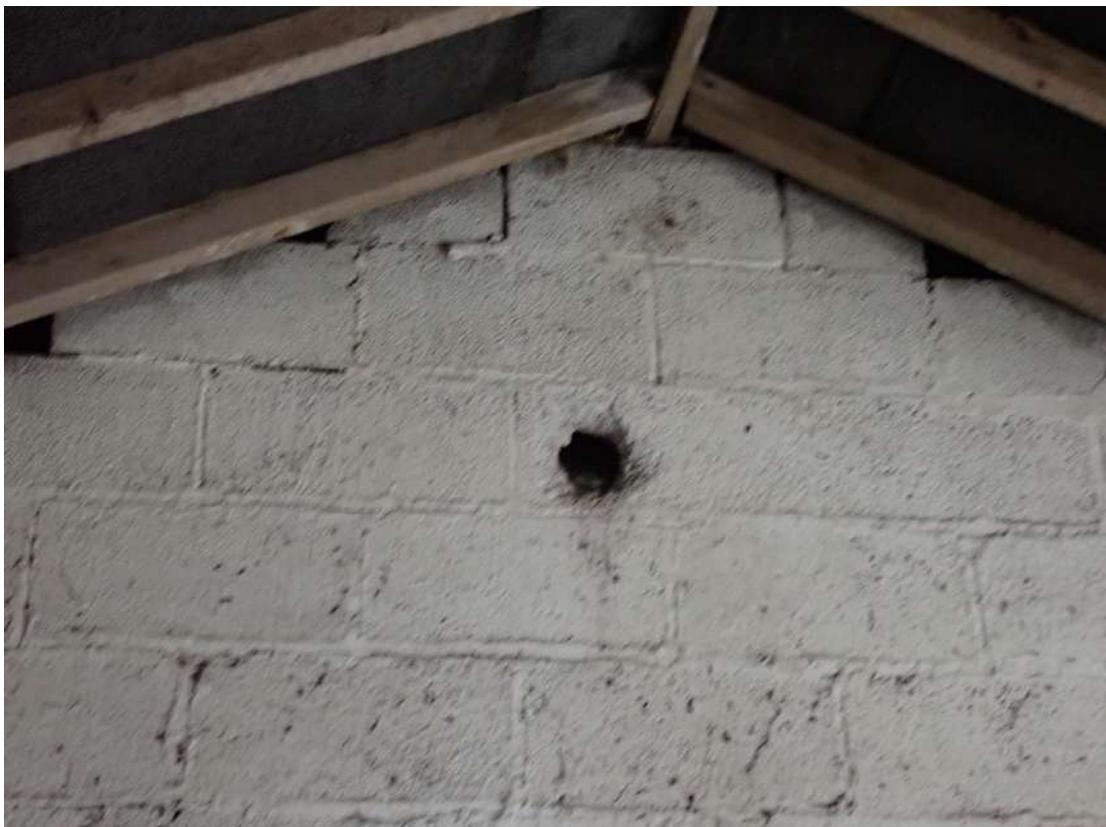
Photograph 47 – View of the gap in the wall above the final brick and the beam allowing access into the wall cavity of the eastern room of the pig sty section of Building 2.

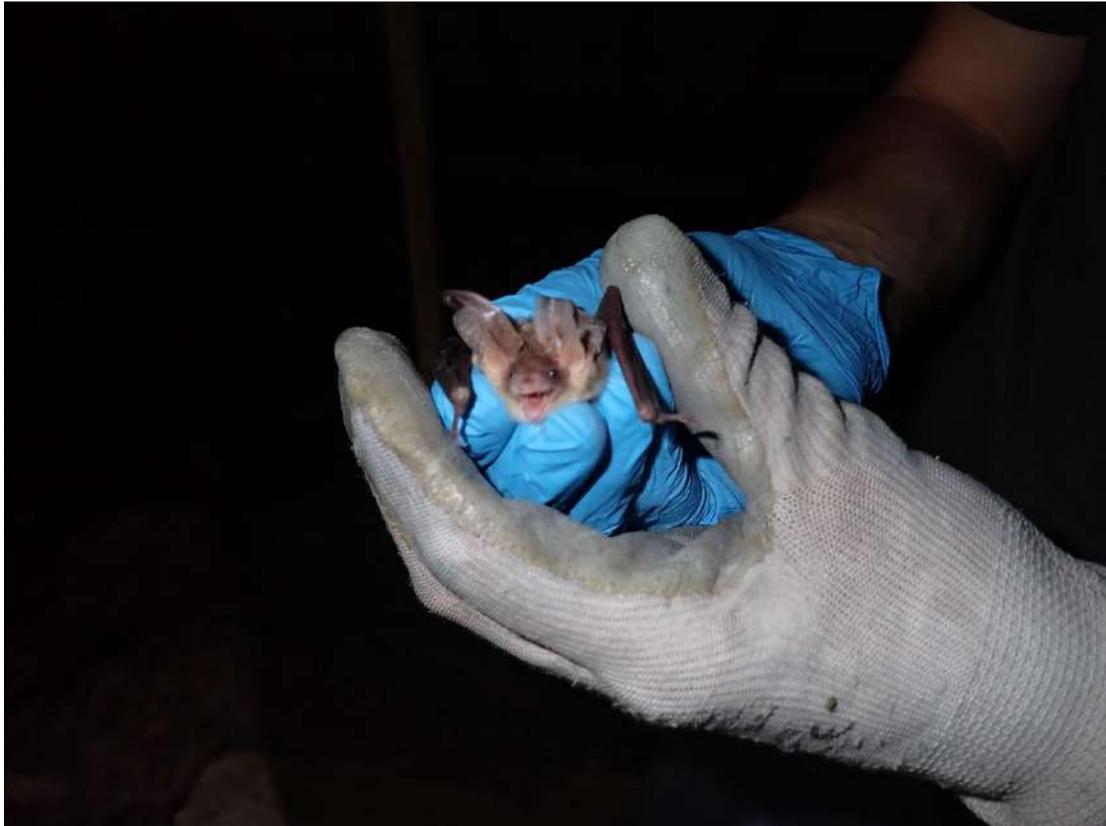
**Roost 4** – A brown long-eared bat roost located in the loft space of Building 3. This roost was identified during the internal building inspection when a bat was observed within the loft space. The access point of this roost could not be determined since no bats were recorded emerging from this location during the surveys. This is considered to be a day roost used on an occasional basis by a single bat.

Photograph 52 – View of the brown long-eared bat on the breathable membrane lining the loft in the farmhouse section of Building 3.

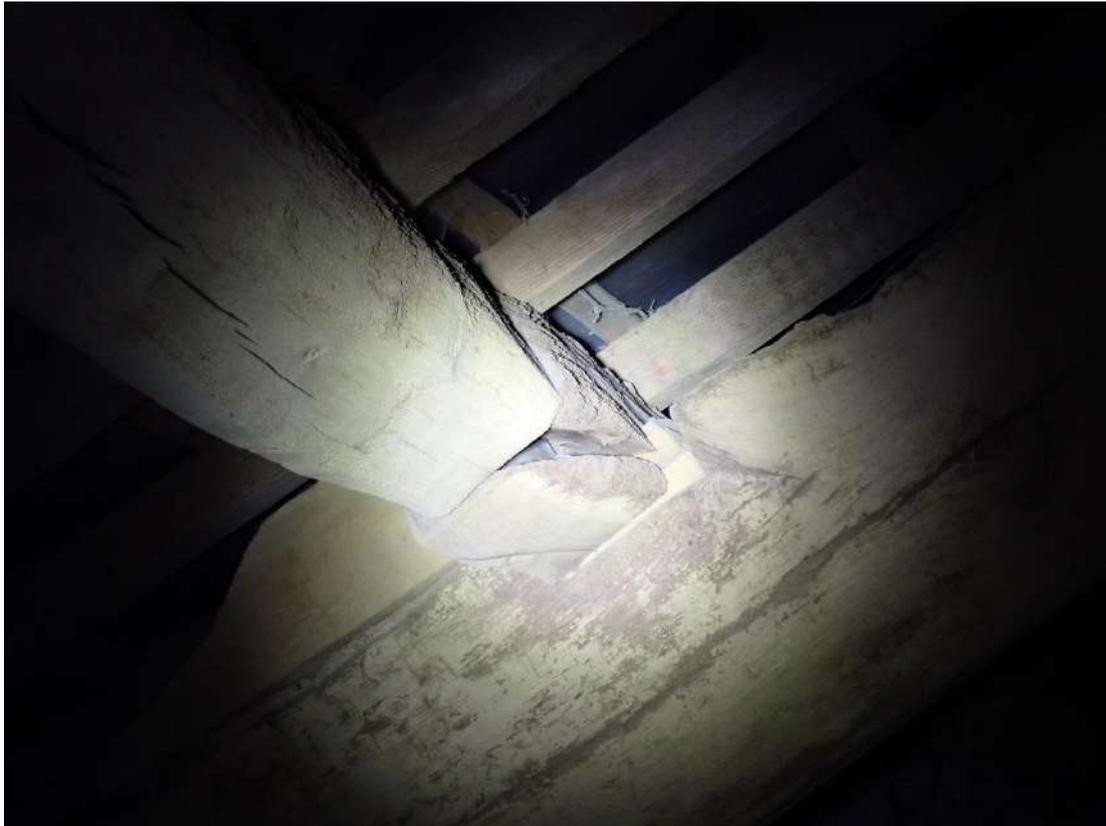
Photograph 58 – View of a PRF in the form of a gap around mortice joints in the wooden beams in the barn section of Building 3.

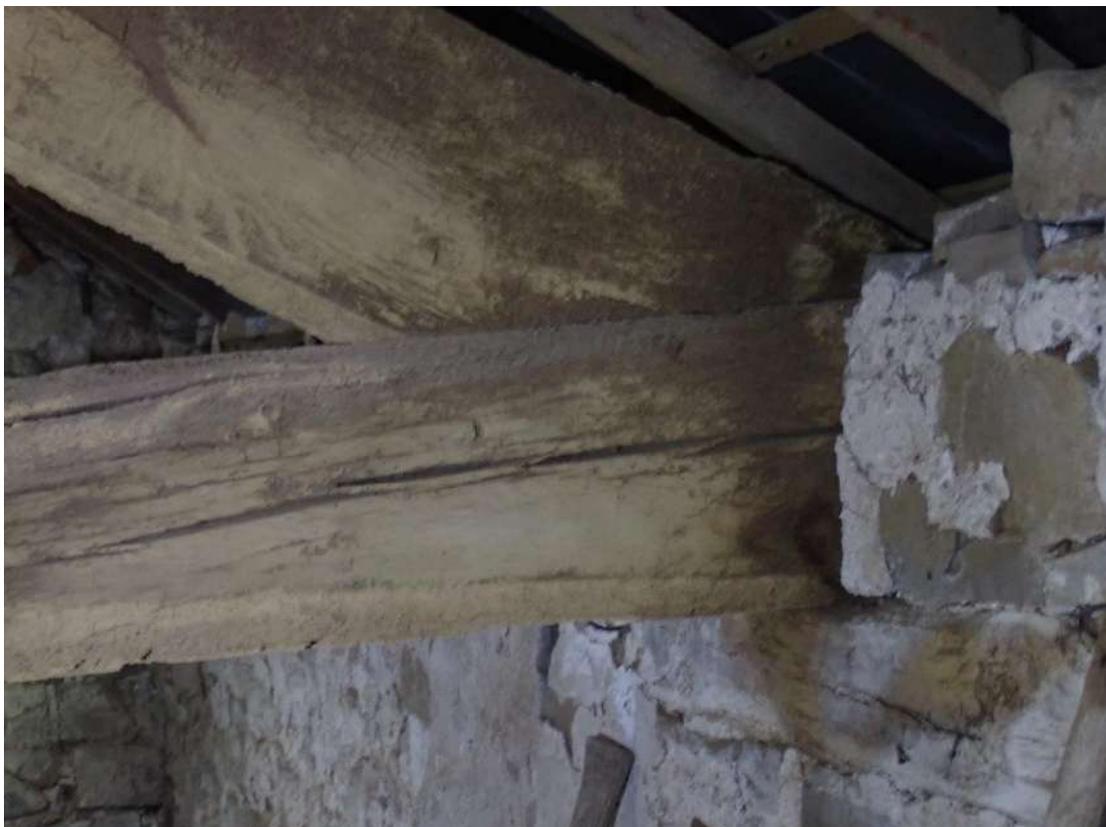
Photograph 59 – View of a PRF formed by ill-fitting joints in the timber structure of the barn section of Building 3.
