**BAT PRESENCE / ABSENCE SURVEY**

**Black Moss Farm**

Elmridge Lane  
Chipping  
Preston  
Lancashire  
PR3 2NY

Date: 9<sup>th</sup> September 2024  
UES reference: UES03941/08

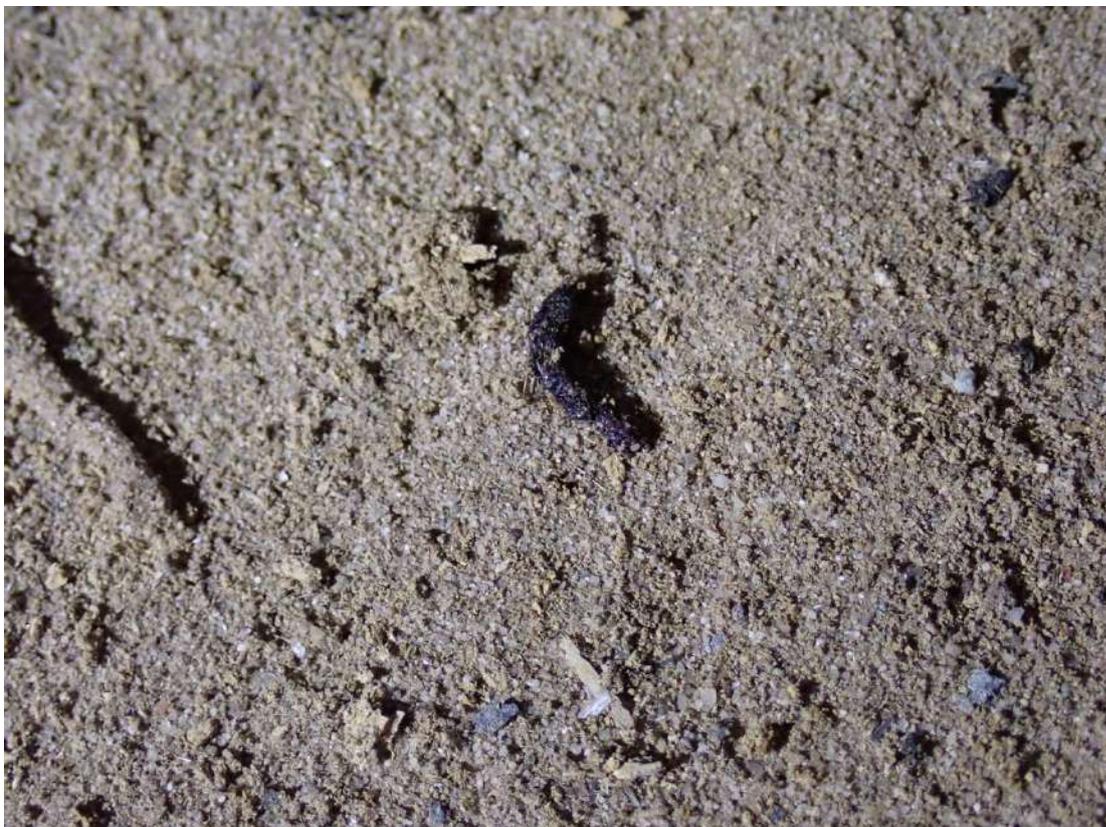
Photograph 63 – View of the bat droppings scattered throughout the first floor of the barn section of Building 3.

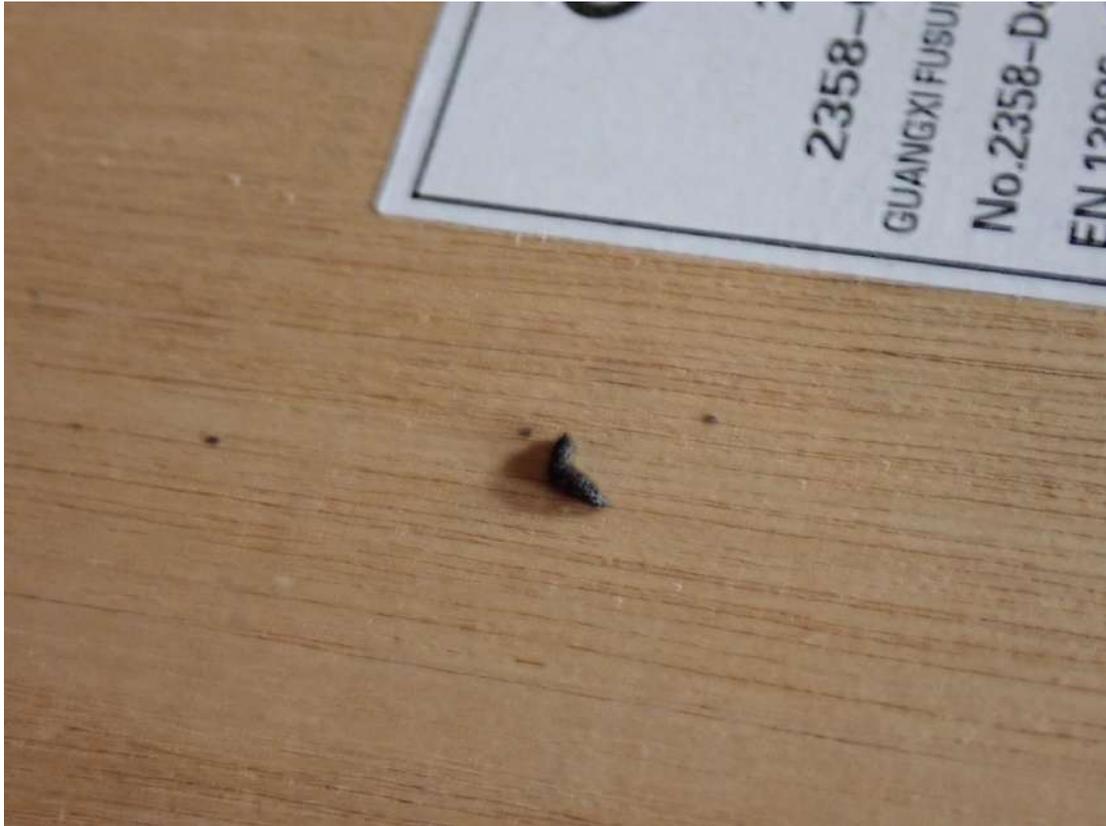
Photograph 64 – View of the fresh droppings located in the barn section of Building 3.

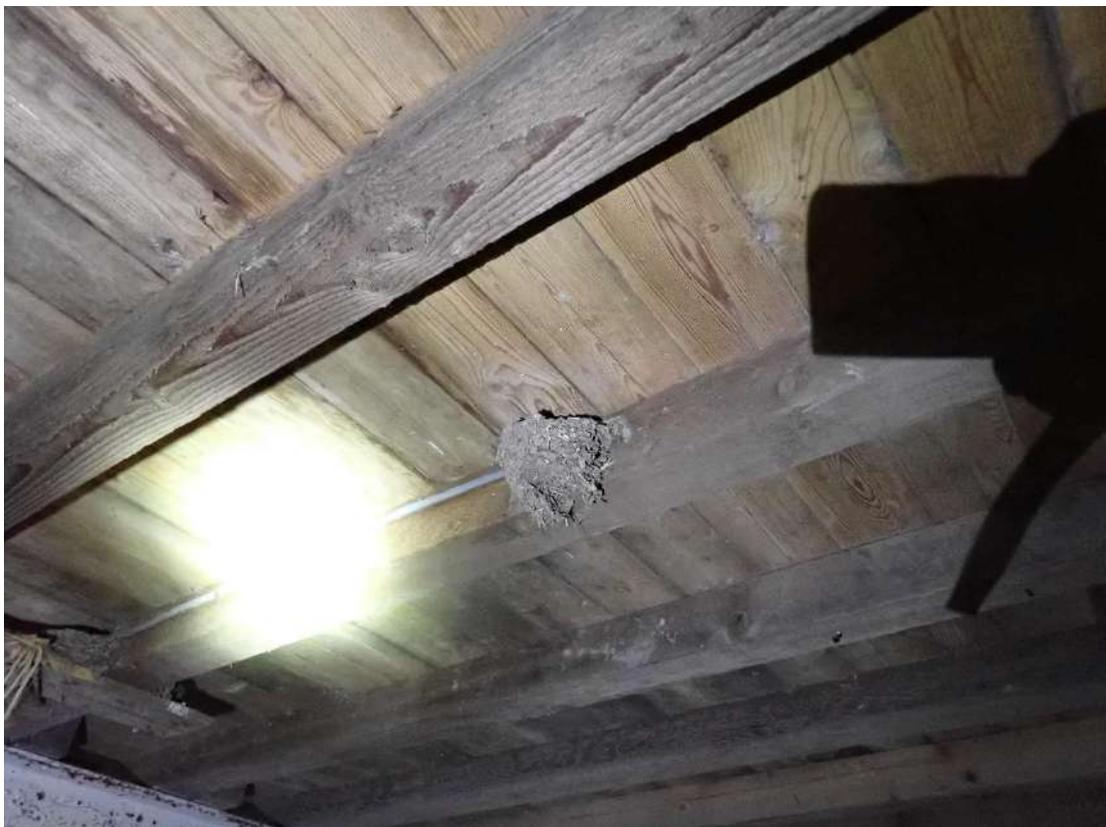
Photograph 65 - View of a bat dropping located in the ground floor of the barn section of Building 3.
