# Preliminary Roost Assessment

65 Mitton Road  
Whalley  
Lancashire  
BB7 9RY

# Gritstone Ecology

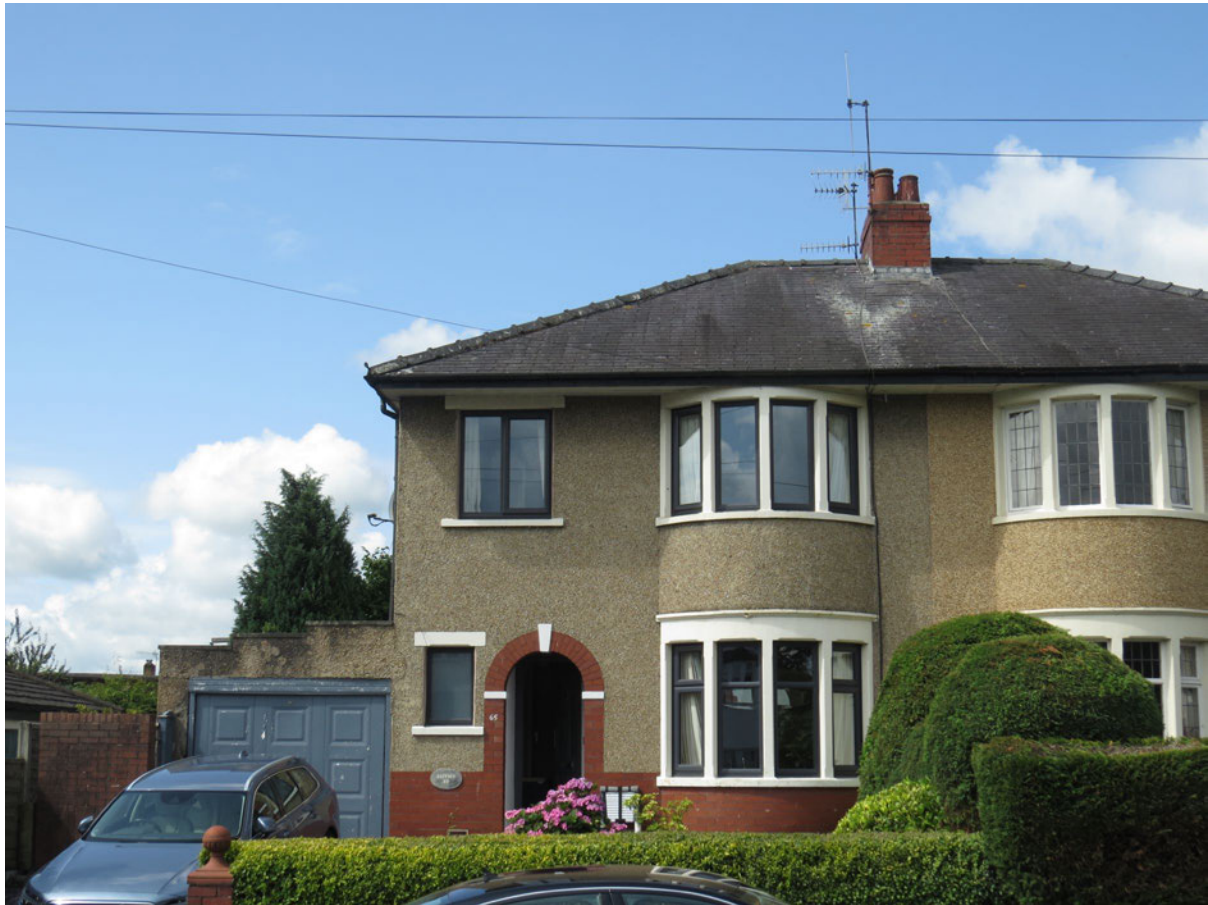
3.1a – The front of the house.

Nº65 Mitton Road, Whalley, is a pre-1950's semi-detached house, which is currently occupied. It has a pitched, hipped, roof, covered with slate roof tiles and ceramic ridge tiles. Ground floor extensions to the side and rear have single pitched roofs covered with slate tiles. The garage has a single pitched roof covered with corrugated asbestos cement panels. There is a UPVC and glass conservatory to the rear.

The building was constructed to a high standard, it is well maintained, and in good condition. Ridge tiles are fixed tightly, there are no damaged or missing ridge tiles. There are no damaged, slipped, or missing roof tiles. Roof tiles are tightly fitted, with no gaps between tiles. Timber fascia boards and boxed soffits are fitted tightly against the walls with no gaps. Walls and render are in good condition, with no missing mortar or cracks.

There are no features externally which are likely be used by roosting bats, and no evidence of use by bats was present during the inspection.

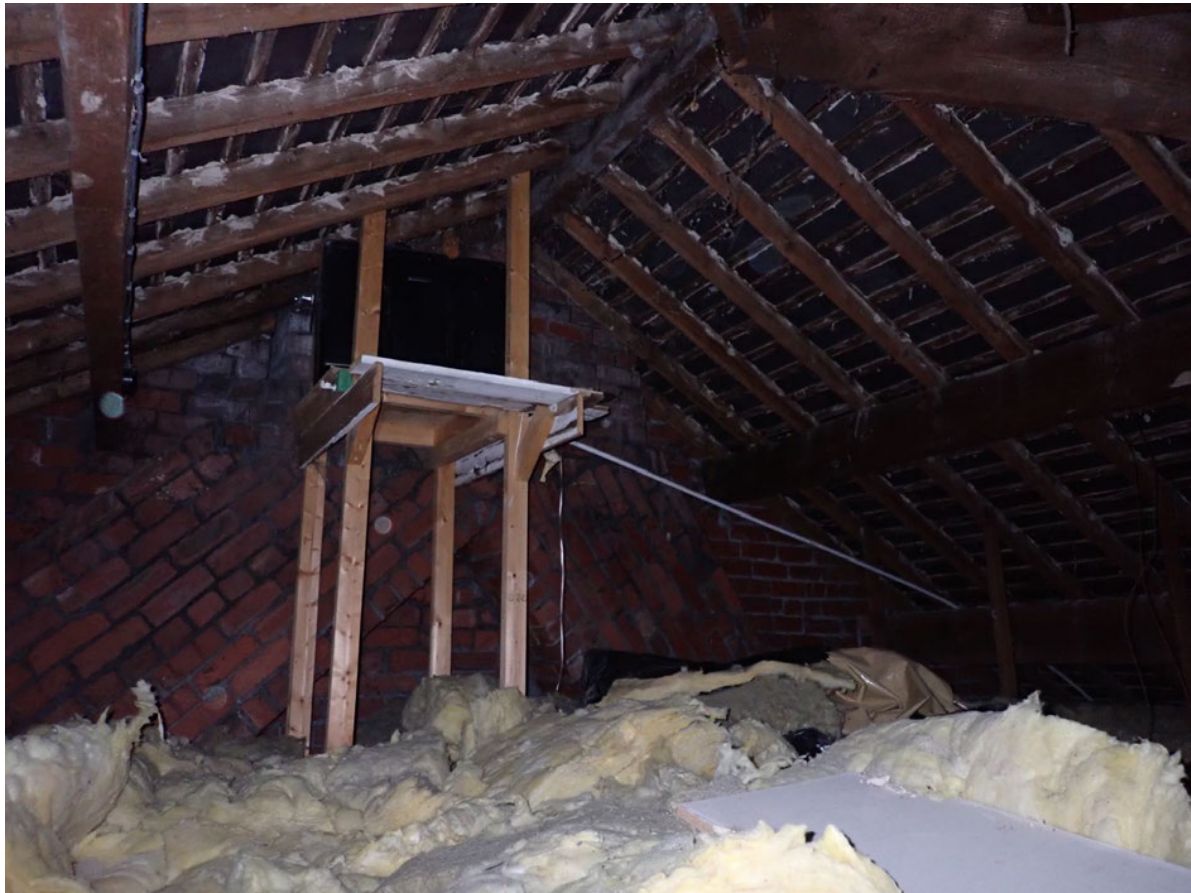
3.2a – The roof void.

The house has a single roof void, which is not used for storage, it is undisturbed, and is only accessed for essential maintenance.

The roof has a timber rafter and purlin structure, which is not lined, and the underside of tiles and timbers is exposed. The loft is insulated with mineral wool between ceiling joists. The roof is in good condition with no obvious gaps.

The wall cavity has been filled with insulation and was inspected at the wall plate using an endoscope. There are no gaps at the wall-plate; and there are no gaps which give direct access to the roof void from the outside. Boxed soffits open into the roof void and were inspected from above.

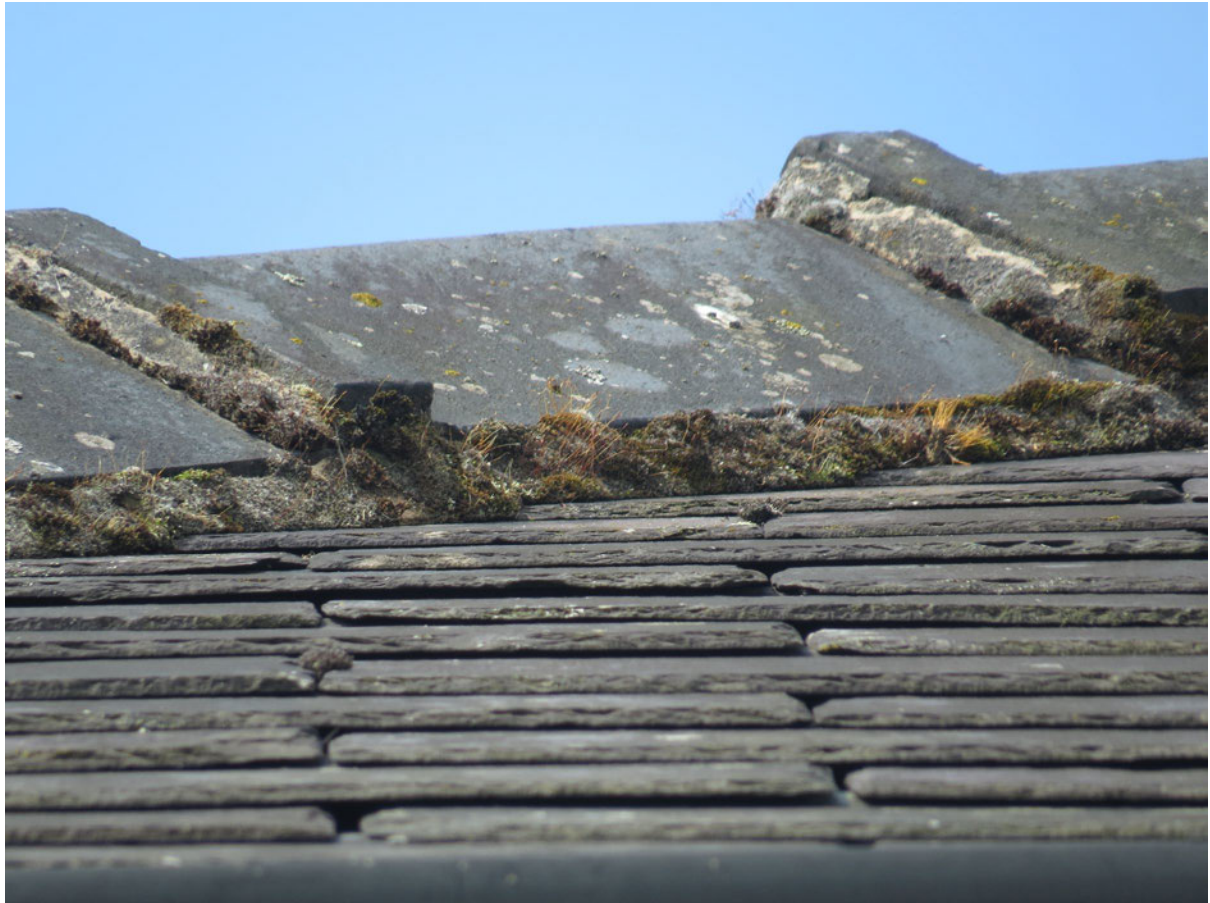
Roof and ridge tiles are in good condition; ridge tiles are sealed with cement. There are no gaps between roofing materials which could be used by roosting bats.

3– Roof and ridge tiles are in good condition with no suitable gaps.

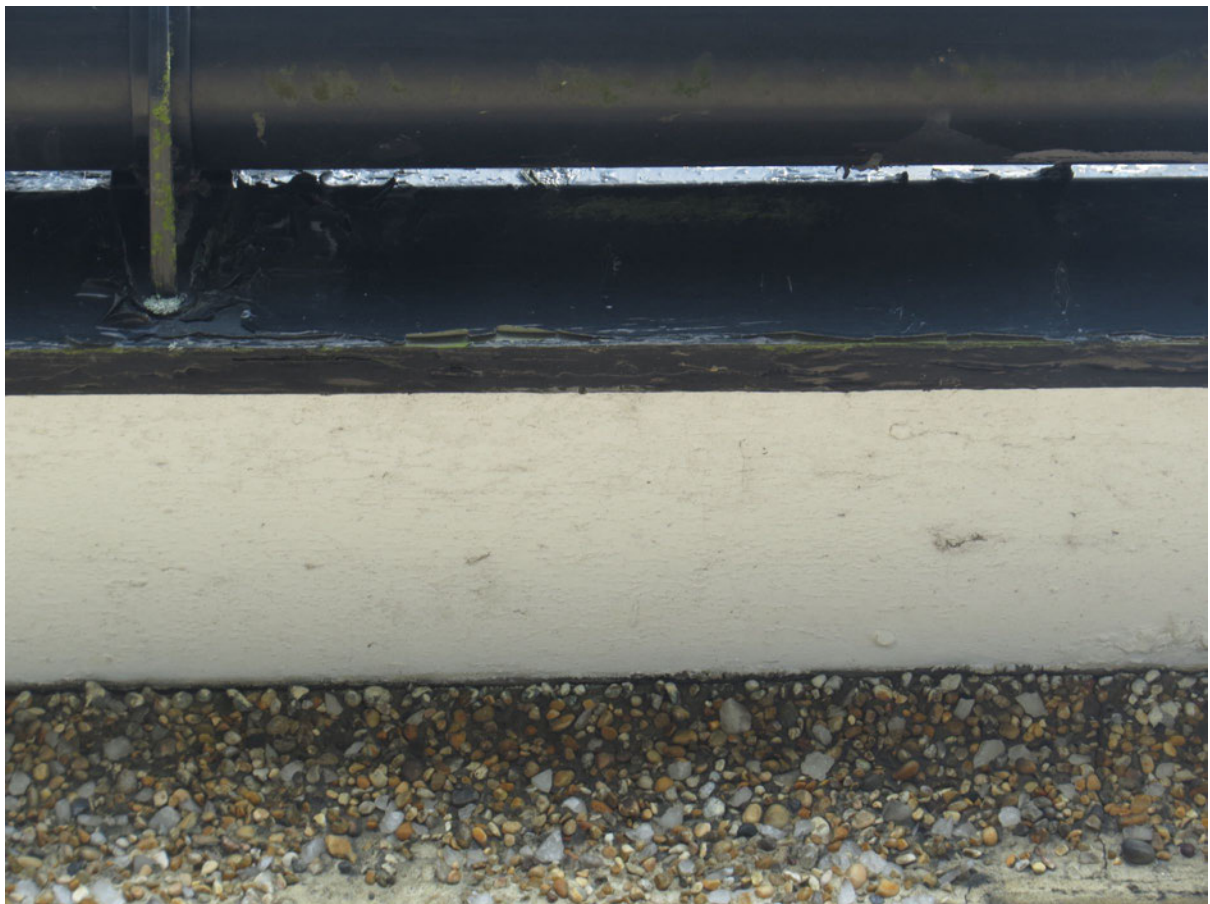
Timber fascia boards and boxed soffits at the eaves are fixed tightly against brickwork, with no suitable gaps; wall cavities and boxed soffits open into the roof void, and were inspected from above.

4 – Timber fascia boards and soffits at the eaves are fixed tightly against brickwork.

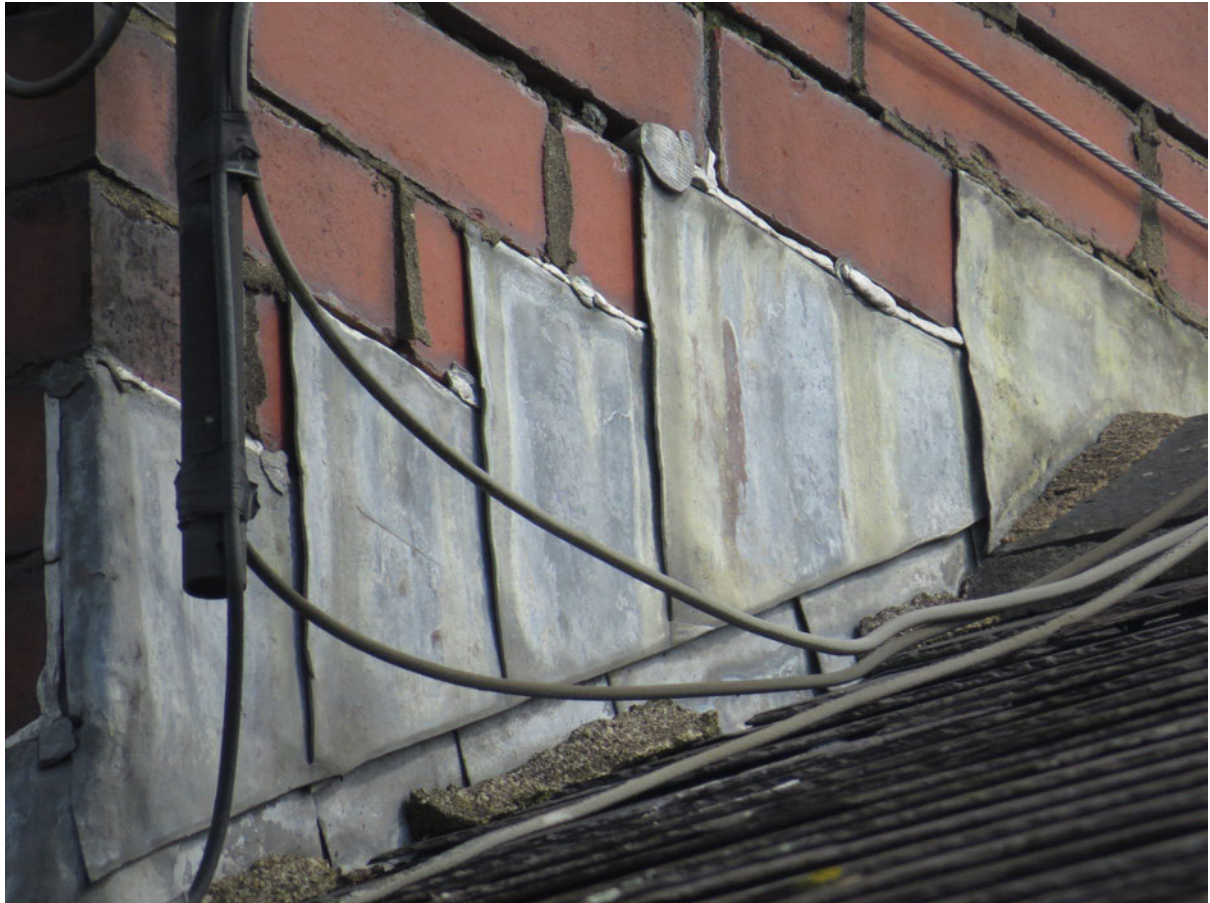
5 – Lead flashing is fitted tightly with no suitable gaps.

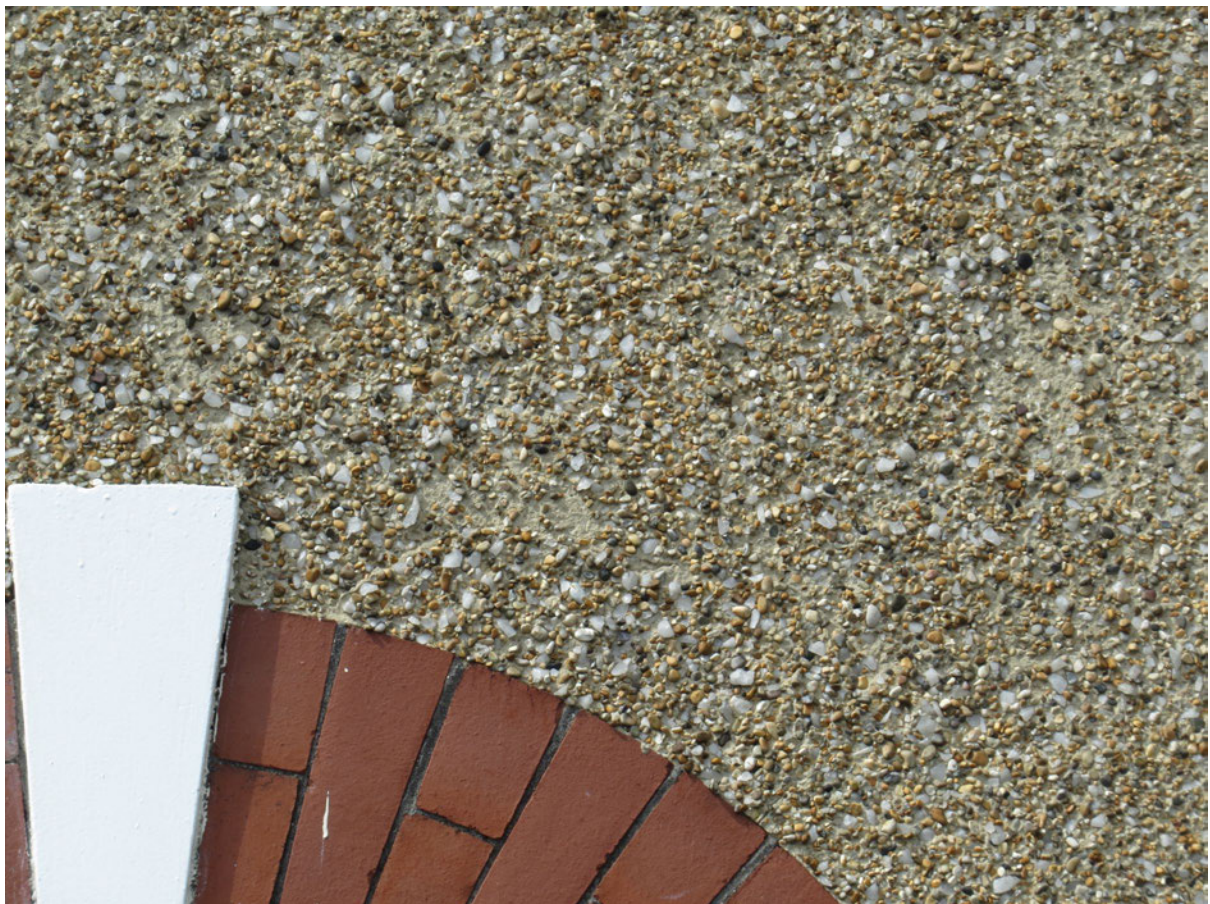
Walls are brick with an insulating cavity. The wall cavity has been filled with insulation. Walls are in good condition, with no cracks, or missing mortar which could be used by crevice dwelling bats.

6 – Brickwork and render are in good condition with no suitable gaps.

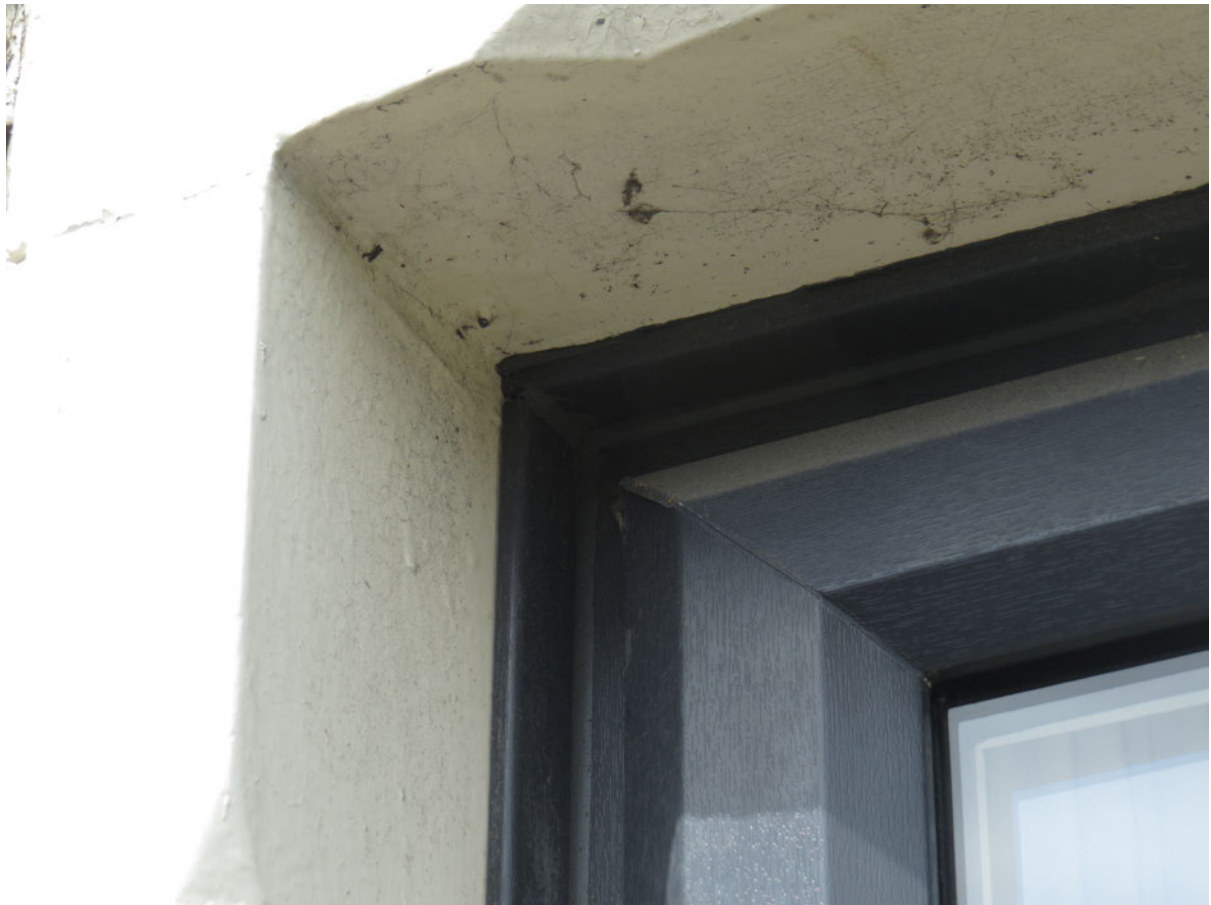
Window and door frames are fixed into the brickwork, gaps are filled with sealant, and offer no suitable roosting opportunities.

7 – Window and door frames are tightly sealed into brickwork with no suitable gaps.

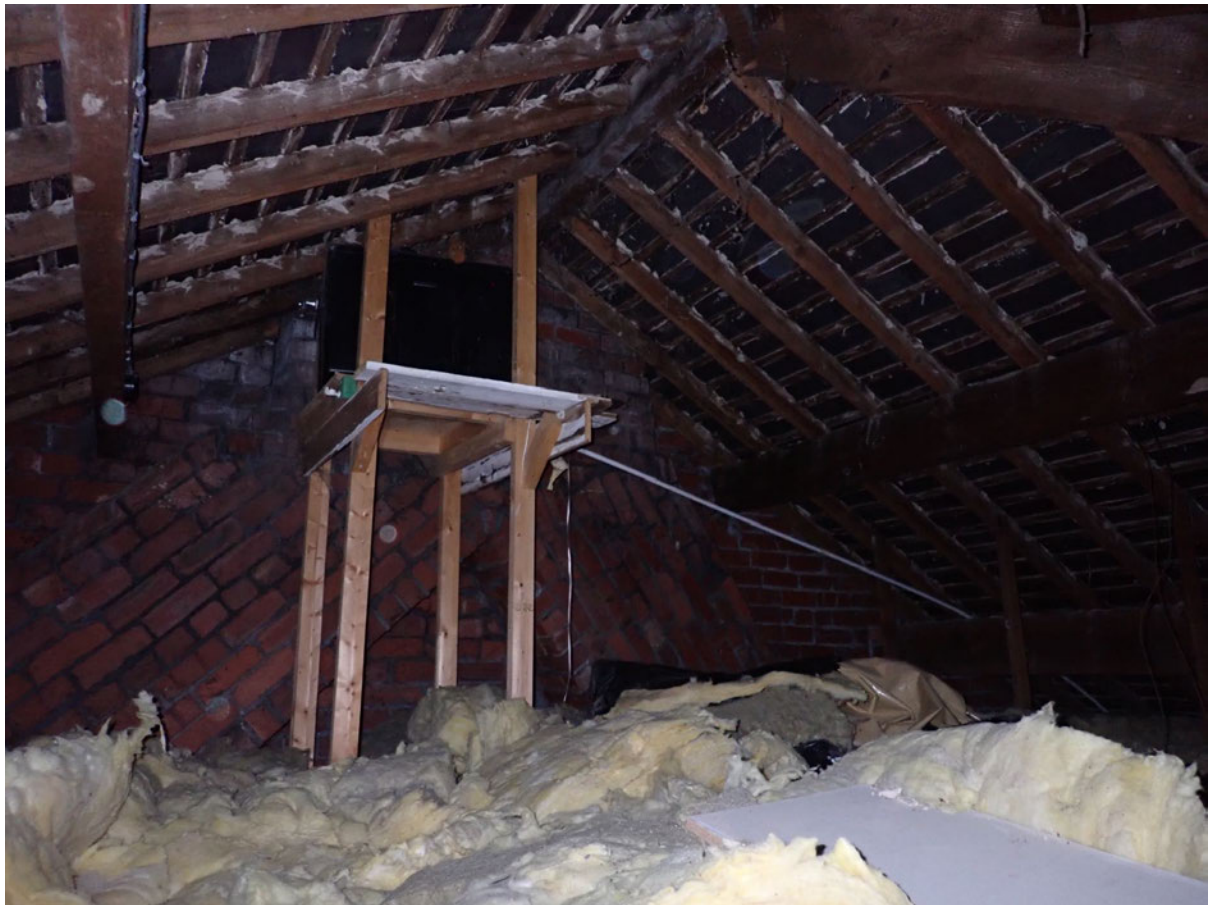
9 – The house has a single roof void which is not used for storage.

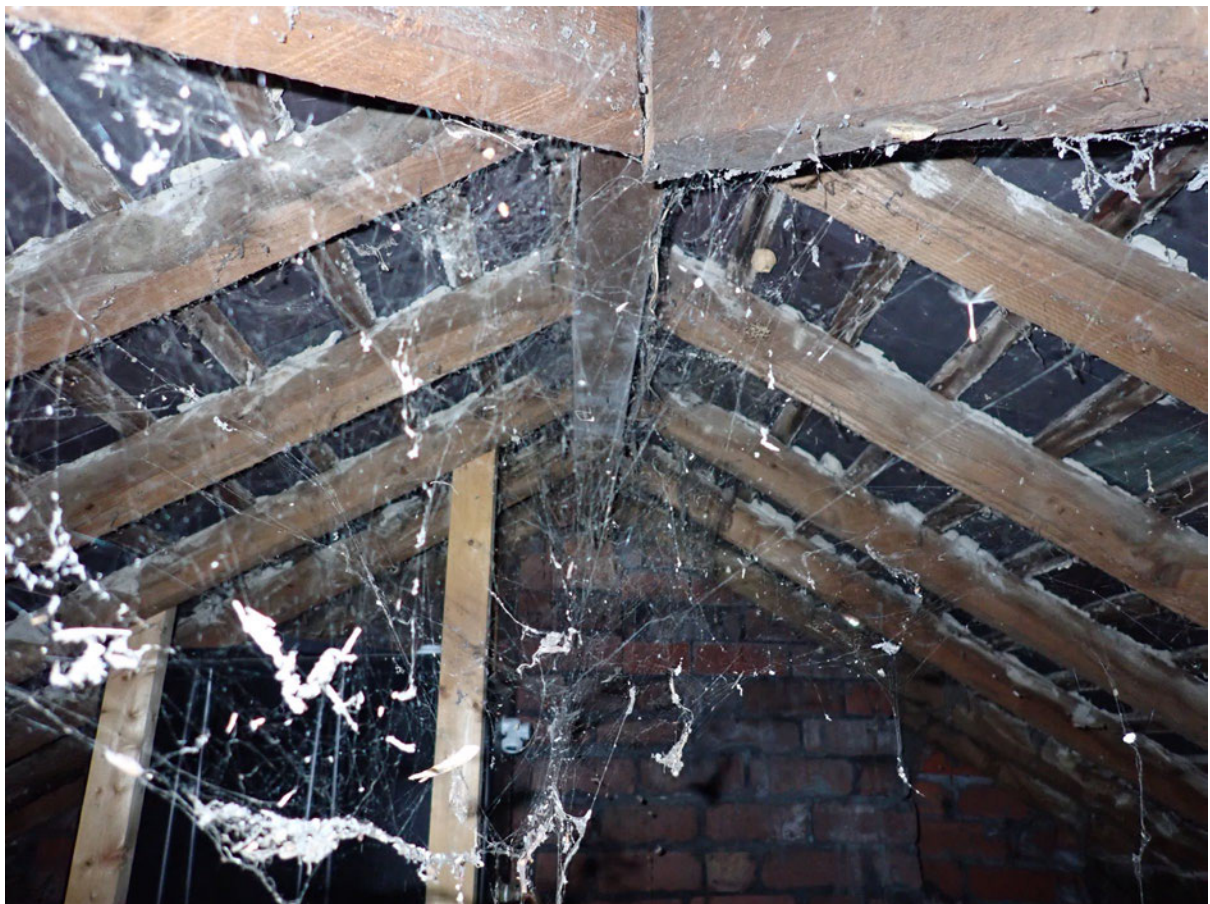
10 – Roof timbers are covered in dusty cobwebs.
