Tree Condition Report

Somerset Avenue,
Wilpshire,
BB1 9JD

08/11/2024

13/11/2024

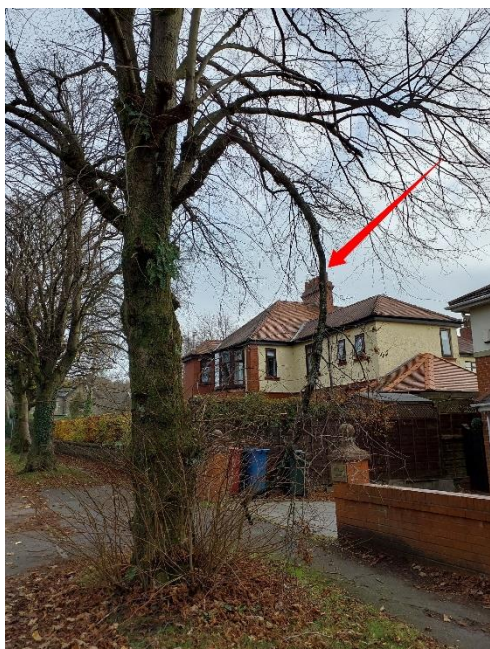
T10 – prune snapped branch
