Preliminary Roost Assessment

65 Mitton Road
Whalley
Lancashire
BB7 9RY

Gritstone Ecology

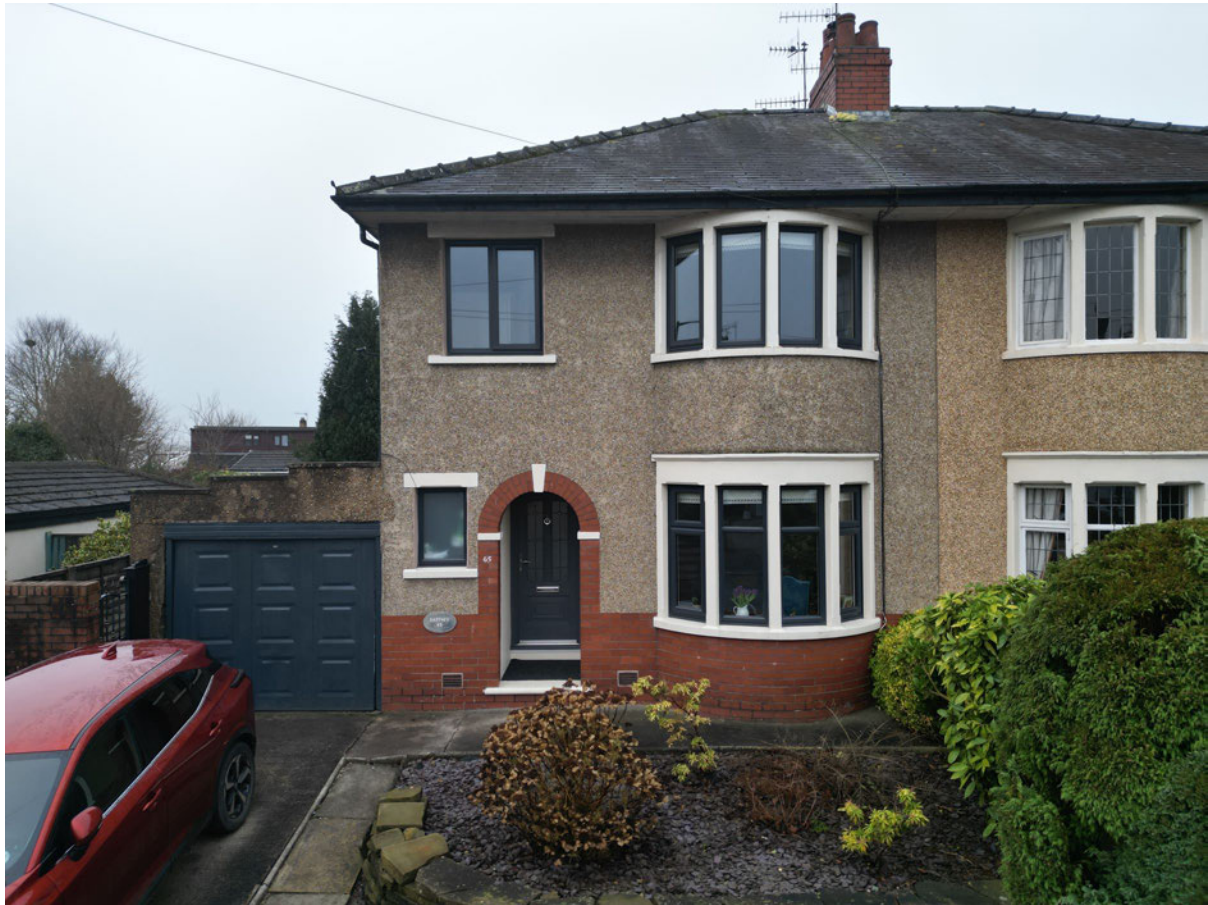
3.1a – The front of the house.

The building was constructed to a high standard, it is well maintained, and in good condition. Ridge tiles are fixed tightly, there are no damaged or missing ridge tiles. There are no damaged, slipped, or missing roof tiles. Roof tiles are tightly fitted, with no gaps between tiles. Timber fascia boards and boxed soffits are fitted tightly against the walls with no gaps. Walls and render are in good condition, with no missing mortar or cracks.

There are no features externally which are likely be used by roosting bats, and no evidence of use by bats was present during the inspection.

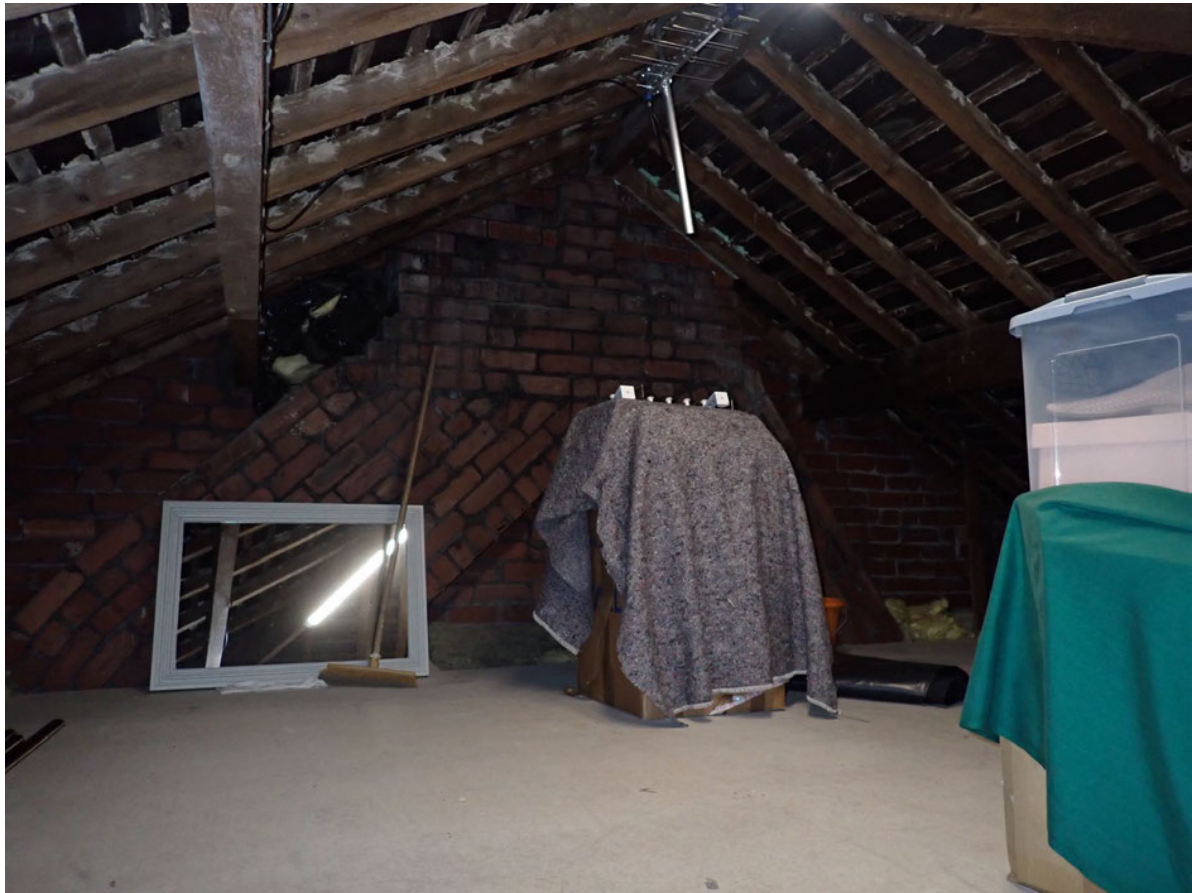
3.2a – The roof void.

The house has a single roof void, which is used for storage, and accessed for essential maintenance work. Since the 2023 survey the loft has been boarded, and gaps have been sealed using expanding foam.

The roof has a timber rafter and purlin structure, which is not lined, and the underside of tiles and timbers is exposed. The loft is insulated with mineral wool between ceiling joists. The roof is in good condition with no obvious gaps.

The wall cavity has been filled with insulation and was inspected at the wall plate using an endoscope. There are no gaps at the wall-plate; and there are no gaps which give direct access to the roof void from the outside. Boxed soffits open into the roof void and were inspected from above.

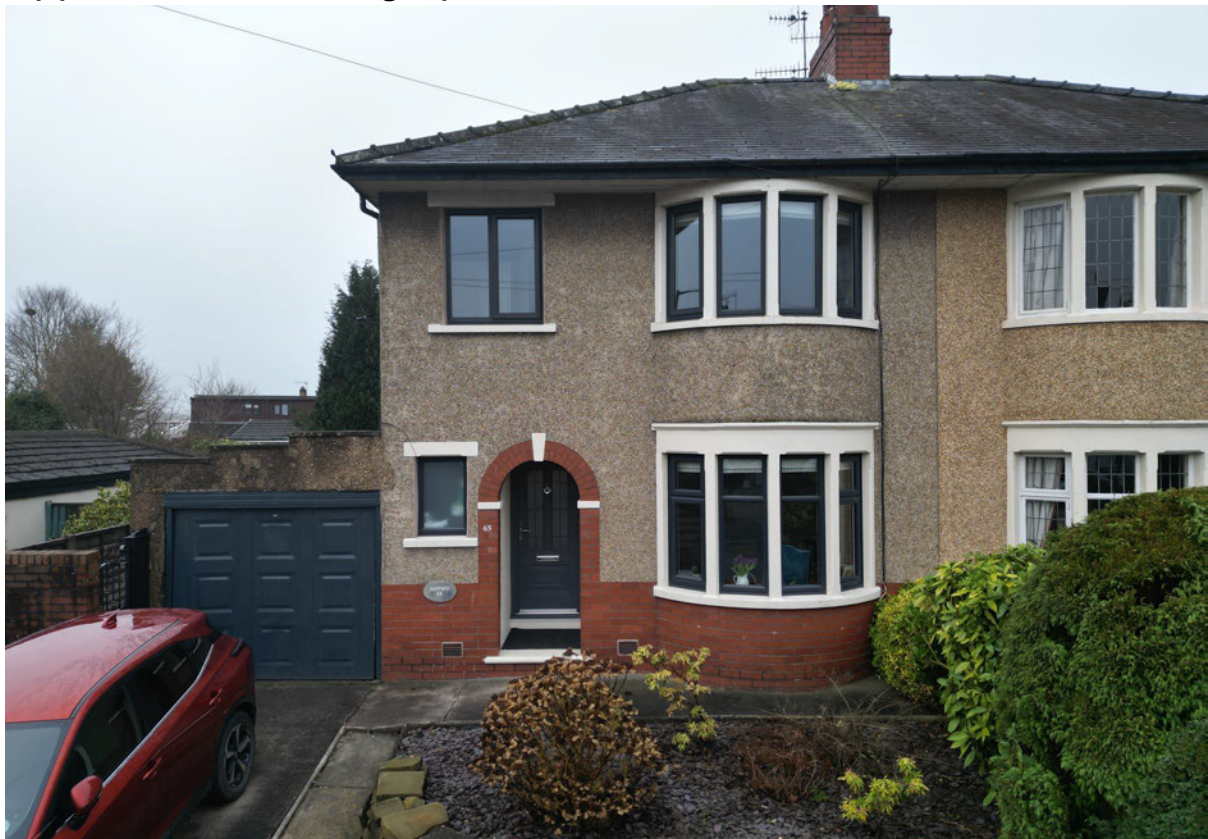
1 – The front of the house.

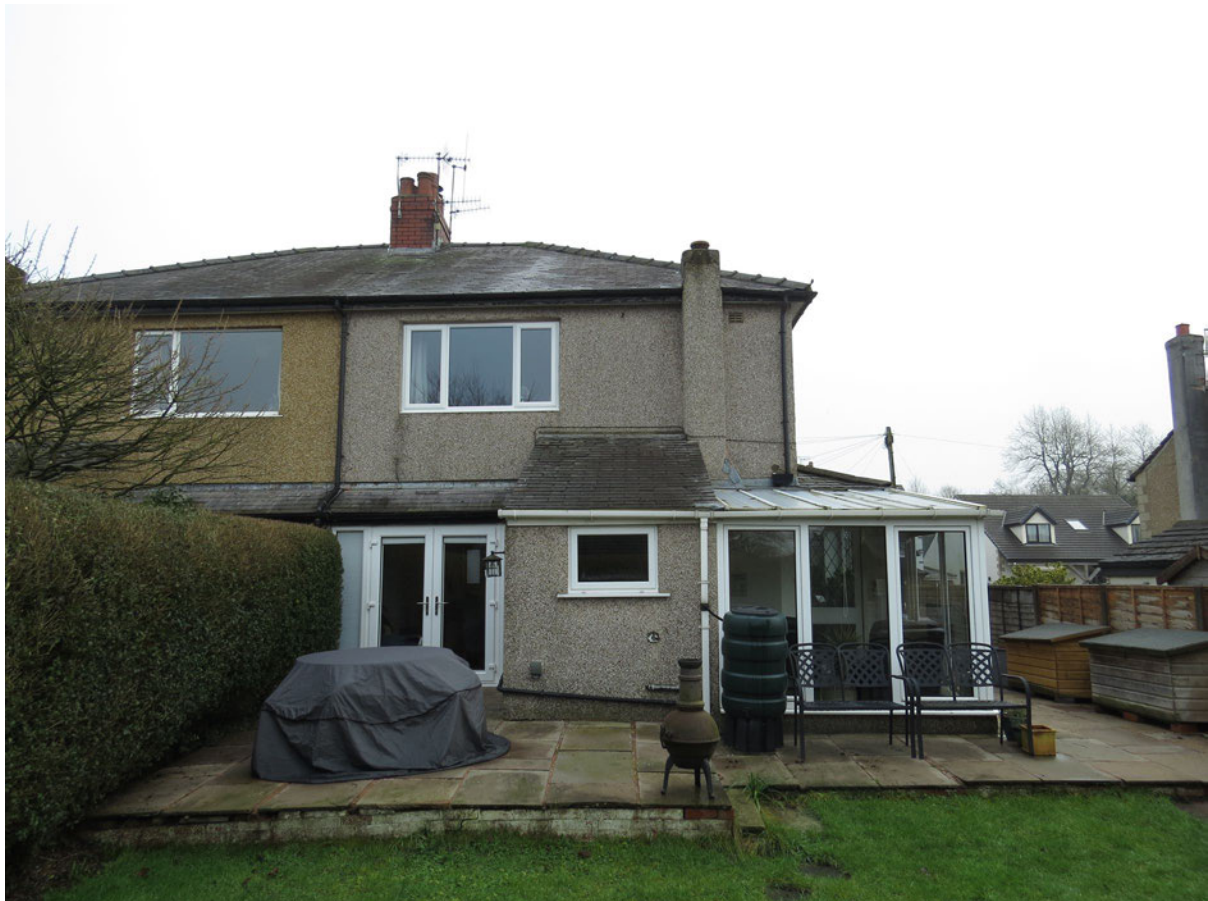
2 – The rear of the house.

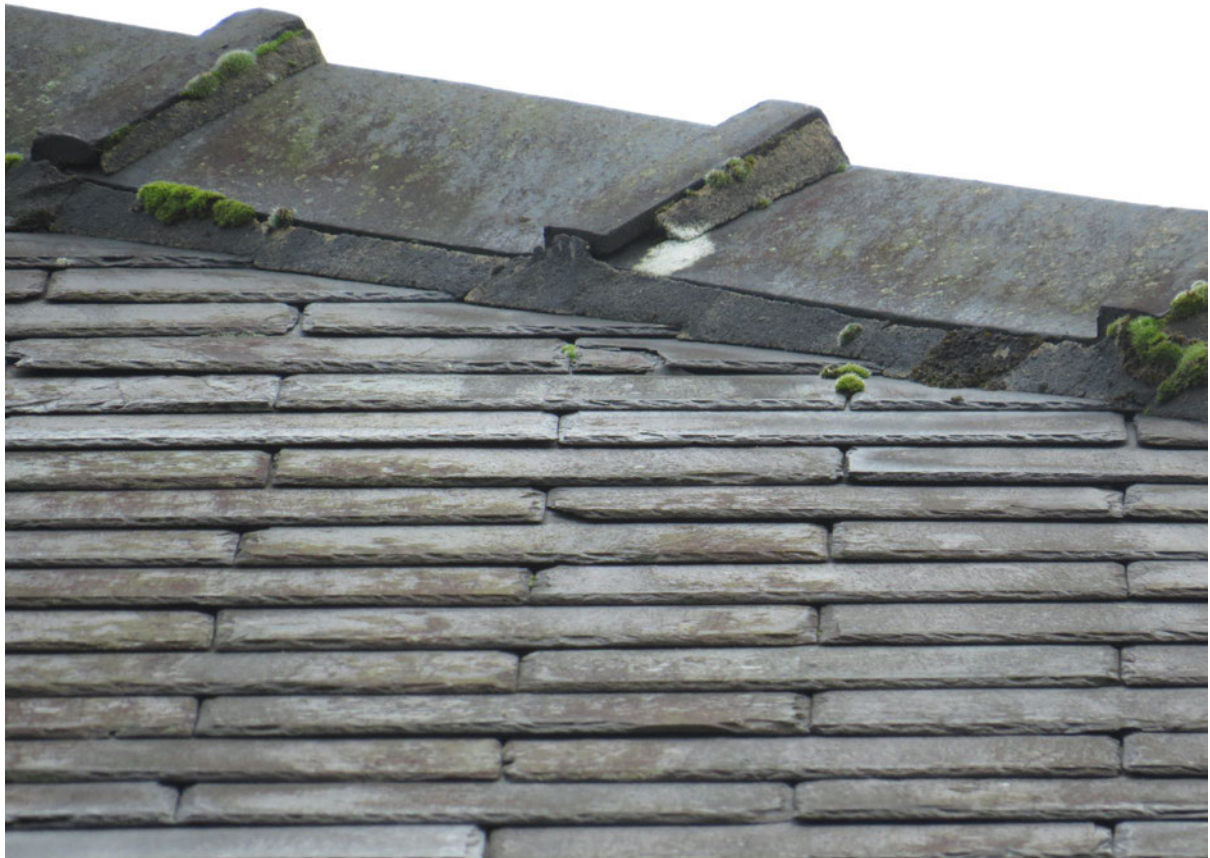
Roof and ridge tiles are in good condition; ridge tiles are sealed with cement. There are no gaps between roofing materials which could be used by roosting bats.

3 – Roof and ridge tiles are in good condition with no suitable gaps.

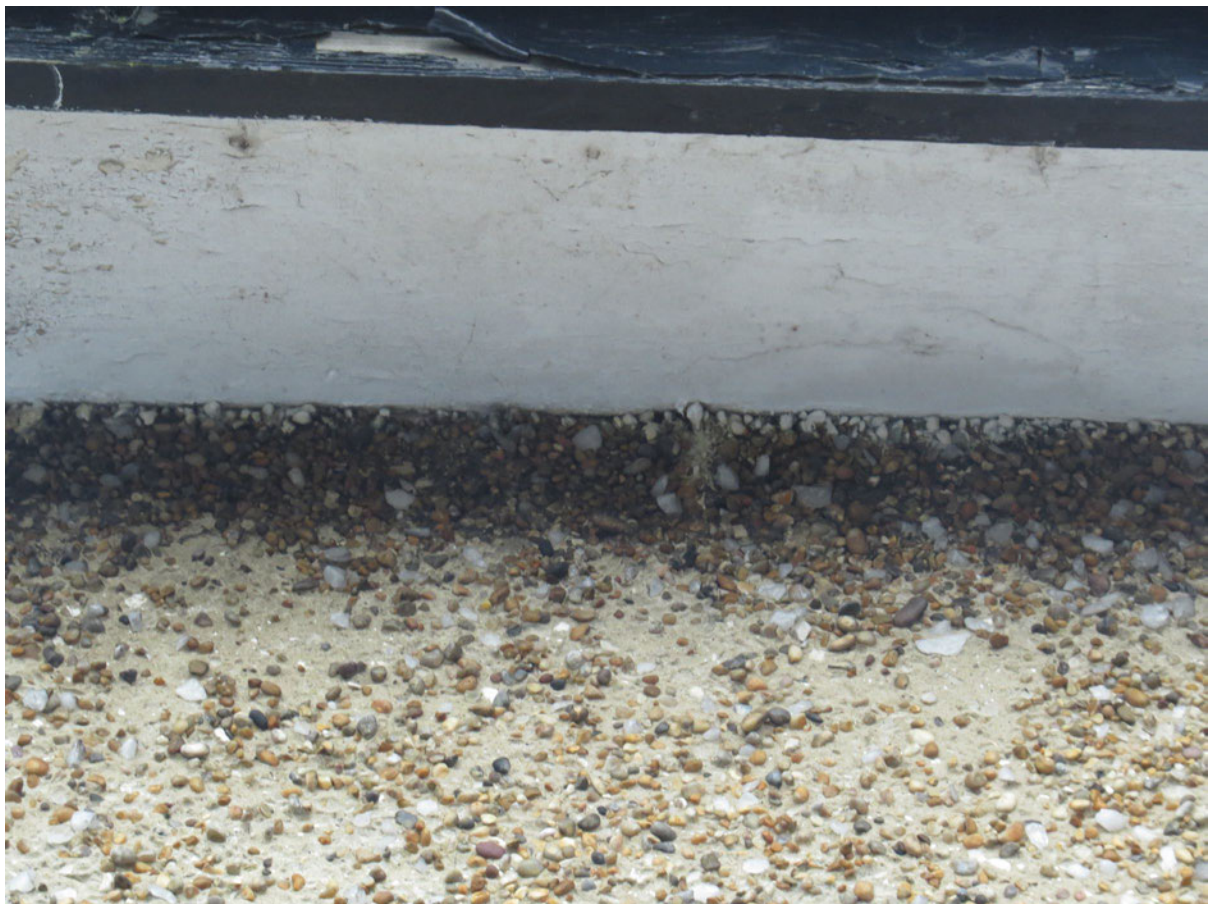
Timber fascia boards and boxed soffits at the eaves are fixed tightly against brickwork, with no suitable gaps; wall cavities and boxed soffits open into the roof void, and were inspected from above.

4 – Fascia boards and soffits at the eaves are fixed tightly against brickwork.

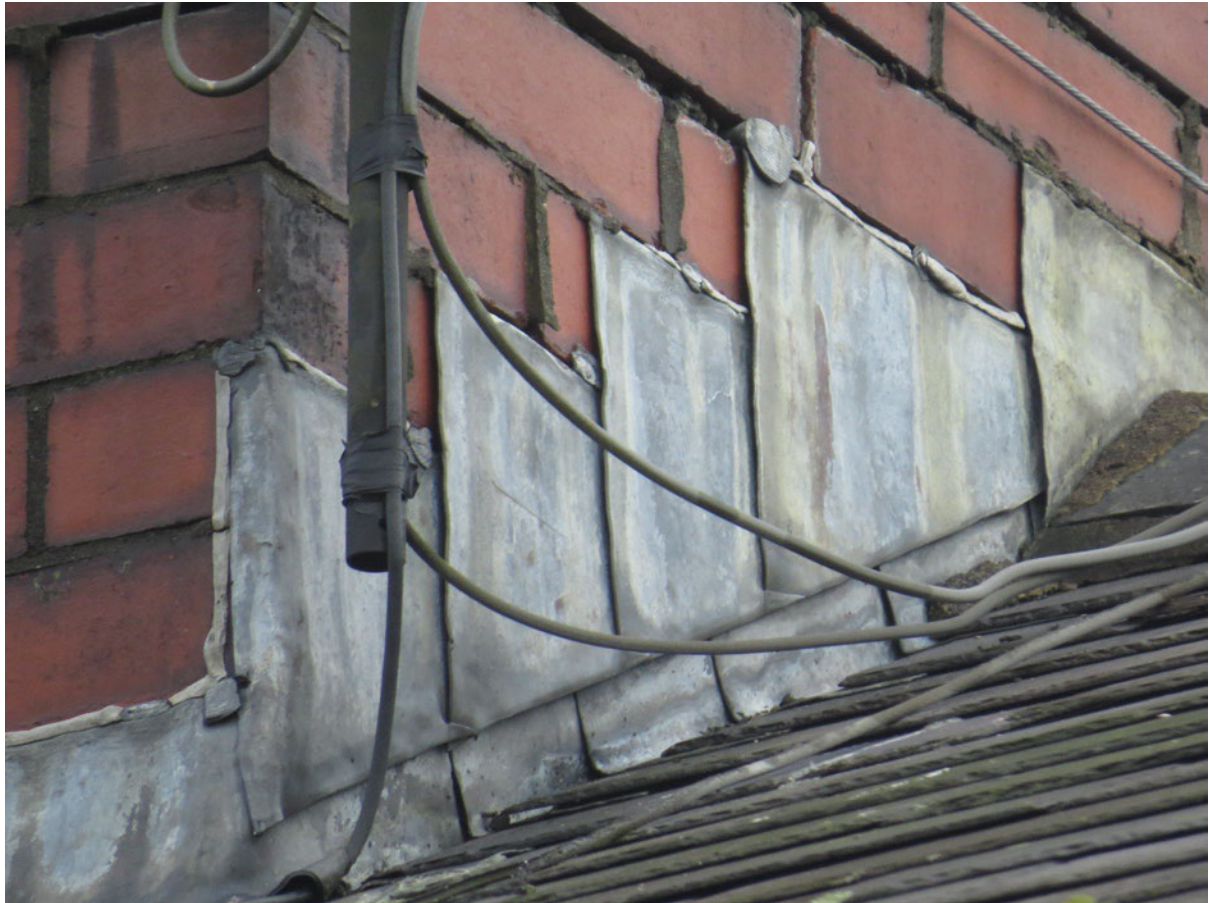
5 – Lead flashing is fitted tightly with no suitable gaps.

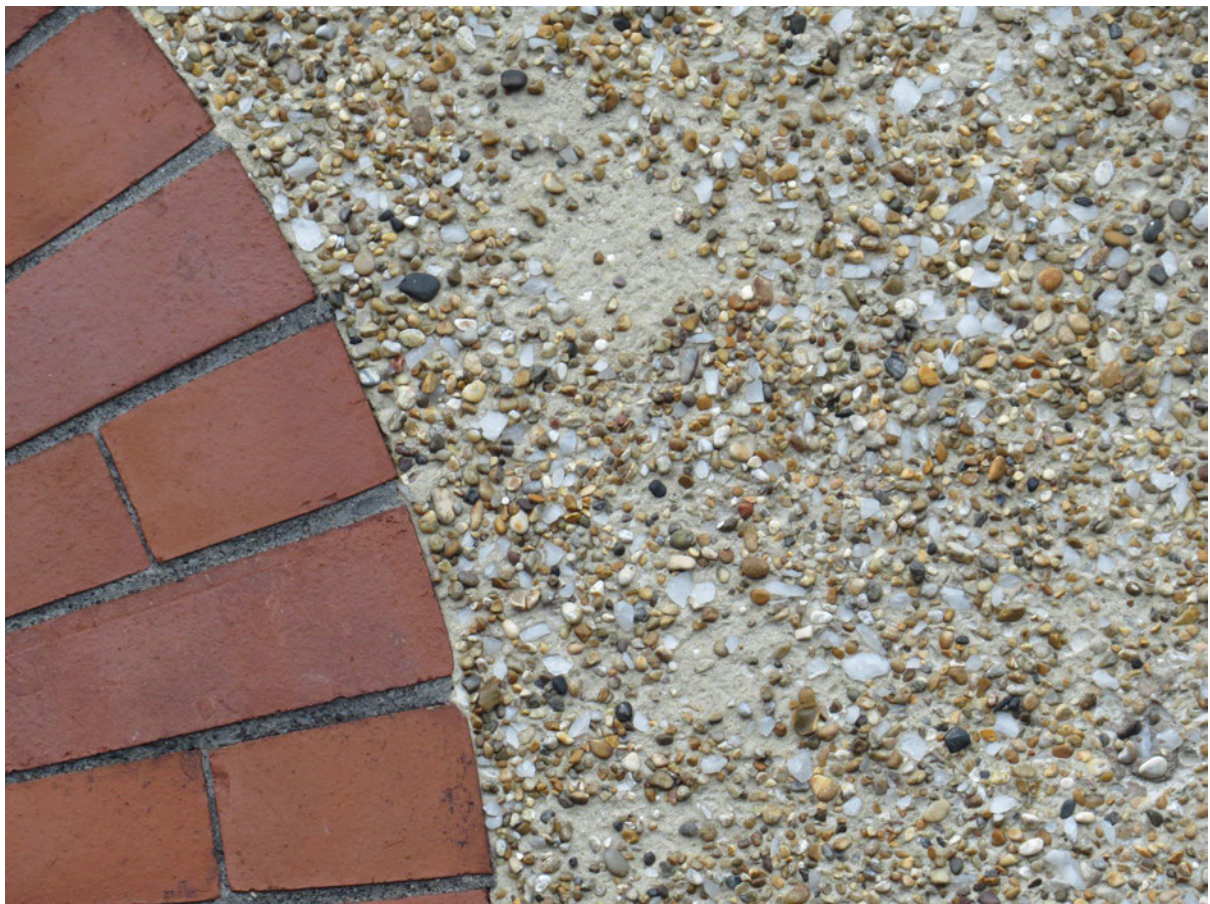
Walls are brick with an insulating cavity. The wall cavity has been filled with insulation. Walls are in good condition, with no cracks, or missing mortar which could be used by crevice dwelling bats.

6 – Brickwork and render are in good condition with no suitable gaps.

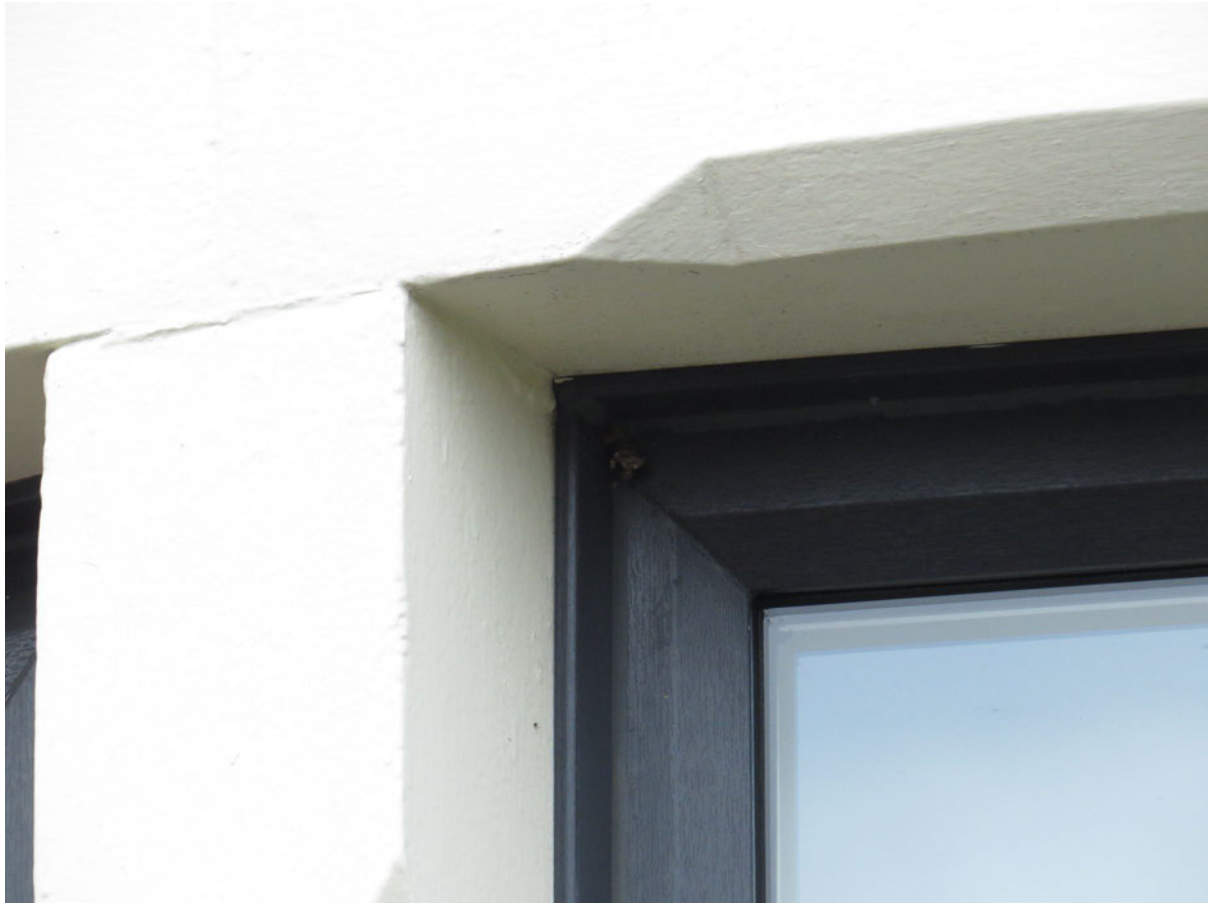
Window and door frames are fixed into the brickwork, gaps are filled with sealant, and offer no suitable roosting opportunities.

7 – Window and door frames are tightly sealed into brickwork with no suitable gaps.

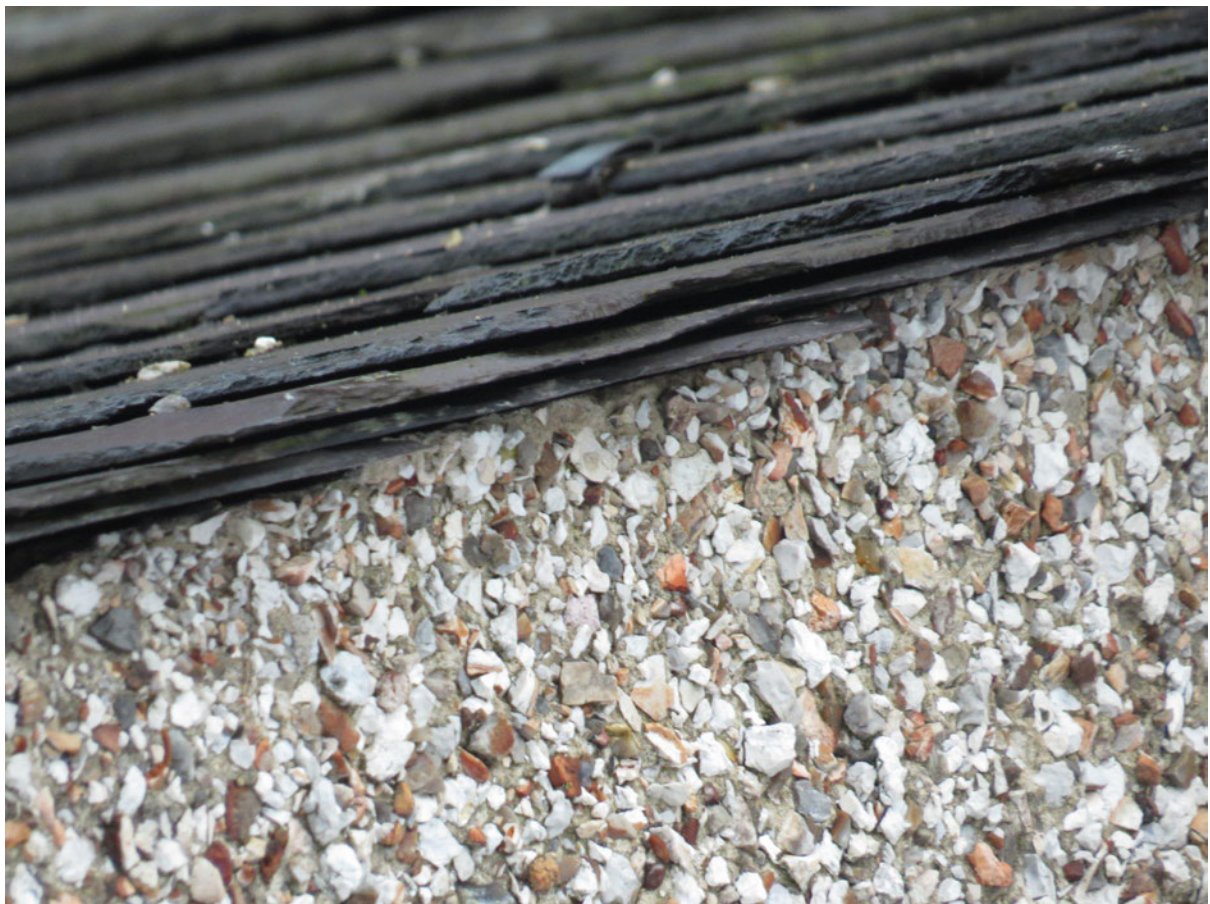
8 – End tiles at the verges are sealed with cement.

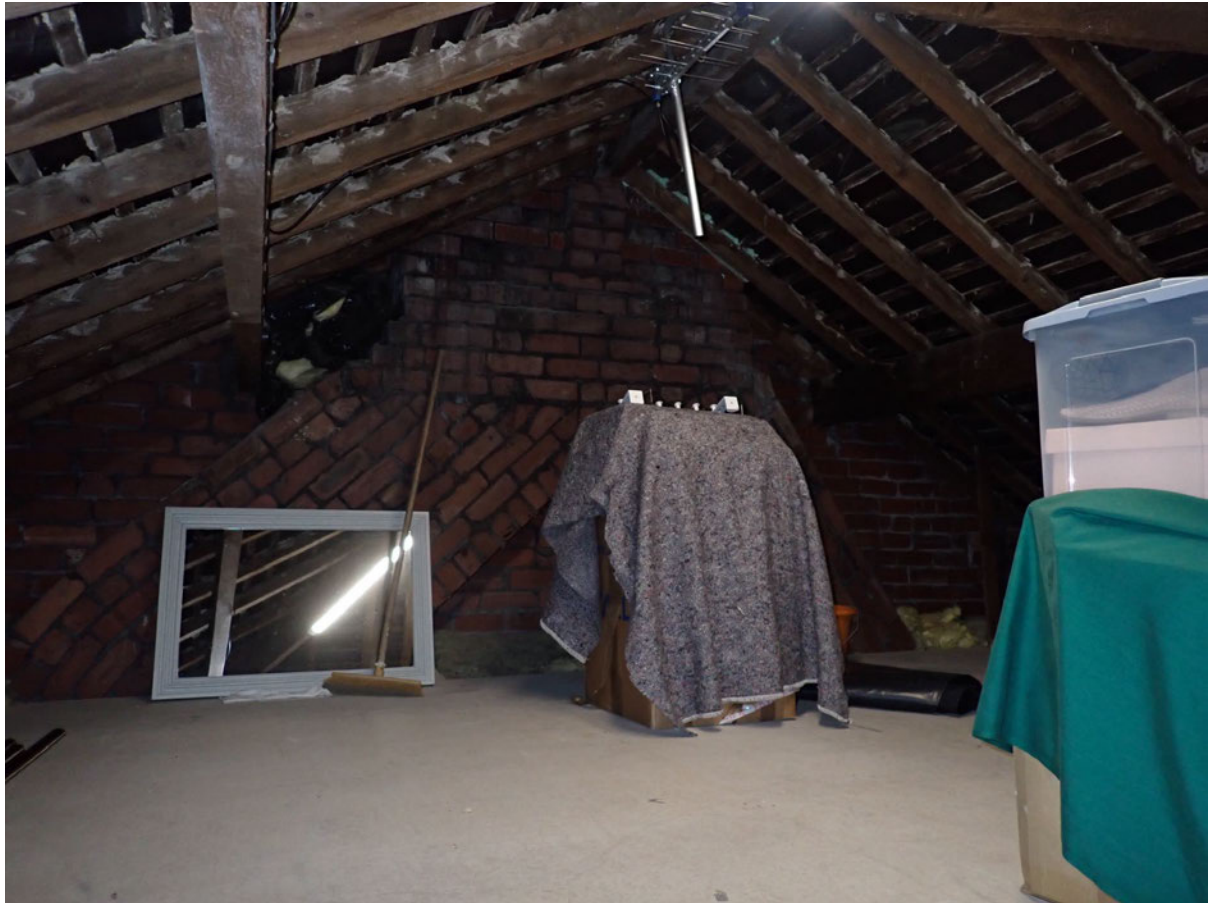
9 – The house has a single roof void.

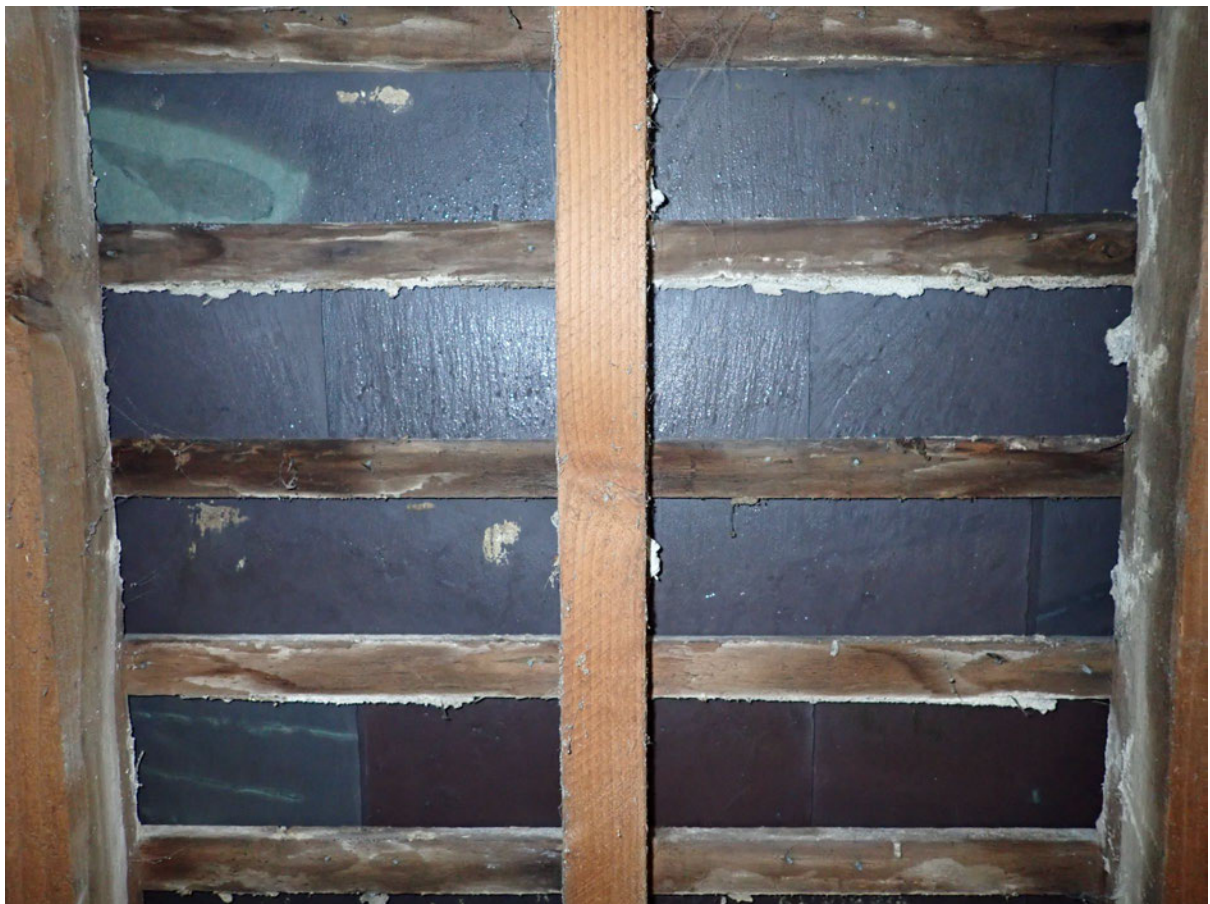
The small gaps between brickwork, roof timbers, and roofing materials, in the roof void were inspected in detail using an endoscope. No droppings were found, and no suitable gaps were present which could give access, or shelter to roosting bats.

10 – The roof is not lined, tiles are in good condition with no gaps.
