**Project Name:** GR77254\_CCTV  
**Project Description:** WinCan Import in Miraculix Standard  
**Project Number:** GR77254  
**Project Status:** Complete  
**Project Date:** 22/01/2025

# ***CCTV DRAINAGE SURVEYS***

**Company:** LNT Construction  
**Street:** Bramley View,  
**Town or City:** Barrow  
**County:** Lancashire  
**Post Code:** BB7 9AL

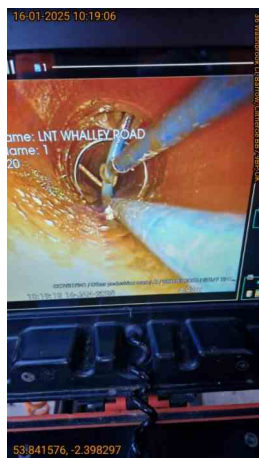
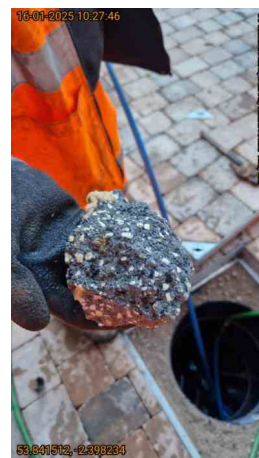
OBSTRUCTION REMOVED

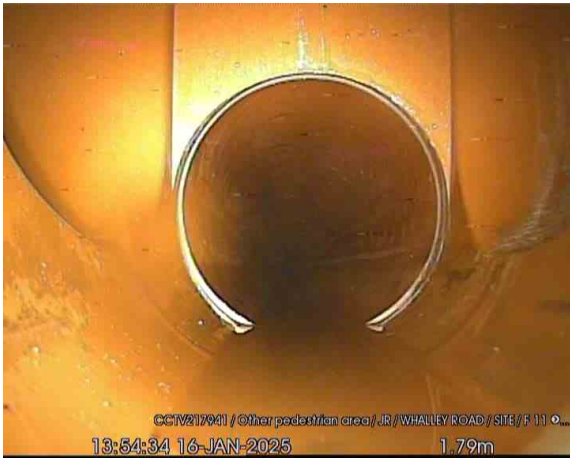
10X\_75bc11af-28d6-4462-af96-b1b80ba10d82\_20250122\_14  
0700\_702.jpg, 00:00:47, 1.79 m  
Finish node, inspection chamber, reference: F 10

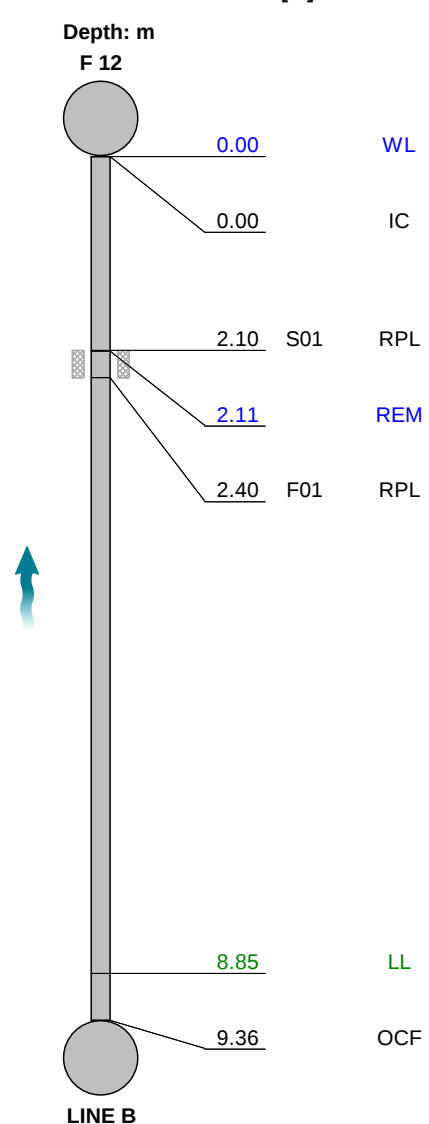
| Scale: | 1:82 | Position [m] | Code | Observation | MPEG | Photo | Grade |
|---|---|---|---|---|---|---|---|
| | | 2.10 | S01 RPL | Point repair, localised lining from 12 o'clock to 12 o'clock, start | 00:00:11 | | |
| | | 2.40 | F01 RPL | Point repair, localised lining from 12 o'clock to 12 o'clock, finish | 00:00:13 | | |
| | | 8.85 | LL | Line deviates left | 00:00:22 | | |

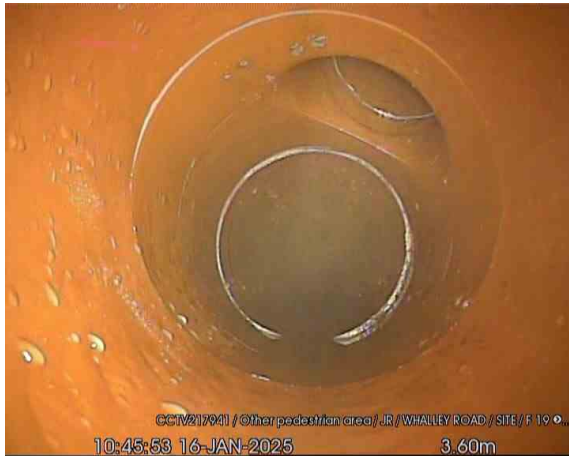
20X\_23a8726f-e5b7-4400-90cc-dea28486837a\_20250122\_12  
 1944\_607.jpg, 00:00:15, 3.60 m  
 Junction at 1 o'clock, 100mm dia

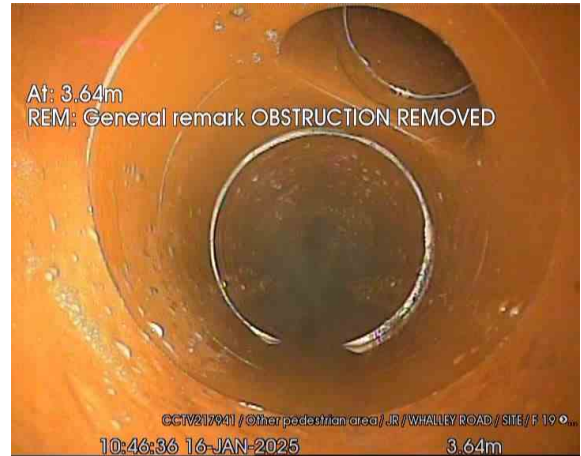
20X\_b19f4c65-41df-4e20-9a8a-d6e63378d26e\_20250122\_12  
 1949\_885.jpg, 00:00:18, 3.64 m  
 General remark, OBSTRUCTION REMOVED

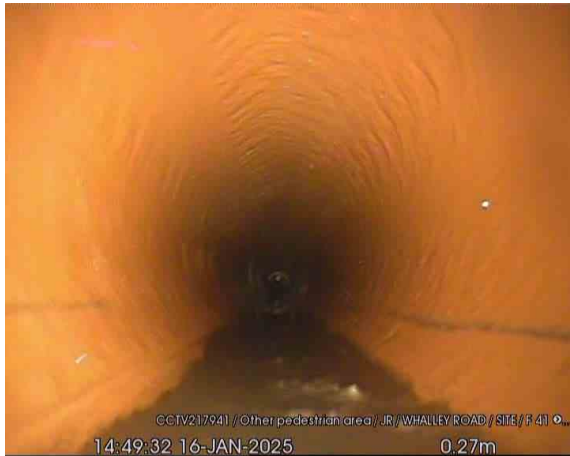
41X\_3a251d1f-a586-4123-9e7b-38d604a97fd6\_20250122\_14  
4739\_981.jpg, 00:00:22, 0.00 m  
Settled deposits, fine, 5% cross-sectional area loss
