**Project****Project Name:** LNT - Barrow Clitheroe**Project Description:** WinCan Import in Miraculix WRc4 Standard**Project Date:** 10/01/2025

**Project Information****Project Name**  
LNT - Barrow Clitheroe**Project Number****Project Date**  
10/01/2025**Client**

## Section Inspection - 12/12/2024 - F41X

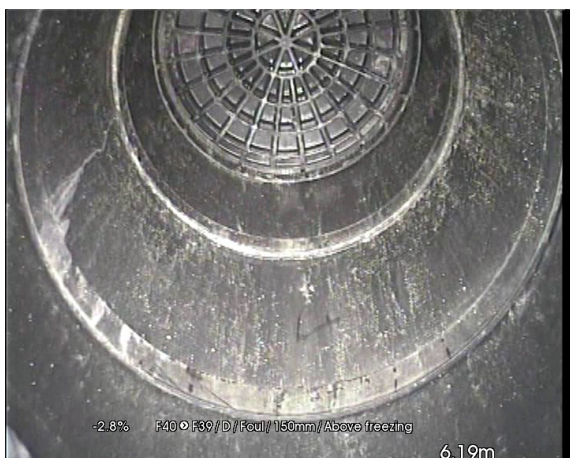
F40X\_f4273175-1b06-4cb3-8b33-5762b4619329\_20250110\_145638\_490.jpg, 00:00:40, 6.19 m  
Finish node, inspection chamber, reference: F39

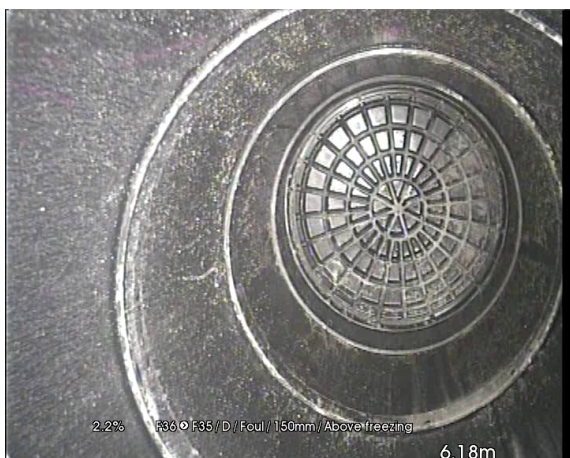
F36X\_49301c29-35f2-440a-9072-84573b046003\_20250110\_153539\_096.jpg, 00:00:49, 6.18 m  
Finish node, manhole, reference: F35

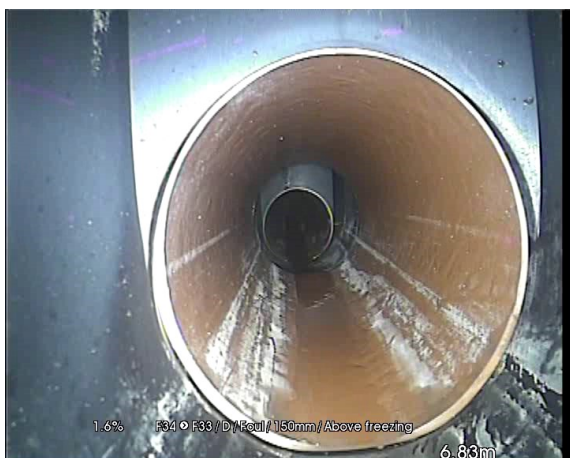
F34X\_35994a9d-506a-4404-8cf3-6aa3551530a1\_20250113\_081354\_950.jpg, 00:00:50, 6.83 m  
Finish node, manhole, reference: F33

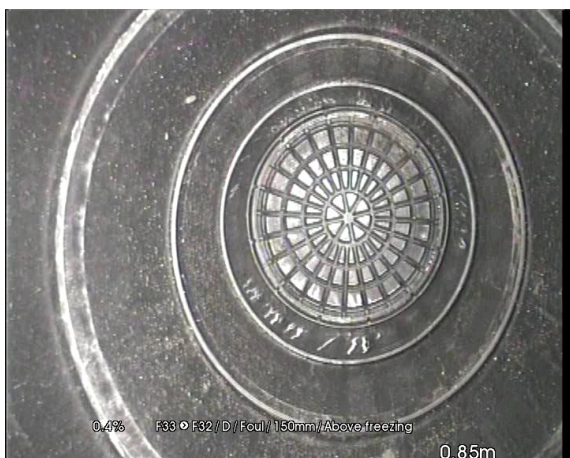
F33X\_2d308da6-3295-42cc-a564-6b967ba88c66\_20250113\_081655\_992.jpg, 00:00:17, 0.85 m  
Finish node, manhole, reference: F32

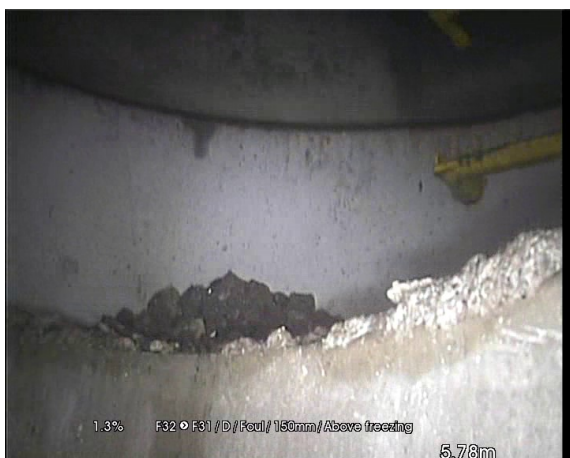
F32X\_215f00d8-43ff-4ab6-8c6e-f14bd1ddca18\_20250113\_082026\_450.jpg, 00:01:02, 5.78 m  
Finish node, manhole, reference: F31

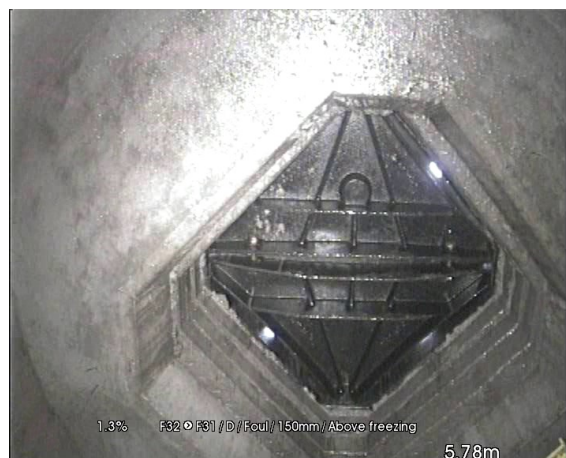
F32X\_11d08de3-ed06-4626-9b91-d94624265668\_20250113\_082035\_028.jpg, 00:01:02, 5.78 m  
Finish node, manhole, reference: F31

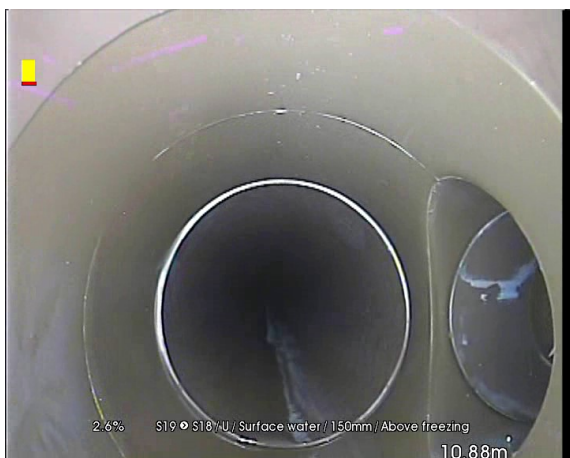
S19X\_c9a65b3a-d43f-4d96-aee1-a3b521ab065a\_20250113\_082447\_027.jpg, 00:01:13, 10.88 m  
Junction at 3 o'clock, diameter: 100mm

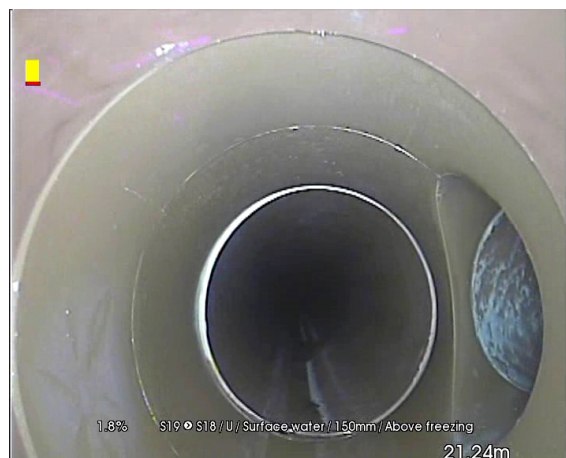
S19X\_0696d987-2a7a-43a5-9448-b5d8fa67a5ff\_20250113\_082611\_492.jpg, 00:02:14, 21.24 m  
Junction at 3 o'clock, diameter: 100mm

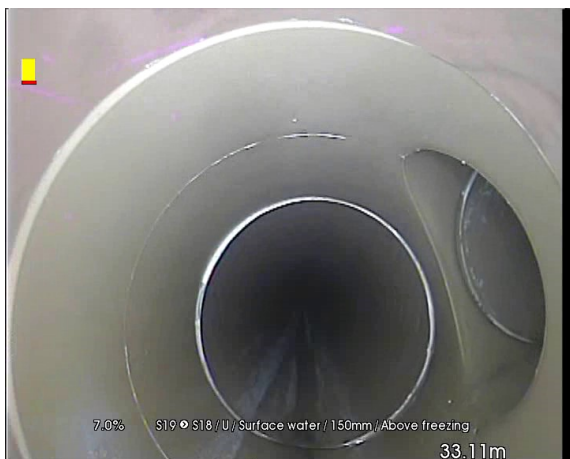
S19X\_760acfd5-202e-424c-8b42-26ac3cacf73e\_20250113\_082802\_885.jpg, 00:03:32, 33.11 m  
Junction at 3 o'clock, diameter: 100mm

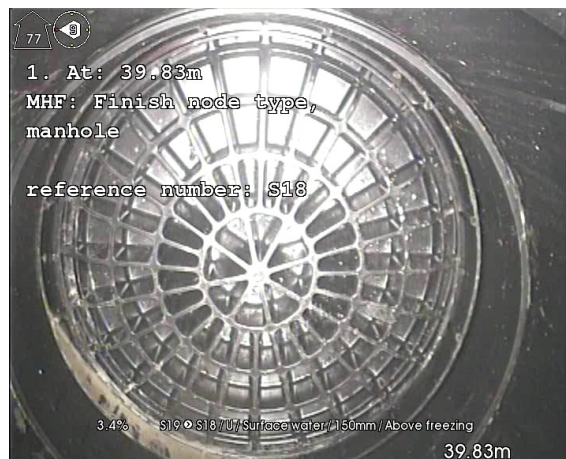
S19X\_8a0912e7-086b-474c-9e31-0f603f7283ed\_20250113\_082914\_177.jpg, 00:04:15, 39.83 m  
Finish node, manhole, reference: S19

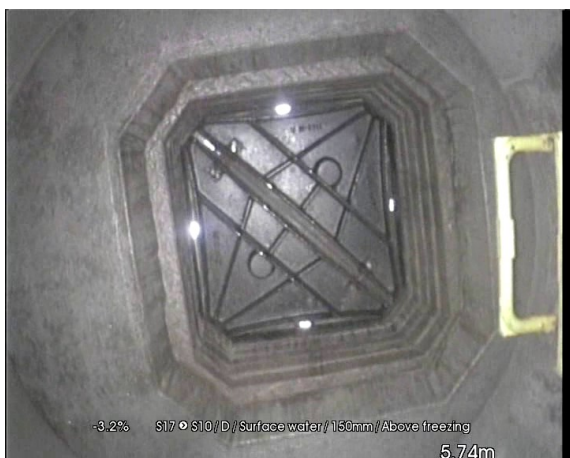
S17X\_fc2e37ff-13c3-4b85-8440-c40d25bbafb5\_20250113\_08  
4420\_927.jpg, 00:00:37, 5.74 m  
Finish node, manhole, reference: S17

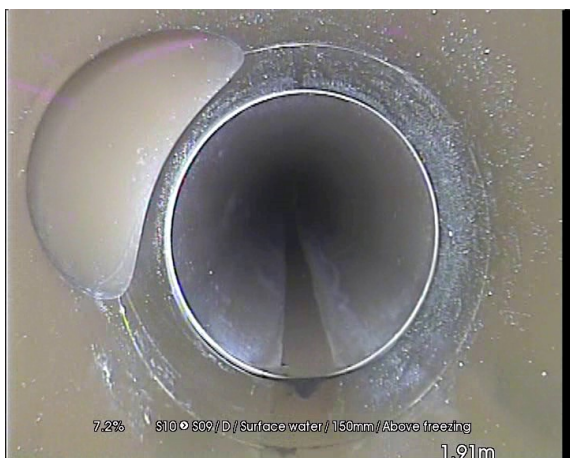
S10X\_f9446d50-ba42-498e-849a-1707c933ff99\_20250113\_084646\_473.jpg, 00:00:13, 1.91 m  
Junction at 10 o'clock, diameter: 100mm

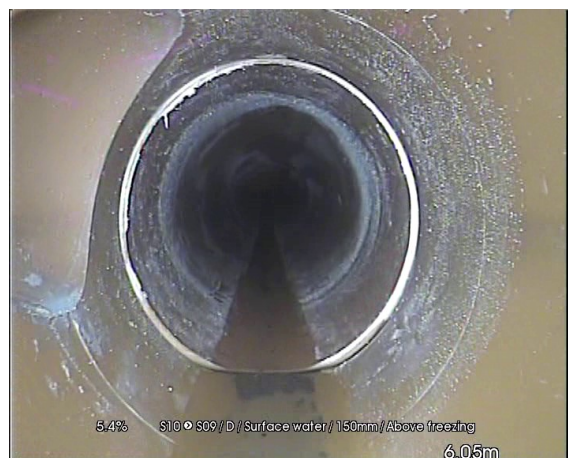
S10X\_50b5d0d3-e8fd-429b-bef8-979ea171d560\_20250113\_085426\_991.jpg, 00:00:41, 6.05 m  
Junction at 10 o'clock, diameter: 100mm

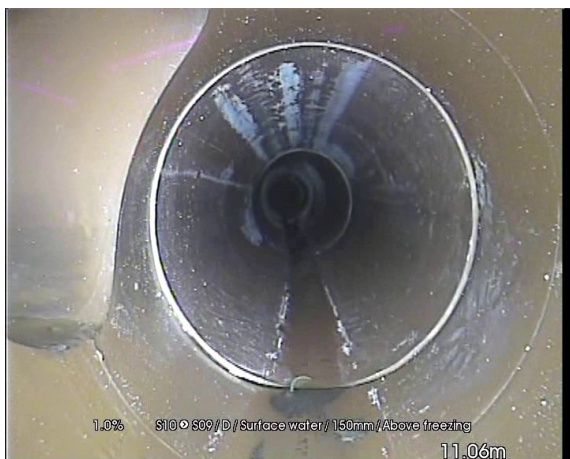
S10X\_4ee92ac1-4a4e-43dc-972d-f44ff607f18a\_20250113\_085517\_857.jpg, 00:01:13, 11.06 m  
Junction at 10 o'clock, diameter: 100mm

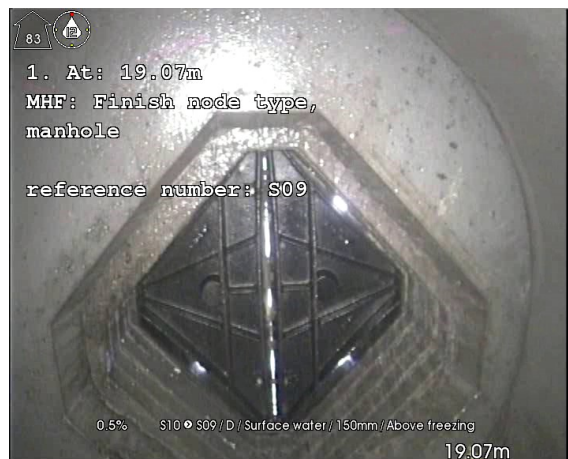
S10X\_8bf43c25-5d20-400b-9aaa-4247d52b0cf5\_20250113\_085624\_334.jpg, 00:02:06, 19.07 m  
Finish node, manhole, reference: S09

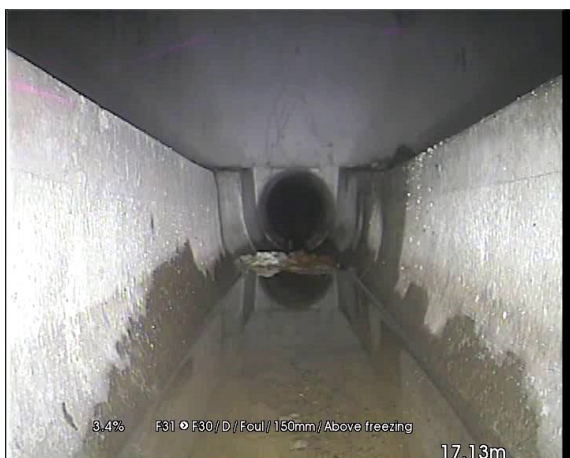
F31X\_c2fb8d65-9315-4f0e-a22b-0931f022b8df\_20250113\_09  
 0133\_435.jpg, 00:01:59, 17.13 m  
 Finish node, manhole, reference: F30

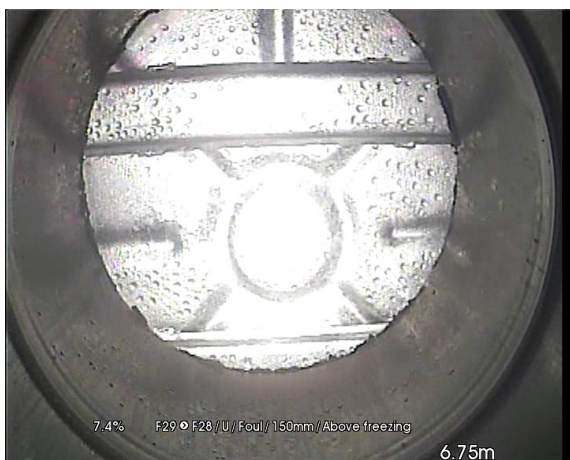
F29X\_13d53fc7-b681-42db-a7dd-f36aed7f8997\_20250113\_0  
90434\_805.jpg, 00:01:02, 6.75 m  
Finish node, manhole, reference: F28

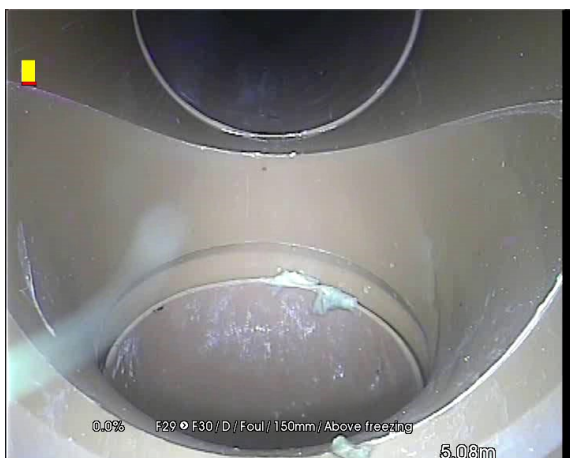
F29X\_f643d68d-cc6e-471a-baf3-490c243b65d1\_20250113\_091046\_858.jpg, 00:00:56, 5.06 m  
General remark, Back Drop

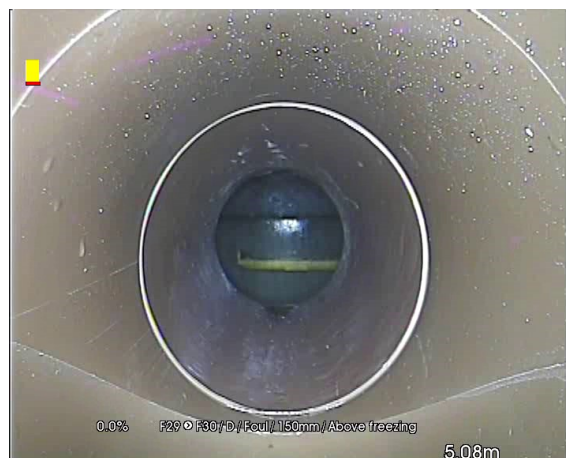
F29X\_03fd5aaa-e1a2-4dbb-a5dd-0acae4d5f5df\_20250113\_091107\_325.jpg, 00:01:01, 5.08 m  
Finish node, manhole, reference: F30

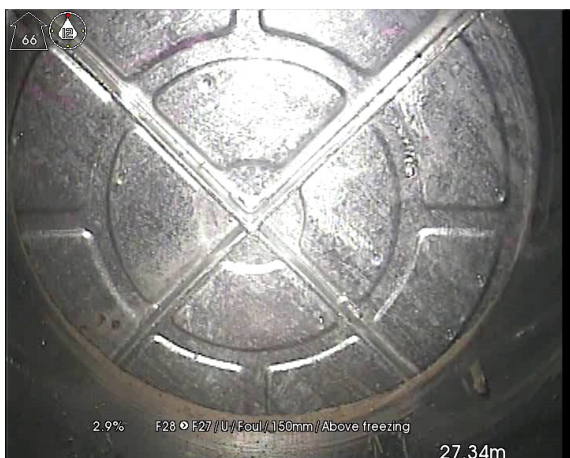
F27X\_664e960a-7475-4132-b40a-9f5d43a41aba\_20250113\_092056\_432.jpg, 00:02:49, 27.34 m  
Finish node, manhole, reference: F27

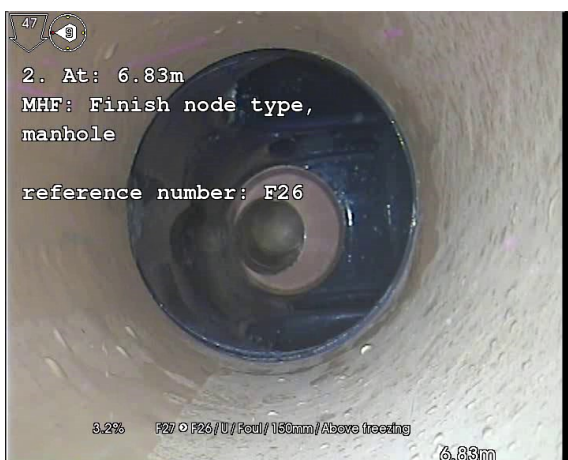
F26X\_3805b488-5353-4b18-b2f9-c1fad7669c46\_20250113\_0  
93146\_399.jpg, 00:00:58, 6.83 m  
Finish node, manhole, reference: F26

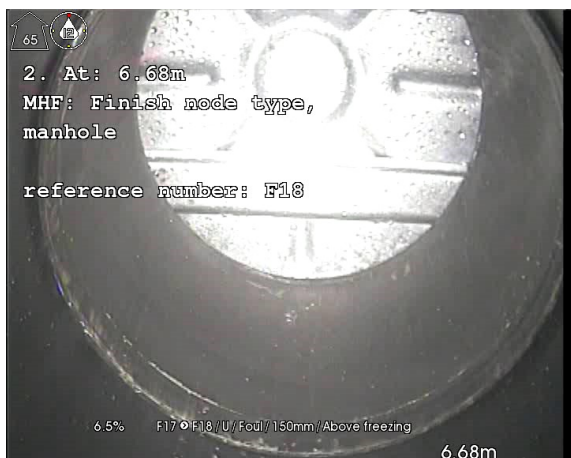
F18X\_1cf73ebc-4931-43d8-9f98-18614cbddd1c\_20250113\_0  
93620\_734.jpg, 00:00:51, 6.68 m  
Finish node, manhole, reference: F18

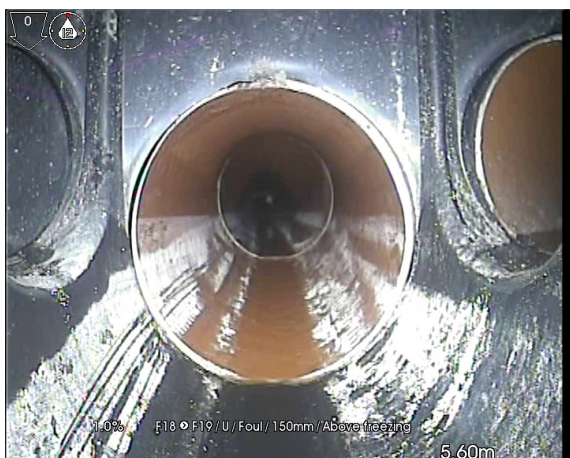
F19X\_cbe9d978-373d-4d32-acf3-56e367400e82\_20250113\_0  
93953\_629.jpg, 00:00:39, 5.60 m  
Finish node, manhole, reference: F19

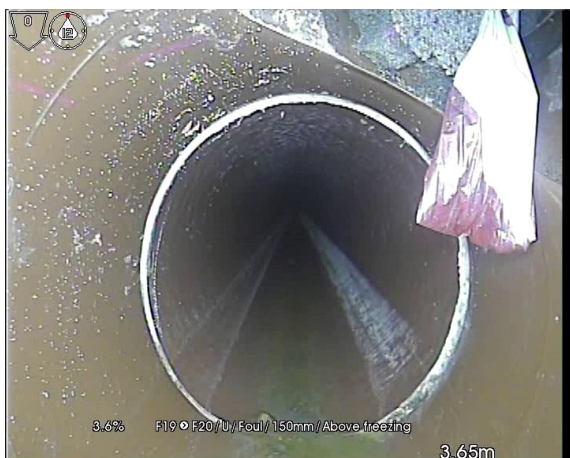
F20X\_4226e9a2-02a5-4848-8a22-caf435f20f7a\_20250113\_094424\_560.jpg, 00:00:28, 3.65 m  
Junction at 1 o'clock, diameter: 100mm

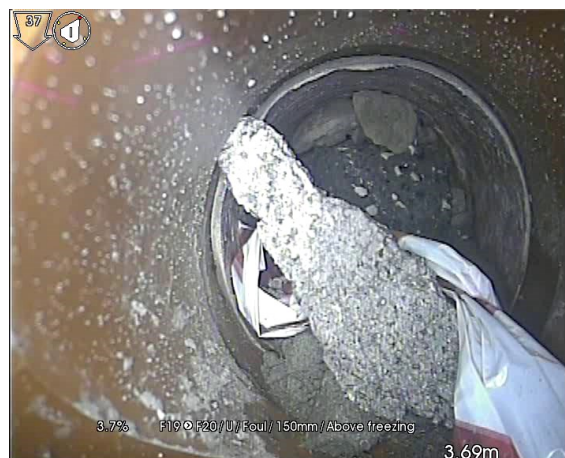
F20X\_3d84a70f-4581-490e-ad73-6543cc097683\_20250113\_094433\_129.jpg, 00:00:28, 3.65 m  
Junction at 1 o'clock, diameter: 100mm

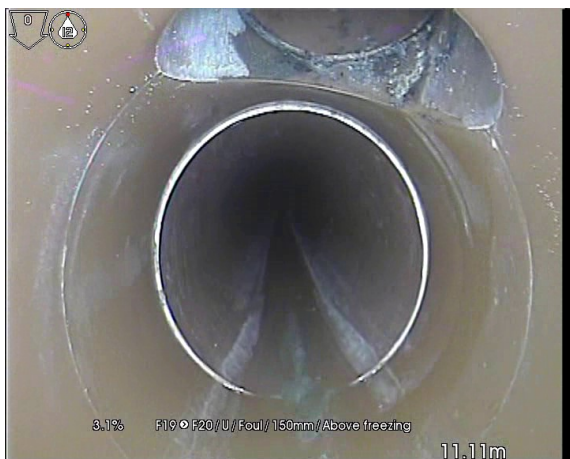
F20X\_6a538748-e3ca-4dc2-9db0-6054f51d338a\_20250113\_094612\_223.jpg, 00:01:51, 11.11 m  
Junction at 12 o'clock, diameter: 100mm

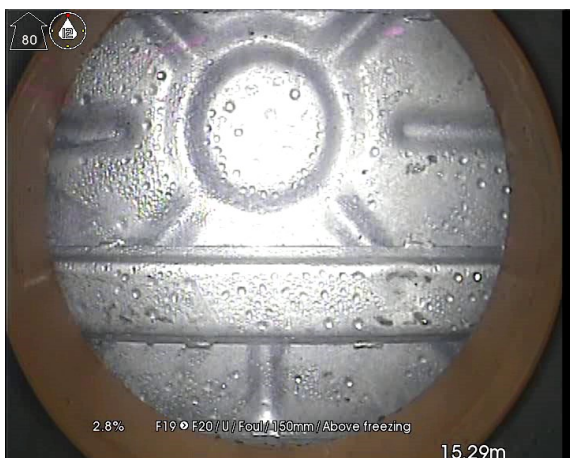
F20X\_51d78f93-ff3e-4e50-afbd-c60ff4b2e8b7\_20250113\_094  
712\_475.jpg, 00:02:35, 15.29 m  
Finish node, manhole, reference: F20

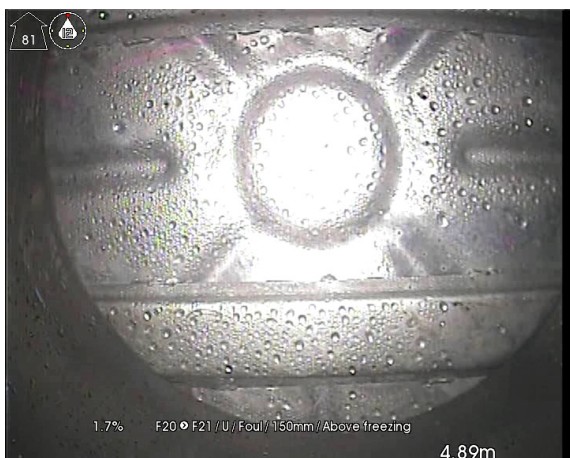
F21X\_14a05c3f-1eea-45f5-a783-61f1c9508b32\_20250113\_10  
0202\_748.jpg, 00:00:35, 4.89 m  
Finish node, manhole, reference: F21

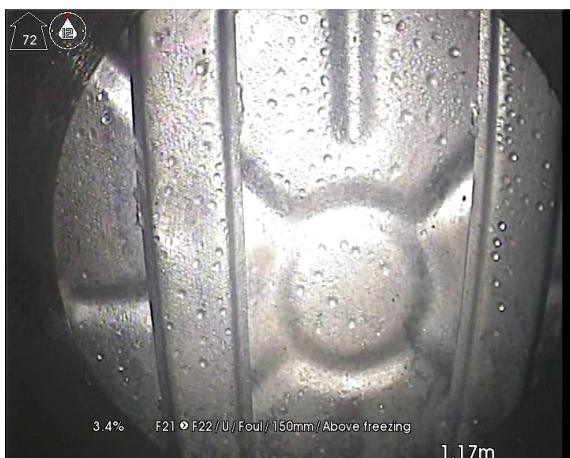
F22X\_c4cf3360-37c2-4d88-ba21-d67ed0c9f7cb\_20250113\_1  
00540\_390.jpg, 00:00:12, 1.17 m  
Finish node, manhole, reference: F22

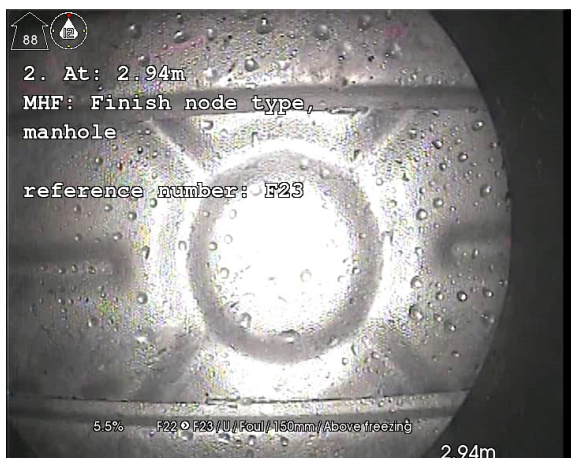
F23X\_43b13ea1-1a77-4b41-b582-6a3a16794676\_20250113\_101017\_610.jpg, 00:00:24, 2.94 m  
Finish node, manhole, reference: F23
