Barn at Cheethall Farm, Edisford Road, Clitheroe, BB7 3LH

Structural Condition Survey for Conversion to Dwelling

PSC-932

November 2024

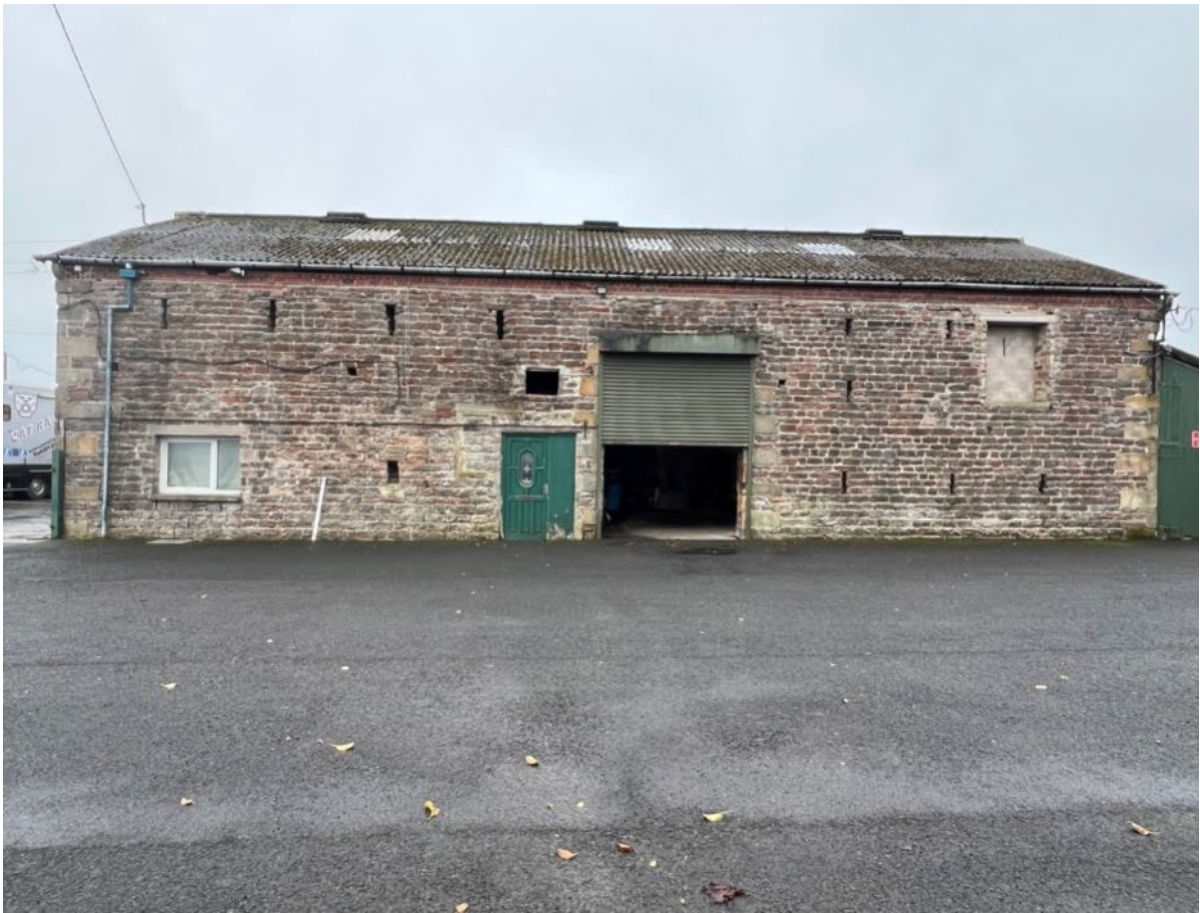
The roof to the main barn is covered with cement/asbestos sheeting (photos 1, 5 & 15). Viewed externally, the roof appears fairly level with the sheets all in place and in reasonable condition. There are 3 rooflights on each face. The rear shippon area has a metal sheeted roof which is in a very good condition.

Photo 1 - North East Elevation

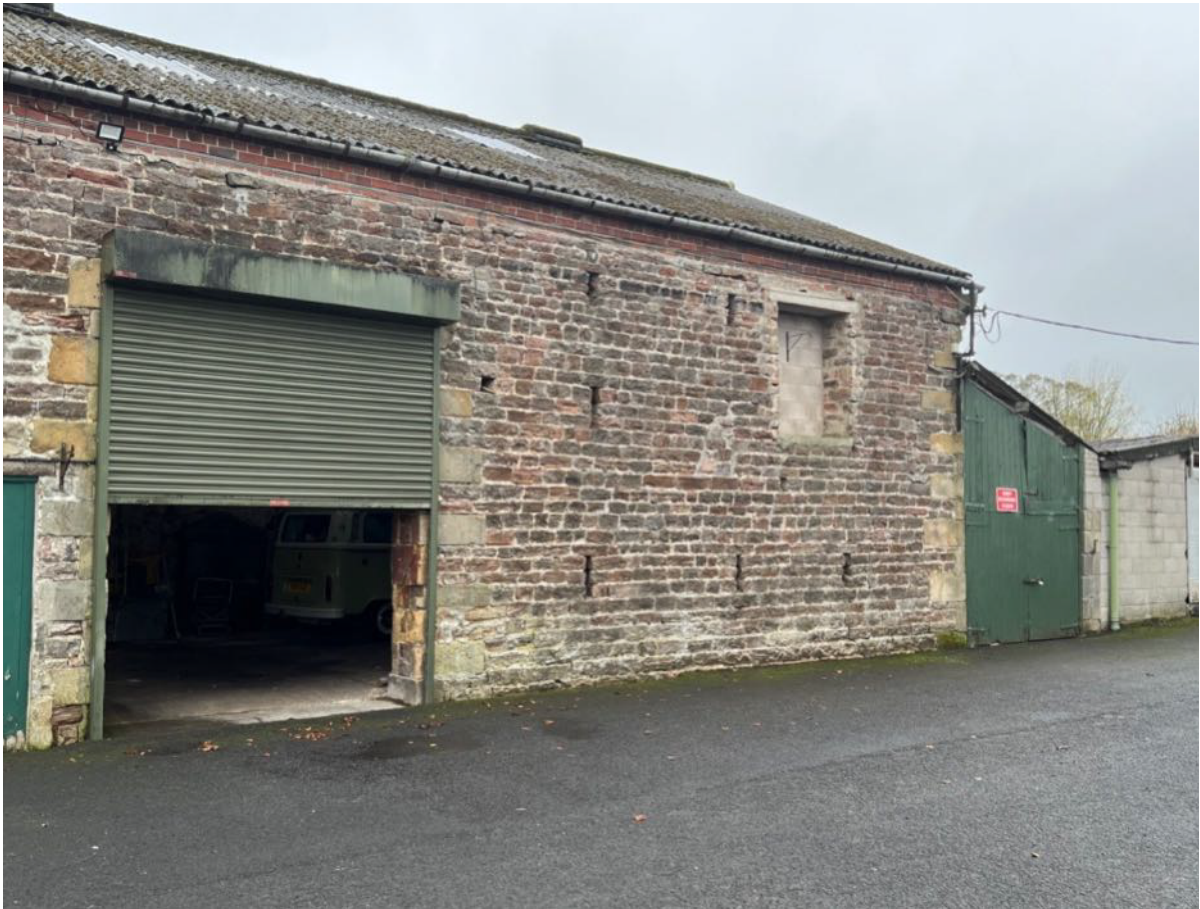
The North-East Elevation is typical of a traditional Lancashire barn, built in coursed sandstone with a large central door (photo 3). At the north-west end is a timber outrigger section (photos 2 & 4). The 500mm thick wall is in good condition. It is plumb and reasonably pointed with lime mortar. There are no signs of previous or ongoing movement. The photos indicate that the roof has been lifted with the addition of 3 courses of brick (photo 5). In addition to the main barn door there is a further door and 3 window openings (one has been infilled with block – photo 4). There are numerous regularly spaced air slots in the stone walls. The timber to the doors

Photo 2 – North East Elevation

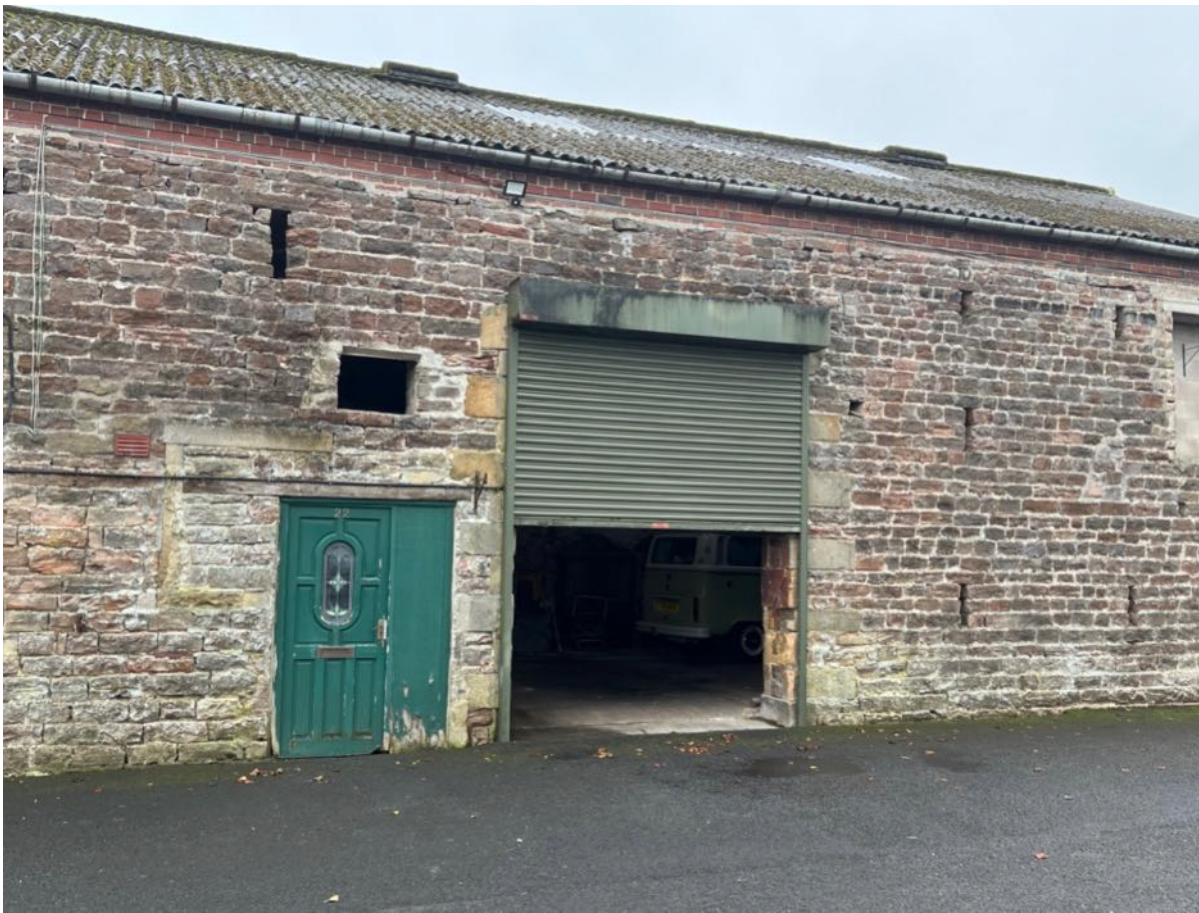
Photo 3- North East Elevation

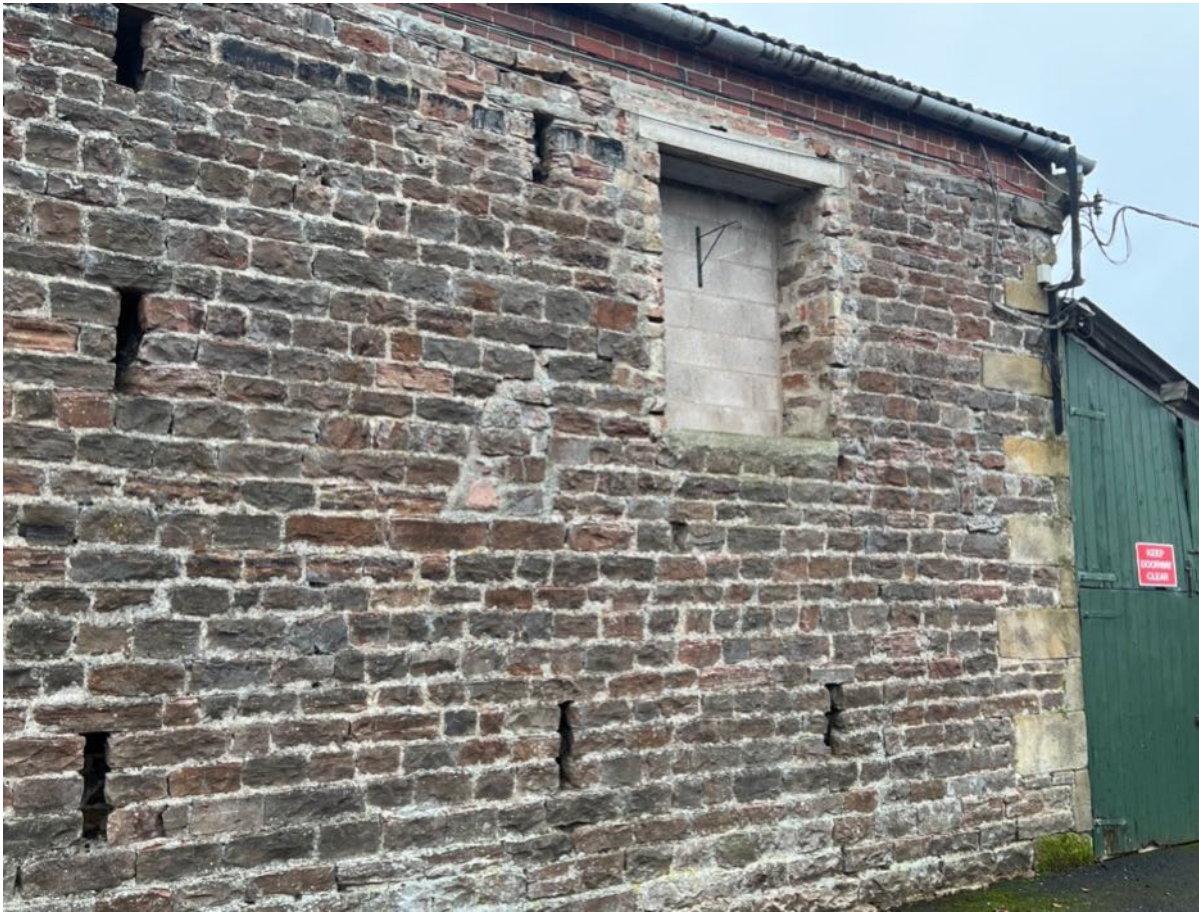
Photo 4 - North East Elevation

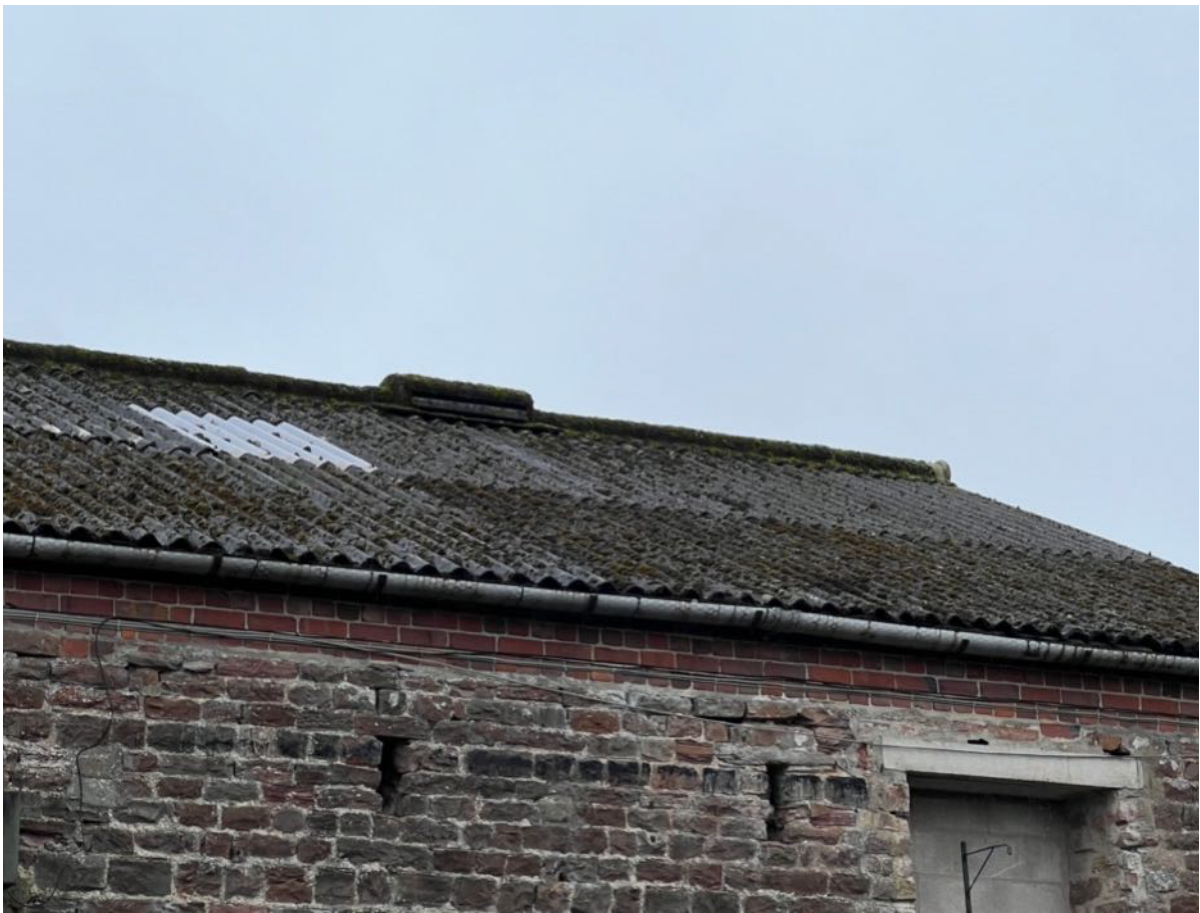
Photo 5 – North East Elevation and roof

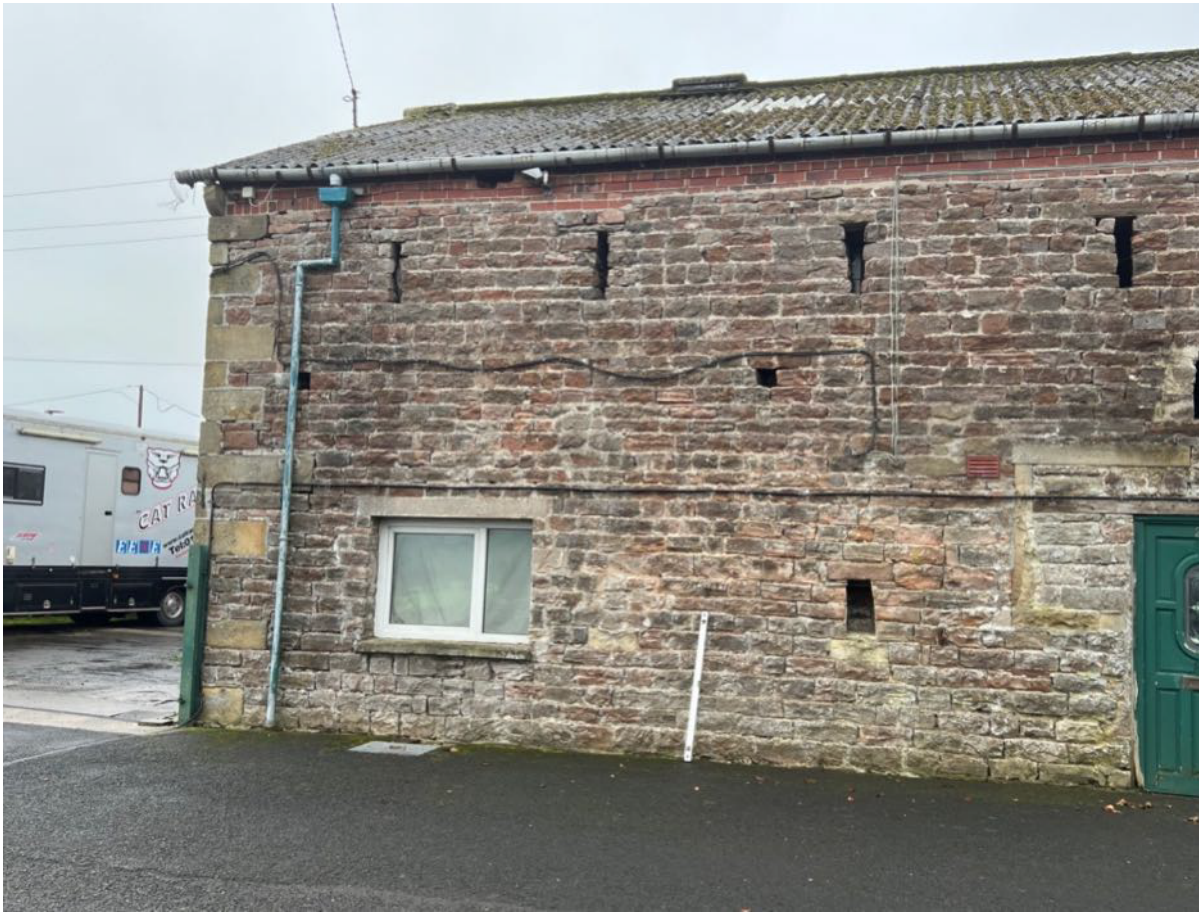
Photo 6 – North East Elevation

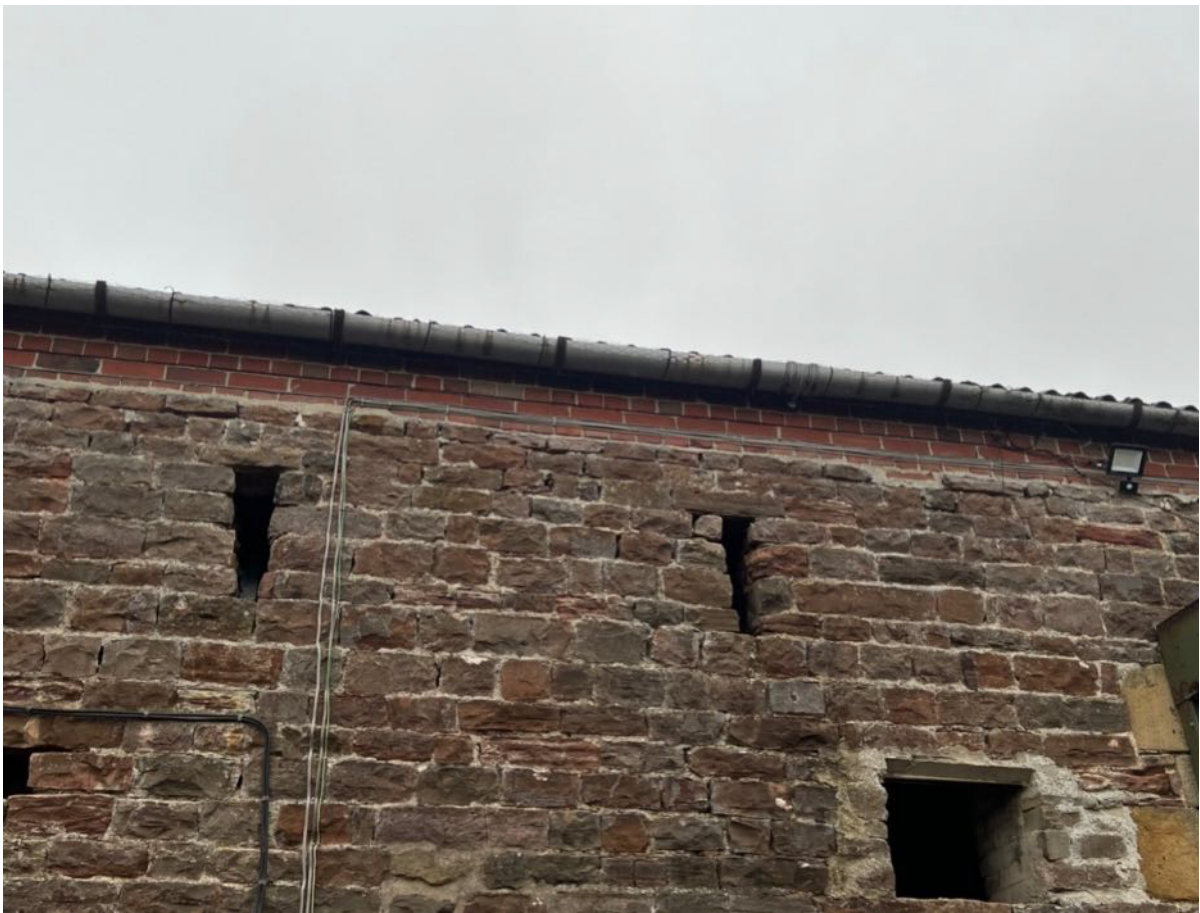
Photo 7 – North East Elevation

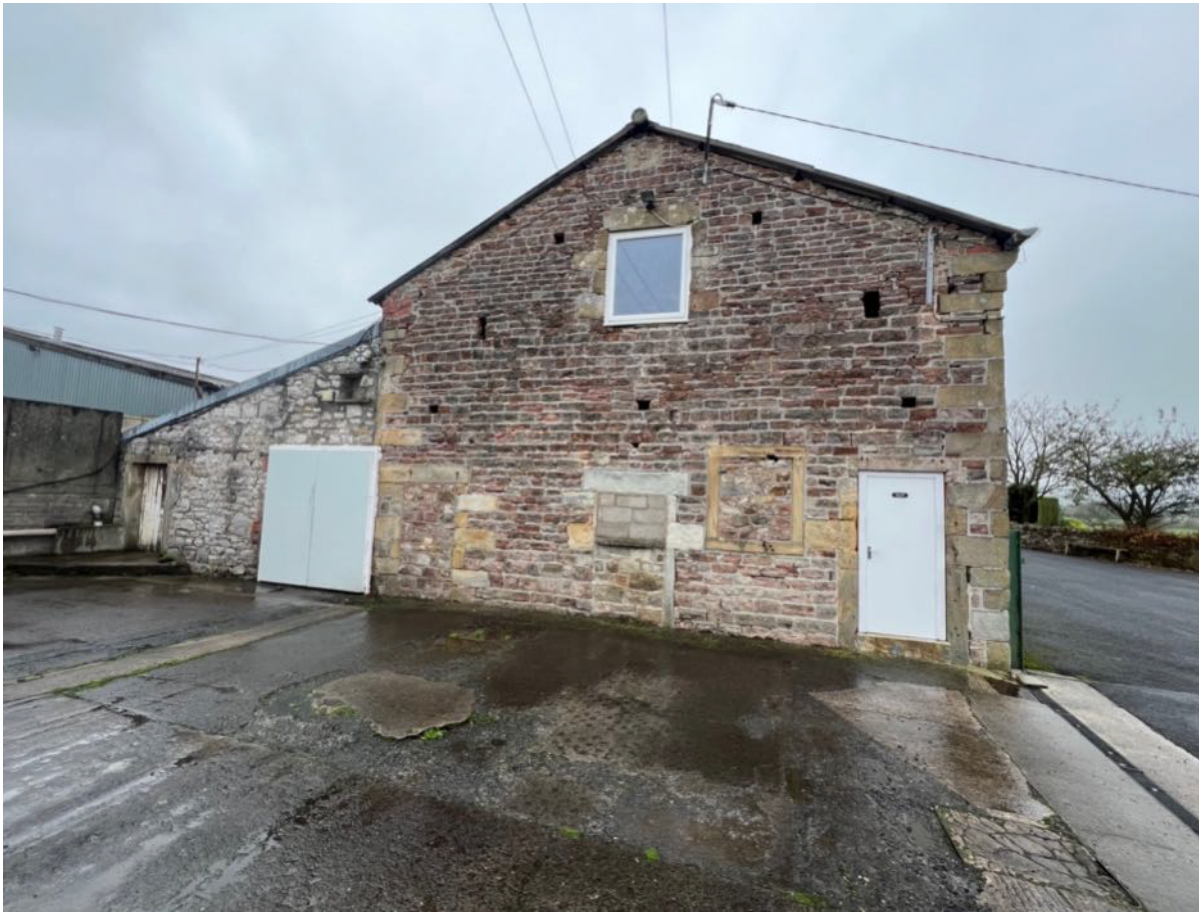
This gable wall is a 500mm thick coursed stone wall to the main barn and random sandstone 300mm thick to the rear shippon area. There are three door openings and one window opening in this elevation. There are 3 further infilled openings. The photos indicate that the outrigger to the shippon to the rear is probably a later addition to the main section of barn with the original quoin stones visible in the photos. The walls are plumb, reasonably pointed and free from any sign of previous or ongoing movement. The doors are in good condition except the rear door to the shippon area which has some signs of rot.

Photo 8 – South East Elevation

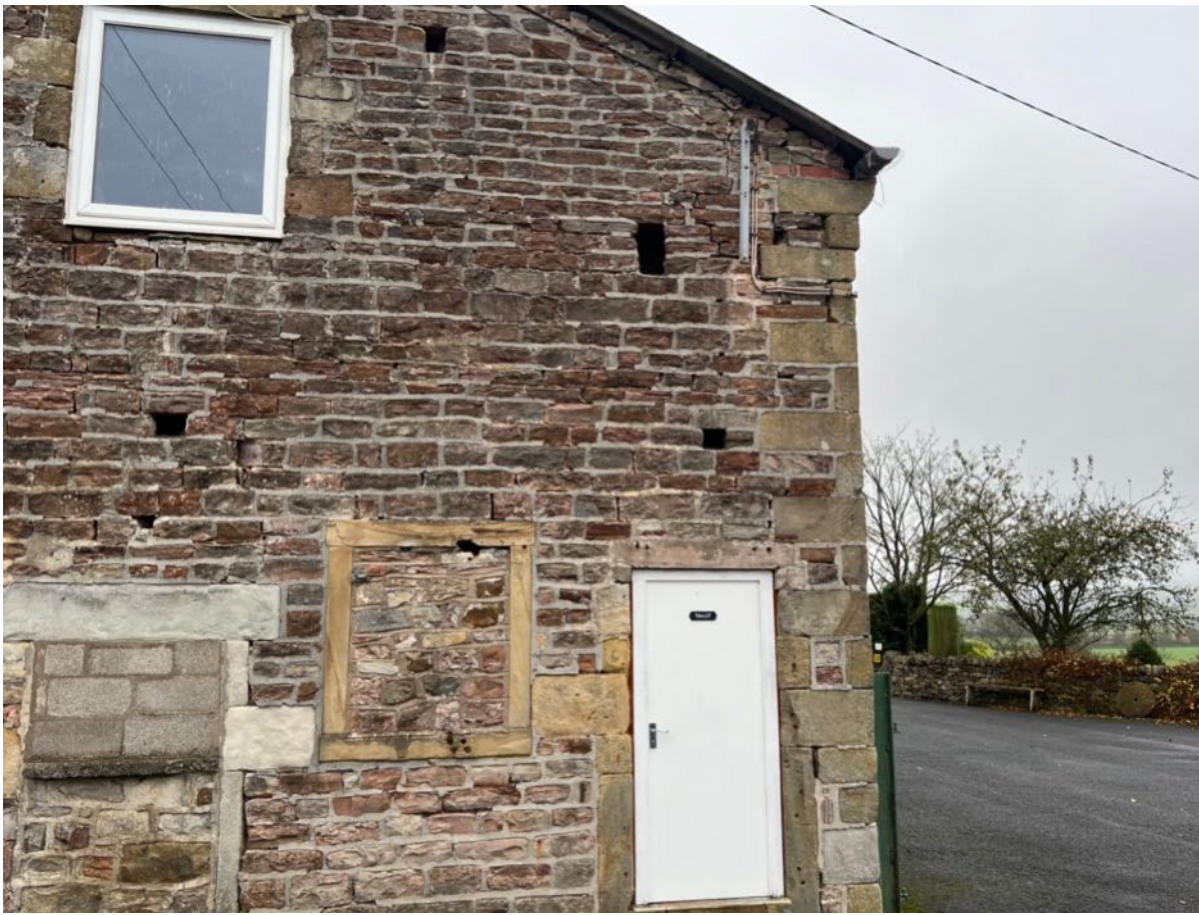
Photo 9 – South East Elevation

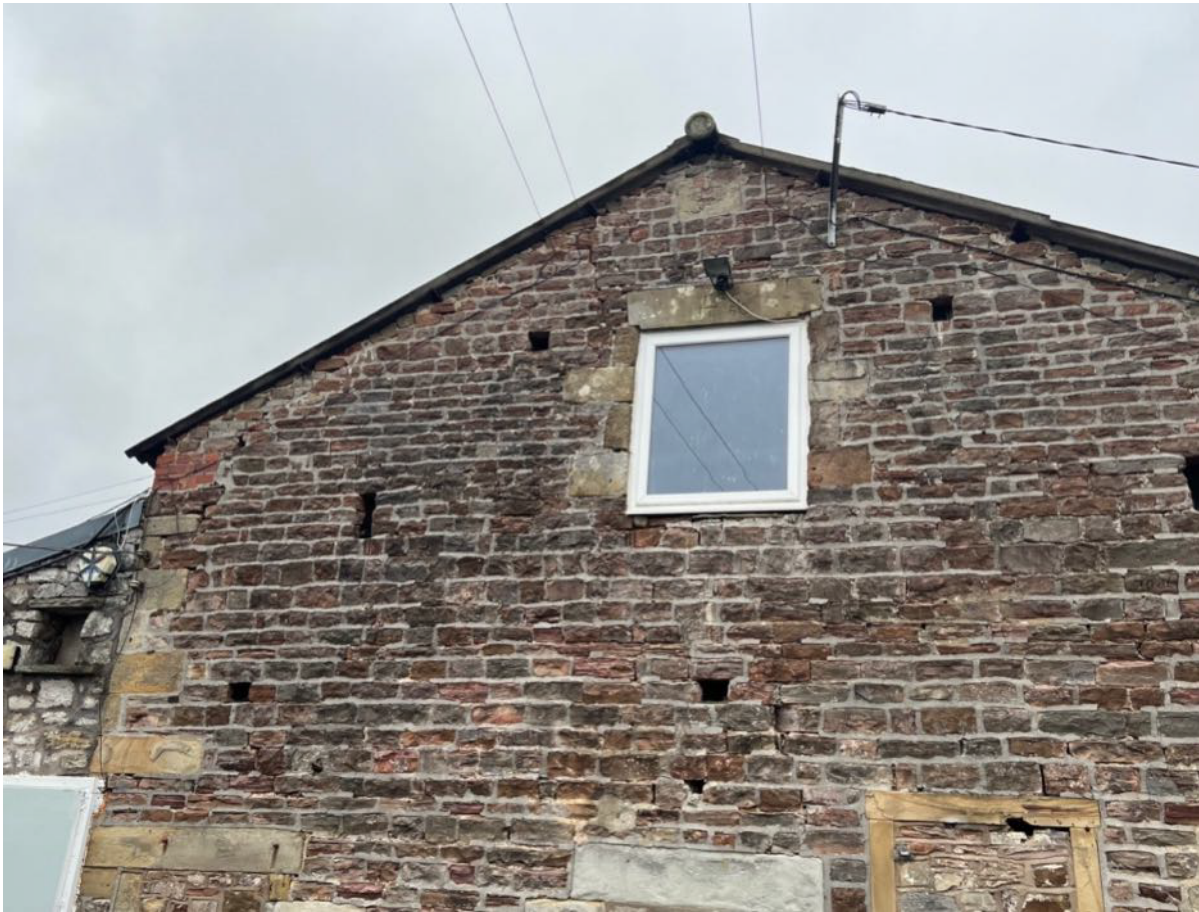
Photo 10 – South East Elevation

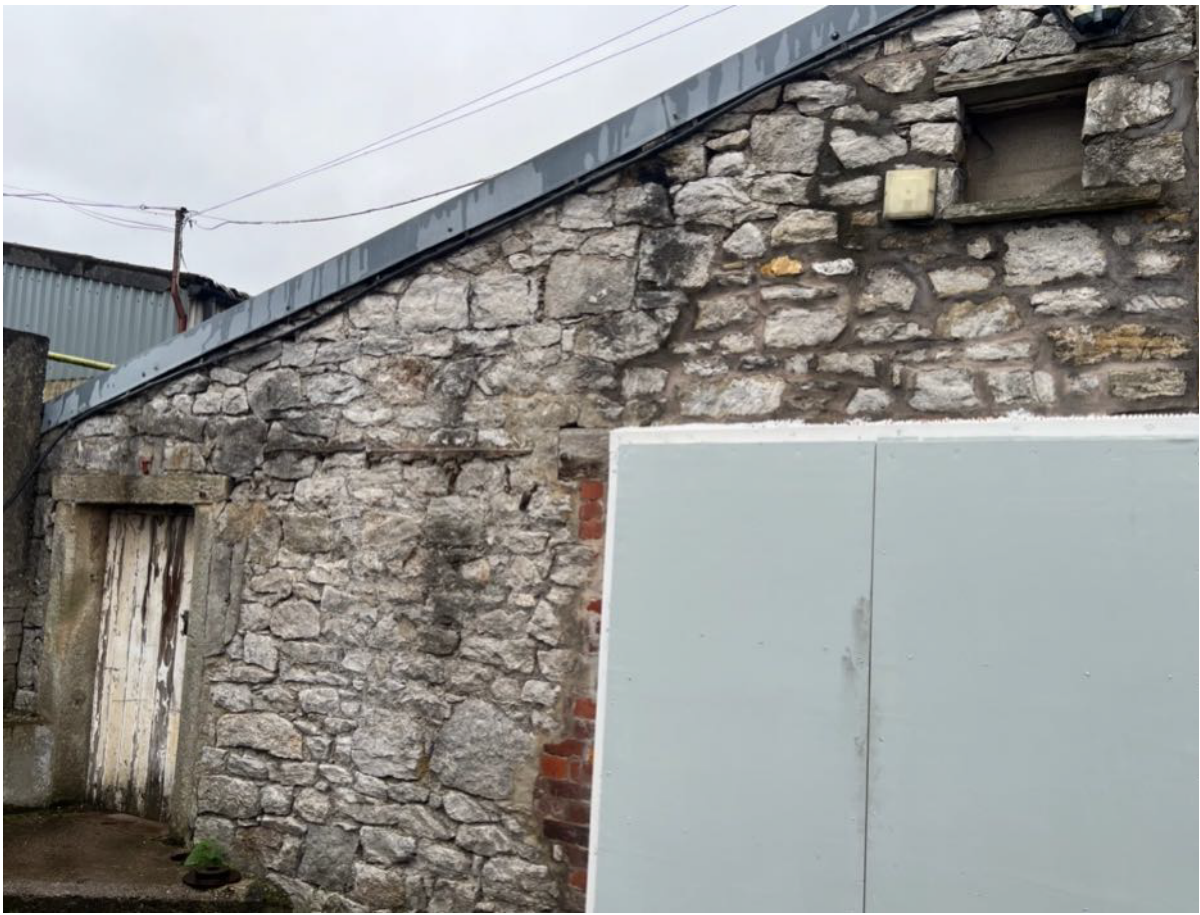
Photo 11 - South East Elevation

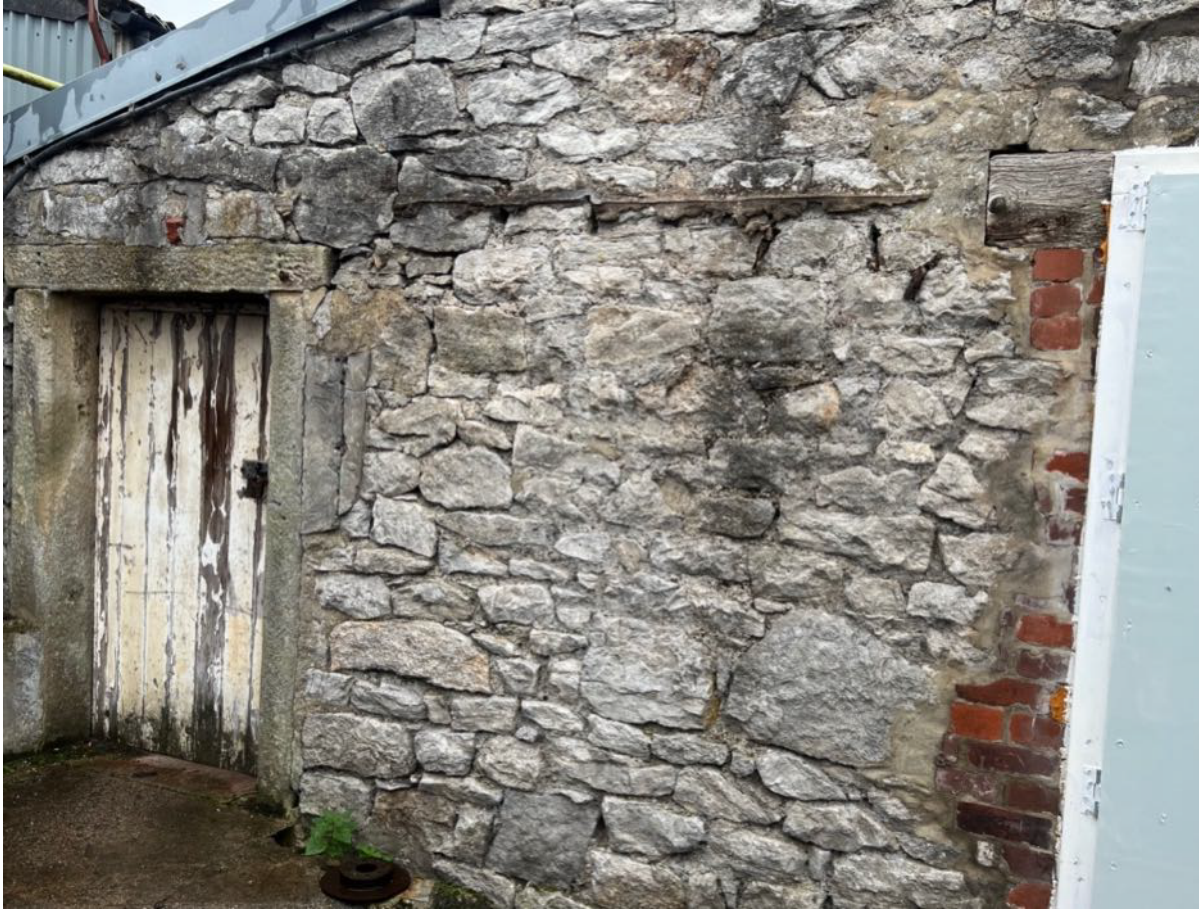
Photo 12 - South East Elevation

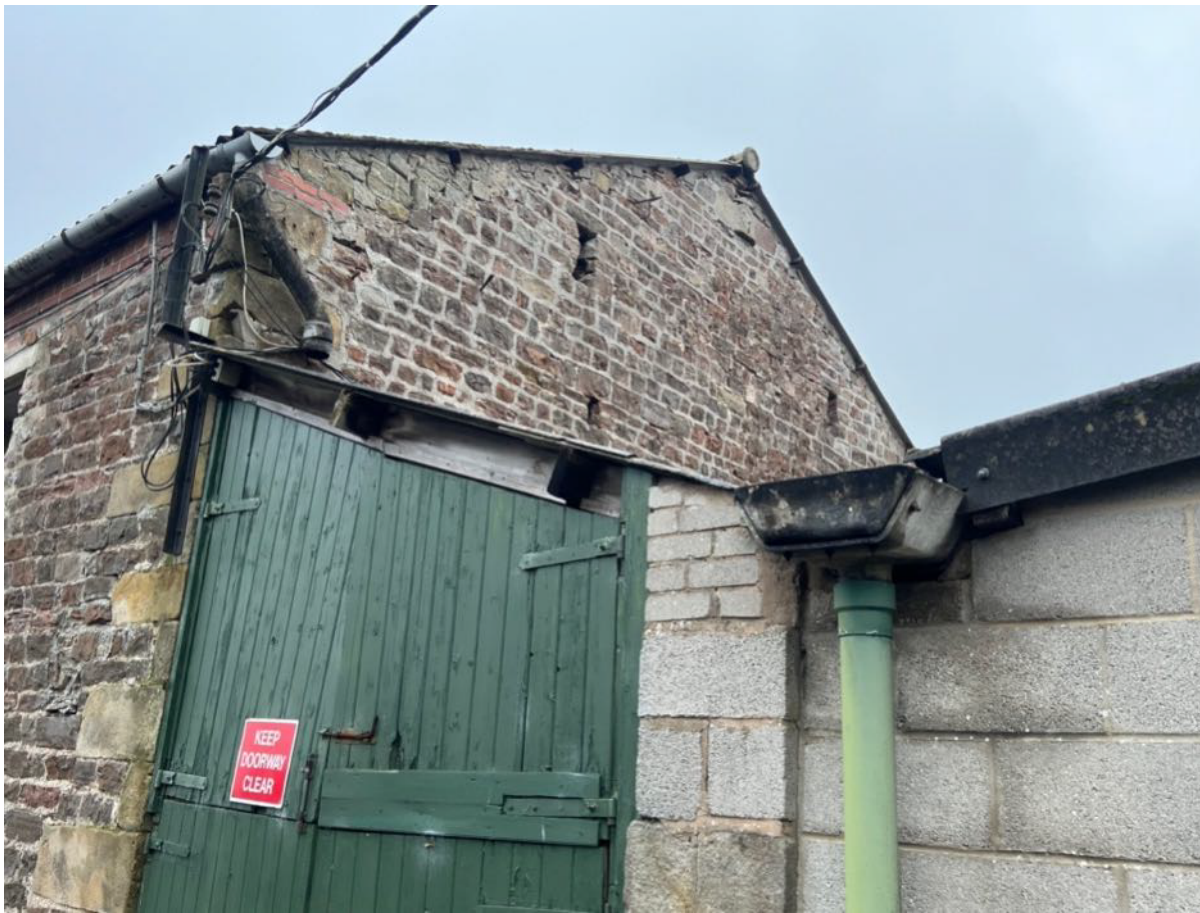
This gable wall is a 500mm thick coursed stone wall to the main barn and rendered stone or block, 300mm thick to the rear shippon area. The main gable has a lean-to section attached which obscures the lower portion of wall. This will not be retained. The wall is plumb, reasonably well pointed and free from signs of movement. There is large roller shutter door giving access to the rear shippon area (photo 15).

Photo 13 – North West Elevation

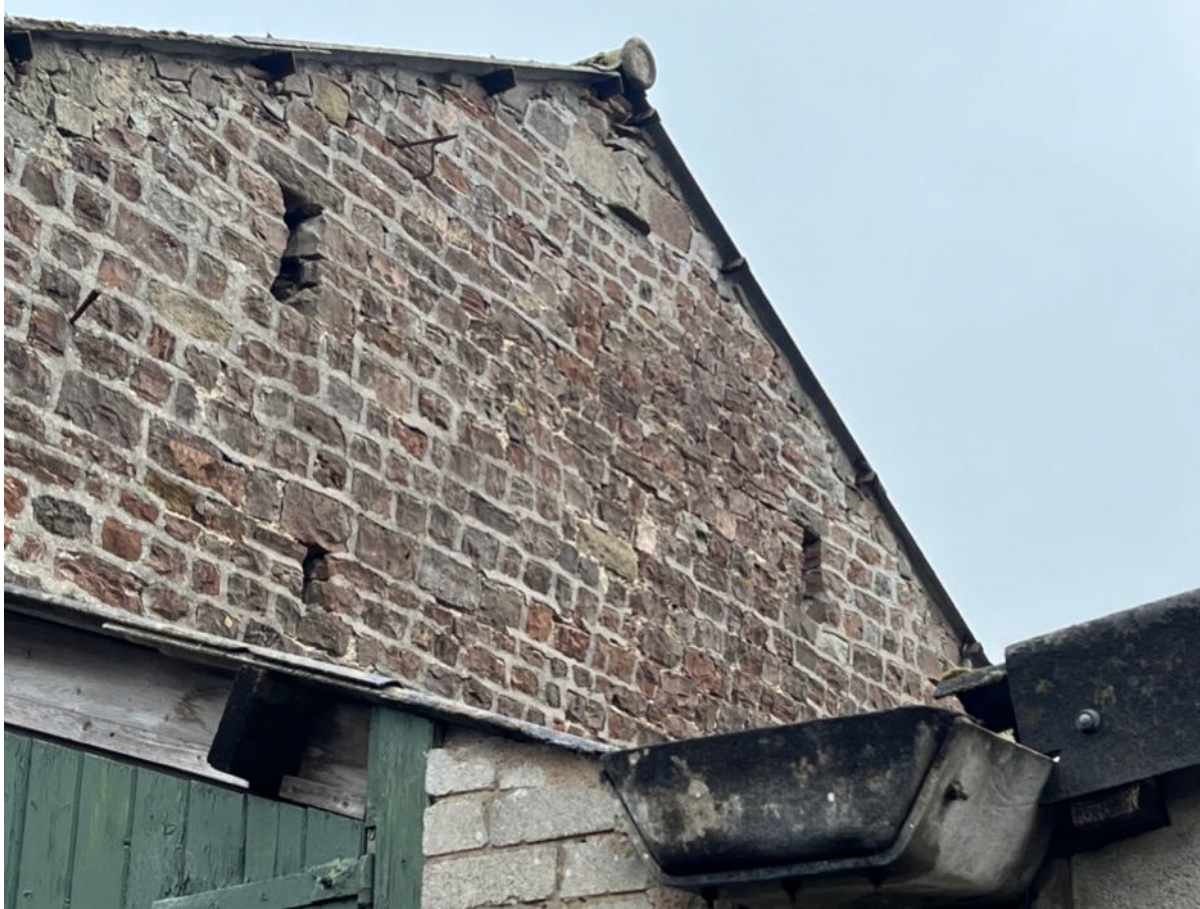
Photo 14 - North West Elevation

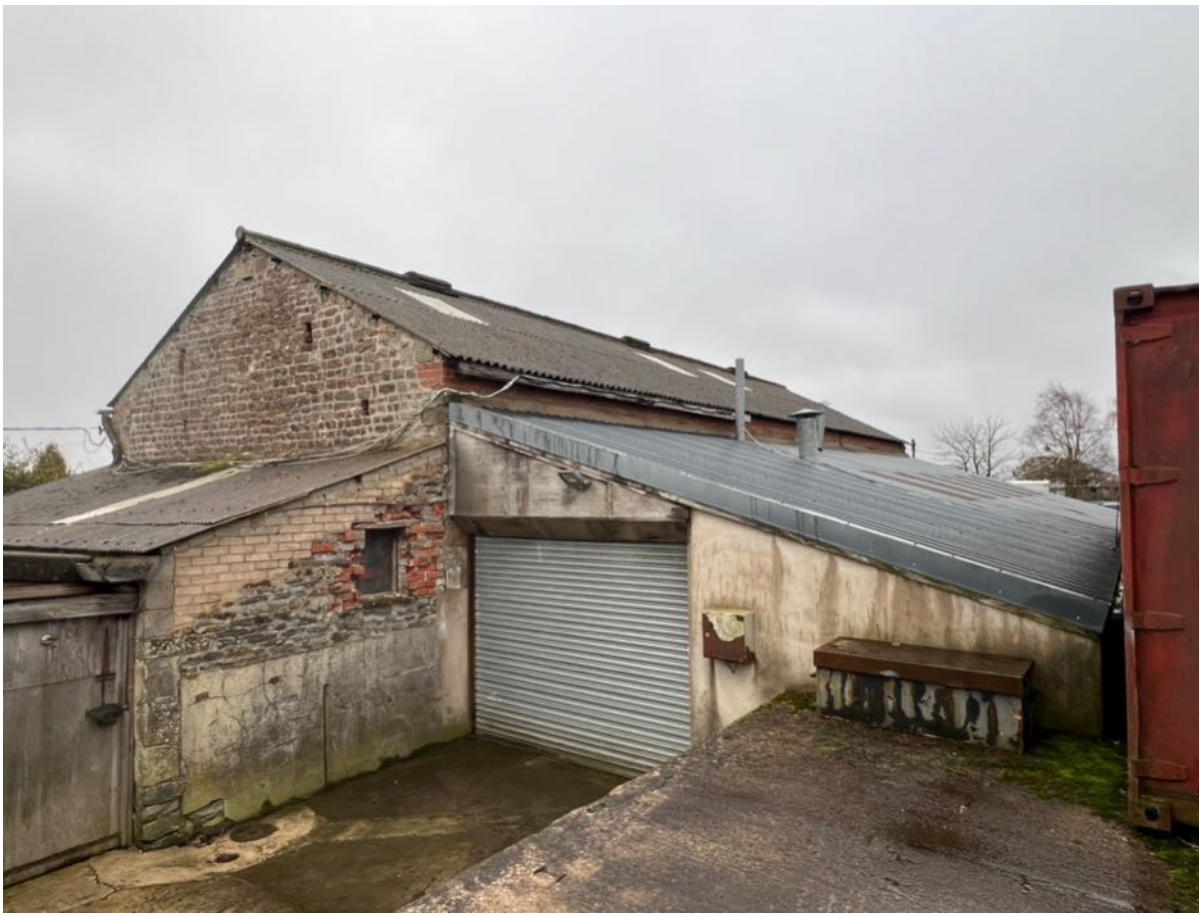
The rear wall to the main barn is discussed in the section covering internal inspections below. Photos 15 & 16 show the wall raised by brickwork as per the front elevation. Interestingly, the gables do not have areas of additional brickwork suggesting the brickwork to the elevations may have replaced stone. The rear wall to the shippon area is obscured by the ground behind it which is at a higher level and retained by this wall. External inspection of this higher ground did not reveal any signs of movement.

Photo 15 - North West Elevation, rear lean to section and roofs

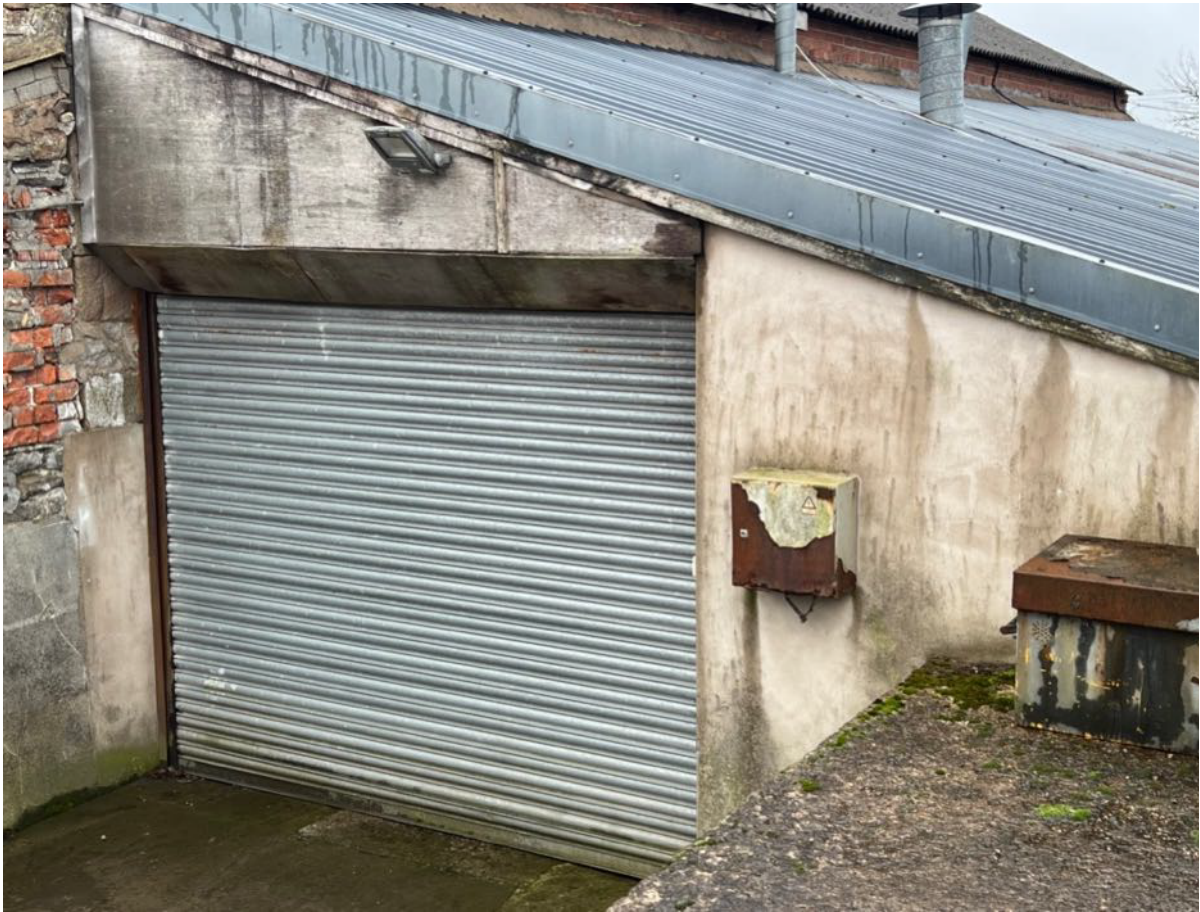
Photo 16 - North West Elevation to rear lean to

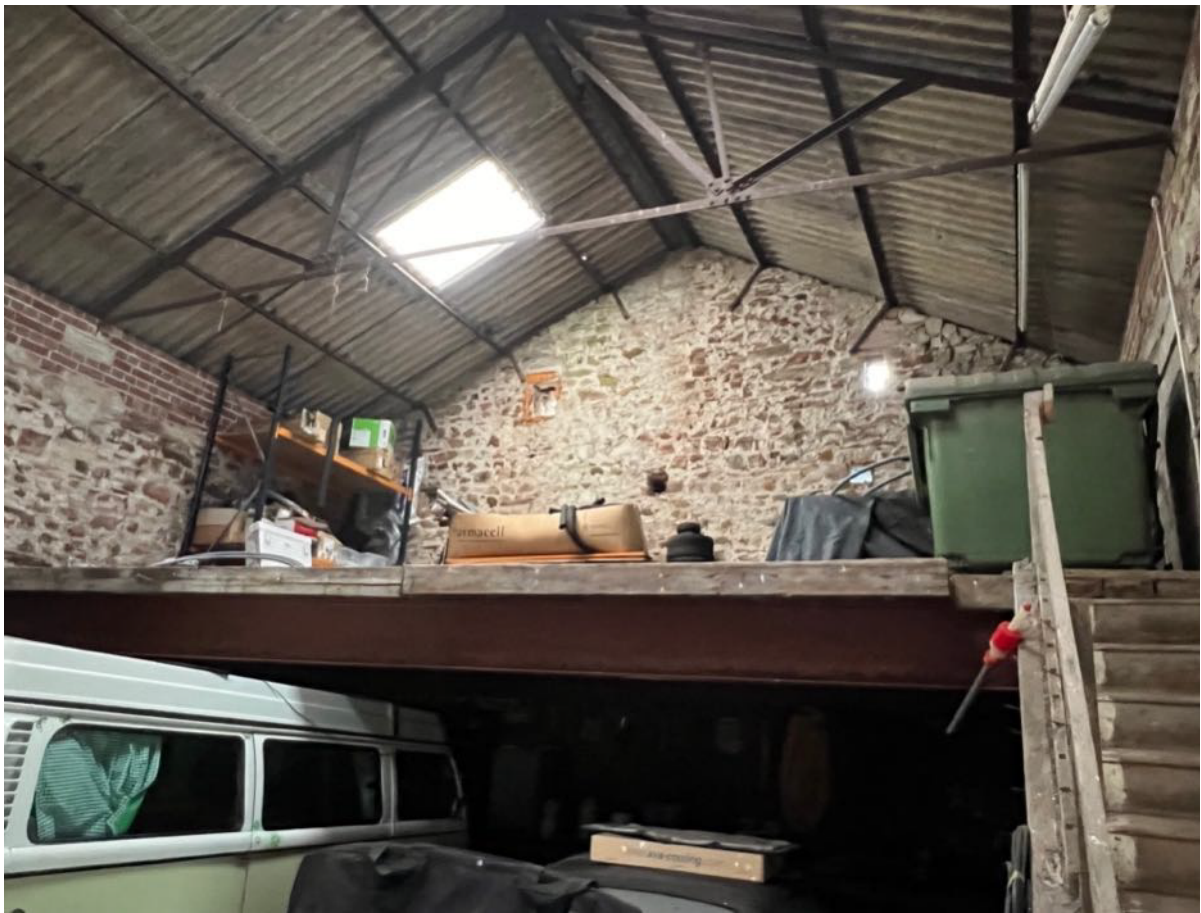
Photo 17 – Internal looking North West

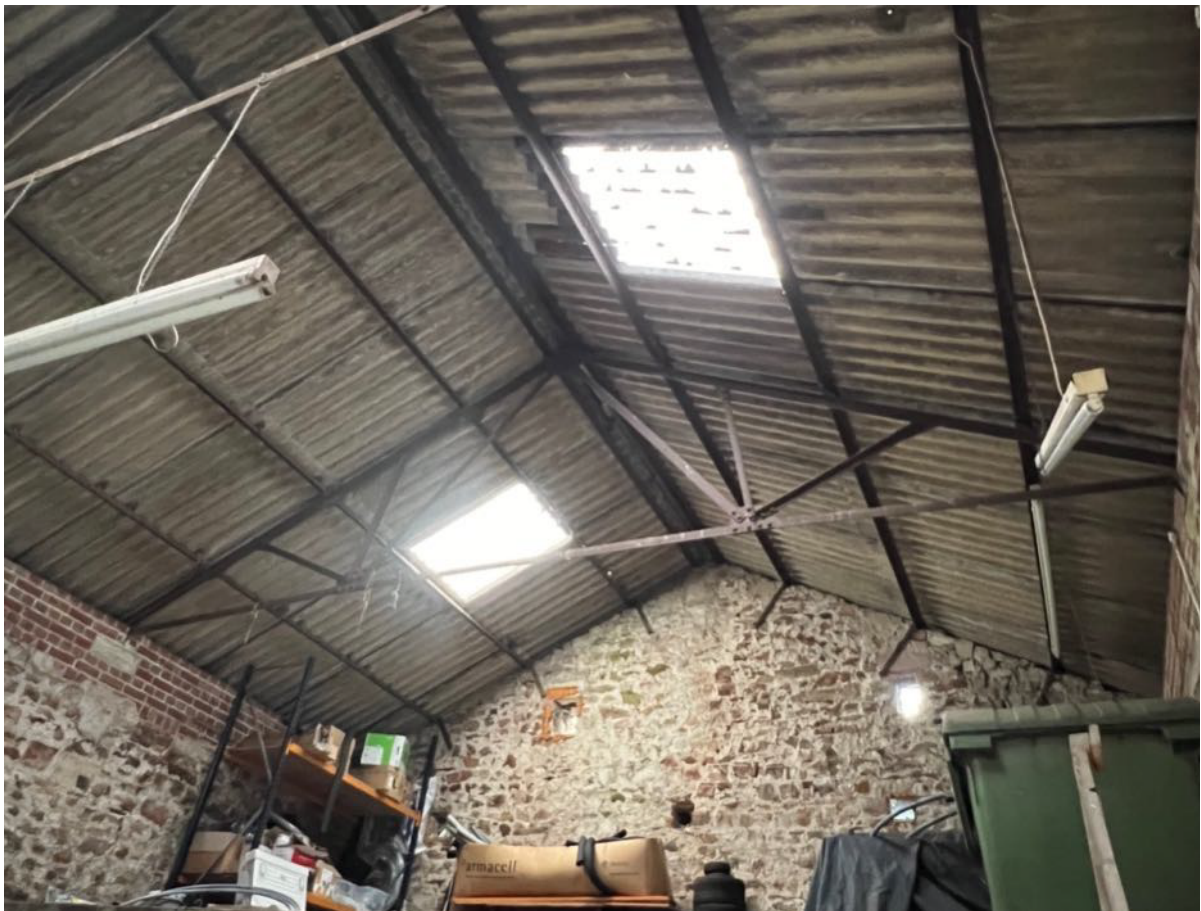
Photo 18 – Internal showing steel trusses and purlins

The existing trusses and purlins appear to be in good condition with little sign of rot or infestation. Any timber retained should be assessed by a timber specialist, with regard to rot and infestation. All retained timber should be treated against rot/infestation and an indication of residual section given for structural purposes. All retained timber to be used structurally should be checked for structural adequacy. The roof to the stone barn is likely to revert back to slate.

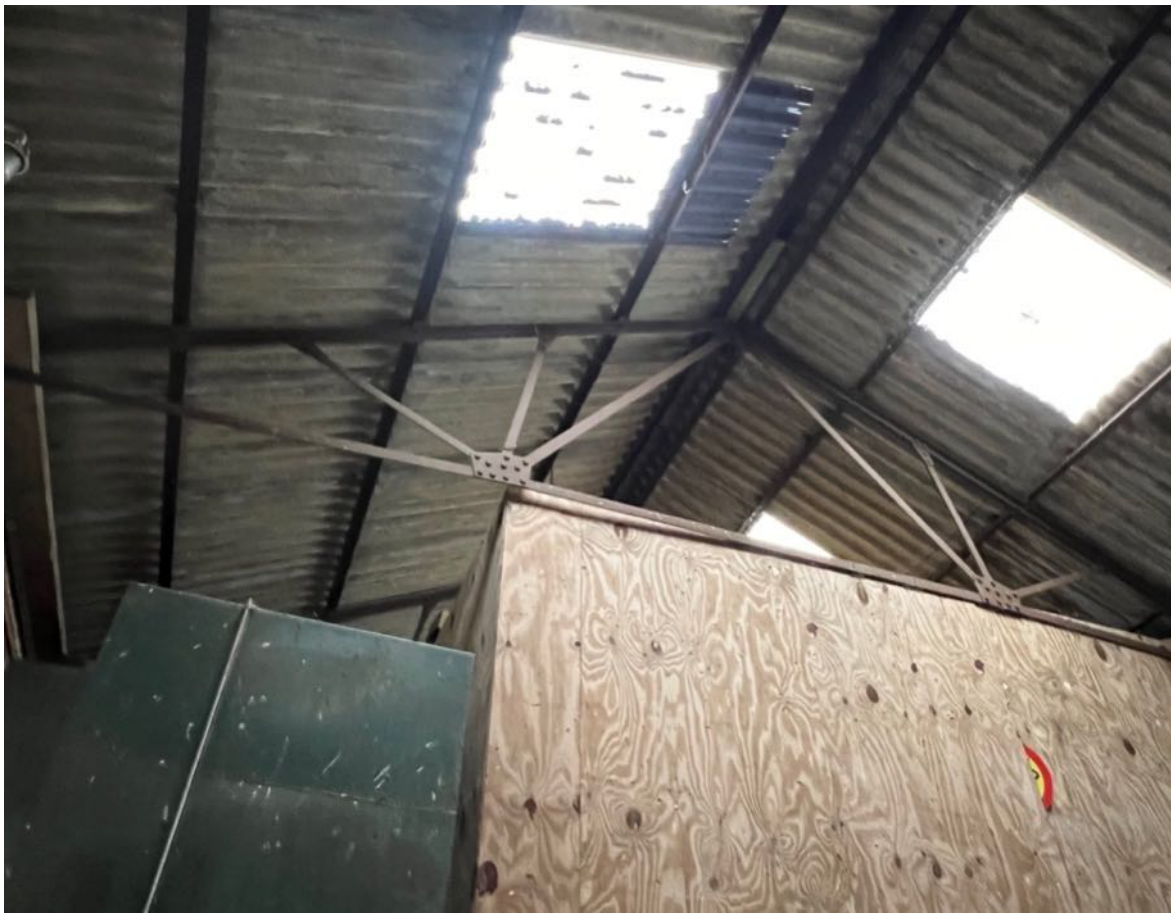
Photo 19 – Internal with storage at North East End

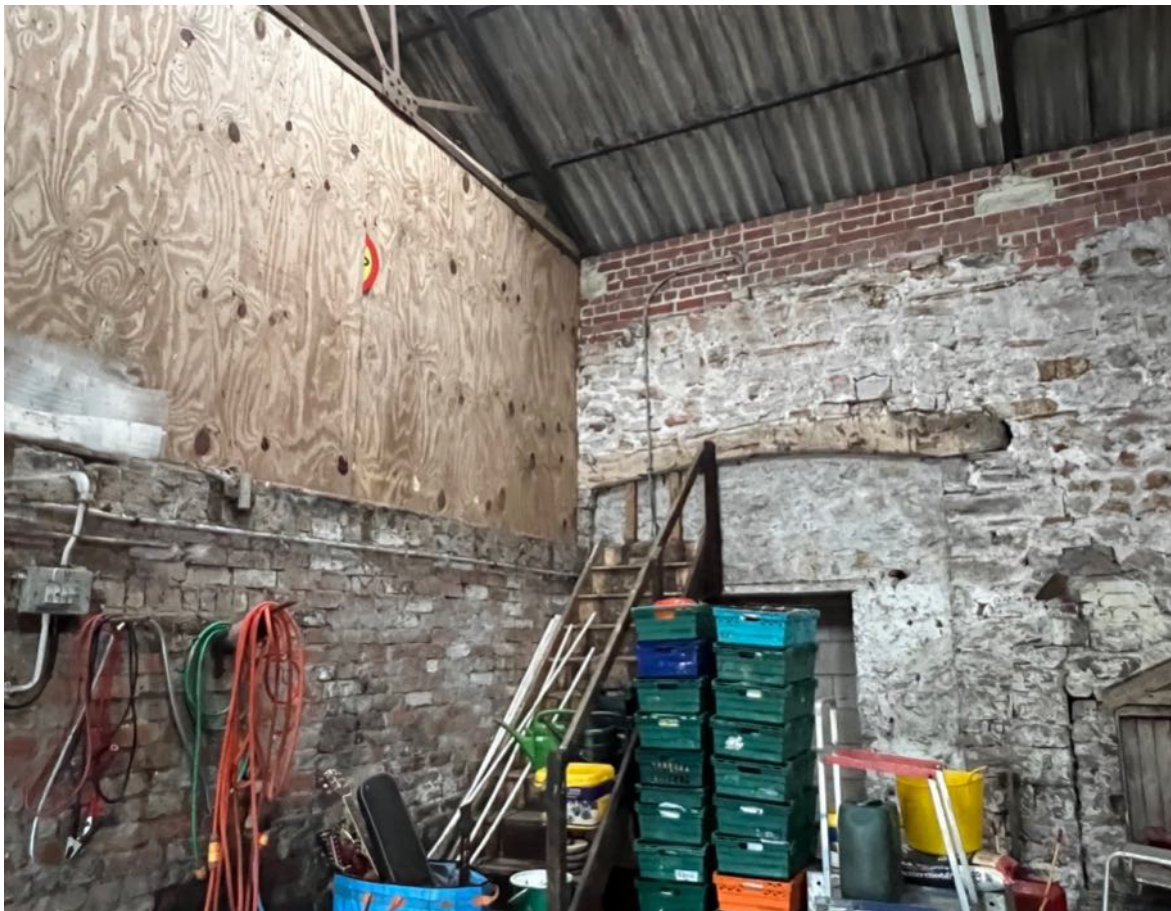
The main area of the barn is split into two halves with a central full height section and two mezzanine store areas adjacent to each gable. The area to the south east gable of the barn has a solid brick wall at ground floor level and a timber stud wall above (photo 20). Internal inspection reflects the external findings i.e. the barn is in good condition with no sign of previous or ongoing movement. The roof is carried by steel trusses and timber purlins (photos 17 to 19). Photo 22 shows the additional courses of brickwork which are 6 course deep on the internal face. Photo 21 shows a precious large barn door access to the rear wall which has been infilled presumably after the construction of the rear shippon. Photo 24 shows a typical steel beam carrying the mezzanine floor above. The existing access to the front elevation

Photo 20 - Internal with storage at North East End and South West Wall internal
