Barn at Cheethall Farm, Edisford Road, Clitheroe, BB7 3LH

Structural Condition Survey for Conversion to Dwelling

PSC-932

November 2024

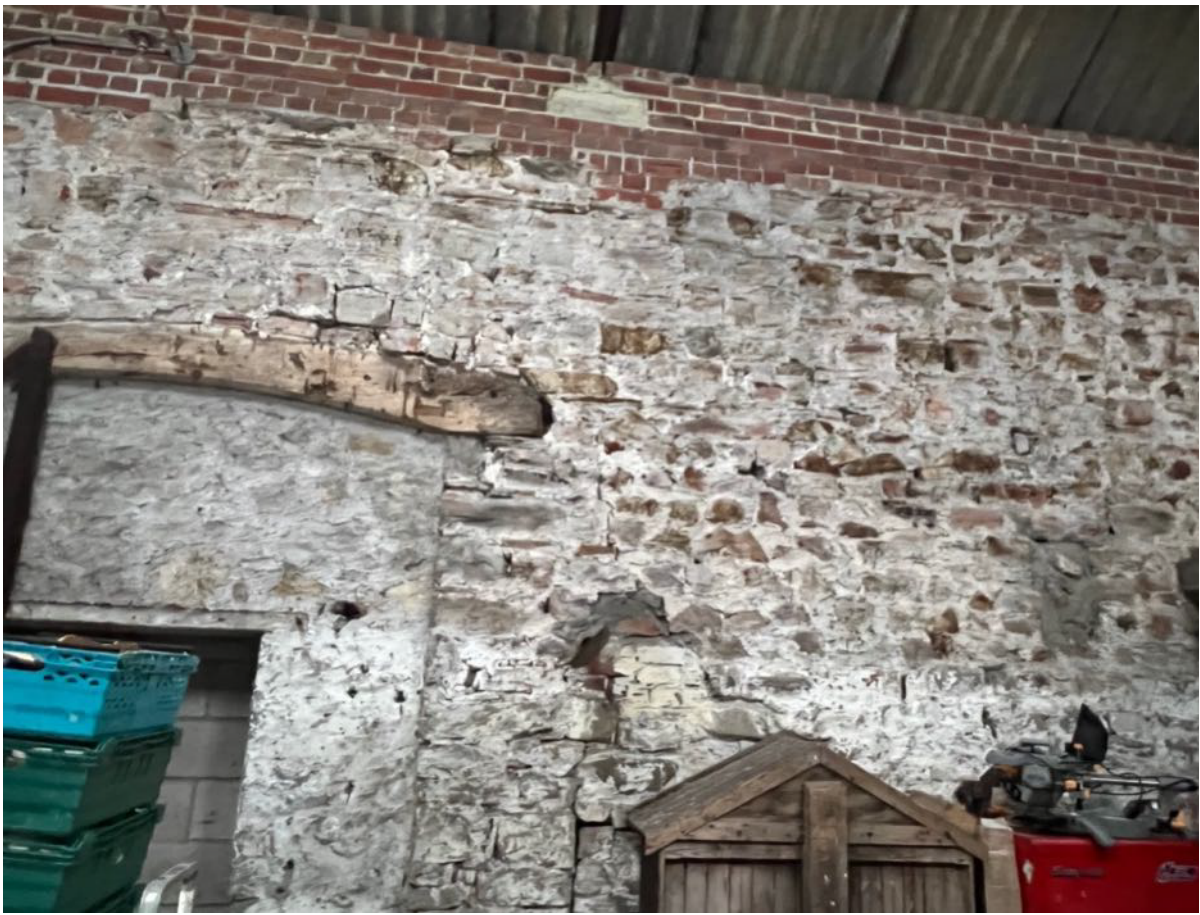
Photo 21 – South West Wall Internal

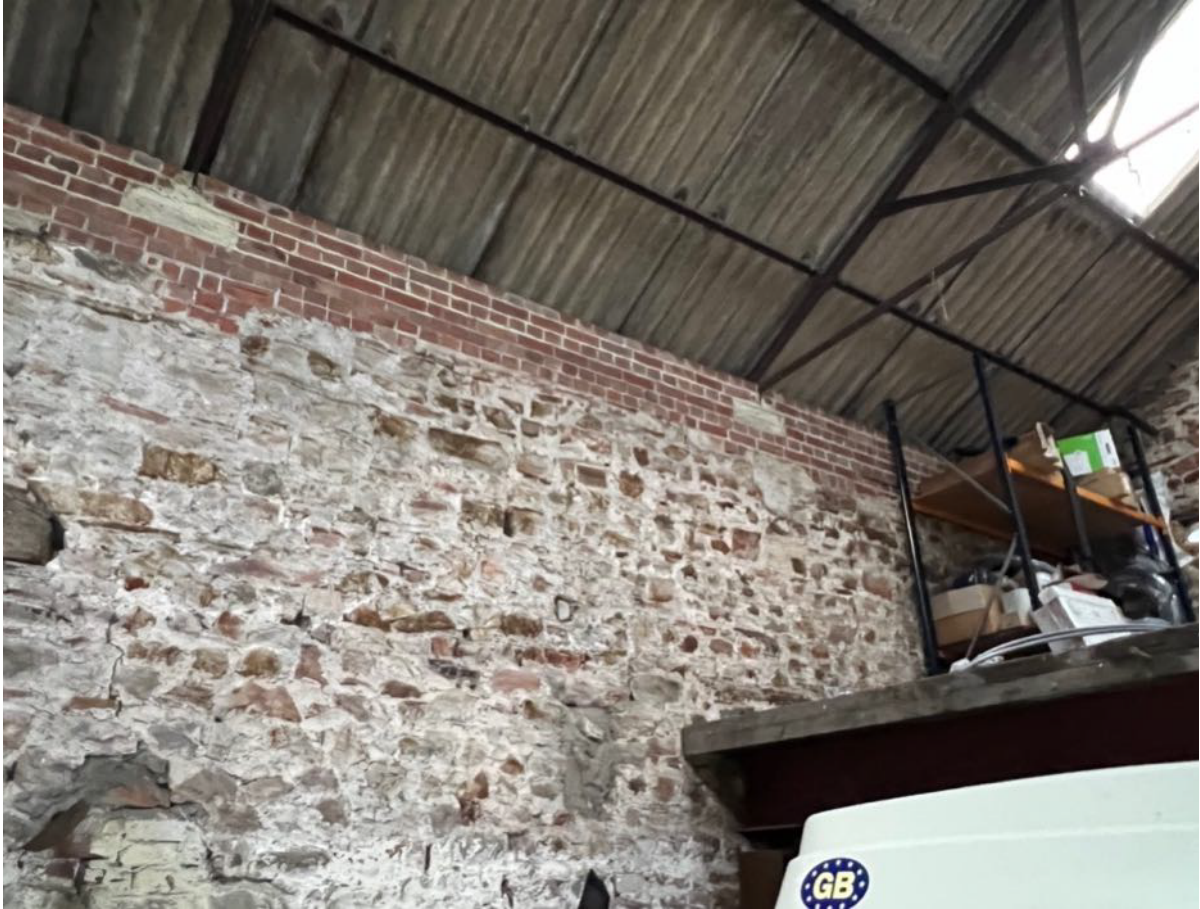
Photo 22 - South West Wall Internal with storage mezzanine at North West end

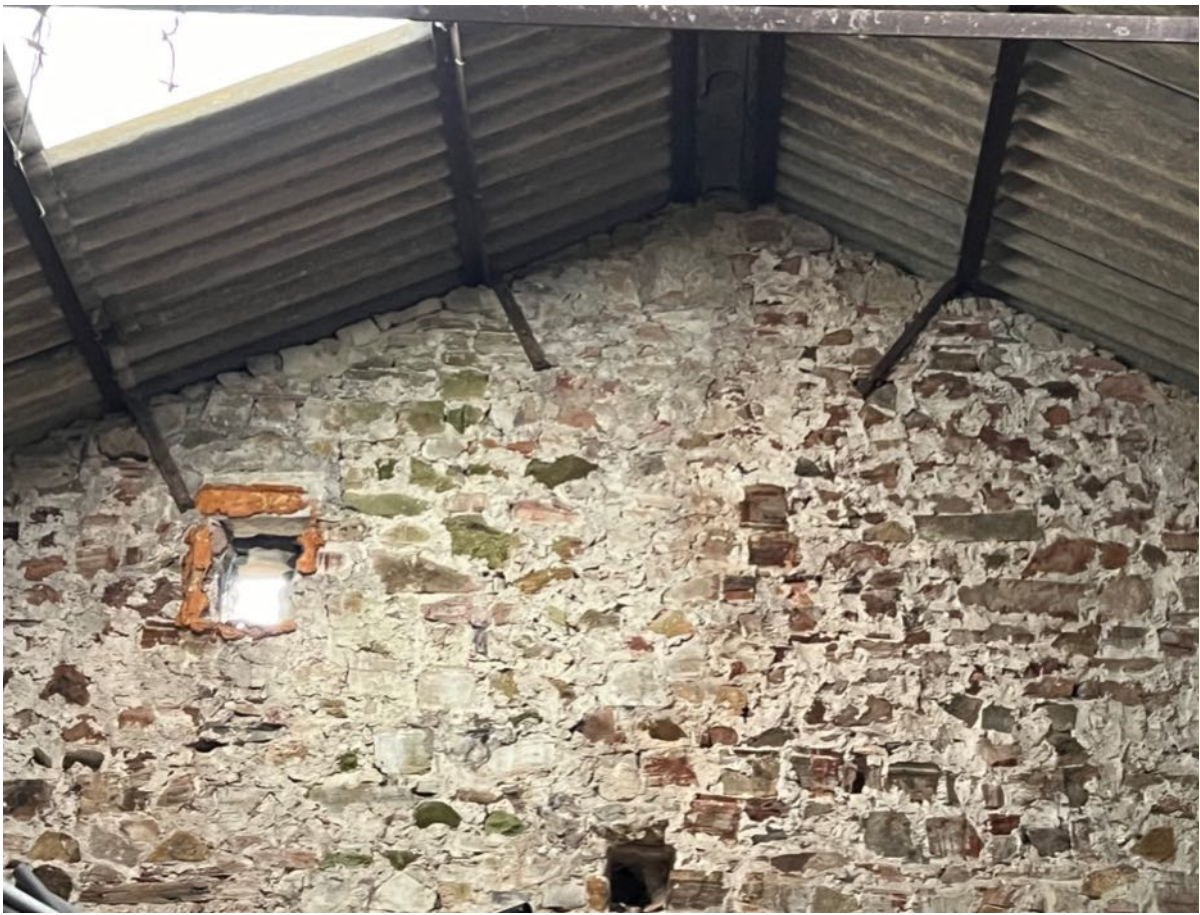
Photo 23 – North West gable

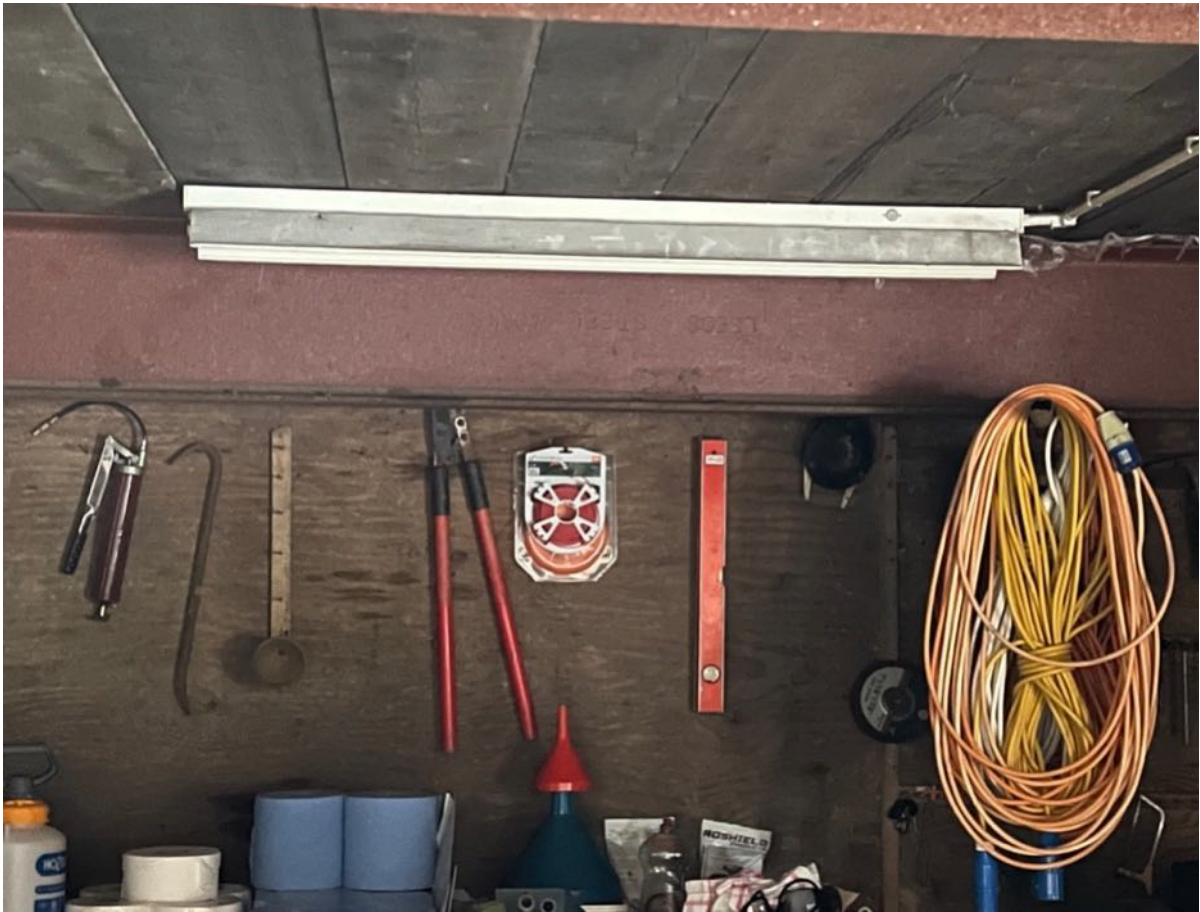
The main area of the barn is split into two halves with a central full height section and two mezzanine store areas adjacent to each gable. The area to the south east gable of the barn has a solid brick wall at ground floor level and a timber stud wall above (photo 20). Internal inspection reflects the external findings i.e. the barn is in good condition with no sign of previous or ongoing movement. The roof is carried by steel trusses and timber purlins (photos 17 to 19). Photo 22 shows the additional courses of brickwork which are 6 course deep on the internal face. Photo 21 shows a precious large barn door access to the rear wall which has been infilled presumably after the construction of the rear shippon. Photo 24 shows a typical steel beam carrying the mezzanine floor above. The existing access to the front elevation

Photo 24 – Steel beam to mezzanine

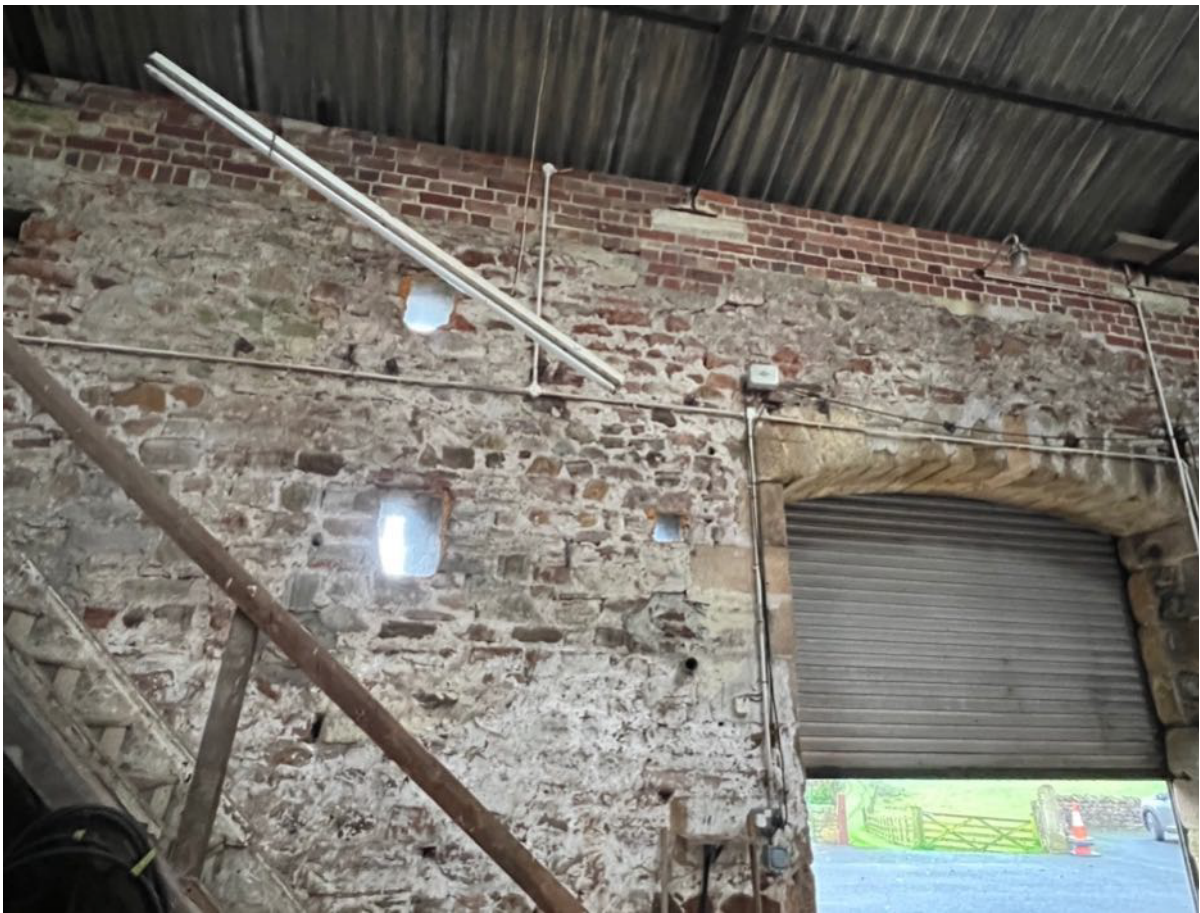
shown in photo 25 has a stone arch whereas the infilled door at the rear has a timber lintel (photo 26).

Photo 25 – Internal north east elevation and main door

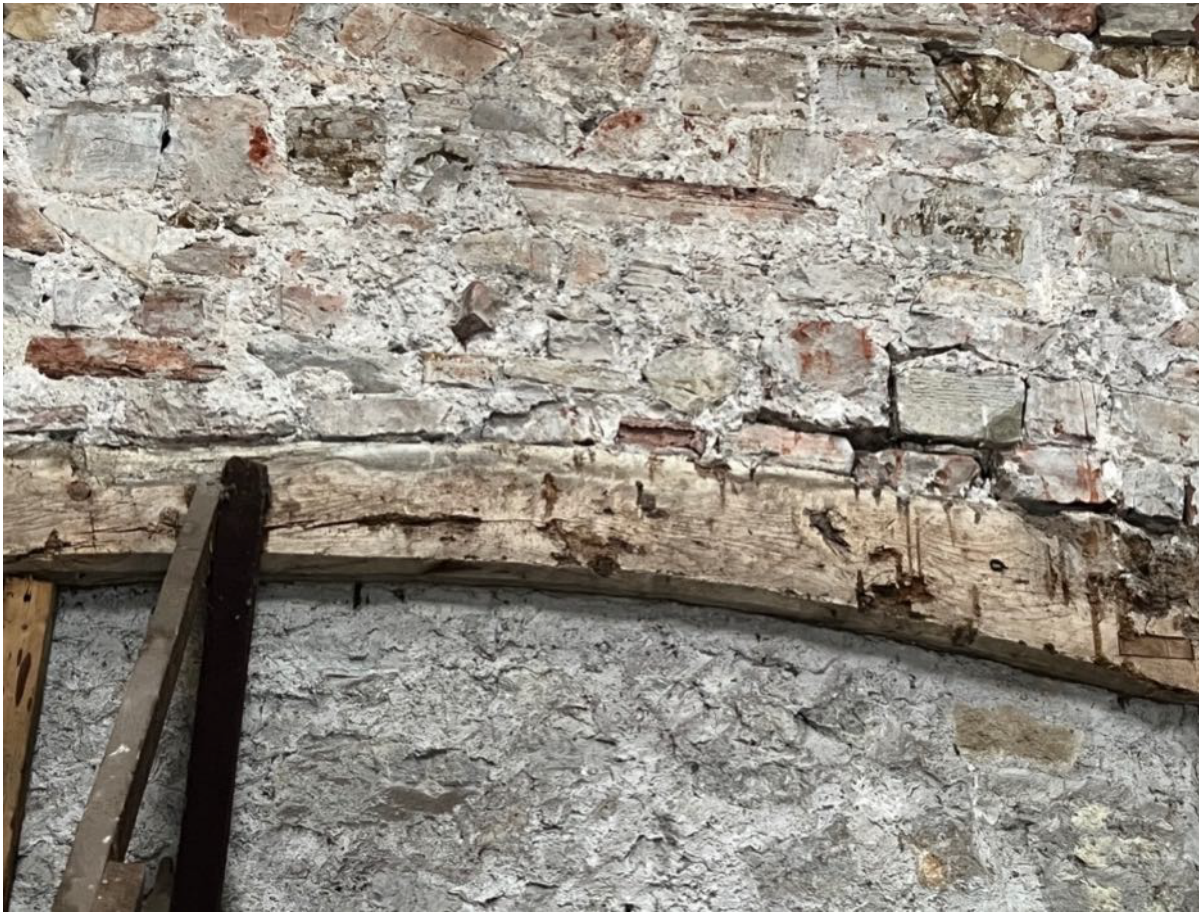
Photo 26 – Timber curved lintel to former opening in rear elevation of main barn

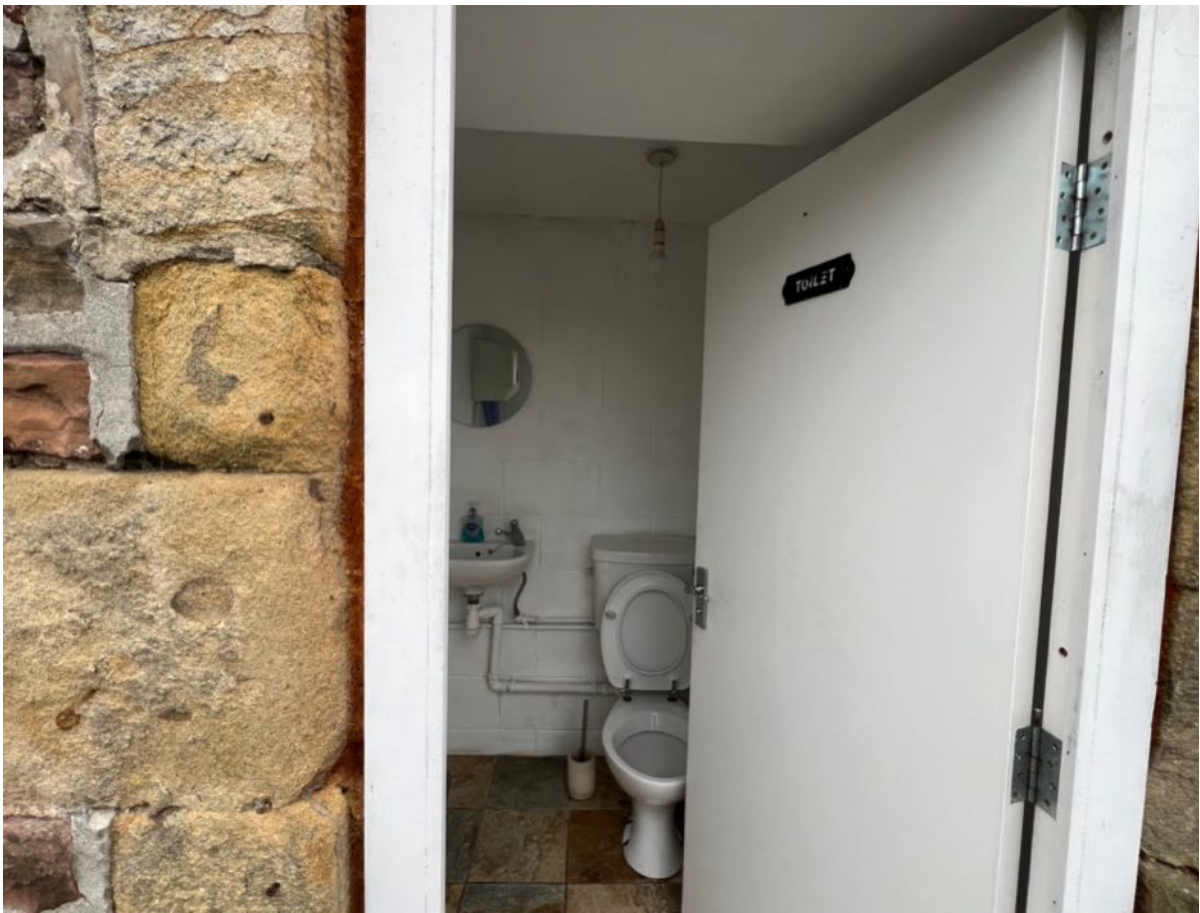
Photo 27 – Toilet at south east elevation

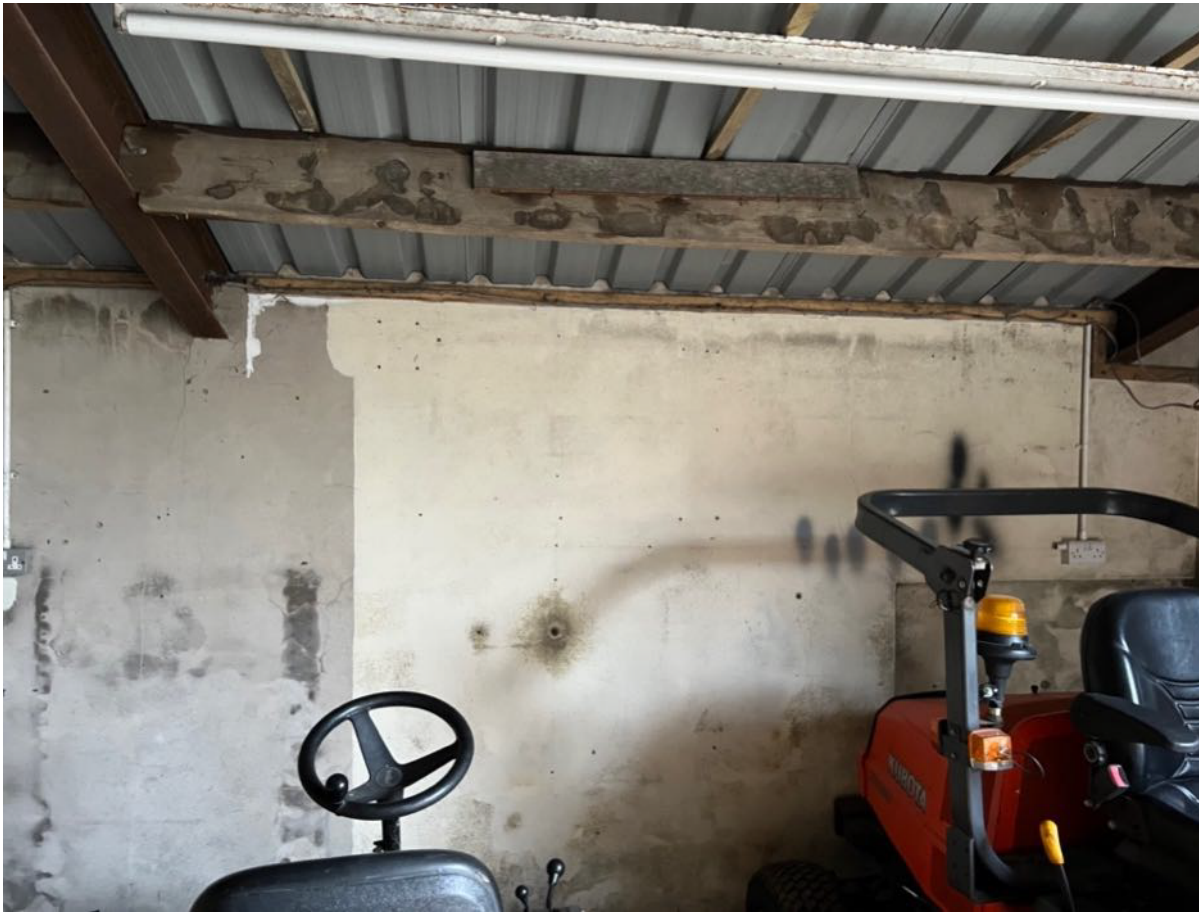
The rear shippon area gives access to the main barn rear wall which is in coursed sandstone and in good condition (photos 29 & 30). Photo 30 indicates vents in the rear wall. The rear wall to the shippon is rendered as illustrated in photo 28. There is no sign of movement to this wall.

Photo 28 – Rear wall of lean to on south west elevation

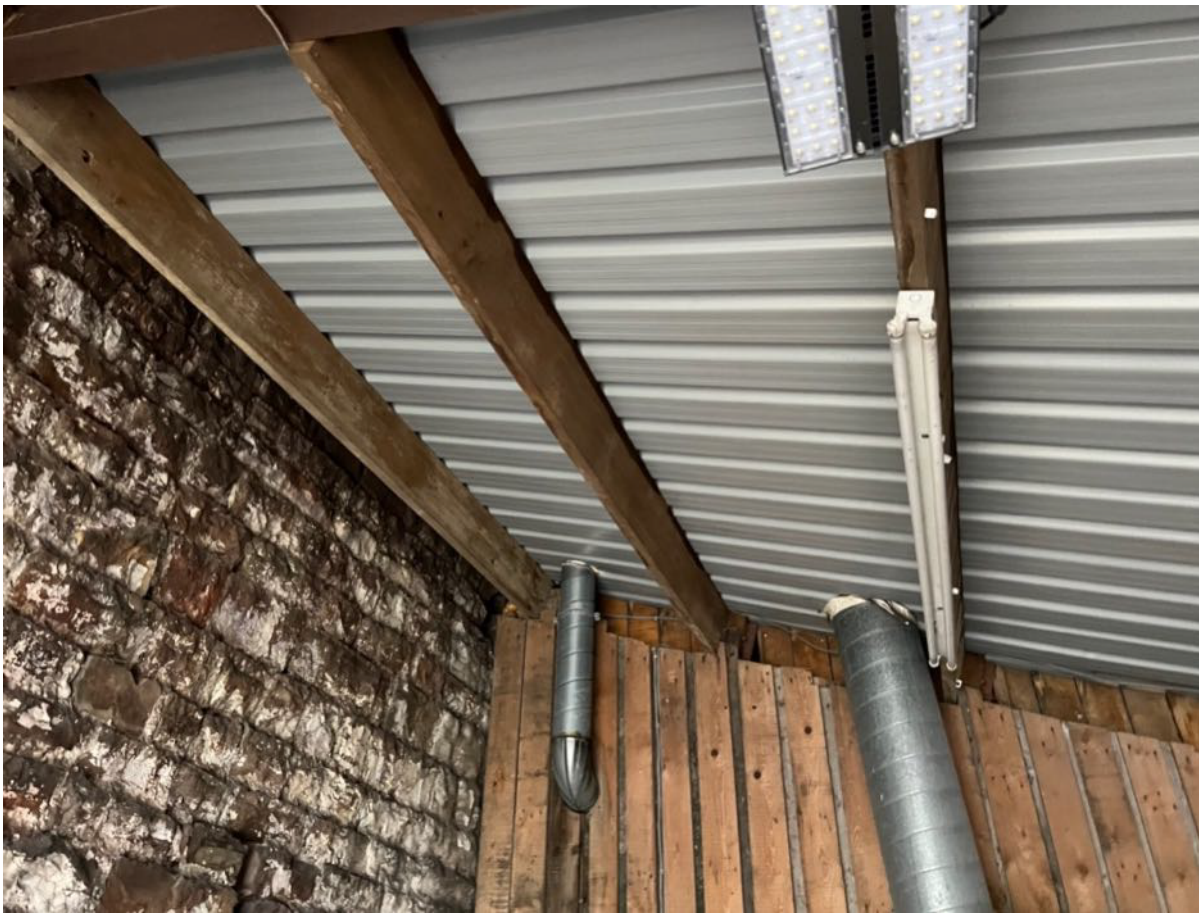
Photo 29 – Rear south west wall of main barn and roof to rear lean to

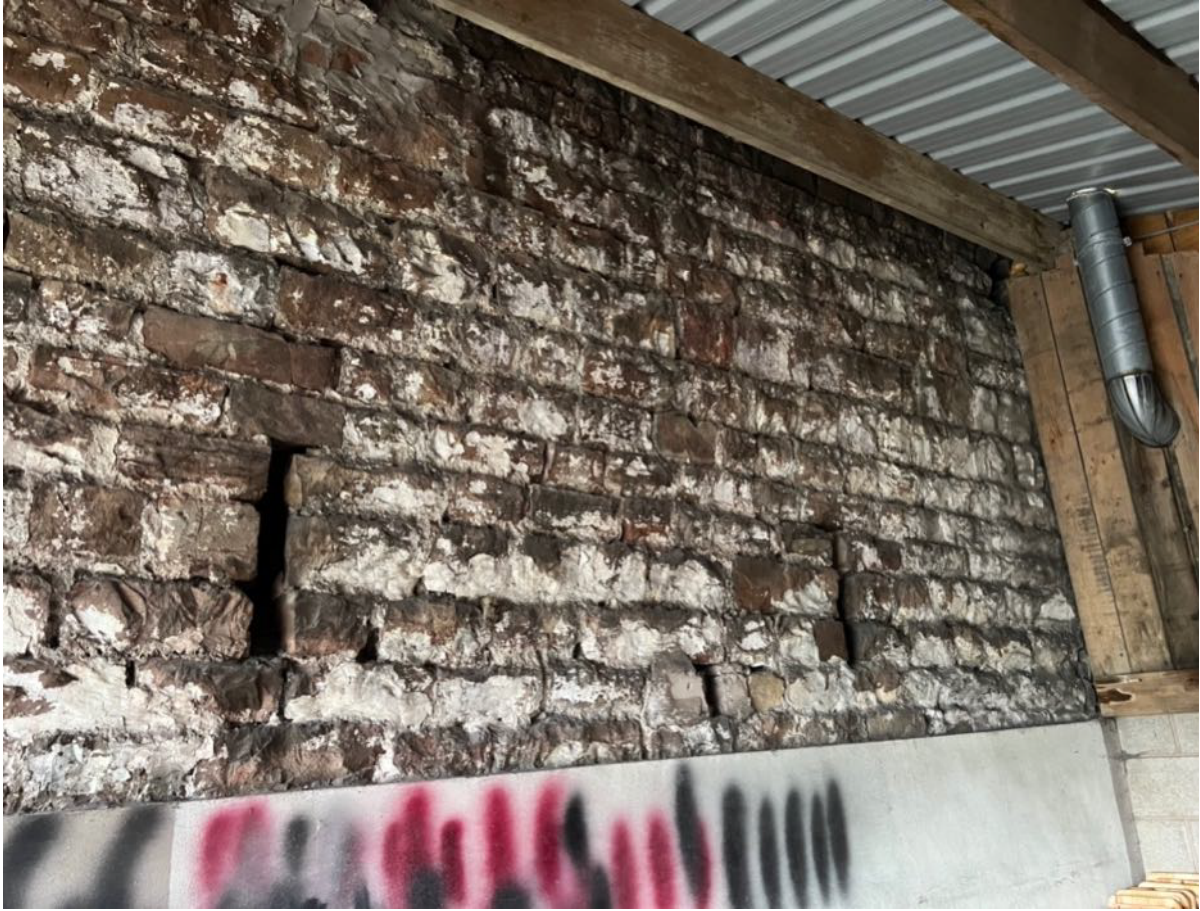
Photo 30 - Rear south west wall of main barn in rear lean to
