# Laneside Barn, Grindleton – Structural Inspection for Planning

**Version:** 1.0

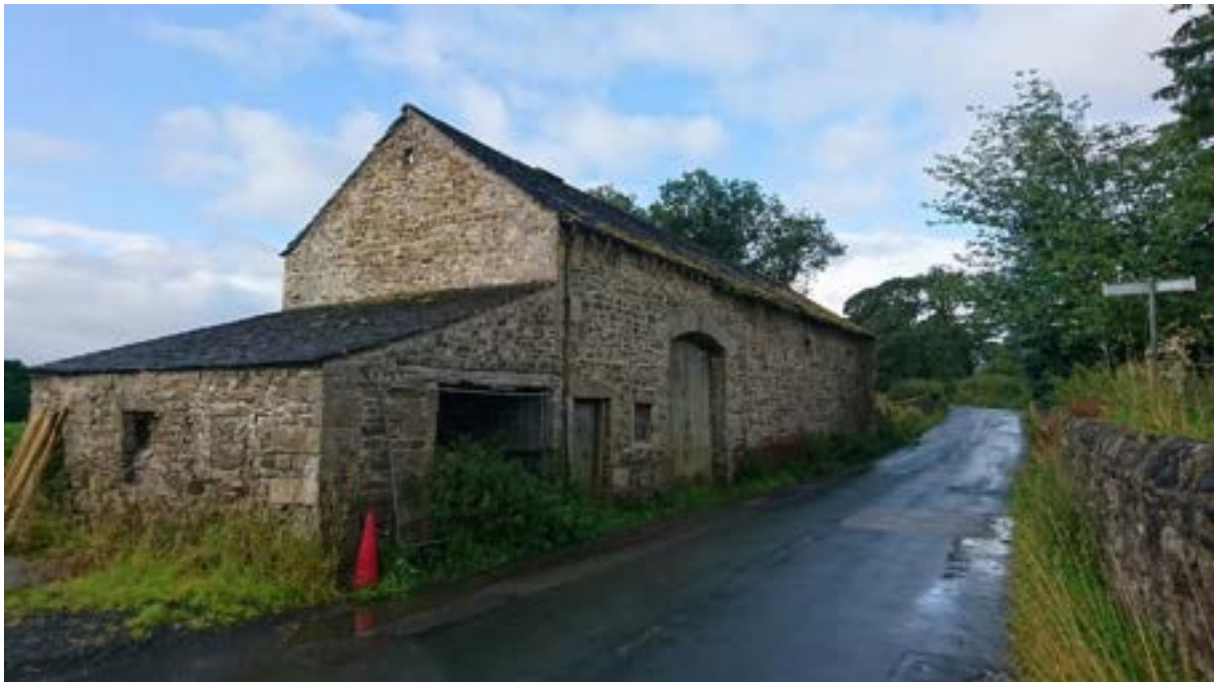
*Figure 1: Laneside barn, Grindleton.*

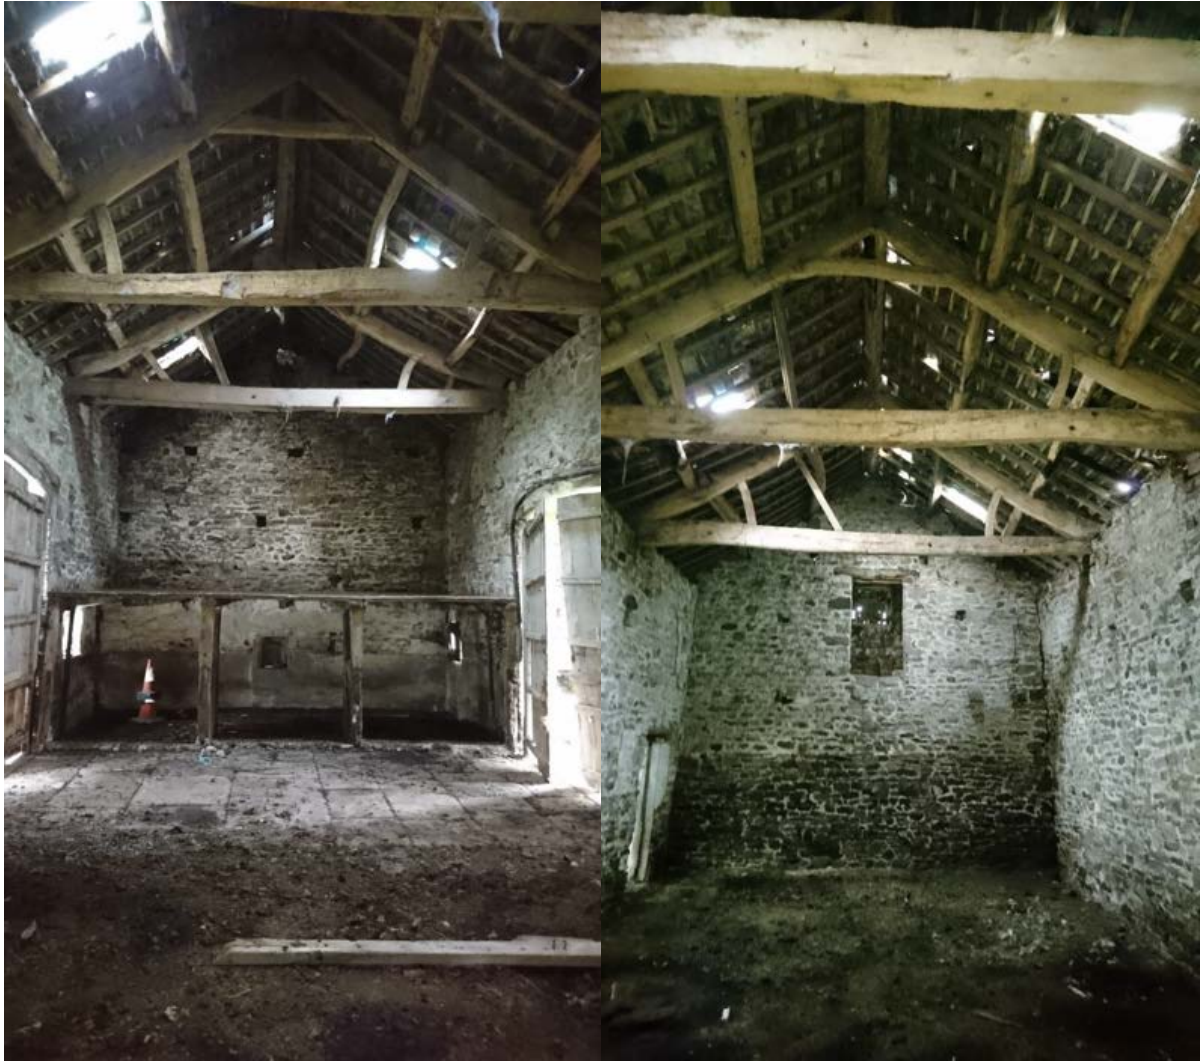
*Figure 3: The roof from inside the Main Barn, viewed from the west (image left) and viewed from the east (image right).*

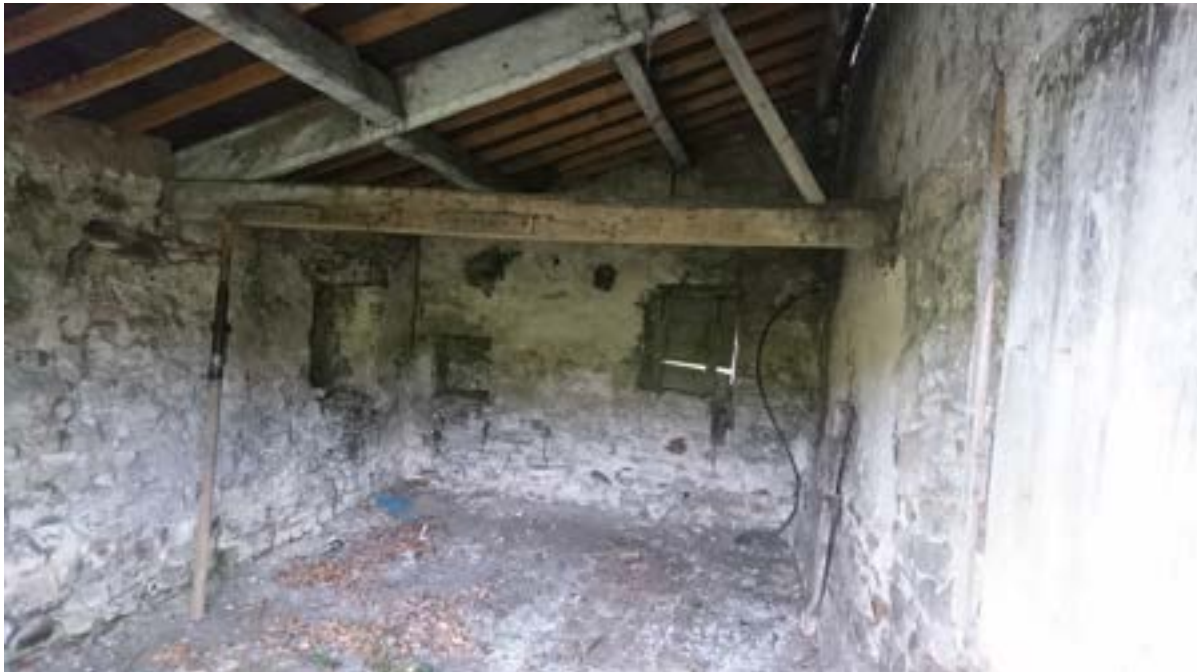
*Figure 6: The roof from inside Extension 1, noting the prop to the truss at WP 11.*

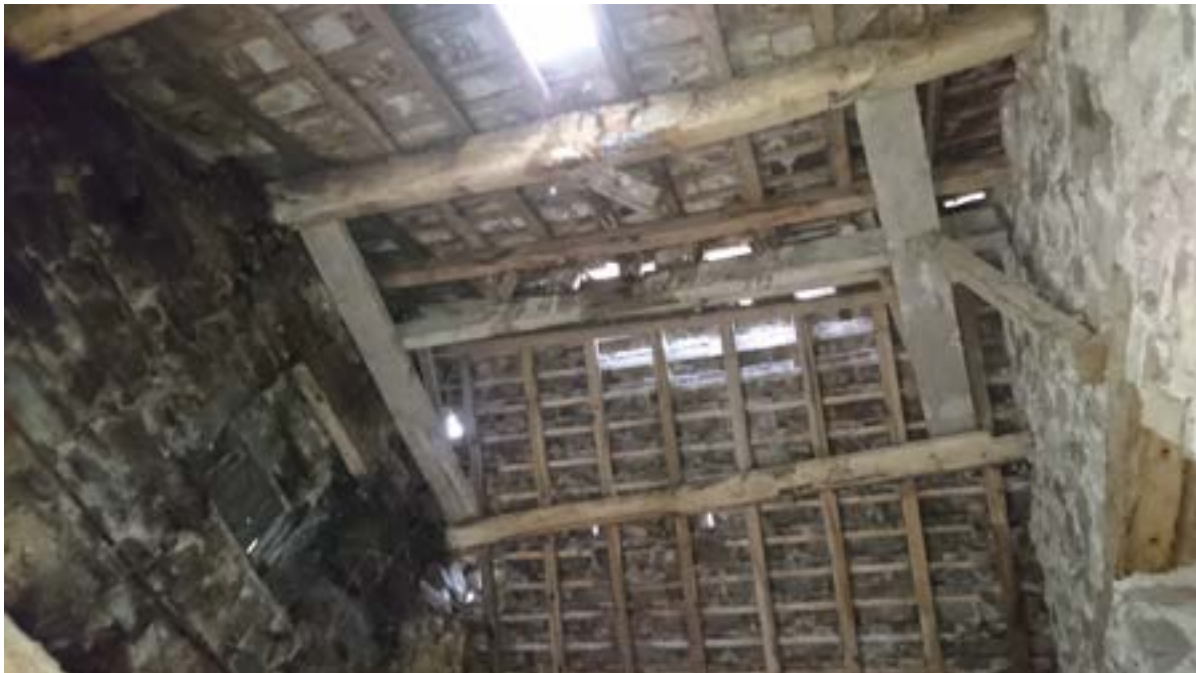
*Figure 8: The new ridge, supported by various props and two boards spanning between the two upper purlins.*

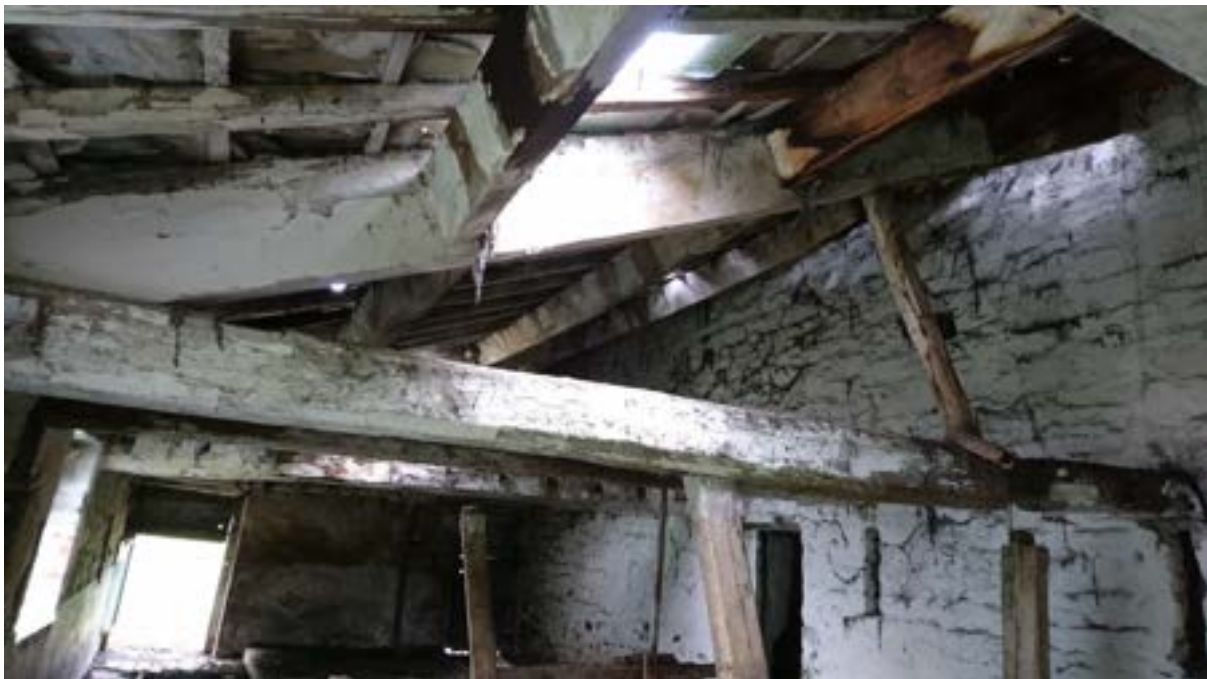
Figure 10: Typical internal view of the roof structure in Extension 2.

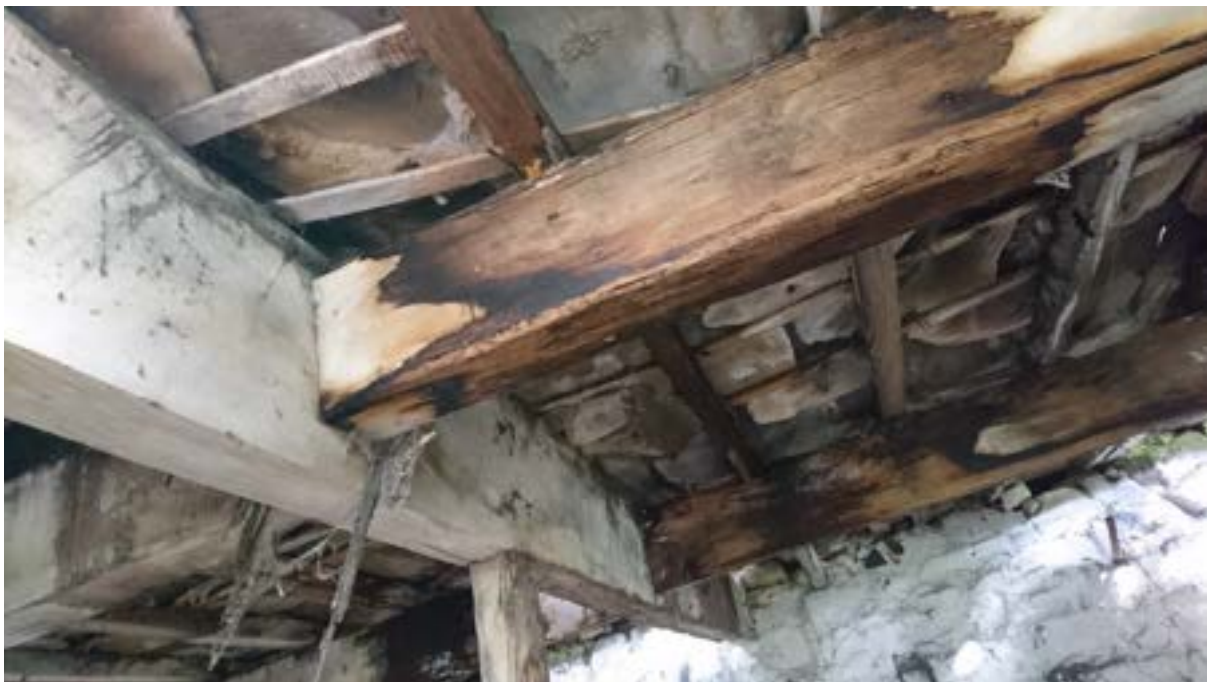
*Figure 12: Example of superficial decay under holes in the roof.*

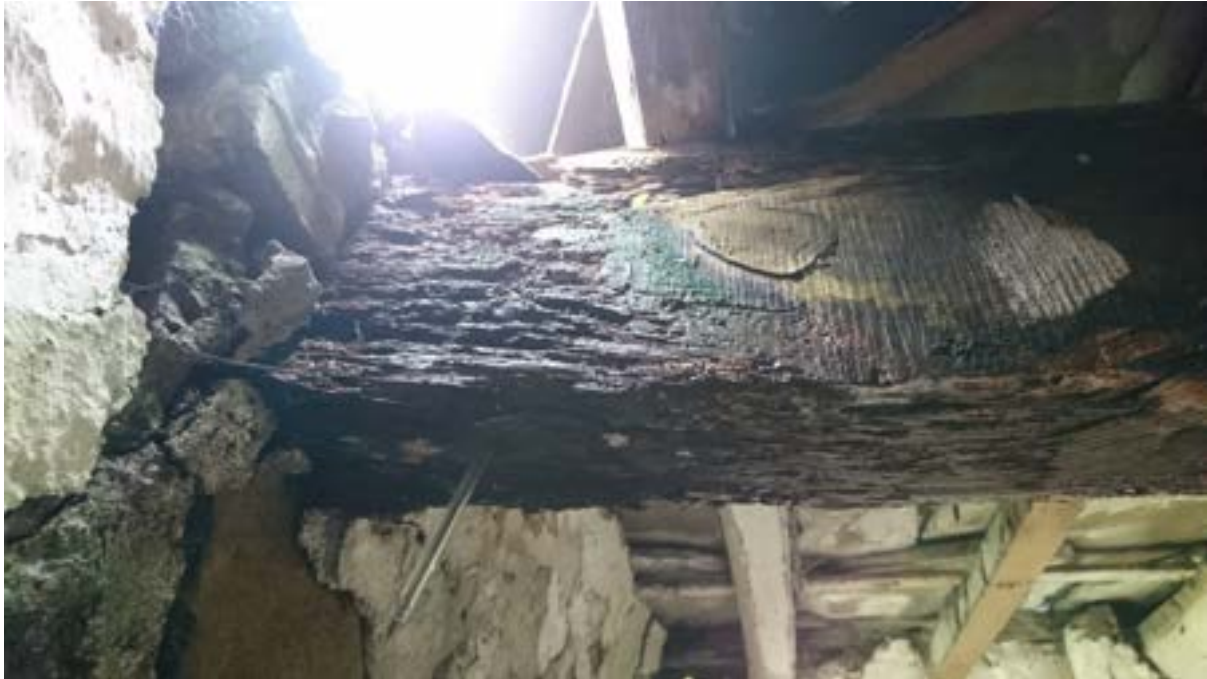
*Figure 13: Example of heavy decay of a purlin at the eastern gable, note the embedded pen.*

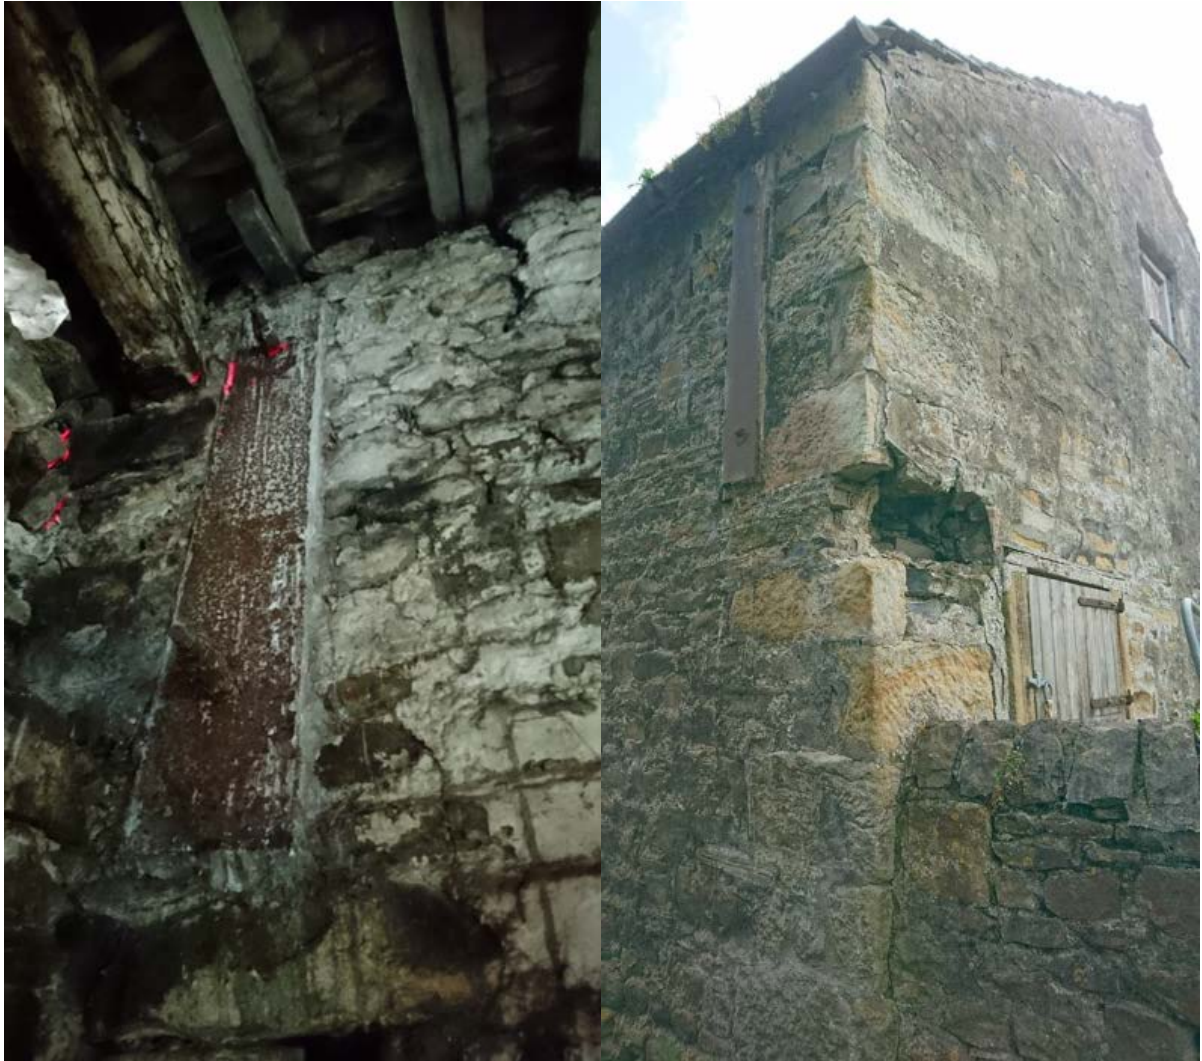
*Figure 14: Steel parrass plates in WP 3 (image left) and WP1 (image right)*

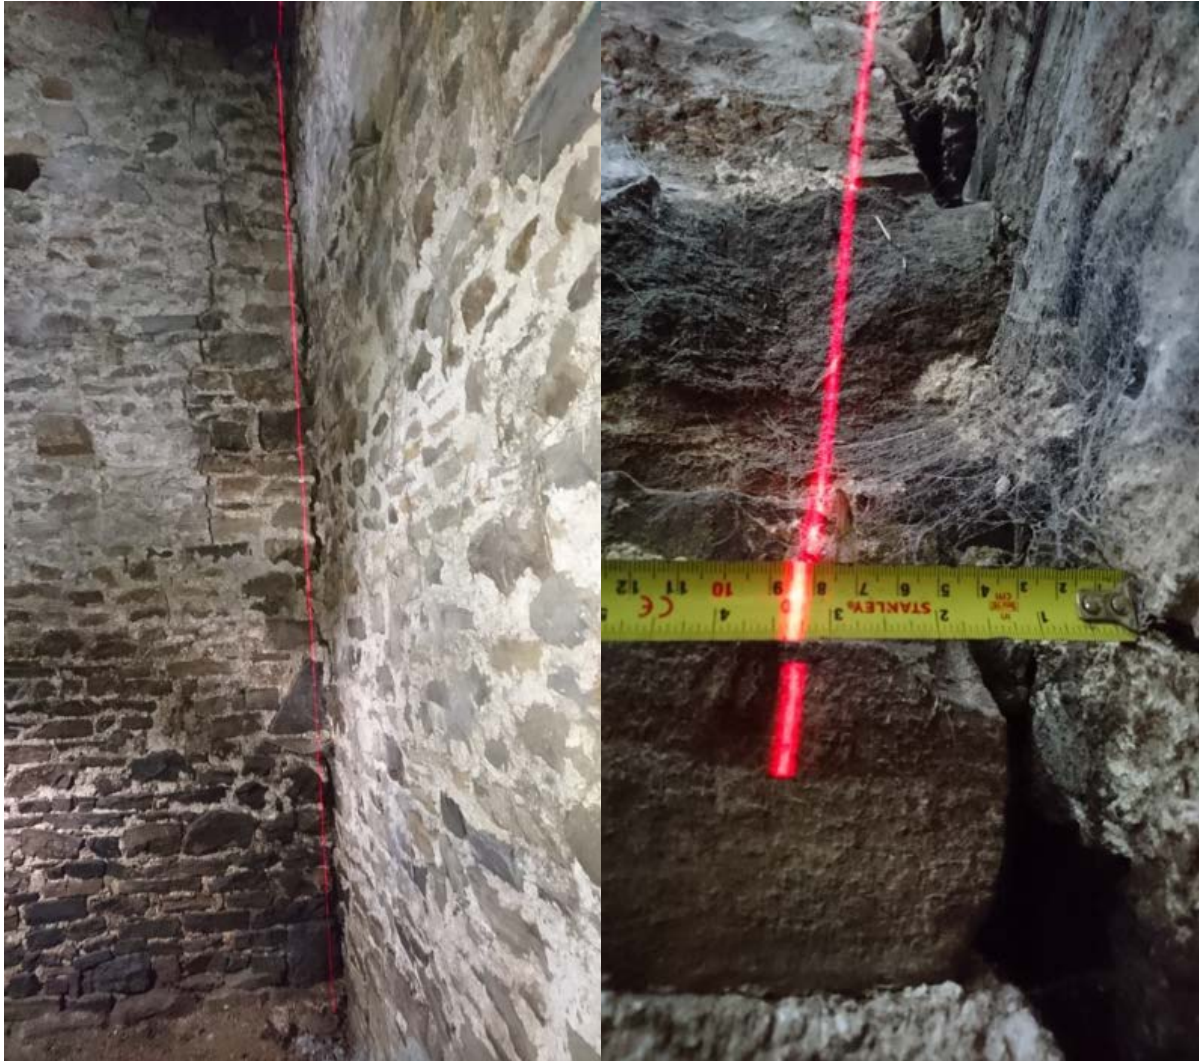
*Figure 16: LEFT: Plumb laser highlighting the deviation from vertical at the abutment to the internal partition (WP4).  
RIGHT: Measurement of the maximum excursion from vertical.*

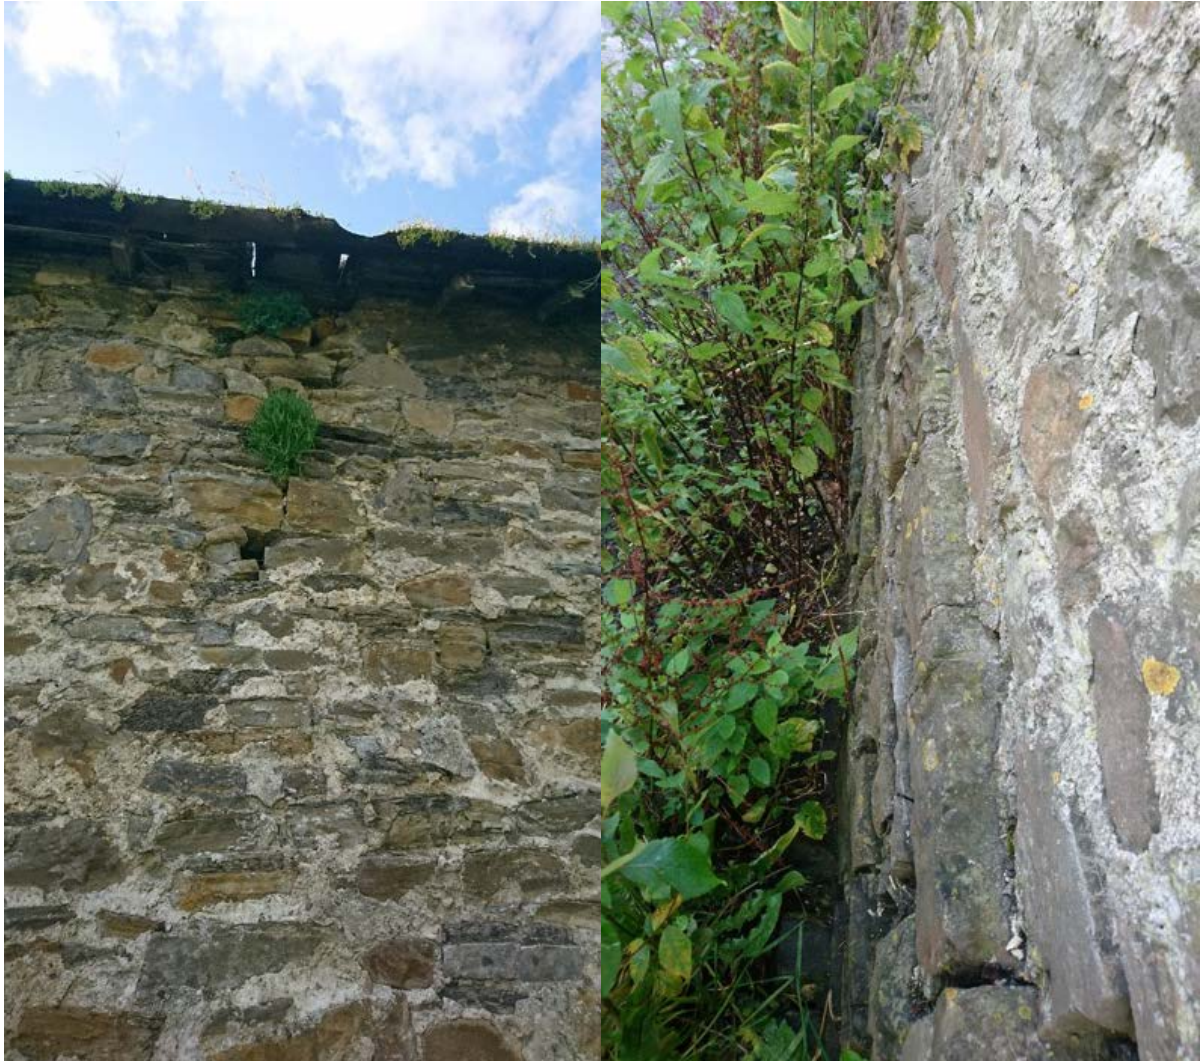
*Figure 20: LEFT: Water damage under the leaking gutter. RIGHT: Stepped lower course construction.*

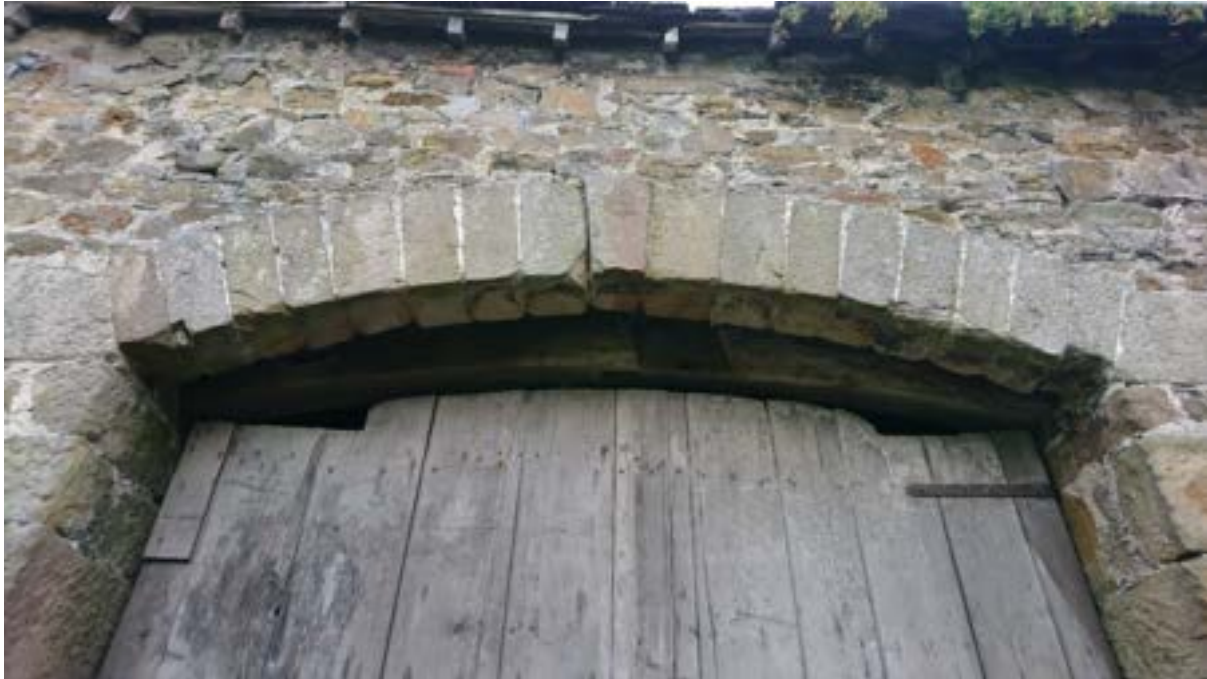
*Figure 21: Masonry arch lintel.*

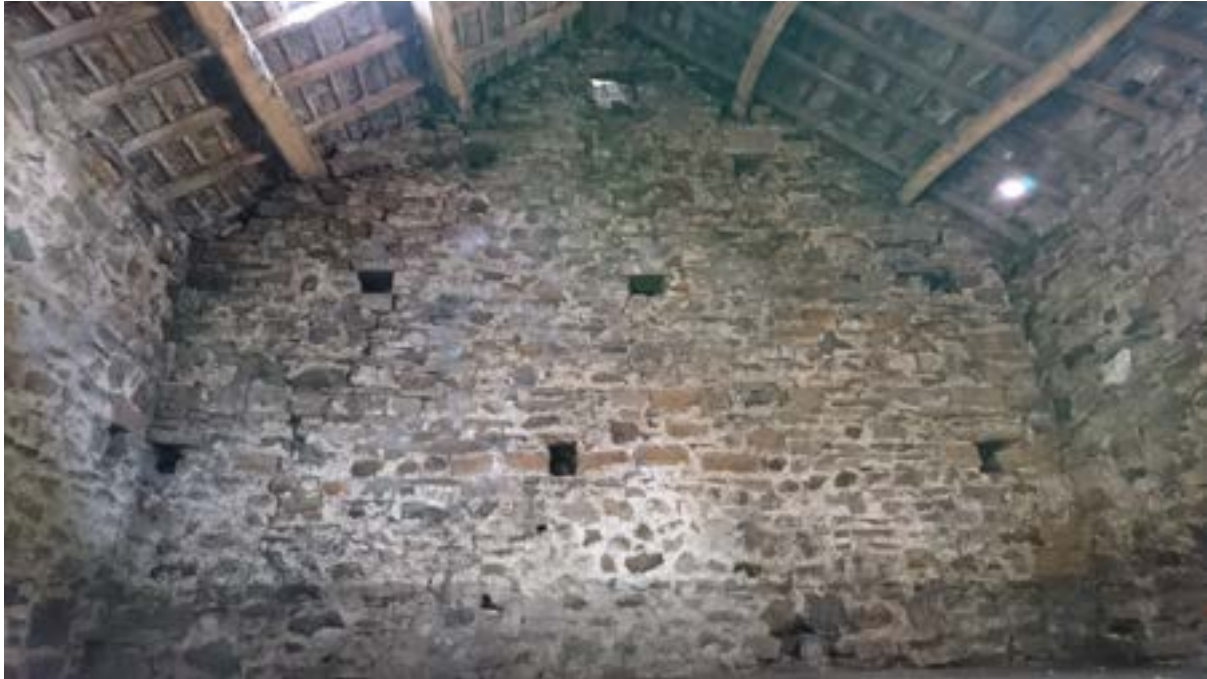
Figure 22: WP2 viewed from the main barn.

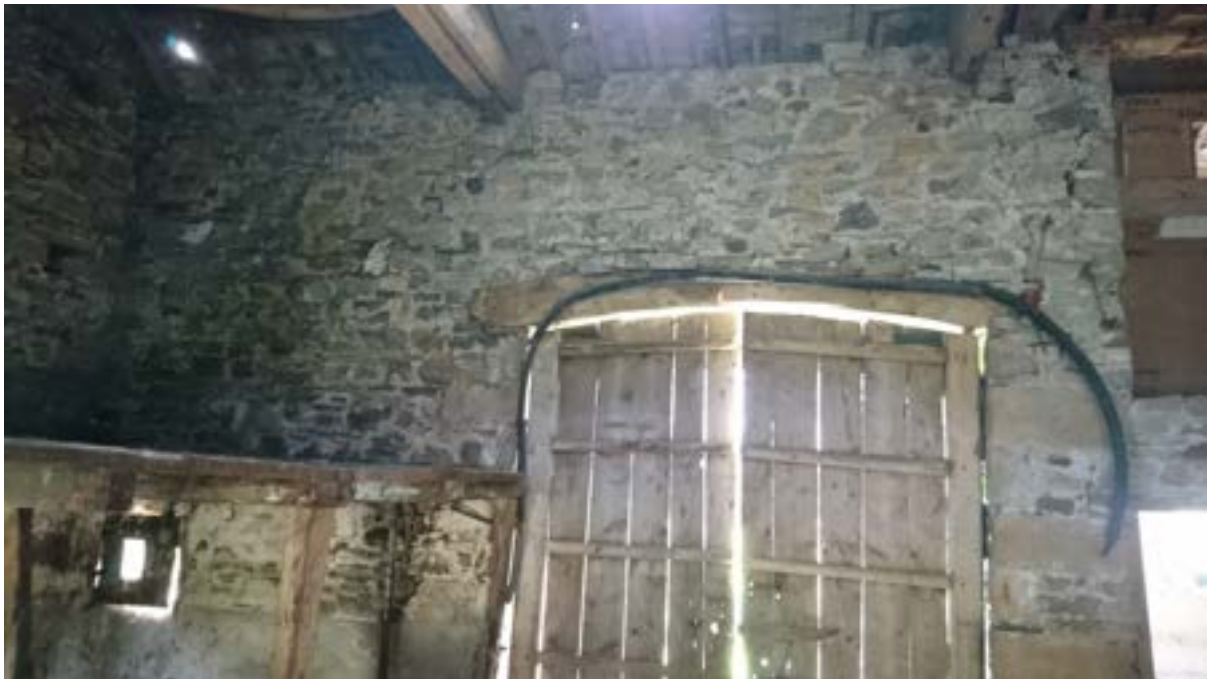
*Figure 23: Internal view of WP3 at the eastern end.*

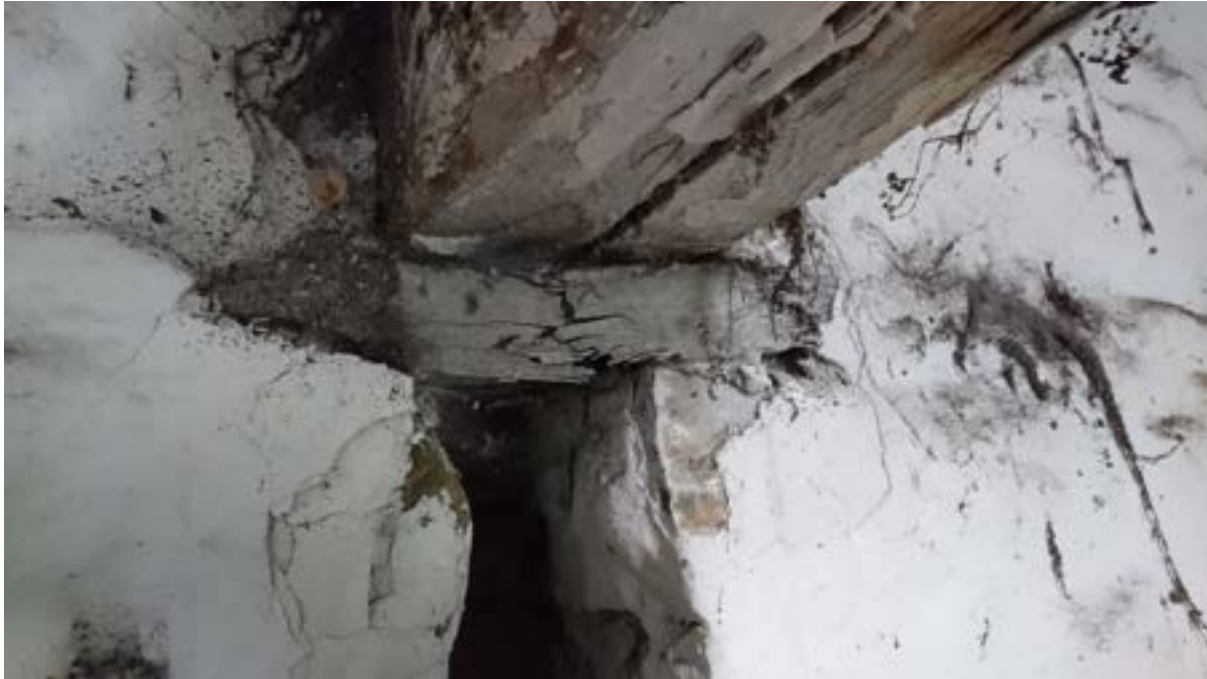
*Figure 26: Fractured mudstone / slate lintel.*

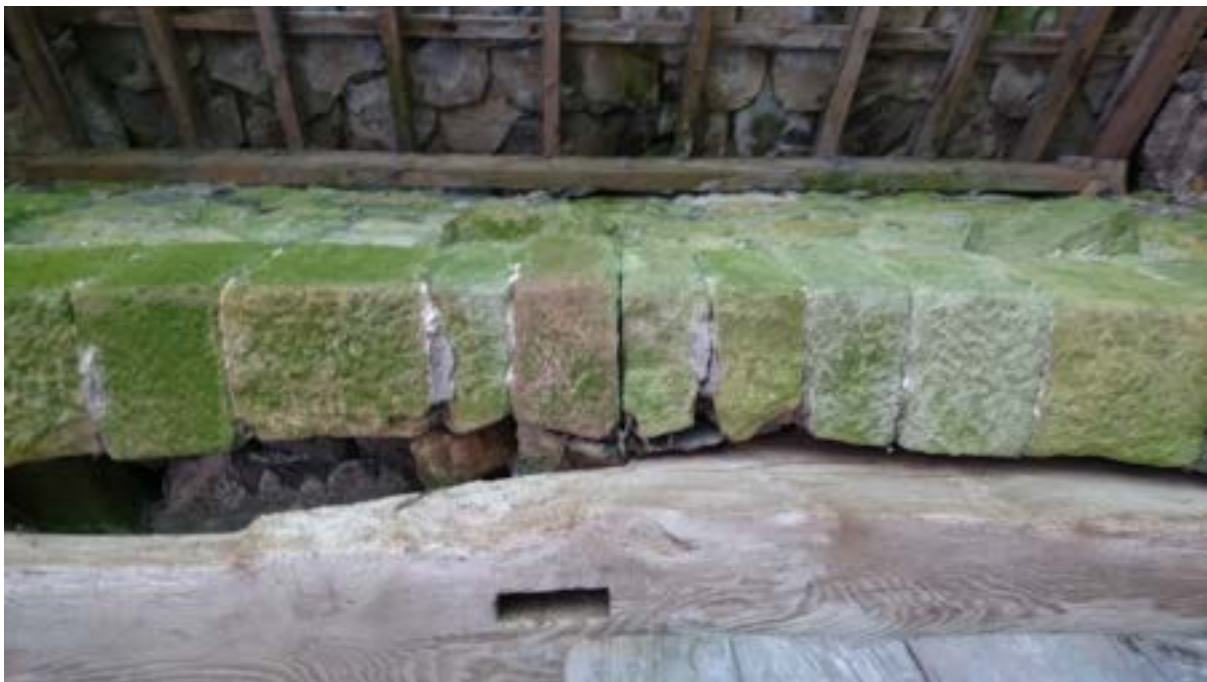
*Figure 27: Opening of vertical joints of the masonry arch in WP3, consistent with outward movement under the outward thrust at one or both bearings.*

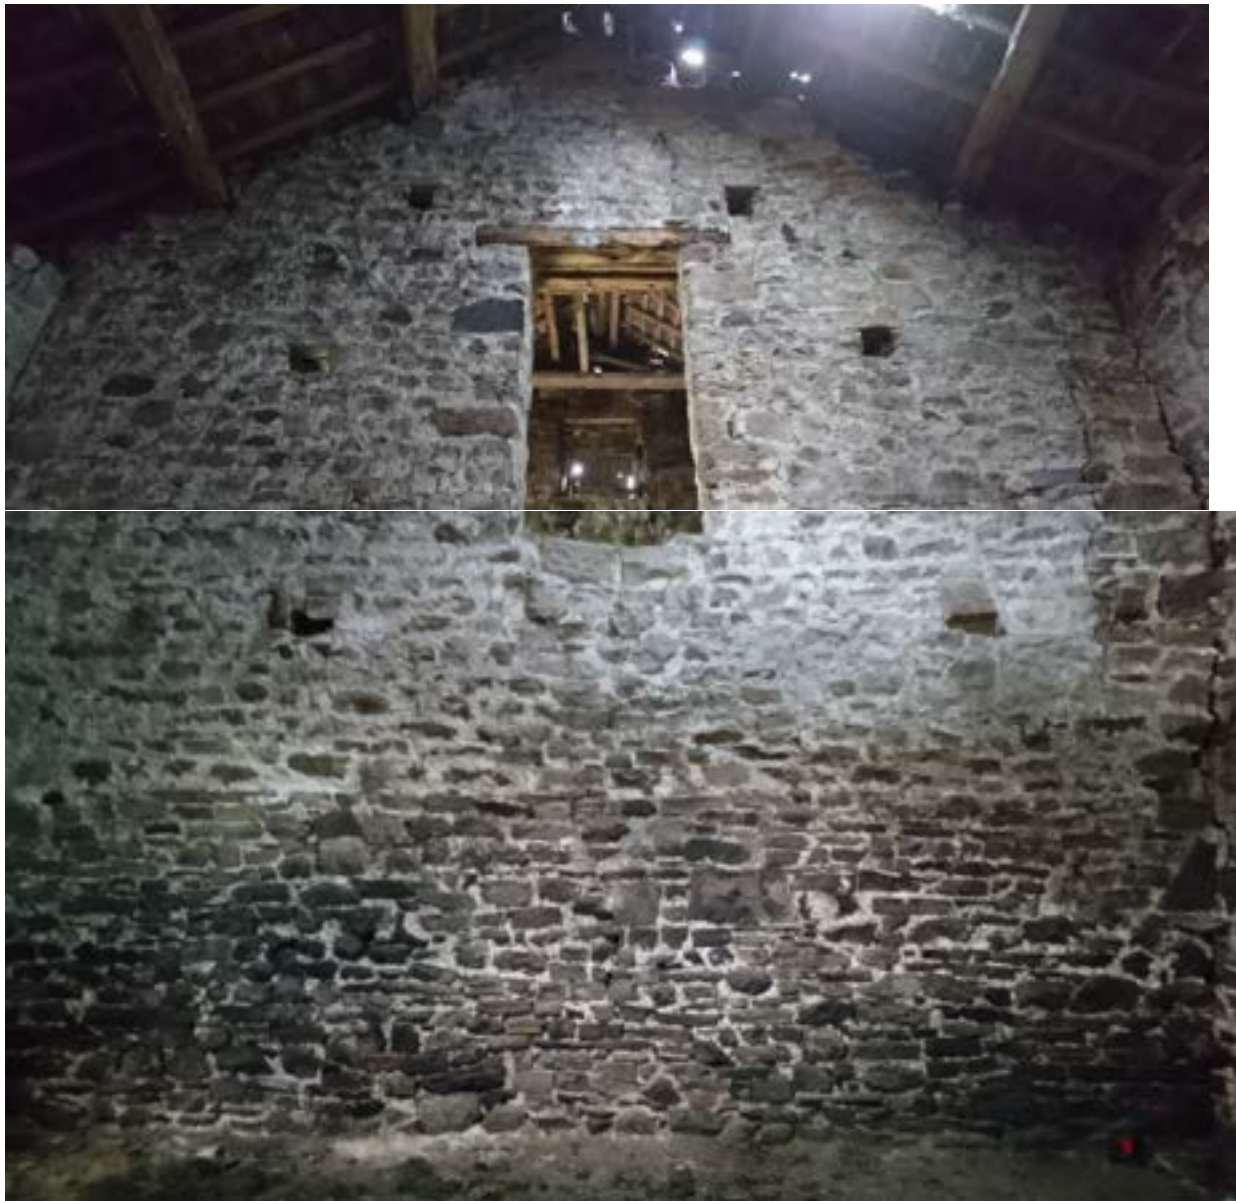
*Figure 30: WP4 viewed from the Main Barn.*

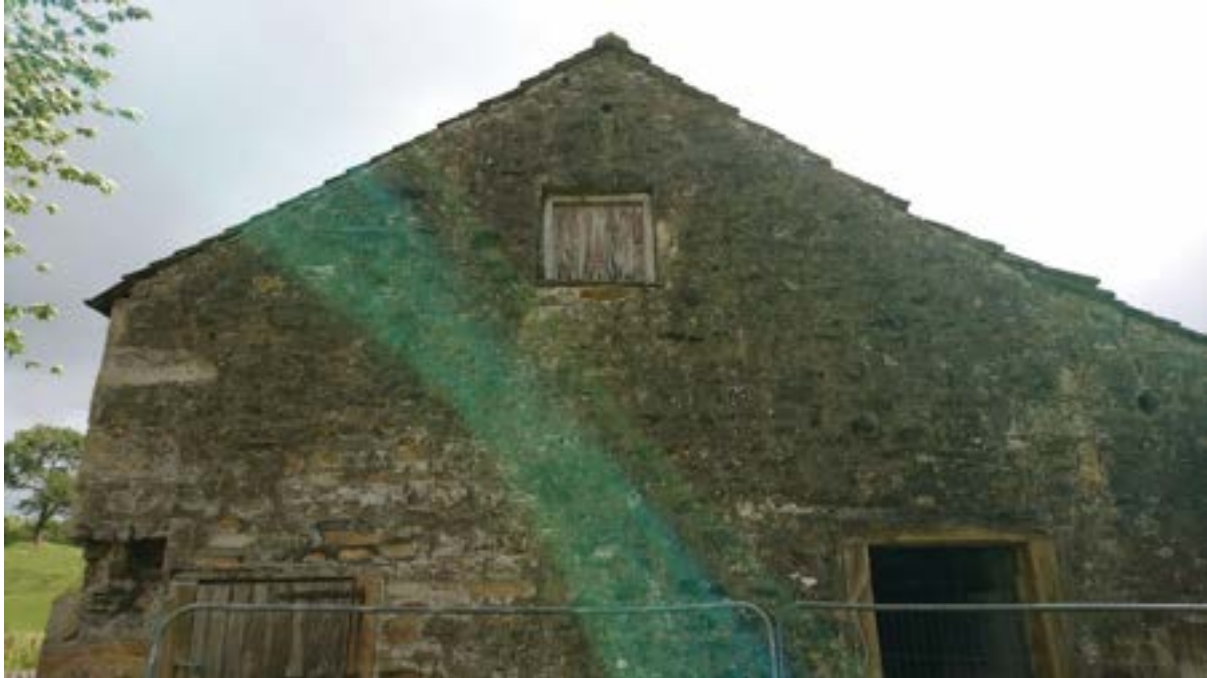
Figure 32: External view of WP5.

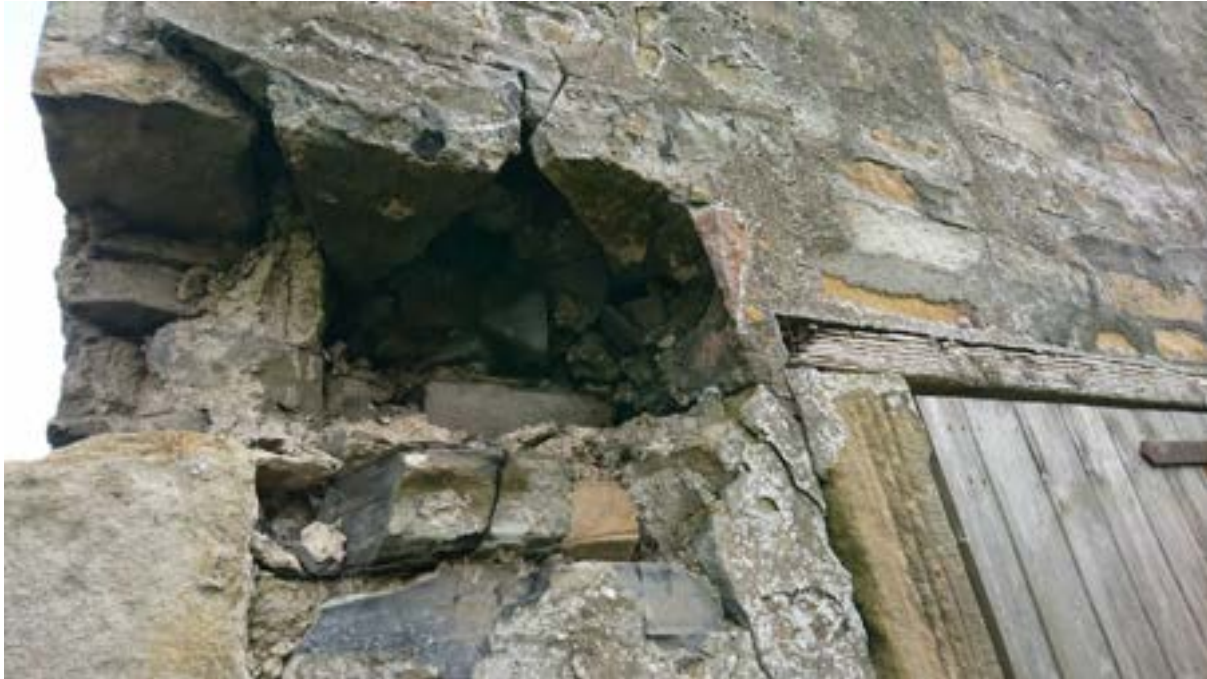
*Figure 36: The missing quoin stone in WP5.*

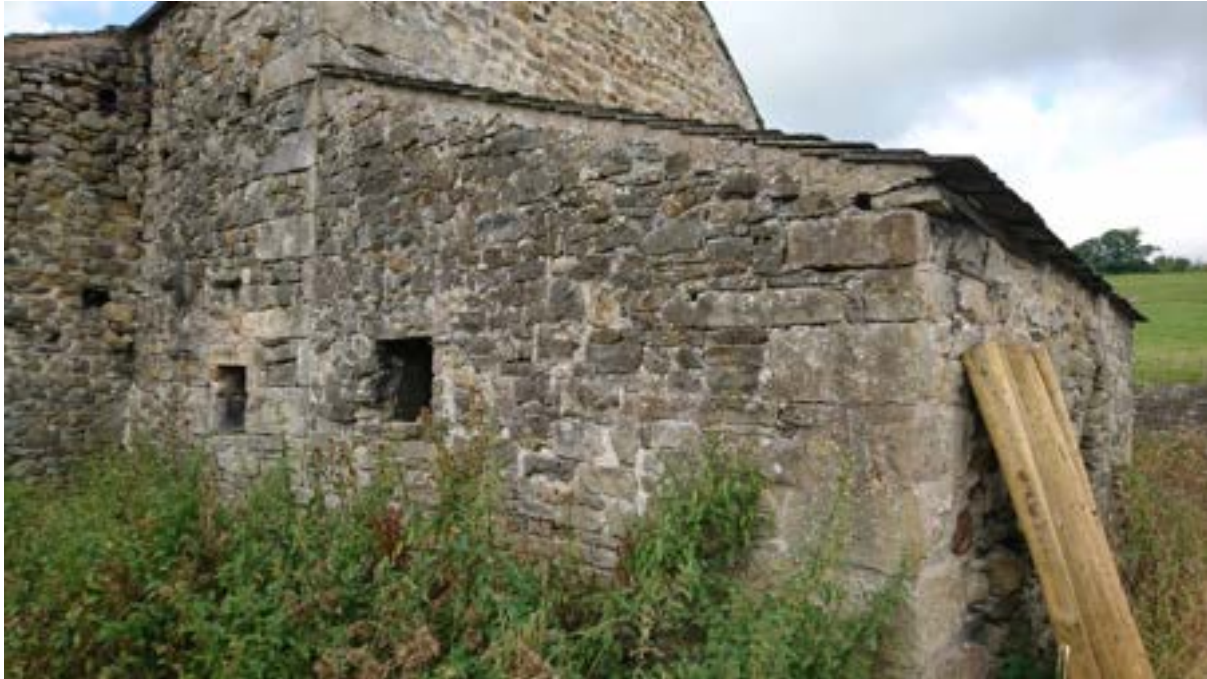
*Figure 37: WP 10 - the southern elevation of Extension 1.*

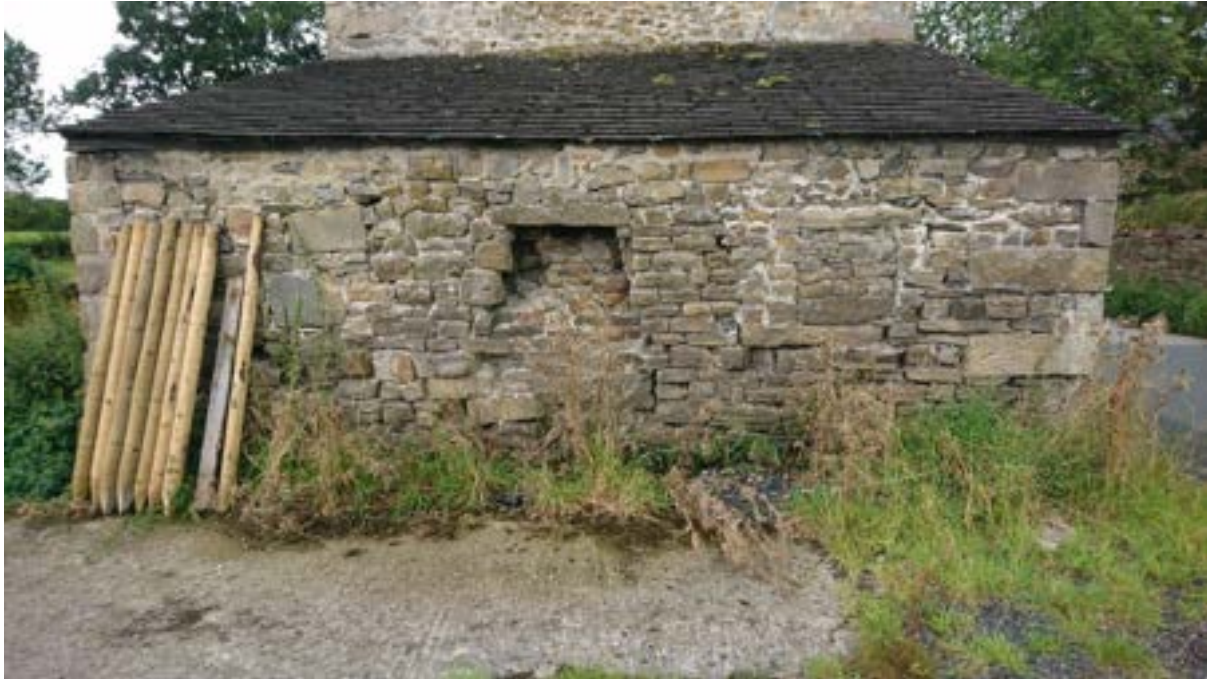
*Figure 38: WP11 - the eastern elevation of Extension 1.*

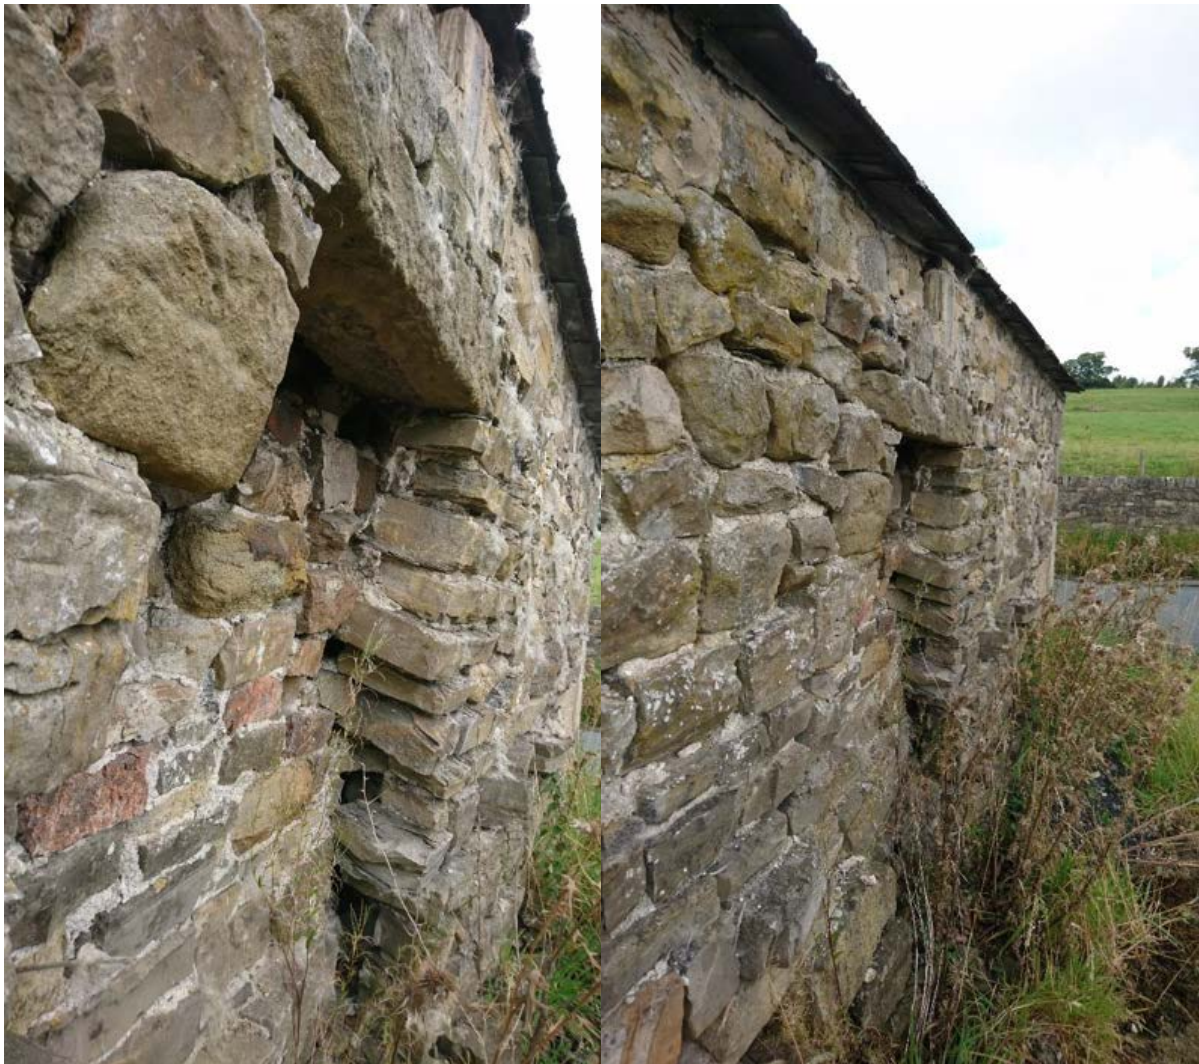
*Figure 39: The eastern elevation of Extension 1. LEFT: Poor quality masonry blocking the opening. RIGHT: The stepped-out nature of the shearing crack visible over the blocked-up opening, just below the gutter.*

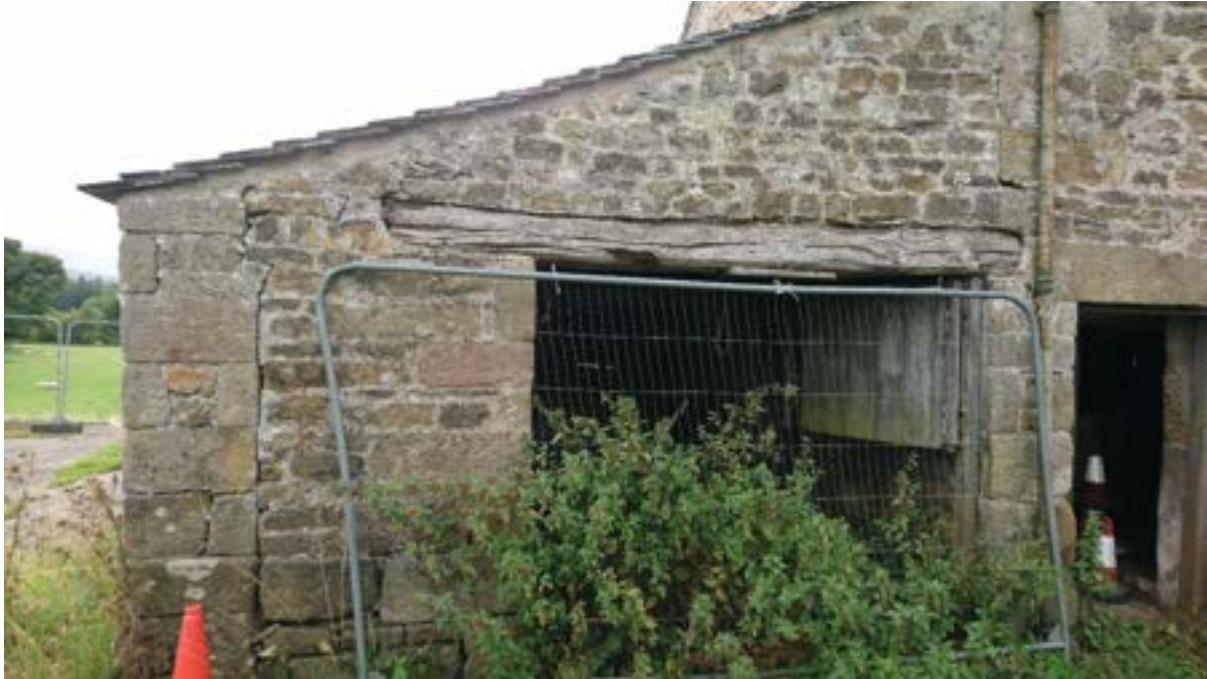
*Figure 40: WP12 - the northern elevation of Extension 1.*

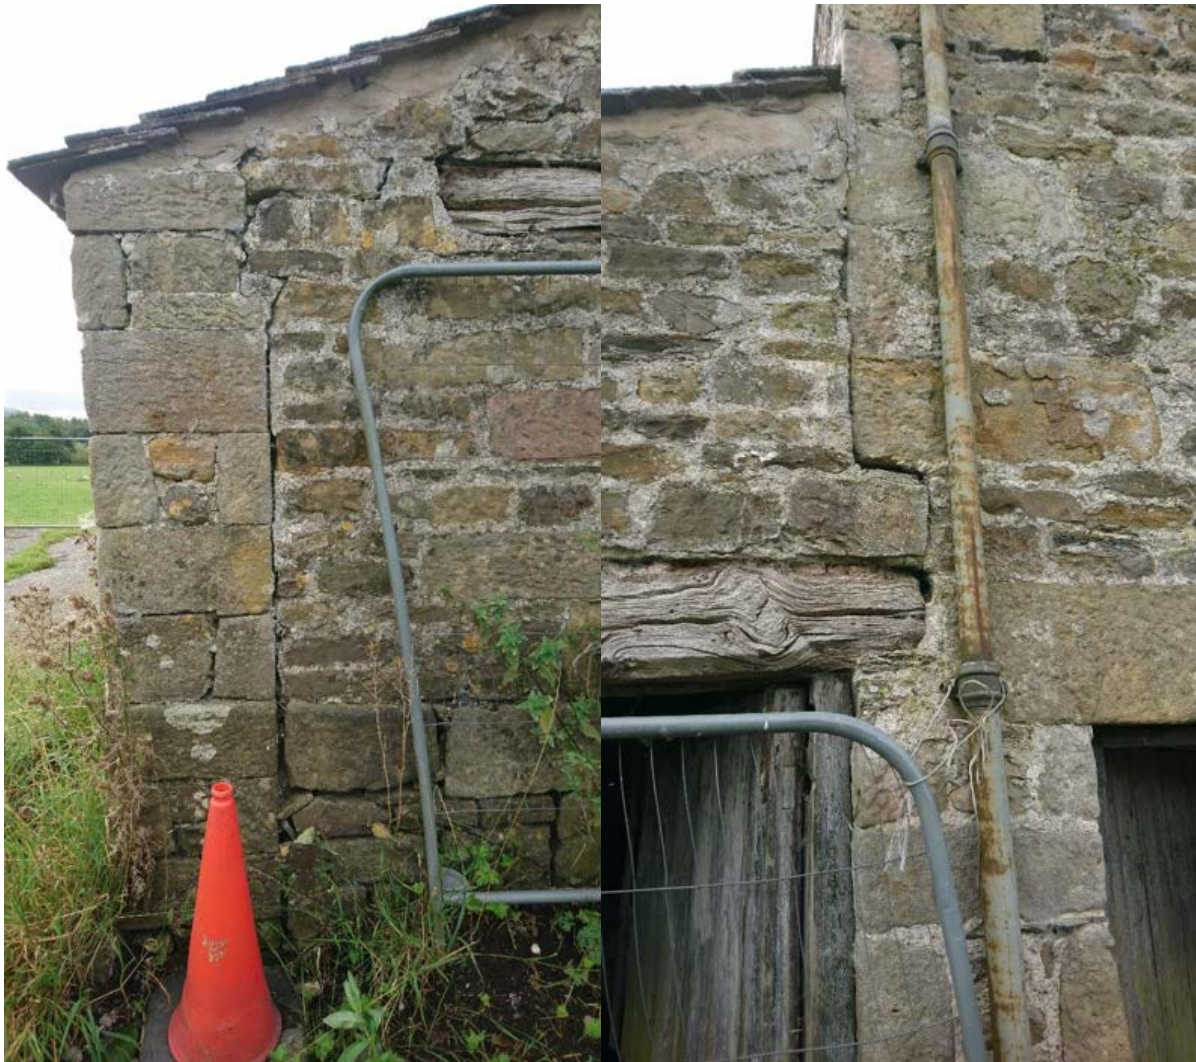
*Figure 41: LEFT: Separation of the eastern elevation from the northern elevation. RIGHT: settlement of the masonry at the abutment with WP12, WP1 and WP2, believed to be related to the compression of the decaying timber lintel over time.*
