# Laneside Barn, Grindleton – Structural Inspection for Planning

**Version:** 1.0

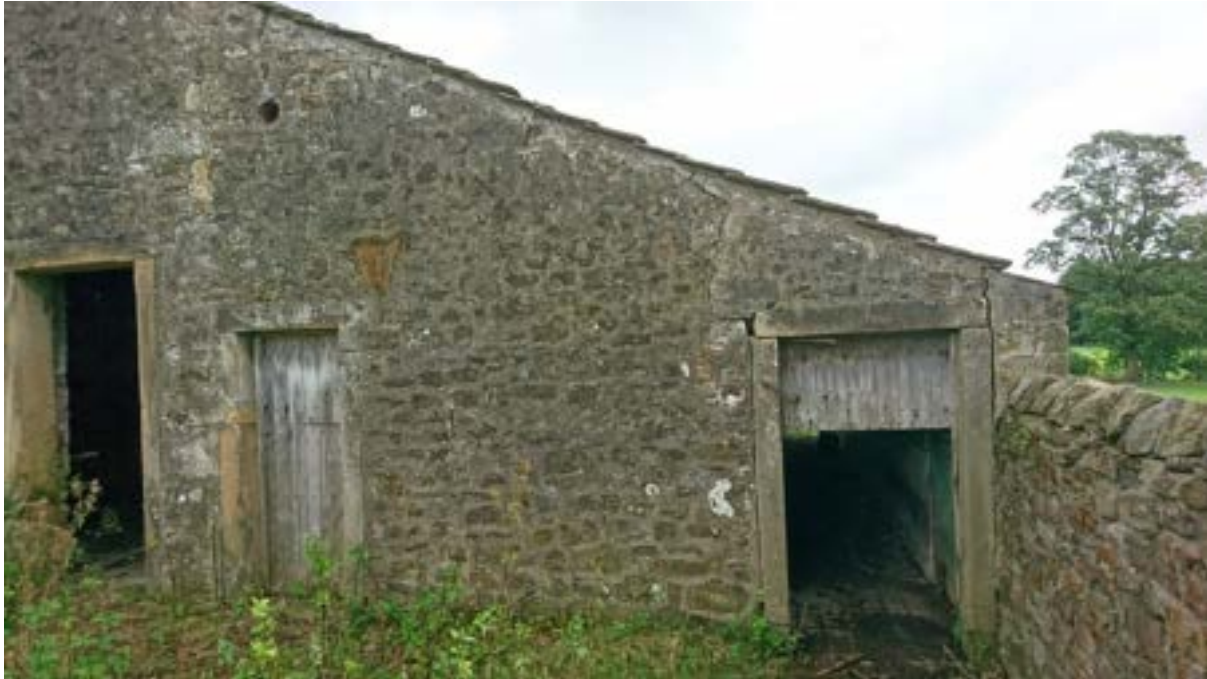
*Figure 42: External view of WP6.*

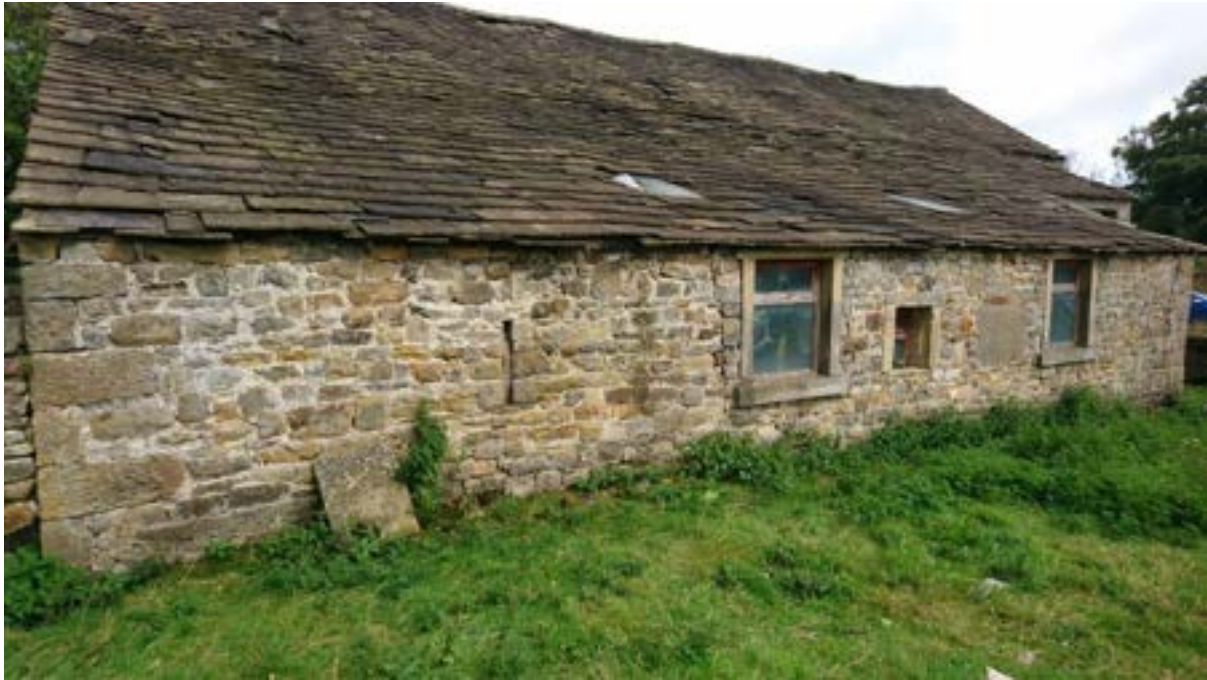
*Figure 45: WP7, viewed from the south.*

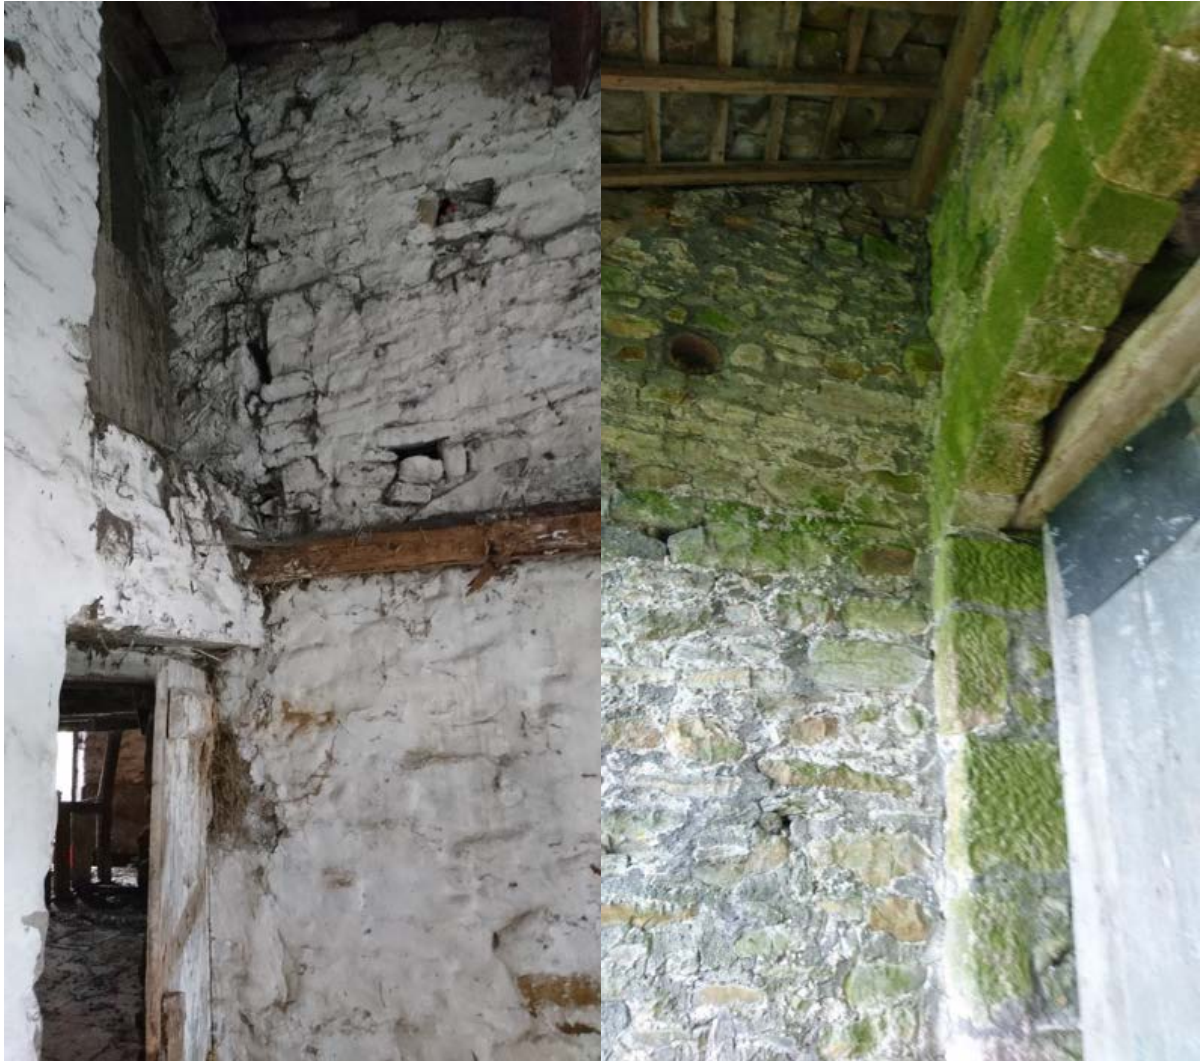
*Figure 47: WP8, internally with a just visible tapering crack running down internally from eaves level (LEFT), which was not visible externally.*

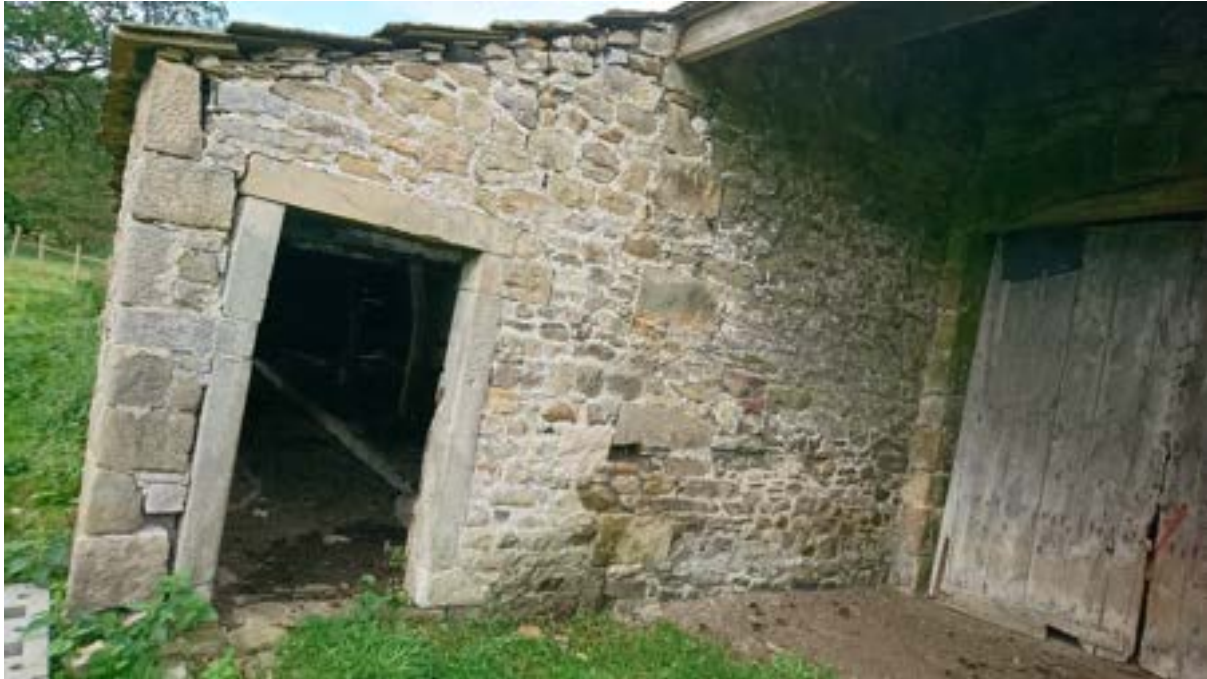
Figure 48: External view of WP8.

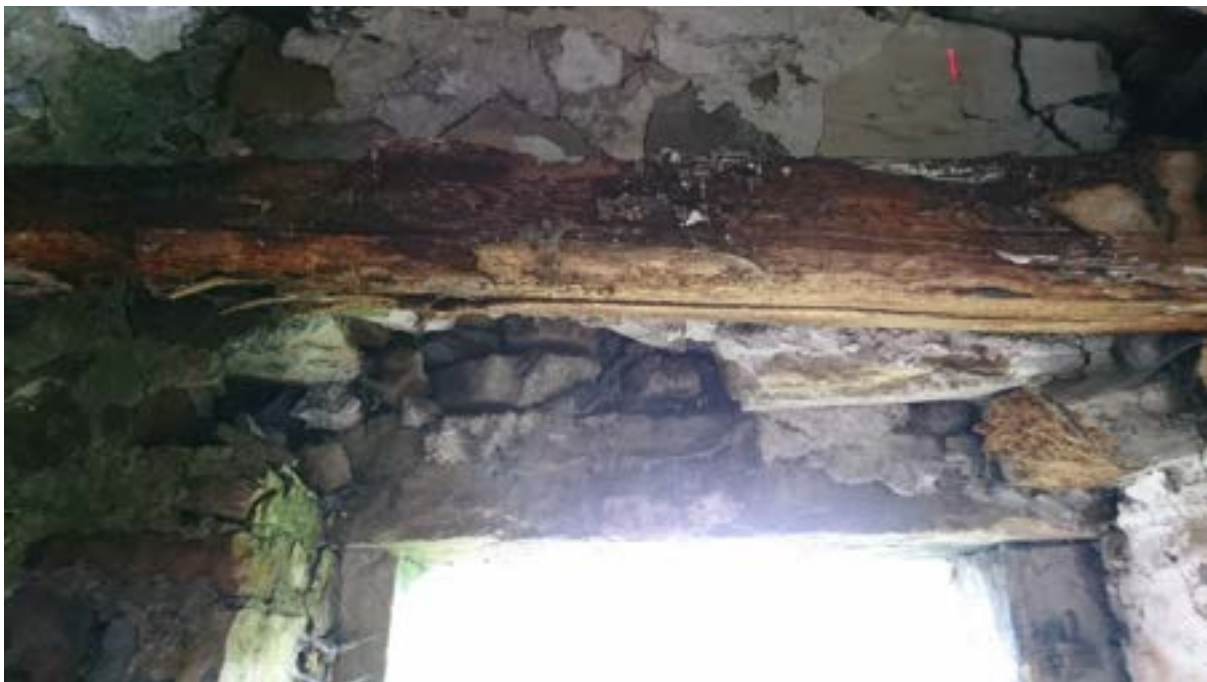
Figure 49: Failed timber lintel remains visible at the 'right hand' bearing just below the timber first floor beam.
