# Laneside Barn, Grindleton – Addendum to the Structural Inspection for Planning

**Version:** 1.1

**Description:** For client and planning approval

**Project:** Laneside Barn  
**Client:** Mr. Keith Lee  
**Description:** Addendum to: Structural Inspection  
**Date:** 4<sup>th</sup> December 2024

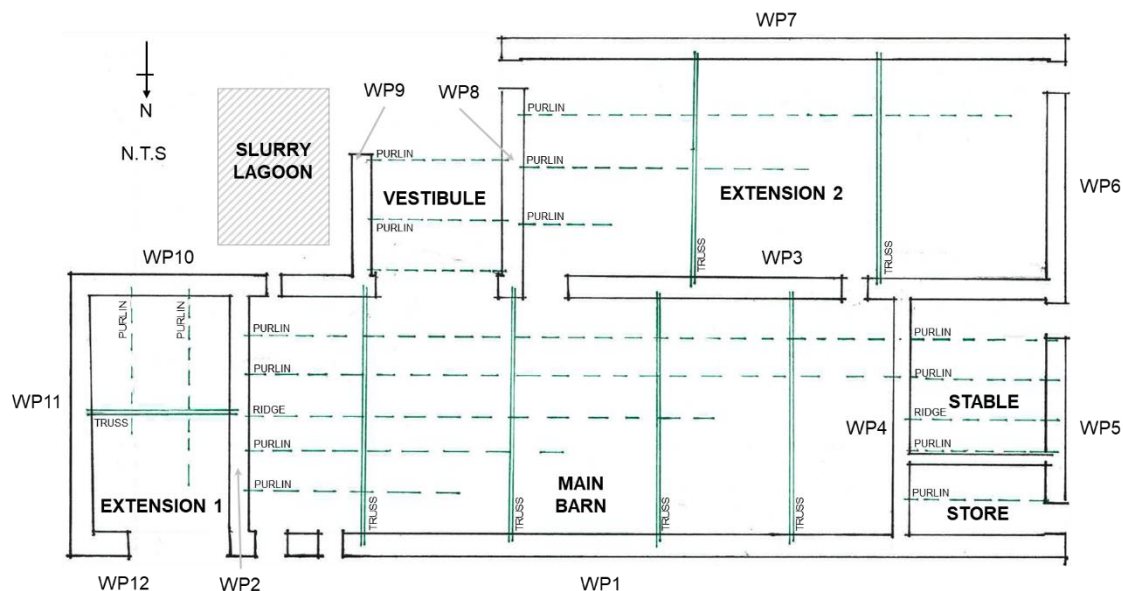
Figure 1: Site layout and nomenclature of the main barn and additional structures.

The inspection found that the barn was suited to conversion subject to several recommendations, one of which was the demolition and rebuilding of the small lean-to extension to the east gable, and another was the demolition of the rear elevation of the rear cat-slide type extension to the southern elevation. This addendum makes reference to the naming system adopted for the individual wall panels, summarised below. Extension 1 and WP7 were recommended for demolition.
