STRUCTURAL APPRAISAL

FARMHOUSE,

LOWER REAPS FARM,

MELLOR

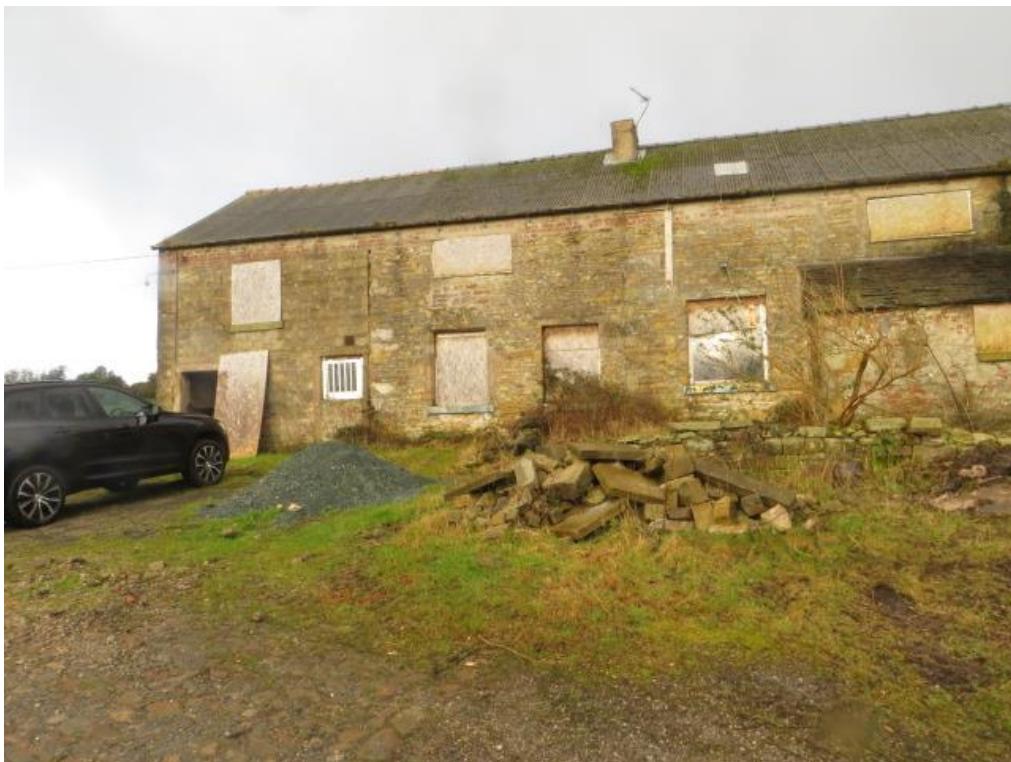
The farmhouse is one of four buildings to the original farmstead and being the original habitated property, although has been vacant for a number of years. The house has been extended twice in the past, the original farmhouse which I understand originates from the 17th century being to the approximate right hand half, which had then been extended to the left hand side and then further extended again to the far left hand side, incorporating a livestock barn with hayloft floor. The farmhouse is constructed in a traditional manner with solid stone external walls, a duo pitched ridged corrugated steel clad roof, and timber board and joist first floor and ground floor construction.

The whole of the property has been raised in height in the past with the introduction of 5 courses of brickwork which has been constructed to the whole of the perimeter of the building.
