Ref: 25E/3549/07

**RE: SUPPLEMENTARY REPORT ON NORTH WALL TO FARMHOUSE**

Further to my Structural Appraisal Report dated January 2025, I would confirm that an accurate electronic dimensional survey of the north elevation has been undertaken to identify the extent of lateral deformation which has occurred to the wall. 5No sections through the wall have been prepared to show the extent of lateral deformation which has occurred. This is identified in the attached drawing.

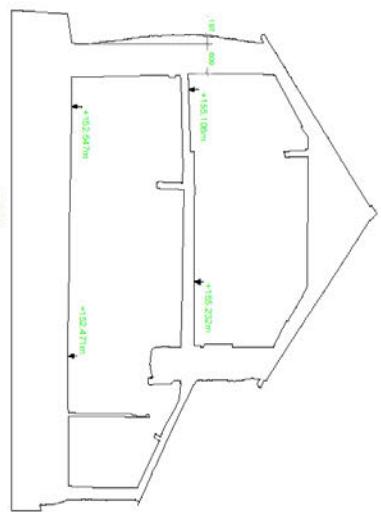
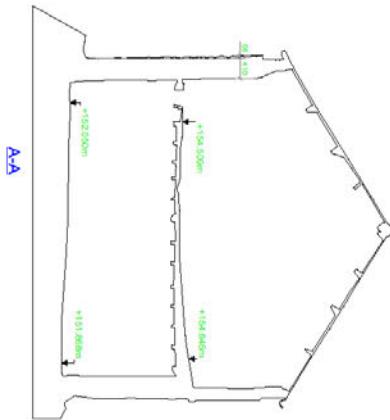
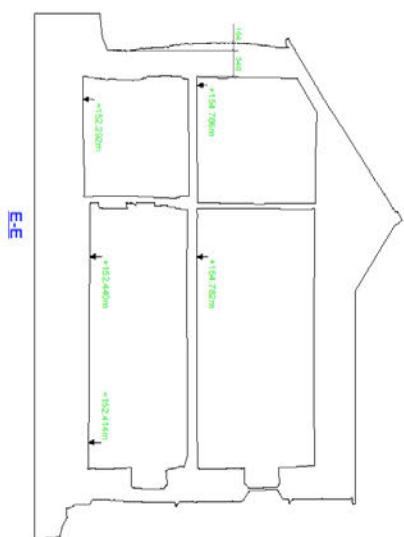
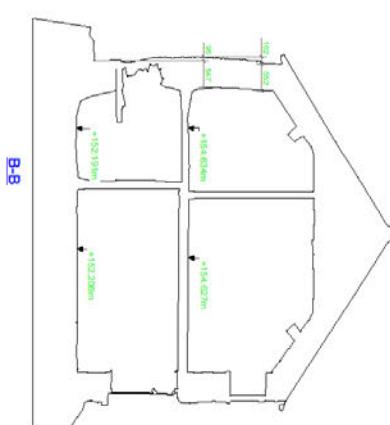
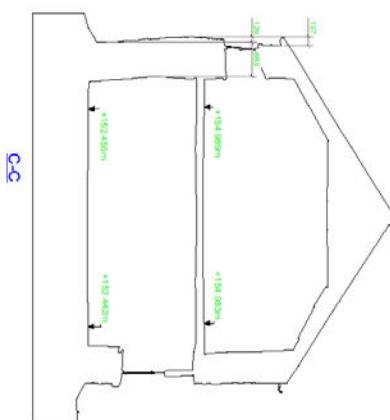
1. Lateral deformation of 68mm with an overall thickness of 478mm.
2. Lateral deformation of 162mm with an overall thickness of 714mm.
3. Lateral deformation of 129mm with an overall thickness of 818mm.
4. Lateral deformation of 197mm with an overall thickness of 806mm
5. Lateral deformation of 164mm with an overall thickness of 704mm.

The survey has identified that the thinnest part of the wall with a minimal deformation of 68mm was 478mm. The construction of the wall is likely to incorporate two leaves of solid stone, likely in the region of 150-225mm with through stones tying the two leaves together and with a rubble stone cavity/core.

For a wall to be stable, the extent of deformation is required to be within the middle third of the overall thickness of the wall, subsequently for a wall of 410mm the allowable lateral deformation would be 68mm and for a wall of 550mm thick the allowable extremity of deformation would be 92mm. The thickness of the wall measured is between 478mm and 818mm, this suggests that the outer leaf has bowed to such an extent that the cavity has increased to possibly in excess of 300mm. With a projection of 197mm with a thickness of 806mm the extent of lateral deformation is well outside of what is considered to be acceptable stability. Considering such extensive deformation, strapping or tying of the walls back to the floor is unsuitable and it would therefore be necessary for the whole of the wall to be taken down and rebuilt.
