TREE RISK AND CONDITION ASSESSMENT OF TREES AT CLITHEROE ST PAUL'S CHURCH, LOW MOOR, CLITHEROE

Client: The Vicar and PCC of St Pauls Church, Edisford Rd, Clitheroe

Date of Tree Inspection: 4.2.2025

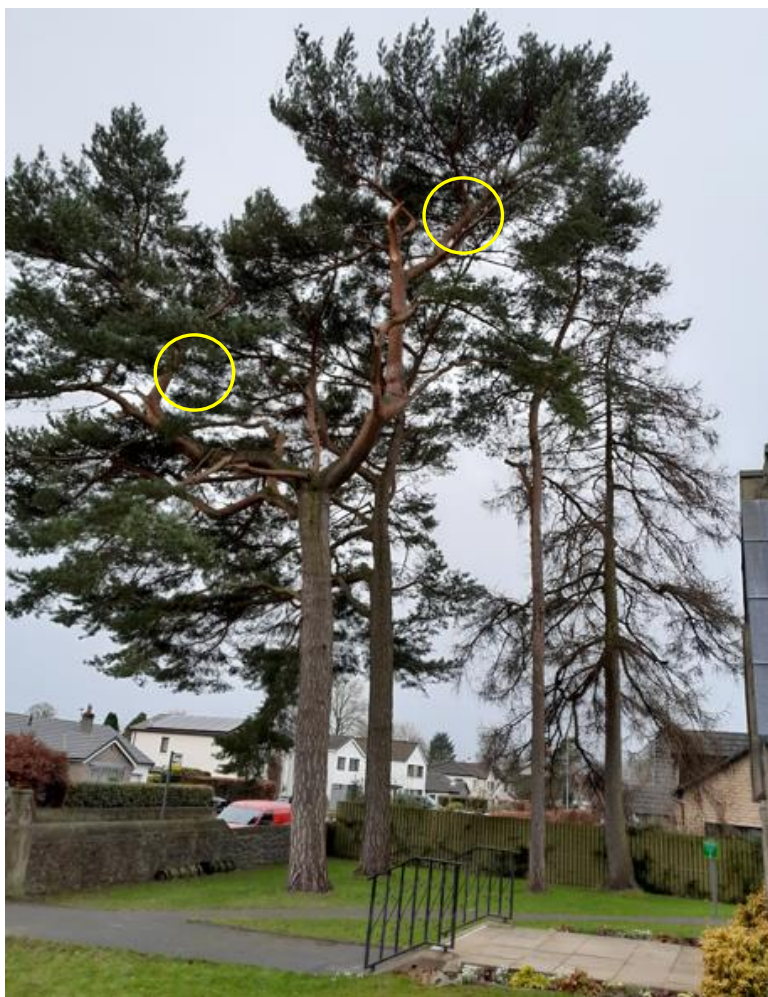
The trees and wind damage

1. The greatest concern is with the late mature Pine (Tag 632) where the tree has suffered upper limb damage on two occasions since November 2024 and alerted the PCC to the apparent connection between climate change and higher wind speeds leading to tree failure.
2. The attached schedule lists the trees which require attention and provide more information on trees health and recommendation for Risk of harm mitigation.

In Practical terms we are recommending some canopy thinning and reductions to reduce wind exposure and a review of the branch loss/history in February 2027. If the history of wind damage continues this will inform proposals for future work
