Tree Condition Report

Bramley Meade Hall
Wiswell lane
Whalley
BB7 9AF

Job Ref: 2092

VTA assessment of 2x trees - Ref: 2092

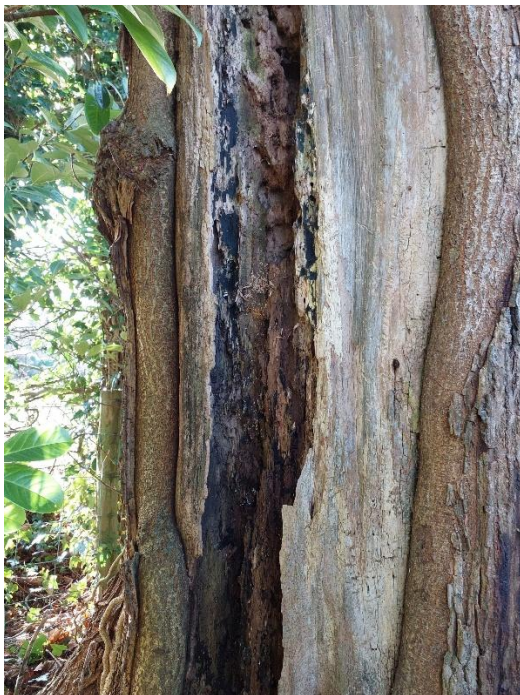
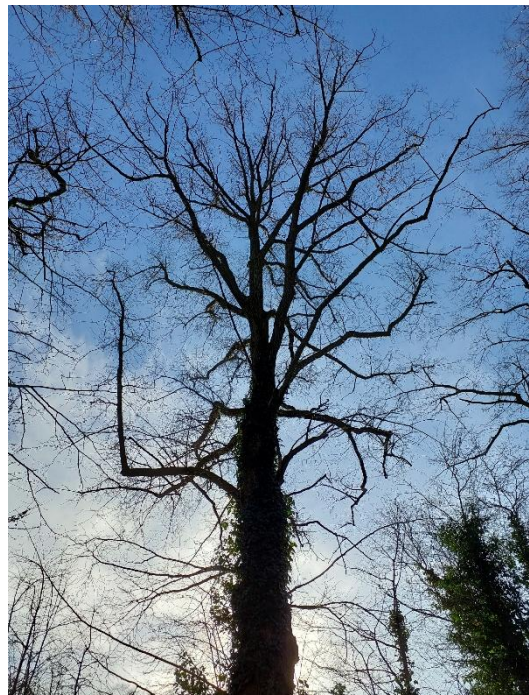
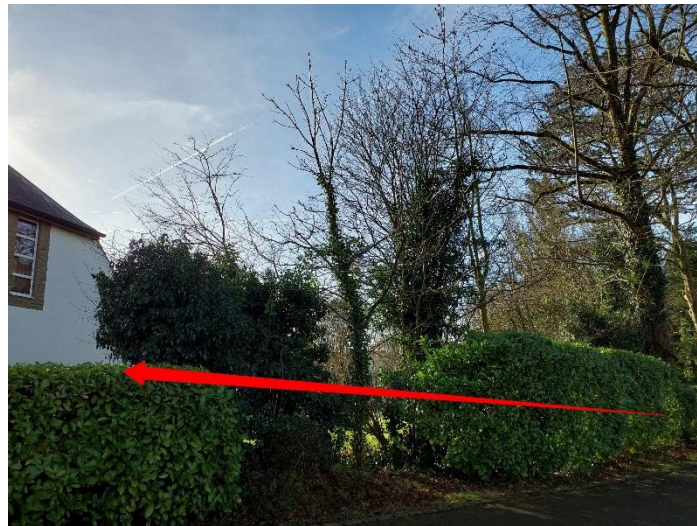
- 19.1. The tree data and any identified works are shown in the tree schedule any recommended works should be carried out within the identified timeframes, giving priority to any tree highlighted as a safety concern.
- 19.2. The Lime tree T001, has internal decay within the stem that has the potential to lead to a whole tree failure due to the reduced strength and ability to support the upper framework of the mature tree canopy, the internal qualities of the stem have been clarified using a resistograph.
- 19.3. Removal of T001 to ground level is recommended on safety grounds as there is a residential property, garage, driveway and garden area within the target area of the tree.

T001 – Lime tree with decay in the stem and within falling distance of residential property.

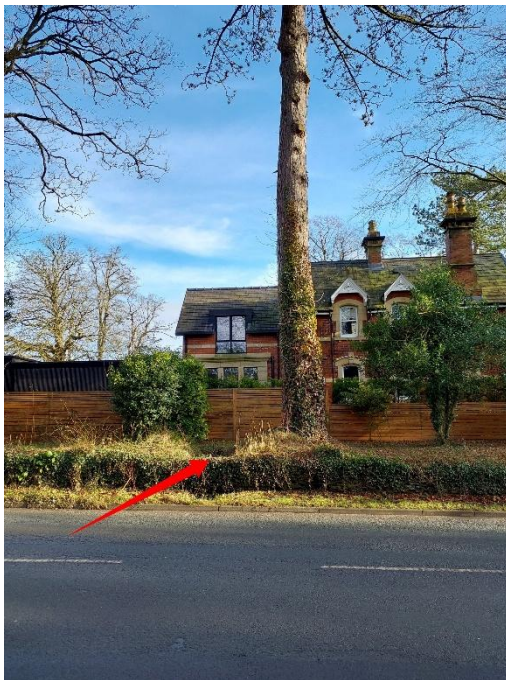
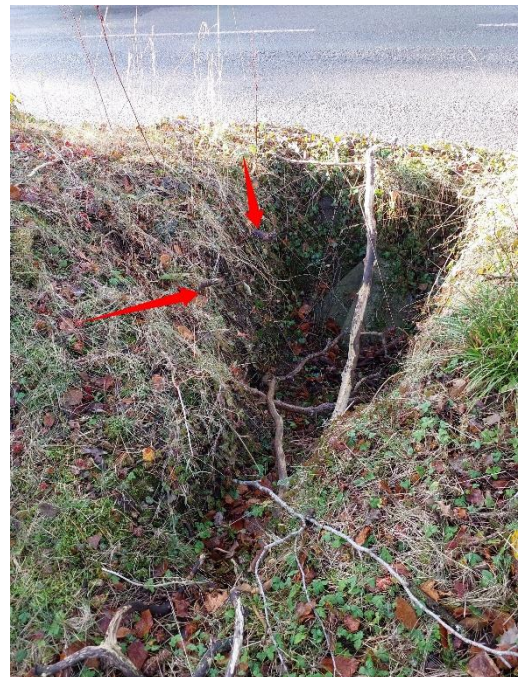
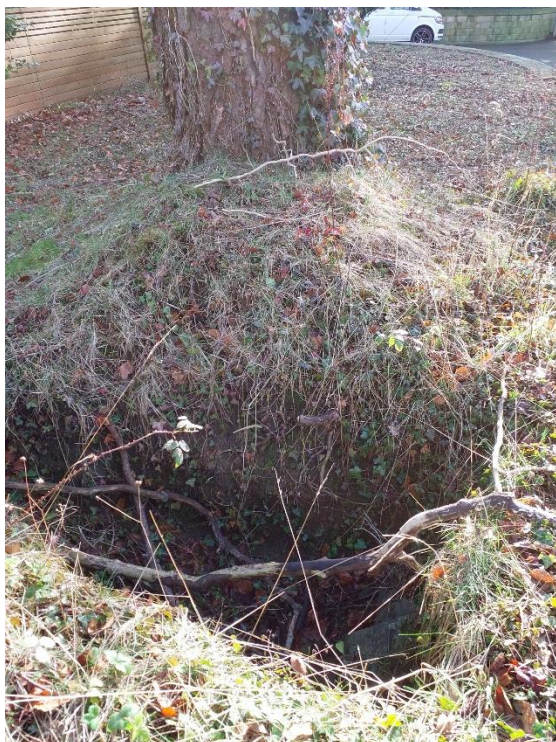
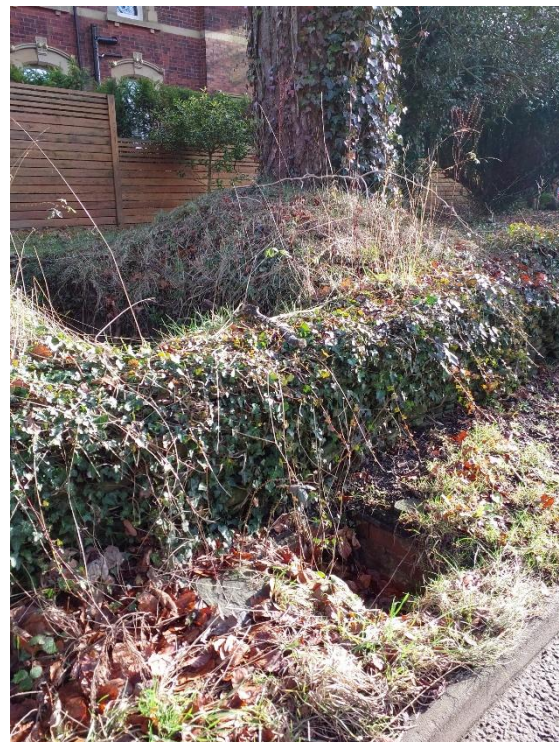
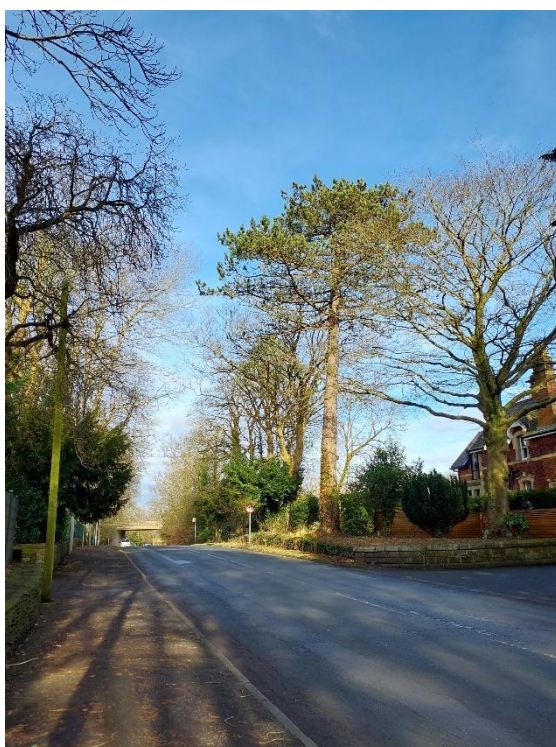
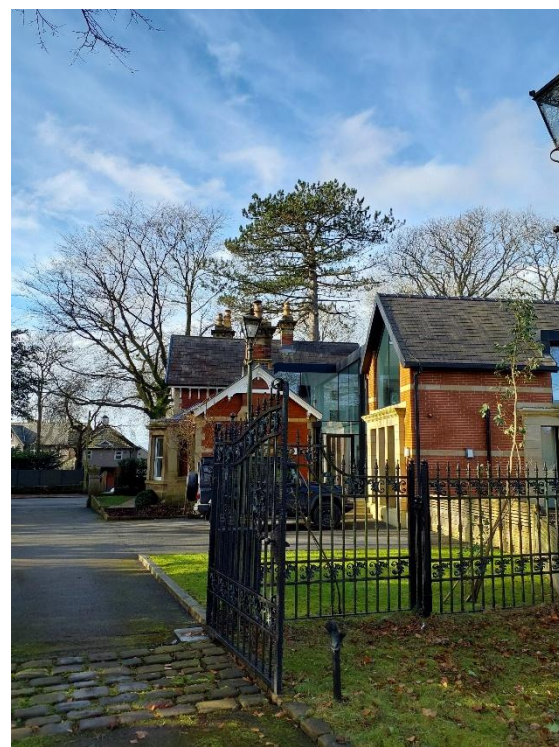
- 19.4. Within 2m of the mature pine tree, T002, a trench has been previously dug to a depth of approximately 1m where severed roots can be seen, see photos, this appears to be some form of land drainage as the trench leads to what appears to be a drain on the roadside of the wall. The client informed me that he does know who or when the trench was dug.

- 19.5. The tree has an already restricted rooting area due to the road and the difference in ground levels. The tree is circa 23m in height with occupied residential properties and a busy road within the trees target area.

- 19.6. My concern is that due to the recent root severance and existing restricted rooting area constraints, there is a foreseeable risk that the tree could suffer a whole tree failure in high winds due to the height and canopy spread of the tree, with high-risk targets where the tree could land.

T002 – Pine tree with root severance – photos showing trench and tree in reference to surrounding target areas.

- 19.7. Removal of T002 to ground level is recommended on safety grounds as there is residential properties, driveway, garden and road area within the target area of the tree.

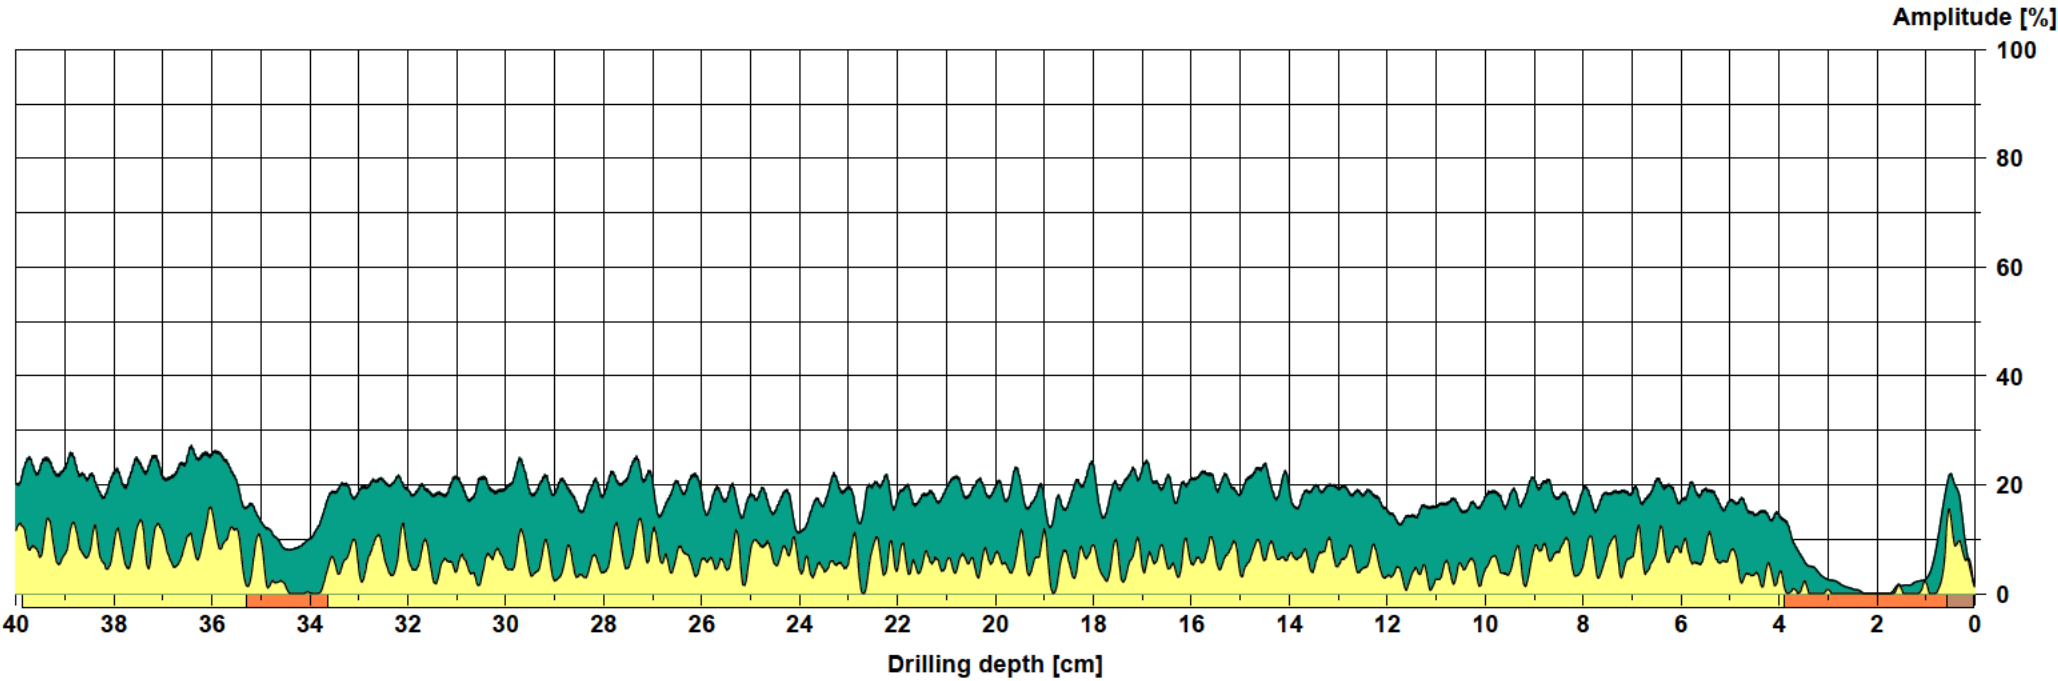
From	0.03 cm	to	0.58 cm	:	Bark
From	0.58 cm	to	3.90 cm	:	Decay
From	3.90 cm	to	33.64 cm	:	Partial decay
From	33.64 cm	to	35.30 cm	:	Decay
From	35.30 cm	to	39.86 cm	:	Partial decay

internal decay / dysfunction present.

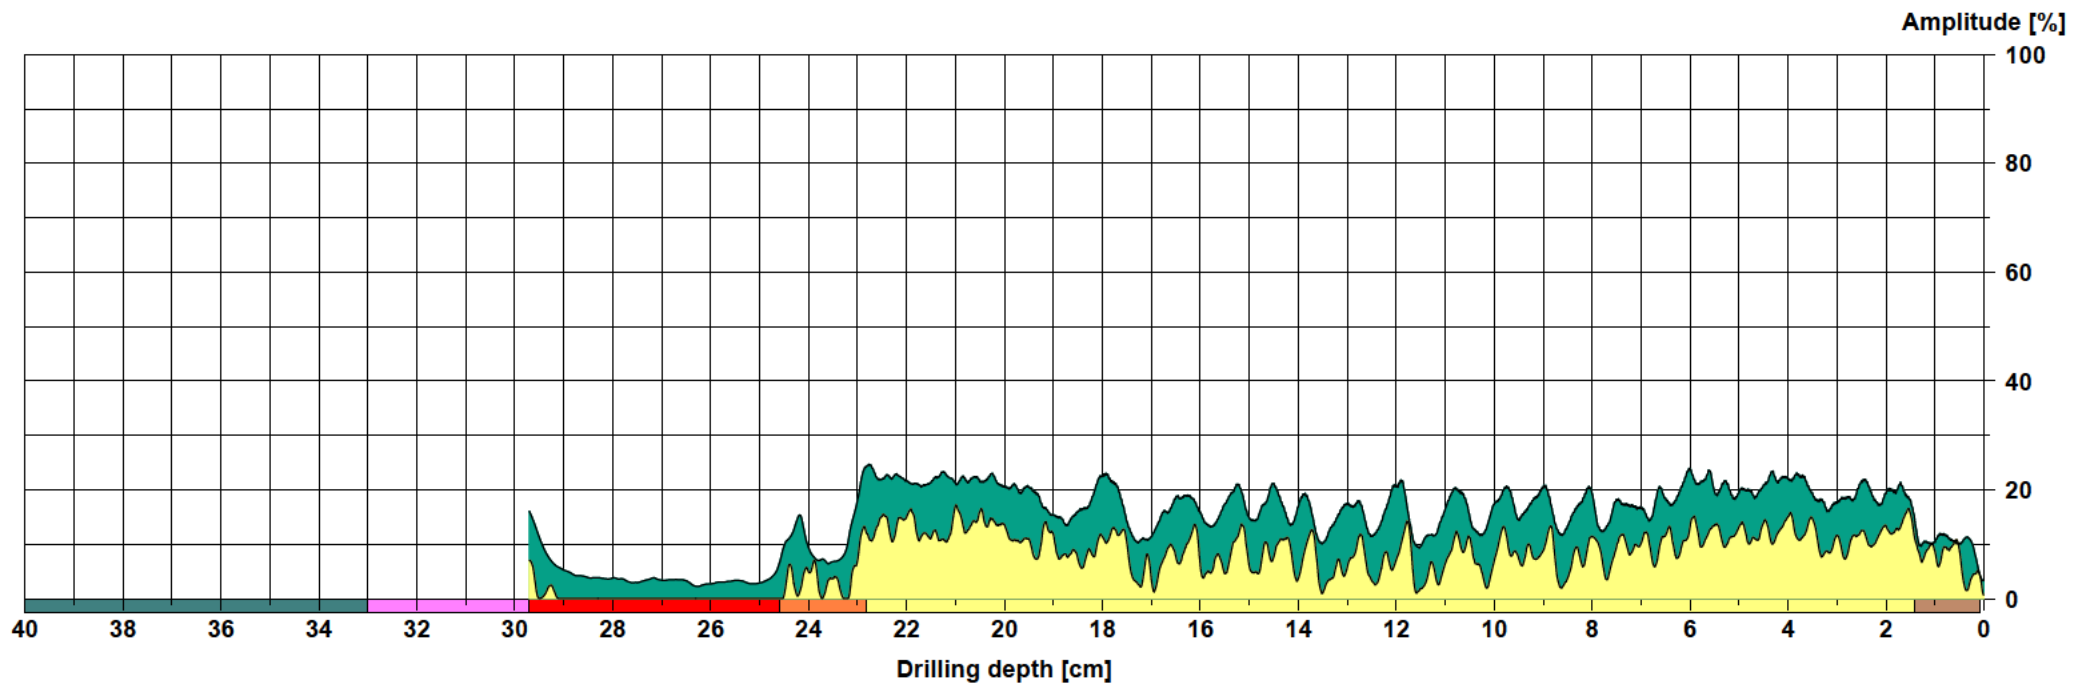
From 0.08 cm to 1.41 cm	: Bark
From 1.41 cm to 22.83 cm	: Partial decay
From 22.83 cm to 24.60 cm	: Decay
From 24.60 cm to 29.72 cm	: Extensive decay
From 29.72 cm to 33.00 cm	: Cavity
From 33.00 cm to 40.00 cm	: Drill retraction

Extensive decay present at 24cm with the automatic needle retraction at 30cm due to cavity

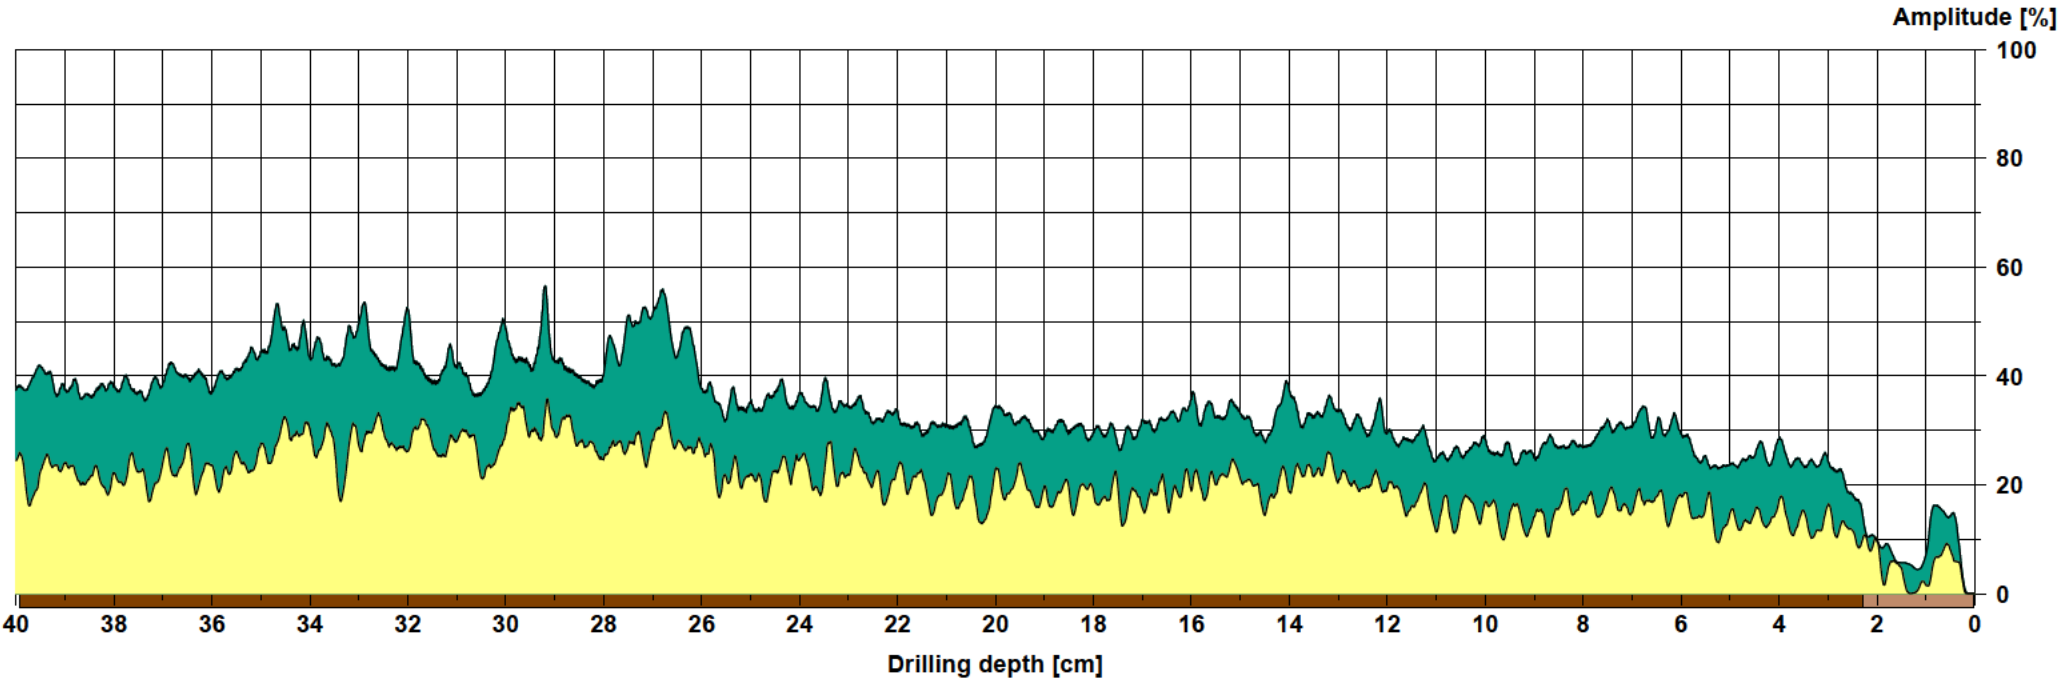
- From 0.03 cm to 2.29 cm : Bark
- From 2.29 cm to 39.93 cm : Structural wood

This test drilling on a healthy Lime tree on site shows the expected resistance graph of structural wood.
