**Job No. 6955**

**BUILDING STRUCTURAL SURVEY**

PROPOSED CONVERSION OF  
GREEN BARN, PART OF OUTBUILDING 01 AND OUTBUILDING 02  
AT EAVES HOUSE FARM,  
WEST BRADFORD,  
CLITHEROE,  
BB7 3JF

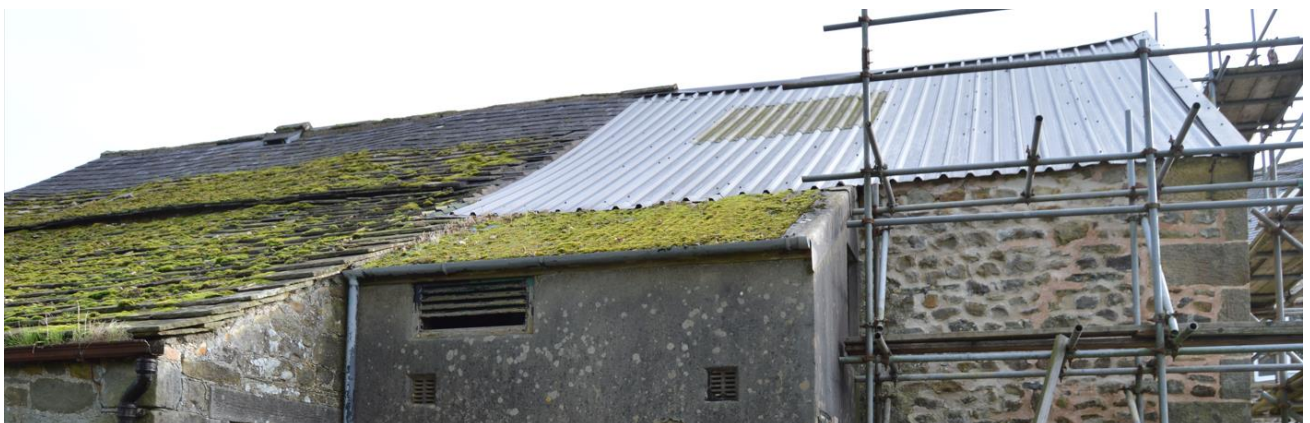
*PL11: West Elevation Photo: showing stone slates to the left hand side of the barn roof and metal roof sheeting to right hand side. The rear rendered add on is proposed to be removed. The gutters and rainwater pipes are a mix of grey pvcu, black cast and missing sections of gutters.*

The existing pvcu grey rainwater gutters and pipes and black cast rainwater pipes were in poor condition and elements were absent. New gutters and rainwater pipes to be provided throughout. Recommended for rise and fall powder coated black aluminium gutters and rainwater pipes throughout. It is proposed to replace with black powder coated aluminium gutters and rainwater pipes.

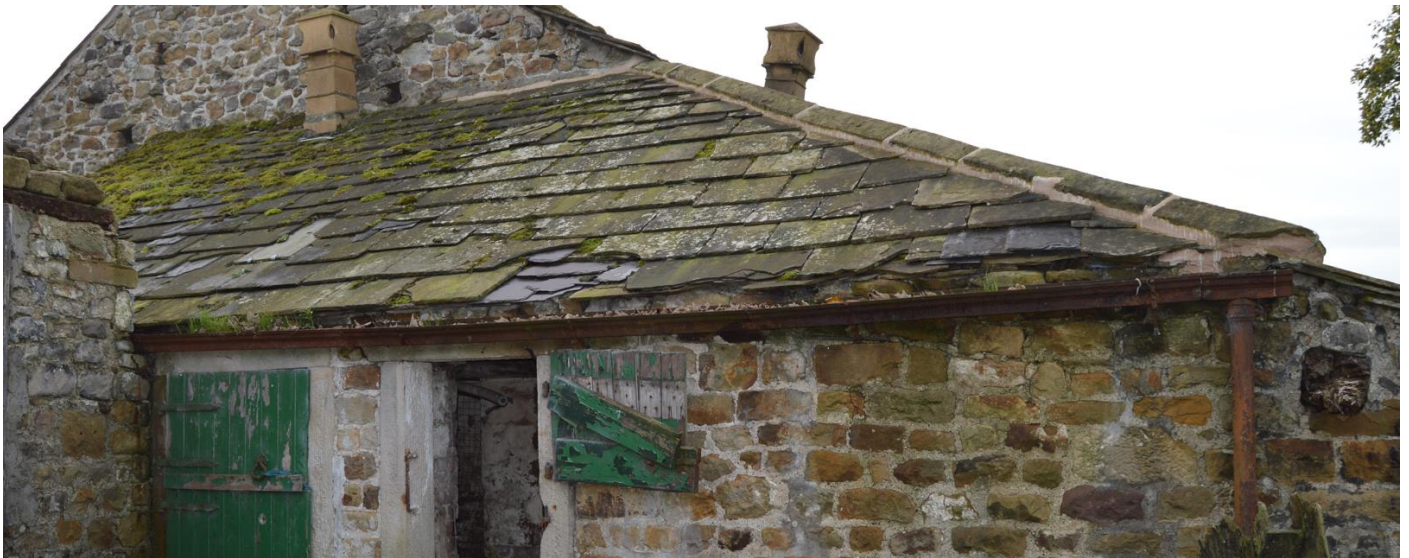
*PL12: North Elevation Photo: showing stone slates and sand and cement pointed ridge tiles. A number of the original stone slates have broken and have been replaced and patched with blue slate. Rusted cast gutter and rainwater pipe.*

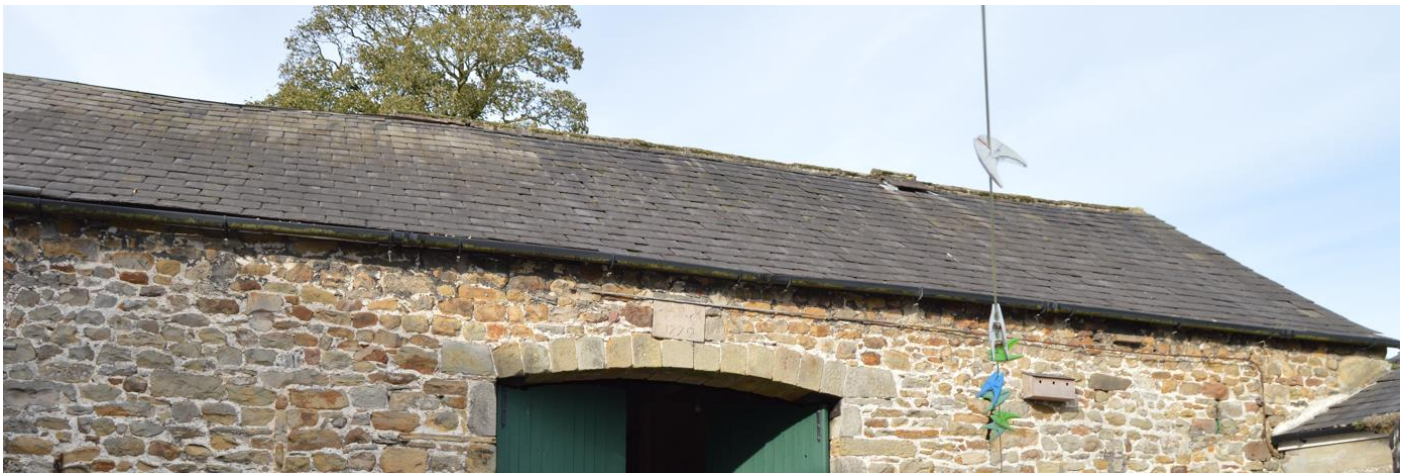
*PL13: East Elevation Photo: Blue slate to roof slope, part sand and cement pointed ridge tile and part ridge flashing.*

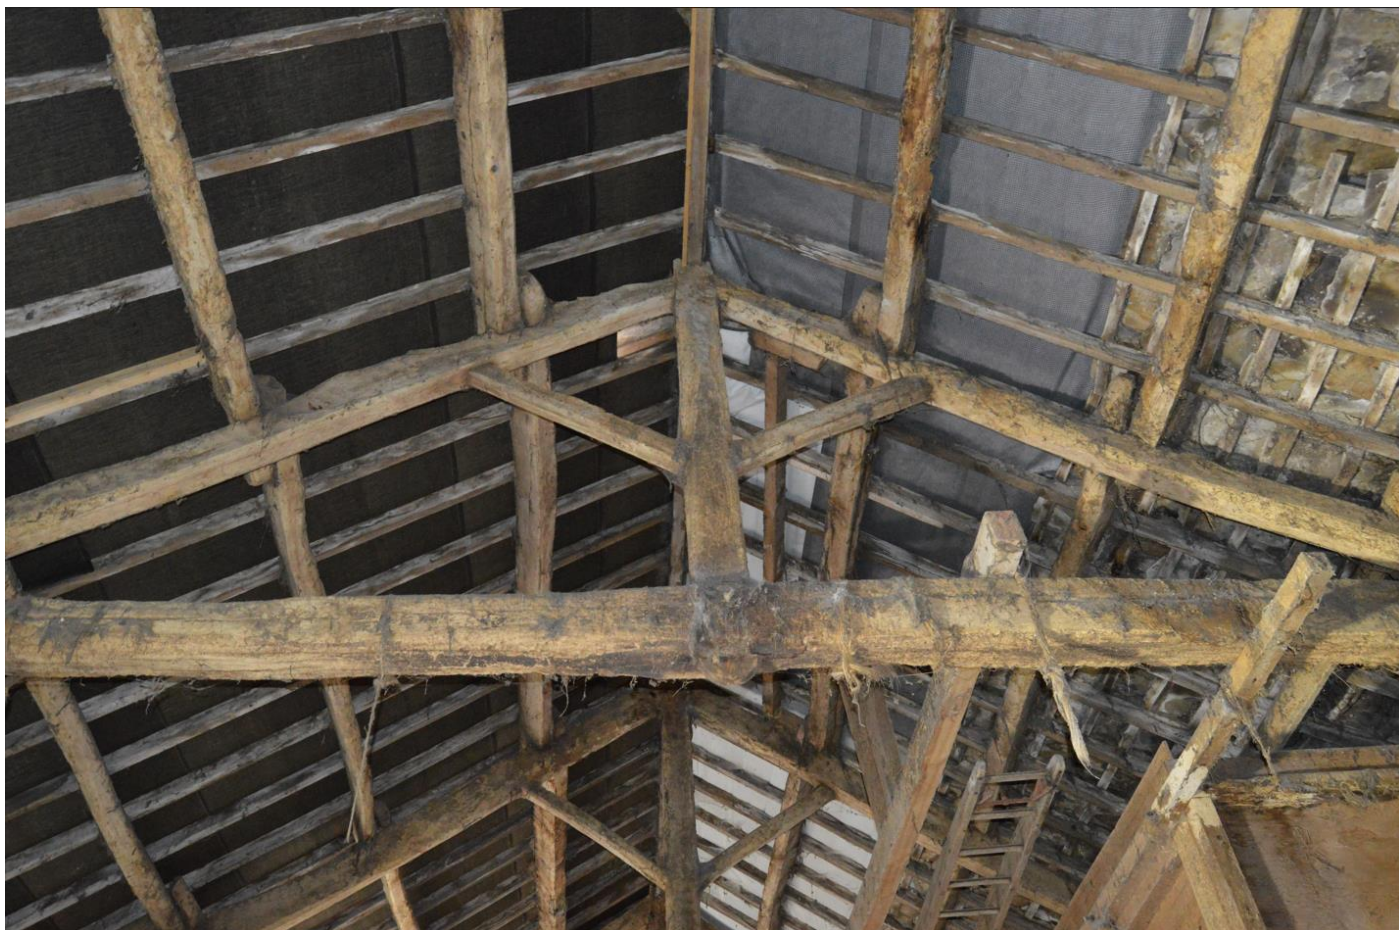
*PL14: Photo showing internal roof structure with king post trusses.*

The roof structure to the barn appeared to be in good condition at the time of inspection and free of obvious decay. The trusses and purlins were built into the existing external walls and is considered to be traditional practice. However, where there is localised moisture penetration / water ingress, this can leave the timbers susceptible to decay. However, there was no significant evidence of decaying timber noted to the ends of the trusses or purlins (built into walls) at the time of inspection. However, a closer inspection on erection of a safe working platform should be undertaken to confirm the exact condition of the roof structure. This should also provide an opportunity to assess for evidence of wood boring insect attack to the roof timbers. It may also be prudent to treat the existing roof timbers to increase their longevity.

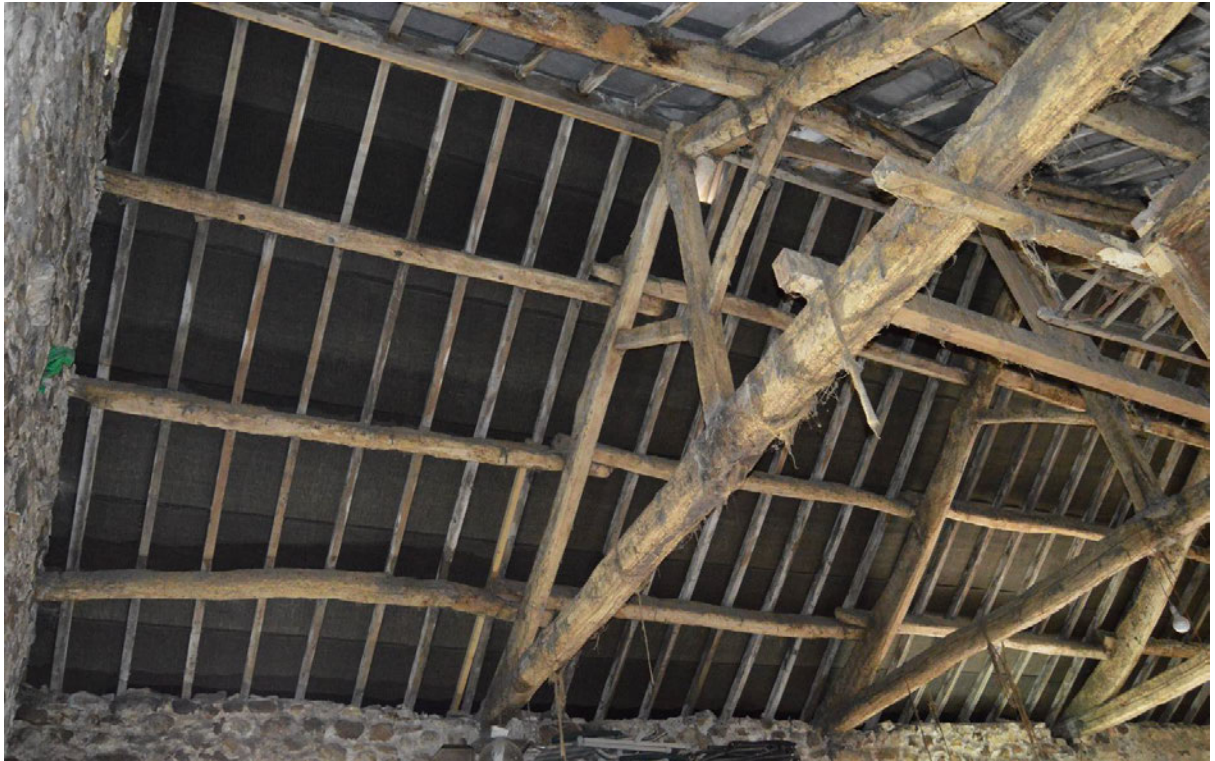
*PL15: Photo showing underside of bituminous roofing felt, with battens and blue slate over. Original timber trusses and purlins.*

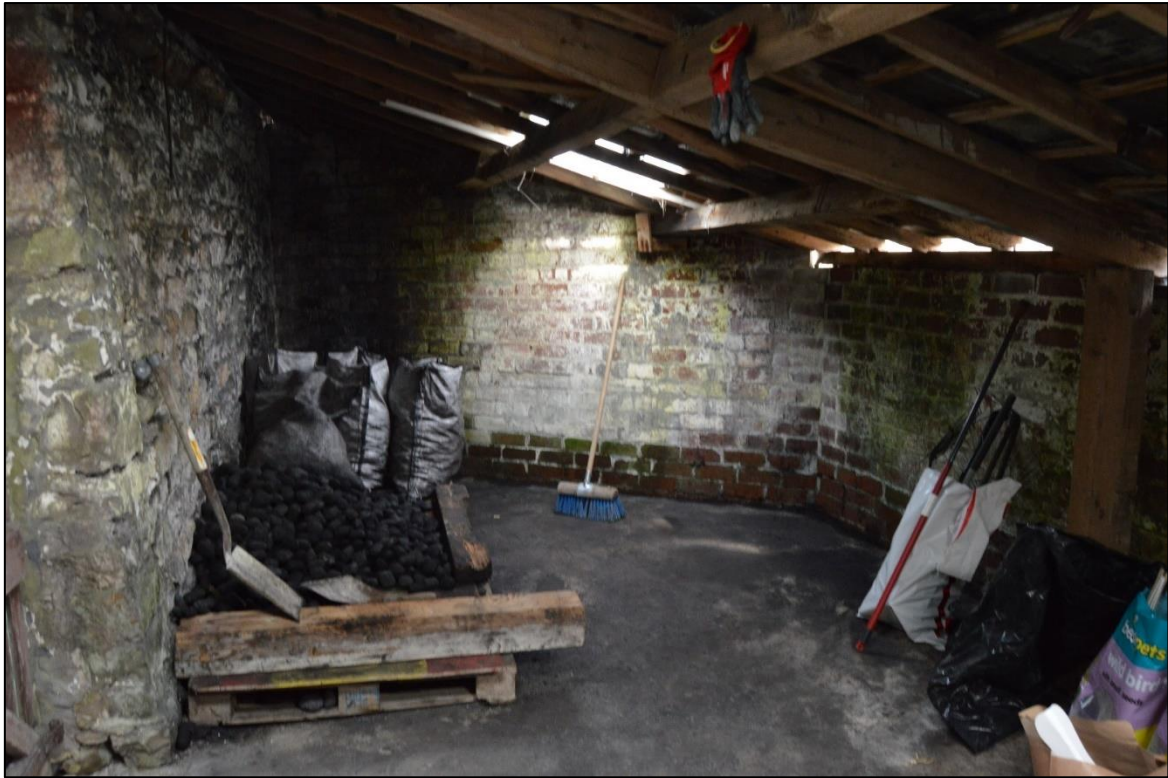
PL19: Photo showing roof structure to Outbuilding 1, comprising of sawn timber purlins and rafters

*Outbuilding 1: The roof structure to outbuilding 1 is constructed of sawn timbers throughout and all appear to be in good condition. The trusses and purlins these are built into the solid brick and stone walls and can all be subject to localized damp. Overall the condition of the roof is good and is fit for conversion for the proposed home office usage. It is advised that it is re-roofed including a breathable underlay over the rafters before battening and re-fixing slate along with reclaimed slate to match existing. It is also recommended that all roof timber is treated with SIKAGARD as recommended to the barn see below.*

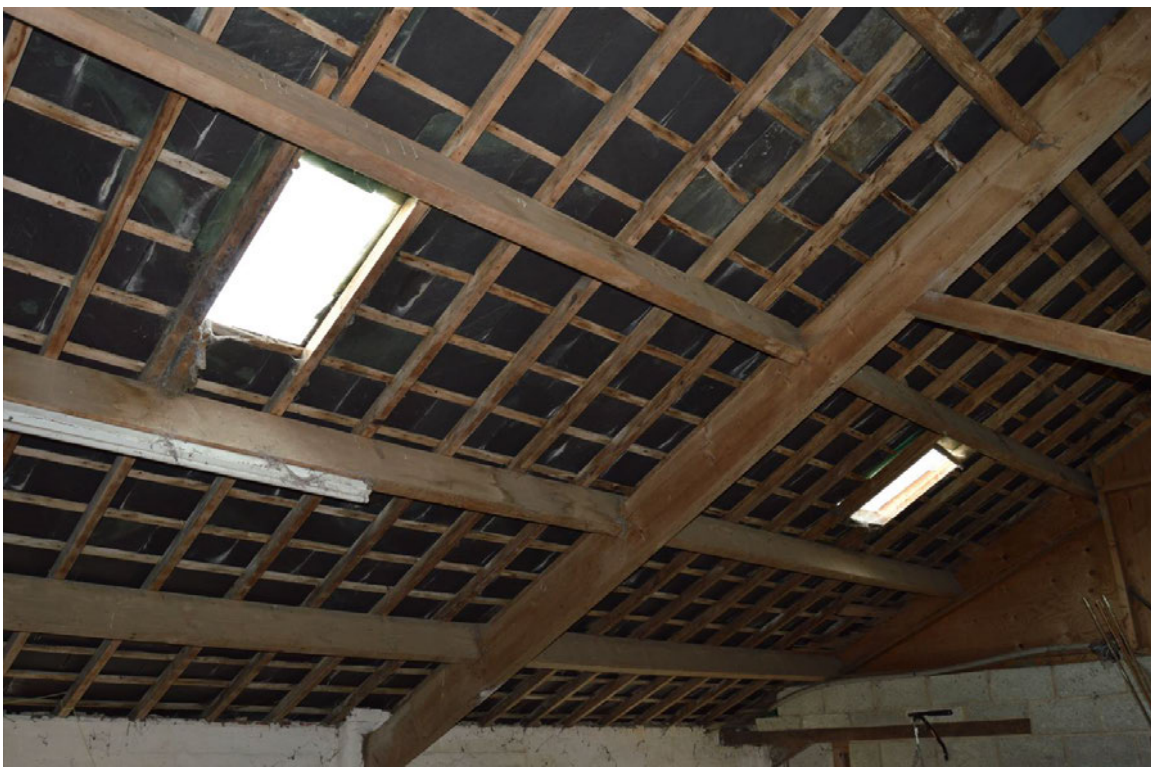
PL19: Photo showing underside of outbuilding 2 roof, comprising of sawn timber half trusses, purlins, rafters battens with natural slate over

*Outbuilding 2: The roof structure to outbuilding 2 is constructed of sawn timbers throughout and all appear to be in good condition throughout. As with outbuilding 1 the trusses and purlins these are built into the solid brick and block walls and can all be subject to localized damp. Overall the condition of the roof is good and is fit for conversion for the proposed garage usage. It is advised that it is re-roofed including a breathable underlay over the rafters before battening and re-fixing slate along with reclaimed slate to match existing. It is also recommended that all roof timber is treated with SIKA SIKAGARD as recommended to the barn see below.*

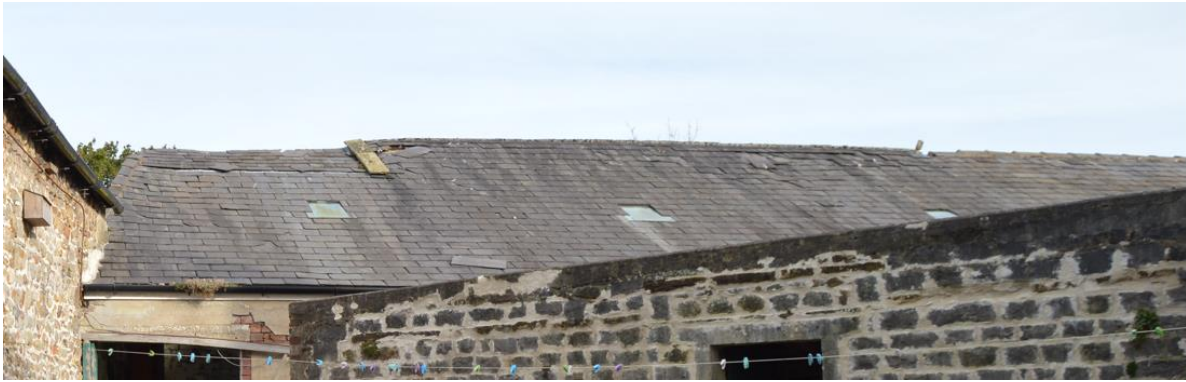
*PL20: Photo showing mono pitch slate roof to outbuilding 2, a number of slate are missing and loose and a number of ridge tiles are missing.*

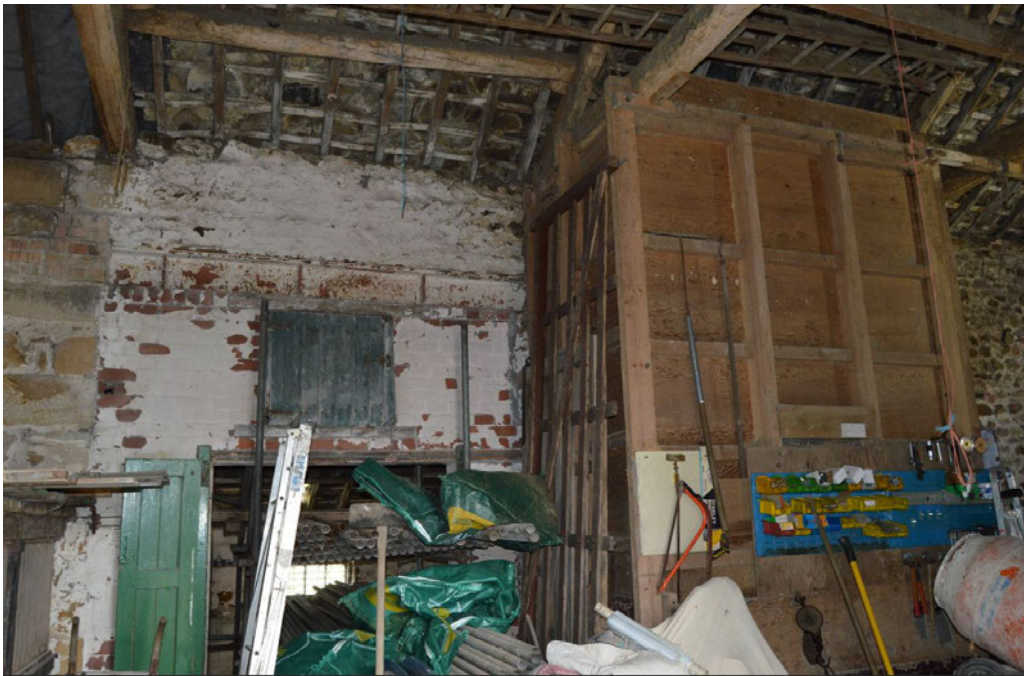
*PL21: Original opening built up with brickwork with steel beam over.*
