Job No. 6955

BUILDING STRUCTURAL SURVEY

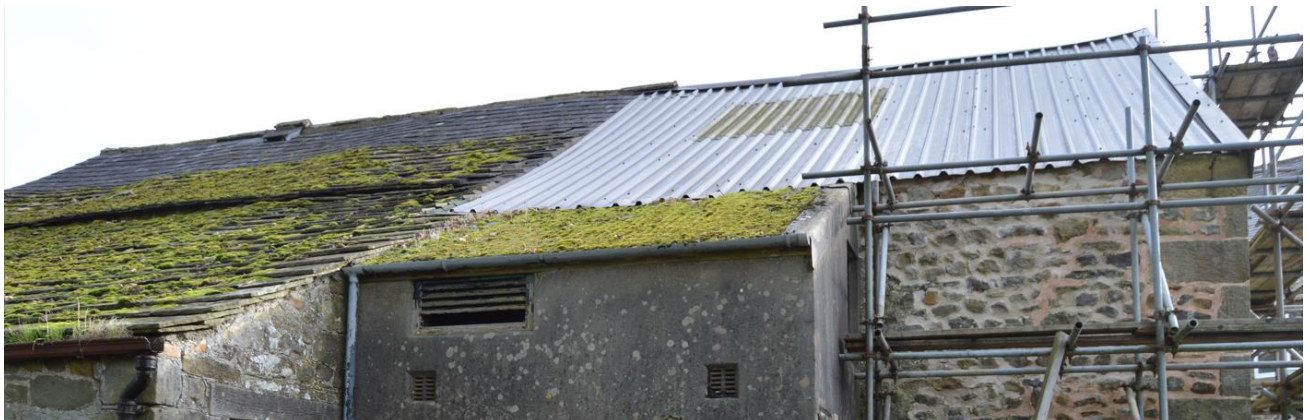
PL11: West Elevation Photo: showing stone slates to the left hand side of the barn roof and metal roof sheeting to right hand side. The rear rendered add on is proposed to be removed. The gutters and rainwater pipes are a mix of grey pvcu, black cast and missing sections of gutters.

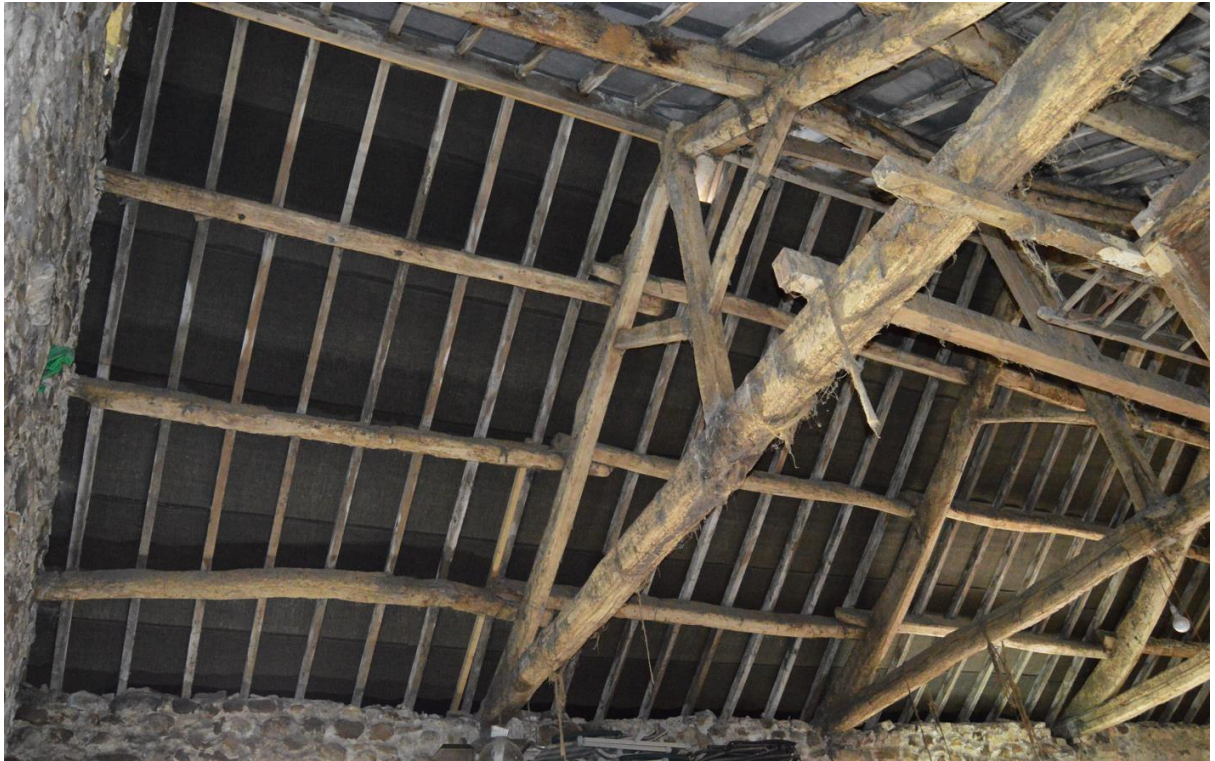
PL15: Photo showing underside of bituminous roofing felt, with battens and blue slate over. Original timber trusses and purlins.

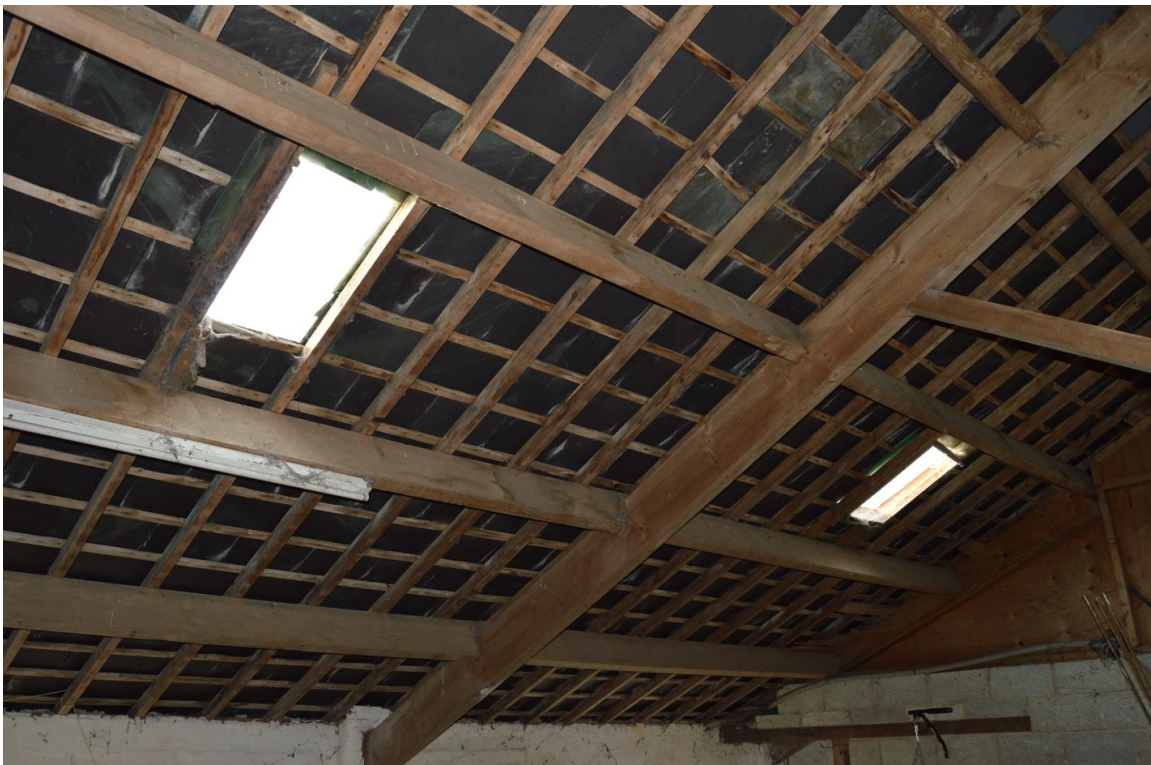
PL19: Photo showing underside of outbuilding 2 roof, comprising of sawn timber half trusses, purlins, rafters battens with natural slate over

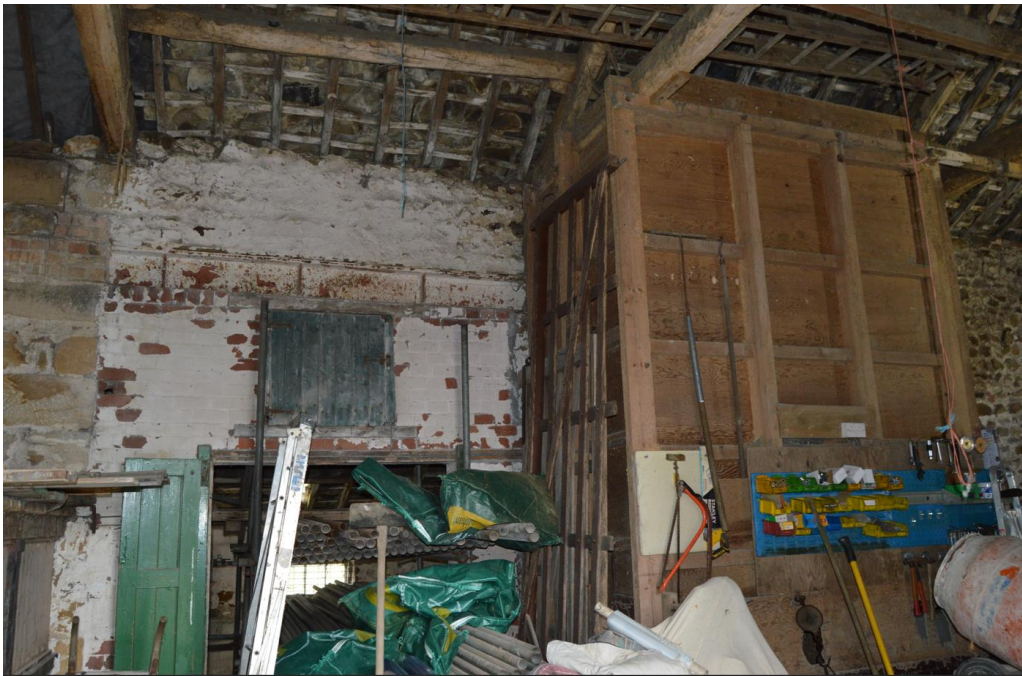
PL21: Original opening built up with brickwork with steel beam over.
