Bridge End Farm

Historic Building Report: Analysis and Interpretation

J. Deadman Historic Buildings Survey and Research

2025

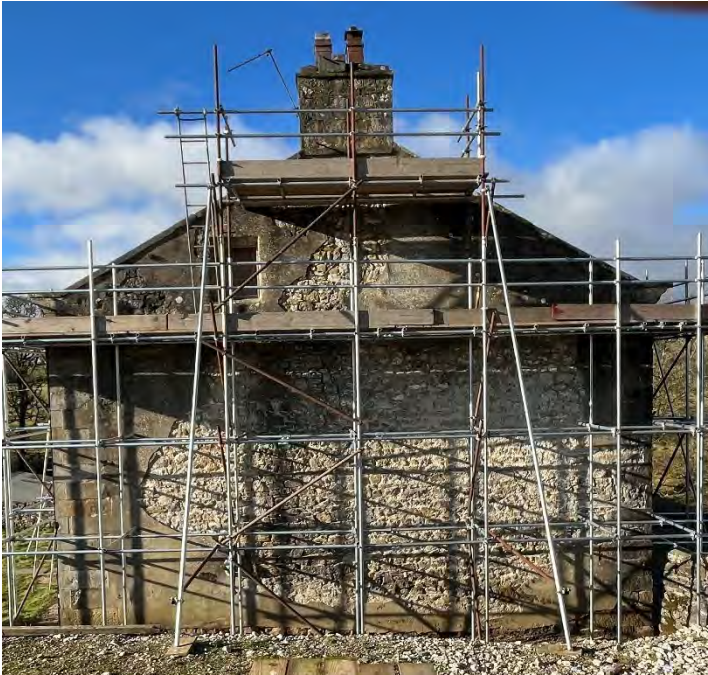
East gable. Note remains of 20th century cement render.

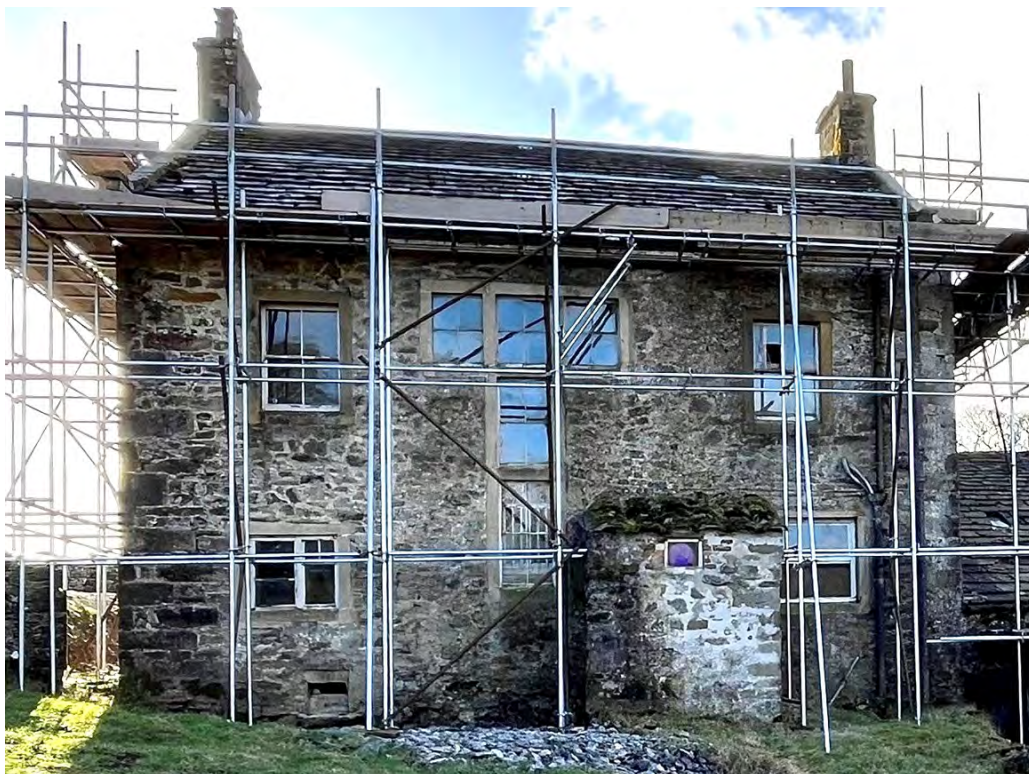
The two upper windows comprise vertical sliding sashes with four lights. The frames to both pantry window, ground floor left, and kitchen window, ground floor right, have been replaced in the 20th century. A small cellar window/light is visible below the pantry at ground level. All, apart from the cellar light, retain the original monolithic cills, lintels and jambs.

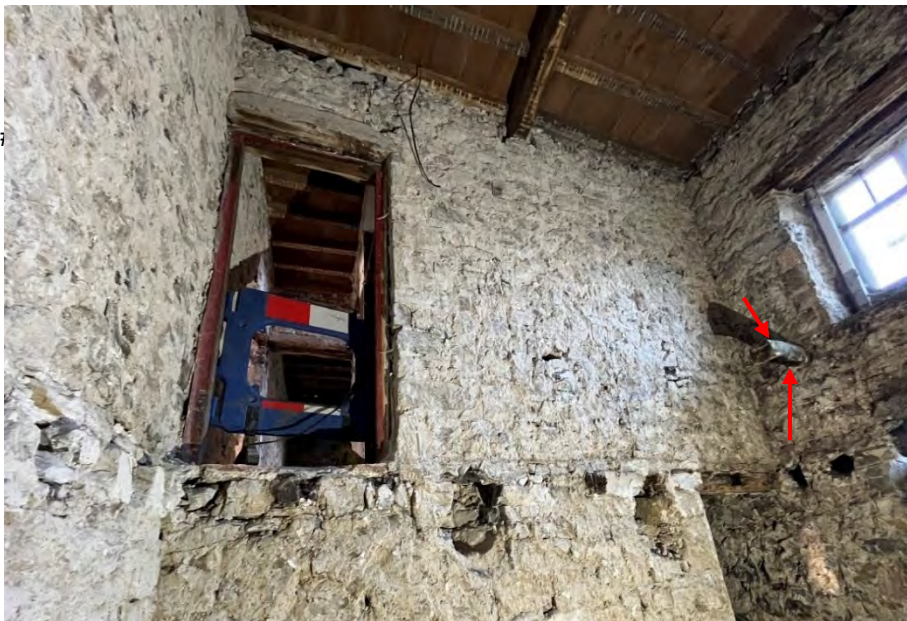
Plate 40

The pantry/dairy is accessed off the lobby to the right. The floor has been removed so it can only be viewed from the cellar below. Joist holes indicate the floor height. However, joist holes on all four walls suggest the floor structure has failed at some point in the past and possibly a second time in the more recent times.

View from cellar

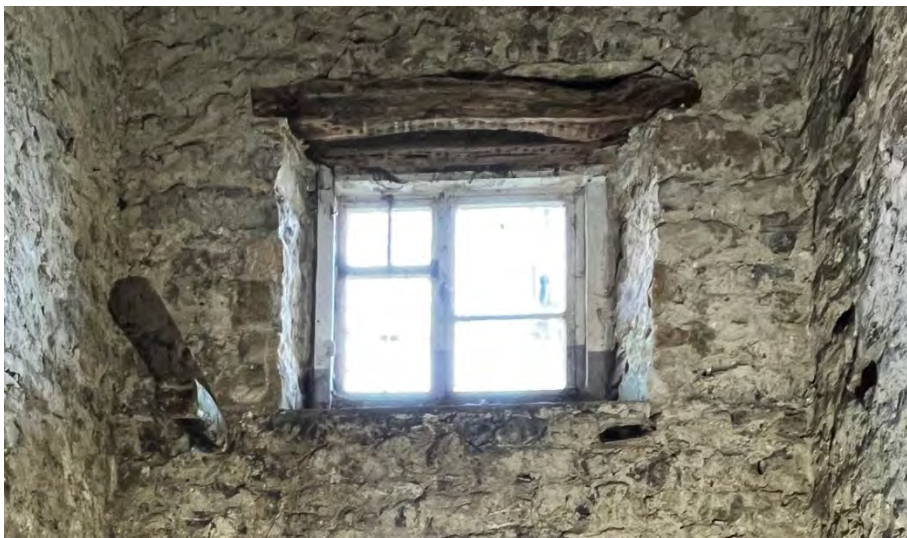
Plate 41

Pantry window with heavy wooden lintel

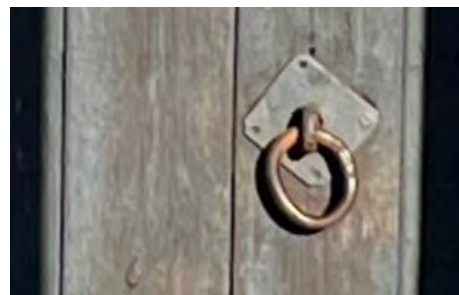
Plates 64,65

Beyond, is the byre entry, a plank door with standard 19th/20th century ironmongery. Note the reveal to right is a later replacement, the original possibly having suffered from cattle damage.

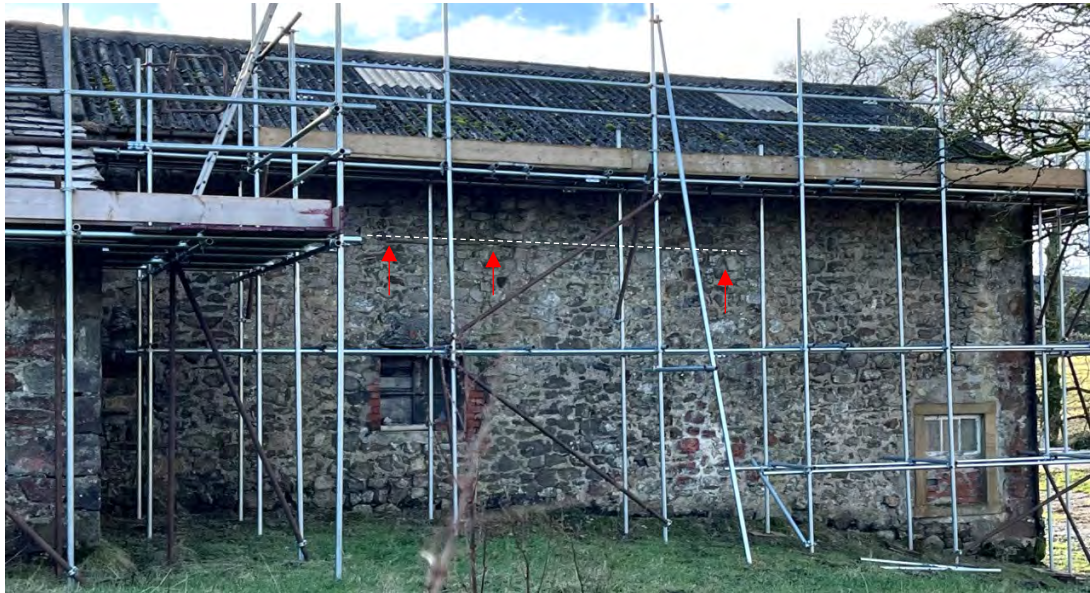
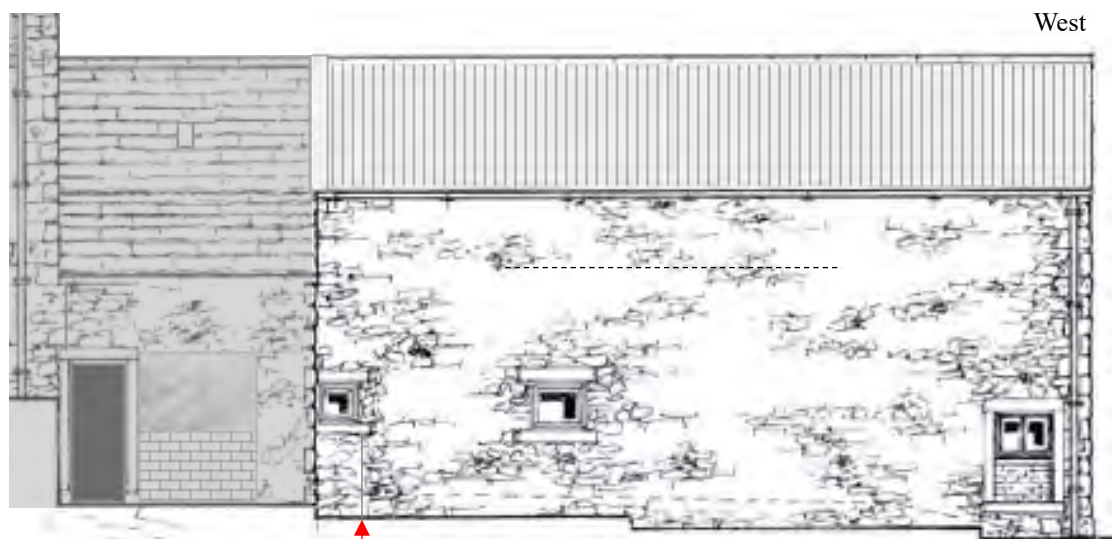
Plates 68, 69

Straight joint ?

Window, possible site of earlier muck hole

Working from west to east is first, a large window with monolithic sandstone jambs, lintel and cill. Although stylistically 19th century in design it is remarkably unweathered considering its north facing location. It has been reduced in size with brick blocking. Although a doorway is frequently found in this location in a hay mew, there is no evidence for straight joints below the window to indicate the location of a former entry. Either the window was a later insertion or simply replaced a smaller aperture.

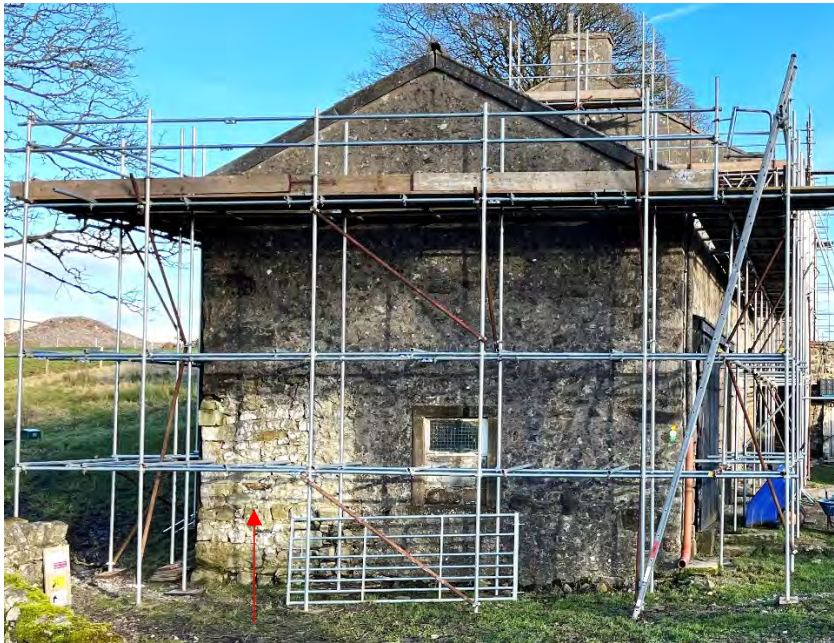
Plate 74

Visible to the north is an area of clean stone where formerly a small single storey building adjoined the barn. It was roofless by 1907 (Ref OS map) Centrally placed on the west gable is an inserted window, sporting monolithic jambs, cill and lintel, now partially blocked.

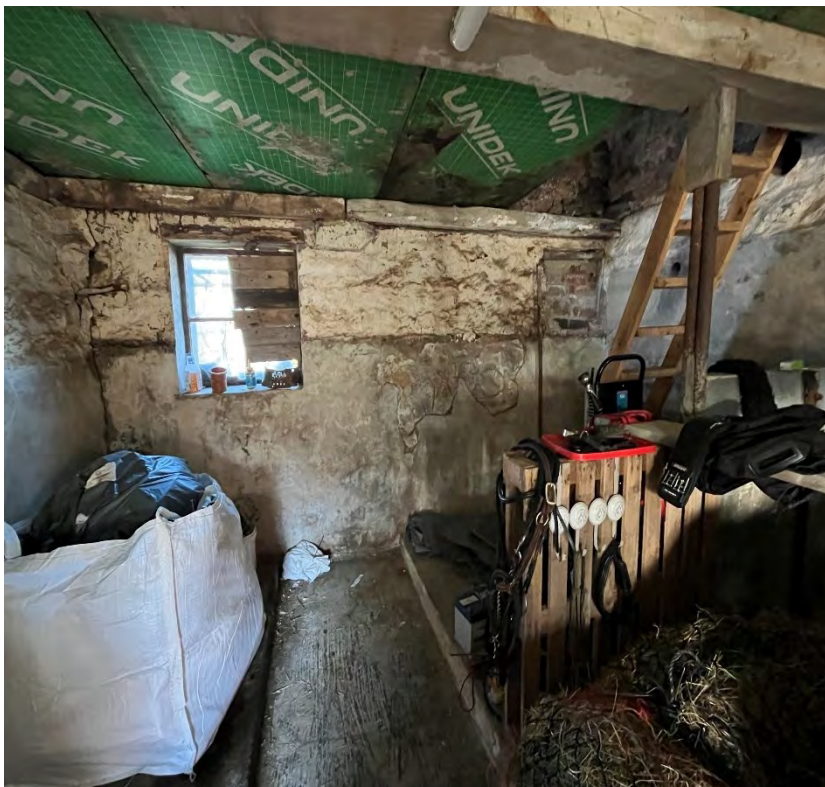
Plate 77

The byre accommodated six cattle according to the 1911 survey. All original fittings were removed by the mid-20th century, and replaced with concrete stalls, cement rendered walls and a concrete floor.

The original loft floor has been replaced with chip board.

View across byre from cattle entry

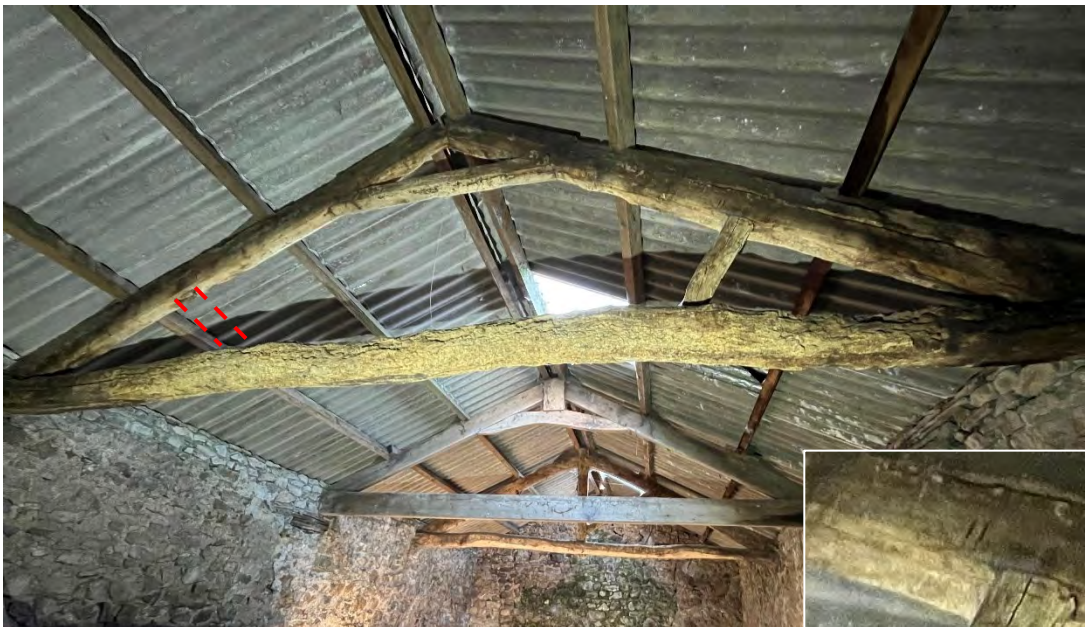
Plate 80

The truss in the foreground is classed as a principal rafter truss with collar and struts, although it is now missing a strut. It is numbered 11, suggesting it is not in its original position. Its location at the end of a run of three trusses should number 1 or 111.

The roman numeral, 11, is neatly chiselled into the wood, suggesting it is 17th or 18th century in date. A shallower, less precise mark as created by a rase knife, would suggest an earlier 16th century date.

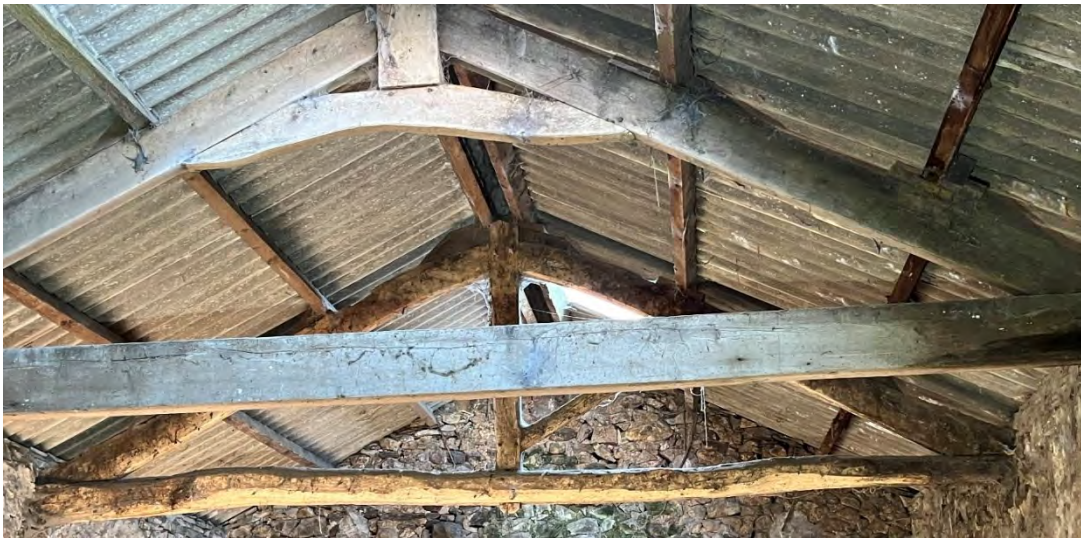
Plate 83

The third truss is of king post construction, with curved principals set into the head of the post and secured with wooden pegs. The king post itself is pegged to the tie beam. Two struts, one of which is missing, rise from post to principal rafters. It is too abraded to reveal any numbering.

Head of king post with slightly cambered principal rafters
