ARBORICULTURAL ASSESSMENT

11 Knowle Green Cottage
Clitheroe

Treeworks Arboricultural services | 20 St Michaels court Barrowford BB98NU

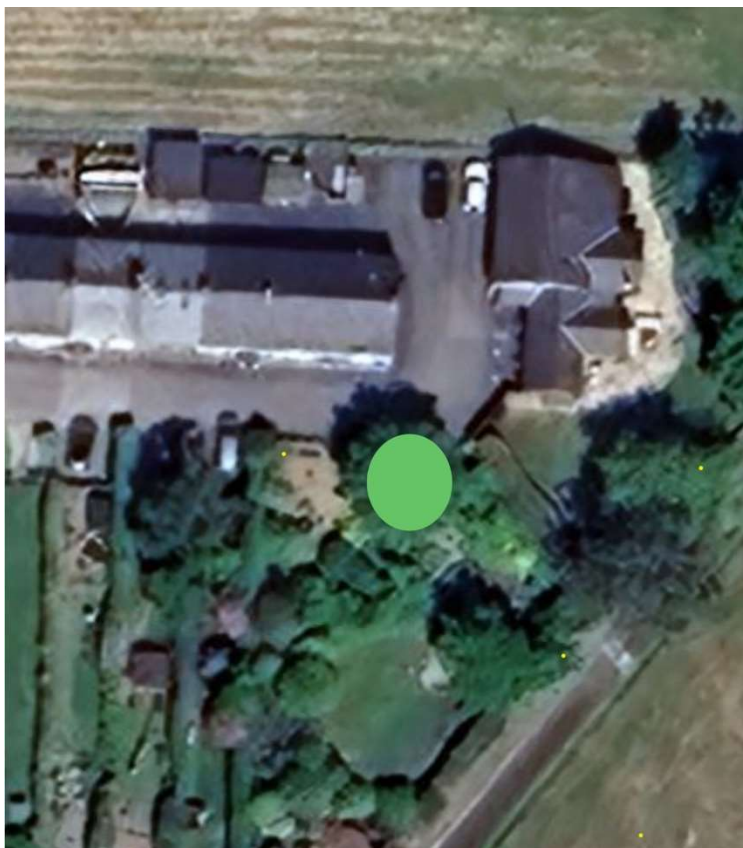
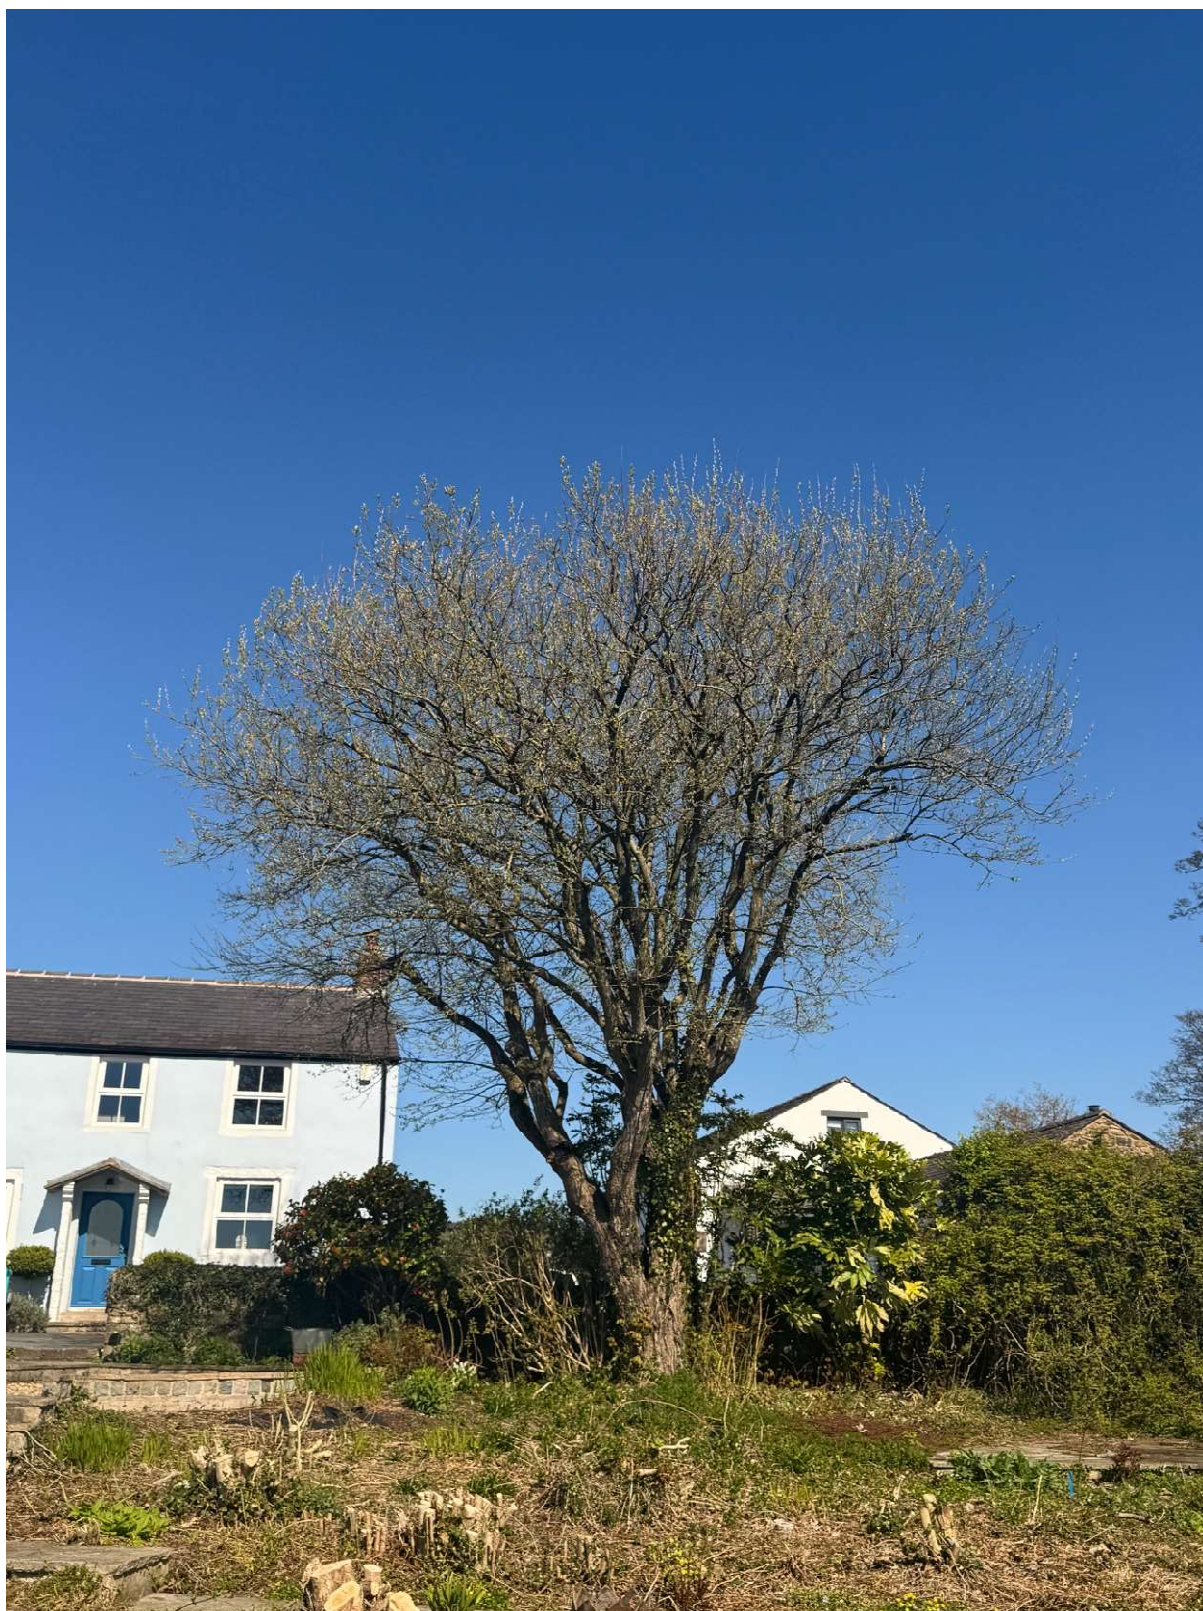
- **Species:** Goat Willow (*Salix caprea*)
- **Age Class:** Semi-mature
- **Approximate Height:** 5 metres
- **Stem Diameter (at 1.5m):** ~85cm
- **Crown Spread:** Approx. 4–5 metres radius
- **Previous Management:** The tree has been historically pollarded at approx. 1.8m above ground level, resulting in dense vertical regrowth. This prior intervention has influenced the current structural and physiological characteristics of the tree.

- **Crown Form:** Multiple upright stems with tight unions and included bark—a structural fault increasing risk of vertical stem failure.
- **Woundwood:** Some evidence of historic branch loss and occluded wounds, indicating mechanical stress over time.
- **Base & Root Flare:** Pronounced buttress roots extend toward adjacent built features.

- **Root Intrusion into Drainage:** Structural roots have entered and contributed to the collapse of a waste pipe, causing repeated blockages and water flow restrictions.
- **Boundary Wall Damage:** Roots have displaced the masonry boundary wall, resulting in cracks and deformation.
- **Surface Damage:** Pavement and tarmac surfaces near the tree show uplift and cracking consistent with root expansion.
- **Soil Movement:** Evidence of shrink-swell soil activity, likely linked to excessive moisture extraction by the tree's root system.

Fell the Goat Willow to ground level. Removal should be completed by trained arborists using safe and approved methods. A traffic management plan may be necessary depending on proximity to road or pedestrian access.
