Arboricultural Impact Assessment

Mellor House
Primrose Hill
Mellor
BB1 9DL

October 2024

Job no.	LTC278
Site	Mellor House, Primrose Hill, Mellor, BB1 9DL
Client	Gordon Perplus
Agent	Stanton Andrews Architects
Arboriculturist	Jennie Keighley PhD MSc MArborA
Local authority	Ribble Valley Borough Council
Date	30 October 2024
Issue	Final issue for planning

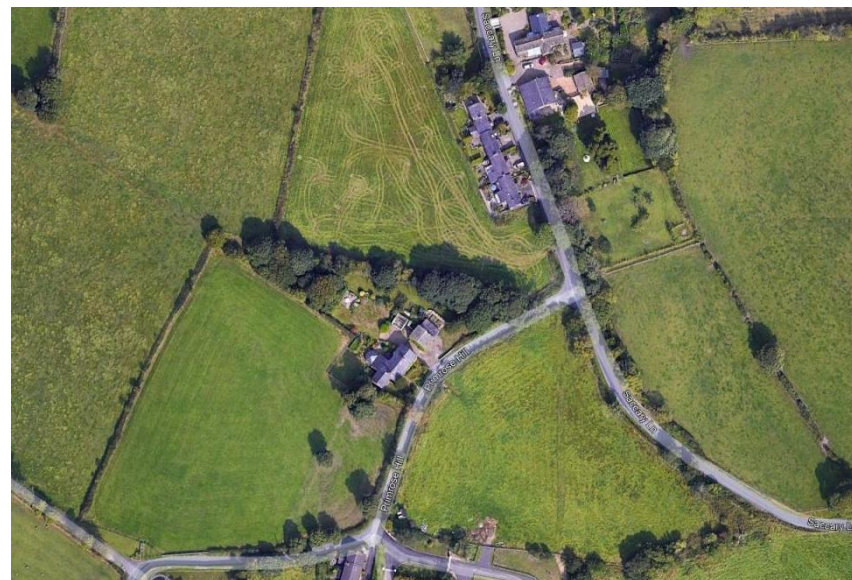
Figure 1: Google Earth image of application site
(dated 2 September 2022)

3.1 The site is currently a detached residential dwelling with a large outbuilding to the north-east, a further detached garage and garden outbuilding, and surrounding garden areas (see Figure 1). It is bounded to the north, south and west by agricultural pasture and to the south-east by Primrose Hill, from which there is existing vehicular access.

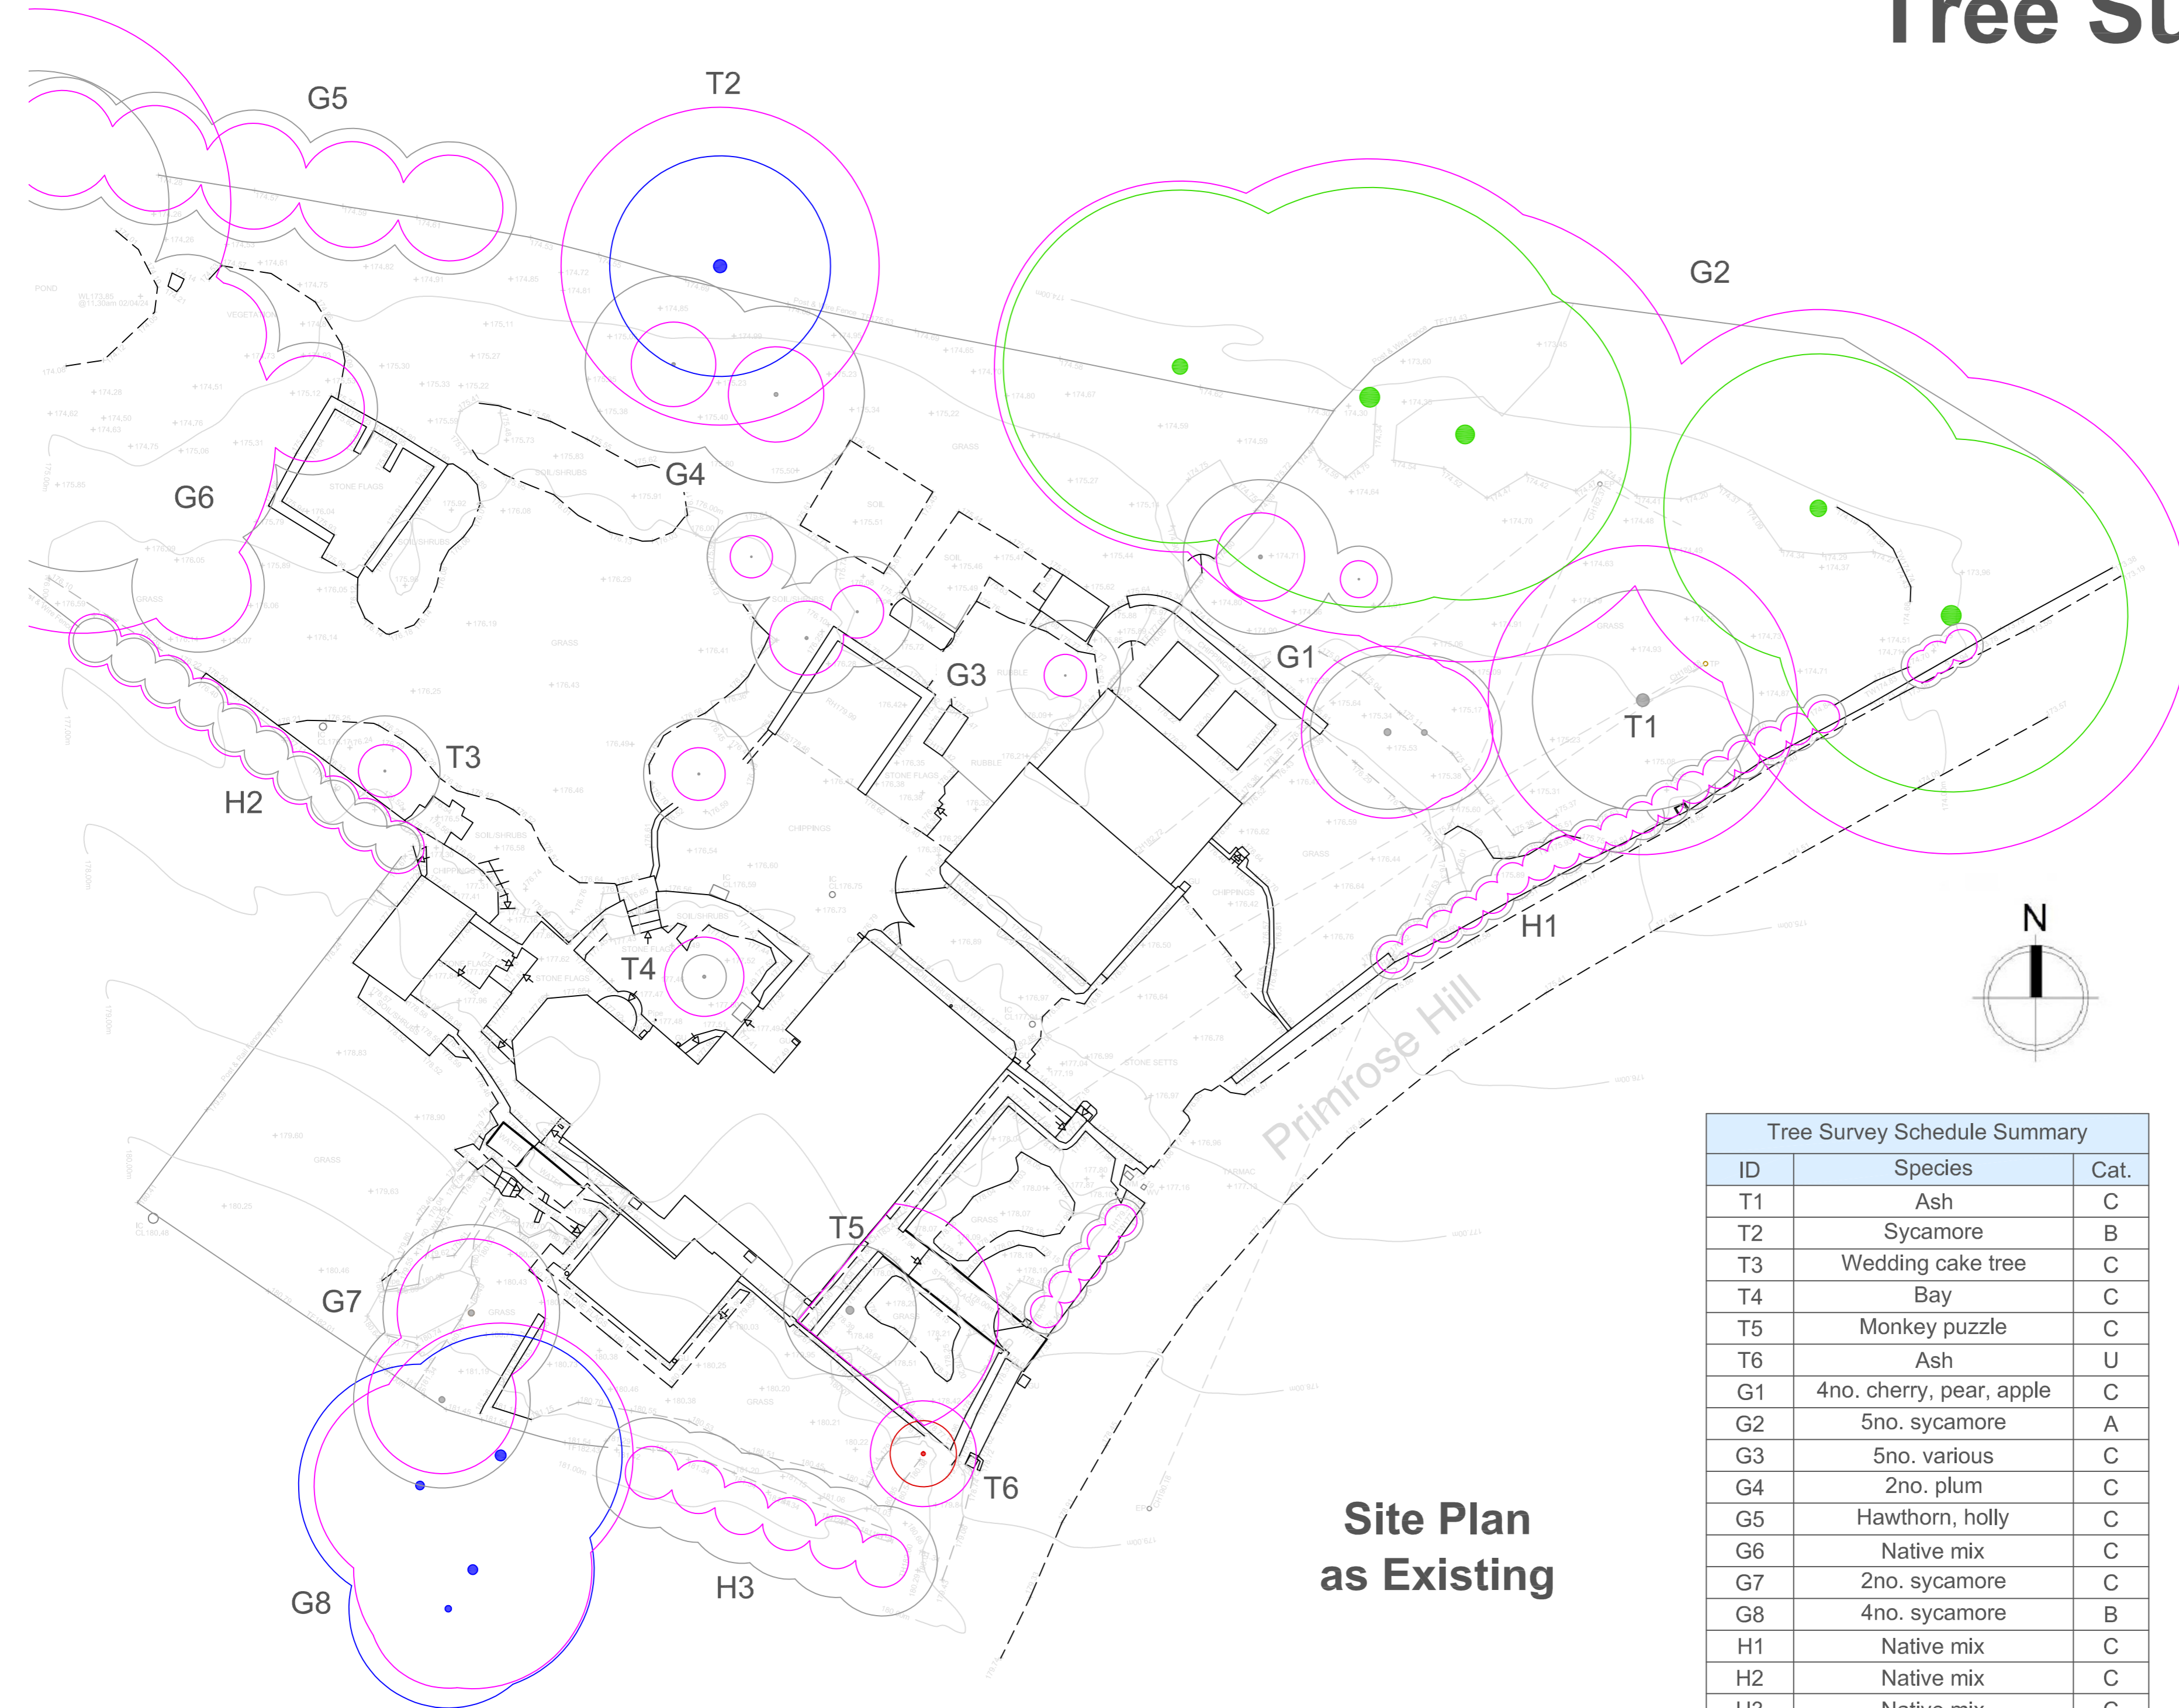
Date: June 2024
Scale: 1:200 at A2
Drawing: LTC278-TSP
Drawn by: JK

Tree Survey Schedule Summary		
ID	Species	Cat.
T1	Ash	C
T2	Sycamore	B
T3	Wedding cake tree	C
T4	Bay	C
T5	Monkey puzzle	C
T6	Ash	U
G1	4no. cherry, pear, apple	C
G2	5no. sycamore	A
G3	5no. various	C
G4	2no. plum	C
G5	Hawthorn, holly	C
G6	Native mix	C
G7	2no. sycamore	C
G8	4no. sycamore	B
H1	Native mix	C
H2	Native mix	C
H3	Native mix	C

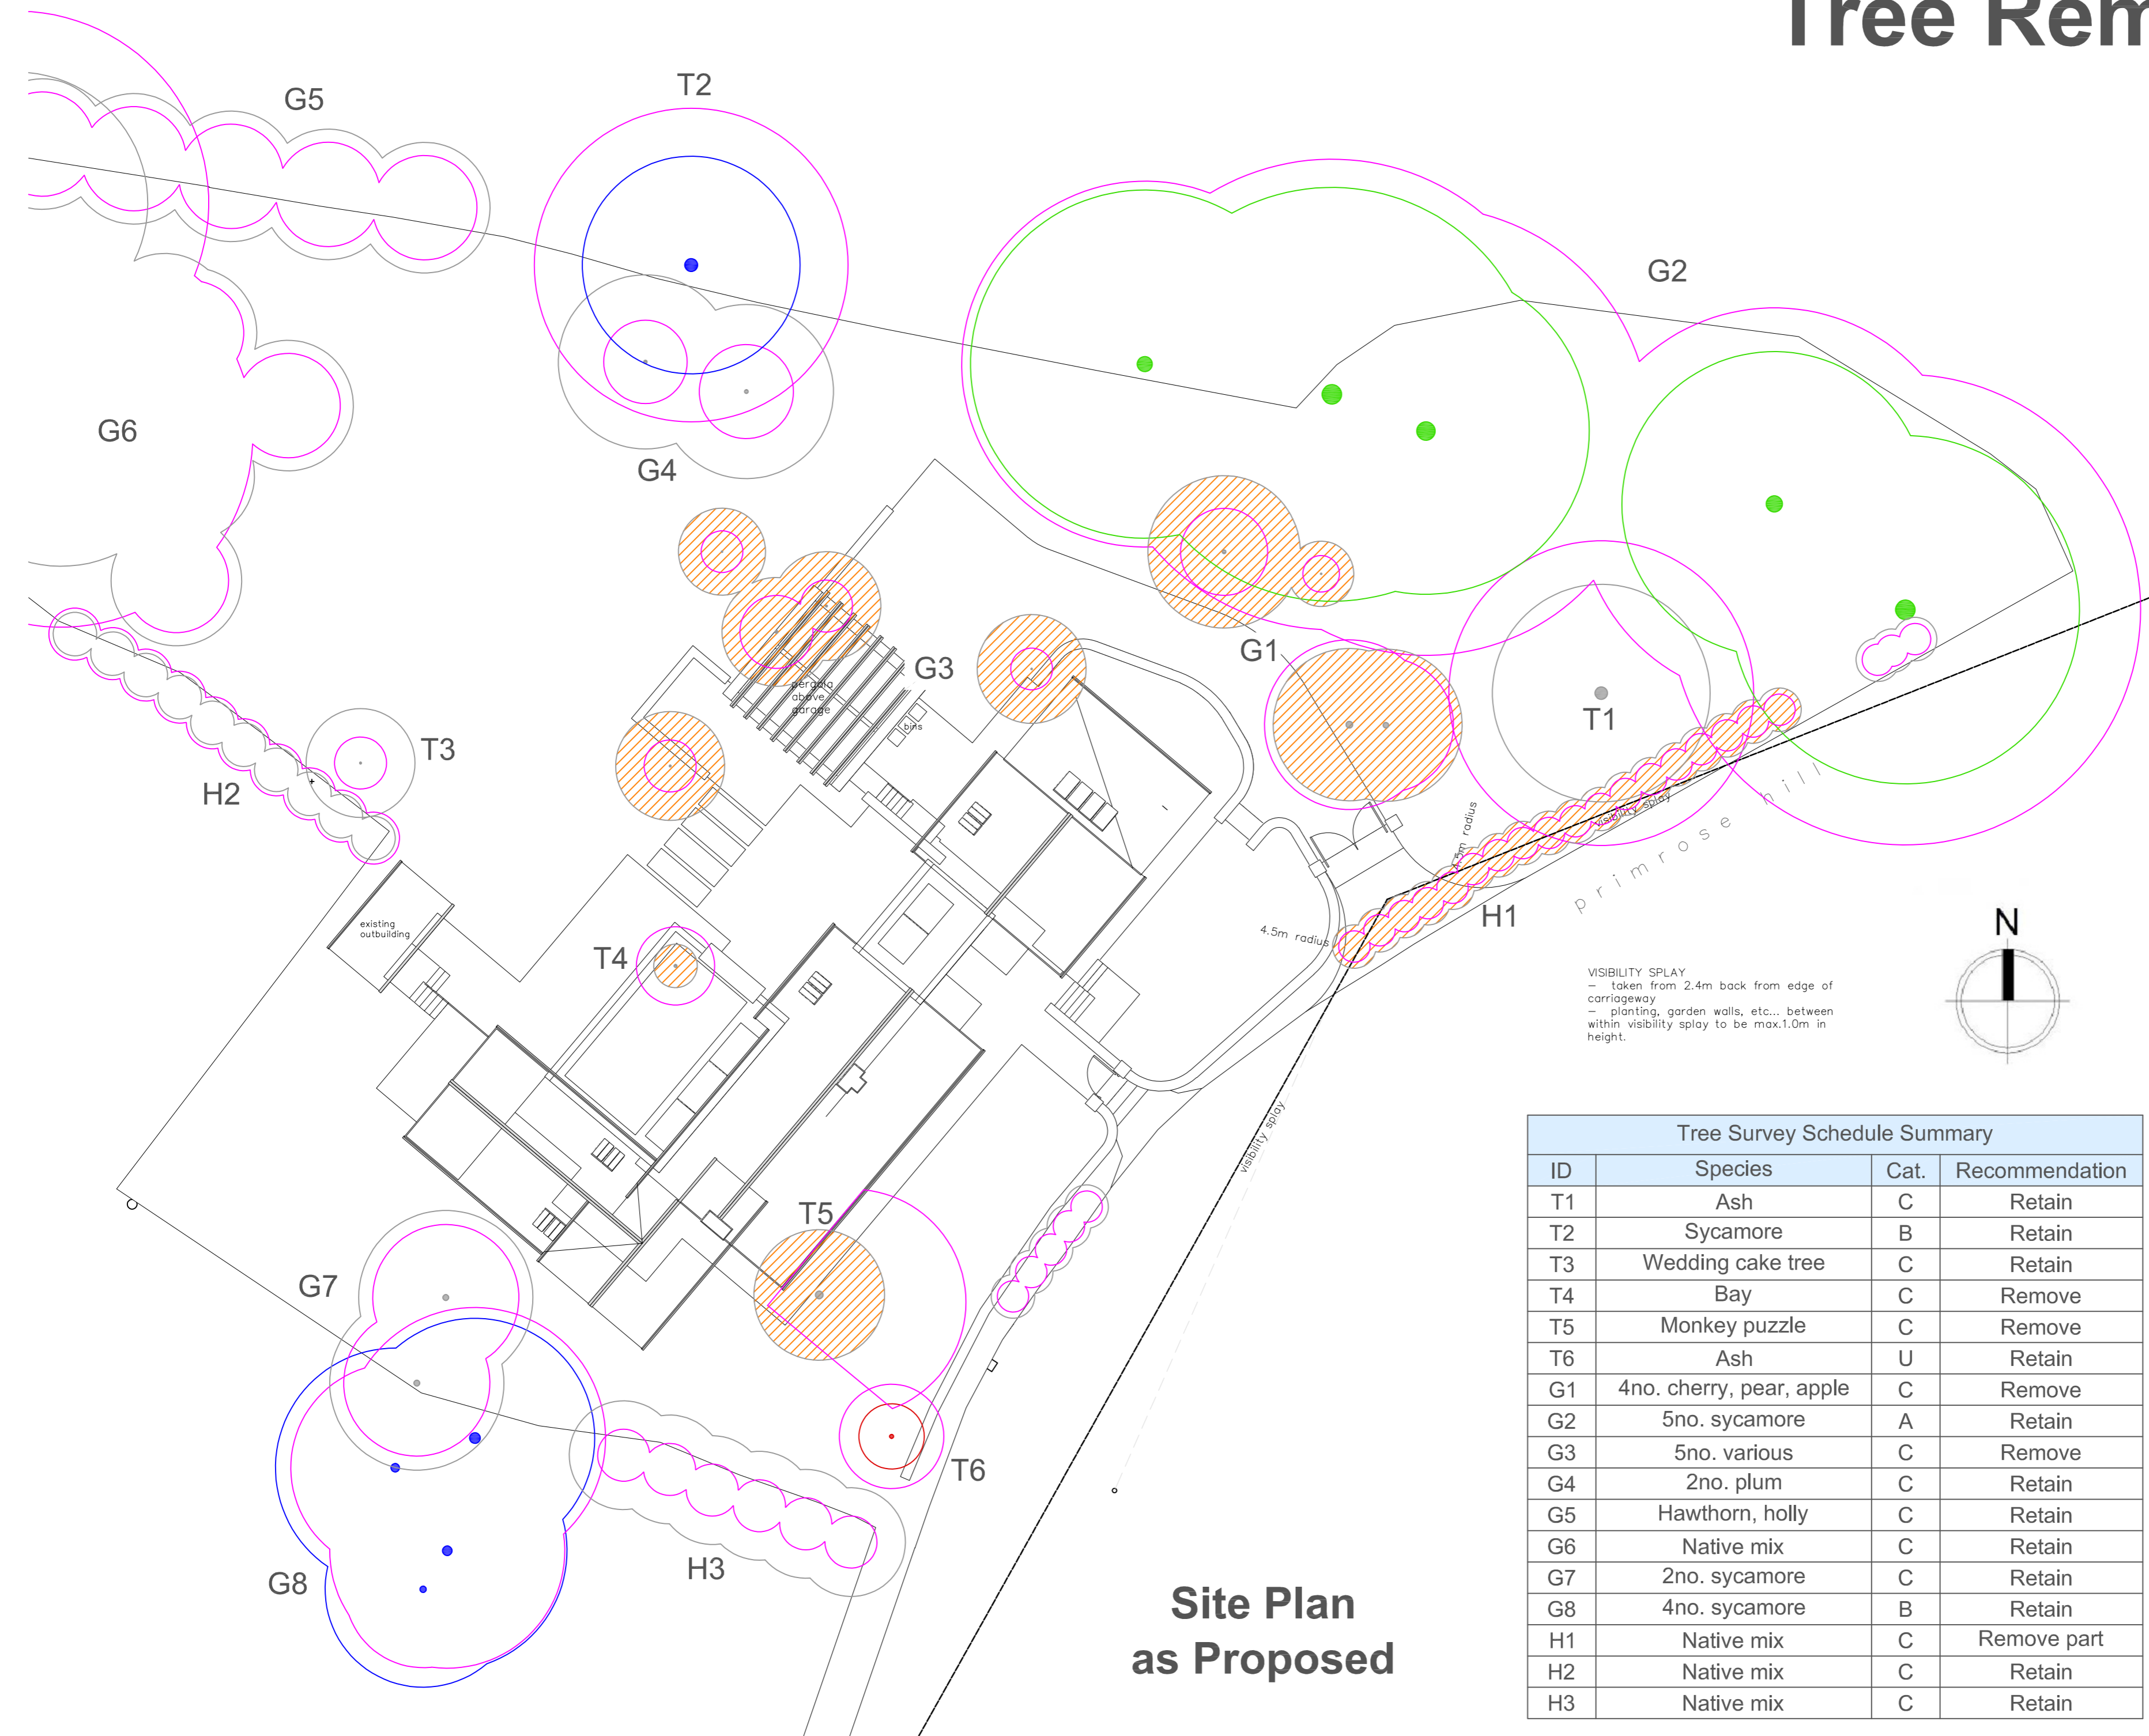
Drawing: LTC278-TRP

Tree Survey Schedule Summary			
ID	Species	Cat.	Recommendation
T1	Ash	C	Retain
T2	Sycamore	B	Retain
T3	Wedding cake tree	C	Retain
T4	Bay	C	Remove
T5	Monkey puzzle	C	Remove
T6	Ash	U	Retain
G1	4no. cherry, pear, apple	C	Remove
G2	5no. sycamore	A	Retain
G3	5no. various	C	Remove
G4	2no. plum	C	Retain
G5	Hawthorn, holly	C	Retain
G6	Native mix	C	Retain
G7	2no. sycamore	C	Retain
G8	4no. sycamore	B	Retain
H1	Native mix	C	Remove part
H2	Native mix	C	Retain
H3	Native mix	C	Retain

4.3 As shown on the appended tree removal plan and in Table 1, below, construction of the development will require the removal of two C-category trees, two C-category groups and part of a C-category hedge.

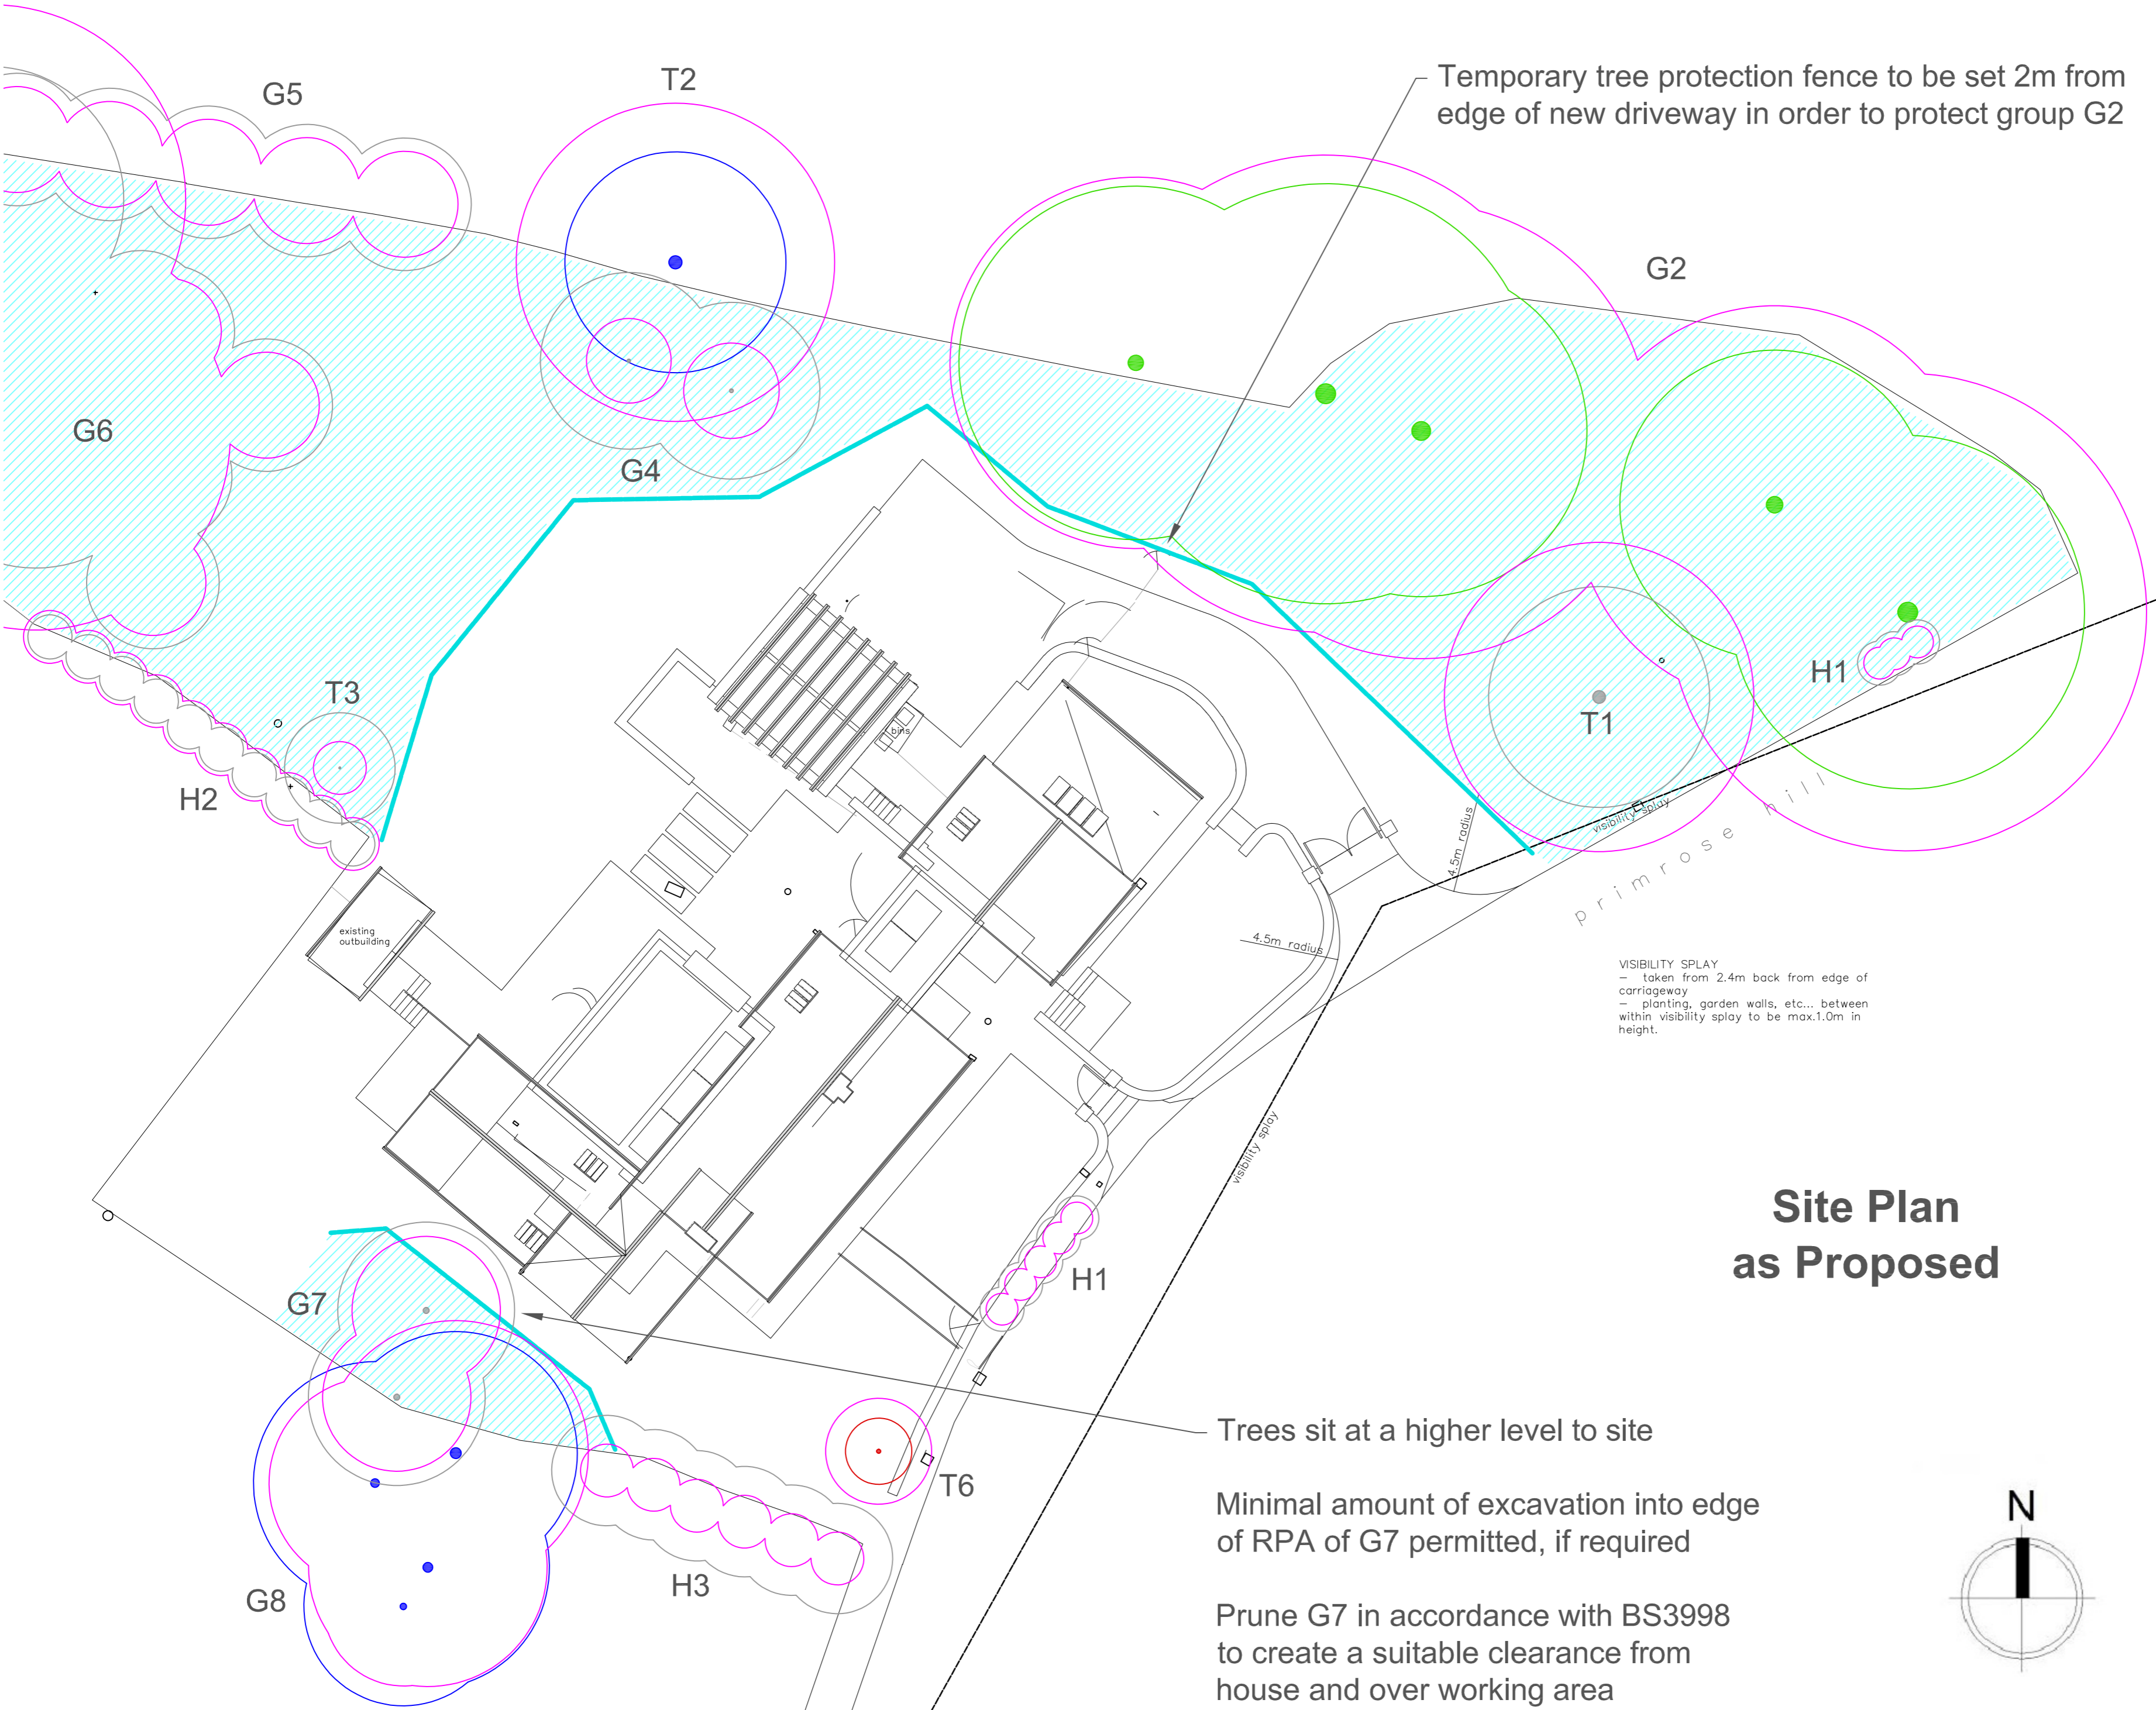
Date: October 2024
Scale: 1:200 at A2
Drawing: LTC278-TPP
Drawn by: JK

Trees sit at a higher level to site

Minimal amount of excavation into edge of RPA of G7 permitted, if required

Prune G7 in accordance with BS3998 to create a suitable clearance from house and over working area
