Project**Project Name:** 2024-11-30882 The Garage Site Dunsop Bridge BB7 3BB**Project Date:** 20/01/2025**Inspection Standard:** MSCC5 Sewers & Drainage GB (SRM5 Scoring)

Project Notes**Survey Comments****Job 2****525mm outfall across the field.**

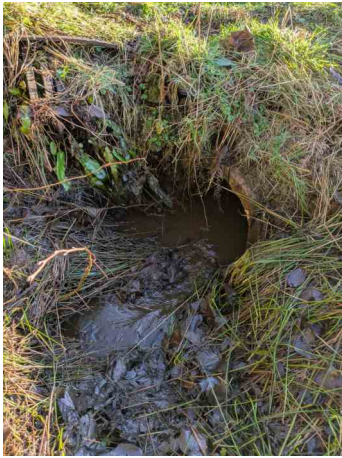
Outfall flowing better after jetting

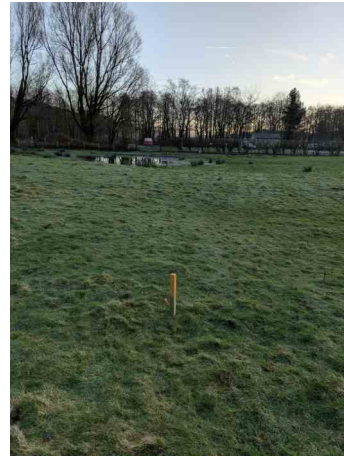
Mark 1 upstream of 525mm outfall

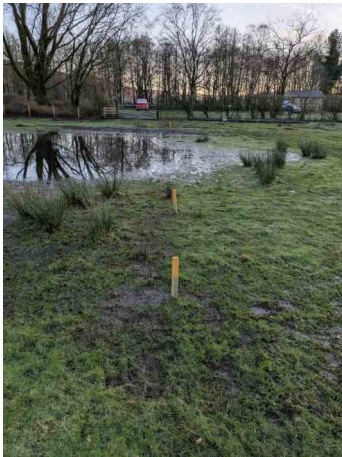
Mark 2 & 3 upstream of 525mm outfall

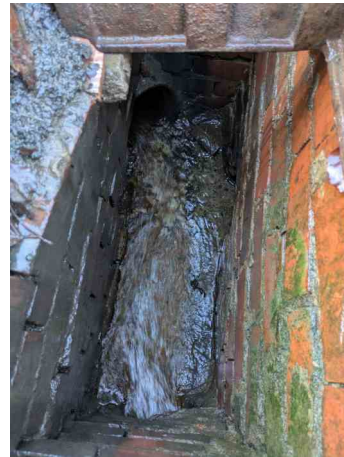
Gully 6

The gully at position 6 was cleaned and surveyed up 'A' & 'B' upstream and downstream to the river.

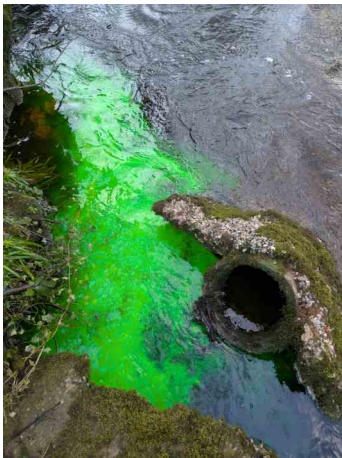
Gully 6 proven outfall to river

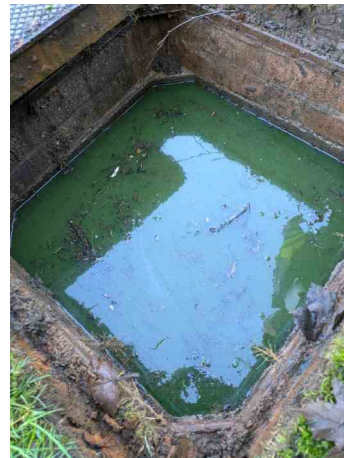
We tried in vain to suck all the water from the catchpit MH3 due to the large amount of water coming from the 525mm outfall. The suction could not overcome the volume of water flowing into MH3.

MH3 with dye

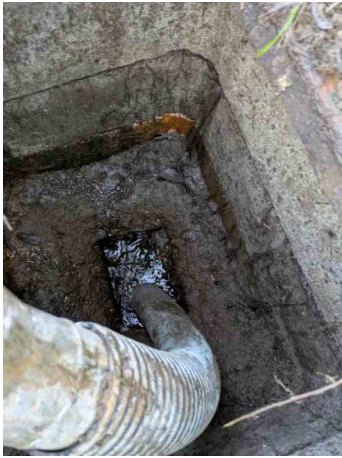
A CCTV survey was attempted from the verge manhole upstream, under the road to MH3. This was unsuccessful due to water flowing back into the manhole from the river quicker than the manhole could be emptied. A camera survey was attempted, the camera was under water but only travelled .75m up the pipe.

Sucking water from verge manhole but refilling from river

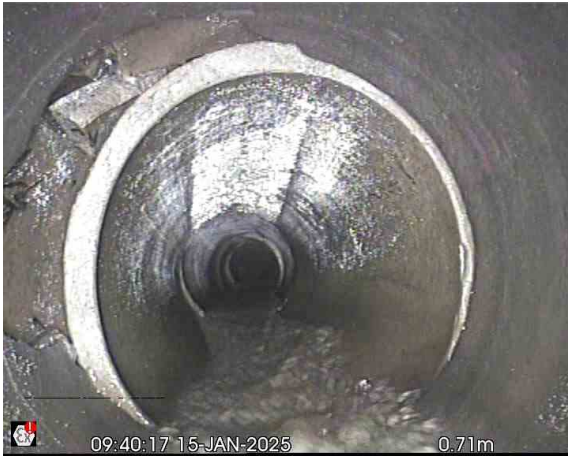
Branch
 BX_4dce1fac-847e-46a0-8b54-6a38226a0431_20250120_13
 4445_963.jpg, 00:00:13, 0.71 m
 Hole in drain or sewer from 7 o'clock to 12 o'clock

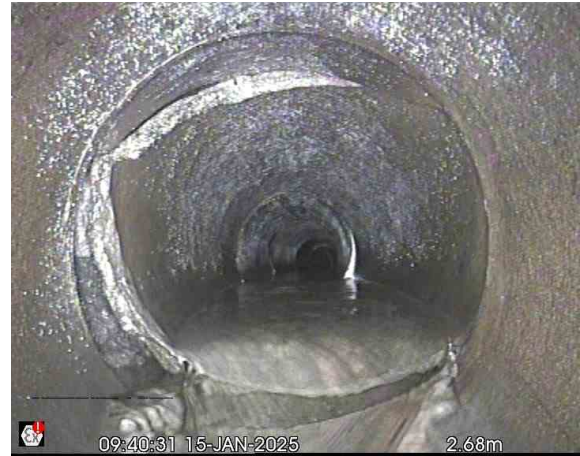
Branch
 BX_191e6468-be29-4b7d-ad17-b3a19b03bf7d_20250120_13
 4506_450.jpg, 00:00:26, 2.68 m
 Broken pipe at joint from 12 o'clock to 12 o'clock

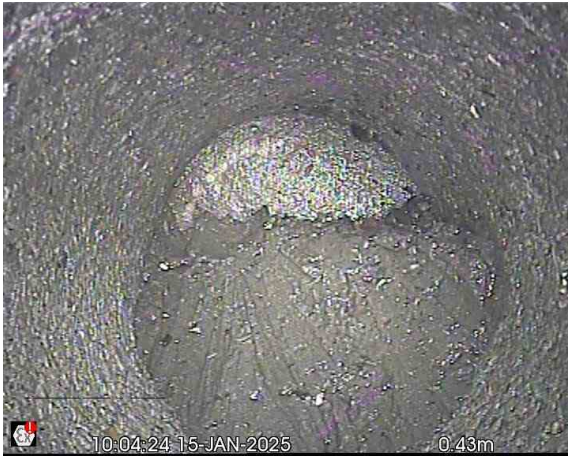
Branch
CX_a2c598b8-e010-42cc-b77c-76a82dda56c3_20250120_13
4717_789.jpg, 00:00:16, 0.43 m
Finish node, other special chamber, reference: Branch C, line
capped

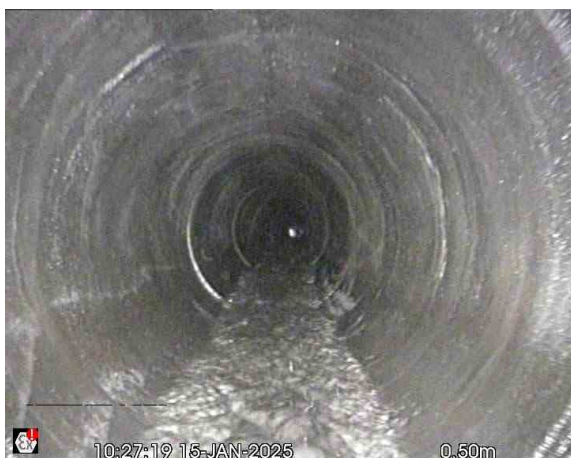
10:27:19 15-JAN-2025 0.50m
 Gully
 6X_e12484a8-6243-493b-8e77-e5601581f963_20250120_13
 4827_152.jpg, 00:00:09, 0.50 m
 Crack, circumferential from 12 o'clock to 12 o'clock

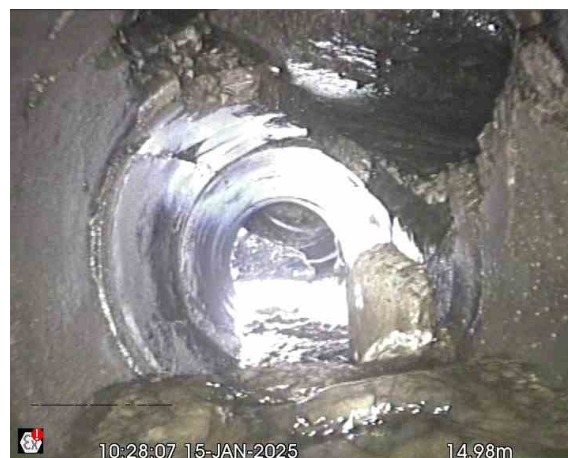
10:28:07 15-JAN-2025 14.98m
 Gully
 6X_0b17438e-793e-4b31-8b67-90dc28e43b84_20250120_13
 4913_730.jpg, 00:00:57, 14.98 m
 Hole in drain or sewer from 10 o'clock to 03 o'clock

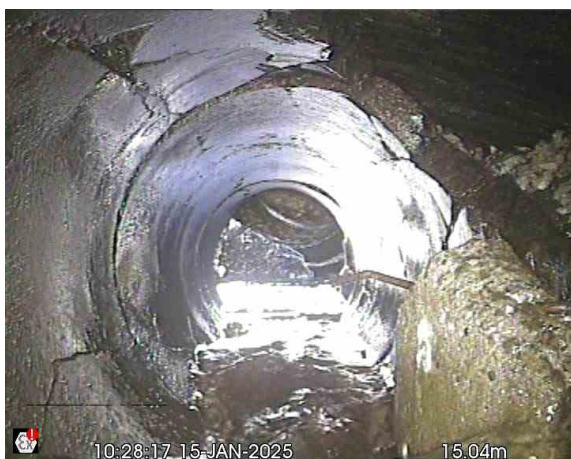
10:28:17 15-JAN-2025 15.04m
 Gully
 6X_c4e54004-587e-41ca-ab3c-9ca7126bb01a_20250120_13
 4949_800.jpg, 00:01:07, 15.04 m
 Other obstacles, other object in invert from 03 o'clock to 6 o'clock, 15% cross-sectional area loss, stone fallen from hole
